**Ministry of Works, Transport and Communications
Reli Assets Holding Company
United Republic of Tanzania**

**Preparatory Survey on
Flood Protection Measures for
Central Railway Line
in the United Republic of Tanzania**

**Final Report
Volume 2: Appendices**

July 2016

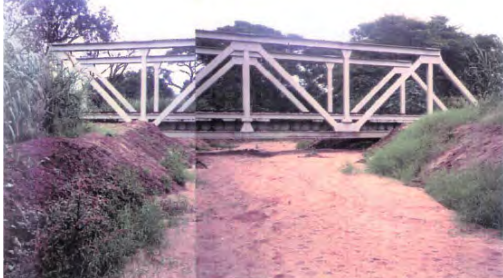
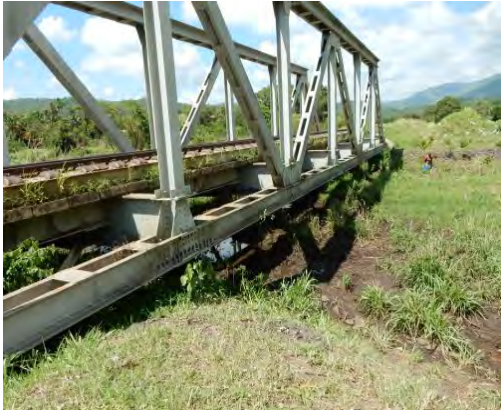
Location	Activities	Photos, Maps, etc.
<p>Km 288 Mkadage Bridge</p>	<p>➤ Problems:</p> <ul style="list-style-type: none"> • Due to siltation, the bridge blocked the river. <p>➤ Countermeasure:</p> <ul style="list-style-type: none"> • Demolition of the old center pier & abutments currently buried under the existing bridge deck • Excavation and re-alignment of the river channel over 625m length <p>(Comments by JICA Study Team) It is recommended to re-conduct the excavation and re-alignment of the river channel.</p>	<p>Year 1997 (Toward downstream)</p>

<p>Year 2014 (Toward Kidete)</p>

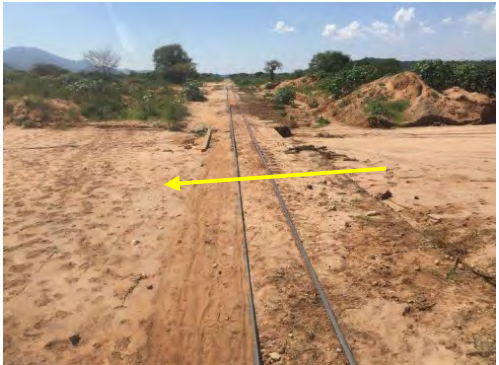
<p>Maswala section: Google map Year 2012</p>

<p>Km 349/4b, 4c Maswala Cross Drainage</p>	<p>➤ Problems:</p> <ul style="list-style-type: none"> • Inadequate Cross drainage (culverts) under the railway <p>➤ Countermeasure:</p> <ul style="list-style-type: none"> • Track raising by 1.25 m • Provision of 9 nr 2.0 x 2.0 precast Culverts • Minor stream training and protection works • Demolition the existing culverts • Excavation in river channels • Gabion works, etc. <p>(Comments by JICA Study Team) Currently, flood waters still go over the railway, when it rains at the mountain side. It is recommended to conduct sustainable countermeasures, such as a relocation of the railway toward the mountain side.</p>	<p>Year 1997 (Toward downstream)</p>

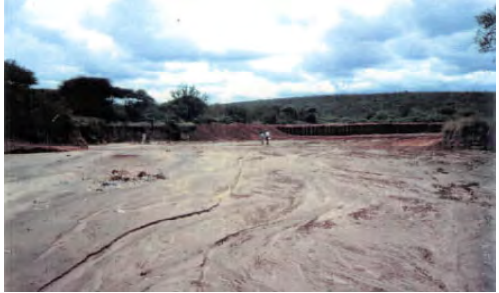
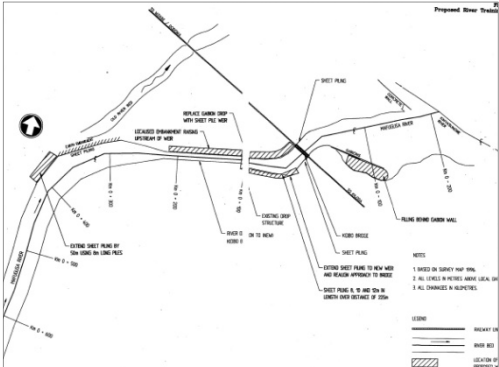
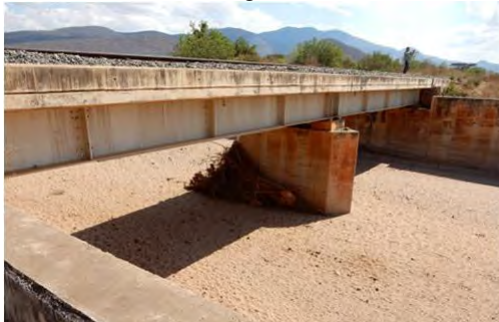
Location	Activities	Photos, Maps, etc.
<p>Km 355 Kidibo Mafugusa River Crossing</p>	<p>➤ Problems:</p> <ul style="list-style-type: none"> • Due to tree felling and land reclamation, runoff has been increased significantly. • The former crossings tended to silt up and major flooding of the railway line was experienced at a depth of over 0.5 m at the site. • In 1991, the new Kidibo Bridge was constructed approximately 350 m up-line of the old crossing at Km 355.4. <p>Design by Gauff Consulting Eng. Construction by Riepl</p> <ul style="list-style-type: none"> • In 1995, the report on Mafugusa River Rehabilitation of Bridge Km 355.446 by Technical University Munich, Hydraulic Laboratory (TUM/HRO) for Deutsche Eisenbahn-Consult proposed the stabilization of the river channel and bridge structure, including sheet piling. • However, the design of the bridge appears to have greatly underestimated the flood impact. <p>➤ Countermeasure:</p> <ul style="list-style-type: none"> • Sheet piling for drop structure and bed protection • Excavation in river channel and form embankments • Excavation from an approved borrowing area to form an embankment • Concrete for pile capping 	<p>Mafugusa River toward Kidibo Bridge Year 1997</p>

<p>Proposed River Training Works</p>

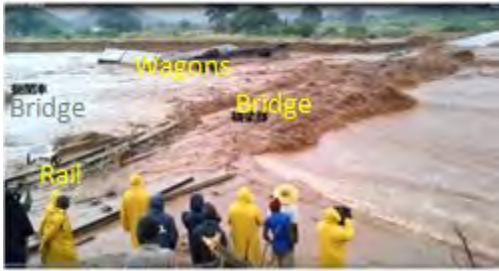
<p>Km 365 Mzase Crossing</p>	<p>➤ Problems:</p> <ul style="list-style-type: none"> • The Mzase catchment is relatively small but very steep and thus has high peak floods with substantial velocities. • Over the past several years, a large area has been cleared for agricultural use. This results in intensified erosion in the upper catchment and siltation in the lower floodplains. • The erosion of the upstream catchment has been increasing, despite the river training and erosion protection at the upstream of the railway. <p>➤ Countermeasure:</p> <ul style="list-style-type: none"> • Catchment management planning and implementation • Further river training 	<p>30 March 2014 Mzase Bridge</p>

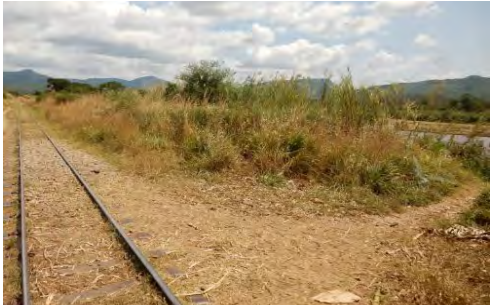
<p>(Km 297.3: Dec.2014) (Toward Kidete)</p>

Typical Construction Measures	1) Re-construction of embankment 2) Re-routing of the track 3) Temporary drainage structures 4) Protection measures, such as gabions, rip rap, etc.	6. <u>Km 293.1 (60 m)</u> : eroded & loss of protection *Re-construction & protection works 7. <u>Km 293.4 (500 m)</u> : high bank eroded by parallel river, 1st half erosion to 20 m beyond the track *Re-routing is recommended 8. <u>Km 297.3 (80 m)</u> : erosion parallel to the track

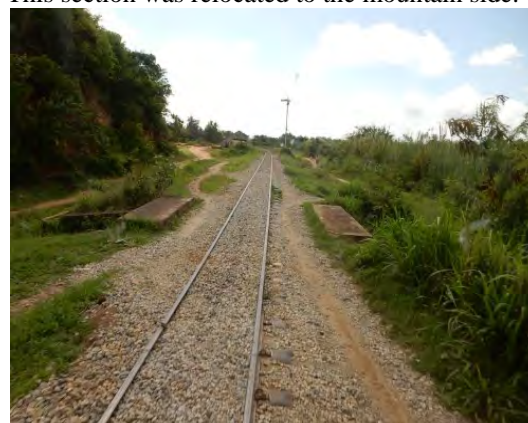
1) Km 283.6 (300 m):

Km 283.65 (5 Dec. 2014) (Toward Kidete)
This section was relocated to the mountain side.

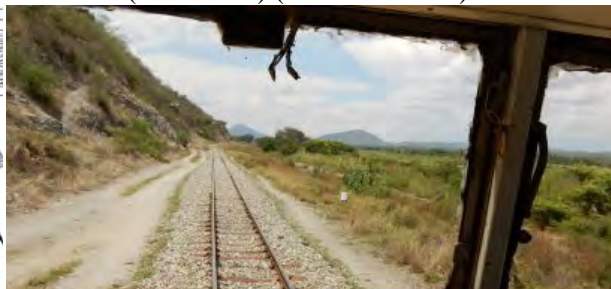
Km 314.4 (Dec. 2014) (Toward Kidete)

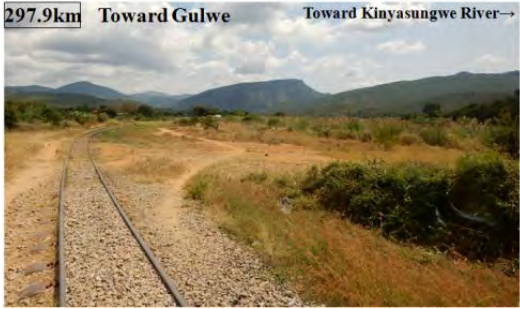
Location	Pattern of Damage	Temporary Remedial Works in the past	Distance between track and river * ¹	Difference of elevation between track and river * ²	Photos of the section	Possible Flood Protection Measures	Priority for Flood Protection
Km 297.1– Km 298.3	• Pattern 1-3	• Restoration of the washed-away track	10 m–70 m	2.0 m

<ul style="list-style-type: none"> • Track raising by embankment • Protection from the erosion of the riverbank, etc. 	Medium - High
Km 298.3– Km 299.3	• Pattern 1-3	• Restoration of the washed-away track	30 m–100 m	2.0 m

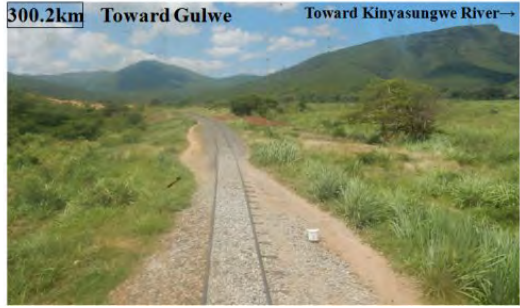
<ul style="list-style-type: none"> • Track raising by embankment • Protection from the erosion of the riverbank, etc. 	Medium
Km 299.3– Km 302.6	• Pattern 1-2, 1-3	<ul style="list-style-type: none"> • Restoration of the washed- away track • Repair of the ballast 	20 m–170 m	2.0 m

<ul style="list-style-type: none"> • Re-routing toward the mountain side • Track raising by embankment • Protection from the erosion of the riverbank, etc. 	Medium - High

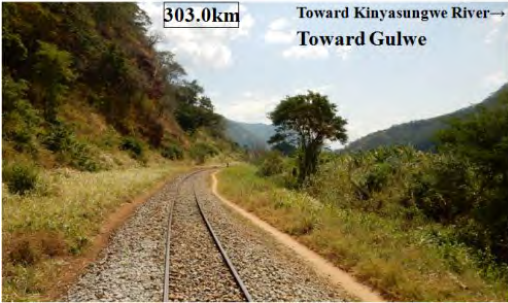
<p>302.7km Toward Gulwe Toward Kinyasungwe River→</p>	<ul style="list-style-type: none"> • Re-routing toward the mountain side • Track raising by embankment • Protection from the erosion of the riverbank, etc. • River training works 	High
Km 302.8– Km 303.4	• Pattern 1-3	• Restoration of the washed-away track	30 m–150 m	2.0 m – 2.5 m

<p>303.0km Toward Kinyasungwe River→ Toward Gulwe</p>	<ul style="list-style-type: none"> • Protection from the erosion of the riverbank, etc. 	Medium
Km 303.4– Km 303.7	• Pattern 2-1		150 m	2.5 m

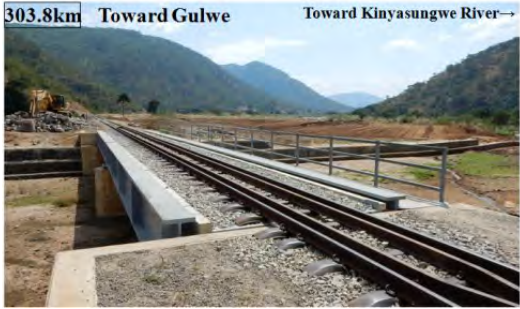
Location	Pattern of Damage	Temporary Remedial Works in the past	Distance between track and river * ¹	Difference of elevation between track and river * ²	Photos of the section	Possible Flood Protection Measures	Priority for Flood Protection
Km 303.8	<ul style="list-style-type: none"> • Pattern 1-1, 1-2 to the old bridge • Pattern 2-1, 2-2 to the new bridge 	<ul style="list-style-type: none"> • A new bridge was constructed at the mountain side (2014), as the old bridge close to the Kinyasungwe River was washed away in 2008. 	100 m	2.5 m

<ul style="list-style-type: none"> • Protection from the erosion of the tributary bank, etc. 	Medium
Km 303.9– Km 307.0	<ul style="list-style-type: none"> • Pattern 1-1, 1-2, 2-1, 2-2 		6 m–100 m	3.0 m

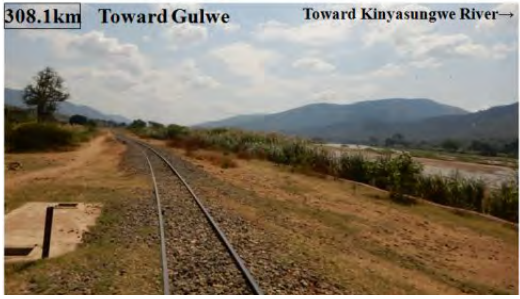
<ul style="list-style-type: none"> • Protection from the erosion of the riverbank, etc. 	Medium
Km 307.0– Km 309.0	<ul style="list-style-type: none"> • Pattern 1-3 		20 m–40 m	2.0 m – 3.0 m

<ul style="list-style-type: none"> • Protection from the erosion of the riverbank, etc. 	Medium

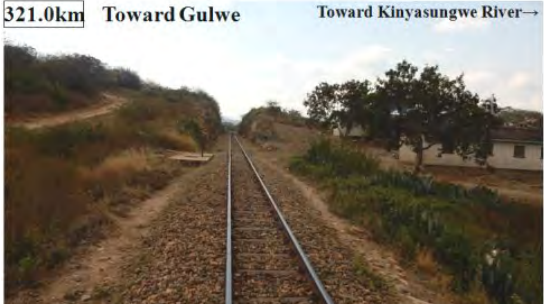
• Protection from the erosion of the tributary bank, etc.	Low
Km 320.9– Km 321.1	• Pattern 2-1		900 m	4.0 m	<p>321.0km Toward Gulwe Toward Kinyasungwe River→</p>

• Improvement of cross-drainage	Low

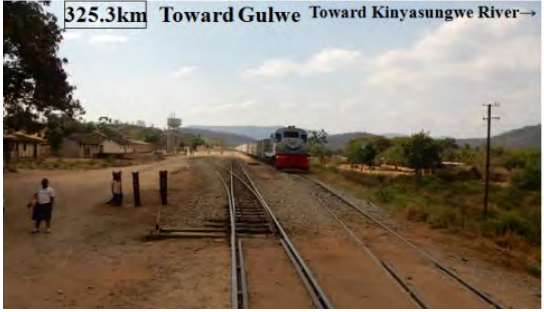
• Repair of the gabion works	Low
Km 325.2– Km 325.5 Kidete Station	• Pattern 2-1		480 m	7.0 m	<p>325.3km Toward Gulwe Toward Kinyasungwe River→</p>

Low

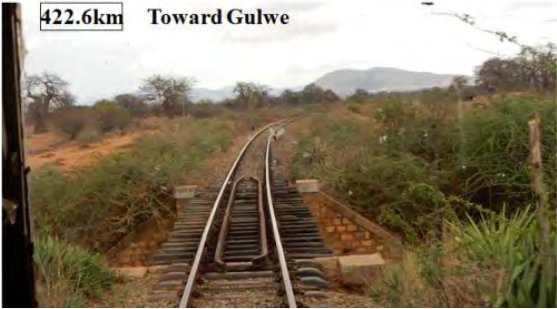
<p>422.6km Toward Gulwe</p>	<ul style="list-style-type: none"> • Improvement of cross-drainage 	Low
Km 426.0 Meyundi River (Tributary) Kikombo	<ul style="list-style-type: none"> • Pattern 2-1, 2-2 		A tributary of the Kinyasungwe River crosses under the track

Location	Pattern of Damage	Temporary Remedial Works in the past	Distance between track and river * ¹	Difference of elevation between track and river * ²	Photos of the section	Possible Flood Protection Measures	Priority for Flood Protection
Km 415.0– Km 426.0	<ul style="list-style-type: none"> • Pattern 2-2 	<ul style="list-style-type: none"> • Improvement of cross-drainage • Gabion works 	*There are some streams crossing under the track.

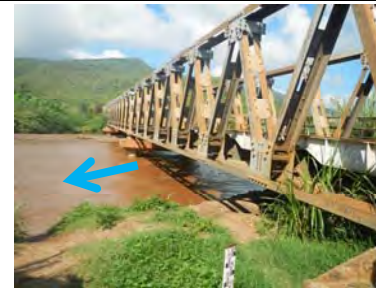
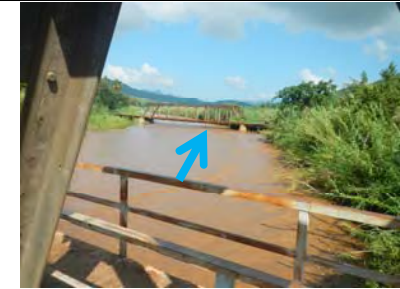
2-18	Damaged Record, if any (year/month)	A flood overflowed from left bank of Mkondoa bridge to Kilosa City in 2014.
2-19	Reason of	Overflow the Bank
2-20	Pattern of Riverbed

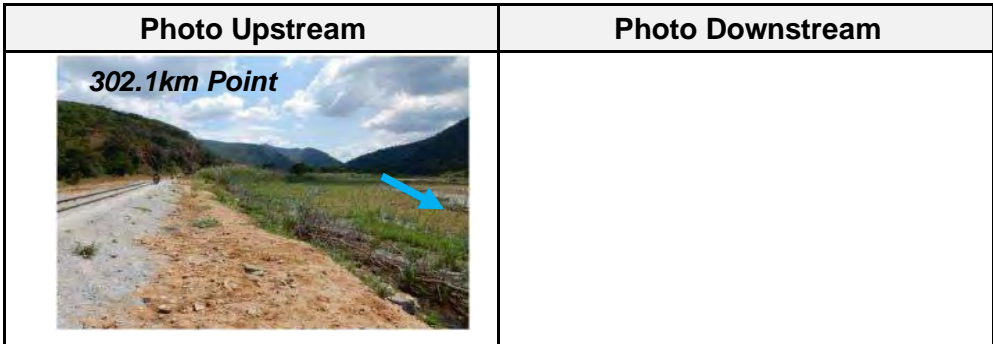
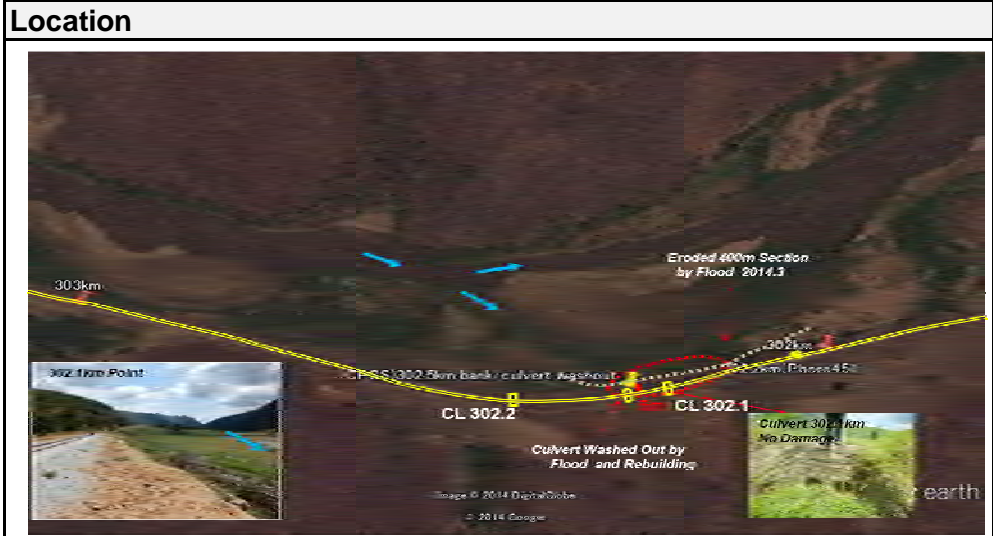
2. Characteristics of Physical Condition of River Channel			
2-1	Length of Objective Area		
2-2	Nos. of River Facility		3 culverts
2-3	River Channel Alignment		Meandering , Water Hit Area
2-4	River Cross Section		Compound section
2-5	River Width	Wf: m, Wr: m	Bl: m, Bc: 45 m, Br: m
2-6	Riverbed Slope		
2-7	Riverbed Material	Material	sand
2-8	River Bank	Bank Height	Hl: 3 m
2-9		Side Slope	Sl: 1v: , Sr: 1v:
2-10	Vegetation		
2-11	Estimated Flow Velocity		normal: m/s, flood m/s
2-12	Characteristic of environmental condition of river channel		Riverside forests, Sandbar, Pool, shoal, fishes, etc
2-13	Land Use		none
2-14	Soil Type		
2-15	Topography		left: ← , right →
2-16	Structures/Houses, road		none
2-17	Location of Railway		d = 5 m
2-18	Damaged Record, if any (year/month)	One Culvert and Gabion(400 m) had been washed out by a flood in 2014.	
2-19		Reason of	Bank Erosion
2-20	Pattern of Riverbed
