Inventory Sheet for River/Channel

Station: From KM305 to KM306 **Sheet No.: CH- KM 305**

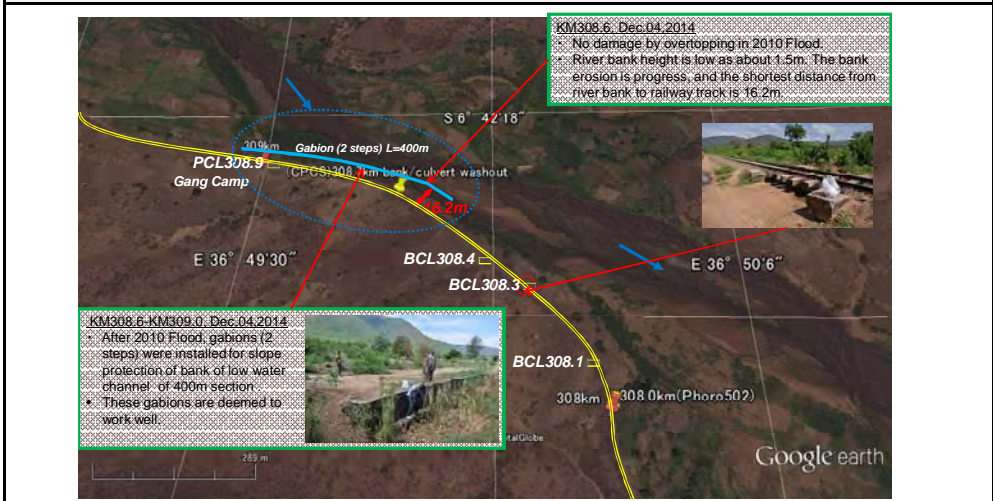
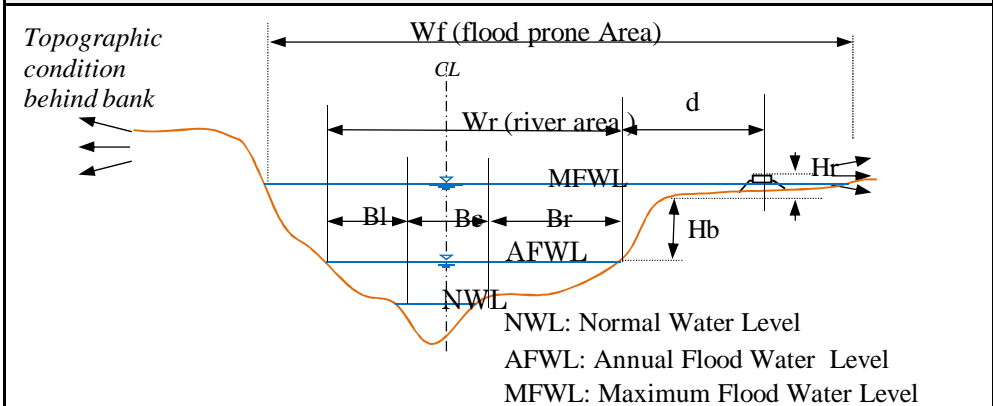
Station: From KM308-KM309 **Sheet No.: CH-308**

2-18	Damaged Record, if any (year/month)	After damaged by 2010 flood, 2 steps of gabions were constructed.	
2-19	Reason of	Bank erosion	
2-20	Pattern of Riverbed	Rising of riverbed in long distance

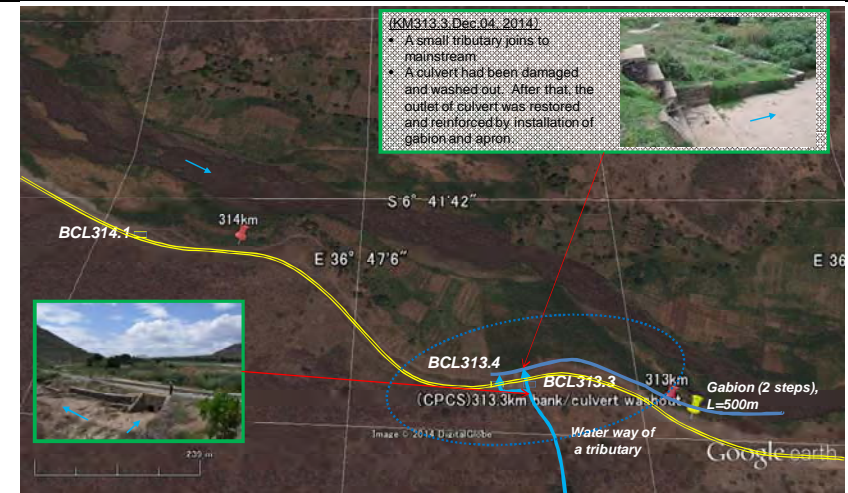
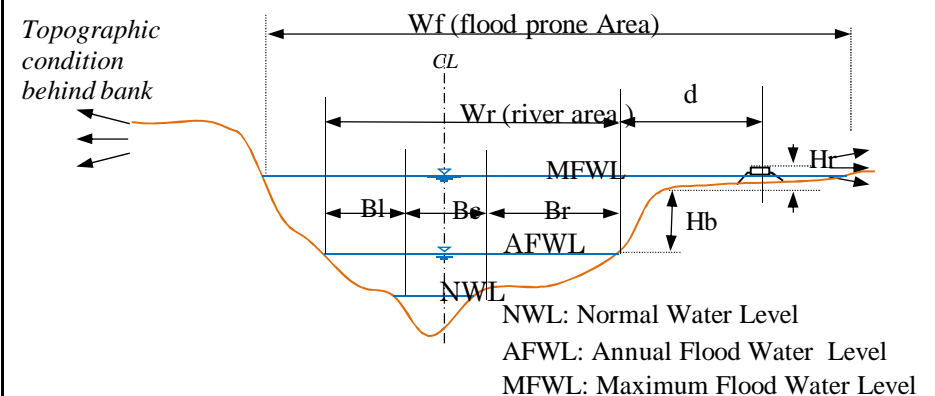
Station: From KM312.8 to 313.3 **Sheet No.: CH-312.8**

2-18	Damaged Record, if any (year/month)	Gabions (2 steps) are installed for bank protection of low water channel in the 500m section and at outlet of culvert.
2-19	Reason of	
2-20	Pattern of Riverbed

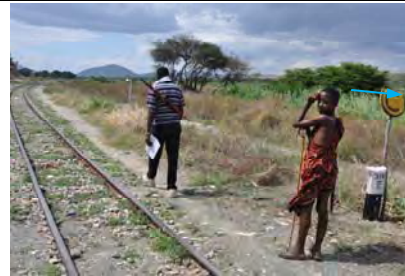
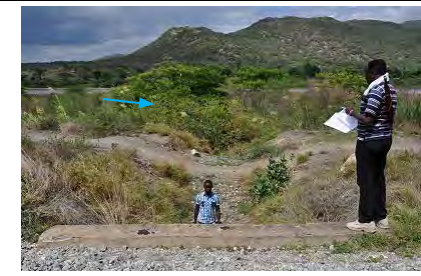
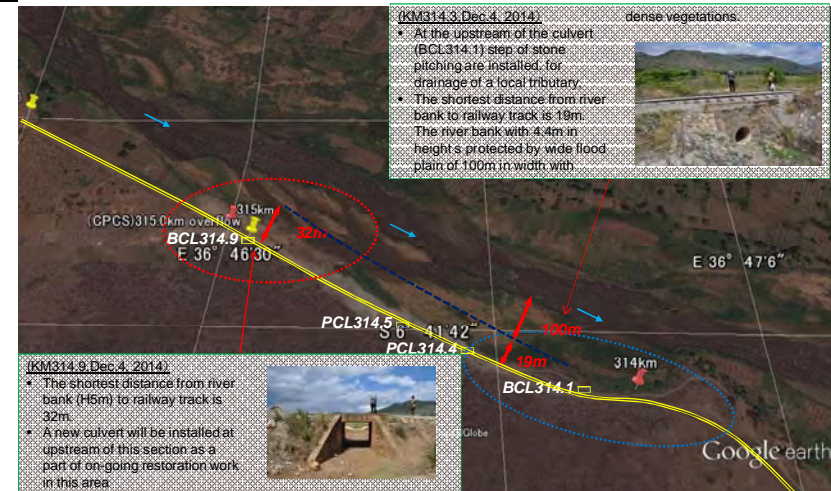
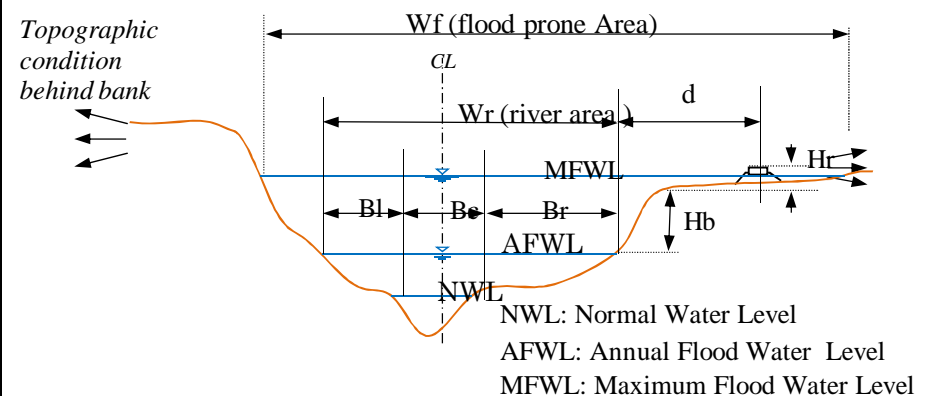
Station: From KM314.3		Sheet No.: CH-314.3	
1. General			
1-1	Name of Inspector	T.Fukuda, Mr. Kido, Mr. Philipo	
1-2	Organization of Inspector	Team B	
1-3	Date/Time of Inspection	Dec. 4, 2014 1410	
1-4	Location	Lat	06° 41' 44.0"
1-5		Long	36° 46' 47.1"

2. Characteristics of Physical Condition of River Channel			
2-1	Length of Objective Area		
2-2	Nos. of River		
2-3	River Channel Alignment	Straight, water hit area	
2-4	River Cross Section	Compound section	
2-5	River Width	Wf: approx.500m, Wr: m	
2-6	Riverbed Slope	Bl: m, Bc: m, Br: 100m	
2-7	Riverbed Material	Material	Sand
2-8	River Bank	Bank Height	Hr: 1.4m, Hb=3.0m
2-9		Side Slope	Sl: 1v: 2.0, Sr: 1v:
2-10		Vegetation	grass
2-11	Estimated Flow Velocity	normal: m/s, flood	m/s
2-12	Characteristic of environmental condition of river channel	Riverside forests, Sandbar, Pool, shoal, fishes, etc	
2-13	Land Use	none	
2-14	Soil Type	black	
2-15	Topography	left: ←, right: →	
2-16	Structures/Houses, road	none	
2-17	Location of Railway	d=19m@Km314.3	
2-18	Damaged Record, if any (year/month)	none	
2-19		Reason of	
2-20		Pattern of Riverbed	Local sediment deposition

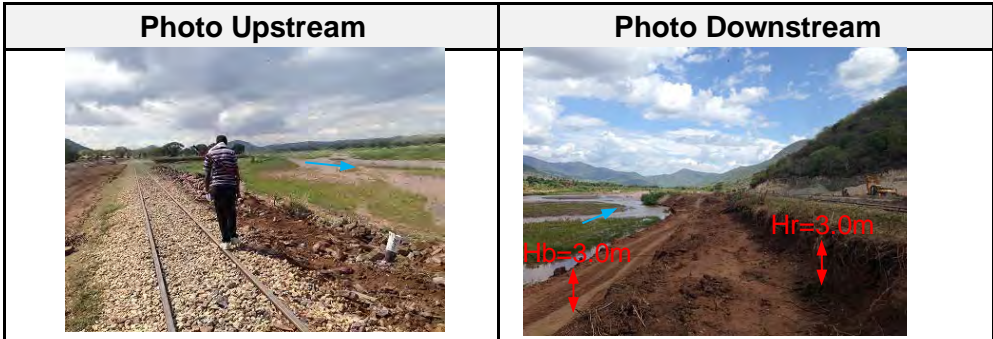
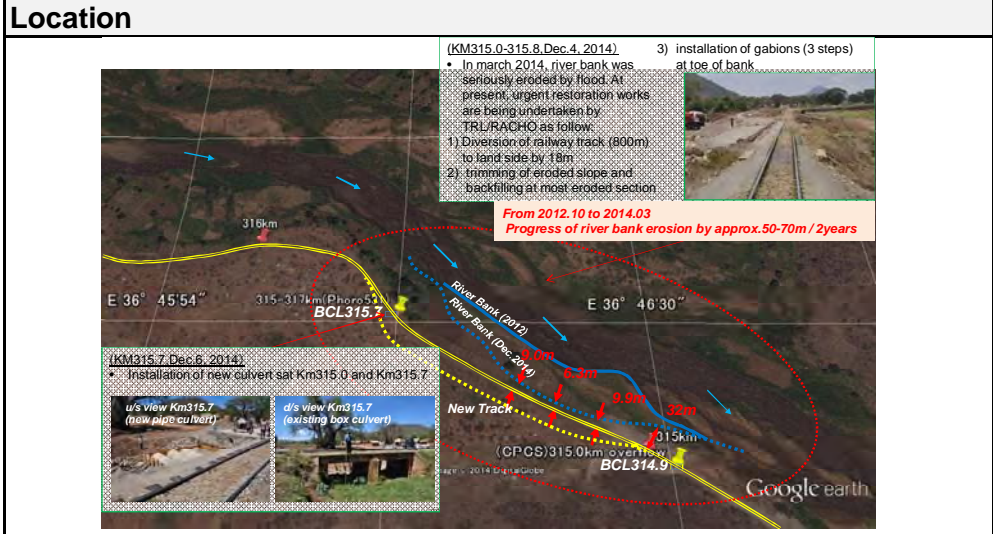
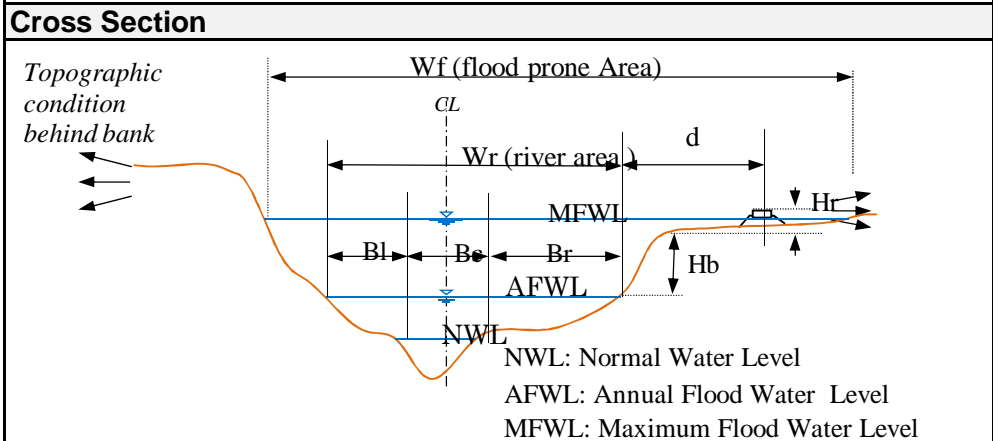
Station: From KM315 to KM316		Sheet No.: CH-315
1. General		
1-1	Name of Inspector	T.Fukuda, Mr. Kido, Mr. Philipo
1-2	Organization of Inspector	Team B
1-3	Date/Time of Inspection	Dec. 4, 2014
1-4	Location	Lat
1-5		Long

2. Characteristics of Physical Condition of River Channel		
2-1	Length of Objective Area	800m, Km315.0-315.8
2-2	Nos. of River	Culvert (1)
2-3	River Channel Alignment	meandering
2-4	River Cross Section	Compound section
2-5	River Width	Wf: m, Wr: m Bl: m, Bc: m, Br: m
2-6	Riverbed Slope	Gentle
2-7	Riverbed Material	Material: Sand
2-8	River Bank	Bank Height: Hr: 3 m, Hb: 3 m
2-9		Side Slope: Sl: 1v: 2 , Sr: 1v:
2-10		Vegetation: grass
2-11	Estimated Flow Velocity	normal: 0.6 m/s, flood m/s
2-12	Characteristic of environmental condition of river channel	Riverside forests, Sandbar, Pool, shoal, fishes, etc
2-13	Land Use	none
2-14	Soil Type	laterite
2-15	Topography	left: ← , right →
2-16	Structures/Houses, road	none
2-17	Location of Railway	d=32m@KM315.0, 6.3m@Km315.2
2-18	Damaged Record, if any (year/month)	Previously damaged. In march 2014, river bank was seriously eroded by flood. At present, urgent restoration works with diversion are being undertaken by TRL/RACHO.

2-19		Reason of
2-20	Pattern of Riverbed	Rising of riverbed in long distance

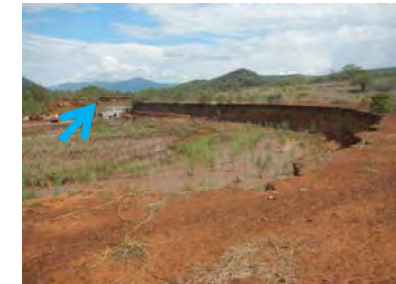
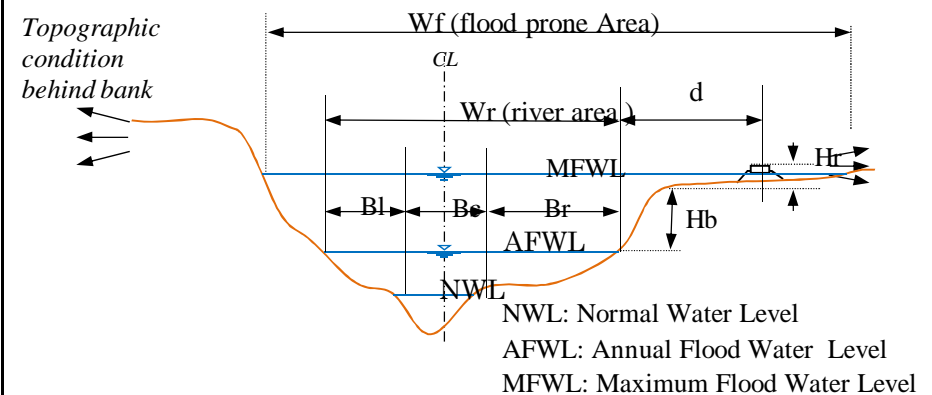
Station: From KM327 to KM328 **Sheet No.: CH- KM 327**

2-18	Damaged Record, if any (year/month)	Notable riverbank corrosion has been occurred at 327.95 km point of the water colliding front. About 50m corrosion has been advancing during two years and a half between present
2-19	Reason of	Bank Erosion
2-20	Pattern of Riverbed

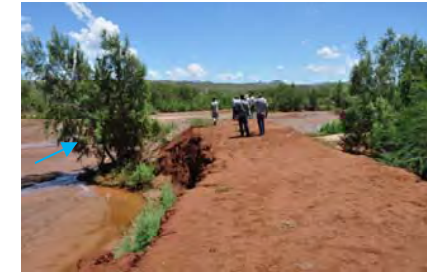
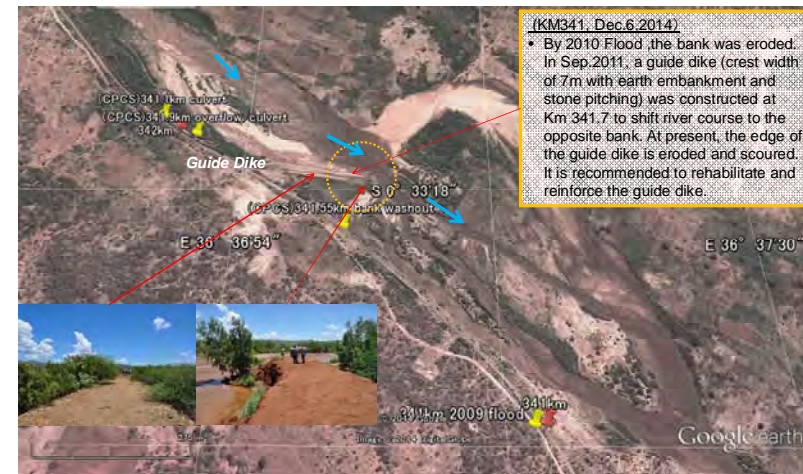
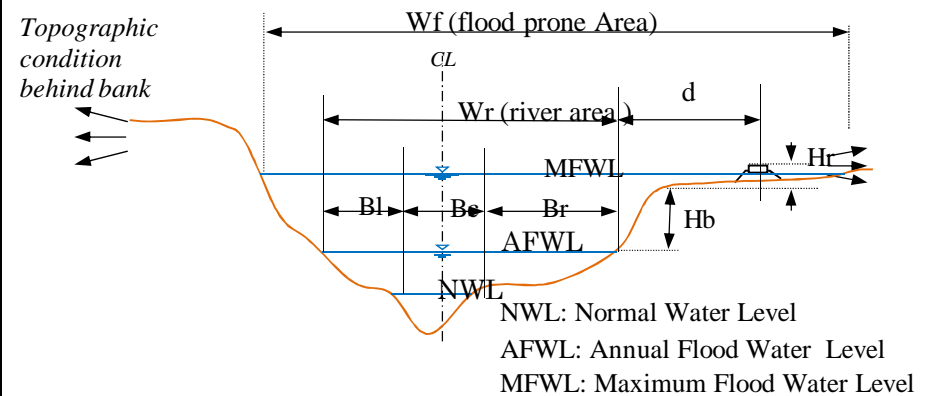
Station: From KM344.8 **Sheet No.: CH-344.8**

2-18	Damaged Record, if any (year/month)	none	
2-19	Reason of	Bank erosion	
2-20	Pattern of Riverbed	Rising of riverbed in long distance

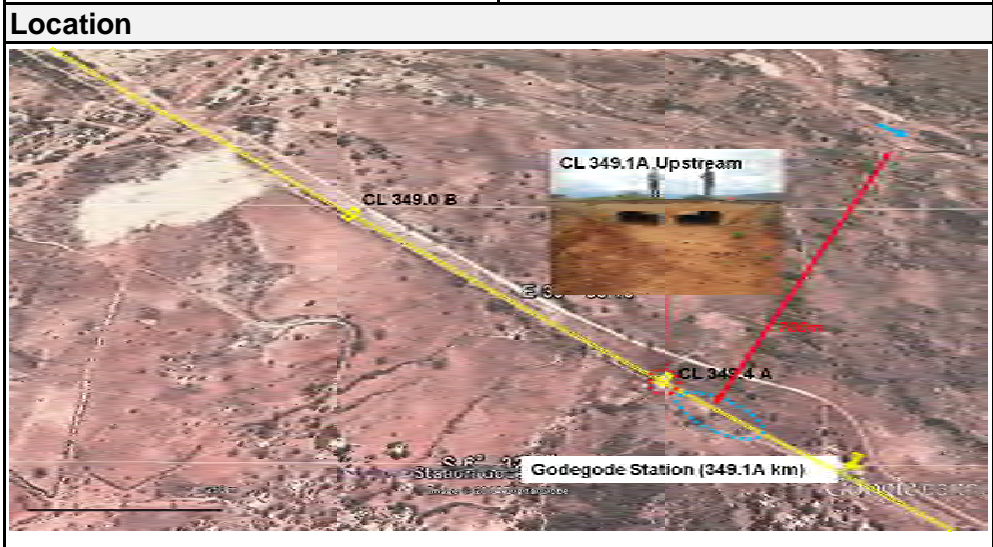
Photo Upstream	Photo Downstream

2-18	Damaged Record, if any (year/month)	Culverts of the railroad have been deposited by the sediment in the tributary MASUWALA RIVER, and river flow prevention has been occurred . The railroad bank has been scored by the	
2-19	Reason of	Flood flow overtopped railway track	
2-20	Pattern of Riverbed

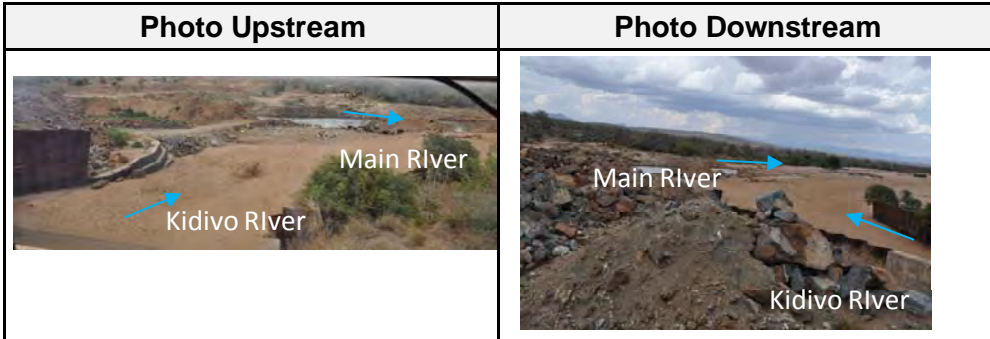
2. Characteristics of Physical Condition of River Channel		
2-1	Length of Objective Area	300m, Km355.2-Km355.5
2-2	Nos. of River	
2-3	River Channel Alignment	Straight
2-4	River Cross Section	
2-5	River Width	Wf: m, Wr: m Bl: m, Bc: m, Br: m
2-6	Riverbed Slope	Gentle
2-7	Riverbed Material	Material: Sand
2-8	River Bank	Bank Height: Hl: m
2-9		Side Slope: Sl: 1v: , Sr: 1v:
2-10	Vegetation	Tall grass
2-11	Estimated Flow Velocity	normal: m/s, flood: m/s
2-12	Characteristic of environmental condition of river channel	Riverside forests, Sandbar, Pool, shoal, fishes, etc
2-13	Land Use	none
2-14	Soil Type	Laterite
2-15	Topography	left: ← , right: →
2-16	Structures/Houses, road	none
2-17	Location of Railway	d=28.6m@ Km355.2
2-18	Damaged Record, if any (year/month)	Steel sheet pile and gabion (3 steps) are installed for protection of left and right banks of outlet channel at confluence of Kidivo River.
2-19		Reason of

2-20	Pattern of Riverbed	siltation at confluence
