## **APPENDIX F**

### **INVENTORY SHEET OF CULVERT**

## Inventory Sheet for Culvert

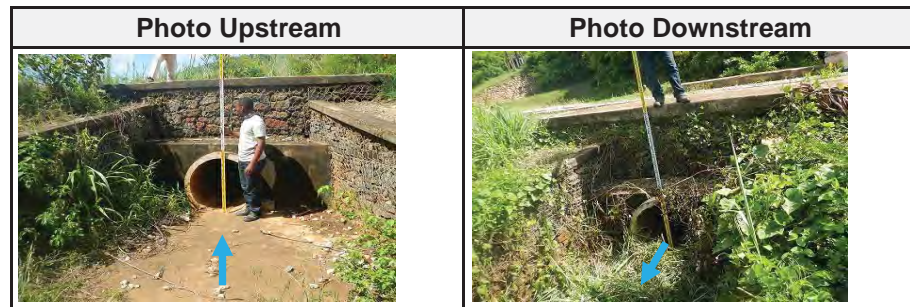
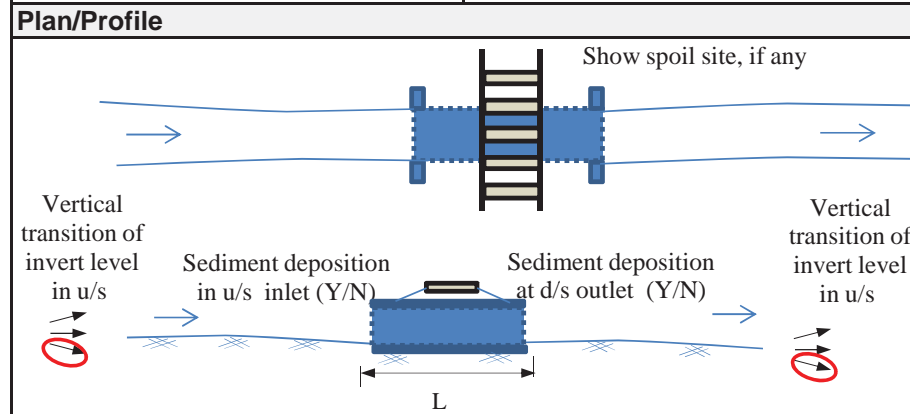
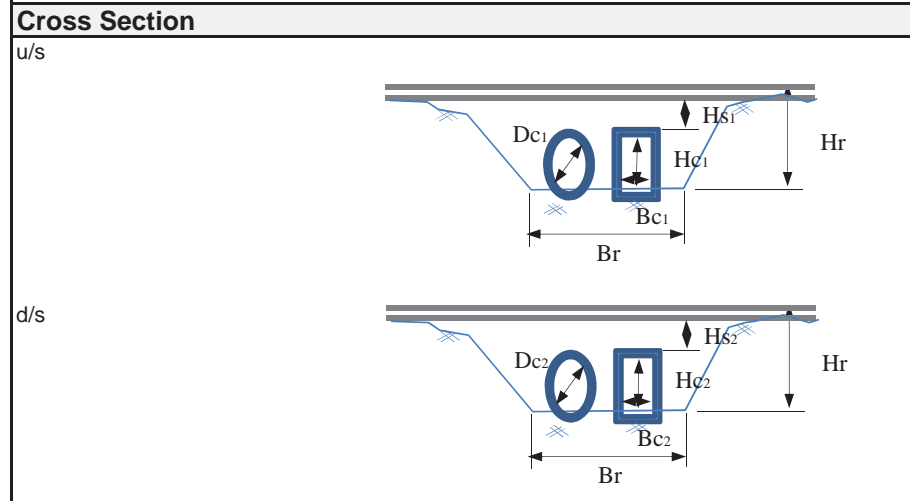
**Station: at KM 283.6**      **Sheet No.: PCL 283.6**

2. Characteristics of Physical Condition of Culvert		
2-1	Length of Culvert	5.0 m
2-2	Shape of Cross Section	Square: Rectangular: Circle: (1)
2-3	Height	Hc1 = 0.9 m , Hc2 = 0.9 m
2-4	Flow Area	Width Dc1 = 0.9 m , Dc2 = 0.9 m
2-5	Other	Hs1 = 1.2 m , Hs2 = 1.2 m
2-6	Connecting Channel	Height
2-7		Width
2-8		Side Slope
2-9	Type of Culvert	Concrete
2-10	Riverbed	Material Silty sand
2-11	Sediment	u/s No ( 0% rate)
2-12	deposition	d/s No ( 0% rate)
2-13	Topography	u/s: , d/s:
2-14	Land Use	
2-15	Structures/Houses, road

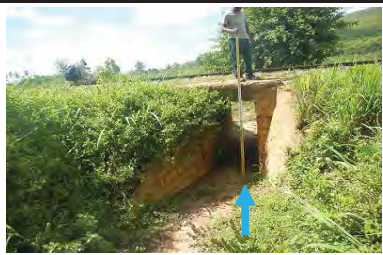
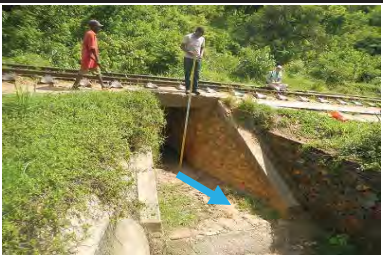
<b>Photo Upstream</b>	<b>Photo Downstream</b>

<b>Station: at KM 283.9</b>		<b>Sheet No.: BCL 283.9</b>	
<b>1. General</b>			
1-1	Name of Inspector	T. Kawaguchi , Hussein , Abiud	
1-2	Organization of Inspector	JICA Study Team	
1-3	Date/Time of Inspection	2014/5/12	
1-4	Location	Lat	06° 49' 38" 36"
1-5		Long	036° 58' 31" 13"
1-6	Elevation		
<b>2. Characteristics of Physical Condition of Culvert</b>			
2-1	Length of Culvert	6.0 m	
2-2	Shape of Cross Section	Square: Rectangular: (1) Circle:	
2-3	Flow Area	Height	Hc1 = 1.7 m , Hc2 = 1.7 m
2-4		Width	Bc1 = 1.0 m , Bc2 = 1.0 m
2-5		Other	Hs1 = 1.2 m , Hs2 = 1.2 m
2-6	Connecting Channel	Height	
2-7		Width	
2-8		Side Slope	
2-9	Type of Culvert	Concrete	
2-10	Riverbed	Material	Silty sand
2-11	Sediment deposition	u/s	No ( 0% rate)
2-12		d/s	No ( 0% rate)
2-13	Topography	u/s:	d/s:
2-14	Land Use		
2-15	Structures/Houses, road		
<b>3. Damaged Flood Records</b>			
3-1	(Year/Month)	(Type)	(Reason, etc.)

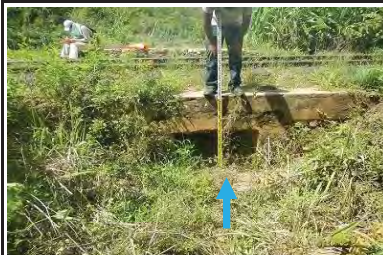
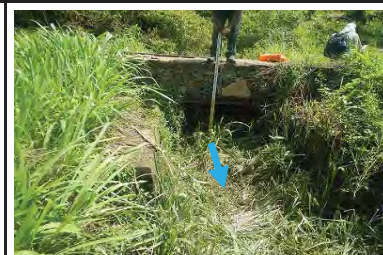
<b>Photo Upstream</b>	<b>Photo Downstream</b>

<b>Station: at KM 284.47</b>		<b>Sheet No.: BCL 284.47</b>	
<b>1. General</b>			
1-1	Name of Inspector	T. Kawaguchi , Hussein , Abiud	
1-2	Organization of Inspector	JICA Study Team	
1-3	Date/Time of Inspection	2014/5/12	
1-4	Location	Lat	06° 49' 28" 56'''
1-5		Long	036° 58' 18" 31'''
1-6	Elevation		
<b>2. Characteristics of Physical Condition of Culvert</b>			
2-1	Length of Culvert	5.0 m	
2-2	Shape of Cross Section	Square: <u>Rectangular:(1)</u> Circle:	
2-3	Flow Area	Height	Hc1 = 0.65 m , Hc2 = 0.9 m
2-4		Width	Bc1 = 1.0 m , Bc2 = 1.9 m
2-5	Other	Hs1 = 0.4 m , Hs2 = 0.8 m	
2-6	Connecting Channel	Height	
2-7		Width	
2-8		Side Slope	
2-9	Type of Culvert	Concrete	
2-10	Riverbed	Material	Silty sand
2-11	Sediment deposition	u/s	Light ( 30% rate)
2-12		d/s	Light ( 20% rate)
2-13	Topography	u/s:  , d/s:	
2-14	Land Use		
2-15	Structures/Houses, road		
<b>3. Damaged Flood Records</b>			
3-1	(Year/Month)	(Type)	(Reason,etc.)

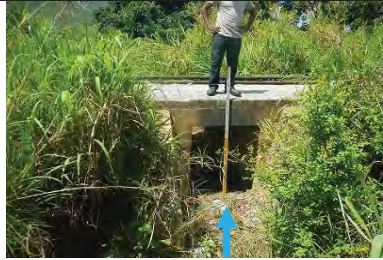
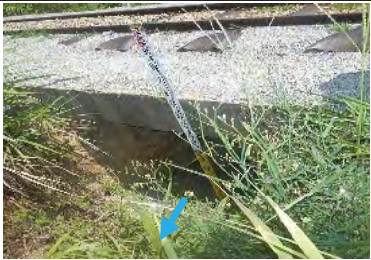
<b>Photo Upstream</b>	<b>Photo Downstream</b>

<b>Station: at KM 285.65</b>		<b>Sheet No.: BCL 285.65</b>	
<b>1. General</b>			
1-1	Name of Inspector	T. Kawaguchi , Hussein , Abiud	
1-2	Organization of Inspector	JICA Study Team	
1-3	Date/Time of Inspection	2014/5/12	
1-4	Location	Lat	06° 48' 54" 41'''
1-5		Long	036° 58' 02" 51'''
1-6	Elevation		
<b>2. Characteristics of Physical Condition of Culvert</b>			
2-1	Length of Culvert	5.0 m	
2-2	Shape of Cross Section	Square: <u>Rectangular:(1)</u> Circle:	
2-3	Flow Area	Height	Hc1 = 1.2 m , Hc2 = 1.2 m
2-4		Width	Bc1 = 1.0 m , Bc2 = 1.0 m
2-5		Other	Hs1 = 0.4 m , Hs2 = 0.4 m
2-6	Connecting Channel	Height	
2-7		Width	
2-8		Side Slope	
2-9	Type of Culvert	Concrete	
2-10	Riverbed	Material	Silty sand
2-11	Sediment deposition	u/s	No ( 0% rate)
2-12		d/s	No ( 0% rate)
2-13	Topography	u/s:  , d/s:	
2-14	Land Use		
2-15	Structures/Houses, road		
<b>3. Damaged Flood Records</b>			
3-1	(Year/Month)	(Type)	(Reason,etc.)

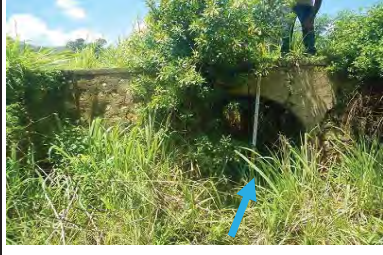
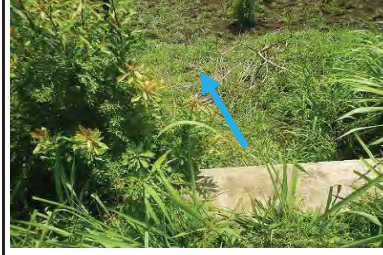
<b>Photo Upstream</b>	<b>Photo Downstream</b>

<b>Station: at KM 286.15</b>		<b>Sheet No.: PCL 286.15</b>	
<b>1. General</b>			
1-1	Name of Inspector	T. Kawaguchi , Hussein , Abiud	
1-2	Organization of Inspector	JICA Study Team	
1-3	Date/Time of Inspection	2014/5/12	
1-4	Location	Lat	06° 48' 38" 58"
1-5		Long	036° 58' 02" 40"
1-6	Elevation		
<b>2. Characteristics of Physical Condition of Culvert</b>			
2-1	Length of Culvert	5.0 m	
2-2	Shape of Cross Section	Square: Rectangular: Circle:(1)-with steel lining	
2-3	Flow Area	Height	Hc1 = 2.0 m , Hc2 = 2.0 m
2-4		Width	Dc1 = 2.0 m , Dc2 = 2.0 m
2-5		Other	Hs1 = 0.4 m , Hs2 = 0.4 m
2-6	Connecting Channel	Height	
2-7		Width	
2-8		Side Slope	
2-9	Type of Culvert	Concrete	
2-10	Riverbed	Material	Silty sand
2-11	Sediment deposition	u/s	No ( 0% rate)
2-12		d/s	No ( 0% rate)
2-13	Topography	u/s:	,d/s
2-14	Land Use		
2-15	Structures/Houses, road		
<b>3. Damaged Flood Records</b>			
3-1	(Year/Month)	(Type)	(Reason,etc.)

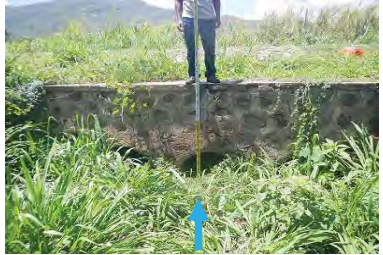
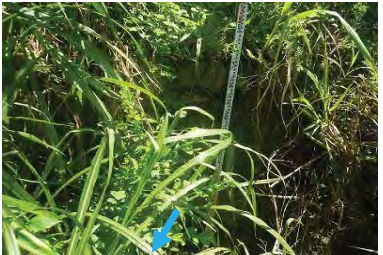
<b>Photo Upstream</b>	<b>Photo Downstream</b>

<b>Station: at KM 286.4</b>		<b>Sheet No.: PCL 286.4</b>	
<b>1. General</b>			
1-1	Name of Inspector	T. Kawaguchi , Hussein , Abiud	
1-2	Organization of Inspector	JICA Study Team	
1-3	Date/Time of Inspection	2014/5/12	
1-4	Location	Lat	06° 48' 30" 04'''
1-5		Long	036° 58' 02" 83'''
1-6	Elevation		
<b>2. Characteristics of Physical Condition of Culvert</b>			
2-1	Length of Culvert	5.0 m	
2-2	Shape of Cross Section	Square: Rectangular: Circle:(3)	
2-3	Flow Area	Height	Hc1 = 0.45 m , Hc2 = 0.63 m
2-4		Width	Dc1 = 0.9 m , Dc2 = 0.9 m
2-5		Other	Hs1 = 1.0 m , Hs2 = 1.0 m
2-6	Connecting Channel	Height	
2-7		Width	
2-8		Side Slope	
2-9	Type of Culvert	Concrete	
2-10	Riverbed	Material	Silty sand
2-11	Sediment deposition	u/s	Middle ( 40% rate)
2-12		d/s	Middle ( 30% rate)
2-13	Topography	u/s:	,d/s:
2-14	Land Use		
2-15	Structures/Houses, road		
<b>3. Damaged Flood Records</b>			
3-1	(Year/Month)	(Type)	(Reason,etc.)

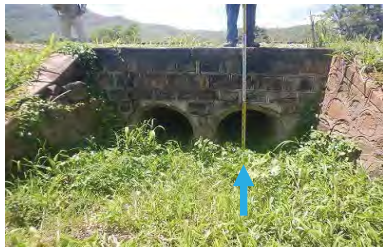
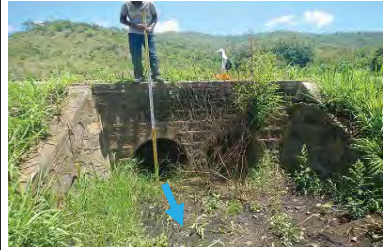
<b>Photo Upstream</b>	<b>Photo Downstream</b>

<b>Station: at KM 286.88</b>		<b>Sheet No.: PCL 286.88</b>	
<b>1. General</b>			
1-1	Name of Inspector	T. Kawaguchi , Hussein , Abiud	
1-2	Organization of Inspector	JICA Study Team	
1-3	Date/Time of Inspection	2014/5/12	
1-4	Location	Lat	06° 48' 16" 25'''
1-5		Long	036° 57' 55" 65'''
1-6	Elevation		
<b>2. Characteristics of Physical Condition of Culvert</b>			
2-1	Length of Culvert	5.0 m	
2-2	Shape of Cross Section	Square: Rectangular: Circle:(2)	
2-3	Flow Area	Height	Hc1 = 0.9 m , Hc2 = 0.9 m
2-4		Width	Dc1 = 0.9 m , Dc2 = 0.9 m
2-5		Other	Hs1 = 1.0 m , Hs2 = 1.0 m
2-6	Connecting Channel	Height	
2-7		Width	
2-8		Side Slope	
2-9	Type of Culvert	Concrete	
2-10	Riverbed	Material	Silty sand
2-11	Sediment deposition	u/s	No ( 0% rate)
2-12		d/s	No ( 0% rate)
2-13	Topography	u/s: , d/s:	
2-14	Land Use		
2-15	Structures/Houses, road		
<b>3. Damaged Flood Records</b>			
3-1	(Year/Month)	(Type)	(Reason, etc.)

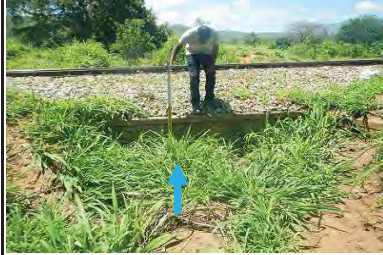
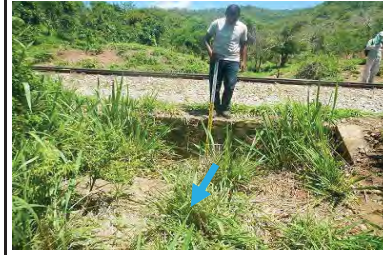
<b>Photo Upstream</b>	<b>Photo Downstream</b>

<b>Station: at KM 287.15</b>		<b>Sheet No.: PCL 287.15</b>	
<b>1. General</b>			
1-1	Name of Inspector	T. Kawaguchi , Hussein , Abiud	
1-2	Organization of Inspector	JICA Study Team	
1-3	Date/Time of Inspection	2014/5/12	
1-4	Location	Lat	06° 48' 06" 44"
1-5		Long	036° 57' 52" 13"
1-6	Elevation		
<b>2. Characteristics of Physical Condition of Culvert</b>			
2-1	Length of Culvert	6.0 m	
2-2	Shape of Cross Section	Square: Rectangular: Circle:(2)	
2-3	Flow Area	Height	Hc1 = 0.18 m , Hc2 = 0.0 m
2-4		Width	Dc1 = 0.9 m , Dc2 = 0.9 m
2-5		Other	Hs1 = 0.5 m , Hs2 = 0.5 m
2-6	Connecting Channel	Height	
2-7		Width	
2-8		Side Slope	
2-9	Type of Culvert	Concrete	
2-10	Riverbed	Material	Silty sand
2-11	Sediment deposition	u/s	Heavy ( 80% rate)
2-12		d/s	(Heavy (100% rate)
2-13	Topography	u/s: , d/s:	
2-14	Land Use		
2-15	Structures/Houses, road		
<b>3. Damaged Flood Records</b>			
3-1	(Year/Month)	(Type)	(Reason,etc.)

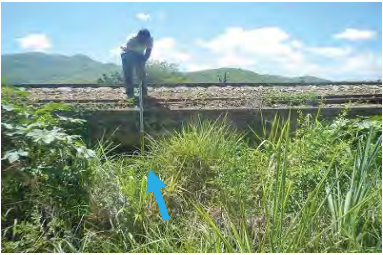
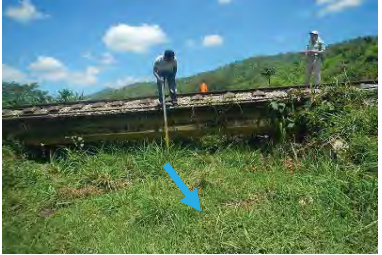
<b>Station: at KM 287.25</b>		<b>Sheet No.: BCL 287.25</b>	
<b>1. General</b>			
1-1	Name of Inspector	T. Kawaguchi , Hussein , Abiud	
1-2	Organization of Inspector	JICA Study Team	
1-3	Date/Time of Inspection	2014/5/12	
1-4	Location	Lat	06° 48' 04" 11"
1-5		Long	036° 57' 50" 84"
1-6	Elevation		
<b>2. Characteristics of Physical Condition of Culvert</b>			
2-1	Length of Culvert	5.0 m	
2-2	Shape of Cross Section	Square: <u>Rectangular:(1)</u> Circle:	
2-3	Flow Area	Height	Hc1 = 1.0 m , Hc2 = 0.9 m
2-4		Width	Bc1 = 7.0 m , Bc2 = 7.0 m
2-5	Other	Hs1 = 0.5 m , Hs2 = 0.5 m	
2-6	Connecting Channel	Height	
2-7		Width	
2-8		Side Slope	
2-9	Type of Culvert	Concrete	
2-10	Riverbed	Material	Silty sand
2-11	Sediment deposition	u/s	Middle ( 40% rate)
2-12		d/s	Heavy ( 60% rate)
2-13	Topography	u/s: , d/s:	
2-14	Land Use		
2-15	Structures/Houses, road		
<b>3. Damaged Flood Records</b>			
3-1	(Year/Month)	(Type)	(Reason,etc.)

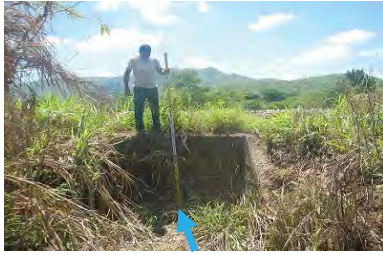
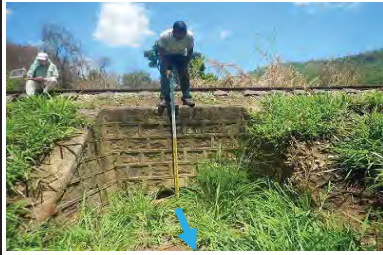
F-15

<b>Station: at KM 287.3</b>		<b>Sheet No.: PCL 287.3</b>	
<b>1. General</b>			
1-1	Name of Inspector	T. Kawaguchi , Hussein , Abiud	
1-2	Organization of Inspector	JICA Study Team	
1-3	Date/Time of Inspection	2014/5/12	
1-4	Location	Lat	06° 48' 01" 45'''
1-5		Long	036° 57' 48" 35'''
1-6	Elevation		
<b>2. Characteristics of Physical Condition of Culvert</b>			
2-1	Length of Culvert	5.0 m	
2-2	Shape of Cross Section	Square: Rectangular: Circle: (1)	
2-3	Flow Area	Height	Hc1 = 0.18 m , Hc2 = 0.09 m
2-4		Width	Dc1 = 0.9 m , Dc2 = 0.9 m
2-5		Other	Hs1 = 0.4 m , Hs2 = 0.4 m
2-6	Connecting Channel	Height	
2-7		Width	
2-8		Side Slope	
2-9	Type of Culvert	Concrete	
2-10	Riverbed	Material	Silty sand
2-11	Sediment deposition	u/s	Heavy ( 80% rate)
2-12		d/s	Heavy ( 90% rate)
2-13	Topography	u/s:  , d/s:	
2-14	Land Use		
2-15	Structures/Houses, road		
<b>3. Damaged Flood Records</b>			
3-1	(Year/Month)	(Type)	(Reason, etc.)

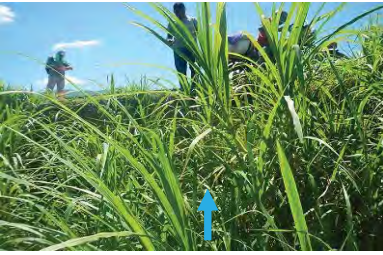
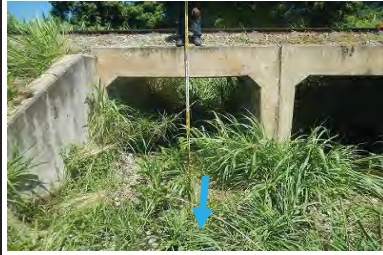
F-16

<b>Station: at KM 287.7</b>		<b>Sheet No.: BCL 287.7</b>	
<b>1. General</b>			
1-1	Name of Inspector	T. Kawaguchi , Hussein , Abiud	
1-2	Organization of Inspector	JICA Study Team	
1-3	Date/Time of Inspection	2014/5/12	
1-4	Location	Lat	06° 47' 51" 65'''
1-5		Long	036° 57' 42" 79'''
1-6	Elevation		
<b>2. Characteristics of Physical Condition of Culvert</b>			
2-1	Length of Culvert	6.0 m	
2-2	Shape of Cross Section	Square:(2) Rectangular: Circle:	
2-3	Flow Area	Height	Hc1 = 1.8 m , Hc2 = 1.8 m
2-4		Width	Bc1 = 2.0 m , Bc2 = 2.0 m
2-5		Other	Hs1 = 0.5 m , Hs2 = 0.5 m
2-6	Connecting Channel	Height	
2-7		Width	
2-8		Side Slope	
2-9	Type of Culvert	Concrete	
2-10	Riverbed	Material	Silty sand
2-11	Sediment deposition	u/s	Light ( 10% rate)
2-12		d/s	Light ( 10% rate)
2-13	Topography	u/s: , d/s:	
2-14	Land Use		
2-15	Structures/Houses, road		
<b>3. Damaged Flood Records</b>			
3-1	(Year/Month)	(Type)	(Reason,etc.)

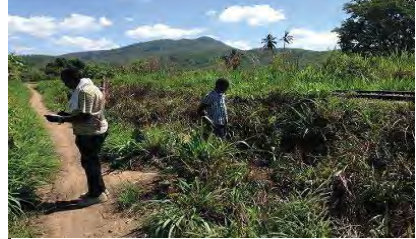
**Station: at KM 289/3**      **Sheet No.: PCL289.3**

3-1	(Year/Month)	(Type)	(Reason,etc.)
	n/a	n/a	n/a

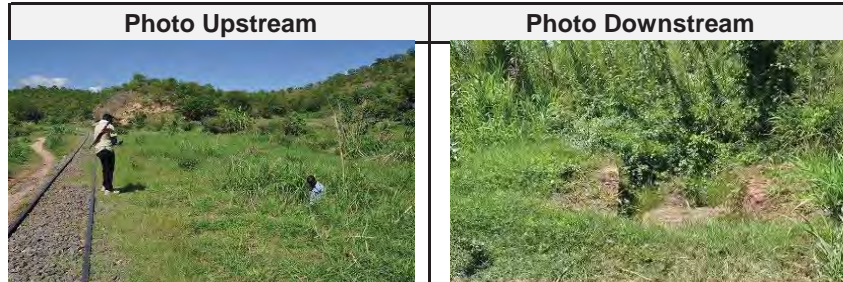
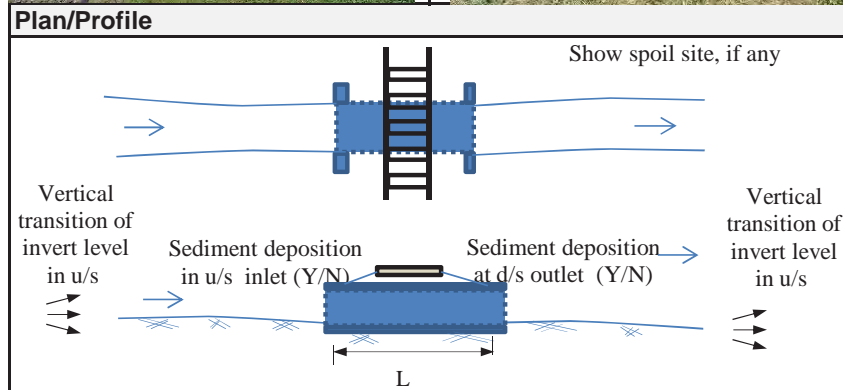
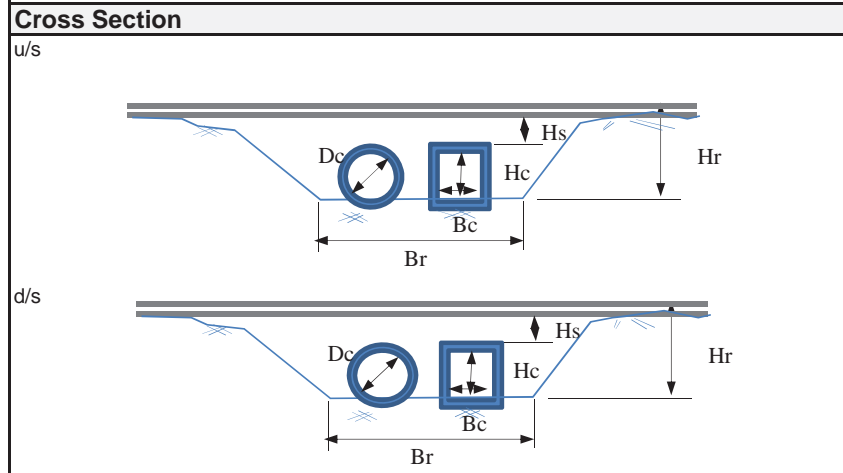
<b>Station: at KM 289/6</b>		<b>Sheet No.: PCL289.6</b>	
<b>1. General</b>			
1-1	Name of Inspector	T.Fukuda, Mr.Kido, Mr.Philipo	
1-2	Organization of Inspector	B	
1-3	Date/Time of Inspection	DEC 5 2014 1416	
1-4	Location	Lat	06°47'15.8"
1-5		Long	036°56'58.5"
1-6	Elevation	n/a	
<b>2. Characteristics of Physical Condition of Culvert</b>			
2-1	Length of Culvert	n/a	
2-2	Shape of Cross Section	Circle x 1	
2-3	Flow Area	Height	n/a
2-4		Width	n/a
2-5		Other	d= 0.9m, WL=5.0m, Hs= 0.2m
2-6	Connecting Channel	Height	n/a
2-7		Width	n/a
2-8		Side Slope	n/a
2-9	Type of Culvert	Concrete	
2-10	Riverbed	Material	n/a
2-11	Sediment deposition	u/s	Y, ?
2-12		d/s	Y, ?
2-13	Topography	u/s: → ,d/s →	
2-14	Land Use	n/a	
2-15	Structures/Houses, road	n/a	
<b>3. Damaged Flood Records</b>			
3-1	(Year/Month)	(Type)	(Reason,etc.)
	n/a	n/a	n/a

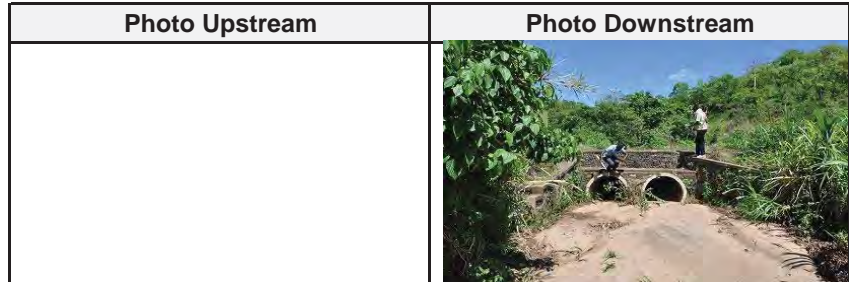
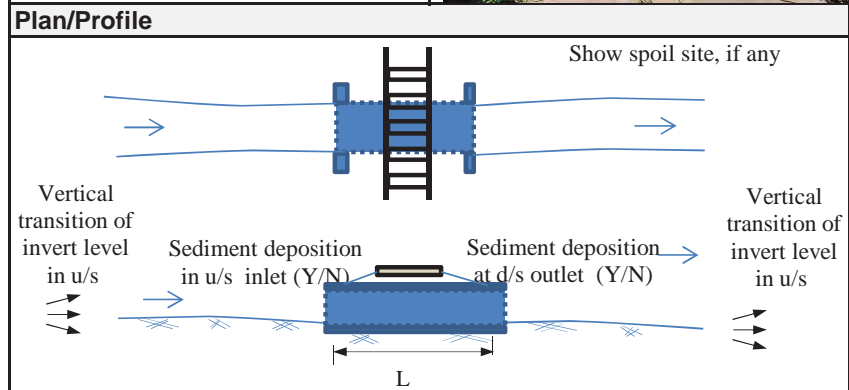
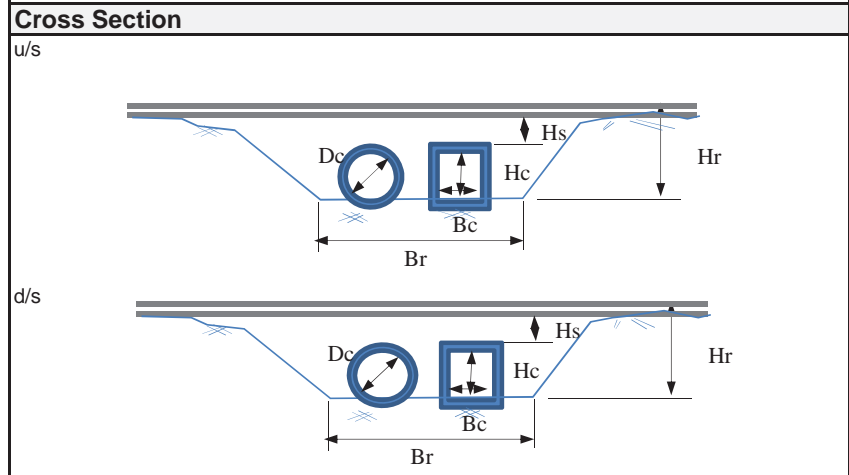
**Station: at KM 289/9**      **Sheet No.: PCL289.9**

2. Characteristics of Physical Condition of Culvert		
2-1	Length of Culvert	n/a
2-2	Shape of Cross Section	Circle × 2
2-3	Flow Area	Height      n/a
2-4		Width      n/a
2-5		Other      d= 1.2m, WL=4.0m, Hs= 0.6m
2-6	Connecting Channel	Height      n/a
2-7		Width      n/a
2-8		Side Slope      n/a
2-9	Type of Culvert	Concrete
2-10	Riverbed	Material      n/a
2-11	Sediment deposition	u/s      Y, 30%
2-12		d/s      Y, 30%
2-13	Topography	u/s: ↘      ,d/s      ↗
2-14	Land Use	n/a
2-15	Structures/Houses, road	n/a

3. Damaged Flood Records			
3-1	(Year/Month)	(Type)	(Reason,etc.)
	n/a	n/a	n/a

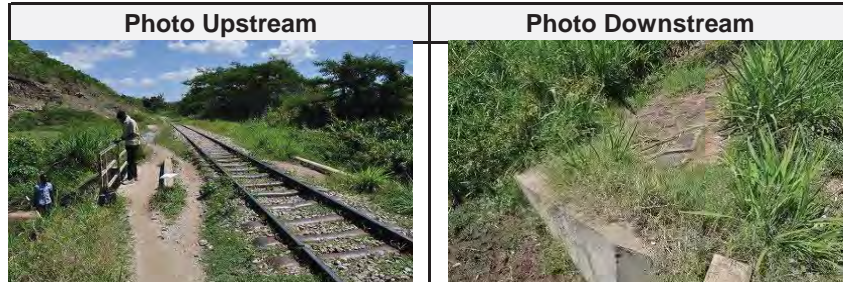
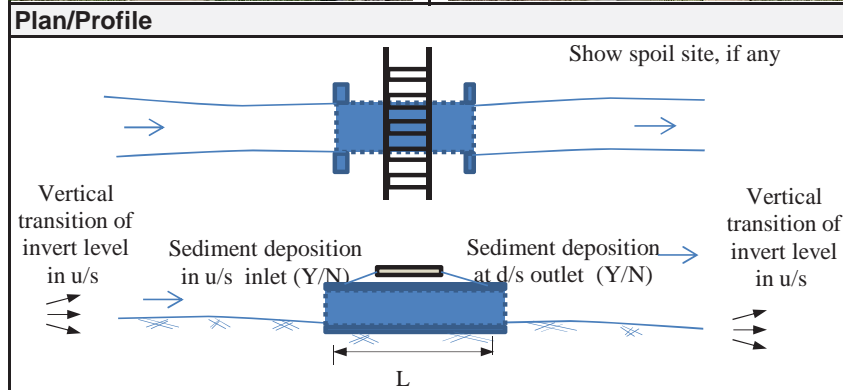
<b>Station: at KM 290/4</b>		<b>Sheet No.: BCL290.4</b>	
<b>1. General</b>			
1-1	Name of Inspector	T.Fukuda, Mr.Kido, Mr.Philipo	
1-2	Organization of Inspector	B	
1-3	Date/Time of Inspection	DEC 5 2014	1357
1-4	Location	Lat	0646'52.0"
1-5		Long	036°56'54.0"
1-6	Elevation	n/a	
<b>2. Characteristics of Physical Condition of Culvert</b>			
2-1	Length of Culvert	n/a	
2-2	Shape of Cross Section	Rectangular: × 1	
2-3	Flow Area	Height	Hc= 1.3m
2-4		Width	Bc= 3.0m
2-5		Other	WL= 3.0m, Hs= 0.5m
2-6	Connecting Channel	Height	n/a
2-7		Width	n/a
2-8		Side Slope	n/a
2-9	Type of Culvert	Concrete	
2-10	Riverbed	Material	n/a
2-11	Sediment deposition	u/s	Y, 60%
2-12		d/s	Y, 60%
2-13	Topography	u/s: → ,d/s →	
2-14	Land Use	n/a	
2-15	Structures/Houses, road	n/a	
<b>3. Damaged Flood Records</b>			
3-1	(Year/Month)	(Type)	(Reason,etc.)
	n/a	n/a	n/a

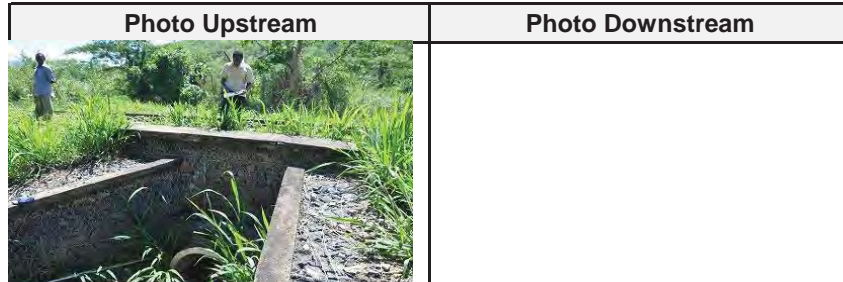
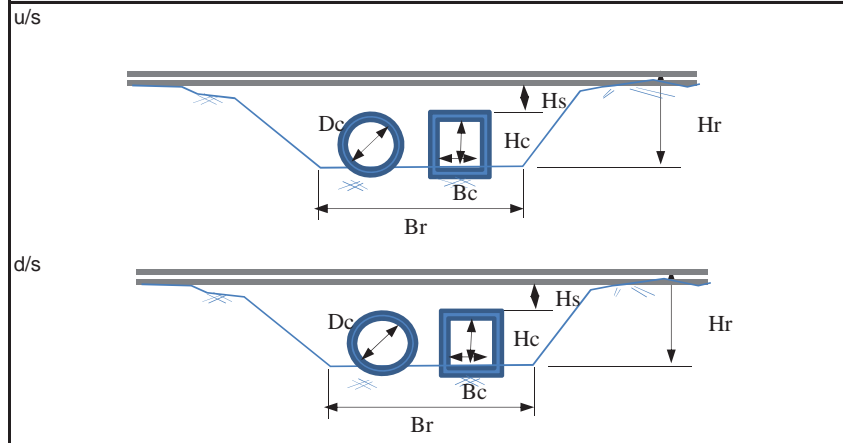
**Station: at KM 290/6**      **Sheet No.: PCL290.6**

3-1	(Year/Month)	(Type)	(Reason,etc.)
	2010	Flood	Railway track was diverted.

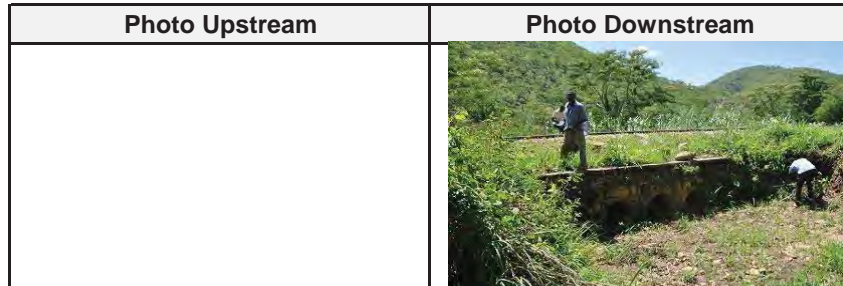
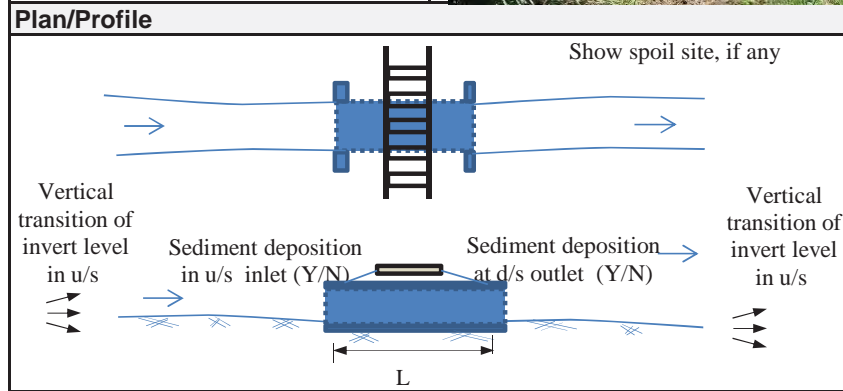
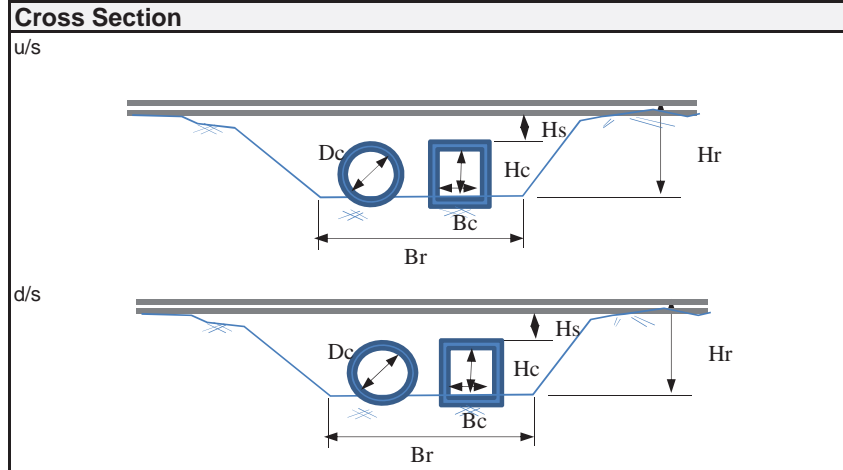
**Station: at KM 291/2**      **Sheet No.: PCL291.2**

2. Characteristics of Physical Condition of Culvert			
2-1	Length of Culvert		n/a
2-2	Shape of Cross Section		Circlex 5
2-3	Flow Area	Height	n/a
2-4		Width	n/a
2-5		Other	d=0.75m, WL= 1.5m, Hs= 0.6m
2-6	Connecting Channel	Height	n/a
2-7		Width	n/a
2-8		Side Slope	n/a
2-9	Type of Culvert		Concrete
2-10	Riverbed	Material	n/a
2-11	Sediment deposition	u/s	Y, 20%
2-12		d/s	Y, 20%
2-13	Topography		u/s: ↘      ,d/s      ↗
2-14	Land Use		n/a
2-15	Structures/Houses, road		n/a

3. Damaged Flood Records			
3-1	(Year/Month)	(Type)	(Reason,etc.)
	n/a	n/a	n/a

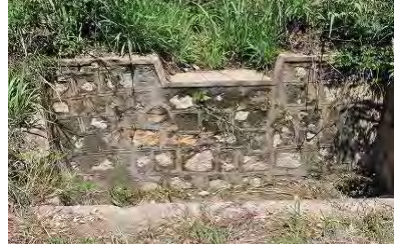
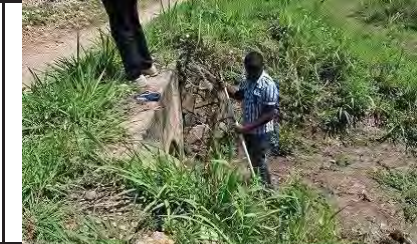
**Station: at KM 291/5**      **Sheet No.: PCL291.5**

3-1	(Year/Month)	(Type)	(Reason,etc.)
	n/a	n/a	n/a

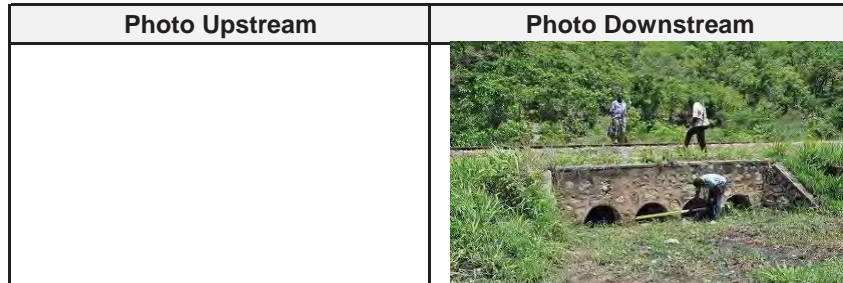
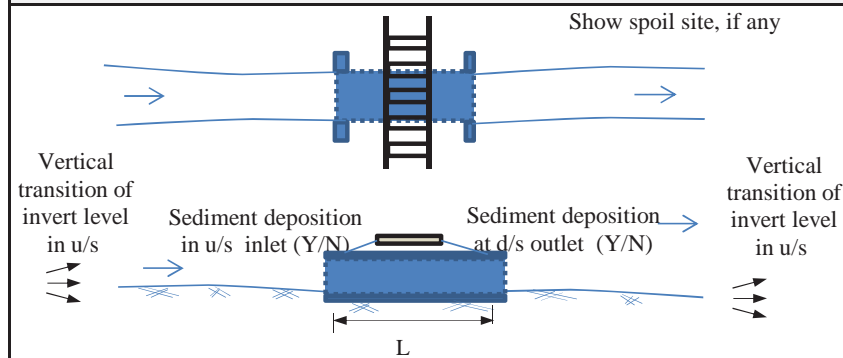
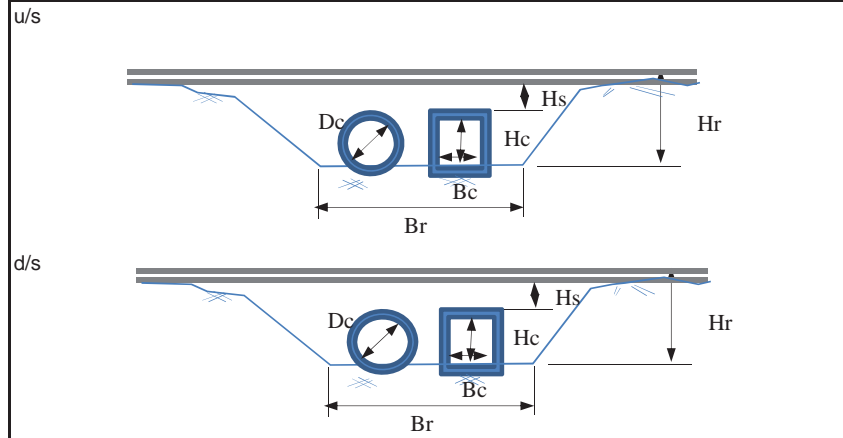
**Station: at KM 291/9**      **Sheet No.: PCL291.9**

3-1	(Year/Month)	(Type)	(Reason,etc.)
	n/a	n/a	n/a

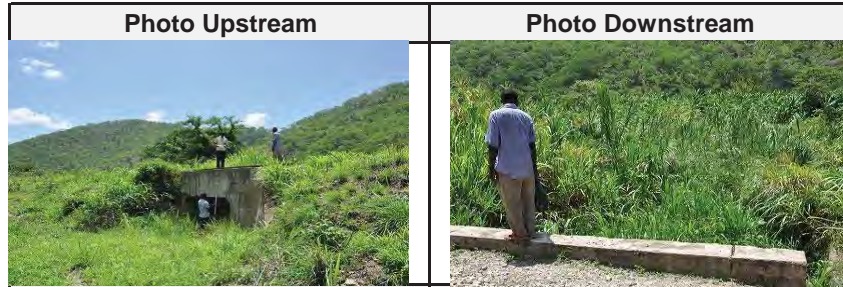
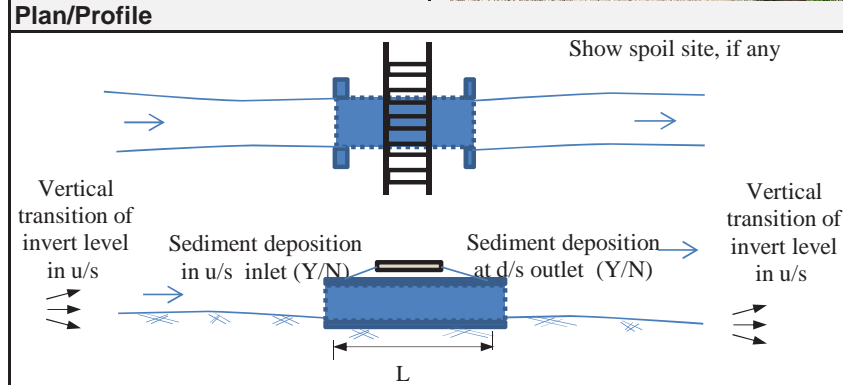
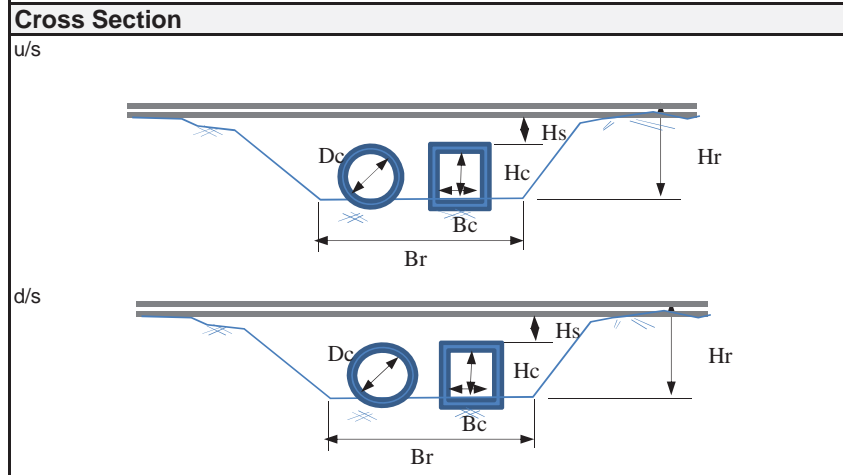
**Station: at KM 292/2**      **Sheet No.: BCL292.2**

<b>2. Characteristics of Physical Condition of Culvert</b>			
2-1	Length of Culvert	n/a	
2-2	Shape of Cross Section	Rectangular × 1	
2-3	Flow Area	Height	Hc = 1.6m
2-4		Width	Bc = 2.5m
2-5		Other	WL= 3.5m, Hs= 0.6m
2-6	Connecting Channel	Height	n/a
2-7		Width	n/a
2-8		Side Slope	n/a
2-9	Type of Culvert	Concrete	
2-10	Riverbed	Material	n/a
2-11	Sediment deposition	u/s	N, 0%
2-12		d/s	Y, 40%
2-13	Topography	u/s: ↘ ,d/s ↗	
2-14	Land Use	n/a	
2-15	Structures/Houses, road	n/a

<b>3. Damaged Flood Records</b>			
3-1	(Year/Month)	(Type)	(Reason,etc.)
	n/a	n/a	n/a

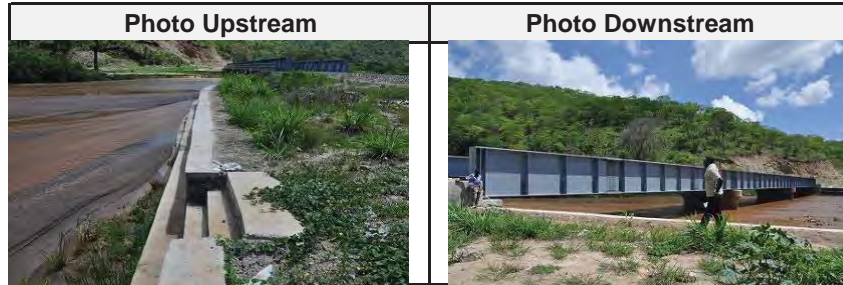
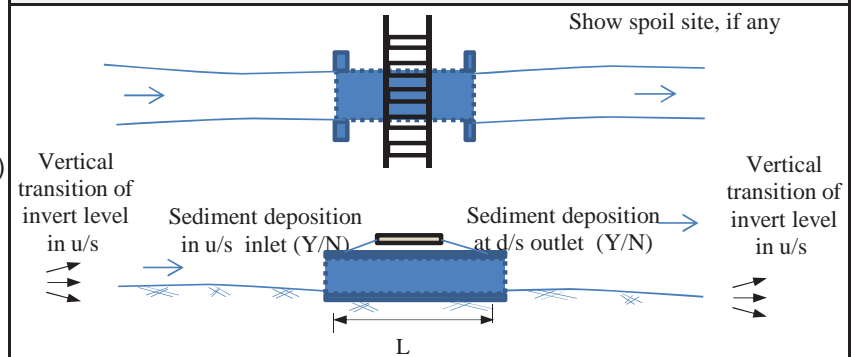
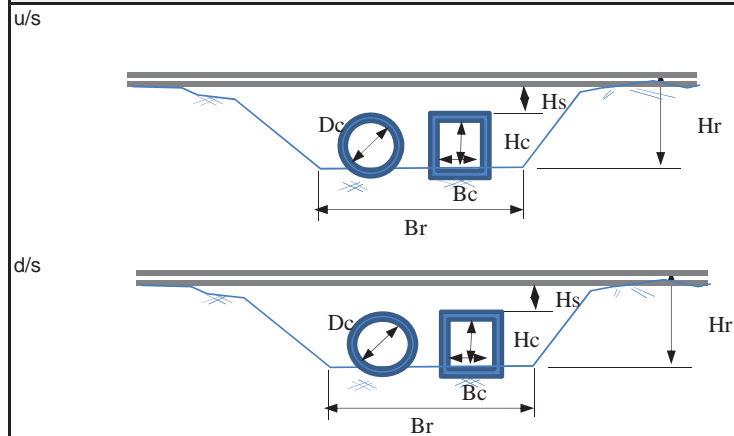
**Station: at KM 293/1**      **Sheet No.: BCL293.1**

3-1	(Year/Month)	(Type)	(Reason, etc.)
	2010(2008?)	Flood	Overtop, wash out of bridge
	1998	Flood	Overtop, wash out of bridge

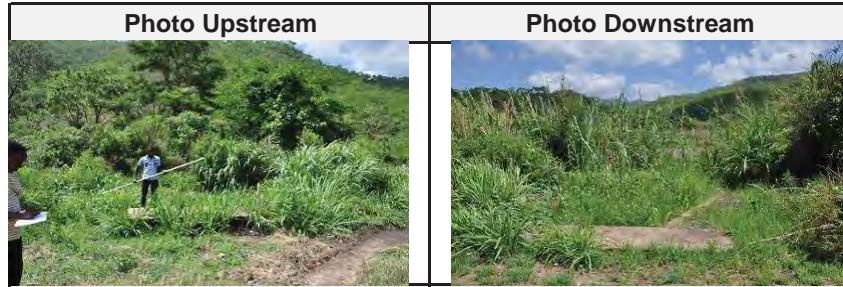
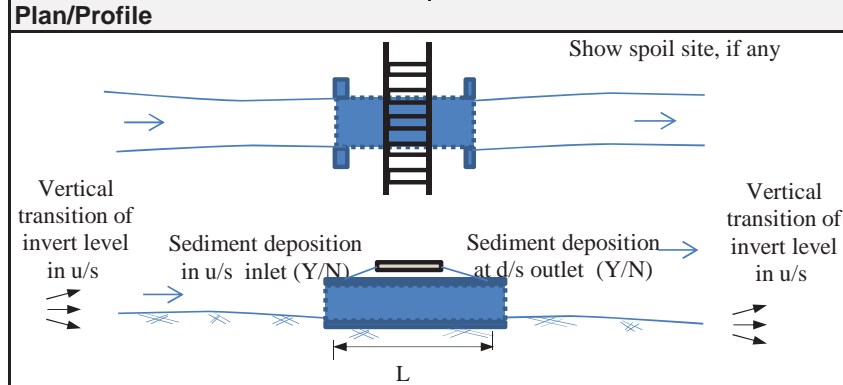
**Station: at KM 293/8**      **Sheet No.: PCL293.8**

<b>2. Characteristics of Physical Condition of Culvert</b>			
2-1	Length of Culvert	n/a	
2-2	Shape of Cross Section	Circle x 1	
2-3	Flow Area	Height	n/a
2-4		Width	n/a
2-5		Other	d = 0.6m, WL = 4.4m, Hs = 0.5m
2-6	Connecting Channel	Height	n/a
2-7		Width	n/a
2-8		Side Slope	n/a
2-9	Type of Culvert	Concrete	
2-10	Riverbed	Material	n/a
2-11	Sediment deposition	u/s	Y, ?
2-12		d/s	Y, ?
2-13	Topography	u/s: → , d/s →	
2-14	Land Use	n/a	
2-15	Structures/Houses, road	n/a

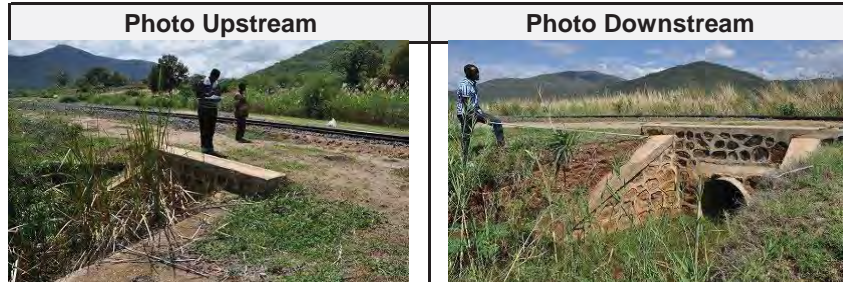
**Station: at KM 308/9**      **Sheet No.: PCL308.9**

3-1	(Year/Month)	(Type)	(Reason,etc.)
	?	washout	?

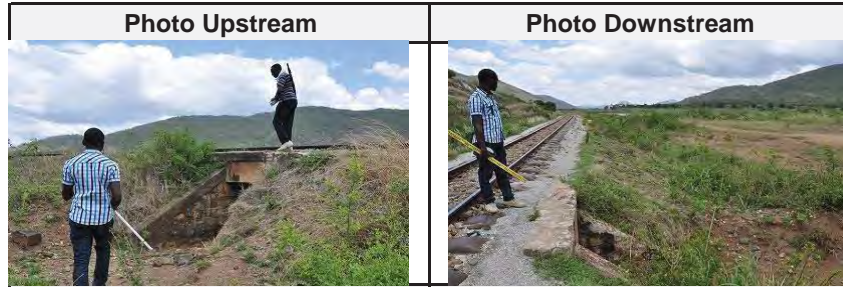
**Station: at KM 312/2**      **Sheet No.: BCL312.2**

<b>2. Characteristics of Physical Condition of Culvert</b>		
2-1	Length of Culvert	n/a
2-2	Shape of Cross Section	Rectangular × 1
2-3	Flow Area	Height      Hc= 1.35m
2-4		Width      Bc= 1.0m
2-5		Other      WL=2.0m, Hs=0.5m
2-6	Connecting Channel	Height      n/a
2-7		Width      n/a
2-8		Side Slope      n/a
2-9	Type of Culvert	Concrete
2-10	Riverbed	Material      n/a
2-11	Sediment deposition	u/s      Y, 0%
2-12		d/s      Y, 0%
2-13	Topography	u/s:      ,d/s      →
2-14	Land Use	n/a
2-15	Structures/Houses, road	n/a

<b>3. Damaged Flood Records</b>			
3-1	(Year/Month)	(Type)	(Reason,etc.)
	?	damaged on	gaion is insatalled along the bank

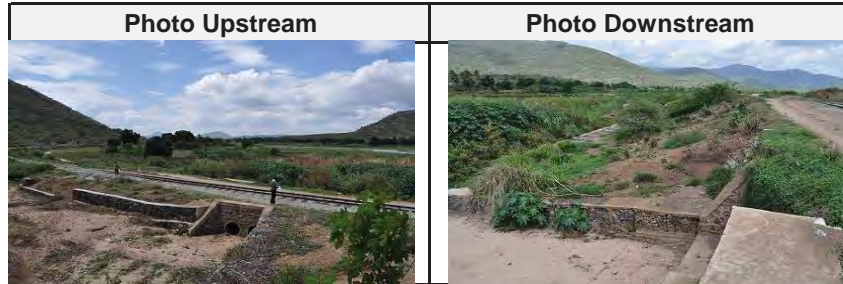
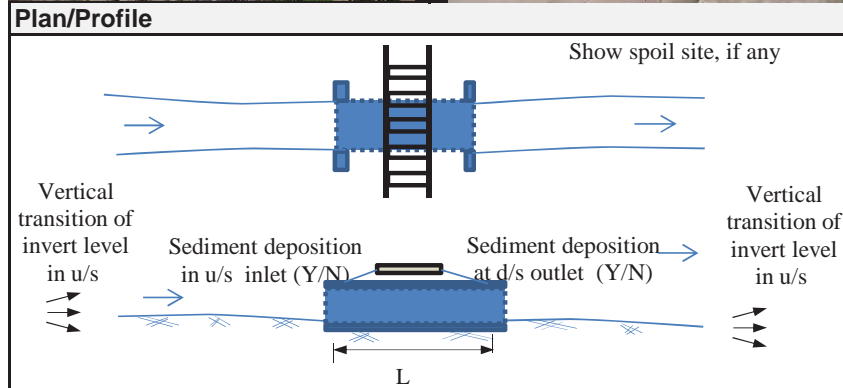
3-1	(Year/Month)	(Type)	(Reason,etc.)
	?	washout	?

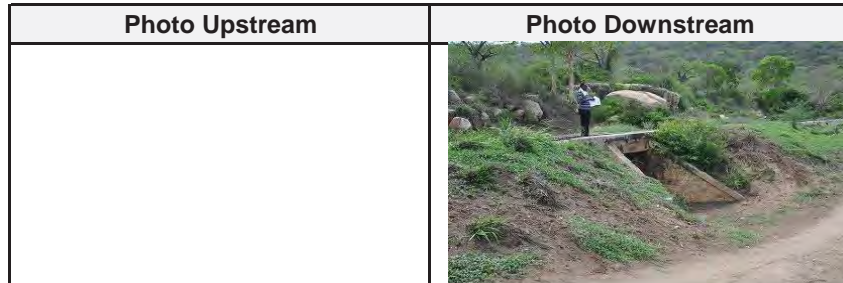
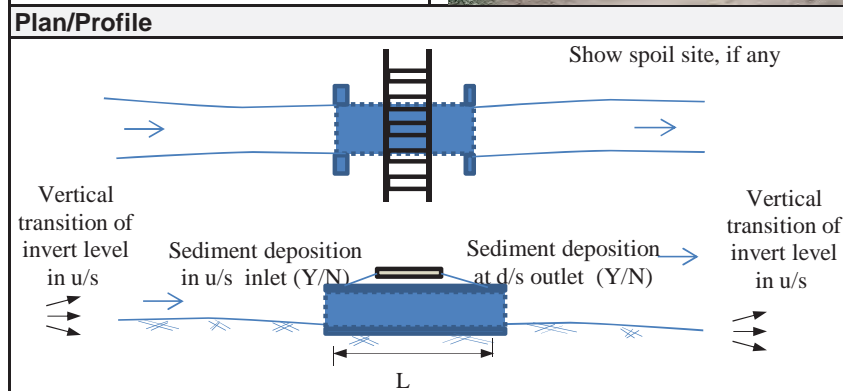
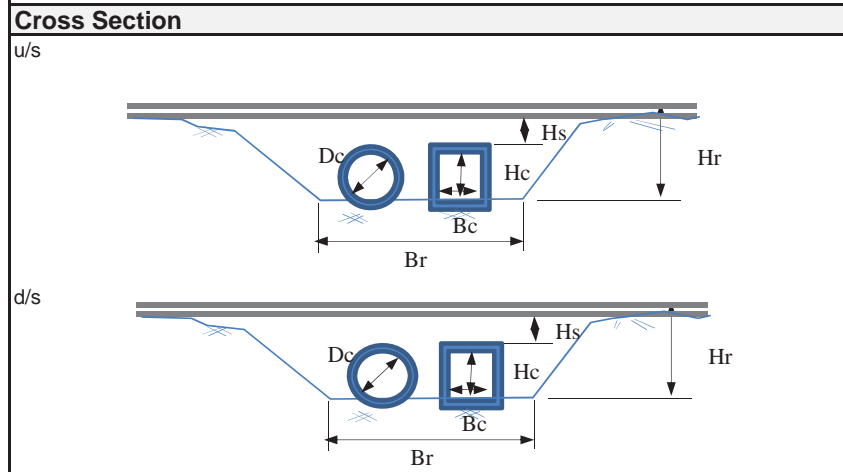
**Station: at KM 313/4**      **Sheet No.: BCL313.3**

3-1	(Year/Month)	(Type)	(Reason,etc.)
	?	washout	?

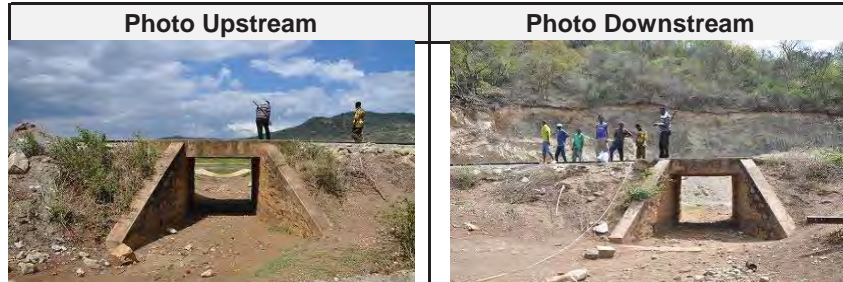
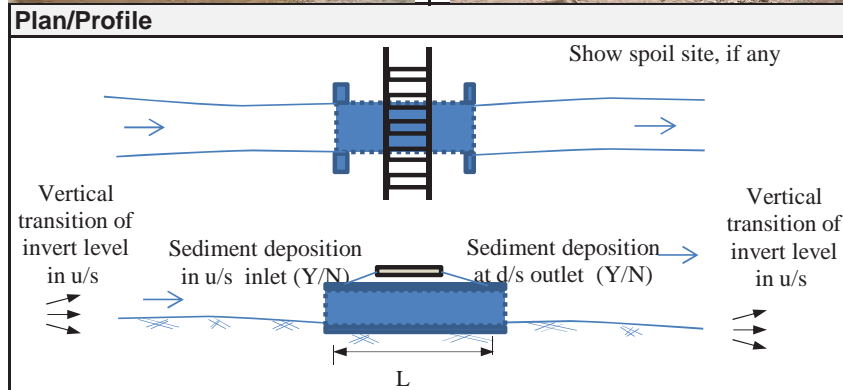
**Station: at KM 314/9**      **Sheet No.: BCL314.9**

3. Damaged Flood Records			
3-1	(Year/Month)	(Type)	(Reason, etc.)
	n/a	overtop	n/a

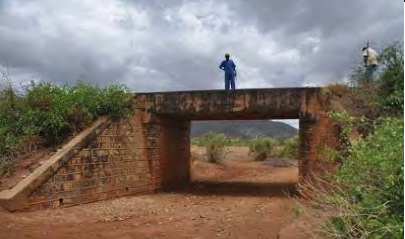
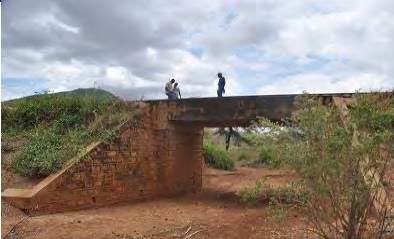
<b>Photo Upstream</b>	<b>Photo Downstream</b>

<b>Station: at KM 333/6</b>		<b>Sheet No.: BCL333.6</b>	
<b>1. General</b>			
1-1	Name of Inspector	T.Fukuda, Mr.Kido, Mr.Philipo	
1-2	Organization of Inspector	B	
1-3	Date/Time of Inspection	DEC 3 2014 1210	
1-4	Location	Lat	06°36'06.1"
1-5		Long	036°39'40.1"
1-6	Elevation	n/a	
<b>2. Characteristics of Physical Condition of Culvert</b>			
2-1	Length of Culvert	n/a	
2-2	Shape of Cross Section	Rectangular × 1	
2-3	Flow Area	Height	Hc= 3.1m
2-4		Width	Bc= 5.0m
2-5		Other	WL=5.0m, Hs= 0.85m
2-6	Connecting Channel	Height	n/a
2-7		Width	n/a
2-8		Side Slope	n/a
2-9	Type of Culvert	Concrete	
2-10	Riverbed	Material	n/a
2-11	Sediment deposition	u/s	Y, 40%
2-12		d/s	Y, 40%
2-13	Topography	u/s: → ,d/s →	
2-14	Land Use	n/a	
2-15	Structures/Houses, road	n/a	
<b>3. Damaged Flood Records</b>			
3-1	(Year/Month)	(Type)	(Reason,etc.)
	n/a	n/a	n/a

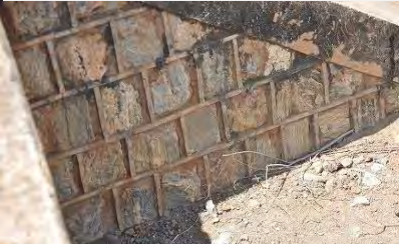
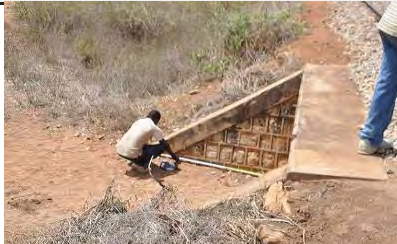
<b>Photo Upstream</b>	<b>Photo Downstream</b>

<b>Station: at KM 335/1</b>		<b>Sheet No.: BCL335.1</b>	
<b>1. General</b>			
1-1	Name of Inspector	T.Fukuda, Mr.Kido, Mr.Philipo	
1-2	Organization of Inspector	B	
1-3	Date/Time of Inspection	DEC 3 2014 1330	
1-4	Location	Lat	06°35'23.6"
1-5		Long	036°39'34.3"
1-6	Elevation	n/a	
<b>2. Characteristics of Physical Condition of Culvert</b>			
2-1	Length of Culvert	n/a	
2-2	Shape of Cross Section	Rectangular × 1	
2-3	Flow Area	Height	Hc=1.75m
2-4		Width	Bc= 2.0m
2-5		Other	WL=2.9m, Hs= 0.5m
2-6	Connecting Channel	Height	n/a
2-7		Width	n/a
2-8		Side Slope	n/a
2-9	Type of Culvert	Concrete	
2-10	Riverbed	Material	n/a
2-11	Sediment deposition	u/s	Y, 15%
2-12		d/s	Y, 15%
2-13	Topography	u/s: ↘ ,d/s ↗	
2-14	Land Use	n/a	
2-15	Structures/Houses, road	n/a	
<b>3. Damaged Flood Records</b>			
3-1	(Year/Month)	(Type)	(Reason,etc.)
	n/a	n/a	n/a

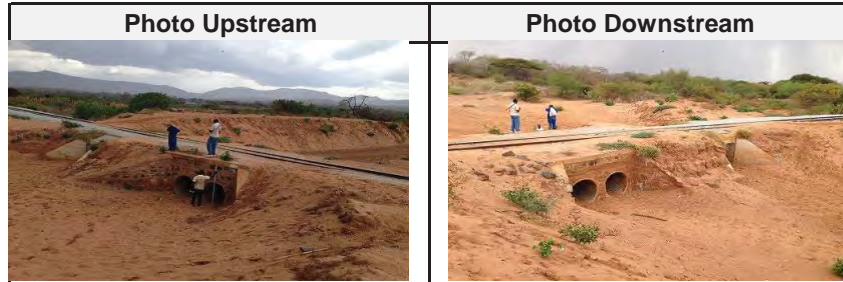
**Station: at KM 337/0**      **Sheet No.: PCL337.0**

3-1	(Year/Month)	(Type)	(Reason,etc.)
	n/a	washout	ballasts

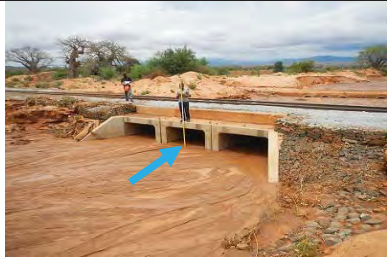
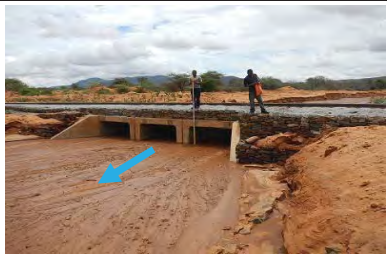
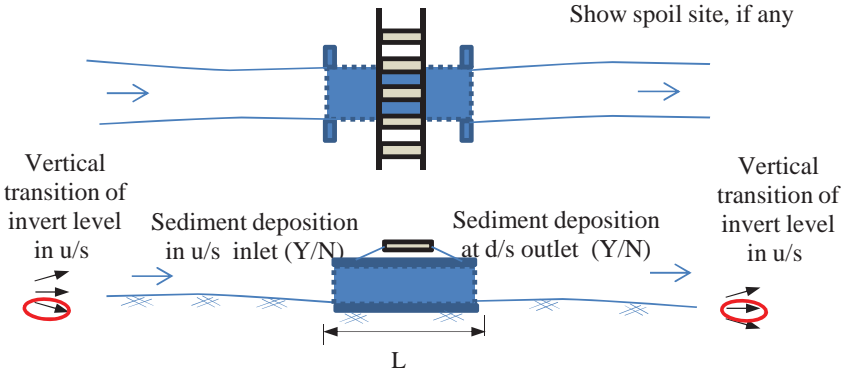
<b>Station: at KM 349.5B</b>		<b>Sheet No.: BCL 349.5B</b>	
<b>1. General</b>			
1-1	Name of Inspector	T. Kawaguchi , Hussein , Abiud	
1-2	Organization of Inspector	JICA Study Team	
1-3	Date/Time of Inspection	212/2014	
1-4	Location	Lat	06° 31' 39" 50"
1-5		Long	036° 32' 52" 25"
1-6	Elevation		
<b>2. Characteristics of Physical Condition of Culvert</b>			
2-1	Length of Culvert	6.0 m	
2-2	Shape of Cross Section	Square:(3) Rectangular: Circle:	
2-3	Flow Area	Height	Hc1 = 0.7 m , Hc2 = 0.7 m
2-4		Width	Bc1 = 2.0 m , Bc2 = 2.0 m
2-5		Other	Hs1 = 0.3 m , Hs2 = 0.3 m
2-6	Connecting Channel	Height	
2-7		Width	
2-8		Side Slope	
2-9	Type of Culvert	Concrete	
2-10	Riverbed	Material	Silty sand
2-11	Sediment	u/s	Heavy ( 60% rate)
2-12	deposition	d/s	Heavy ( 60% rate)
2-13	Topography	u/s: , d/s:	
2-14	Land Use		
2-15	Structures/Houses, road		
<b>3. Damaged Flood Records</b>			
3-1	(Year/Month)	(Type)	(Reason,etc.)

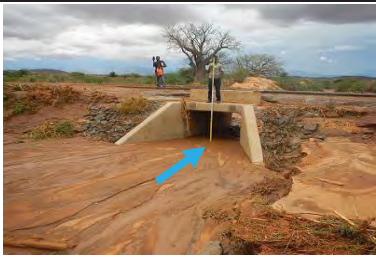
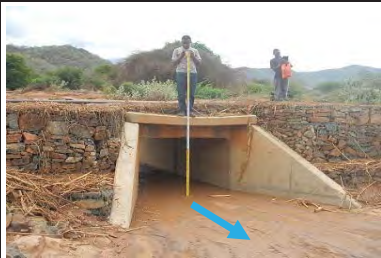
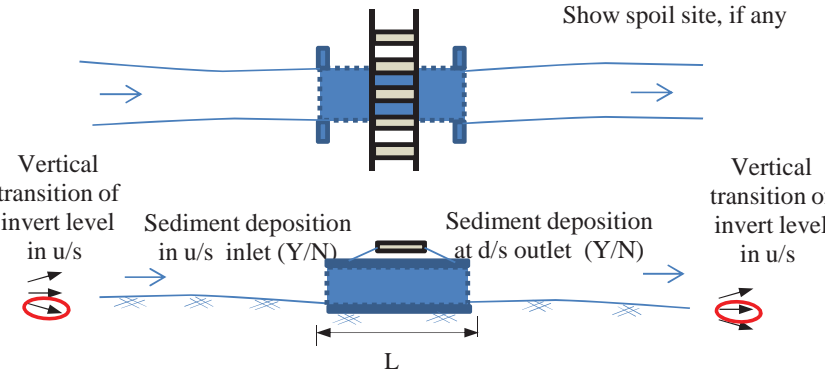
<b>Station: at KM 349.6B</b>		<b>Sheet No.: BCL 349.6B</b>	
<b>1. General</b>			
1-1	Name of Inspector	T. Kawaguchi , Hussein , Abiud	
1-2	Organization of Inspector	JICA Study Team	
1-3	Date/Time of Inspection	2014/2/12	
1-4	Location	Lat	06° 31' 37" 36 ""
1-5		Long	036° 32' 49" 49""
1-6	Elevation		
<b>2. Characteristics of Physical Condition of Culvert</b>			
2-1	Length of Culvert	6.0 m	
2-2	Shape of Cross Section	Square:(1) Rectangular: Circle:	
2-3	Flow Area	Height	Hc1 = 1.1 m , Hc2 = 1.2 m
2-4		Width	Bc1 = 2.0 m , Bc2 = 2.0 m
2-5		Other	Hs1 = 0.3 m , Hs2 = 0.3 m
2-6	Connecting Channel	Height	
2-7		Width	
2-8		Side Slope	
2-9	Type of Culvert	Concrete	
2-10	Riverbed	Material	Silty sand
2-11	Sediment deposition	u/s	Light ( 30% rate)
2-12		d/s	Light ( 30% rate)
2-13	Topography	u/s: , d/s:	
2-14	Land Use		
2-15	Structures/Houses, road		
<b>3. Damaged Flood Records</b>			
3-1	(Year/Month)	(Type)	(Reason,etc.)

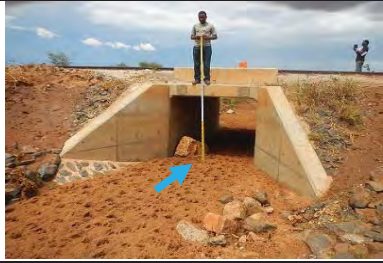
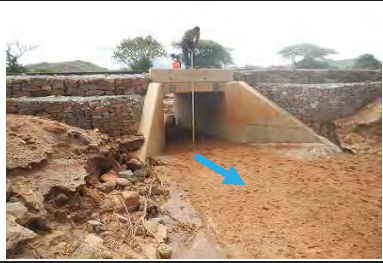
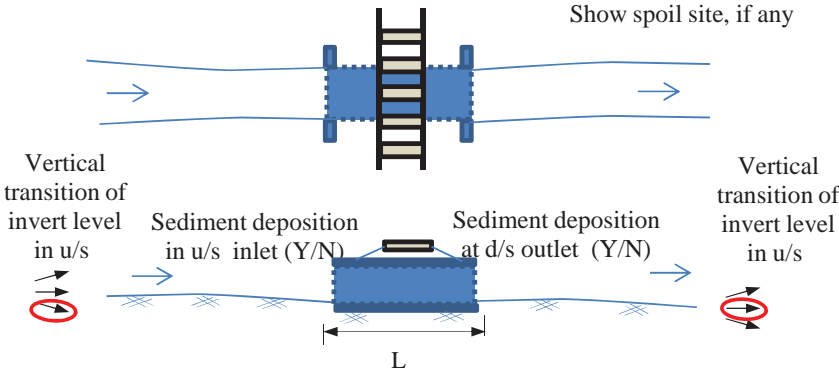
<b>Station: at KM 349.8 B</b>		<b>Sheet No.: BCL 349.8B</b>	
<b>1. General</b>			
1-1	Name of Inspector	T. Kawaguchi , Hussein , Abiud	
1-2	Organization of Inspector	JICA Study Team	
1-3	Date/Time of Inspection	2014/2/12	
1-4	Location	Lat	06° 31' 30" 80"
1-5		Long	036° 32' 40" 39"
1-6	Elevation		
<b>2. Characteristics of Physical Condition of Culvert</b>			
2-1	Length of Culvert	6.0 m	
2-2	Shape of Cross Section	Square:(1) Rectangular: Circle:	
2-3	Flow Area	Height	Hc1 = 1.7 m , Hc2 = 1.7 m
2-4		Width	Bc1 = 2.0 m , Bc2 = 2.0 m
2-5		Other	Hs1 = 0.3 m , Hs2 = 0.3 m
2-6	Connecting Channel	Height	
2-7		Width	
2-8		Side Slope	
2-9	Type of Culvert	Concrete	
2-10	Riverbed	Material	Silty sand
2-11	Sediment deposition	u/s	Light ( 20% rate)
2-12		d/s	Light ( 20% rate)
2-13	Topography	u/s:  , d/s:	
2-14	Land Use		
2-15	Structures/Houses, road		
<b>3. Damaged Flood Records</b>			
3-1	(Year/Month)	(Type)	(Reason,etc.)

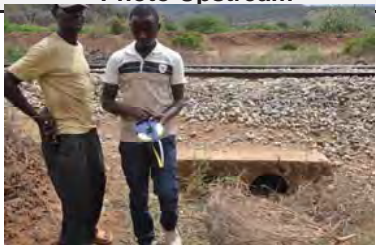
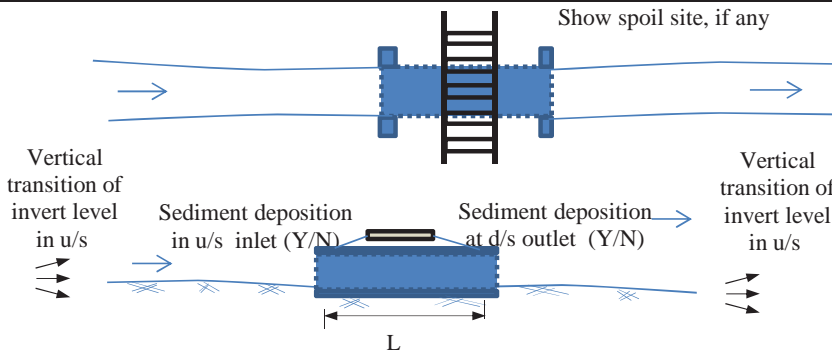
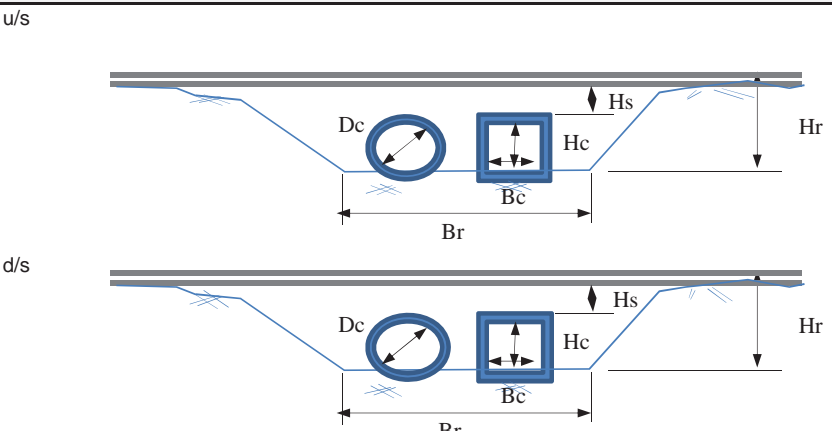
<b>Station: at KM 352/9</b>		<b>Sheet No.: CBL352.9</b>	
<b>1. General</b>			
1-1	Name of Inspector	T.Fukuda, Mr.Kido, Mr.Philipo	
1-2	Organization of Inspector	B	
1-3	Date/Time of Inspection	DEC 2 2014	
1-4	Location	Lat	
1-5		Long	
1-6	Elevation	n/a	
<b>2. Characteristics of Physical Condition of Culvert</b>			
2-1	Length of Culvert	n/a	
2-2	Shape of Cross Section	Circle x 1	
2-3	Flow Area	Height	D=0.9m(2)
2-4		Width	
2-5		Other	
2-6	Connecting Channel	Height	n/a
2-7		Width	n/a
2-8		Side Slope	n/a
2-9	Type of Culvert	Concrete	
2-10	Riverbed	Material	n/a
2-11	Sediment deposition	u/s	Y, 20%
2-12		d/s	Y, 20%
2-13	Topography	u/s: ,d/s	
2-14	Land Use	n/a	
2-15	Structures/Houses, road	n/a	
<b>3. Damaged Flood Records</b>			
3-1	(Year/Month)	(Type)	(Reason,etc.)
	n/a	n/a	n/a
