## **APPENDIX F**

### **INVENTORY SHEET OF CULVERT**

## Inventory Sheet for Culvert

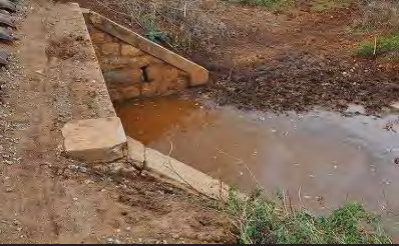
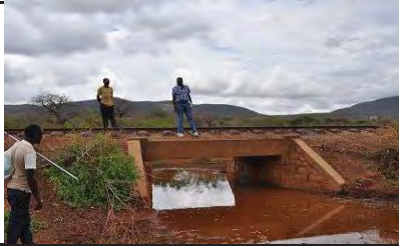
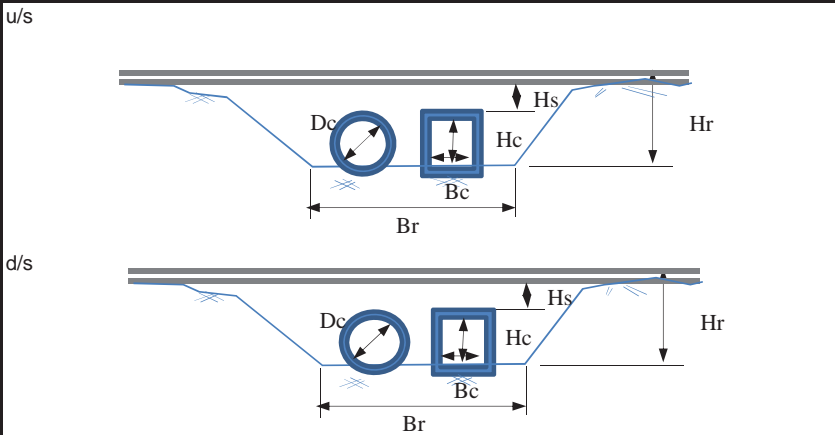
<b>Station: at KM 354/3</b>		<b>Sheet No.: BCL354.3</b>	
<b>1. General</b>			
1-1	Name of Inspector	T.Fukuda, Mr.Kido, Mr.Philipo	
1-2	Organization of Inspector	B	
1-3	Date/Time of Inspection	DEC 2 2014	
1-4	Location	Lat	06°29'46.6"
1-5		Long	036°30'25.1"
1-6	Elevation	n/a	
<b>2. Characteristics of Physical Condition of Culvert</b>			
2-1	Length of Culvert	n/a	
2-2	Shape of Cross Section	Rectangular × 1	
2-3	Flow Area	Height	Hc=0.55m
2-4		Width	Bc= 2.0m
2-5		Other	WL=1..0m, Hs= 0.45m
2-6	Connecting Channel	Height	n/a
2-7		Width	n/a
2-8		Side Slope	n/a
2-9	Type of Culvert	Concrete	
2-10	Riverbed	Material	n/a
2-11	Sediment deposition	u/s	Y, 75%
2-12		d/s	Y, 75%
2-13	Topography	u/s: → ,d/s →	
2-14	Land Use	n/a	
2-15	Structures/Houses, road	n/a	
<b>3. Damaged Flood Records</b>			
3-1	(Year/Month)	(Type)	(Reason,etc.)
	n/a	n/a	n/a

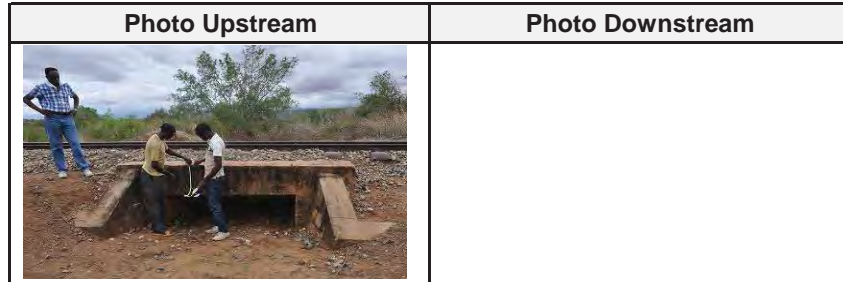
<b>2. Characteristics of Physical Condition of Culvert</b>		
2-1	Length of Culvert	n/a
2-2	Shape of Cross Section	Rectangular × 1
2-3	Flow Area	Height Hc=0.95m
2-4		Width Bc= 3.0m
2-5		Other WL=5.4m, Hs= 0.65m
2-6	Connecting Channel	Height n/a
2-7		Width n/a
2-8		Side Slope n/a
2-9	Type of Culvert	Concrete
2-10	Riverbed	Material n/a
2-11	Sediment deposition	u/s Y, 75%
2-12		d/s Y, 75%
2-13	Topography	u/s: ↘ ,d/s ↘
2-14	Land Use	n/a
2-15	Structures/Houses, road	n/a

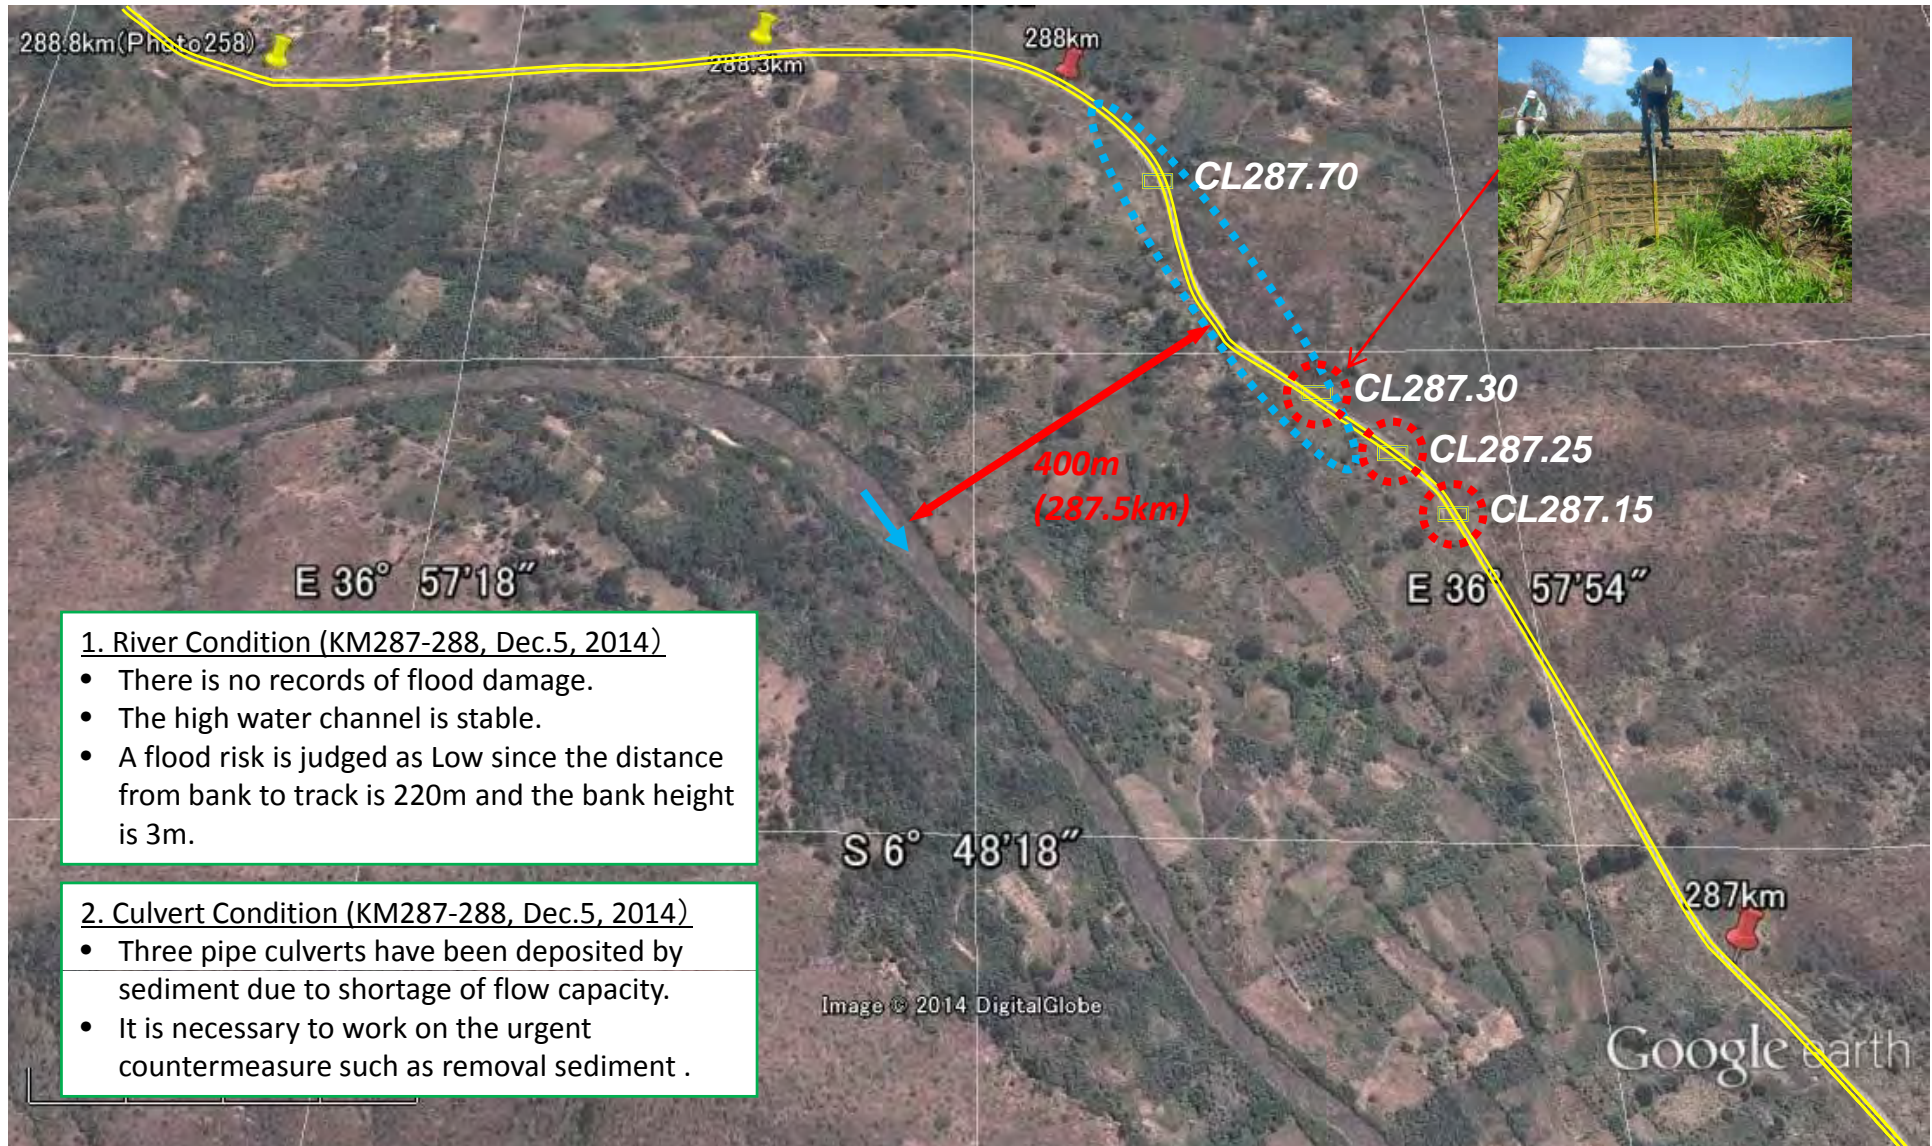
## Inventory Sheet for Culvert

F-54

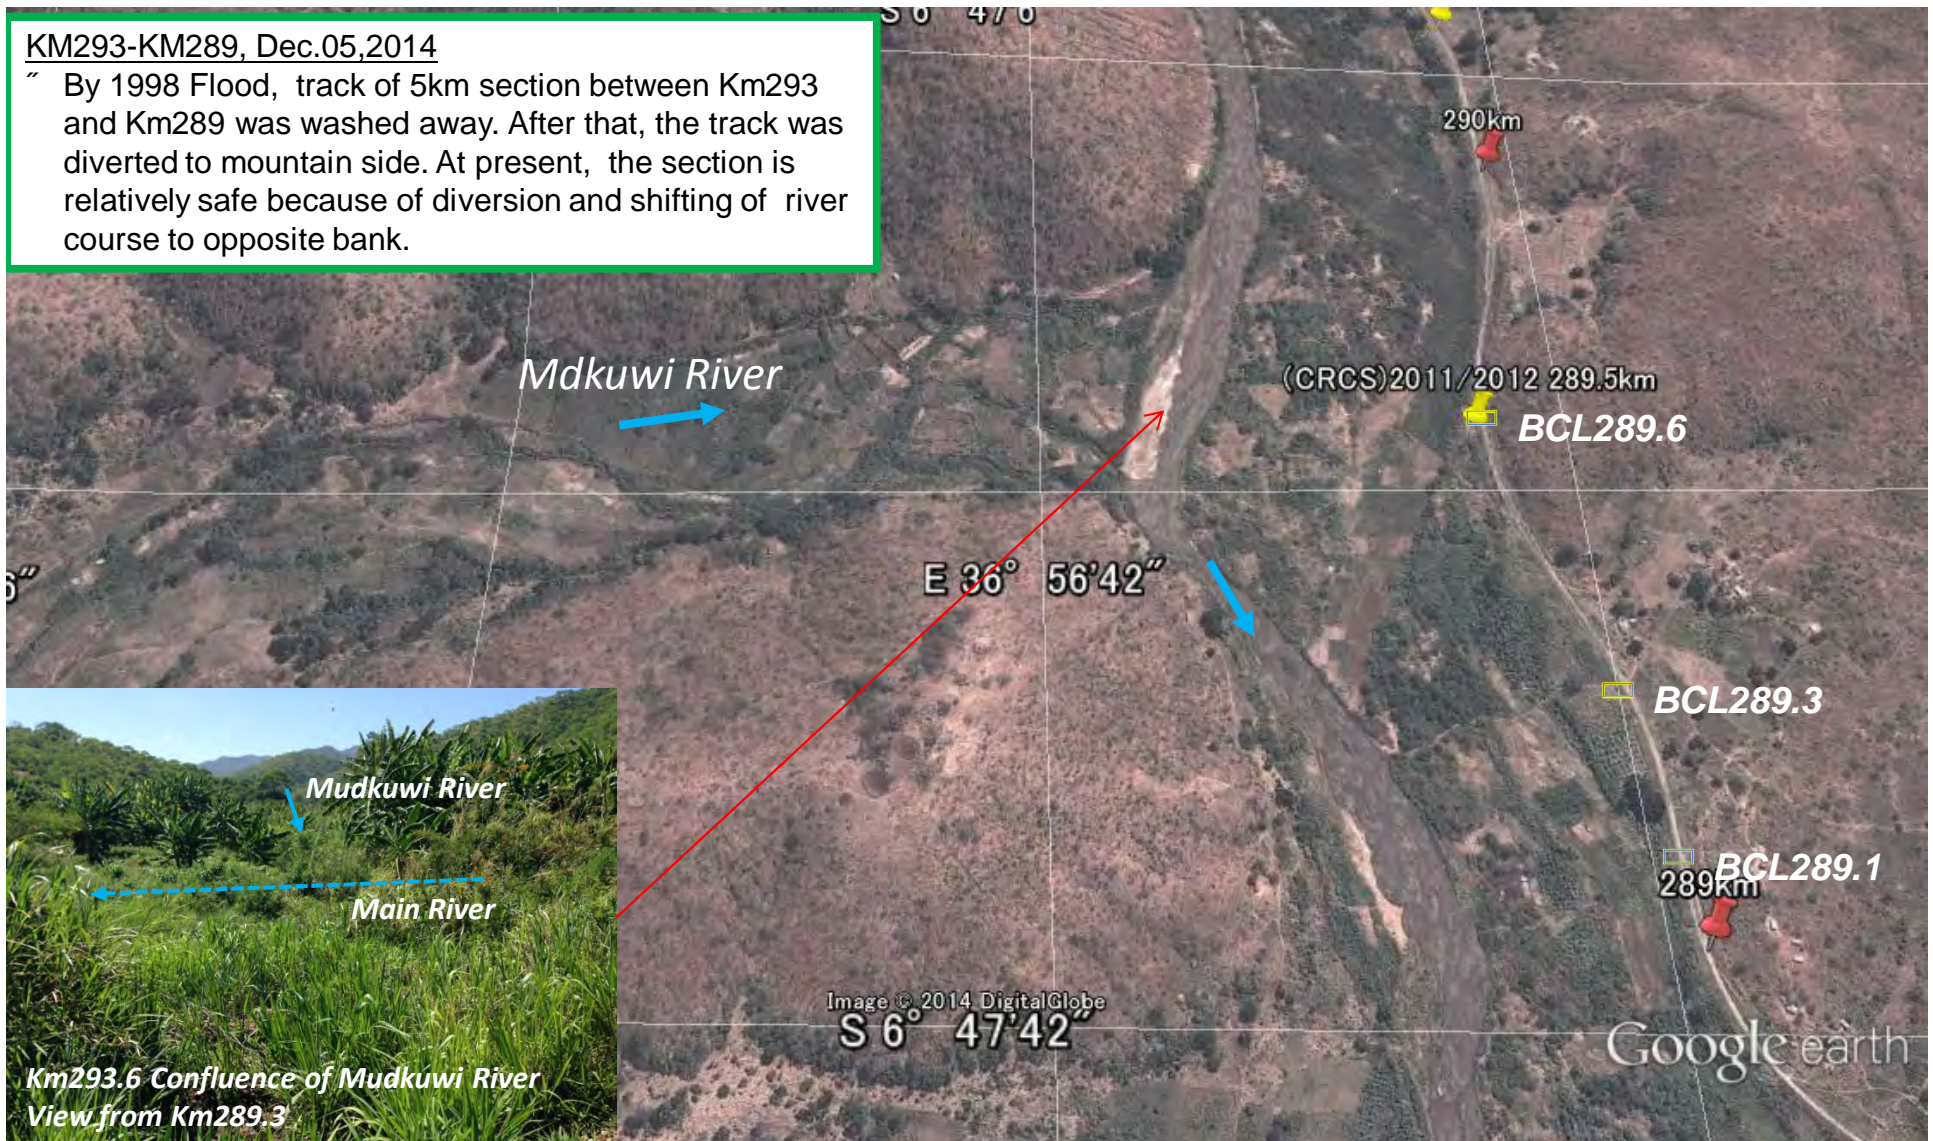
<b>Plan/Profile</b>

<b>Cross Section</b>

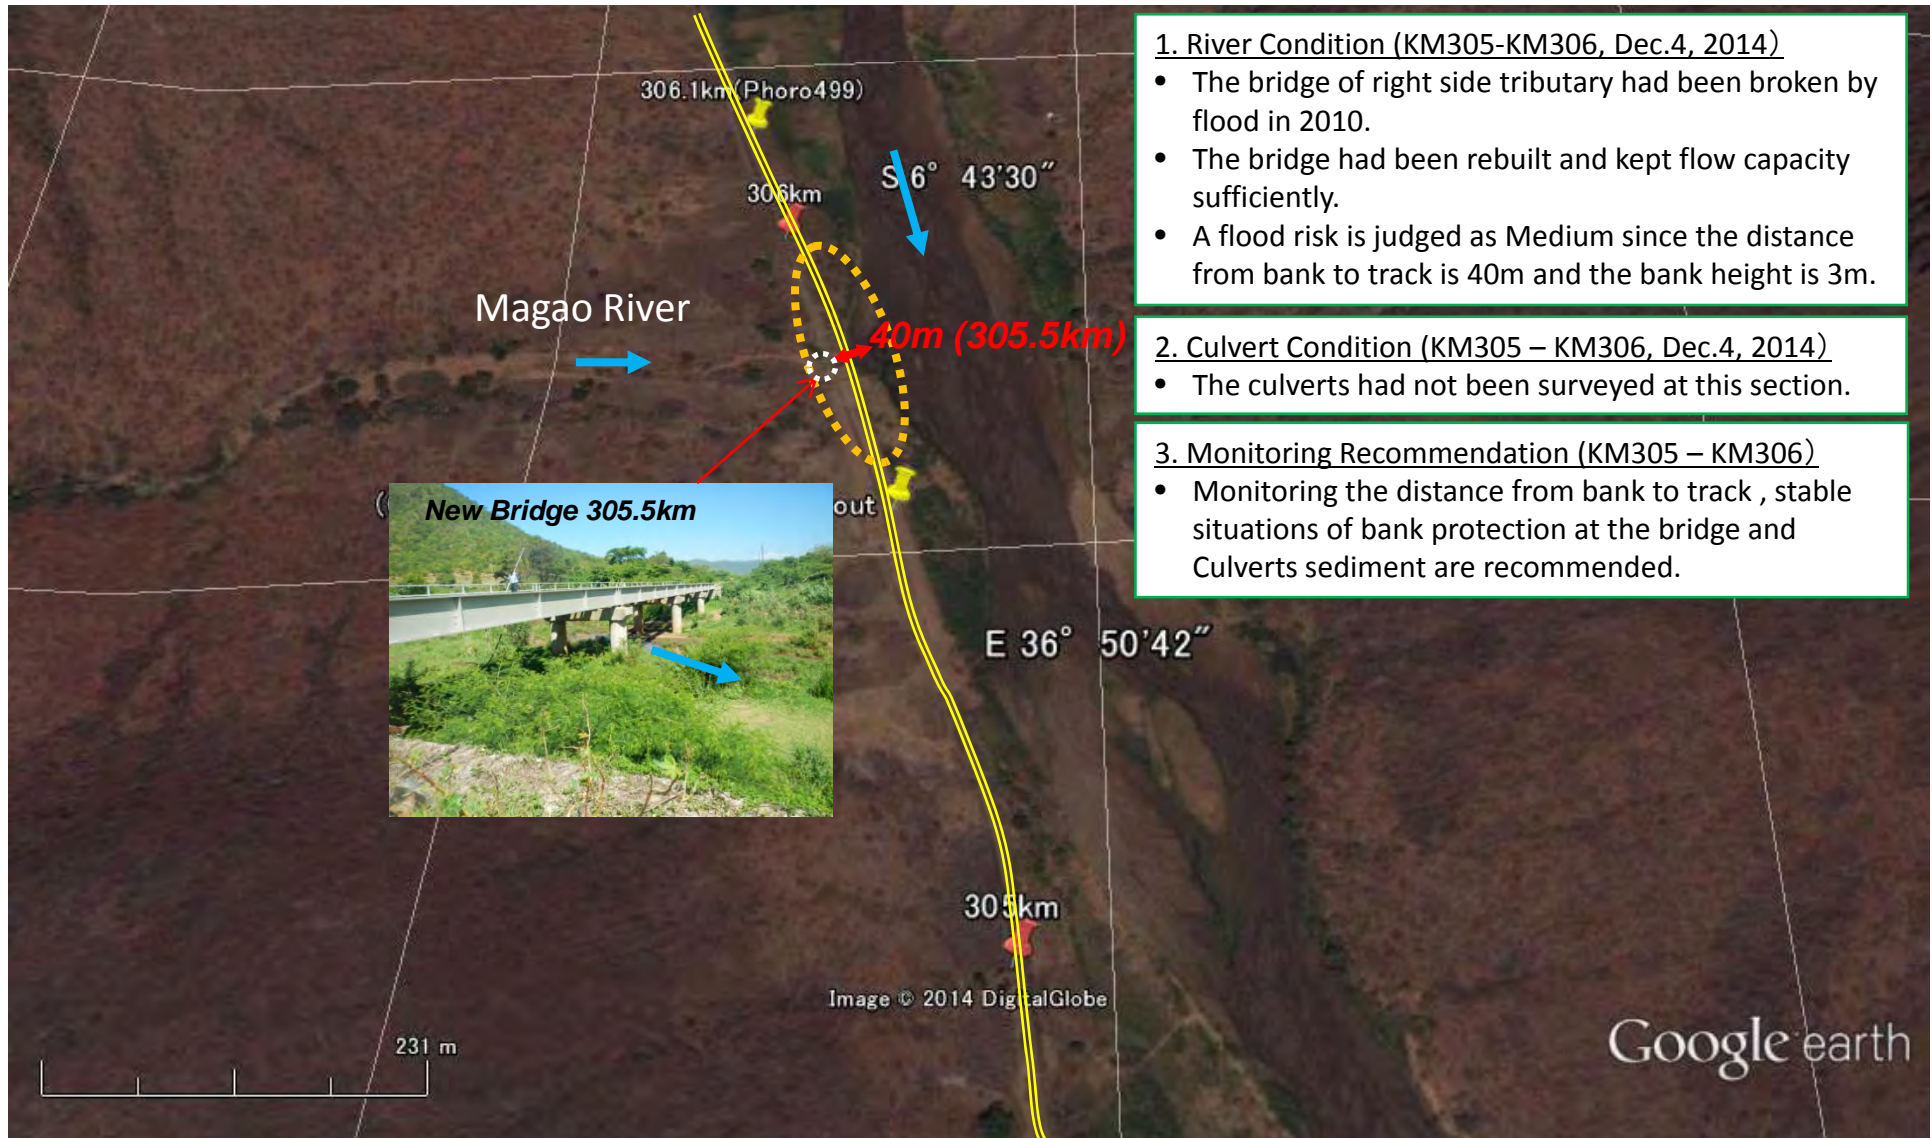
### Cross Section

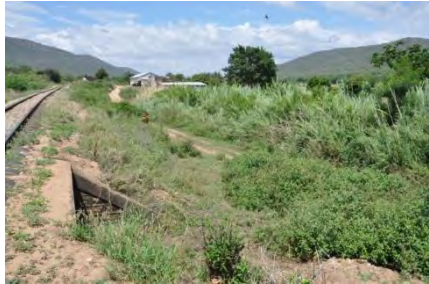
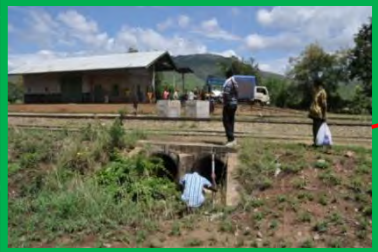
KM310.5, Dec.04,2014  
 " - The area at back of Mzaganza station building is located in low laying area, but no damage is reported on the building.  
 " As the back of the station is located at water hit portion, it is recommended to install river bank protection considering the existence of station.

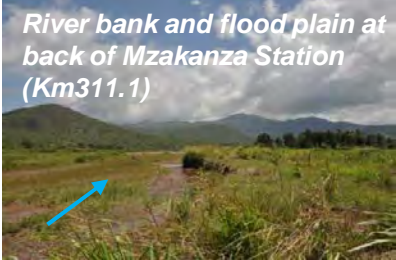
- “ The shortest distance from river bank to railway track is 45 m at Km311.1.
- “ Bank height is 4.5m

*River bank and flood plain at back of Mzaganza Station (Km311.1)*

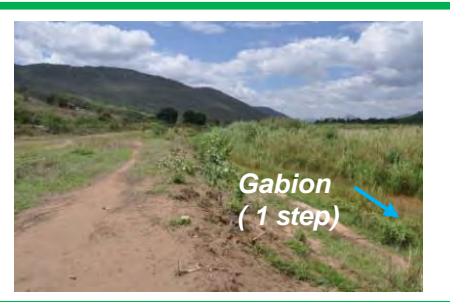
(KM312.1-312.4, Dec.04, 2014)  
 " Damaged in past floods.  
 " Bank height is ranging from 2.0 to 3.4m.  
 " Bank erosion is in progress and the shortest distance from river bank to railway is

21m at Km312.3.  
 " After 2010 Flood, gabion (1step) was installed for protection of bank of low water channel in 200m section from Km312.2 to Km312.4

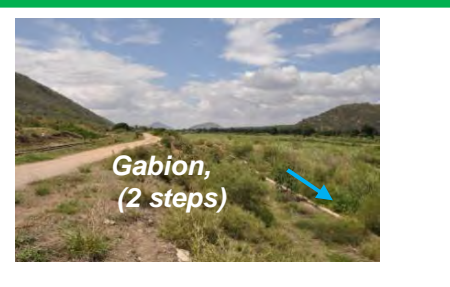
(KM312.8-313.3, Dec.04, 2014)  
 " Gabions (2 steps) are installed for bank protection of low water channel in the 500m section and at outlet of culvert.

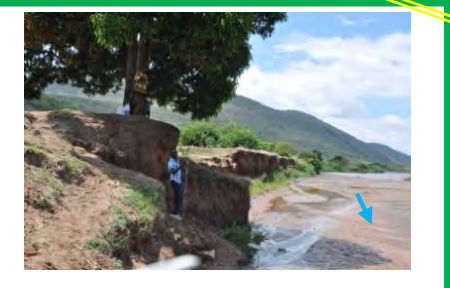
(KM312.3: Dec.04, 2014)  
 " Some of local residents afraid for further progress of bank erosion, and insisting to extend the gabion toward upstream bank.

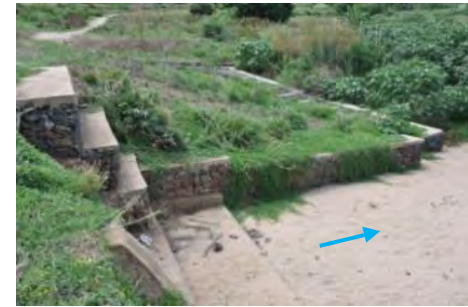
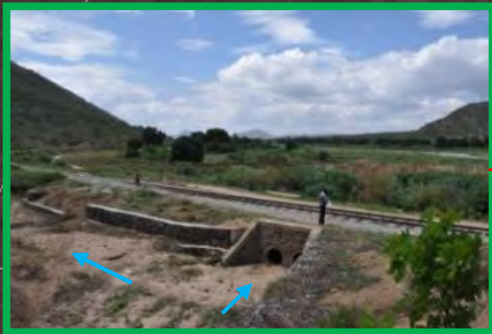
(KM313.3, Dec. 04, 2014)  
" A small tributary joins to mainstream  
" A culvert had been damaged and washed out. After that, the outlet of culvert was restored and reinforced by installation of gabion and apron.

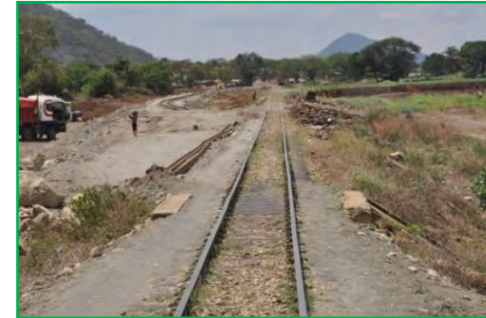
(KM315.0-315.8, Dec.4, 2014)  
 " In march 2014, river bank was seriously eroded by flood. At present, urgent restoration works are being undertaken by TRL/RACHO as follow:

**From 2012.10 to 2014.03**  
**Progress of river bank erosion by approx.50-70m / 2years**

- 1) Diversion of railway track (800m) to land side by 18m
- 2) trimming of eroded slope and backfilling at most eroded section
- 3) installation of gabions (3 steps) at toe of bank

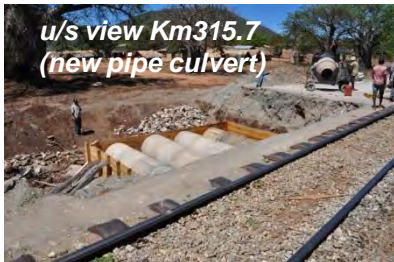
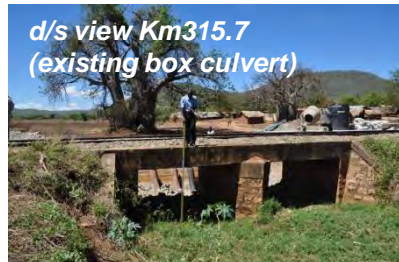
(KM315.7, Dec.6, 2014)  
 " Installation of new culvert sat Km315.0 and Km315.7

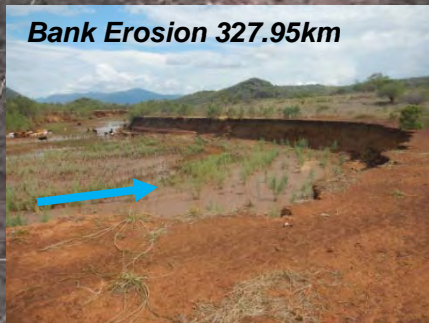
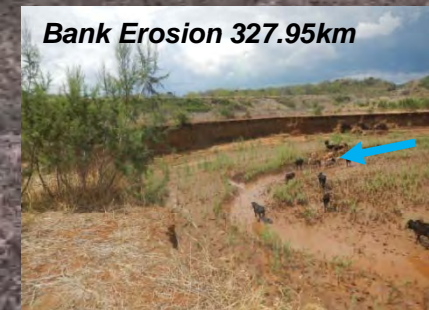
**From Jun 2012 to Dec 2014  
Progress of river bank  
erosion by approx.50m**

- Notable riverbank corrosion has been occurred at 327.95 km point of the water colliding front.
- About 50m corrosion has been advancing during two years and a half between present (December, 2014) and the aerial photograph as of June, 2012.
- A flood risk is judged as Medium since the distance from bank to track is 60m and the bank height is 8m.
- Countermeasures of backfill and installation of low water channel protection are required.

- Monitoring the distance from bank to track at 327.95km point are recommended.

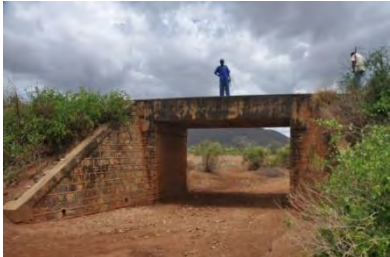
(KM333,4-333,6,Dec.02,2014)  
 " No damage  
 " Culverts in this section are installed aiming at drainage of rainwater

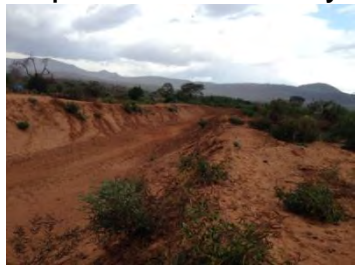
(KM337.0, Dec.02,2014)  
 " Outlet channel is excavated without slope protection and disposal spoils are left on the bank shoulder.  
 " Proper treatment of spoils is necessary.

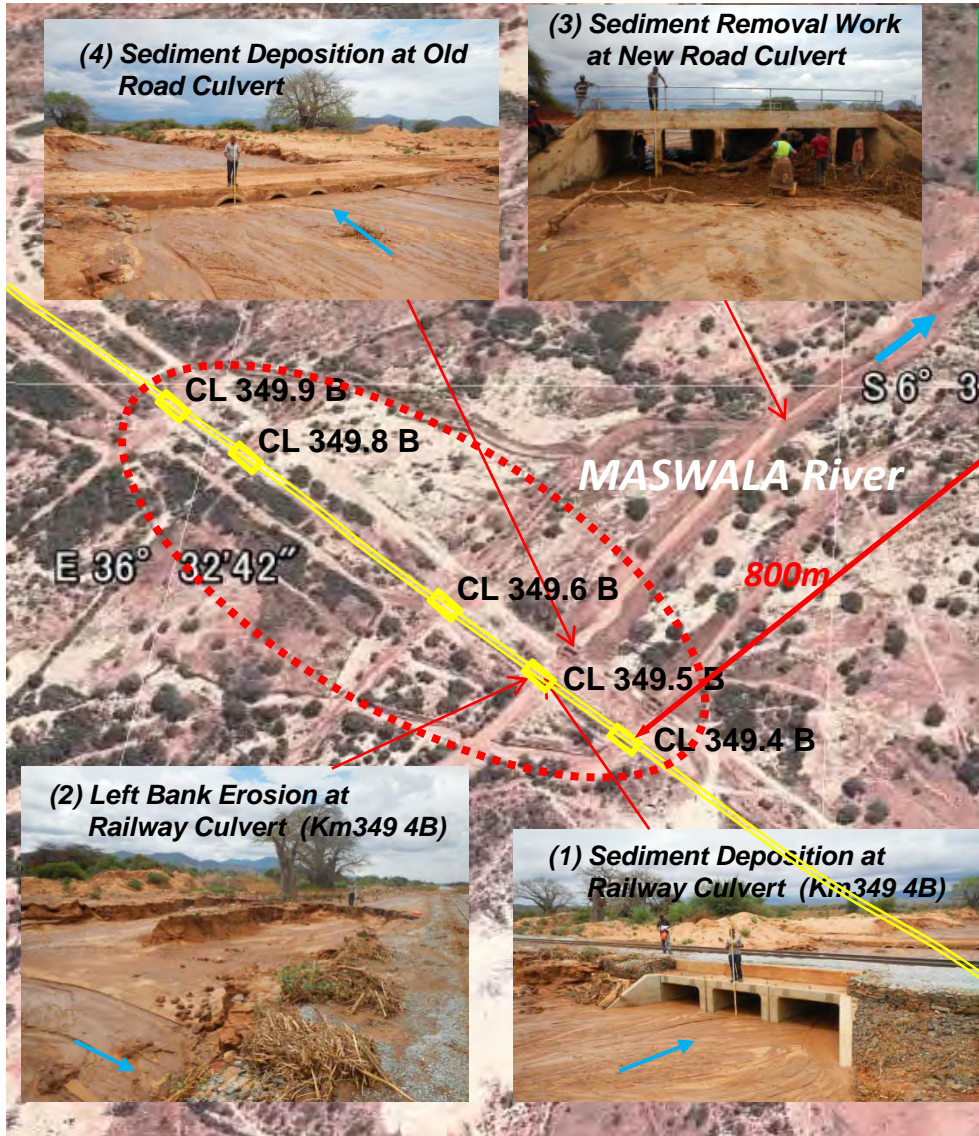
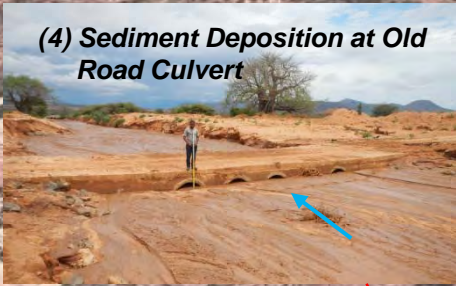
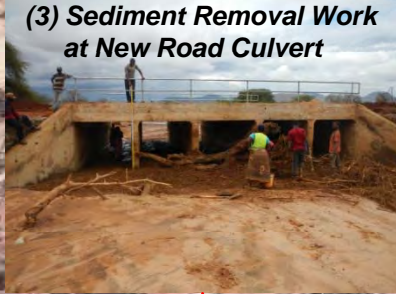
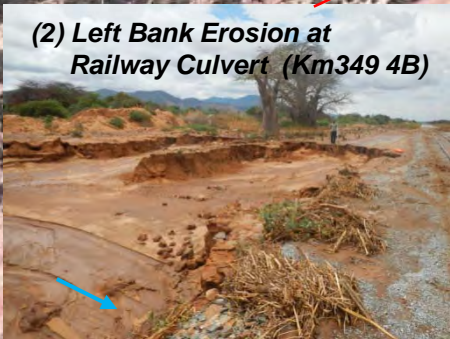
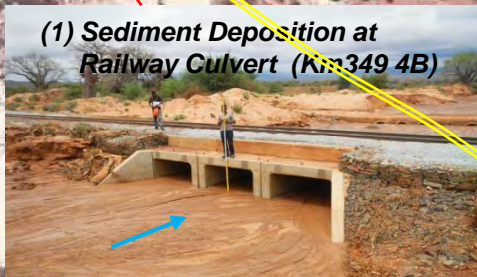
H-43

1. River Condition (KM349.4B-349.9B: Dec.2, 2014)

- A flood risk of bank erosion from main stream is judged as Low since the distance from bank to track is 800m and the bank height is 3m.

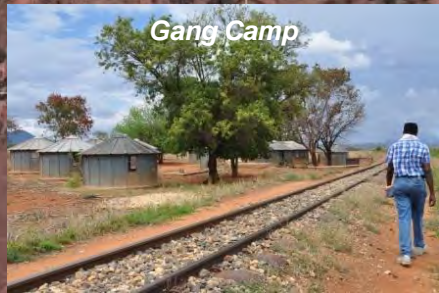
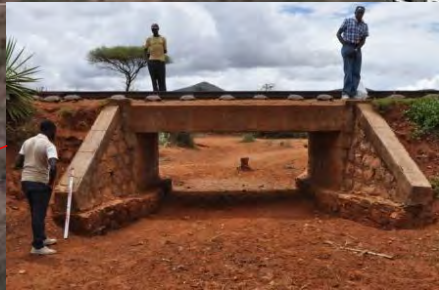
(Km352-Km353, Dec.01,2014)  
" Railway is relatively safe as the river bank is located away from the track.  
" About 30 years ago, there was a Lake Nzuhé in the section between Km 350 and Km352. The weir was collapsed in 1955. At present, the lake was disappeared due to sedimentation and the deposited area is cultivated

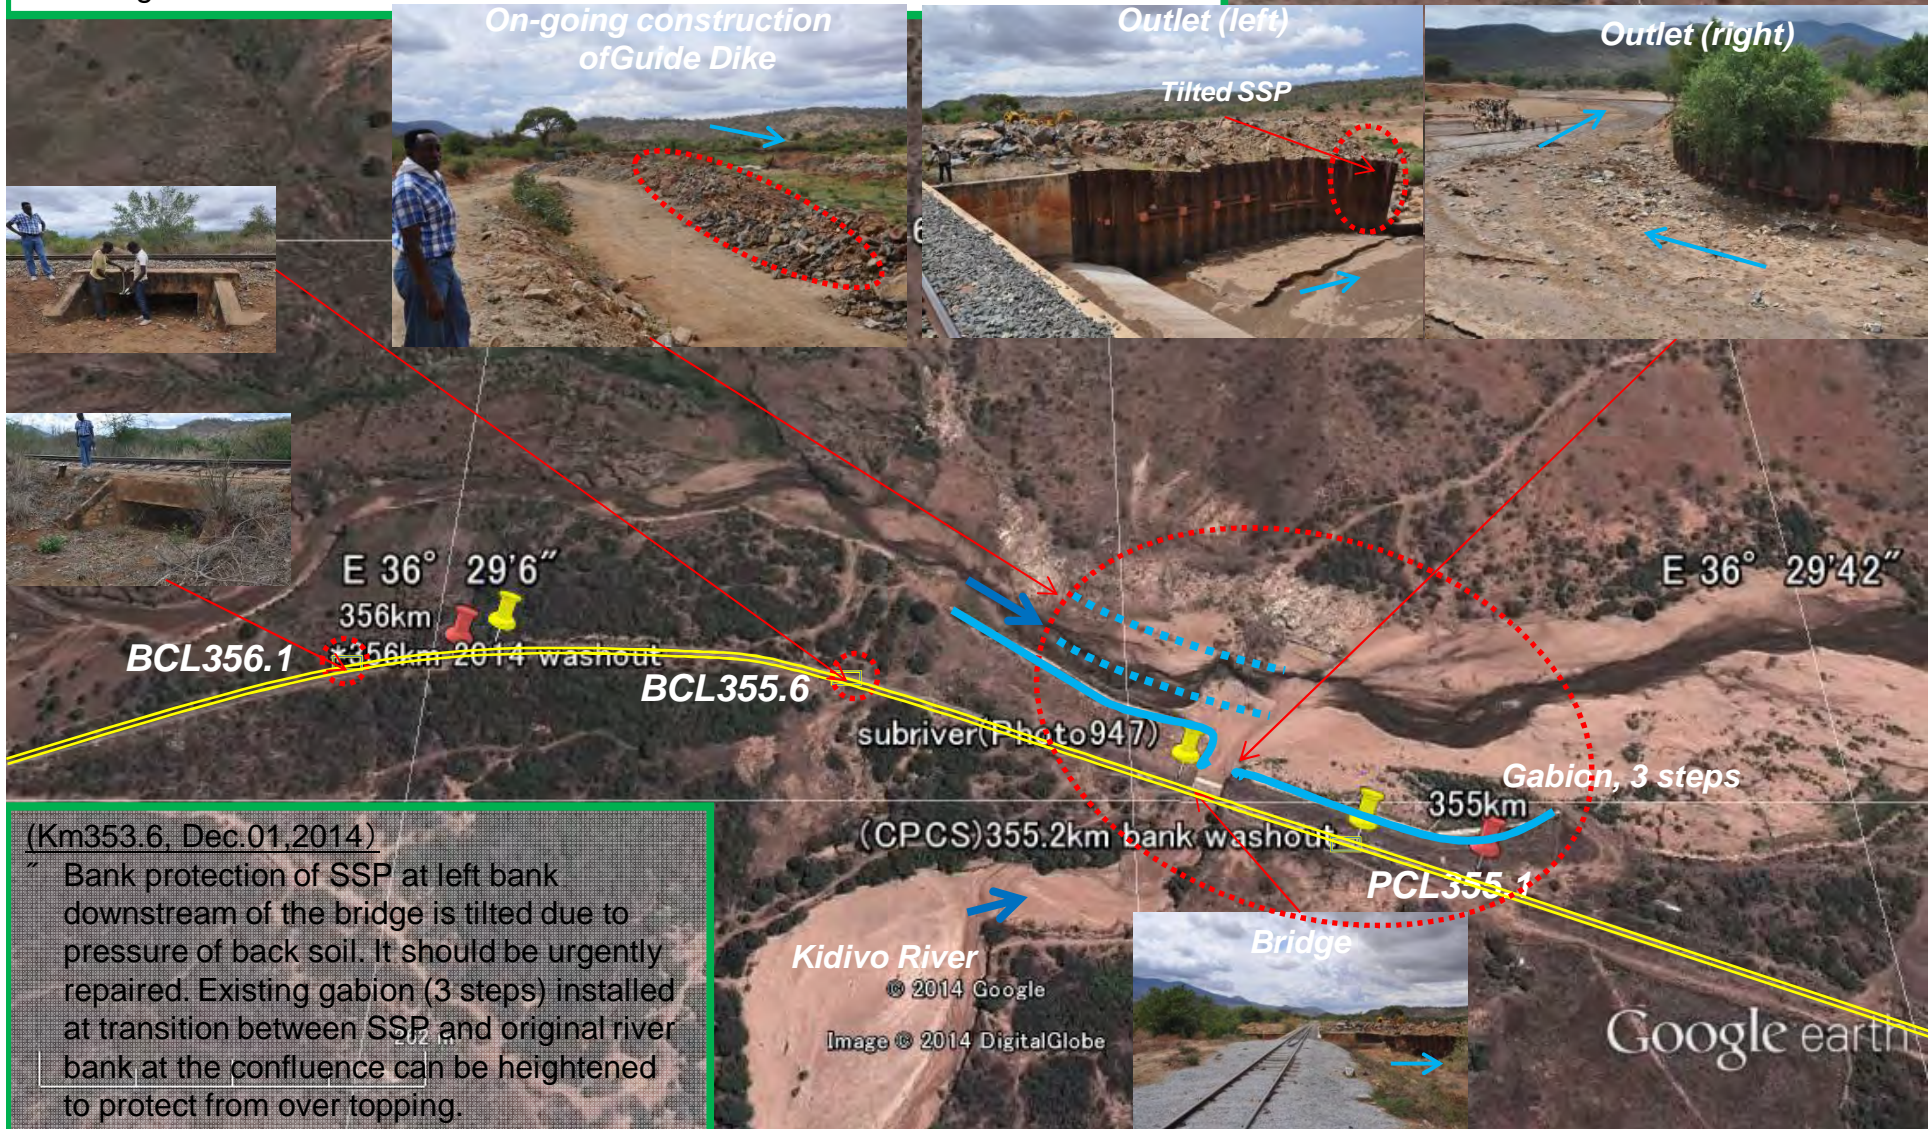
(Km353.6, Dec.01,2014)

- “ Bank protection of SSP at left bank downstream of the bridge is tilted due to pressure of back soil. It should be urgently repaired. Existing gabion (3 steps) installed at transition between SSP and original river bank at the confluence can be heightened to protect from over topping.
