**Preparatory Survey on  
Flood Protection Measures for  
Central Railway Line  
in the United Republic of Tanzania**

**Final Report  
Volume 1: Main Text**

**July 2016**

**JAPAN INTERNATIONAL COOPERATION AGENCY**

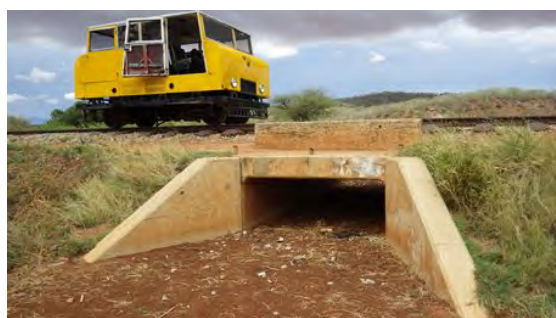
**Figure 3.13: Box Culvert (Km 359)**

Culverts frequently become clogged with sand carried by running water (Figure 3.13 above). When a culvert becomes clogged, running water crossing under the track stops, causing overflows and/or backwater flows. When running water hits an embankment slope, the embankment will be eroded, causing a higher possibility of embankment destruction, to be mentioned below. Moreover, backwater around a culvert causes water penetration into the embankment, reducing its strength.

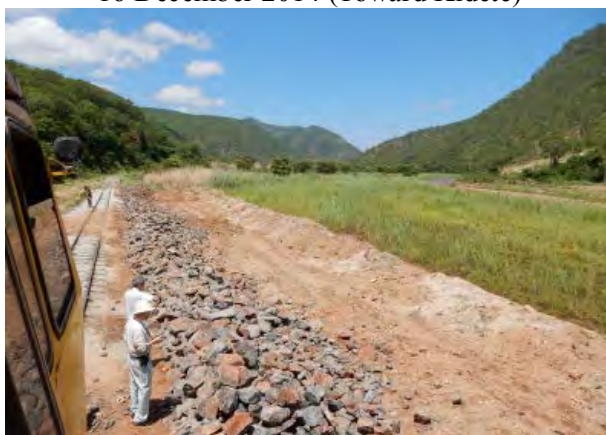
16 December 2014 (Toward Kidete)

In December 2014, to prepare for the protection against the coming rainy season, the temporary urgent protection work was conducted. The work included land filling and gabion works along the riverbank.

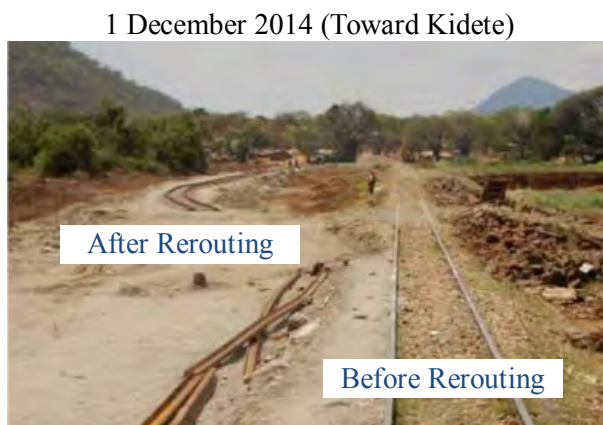
### **Km 315**

The erosion of the riverbank was very close to the track.

In early December 2014, to prepare for the protection against the coming rainy season, the track was re-routed toward the mountain side (max. 18 m diversion).

On 18 December 2014, the trial run was conducted successfully.

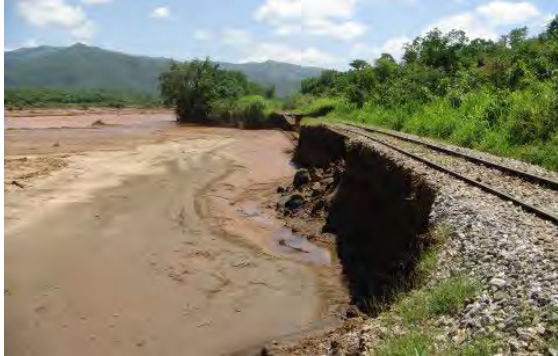
<p><b>Pattern 1-2:</b> Erosion of the track embankment. An example at Km 299.5</p>

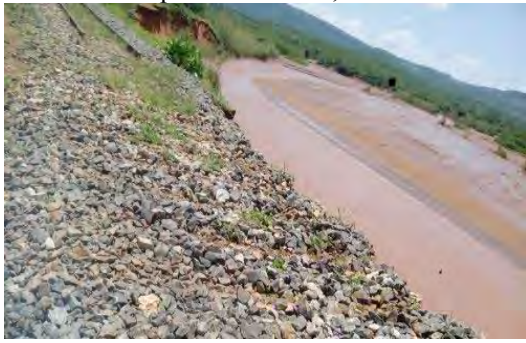
<p>An example at Km 337.4, 6 March 2015</p>

<p><b>Pattern 1-3:</b> Washaway of the track and/or water/mud flowing over the track An example at Km 302 (toward Kilosa) The track was washed away by the flood.</p>

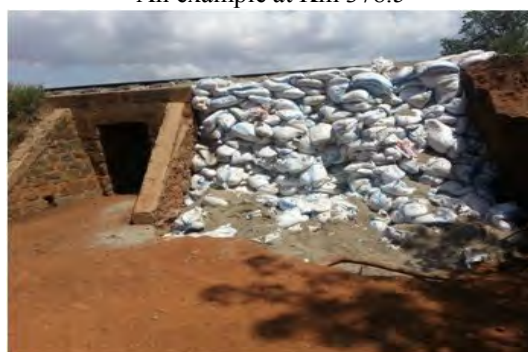
**Pattern 2-2: Damage of the track embankment**  
An example at Km 378.5

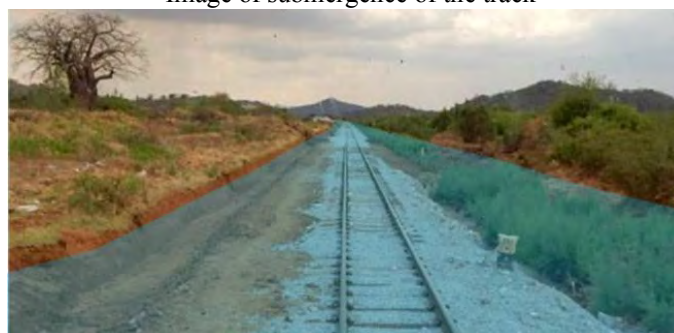
An Example of at Km 363 (toward Gulwe)

**Pattern 3: Submergence of the track by the floodwaters from the main stream and/or tributaries/slopes of mountains, due to inadequate drainage along the railway**

· Image of submergence of the track

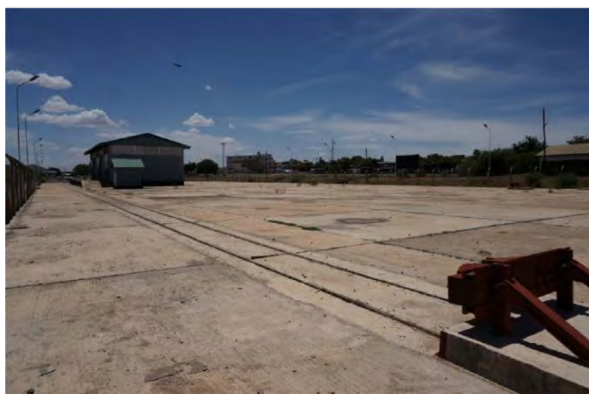
**Figure 3.21: Shinyanga Inland Container Depot, 2013**

Shinyanga ICD has completed construction, but has basically no activity due to the low capacity of TRL. The original rationale for construction for this ICD was to containerize cotton/cotton cake for export, as Shinyanga is a major cotton production area. However, as later described in Chapter 4 (Traffic Demand Forecast), TRL has completely lost this business, and Shinyanga sits idle. The Government of Tanzania is working with Chinese investors to drastically grow industries in this area; many of them are cotton-related but not all of them, so there is potential for future use of the ICD.

RAHCO is still in the process of inviting tenders for leasing this ICD. Two of the five container reach stackers donated by the BTC to RAHCO were intended to go to this ICD, but they are still in Dar es Salaam, and there is an open invitation for bidders for their leasing. At present, there is a low probability that they will actually end up at Shinyanga in the near future, since there is no demand there for their use. (More private ICDs are opening in Dar es Salaam, and it is more likely that they will end up there.) Figure 3.21, from a METI Study Team site visit, demonstrates the lack of activity at Shinyanga ICD in October 2013:

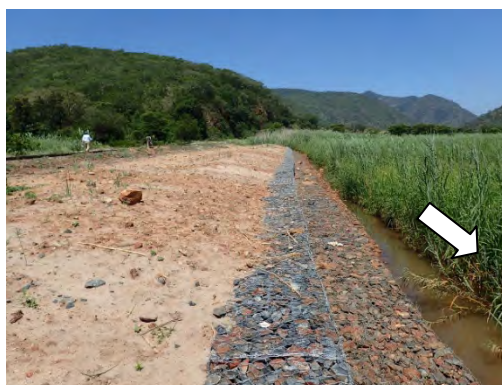
**(2) Km 301.7–302.2**

This site was heavily eroded and the embankment was totally washed away by the flood in March 2014. Then, TRL provided riverbank protection by gabion, completing in February 2015.

**Figure 5.10: Completed Revetment  
by Gabion at Km 302**

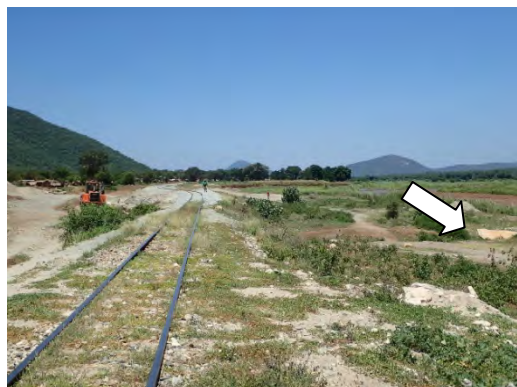
**(3) Km 315.0–315.8**

This site has been considered as the most dangerous site for bank erosion, because in August 2014 only a few meters are left between the existing track alignment and the shoulder of riverbank. Then, in October 2014 TRL started restoration works, including shifting the railway alignment toward the mountainside at maximum 20 m. Shifting of the rail has been completed. On the other hand, the revetment by gabion boxes (upper portion) has been suspended in the middle of this section in February 2015. It is reported that the budget for restoration works has run out and a resumption of work is pending, waiting on a release of funds to complete the remaining section. Construction works of a new box culvert located at Km 316.5 have been completed.

**Figure 5.11: Completed Shifting of Railway Alignment at Km 315**

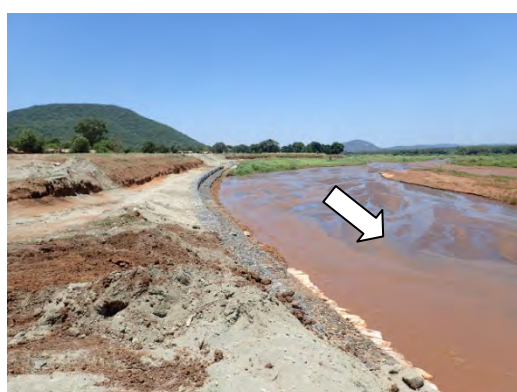
**Figure 5.13: Completed Feature of Revetment Works by Gabion Boxes (Lower Level)**

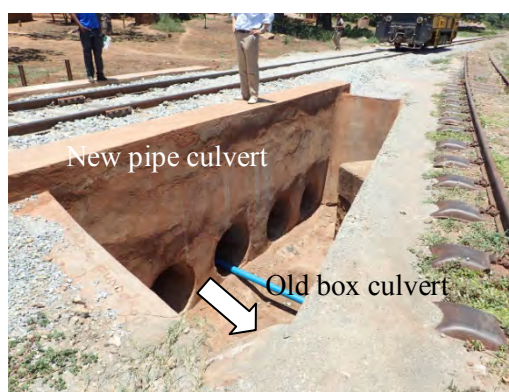
**Figure 5.14: New Pipe Culvert (4 Pipe Culverts) at u/s Side of the Old Box Culvert (2 Barrels, Rectangular)**

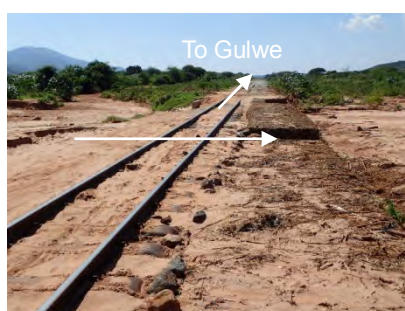
**Figure 5.17:**  
**Near CL 349.8B**  
**(buried)**

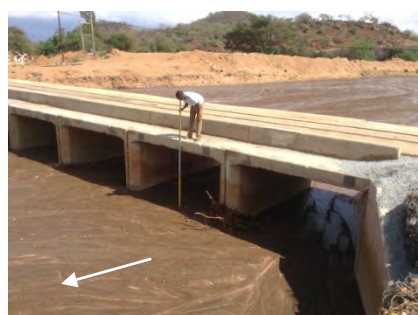
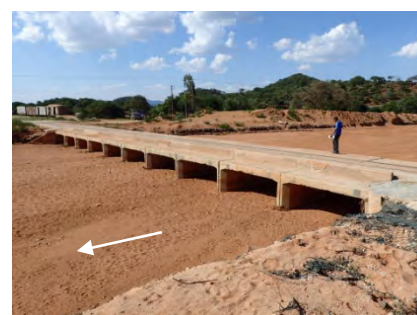
**Figure 5.22: Cross Culvert at Mzase River (Three Different Time)**

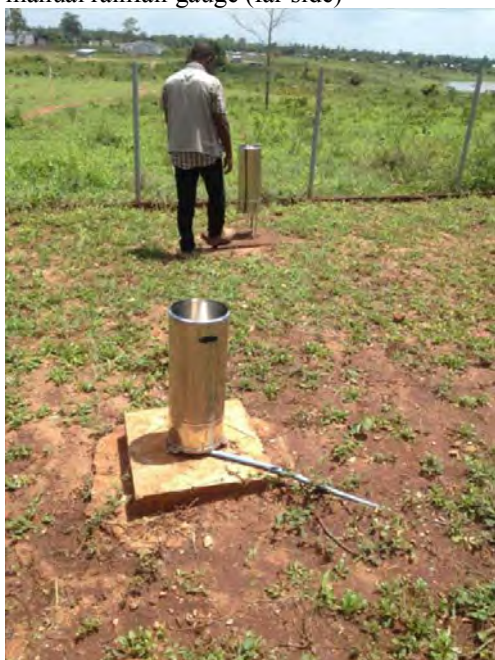
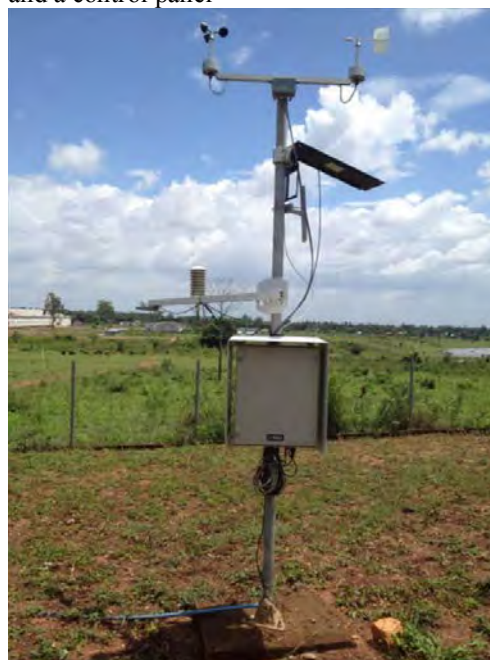
Automatic weather station with a solar panel  
and a control panel

Automatic rainfall data has not been recorded due to a connection error between the gauge and the data logger in the control panel.

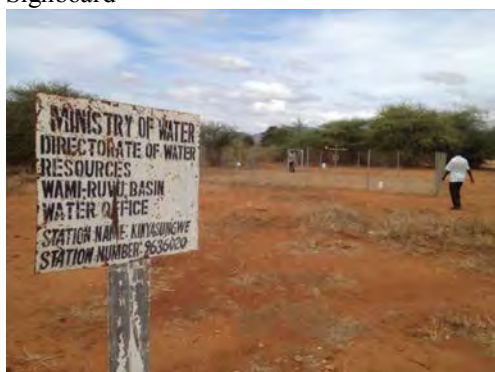
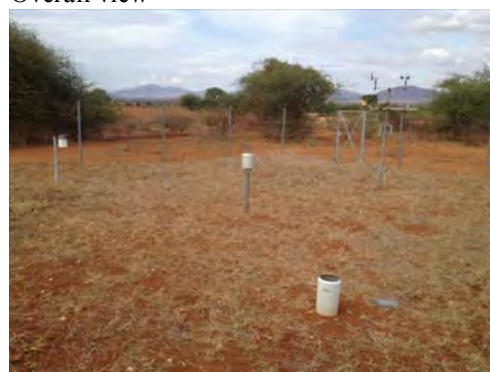
Solar panel of automatic weather station was stolen. Control panel was removed by WRBWO. Manual daily rainfall is only measured.

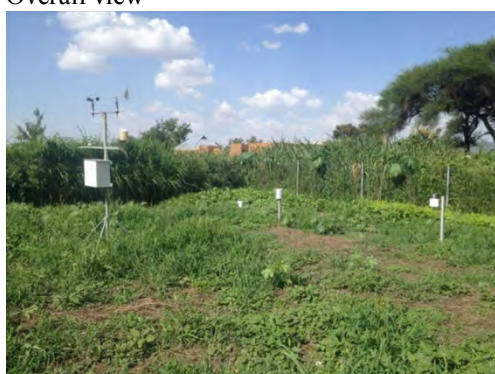
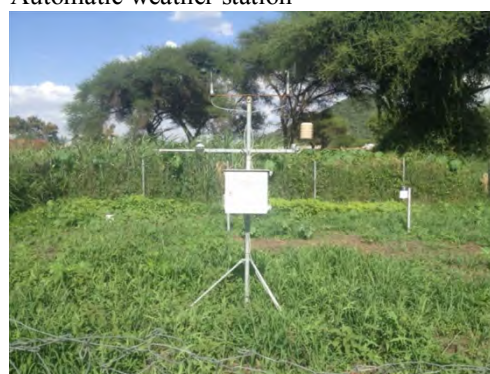
Solar panel of automatic weather station was stolen. Only daily rainfall is measured, manually.

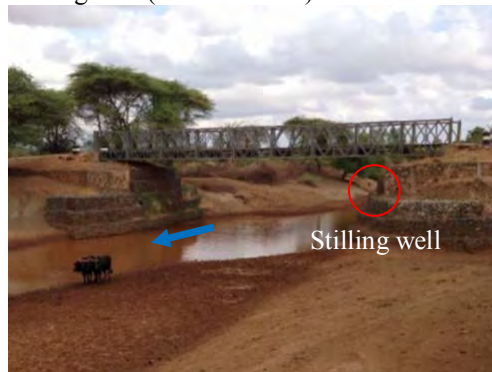
Stilling well (not functional)

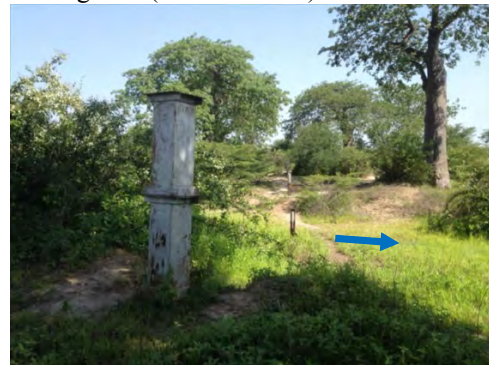
Stilling well (not functional)

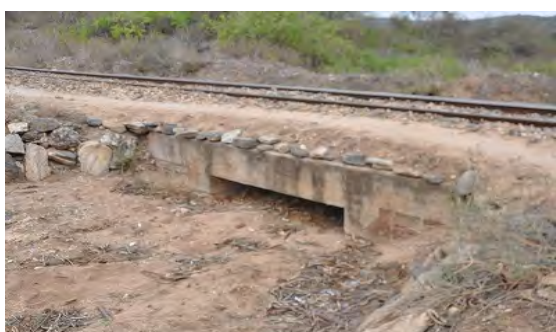
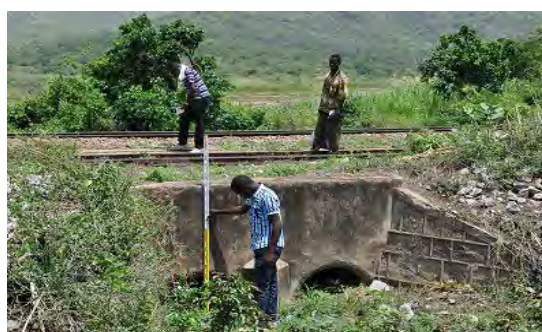
**Figure 6.38: Example of clogged culverts**

During the site reconnaissance in December 2014, the JICA Study Team found frequent clogging of culverts. Figure 6.38 shows typical examples of a “Clogged Culvert”. To assess the flood risk caused to culverts, the criteria was prepared as shown Table 6.23:

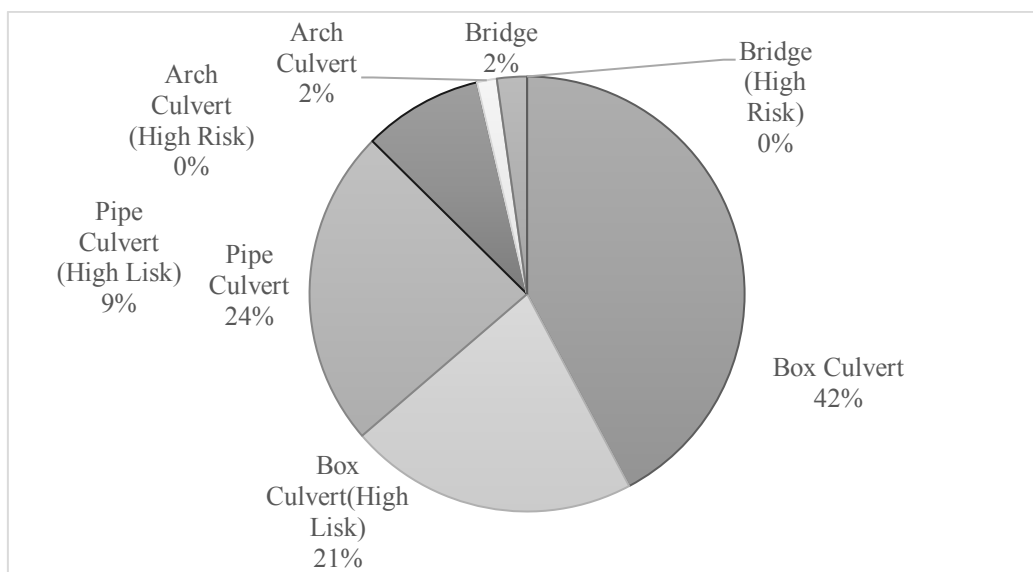
**Figure 6.39: Risk Level of Culverts (135 Structures)**

According to these criteria, the percentage of “high risk” culverts was calculated to be 30% (Figure 6.39).

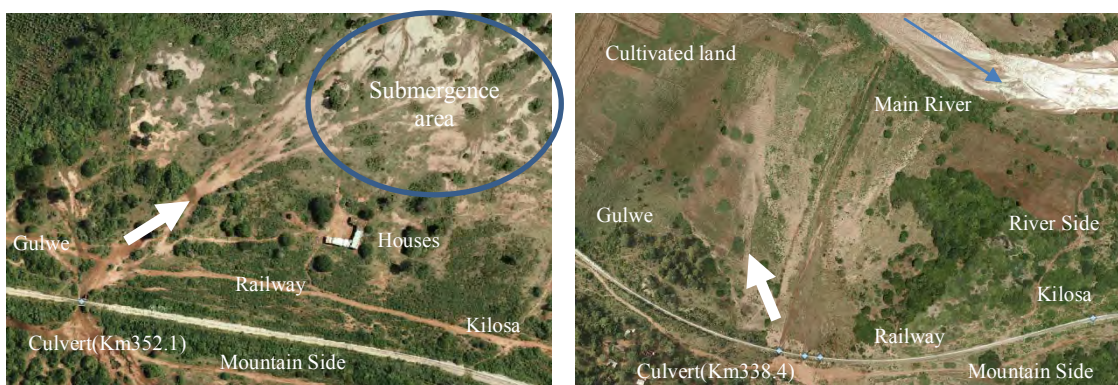
**Figure 6.44: Culvert without Drainage Way**

Figure 6.44 shows examples of culverts without drainage ways. These culverts are usually far from the river. Downstream of these culverts, an area of land is submerged during floods.

Therefore, in order to protect housing and cultivated lands from floods, if the location of the culvert is expected to result in a high discharge of flow from the mountain-side, it is recommended to orient the channel from the culvert toward the main river.

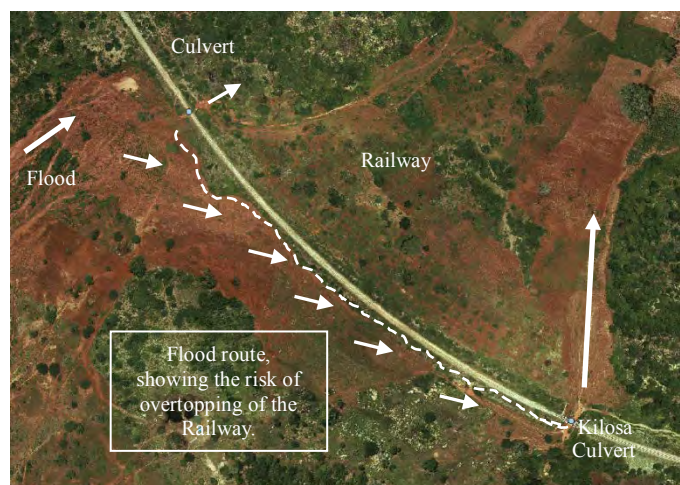
**Figure 6.45: Flood Route around Existing Culverts**

Figure 6.45 is an aerial photo showing the flood route along the railway. In this photo, two culverts were located (upstream and downstream). The flood from mountain-side first met the upstream culvert, but because the capacity of this culvert was not enough, the flood ran along the railway until reaching the downstream culvert. In this case, the floodwaters reached near the ballast of railway. To avoid the risk of such flood disaster, the upstream culvert should have sufficient capacity for drainage.

As demonstrated with this example, for new waterway culverts, topological considerations are very important.

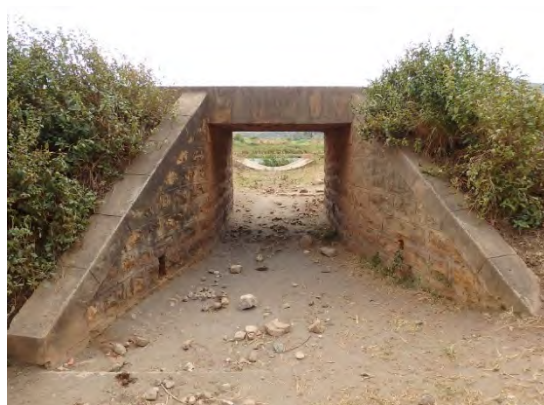
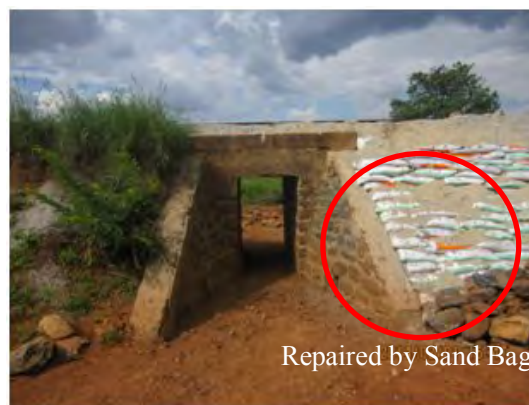
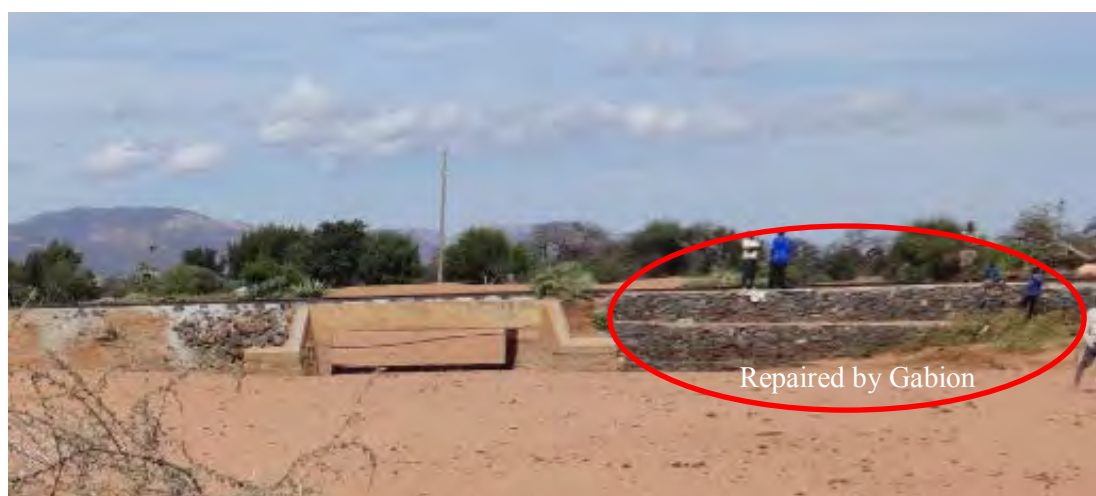
**Figure 6.46: Example of Culvert Intake**

Figure 6.46 shows an example of an intake wall for a waterway culvert, constructed of concrete and masonry. During the site survey, it was found that some culverts had serious damages around the intake. Therefore, it is necessary not only to increase the capacity of culverts, but also to place backfill materials behind the walls of the intakes of culverts.
