## 7. Sediment Analysis

### 7.1 Natural Conditions

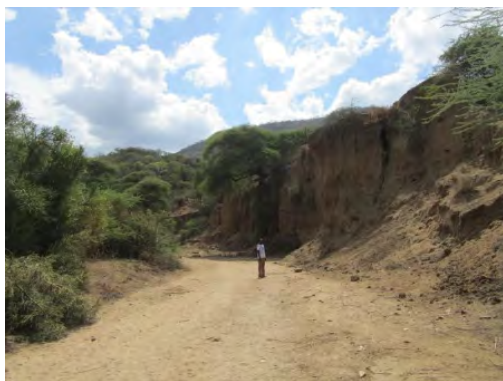
Deposition has No Structural  
Lake Deposit

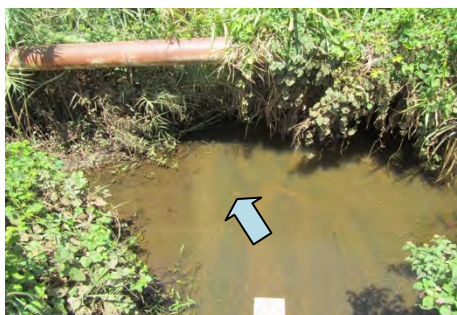
The river condition of the Lumuma River is almost gentle, without riverbank erosion and sediment deposition (Figure 7.22A). The Lumuma River watershed has a valley plain. A small stream, which is the Lumuma River itself, runs through this plain. Traces of sediment transportation are generally not observed in this riverbed.

A: Small River in the Upper Stream

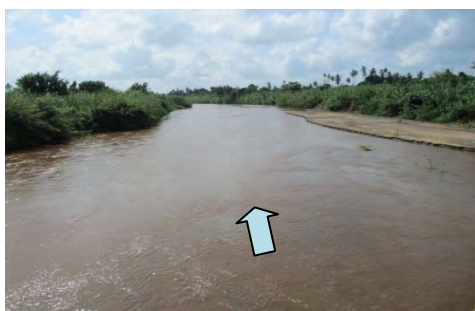
Surface water can be seen at the Kilosa Bridge. However, the water depth is very shallow and a great deal of sediment deposition is observed from the bridge (Figure 7.23A). The material of sediment mostly consists of sand (Figure 7.23B).

A: Marked Sediment Deposition

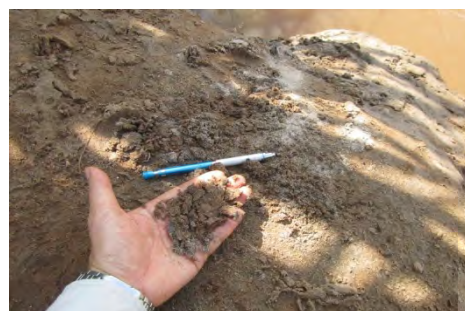
B: Material of Deposition (Sand)

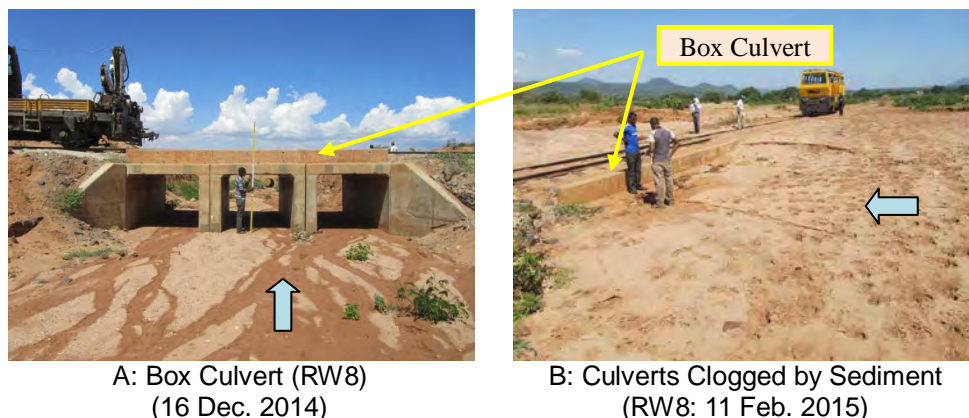
**Figure 7.30: Condition of Maswala River near Godegode Station**

The adjacent areas of these sites are located about 1.5 km from Godegode Station. This section is located in the floodplain of the Maswala River. A great deal of sediment discharge is observed in the riverbed (Figure 7.29A). A thick deposition is spread over this area (Figure 7.29B). The box culvert of Site RW8 was open at the time of reconnaissance on 16 December 2014, but had been clogged by sediment at the reconnaissance time of 11 February 2015 (Figure 7.30A, B).

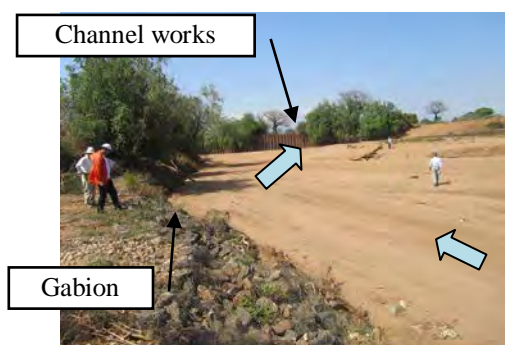
This site is located in the Kidibo River (Km 355.3), which is a right tributary of the Kinyasungwe River. Large areas of cultivated land exist in the upstream areas of the Kidibo River. Therefore, a great deal of sediment is presumed to have been flashed out from there. In this site, channel works were constructed (Figure 7.31A). A large floodplain is observed in the immediate upstream section of Site RW9, and remarkable riverbank erosion is observed along the right bank (Figure 7.31B). On the other hand, the left bank was protected by revetment works (Figure 7.31C, D).

C: Revetment Works along Left Bank

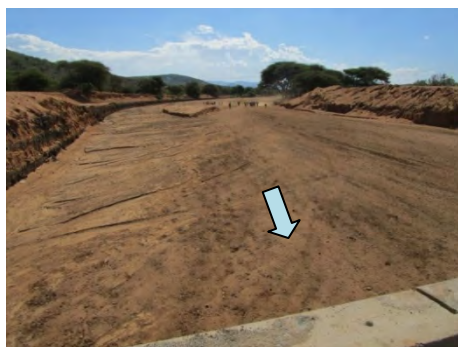
This site is located in the Mzase River, which is stretching out from the southeast side of Gulwe station. A great deal of sediment discharge has been continuing (Figure 7.32A). Riverbed aggradations are the crucial issue for the railway at this site (Figure 7.32B). A great deal of sediment from the Mzase flows into the Kinyasungwe River (Figure 7.32C).

A: Sediment Deposition

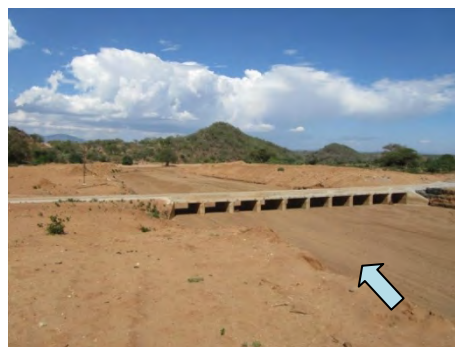
B: Risky Bridge against Flood

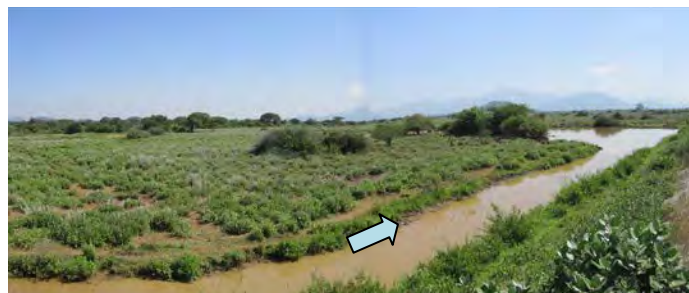
A large plain spreads along the Hodowiku River through the west side of Msagali Village. The railway runs through this plain. This large plain changes to a swamp in the rainy season (Figure 7.33A). Site RW11 is located in this area. The vast plain emerges at the end of rainy season (Figure 7.33B). Sediment which consists of grayish material is observed along the railway (Figure 7.33C). However, the trace, which has a sedimentary structure formed by flooding, is not observed on the outcrop of the deposition. Probably, this deposition is presumed to have been formed in the old age. Similar depositions are confirmed in the upstream areas of the Kinyasungwe and Mzase Rivers.

A: A Large Plain along the Railway (February 2015)

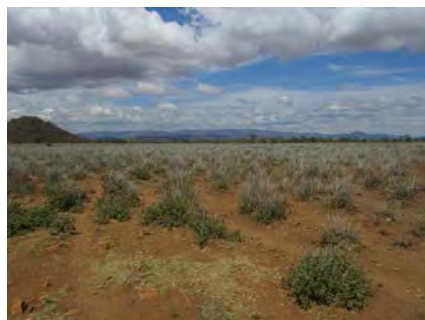
B: Condition in May 2015

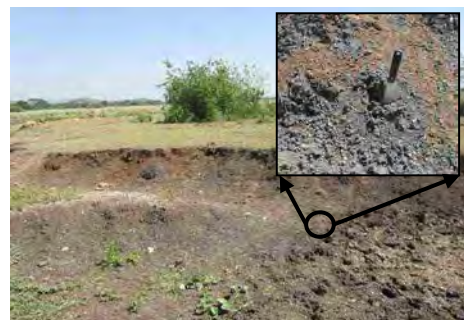
C: Old Sediment Deposition

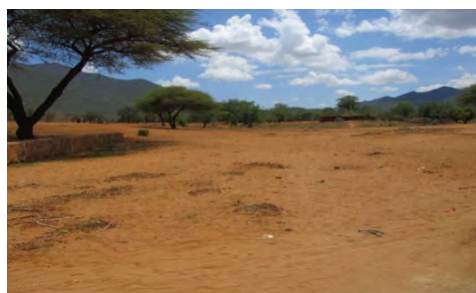
Upstream of the Mzase River, there are widespread large cultivated areas. Figure 7.36A shows the photo during the dry season, and Figure 7.36B shows the condition (covered by grasses) in the wet season. On the other hand, sediment deposition is observed on the upstream side of the road, which has a similar function to the consolidation dam (Figure 7.36C). This sediment was likely transported and deposited by flood discharges from the cultivated lands. The riverbanks of the downstream side are eroded (Figure 7.36D).

A: Cultivated Land of Upstream Side  
(17 Dec. 2014)

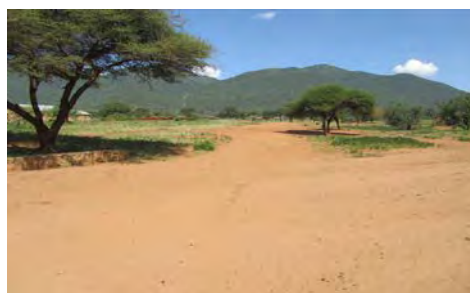
B: Same as (A)  
(5 Feb. 2015)

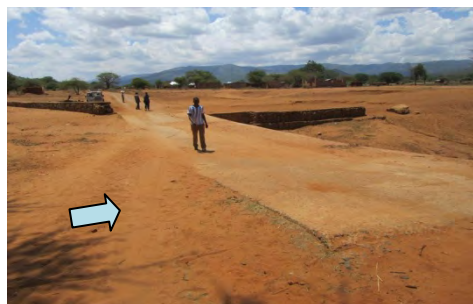
C: Road having Consolidation  
Dam Function

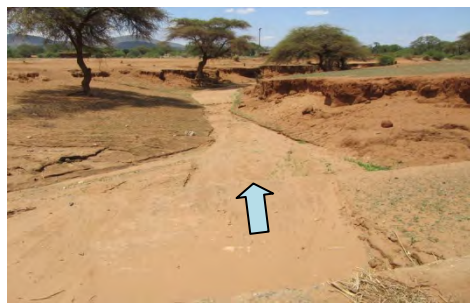
D: Condition of Riverbank Erosion  
at Downstream Side

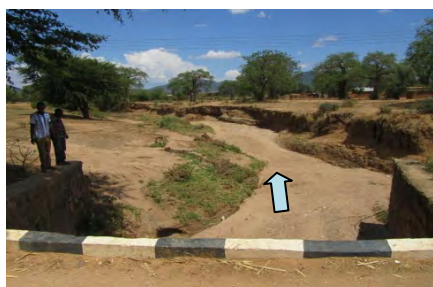
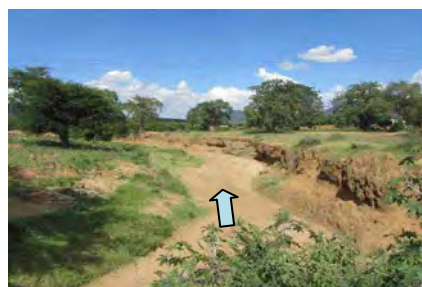
**Figure 7.37: Condition of Upstream Area of the Kidibo River**

This site is located upstream of the Lukole River, which is the left tributary of the Kidibo River. Sediment deposition is observed on the upstream and downstream side of the bridge across the river. However, the deposition is not so significant. Although riverbank erosion is also observed, it is not so serious (Figure 7.37).

A: Sediment Deposition and Riverbank  
Erosion (17 Dec. 2014)

B: Same as on the Left  
(5 Feb. 2015)

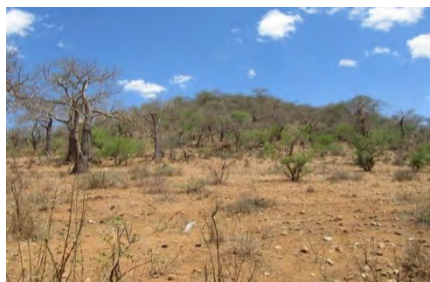
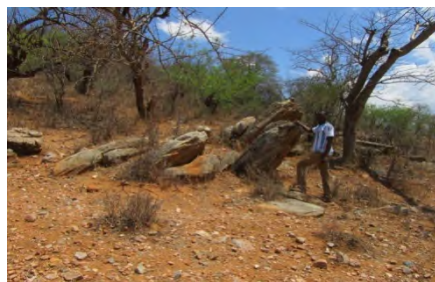
**Figure 7.38: Monadnock, located near Kibakwe Village**

This site is called the “Monadnock”, which as previously mentioned, is a final stage of the historical development of landform (Figure 7.38A). Namely, the current landform shows that this stage of the erosion process has finished. Therefore, the surface soil has been mostly washed away, and an outcrop of the bedrock is observed in places (Figure 7.38B).

A: Monadnock

B: Exposed Bedrock  
and Lack of Surface Soil

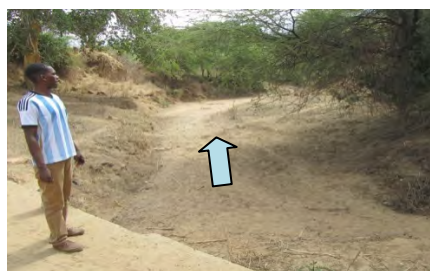
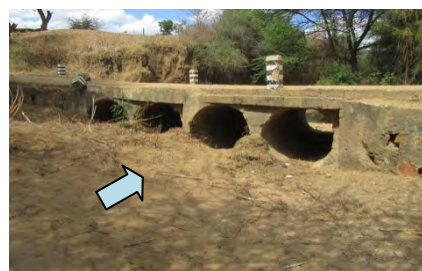
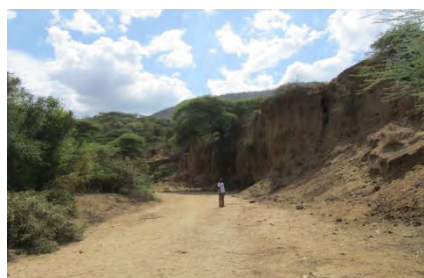
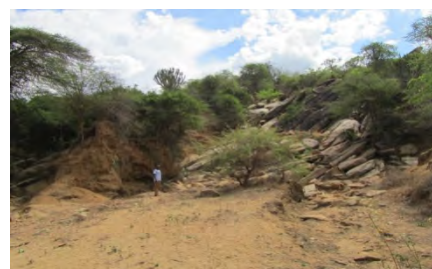
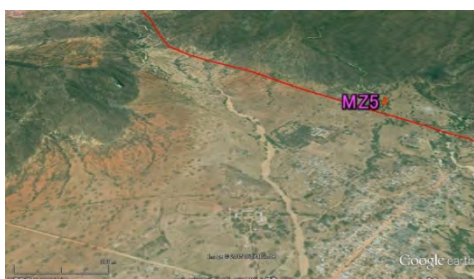
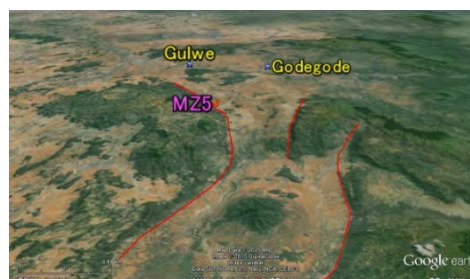
**Figure 7.39: Condition of Upstream Area of the Maswala River**

This site is located upstream of the Maswala River in Kibakwe Village. The sediment discharge in the riverbed is not marked (Figure 7.39A, B). But a great deal of sediment deposition, whose color is grayish brown, is observed at the foot of the mountain (Figure 7.39C). The height of the accumulated deposition of this site is about 10 m. The surface of this deposition forms a very gentle slope. And an outcrop of the bedrock is observed on the river channel at the foot of the mountain (Figure 7.39D). Actually, this landform is unnatural, considering the normal formation process of landforms, because the gentle topographical continuity, which was formed by long-term erosion, is not observed on the boundary between the mountain slope and the deposition. Additionally, the thickness of the deposition is too thick when compared to the height of mountain. In satellite photography, the sediment covering the foot of mountain is clearly observed (Figure 7.39E). Furthermore, according to the satellite photos, it should be noted that this site is located at the end of the small rift valley (Figure 7.39F).

A: River Condition

B: Little Sediment Deposition

C: Thick Deposition

D: River Channel at the Foot of Mountain  
(Outcrop of Bedrock)

E: The Foot of Mountain Covered  
by Sediment Deposition  
(Red Line: Presumed Fault)

F: Site MZ5 Located  
in the Small Rift Valley  
(Red Line: Presumed Fault)

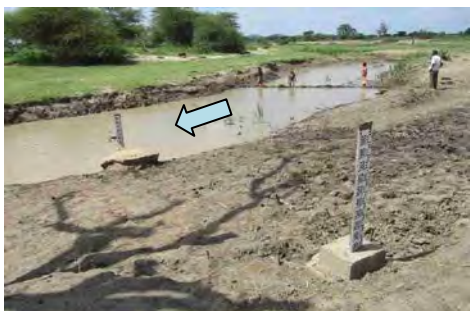
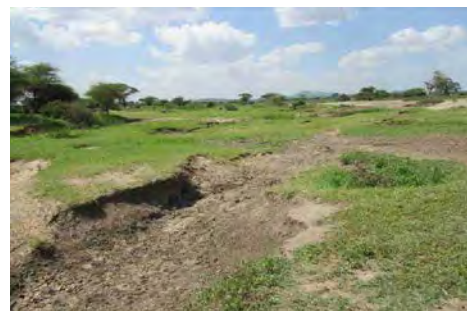
**Figure 7.41: Condition of Itiso Site**

This site (Itiso) is located downstream of Site UG1, and is a water level gauging station (Figure 7.41A) managed by the Wami/Ruvu Basin Water Office. A small amount of surface flow was observed at the time of reconnaissance. The landform is almost flat, as in Site UG1. Some river channels are observed in the plain (Figure 7.41B). The sediment is colored gray, as in Site UG1.

A: A Small Amount of Sediment Deposition

B: River Channel during Rainfall

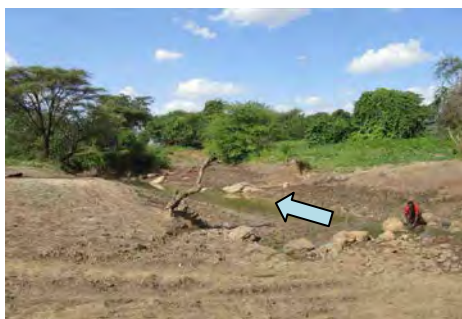
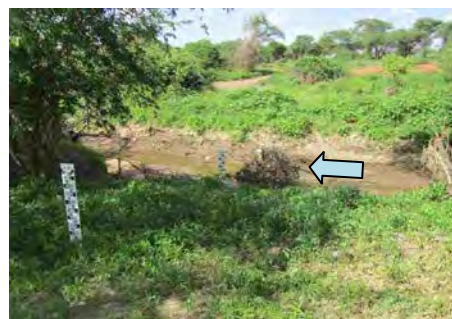
**Figure 7.42: Condition of Ikombo Site**

This site (Ikombo) is located downstream of Site UG2, and is a water level gauging station. The river channel shows a stable river channel. A small amount of sediment deposition is observed (Figure 7.42A, B).

A: A Small Amount of Sediment Deposition

B: Stable River Channel

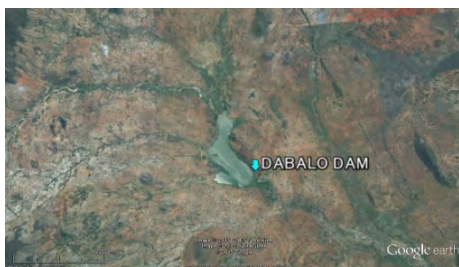
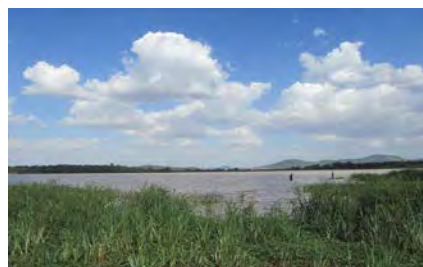
**Figure 7.43: Condition of Dabalo Dam**

Dabalo Dam is located in the upstream area of the Great Kinyasungwe River. Several tributaries flow into the dam reservoir (Figure 7.43A). Since the landform of the Upper Great Kinyasungwe is flat, the sediment discharge is presumed to be minor, as mentioned above. Even if sediment discharges occur, most of the sediment material will deposit in this reservoir (Figure 7.43B).

A: Dabalo Dam

B: Dam Reservoir

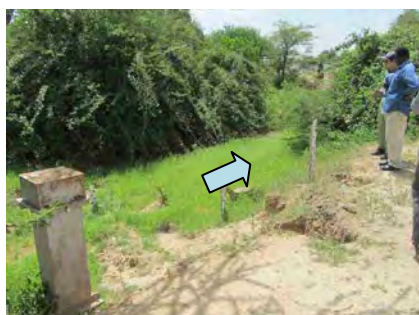
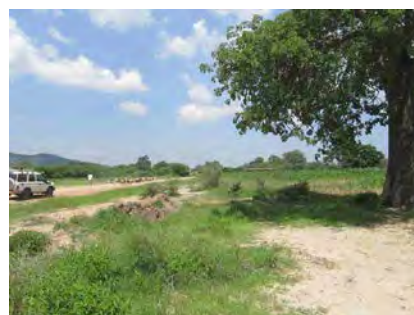
**Figure 7.44: Condition of Mayamaya Site**

This site (Mayamaya) is located upstream of the Little Kinyasungwe River. This site is a water level gauging station (Figure 7.44A). The surrounding landform is flat, and traces of the sediment discharge from the upstream areas are not observed (Figure 7.44B).

A: Water Level Gauging Station

B: Flat Surrounding Landform

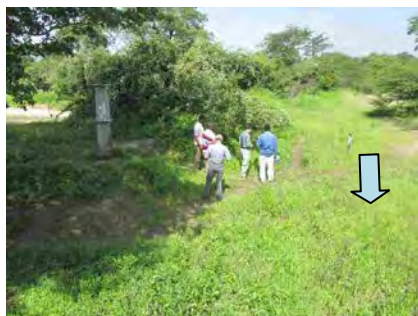
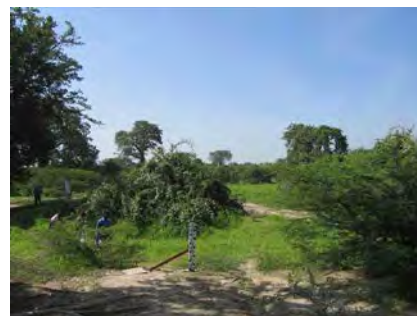
**Figure 7.45: Condition of Chihanga Site**

This site (Chihanga) is located downstream of Site UG5, and is a water level gauging station. The surrounding landform is flat, and traces of the sediment discharge from the upstream area are not observed, as in Site UG5. The river channel is not obviously formed (Figure 7.45A, B).

A: Water Level Gauging Station

B: Obscure River Channel

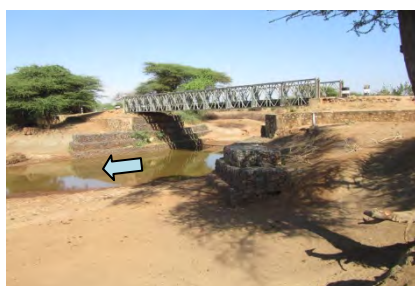
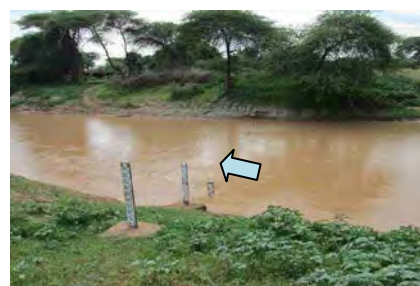
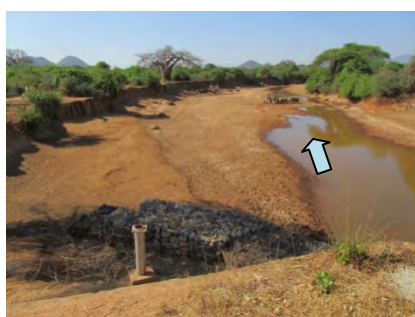
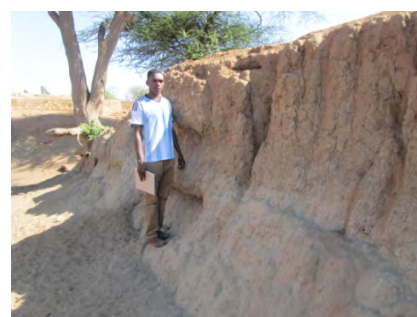
**Figure 7.46: Condition of Kongwa Site**

This site (Kongwa) is located in the middle reaches of Kinyasungwe River, and is a water level gauging station (Figure 7.46A, B). The surrounding landform is almost flat. Obvious sediment deposition transported by floods is not observed in the riverbed (Figure 7.46C). Instead, deposition which does not have an obvious sedimentary structure is observed on the riverbank (Figure 7.46D). Since the surrounding land is formed and composed of this deposition, this channel was formed in a relatively old era.

A: Full View of Site UG7

B: Water Level Gauging Station

C: Riverbed Condition

D: Old Deposition

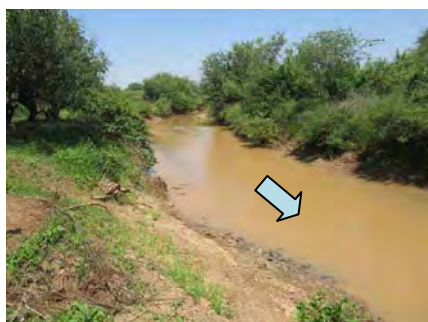
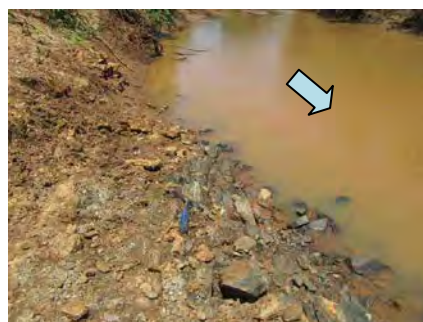
**Figure 7.47: Condition of the Hodwiku River**

This river is the Hodwiku River. This site is located between Gulwe and Msagali. Sediment deposition is not observed in the riverbed (Figure 7.47A). An outcrop of the bedrock is observed in the riverbed (Figure 7.47B).

A: River Condition

B: Outcrop of Bedrock

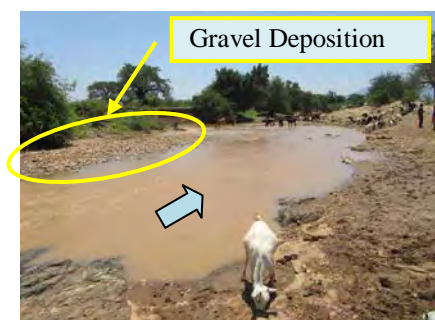
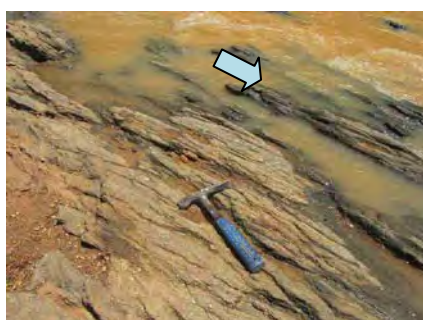
**Figure 7.48: Condition of the Hodwiku River**

This site is located downstream of Site UG8. Sediment deposition is almost not observed in the riverbed (Figure 7.48A). But a small amount of gravel deposition is observed on the left bank. An outcrop of the bedrock is observed in the riverbed (Figure 7.48B).

A: River Condition

B: Outcrop of Bedrock

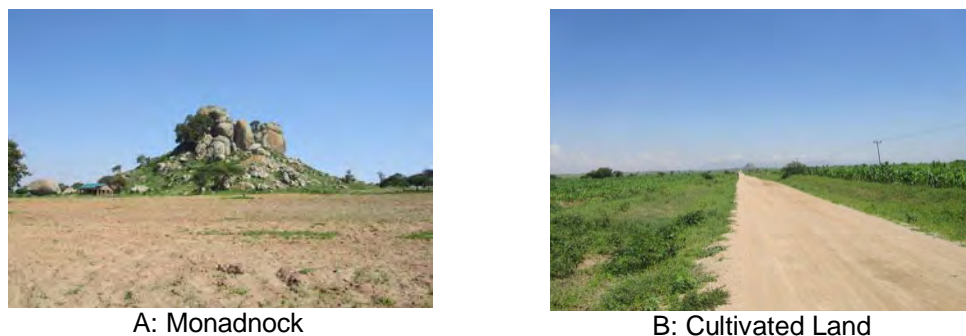
**Figure 7.50: Landform of the Northern Part of Mangweta**

Site Ma1 and Site Ma2 are located near the watershed boundary of the northern part of Mangweta. Site Ma1 is Monadnock, which shows the stage of the old age (refer to Section 7.2.1), and is in the process of topographical change (Figure 7.50A). Site Ma2 reflects the typical landform of the northern area (Figure 7.50B).

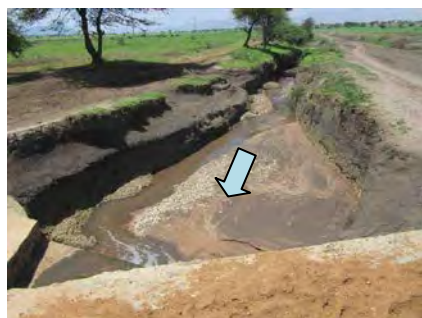
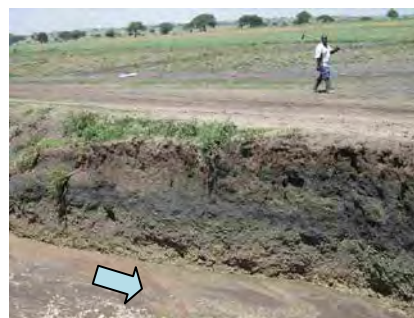
**Figure 7.51: Condition of the Northern Part of Mangweta**

This site is located at the northern part of Mangweta. The northern area is covered by reddish and gray soils. The gray soil is observed along the small rivers (Figure 7.51A). Since this gray

layer does not have a sedimentary structure, this deposition is presumed not to have been the deposition which was formed by floods (Figure 7.51B).

A: Gray Soil along the River Channel

B: Layer Structure in Deposition

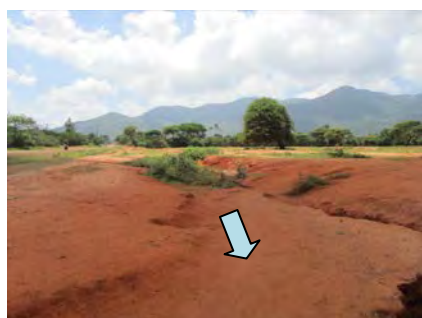
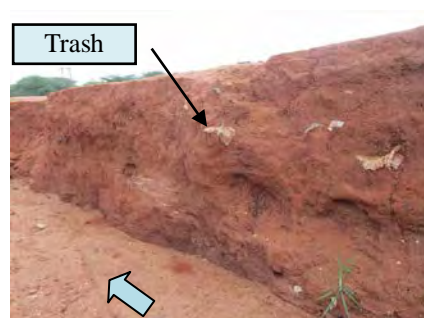
**Figure 7.52: Condition of the Northern Part of Mangweta**

This site is located at the northern part of Mangweta. The reddish soil spreads over this northern area, as shown in Figure 7.52A. However, rubbish, which has been caught between soils, is observed here (Figure 7.52B). Surface erosion seems to be active in this area.

A: Land Covered by Reddish Soil

B: Rubbish Spread throughout the Reddish Soil

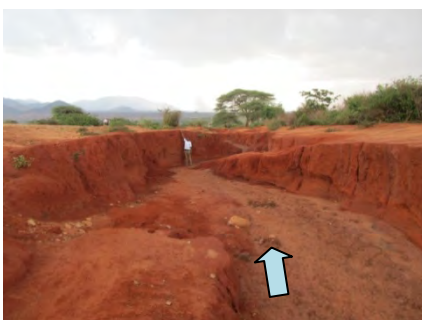
**Figure 7.53: Condition of the Northern Part of Mangweta**

Reddish soil has the characteristic of being susceptible against erosion (Figure 7.53A). The road gutter has been eroded by running waters, which flowed out from the culvert during rainfall. The apron protection works seem effective against erosion (Figure 7.53B).

A: Eroded Road Gutter

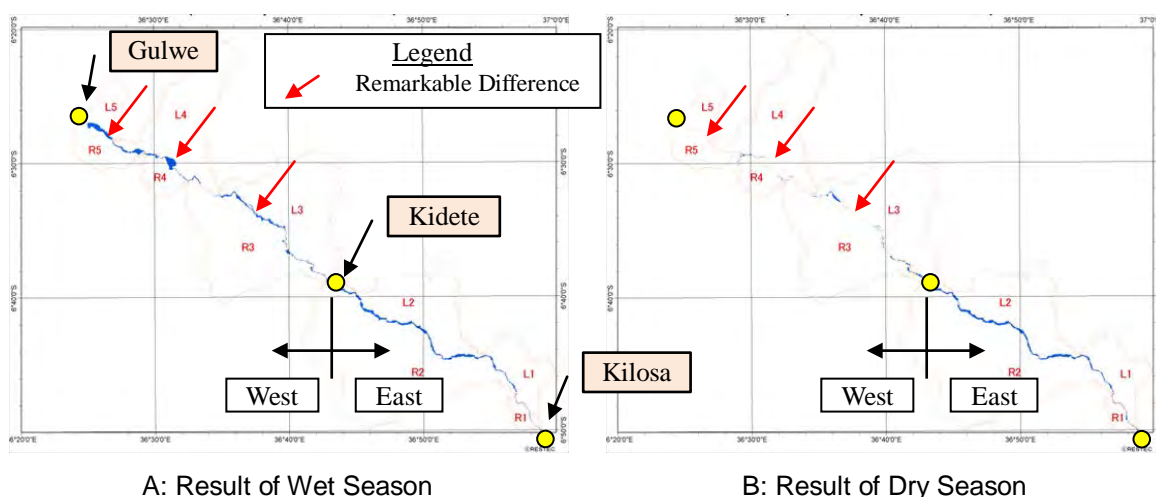
**Figure 7.63: Difference between the Dry Season and the Wet Season**

Figure 7.63 shows the results of analysis. Obvious difference between the rainy and dry seasons is confirmed. The river channel, which is not observed in the dry season between Gulwe and Kidete, is observed in the wet season.

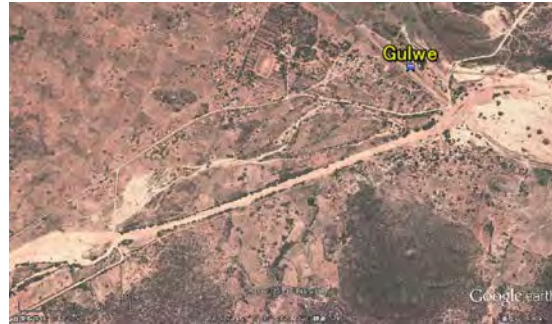
Almost Straight Channel Works

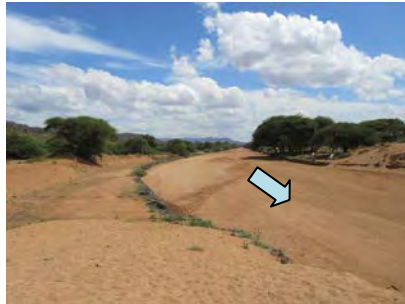
Crooked Zone near the Railway

- i) To straighten the curved channel works near the confluence. The curved channel interferes with the smooth flow and causes the sediment deposition (Section A).
- ii) To stabilize the river channel and to prevent riverbank erosion in the upstream areas of the channel works by means of construction of ground sills, because riverbank erosion would be a major source of sediment (Section B).
- iii) To remain the existing river channel between sections A and B as it is, because the portion works effectively.
- iv) The construction area can be prioritized considering the direct effects to the safety of the railway.

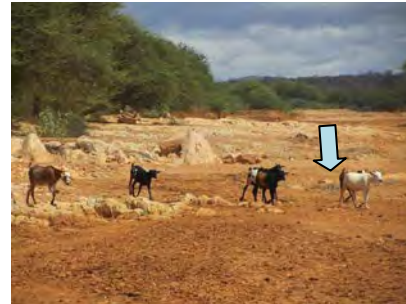
Outcrop in the Channel Works

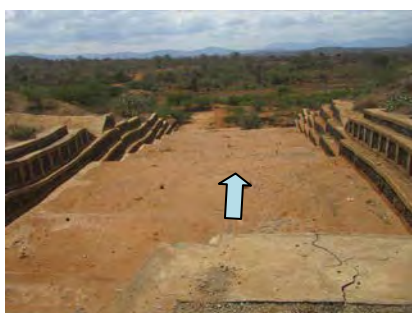
Figure 7.79 shows the current river channels, and Figure 7.79A and B show minor upstream ones. Figure 7.79C and D show the steep slope formed at the end parts of the alluvial fan. Figure 7.79E and F show the downstream river channels which are obstructed by discharged sediment. This condition shows that minor works cannot rectify this situation.

A: Channel Works at the Upstream Side

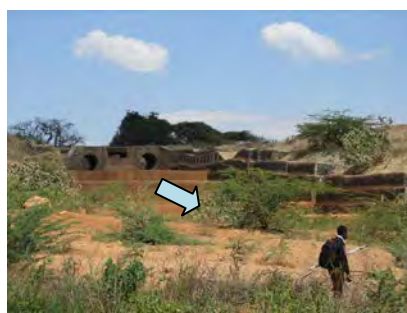
B: Old River Channel

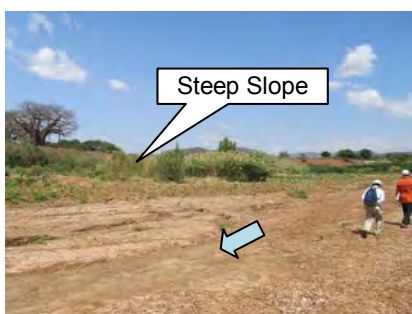
C: Old Alluvial Fan and Mainstream

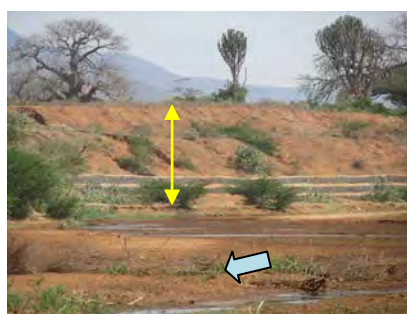
D: Near View of Steep Slope

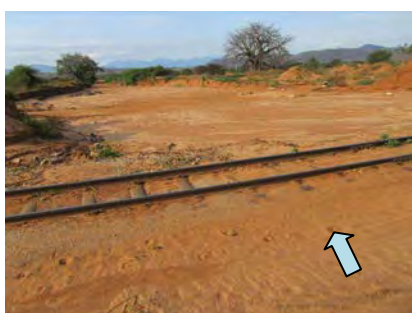
E: Obstructed the Culvert in the Current River Channel

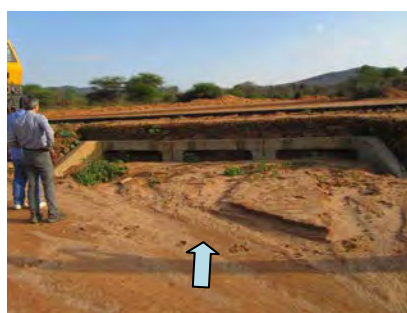
F: Same as on the Left (Next to C)

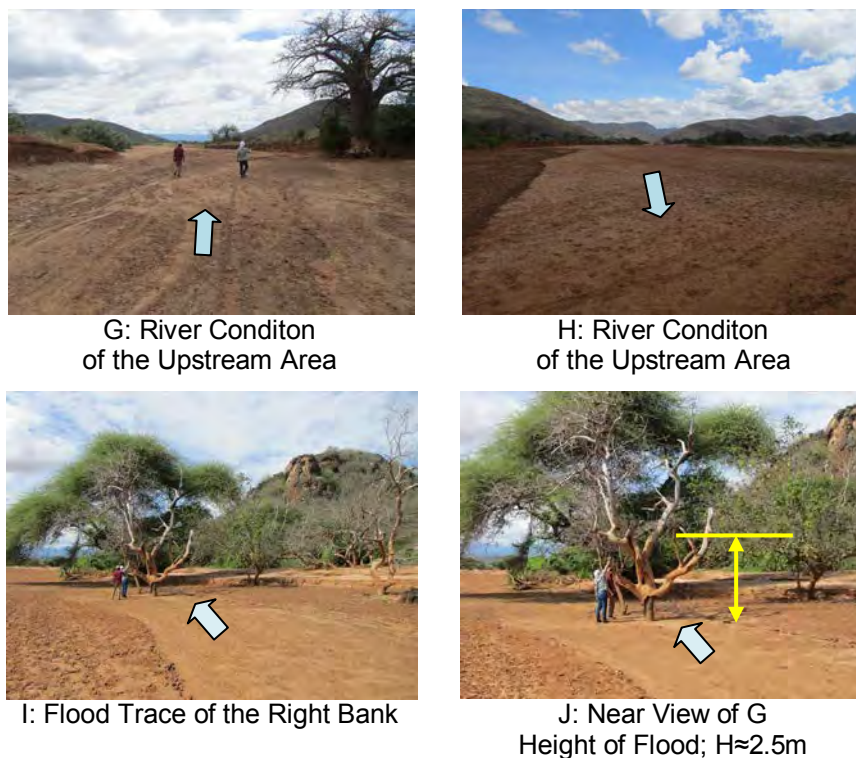
**Figure 7.79: Current River Condition (Maswala)**

On the other hand, Figure 7.79G and H show current condition of the upstream reaches of the river, where the riverbank erosion is remarkable. Figure 7.79I and J show the flood traces on the right bank side. The depth of flood discharge at this site is about 2.5 m.

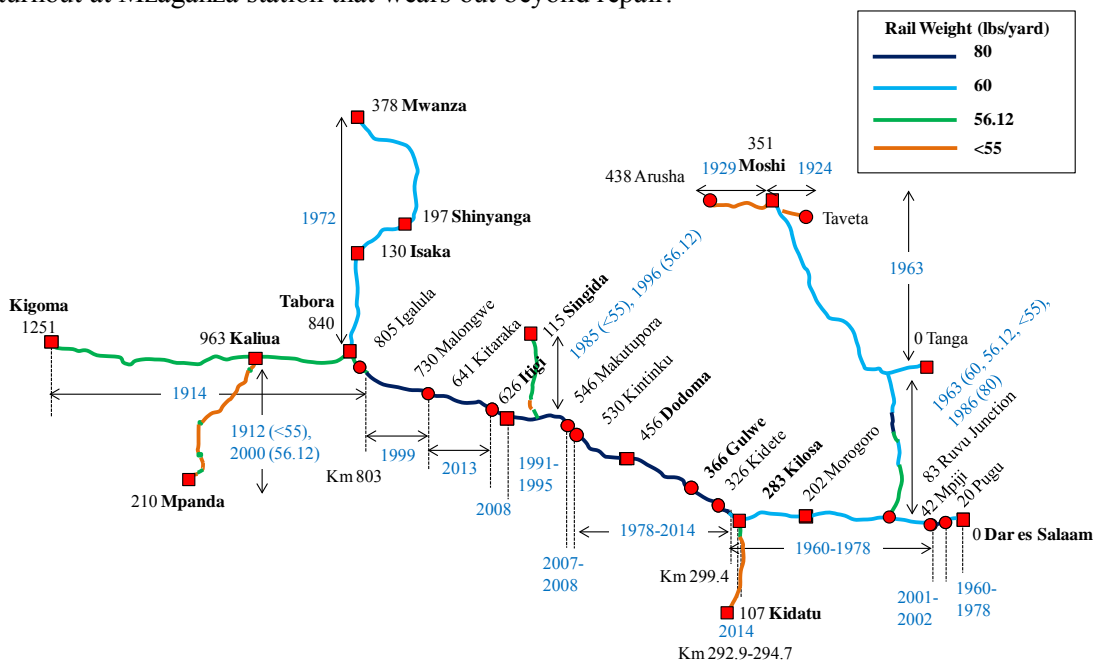
Figure 9.5: Types of the Rails Used on the Central Railway Line

Figure 9.5 shows the distribution of rail weight and installed year on the Central Railway Line. The track from Km 299.4 to Gulwe (Km 366.0) and Dodoma (Km 457.0) re-laid with 80 lb/yd rail between 2001 and 2002 as part of a project to replace 60 lb/yd rail. The track between Km 292.9 and Km 294.7 re-laid with 80 lb/yd as in 2013 as part of a project to construct a new bridge at km 293. The two sections of Kilosa (Km 282.7) to Km 292.9 and Km 294.7 to Km 299.4 remain with 60 lb/yd rail that laid in the 1970s. All 80 lb/yd rails had pandrol compatible sleepers and fastened with pandrol clips while the old 60 lb/yd rails have clip bolt-and-nut type fasteners on K-type sleepers.

Mainline turnouts between Kilosa and Gulwe are of 1:12 dimensions. There are no siding turnouts. There are six 80 lb/yd turnouts between Kilosa and Gulwe while seven similar turnouts are between Gulwe and Dodoma. The intention was to replace all 60 lb/yd turnouts with 80 lb/yd turnouts, but the latter were not in sufficient numbers. Therefore, there are still two 60 lb/yd turnouts between Kilosa and Gulwe and three similar turnouts between Gulwe and Dodoma. All 60 lb/yd turnouts are overdue for replacement due to wear and tear. Turnouts of density 80 lb/yd have some wear but are still in fair condition, except for one monoblock-type turnout at Mzaganza station that wears out beyond repair.

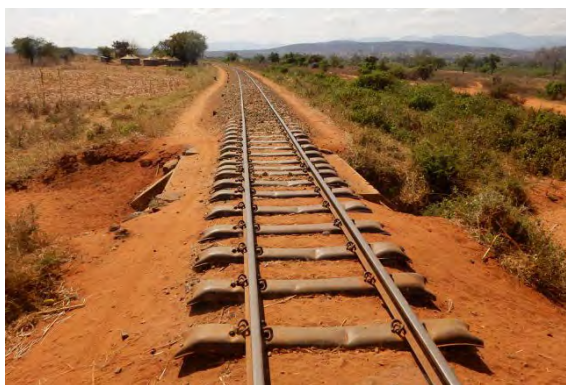
**Figure 9.6: Iron Sleepers**

Some iron sleepers bear buckling scars at their center, presumably because train loads are directed mostly to the center of the rails, due to insufficient ballast thickness underneath, as shown in Figure 9.6.

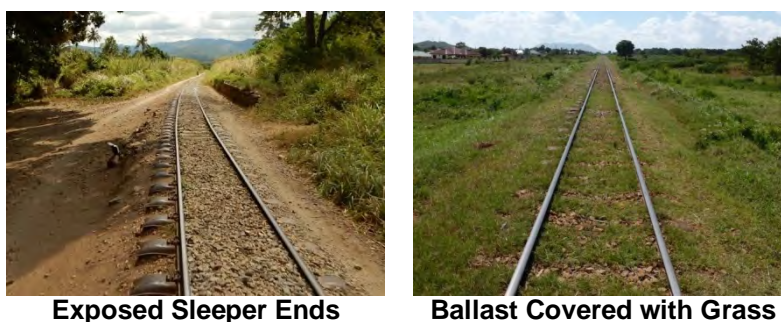
**Figure 9.7: Ballast**

At some places, the ballast is left unattended after spreading in excessive volumes within the track gauge, making it impossible to check the conditions of fish bolts or fishplates (Figure 9.7). The ballast within the track gauge is meaningless for tracks. For the purpose of mechanical maintenance work possible in the future, it is necessary to make sleeper positions clear to determine the tamping points.

The densely grown grass on the track proves that ballast contains large volumes of sand and soil, with the loss of bearing capacity apprehended when floodwaters stay on the roadbed. The Study Team visually confirmed the existence of track irregularities due to ballast subsidence at the joints between bridges and ground-level tracks, presumably because abutments installed on soft grounds had laterally displaced or roadbeds/ballast behind abutments runoff. It is conceivable that reinforcing work is necessary for the future for such civil engineering structures that cannot support ballast track.

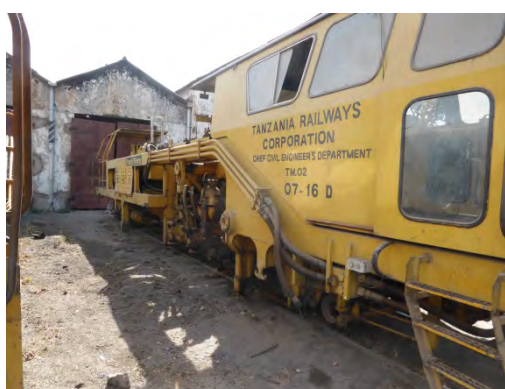
**Figure 9.8: Tamping Machine**

The introduction of heavy maintenance machines is inevitable by increasing destruction of track caused by frequent train operations in the future. TRL owns five tamping machines. One of them is usable of which capacity is 500 m/day. The other four machines do not work because of problems in procuring spare parts.

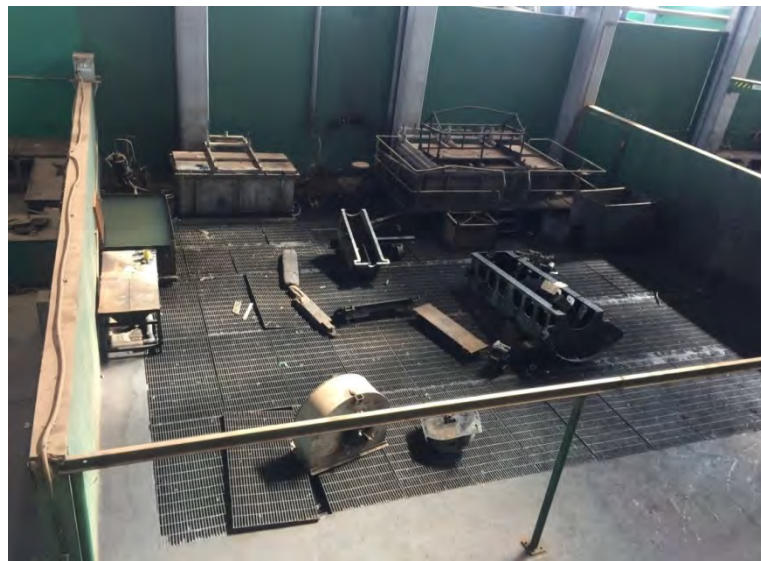
**Figure 9.12: Parts Washing Pool in Inspection Shop**

- 3) Among the inspection and repair facilities, wheel lathes and processing machines are functioning well, but some machines and a boiler are out of order. Before the completion of boiler repair work, machine parts cannot be subject to hot-water washing and now dealt with cold-water washing. Figure 9.12 shows a parts washing pool.

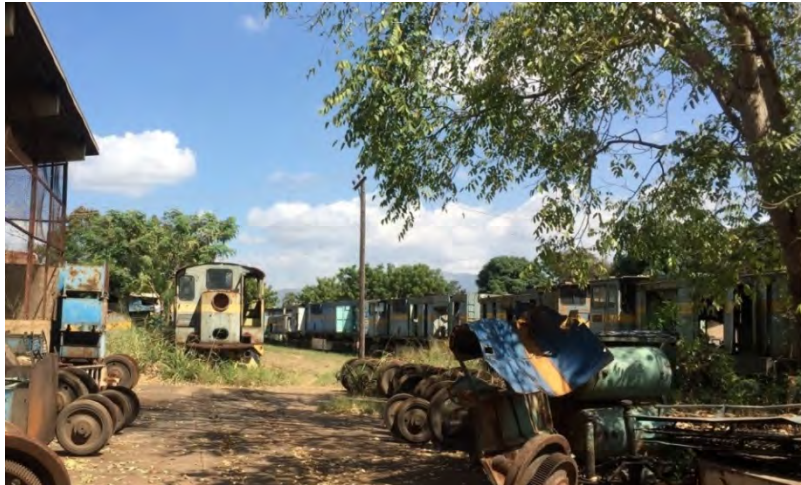
**Figure 9.13: Situation of Dilapidated Locomotives  
in the Morogoro Workshop Yard**

- 1) Major spare parts in short supply are those used for engines, air compressors and main motors, all related to the propulsion and braking function of locomotives to directly govern their availability. TRL remarks that engines for the overhaul are in short supply, in particular.
- 2) As a result, the structure of preventive maintenance has virtually collapsed. For instance, shop-in locomotives for overhaul cannot be provided with repair services due to a shortage of spare parts. Therefore, they cannot be returned to revenue service operation again. Consequently, locomotives on the verge of the overhaul are degraded to a valuable fountain of spare parts for other locomotives, thus terminating their service life. In the workshop yard, the Study Team witnessed many such defunct locomotives. (See Figure 9.13 below for a defunct locomotive.)

- 4) Figure 9.13 displays the situation of old locomotives in the Morogoro Workshop Yard. The remains of old-type locomotives are left in the Morogoro Workshop yard after some parts were removed from and appropriated to repairing other locomotives.

important parts, the Study Team recommends TRL to start joint development of substitute parts from simple consumables (such as motor brushes).

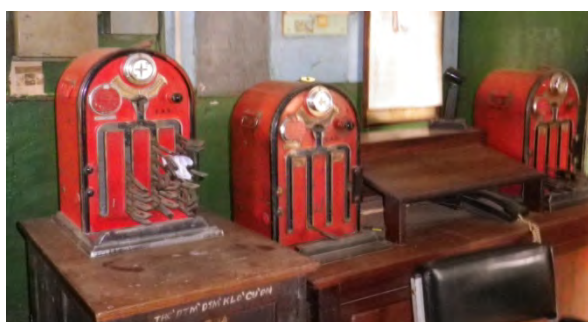
There was a tablet block system in the past, but it damaged and is now out of use.

**Figure 9.15: Devices Used under the Tablet Block System (Now Destroyed and Out of Use)**

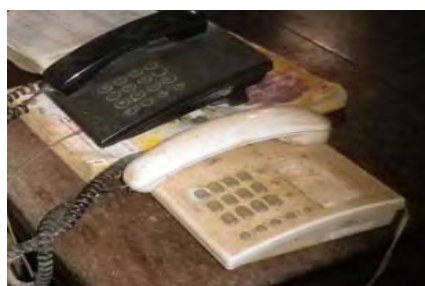
**Figure 9.16: Block Telephone Sets (Out of Use with Copper Cables Broken)**

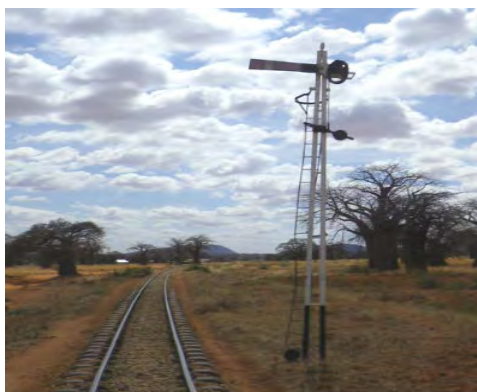
There are semaphore signals as home and departure signals but damaged and not in use (Figure 9.17).

**Figure 9.17: Semaphore Signals  
(Destroyed and Not in Use)**

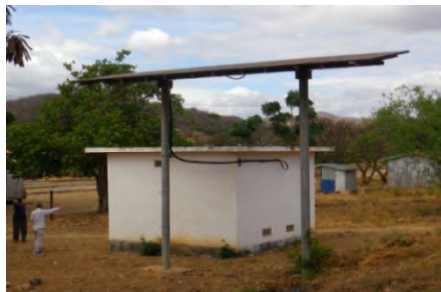
TRL introduced a power supply system of solar panels for signals and telecommunication devices (Figure 9.19). Due to the pilfering of telecommunication lines or breakage of cables by floods, however, the power source has not served its intended purpose thus far.

**Figure 9.19: Solar Energy Source Power Supply System  
(Not in Use)**
