**Preparatory Survey on  
Flood Protection Measures for  
Central Railway Line  
in the United Republic of Tanzania**

**Final Report  
Volume 2: Appendices**

### **RECORDS OF FLOODS IN KILOSA–DODOMA SECTION 2011–2014**

# **THE TEMPORARY URGENT PROTECTION WORK AND OUTLINE OF THE SITE CONDITIONS AT MASWALA AND KIDIBO IN DECEMBER 2014**

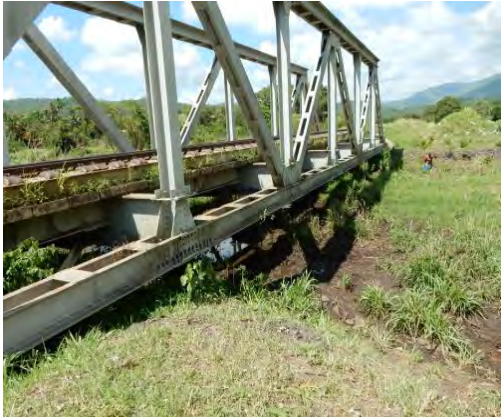
<p>Year 2014 (Toward Kidete)</p>

Location	Activities	Photos, Maps, etc.
<p>Km 288 Mkadage Bridge</p>	<p>➤ Problems:</p> <ul style="list-style-type: none"> <li>• Due to siltation, the bridge blocked the river.</li> </ul> <p>➤ Countermeasure:</p> <ul style="list-style-type: none"> <li>• Demolition of the old center pier &amp; abutments currently buried under the existing bridge deck</li> <li>• Excavation and re-alignment of the river channel over 625m length</li> </ul> <p>(Comments by JICA Study Team) It is recommended to re-conduct the excavation and re-alignment of the river channel.</p>	<p>Year 1997 (Toward downstream)</p>

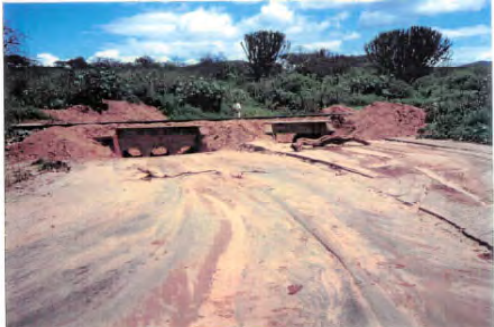
<p>Km 315.6 Gully Erosion</p>	<p>➤ Problems:</p> <ul style="list-style-type: none"> <li>• Cross drainage (culvert) under the railway is eventually undermined causing collapse of the structure</li> </ul> <p>➤ Countermeasure:</p> <ul style="list-style-type: none"> <li>• Excavation of the river channel to form an embankment</li> <li>• Excavation of river channel to spoil areas</li> <li>• Gabion works</li> <li>• Geotextile works</li> </ul>	<p>Year 1997 (Toward upstream)</p>

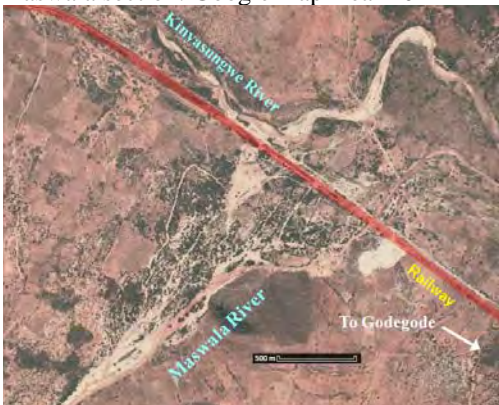
<p>Maswala section: Google map Year 2012</p>

<p>Km 349/4b, 4c Maswala Cross Drainage</p>	<p>➤ Problems:</p> <ul style="list-style-type: none"> <li>• Inadequate Cross drainage (culverts) under the railway</li> </ul> <p>➤ Countermeasure:</p> <ul style="list-style-type: none"> <li>• Track raising by 1.25 m</li> <li>• Provision of 9 nr 2.0 x 2.0 precast Culverts</li> <li>• Minor stream training and protection works</li> <li>• Demolition the existing culverts</li> <li>• Excavation in river channels</li> <li>• Gabion works, etc.</li> </ul> <p>(Comments by JICA Study Team) Currently, flood waters still go over the railway, when it rains at the mountain side. It is recommended to conduct sustainable countermeasures, such as a relocation of the railway toward the mountain side.</p>	<p>Year 1997 (Toward downstream)</p>

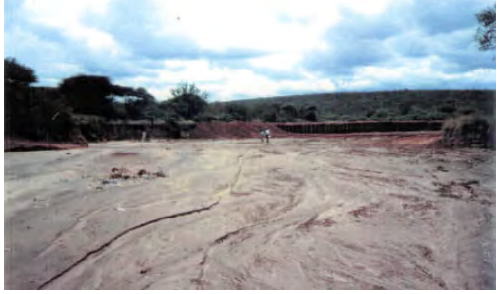
Location	Activities	Photos, Maps, etc.
<p>Km 355 Kidibo Mafugusa River Crossing</p>	<p>➤ Problems:</p> <ul style="list-style-type: none"> <li>• Due to tree felling and land reclamation, runoff has been increased significantly.</li> <li>• The former crossings tended to silt up and major flooding of the railway line was experienced at a depth of over 0.5 m at the site.</li> <li>• In 1991, the new Kidibo Bridge was constructed approximately 350 m up-line of the old crossing at Km 355.4.</li> </ul> <p>Design by Gauff Consulting Eng. Construction by Riepl</p> <ul style="list-style-type: none"> <li>• In 1995, the report on Mafugusa River Rehabilitation of Bridge Km 355.446 by Technical University Munich, Hydraulic Laboratory (TUM/HRO) for Deutsche Eisenbahn-Consult proposed the stabilization of the river channel and bridge structure, including sheet piling.</li> <li>• However, the design of the bridge appears to have greatly underestimated the flood impact.</li> </ul> <p>➤ Countermeasure:</p> <ul style="list-style-type: none"> <li>• Sheet piling for drop structure and bed protection</li> <li>• Excavation in river channel and form embankments</li> <li>• Excavation from an approved borrowing area to form an embankment</li> <li>• Concrete for pile capping</li> </ul>	<p>Mafugusa River toward Kidibo Bridge Year 1997</p>

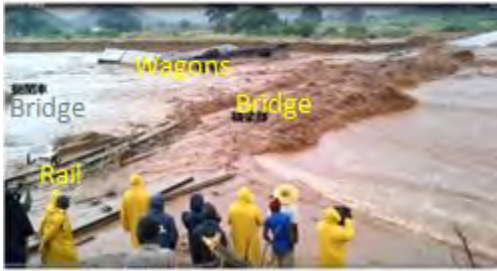
<p>Km 365 Mzase Crossing</p>	<p>➤ Problems:</p> <ul style="list-style-type: none"> <li>• The Mzase catchment is relatively small but very steep and thus has high peak floods with substantial velocities.</li> <li>• Over the past several years, a large area has been cleared for agricultural use. This results in intensified erosion in the upper catchment and siltation in the lower floodplains.</li> <li>• The erosion of the upstream catchment has been increasing, despite the river training and erosion protection at the upstream of the railway.</li> </ul> <p>➤ Countermeasure:</p> <ul style="list-style-type: none"> <li>• Catchment management planning and implementation</li> <li>• Further river training</li> </ul>	<p>30 March 2014 Mzase Bridge</p>

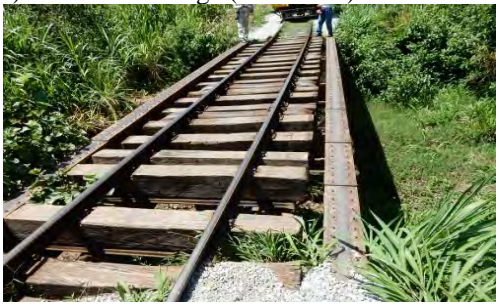
Location	Activities	Photos, Maps, etc.
Further Requirements	<p>1) Km 291: Bridge abutment It is suggested that the bridge structure be raised by raising the level of the abutment. (Note) The rail has been raised with thick wood sleepers. (refer to the photo at right)</p> <p>2) Km 295.6: Kinyasungwe River The riverbank has approached the railway line within 28 m. With continued erosion, the river will undermine the railway embankment.</p> <p>(Comments by JICA Study Team) Currently, the riverbank at 295.6 km is not very close to the railway. In this section, the riverbank at 297.3 km is the closest to the railway.</p> <p>3) Km 303.1: Kinyasungwe River/Cliff erosion The outer bank of the floodplain is within 10 m of the railway embankment.</p> <p>(Comments by JICA Study Team) Currently, the riverbank at 303.1 km is not very close to the railway. In this section, the riverbank at 302.75 km is the closest to the railway. The railway at 302.km was damaged by a flood on March 30, 2014.</p>	<p>1) Km 291.0: Bridge (Dec. 2014)</p>

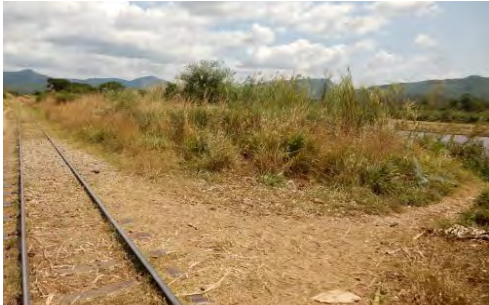
<p>(Km 297.3: Dec.2014) (Toward Kidete)</p>

Location	Activities	Record of Damages and Proposed Actions
Observations outside Project area	1) Lake Gombo–Kidete Dam <ul style="list-style-type: none"> <li>• Kidete Dam was washed away between 10–15 January 1998.</li> <li>• Prior the breach of the dam, the maximum water level was around 2 m. The storage volume was a minimum of 2–3 million m<sup>3</sup>.</li> <li>• The Lumuma railway bridge was damaged by the flood wave after the breach of the dam.</li> </ul> 2) Hombolo Dam <ul style="list-style-type: none"> <li>• If Hombolo Dam is broken, a water quantity much greater than the one of Kidete Dam would discharge down the river.</li> </ul>	1. <u>Km 283.6 (300 m)</u> : high bank eroded by parallel flow *Foot protection to be improved 2. <u>Km 288.4 (300 m)</u> : high bank eroded by river meander to about 80 m beyond the track. *Re-routing has already been initiated by TRC. 3. <u>Km 289.9 (100 m)</u> : high bank eroded by parallel flow, old bridge underscoured & collapsed, regressing erosion along the tributary *Re-construction of embankment, bridge, protection alongside river and in the tributary 4. <u>Km 290.3 (40 0 m)</u> : The first 100 m was washed out beyond the track, the remaining section high bank eroded, 2 culverts underscoured and collapsed *Protection along the foot of the section 5. <u>Km 292.3 (350 m)</u> : high bank eroded by river meander to 100 m beyond the track *Re-construction of 1 culvert, extensive protection 6. <u>Km 293.1 (60 m)</u> : eroded & loss of protection *Re-construction & protection works 7. <u>Km 293.4 (500 m)</u> : high bank eroded by parallel river, 1st half erosion to 20 m beyond the track *Re-routing is recommended 8. <u>Km 297.3 (80 m)</u> : erosion parallel to the track

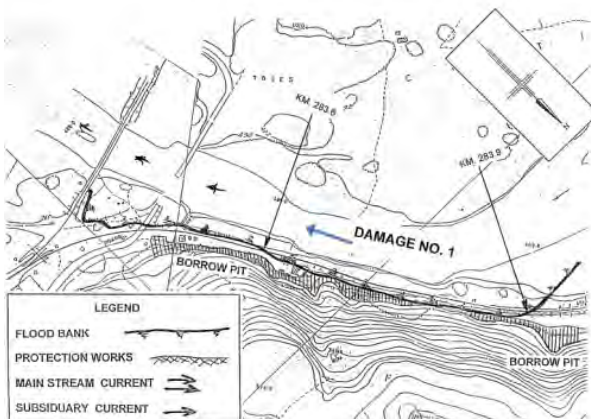
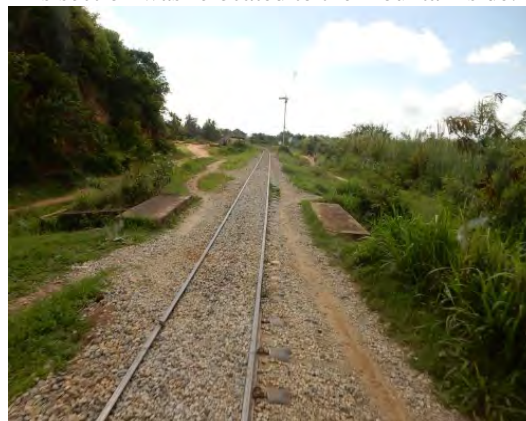
1) Km 283.6 (300 m):

Km 283.65 (5 Dec. 2014) (Toward Kidete)  
This section was relocated to the mountain side.

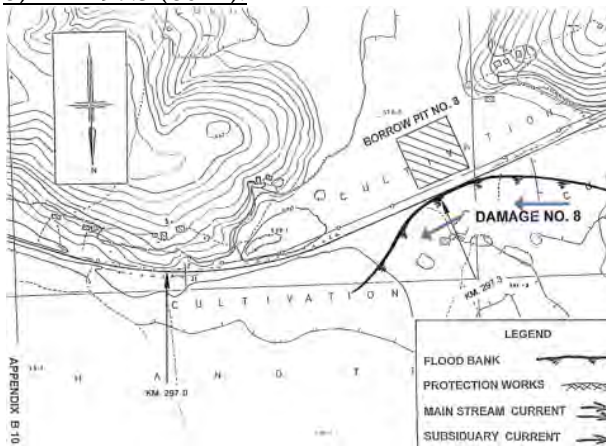
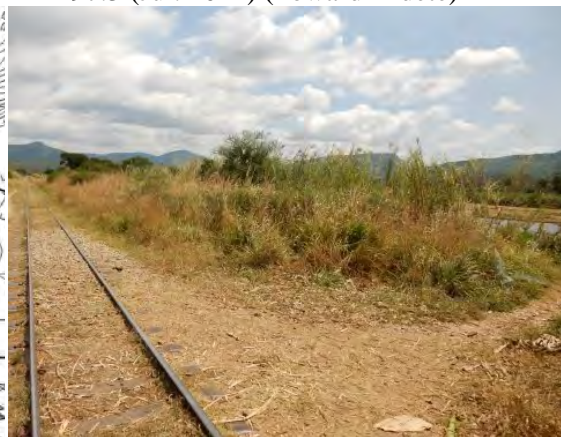
8) Km 297.3 (80 m):

Km 297.3 (Jul. 2014) (Toward Kidete)

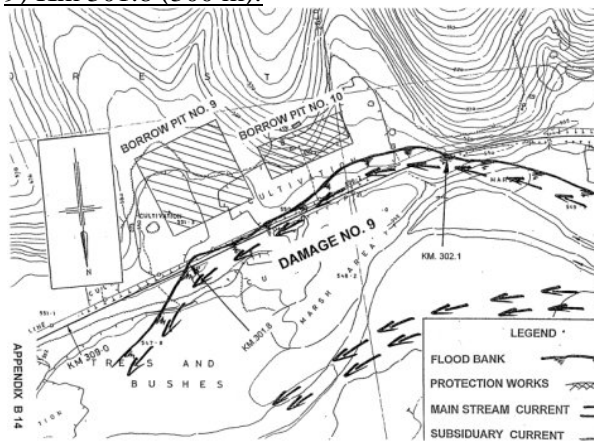
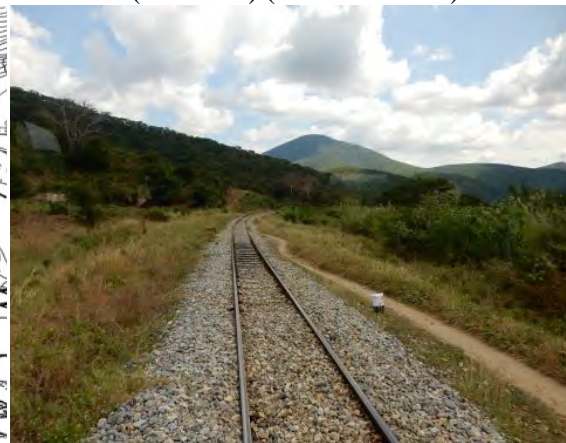
9) Km 301.8 (300 m):

Location	Activities	Record of Damages and Proposed Actions
		<p>*Re-construction &amp; protection works</p> <p>9. <u>Km 301.8 (300 m)</u>: washed out by parallel flow</p> <p>*re-construction &amp; protection. (Re-routing may be an option during permanent works.)</p> <p>10. <u>Km 302.5 (500 m)</u>: washed out by parallel flow</p> <p>* Re-construction of 1 culvert, extensive protection</p> <p>11. <u>Km 303.8 (400 m)</u>: erosion around bridge foundations</p> <p>*Re-construction &amp; protection works</p> <p>12. <u>Km 305.3 (30 m)</u>: Short washput</p> <p>*Re-construction &amp; protection works</p> <p>13. <u>Km 306.9 (200 m)</u>: high bank eroded by flow directed towards the track</p> <p>* Re-construction 1 bridge &amp; protection works</p> <p>14. <u>Km 308.9 (60 m)</u>: Short washput</p> <p>* Re-construction &amp; protection works</p> <p>15. <u>Km 314.2 (450 m)</u>: high bank eroded by flow directed towards the track</p> <p>*It is proposed to re-route the track</p>

Km 302.0 (Jul. 2014) (Toward Kidete)

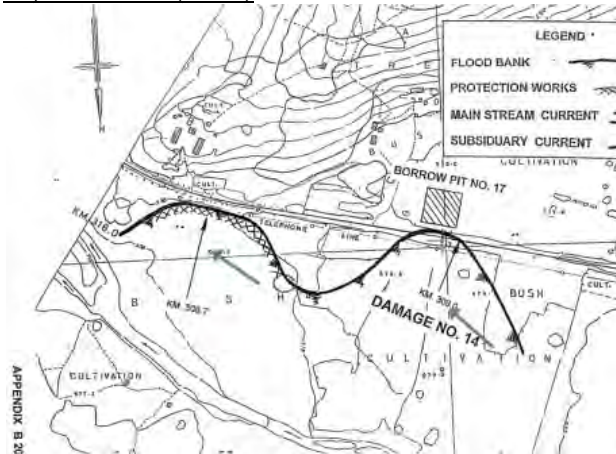
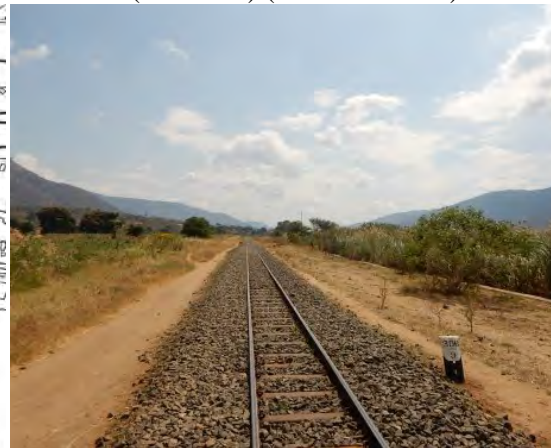
14) Km 308.9 (60 m)

Km 308.9 (Jul. 2014) (Toward Kidete)

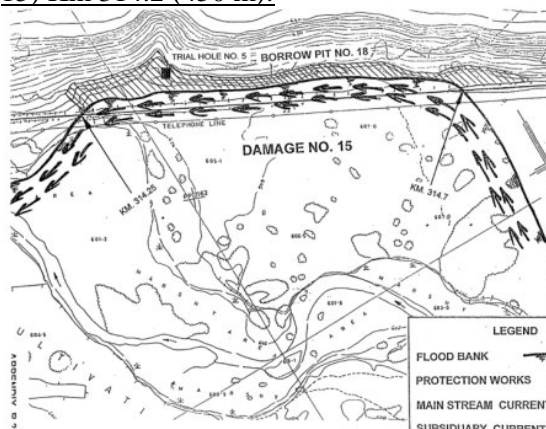
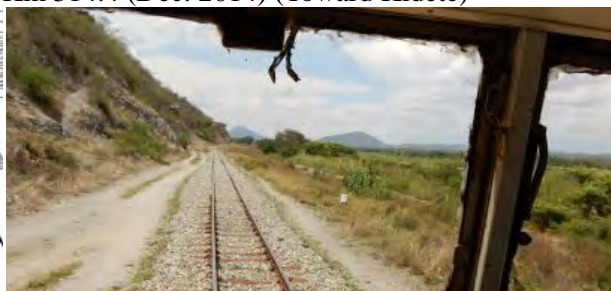
15) Km 314.2 (450 m):

Km 314.4 (Dec. 2014) (Toward Kidete)

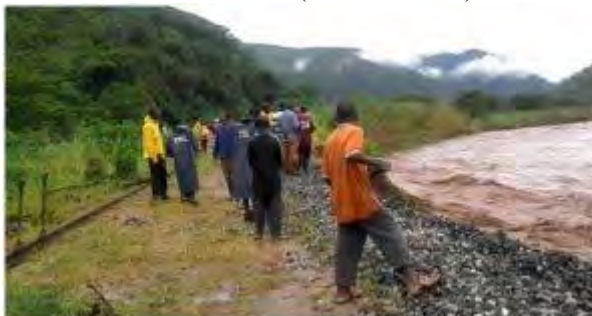
The track of this section was washed away on 30 March 2014.

30 March 2014 (Toward Kidete)

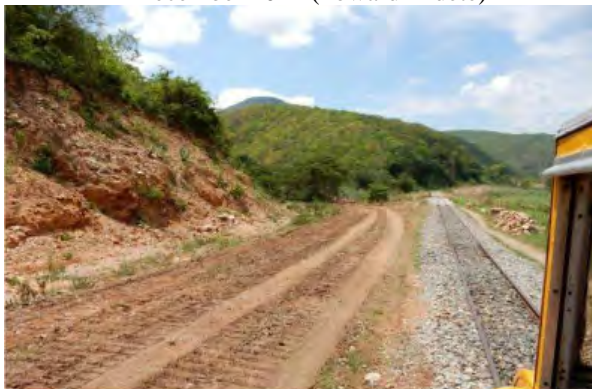
The excavated soil, on the right side of the photo, was land filled at the riverbank.

1 December 2014 (Toward Kidete)

To prepare for the coming rainy season, the temporary urgent protection work has been conducted by TRL

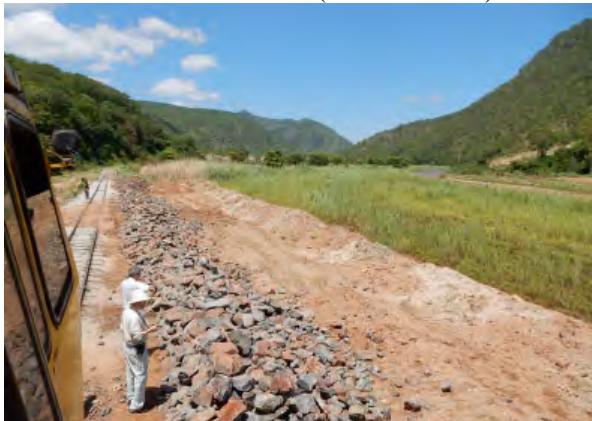
Land filling was on-going at the riverbank.

Gabion works at the riverbank were prepared.

16 December 2014 (Toward Kidete)

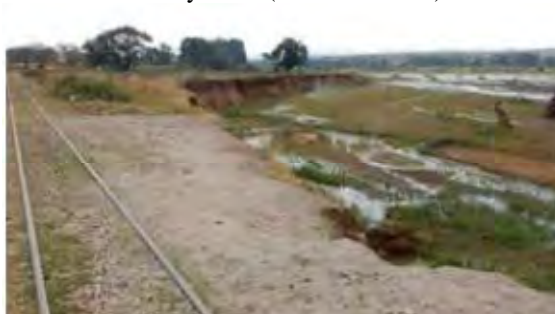
**(2) Km 315**

The erosion of the riverbank was very close to the track.

21 July 2014 (Toward Kidete)

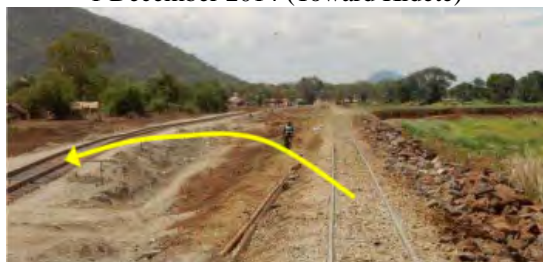
The track was re-routed toward the mountain side (max. 18 m) by TRL in December 2014, as the erosion of the river embankment was close to the track.

1 December 2014 (Toward Kidete)

The work was conducted by TRL staff (the track maintenance gang living along the railway).

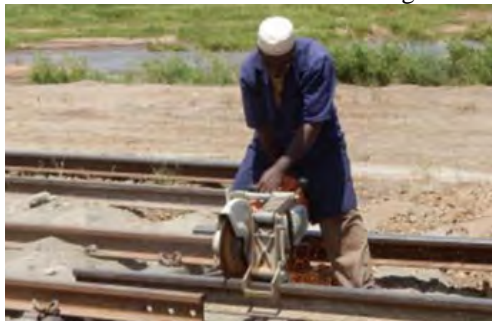
18 December 2014 Rail cutting

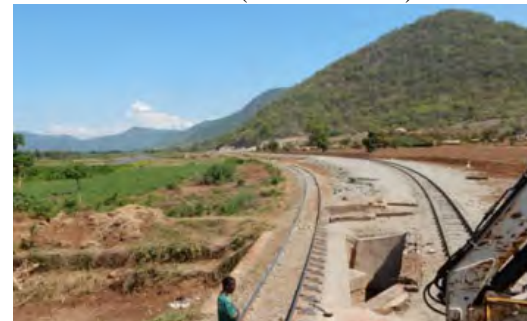
18 December 2014 (Toward Kilosa) Trial Run

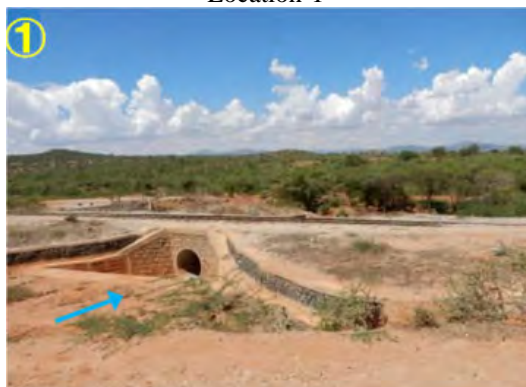
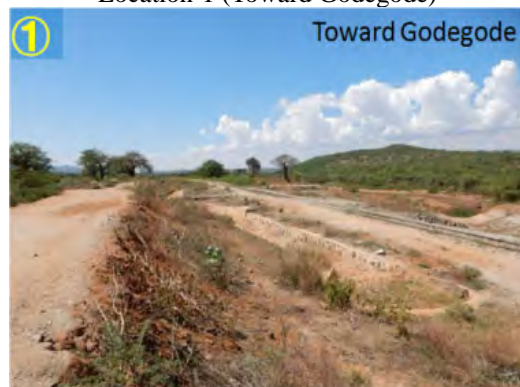
Location-1

This section is the alluvial fan of the Maswala River, where the track has been damage at almost all culvert locations in this section every rainy season due to inadequate cross drainage.

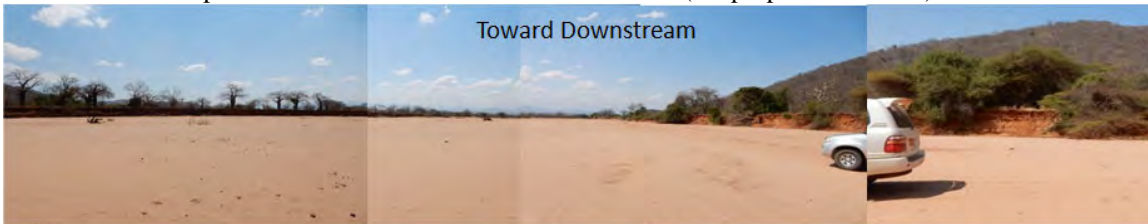
Upstream of Location-8 in the Maswala River (the proposed dam site)

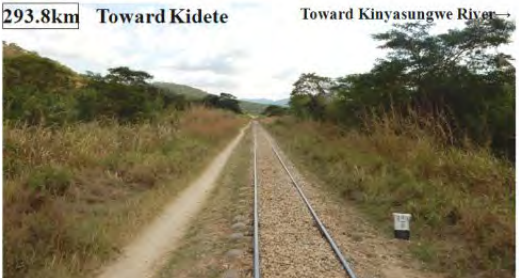
<p>293.2km Toward Kilosa Kinyasungwe River</p>	<ul style="list-style-type: none"> <li>• Expansion of the bridge</li> <li>• Additional gabion works to protect the riverbank</li> <li>• Sustainable excavation of the riverbed</li> </ul>	Medium
Km 293.6– Km 294.4	<ul style="list-style-type: none"> <li>• Pattern 1-3</li> </ul>		6 m–80 m	2.0 m

<p>293.8km Toward Kidete Toward Kinyasungwe River →</p>	<ul style="list-style-type: none"> <li>• Re-routing toward the mountain side</li> <li>• Track raising by embankment</li> <li>• Protection from the erosion of the riverbank, etc.</li> </ul>	Medium - High

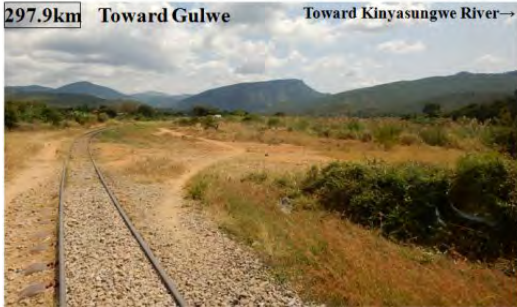
Location	Pattern of Damage	Temporary Remedial Works in the past	Distance between track and river * <sup>1</sup>	Difference of elevation between track and river * <sup>2</sup>	Photos of the section	Possible Flood Protection Measures	Priority for Flood Protection
Km 297.1– Km 298.3	• Pattern 1-3	• Restoration of the washed-away track	10 m–70 m	2.0 m

<ul style="list-style-type: none"> <li>• Track raising by embankment</li> <li>• Protection from the erosion of the riverbank, etc.</li> </ul>	Medium - High
Km 298.3– Km 299.3	• Pattern 1-3	• Restoration of the washed-away track	30 m–100 m	2.0 m

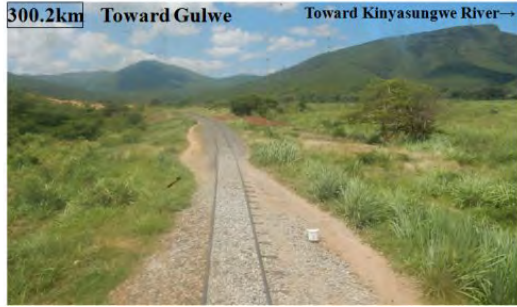
<ul style="list-style-type: none"> <li>• Track raising by embankment</li> <li>• Protection from the erosion of the riverbank, etc.</li> </ul>	Medium
Km 299.3– Km 302.6	• Pattern 1-2, 1-3	<ul style="list-style-type: none"> <li>• Restoration of the washed- away track</li> <li>• Repair of the ballast</li> </ul>	20 m–170 m	2.0 m

<ul style="list-style-type: none"> <li>• Re-routing toward the mountain side</li> <li>• Track raising by embankment</li> <li>• Protection from the erosion of the riverbank, etc.</li> </ul>	Medium - High

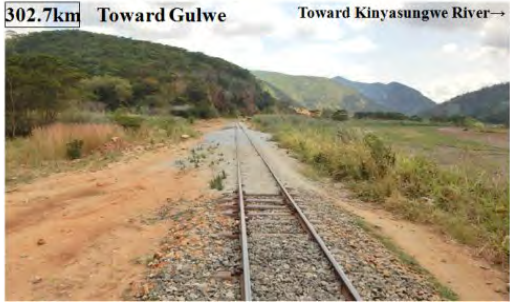
Location	Pattern of Damage	Temporary Remedial Works in the past	Distance between track and river * <sup>1</sup>	Difference of elevation between track and river * <sup>2</sup>	Photos of the section	Possible Flood Protection Measures	Priority for Flood Protection
Km 302.6– Km 302.8	• Pattern 1-2, 1-3	• Restoration of the washed-away track	4 m–10 m	2.0 m

<ul style="list-style-type: none"> <li>• Re-routing toward the mountain side</li> <li>• Track raising by embankment</li> <li>• Protection from the erosion of the riverbank, etc.</li> <li>• River training works</li> </ul>	High
Km 302.8– Km 303.4	• Pattern 1-3	• Restoration of the washed-away track	30 m–150 m	2.0 m – 2.5 m

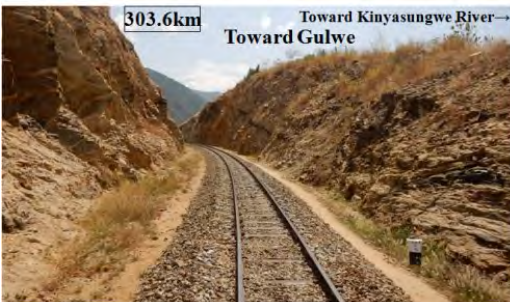
<ul style="list-style-type: none"> <li>• Protection from the erosion of the riverbank, etc.</li> </ul>	Medium
Km 303.4– Km 303.7	• Pattern 2-1		150 m	2.5 m

<ul style="list-style-type: none"> <li>• Rock Cutting and Embankment stabilization</li> </ul>	Low

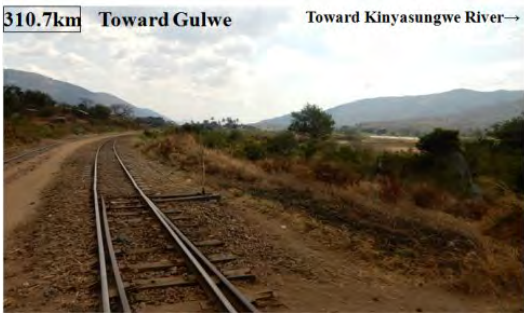
Location	Pattern of Damage	Temporary Remedial Works in the past	Distance between track and river * <sup>1</sup>	Difference of elevation between track and river * <sup>2</sup>	Photos of the section	Possible Flood Protection Measures	Priority for Flood Protection
Km 309.0– Km 311.8	• Pattern 1-3		60 m–300 m	3.0 m – 4.0 m

<p>310.7km Toward Gulwe Toward Kinyasungwe River→</p>	<ul style="list-style-type: none"> <li>• Protection from the erosion of the riverbank, etc.</li> </ul>	Medium
Km 311.8– Km 312.8	• Pattern 1-2, 1-3	• Restoration of the washed-away track	20 m–70 m	3.0 m – 4.0 m

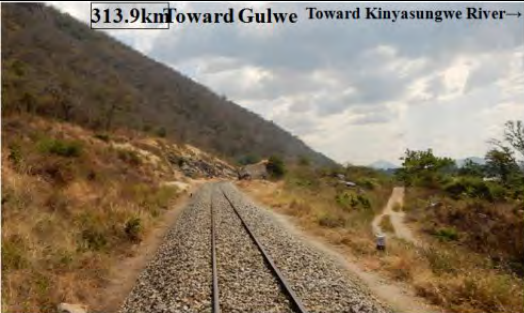
<p>312.0km Toward Gulwe Toward Kinyasungwe River→</p>	<ul style="list-style-type: none"> <li>• Re-routing toward the mountain side</li> <li>• Track raising by embankment</li> <li>• Protection from the erosion of the riverbank, etc.</li> <li>• River training works</li> </ul>	Medium - High
Km 312.8– Km 314.8	• Pattern 1-2, 1-3	• Restoration of the washed-away track	30 m–130 m	3.0 m – 4.0 m

<p>313.9km Toward Gulwe Toward Kinyasungwe River→</p>	<ul style="list-style-type: none"> <li>• Re-routing toward the mountain side</li> <li>• Protection from the erosion of the riverbank, etc.</li> <li>• River training works</li> </ul>	Medium - High

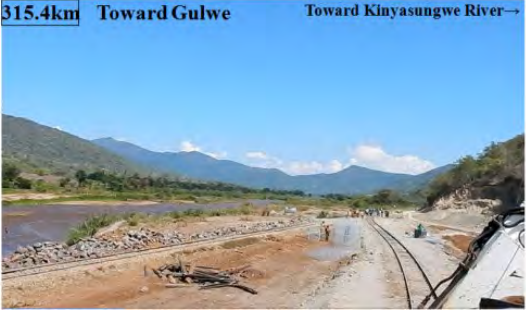
Location	Pattern of Damage	Temporary Remedial Works in the past	Distance between track and river * <sup>1</sup>	Difference of elevation between track and river * <sup>2</sup>	Photos of the section	Possible Flood Protection Measures	Priority for Flood Protection
Km 314.8– Km 317.7	• Pattern 1-2	<ul style="list-style-type: none"> <li>Restoration of the washed-away track</li> <li>The track was re-routed toward the mountain side (max. 18 m) in Dec. 2014, as the erosion of the river embankment was close to the track.</li> </ul>	15 m–80 m	4.0 m

<ul style="list-style-type: none"> <li>Further re-routing toward the mountain side</li> <li>Protection from the erosion of the riverbank, etc.</li> <li>River training works</li> </ul>	High
Km 317.7– Km 318.7	• Pattern 1-3, 2-1		120 m–600 m	4.0 m

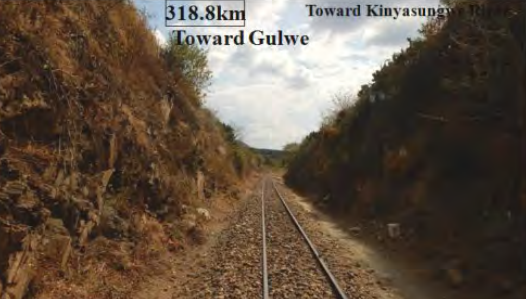
Km 318.7– Km 318.9	• Pattern 2-1		600 m–900 m	4.0 m

<ul style="list-style-type: none"> <li>Rock Cutting and Embankment stabilization</li> </ul>	Low

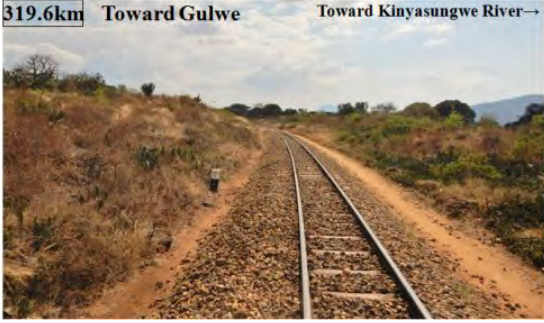
Location	Pattern of Damage	Temporary Remedial Works in the past	Distance between track and river * <sup>1</sup>	Difference of elevation between track and river * <sup>2</sup>	Photos of the section	Possible Flood Protection Measures	Priority for Flood Protection
Km 318.9– Km 320.9	• Pattern 2-1		900 m	4.0 m	<p>319.6km    Toward Gulwe    Toward Kinyasungwe River→</p>

• Improvement of cross-drainage	Low
Km 320.9	• Pattern 2-1, 2-2		900 m	4.0 m	<p>320.9km    Toward Kinyasungwe River→ Toward Gulwe</p>

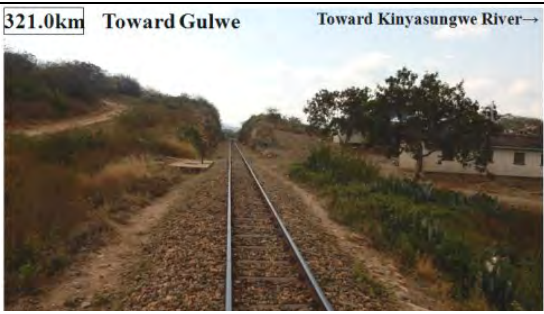
• Protection from the erosion of the tributary bank, etc.	Low
Km 320.9– Km 321.1	• Pattern 2-1		900 m	4.0 m	<p>321.0km    Toward Gulwe    Toward Kinyasungwe River→</p>

• Improvement of cross-drainage	Low

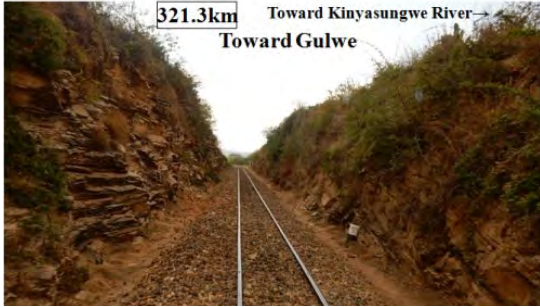
Location	Pattern of Damage	Temporary Remedial Works in the past	Distance between track and river * <sup>1</sup>	Difference of elevation between track and river * <sup>2</sup>	Photos of the section	Possible Flood Protection Measures	Priority for Flood Protection
Km 321.1– Km 321.4	• Pattern 2-1		400 m – 900 m	4.0 m

• Rock cutting and embankment stabilization	Low
Km 321.4– Km323.3	• Pattern 2-1		350 m–400 m	4.0 m – 7.0 m

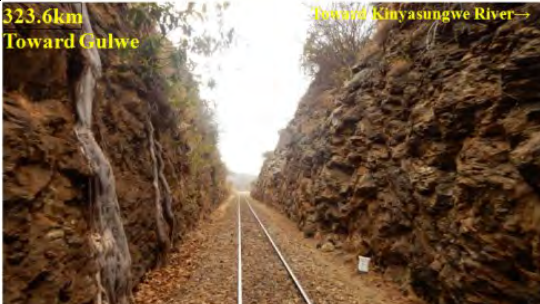
• Improvement of cross-drainage	Low
Km 323.3– Km323.7	• Pattern 2-1		400 m	7.0 m

• Rock cutting and embankment stabilization	Low

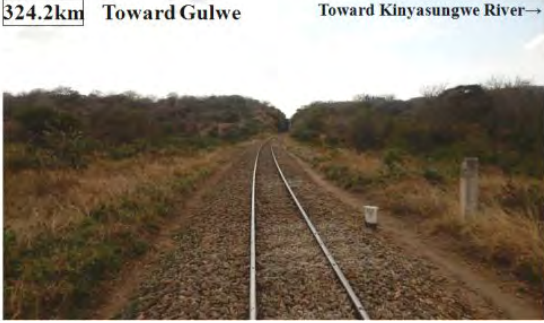
Location	Pattern of Damage	Temporary Remedial Works in the past	Distance between track and river * <sup>1</sup>	Difference of elevation between track and river * <sup>2</sup>	Photos of the section	Possible Flood Protection Measures	Priority for Flood Protection
Km 323.7– Km 325.2	<ul style="list-style-type: none"> <li>• Pattern 2-1</li> </ul>		600 m–500 m	6.0 m – 8.0 m	<p>324.2km Toward Gulwe Toward Kinyasungwe River→</p>

<ul style="list-style-type: none"> <li>• Improvement of cross-drainage</li> </ul>	Low
Km 325.2 Lumuma Bridge	<ul style="list-style-type: none"> <li>• Pattern 2-2</li> </ul>	<ul style="list-style-type: none"> <li>• Repair works was conducted in 1998, as the bridge downstream was scored, gabions were washed away by the flood wave after the failure of Kidete Dam.</li> </ul>	900 m	8.0 m	<p>325.2km Toward Gulwe Toward Kinyasungwe River→</p>

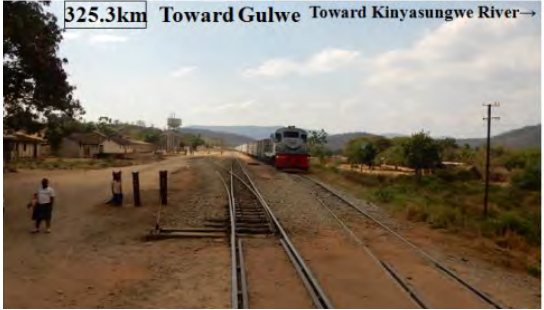
Km 325.2– Km 325.5 Kidete Station	<ul style="list-style-type: none"> <li>• Pattern 2-1</li> </ul>		480 m	7.0 m	<p>325.3km Toward Gulwe Toward Kinyasungwe River→</p>

Low

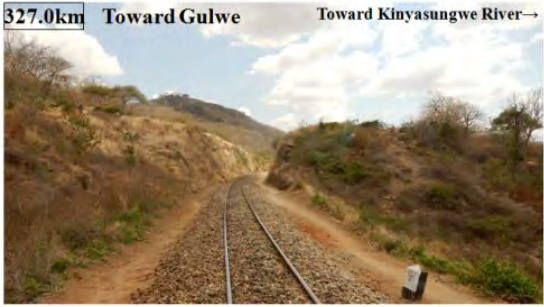
Location	Pattern of Damage	Temporary Remedial Works in the past	Distance between track and river * <sup>1</sup>	Difference of elevation between track and river * <sup>2</sup>	Photos of the section	Possible Flood Protection Measures	Priority for Flood Protection
Km 325.5– Km327.3	<ul style="list-style-type: none"> <li>• Pattern 1-3 in the past</li> </ul>	<ul style="list-style-type: none"> <li>• The track was re-routed to the mountain side from the river side during UK rule.</li> </ul>	40 m–480 m	6.0 m–7.0 m	<p>327.0km Toward Gulwe      Toward Kinyasungwe River→</p>

<ul style="list-style-type: none"> <li>• Improvement of cross-drainage</li> </ul>	Low
Km 327.3– Km 328.0	<ul style="list-style-type: none"> <li>• Pattern 1-3 in the past</li> </ul>	<ul style="list-style-type: none"> <li>• Same as above</li> </ul>	30 m	4.0 m–5.0 m	<p>327.8km Toward the East ↓ Toward Kinyasungwe River</p>

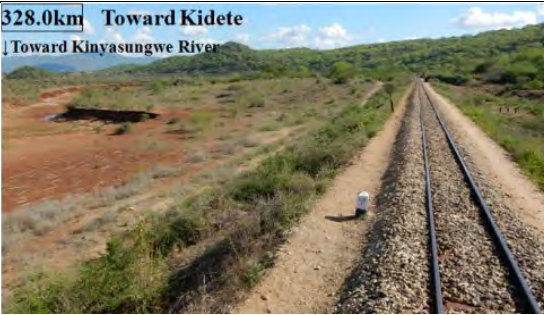
Km 328.0	<ul style="list-style-type: none"> <li>• Pattern 1-2</li> </ul>	(Note) The erosion of the riverbank is close to the track	30 m	4.0 m	<p>328.0km Toward Kidete ↓ Toward Kinyasungwe River</p>

<ul style="list-style-type: none"> <li>• Protection from the erosion of the riverbank, etc.</li> </ul>	Medium

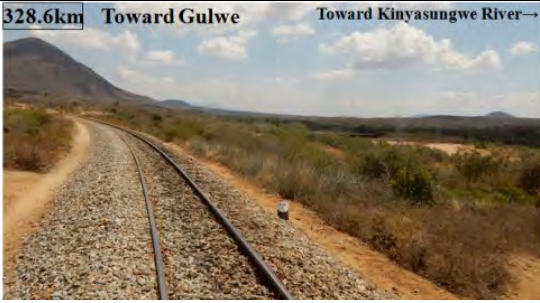
Location	Pattern of Damage	Temporary Remedial Works in the past	Distance between track and river * <sup>1</sup>	Difference of elevation between track and river * <sup>2</sup>	Photos of the section	Possible Flood Protection Measures	Priority for Flood Protection
Km 328.0– Km 329.3	• Pattern 1-2, 1-3	<ul style="list-style-type: none"> <li>• Restoration of the washed-away track</li> <li>• Repair of the ballast damaged by flood overtopping</li> </ul>	30 m–40 m	4.0 m

<p>328.6km Toward Gulwe Toward Kinyasungwe River→</p>	<ul style="list-style-type: none"> <li>• Protection from the erosion of the riverbank, etc.</li> <li>• Improvement of cross-drainage</li> </ul>	Low
Km 329.3– Km331.8	• Pattern 1-2, 1-3	<ul style="list-style-type: none"> <li>• Restoration of the washed-away track</li> <li>• Repair of the ballast damaged by flood overtopping</li> </ul>	10 m–130 m	3.0 m–4.0 m

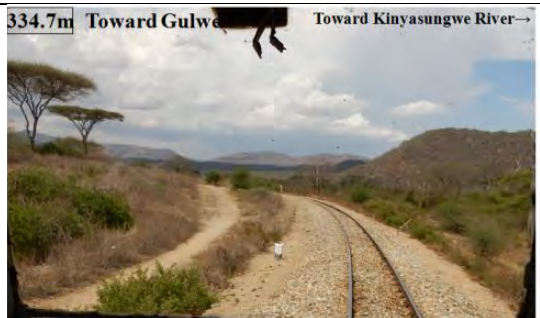
Km 331.8– Km 337.1	• Pattern 1-2, 1-3	<ul style="list-style-type: none"> <li>• In the past, re-routing was conducted 7 times</li> <li>• Improvement of cross-drainage</li> </ul>	80 m–500 m	2.0 m–3.0 m

<p>334.7m Toward Gulwe Toward Kinyasungwe River→</p>	<ul style="list-style-type: none"> <li>• Protection from the erosion of the riverbank, etc.</li> <li>• Improvement of cross-drainage</li> <li>• Track raising</li> </ul>	Low

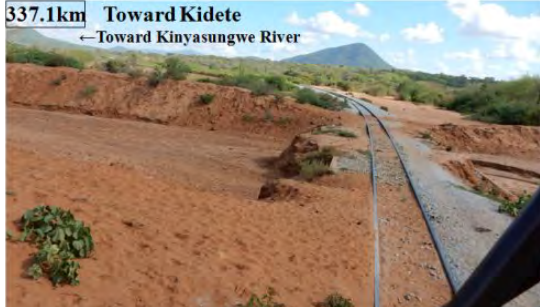
Location	Pattern of Damage	Temporary Remedial Works in the past	Distance between track and river * <sup>1</sup>	Difference of elevation between track and river * <sup>2</sup>	Photos of the section	Possible Flood Protection Measures	Priority for Flood Protection
Km 337.1	<ul style="list-style-type: none"> <li>• Pattern 2-1, 2-2</li> </ul>	<ul style="list-style-type: none"> <li>• Repair of the ballast, many times a year</li> <li>• Improvement of cross-drainage</li> </ul>	100 m	2.0 m

<ul style="list-style-type: none"> <li>• Improvement of cross-drainage</li> <li>• Track raising</li> </ul>	Medium
Km 337.1– Km 337.8	<ul style="list-style-type: none"> <li>• Pattern 1-2</li> </ul>	<ul style="list-style-type: none"> <li>• The riverbank was washed away on Mar.6, 2015. The re-routing &amp; protection of riverbank is on-going.</li> </ul>	3 m	3.0 m

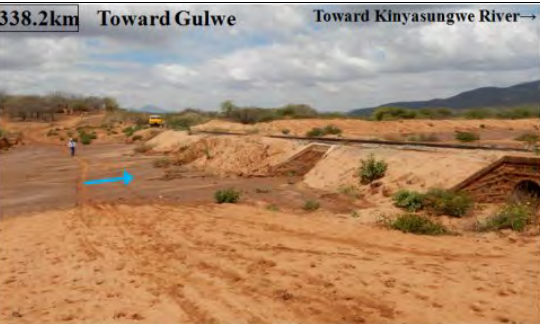
Km 337.8– Km 339.5	<ul style="list-style-type: none"> <li>• Pattern 2-1, 2-2</li> </ul>	<ul style="list-style-type: none"> <li>• Repair of the ballast, many times a year</li> </ul>	100 m–380 m	3.5 m – 5.0 m

<ul style="list-style-type: none"> <li>• Improvement of cross-drainage</li> <li>• Track raising</li> </ul>	Medium

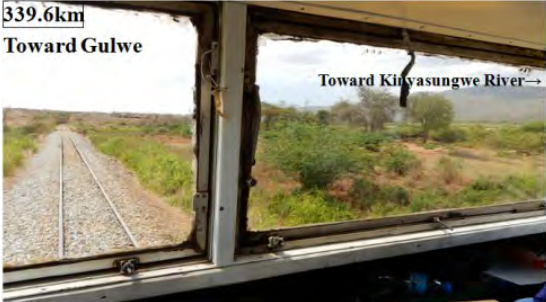
Location	Pattern of Damage	Temporary Remedial Works in the past	Distance between track and river * <sup>1</sup>	Difference of elevation between track and river * <sup>2</sup>	Photos of the section	Possible Flood Protection Measures	Priority for Flood Protection
Km 339.5– Km 340.0	• Pattern 1-3, 2-1		120 m–200 m	2.0 m – 3.5 m

<ul style="list-style-type: none"> <li>• Improvement of cross-drainage</li> <li>• Track raising</li> <li>• Protection from the erosion of the riverbank, etc.</li> </ul>	Low - Medium
Km 340.0– Km 340.8	• Pattern 1-3	• Repair of the track In 2009, flood damaged the track.	120 m–190 m	2.0 m

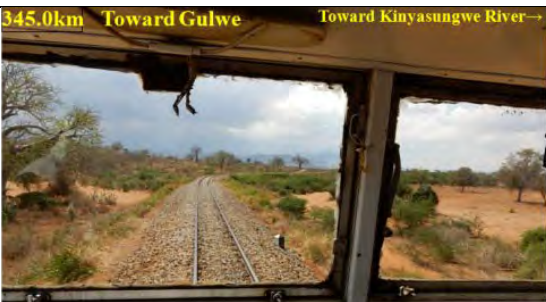
<ul style="list-style-type: none"> <li>• Improvement of cross-drainage</li> <li>• Track raising</li> </ul>	Low
Km 340.8– Km 348.2	• Pattern 1-3	• Restoration of the washed-away track • Improvement of cross-drainage (Note) 2014/1/22 Water passed over Km 341.2– Km 341.9.	30 m–300 m	2.0 m – 6.5 m

<ul style="list-style-type: none"> <li>• Improvement of cross-drainage</li> <li>• Track raising</li> <li>• Protection from the erosion of the riverbank, etc.</li> </ul>	Medium - High

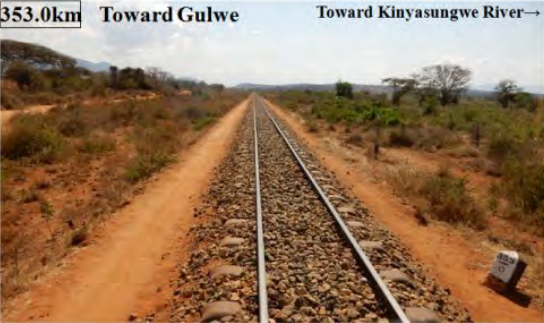
Location	Pattern of Damage	Temporary Remedial Works in the past	Distance between track and river * <sup>1</sup>	Difference of elevation between track and river * <sup>2</sup>	Photos of the section	Possible Flood Protection Measures	Priority for Flood Protection
Km 350.0– Km 355.1	<ul style="list-style-type: none"> <li>• Pattern 2-1</li> </ul>		30 m–500 m	2.0 m – 5.5 m	<p>353.0km    Toward Gulwe    Toward Kinyasungwe River→</p>

<ul style="list-style-type: none"> <li>• Improvement of cross-drainage</li> </ul>	Low
Km 355.1 Mafugusa River Kidibo Bridge	<ul style="list-style-type: none"> <li>• Pattern 2-1, 2-2</li> </ul>	<ul style="list-style-type: none"> <li>• Re-routing the Mafugusa River</li> <li>• Excavation in the river channel and forming embankment</li> <li>• Sheet piling with anchor bolts to protect the riverbanks</li> <li>• Gabion works</li> </ul>	30 m	4.5 m	<p>355.1km    Toward Gulwe    Toward Kinyasungwe River→ Kidibo</p>

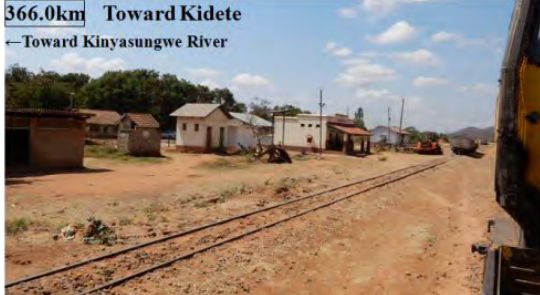
<ul style="list-style-type: none"> <li>Re-routing the track toward the mountain side</li> <li>Tack raising</li> </ul>	High
Km 366.0  Gulwe Station	• Pattern 2-1	<p>(Sometimes, if the space under the bridge is full of mud, Gulwe Station floods.)</p> <ul style="list-style-type: none"> <li>Restoration of the washed-away track</li> </ul>	100 m	2.0 m

<ul style="list-style-type: none"> <li>Relocation of the station toward the mountain side, together with the track</li> </ul>	Low - Medium

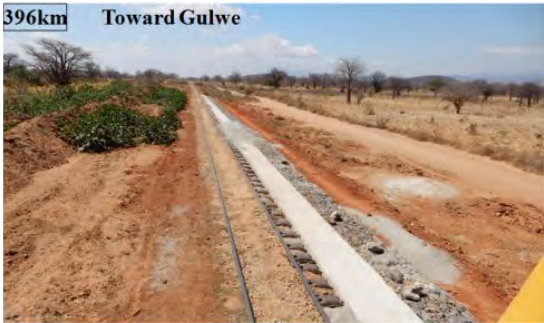
Location	Pattern of Damage	Temporary Remedial Works in the past	Distance between track and river * <sup>1</sup>	Difference of elevation between track and river * <sup>2</sup>	Photos of the section	Possible Flood Protection Measures	Priority for Flood Protection
Km 385.0– Km 403.0	<ul style="list-style-type: none"> <li>• Pattern 2-1, 2-2</li> </ul>	<ul style="list-style-type: none"> <li>• Protection works of the ballast</li> <li>• Improvement of cross-drainage, including replacement of collapsed culverts</li> <li>• Gabion works</li> <li>• Excavation of drainage trench</li> <li>• Repair of the ballast</li> <li>• Repair of bridge abutment</li> <li>• Restoration of the washed-away track, etc.</li> </ul>		2.0 m – 3.0 m

<ul style="list-style-type: none"> <li>• Improvement of cross-drainage</li> </ul>	Low
Km 403.0– Km 415.0  Hodwiku River (Tributary)  Igandu	<ul style="list-style-type: none"> <li>• Pattern 2-1, 2-2</li> </ul>	<ul style="list-style-type: none"> <li>• Excavation and of the stream channels crossing the track</li> <li>• Gabion works</li> <li>• Improvement of cross-drainage</li> <li>• Repair of the ballast</li> </ul>		2.0 m

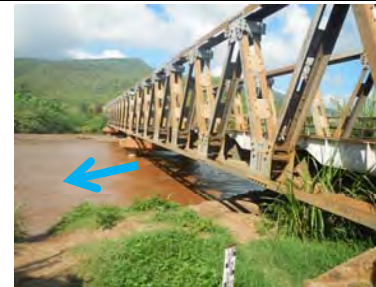
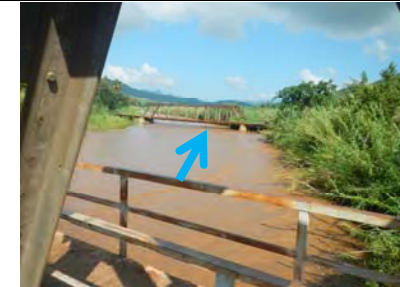
2-18	Damaged Record, if any (year/month)	A flood overflowed from left bank of Mkondoa bridge to Kilosa City in 2014.
2-19	Reason of	Overflow the Bank
2-20	Pattern of Riverbed

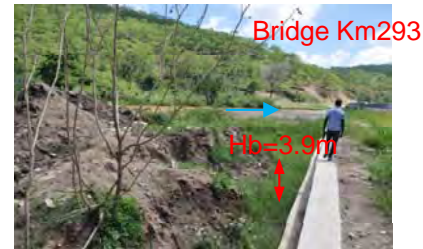
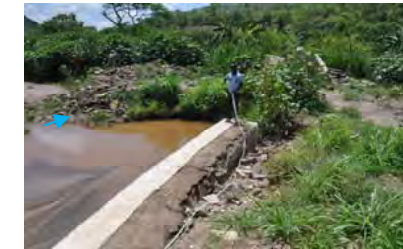
**Station: From KM293 to KM294**      **Sheet No.: CH-293**

2-18	Damaged Record, if any (year/month)	Construction of the new bridge and bank protection of gabion was completed on Jul.21, 2014 (Chinese Contractor)
		2008 flood: overtopped from left upstream bank o the bridge resulting wash out of the bridge

2-19	Reason of	Bank erosion, Overflow, Sliding,
2-20	Pattern of Riverbed	Rising of riverbed in long distance

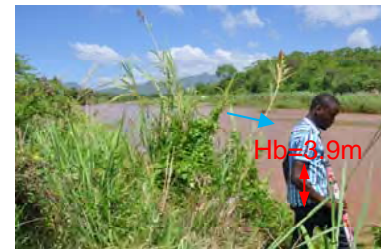
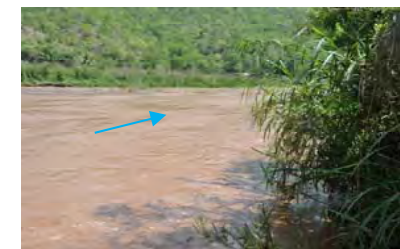
2-13	Land Use	none (cultivated before 2010 flood)	
2-14	Soil Type	Laterite	
2-15	Topography	left: ↖ , right ↗	
2-16	Structures/Houses, road	none	
2-17	Location of Railway	right, d= 14.7 m @Km293.9	
2-18	Damaged Record, if any (year/month)	2010 Flood: overtopped of the track resulting damage on ballasts. After that, gabion were installed for bank protection of low water channel. 1998 Flood: All were washed away. It was planned to divert the track but not realized.	
2-19	Reason of	Bank erosion, Overflow, Sliding,	
2-20	Pattern of Riverbed	Rising of riverbed in long distance

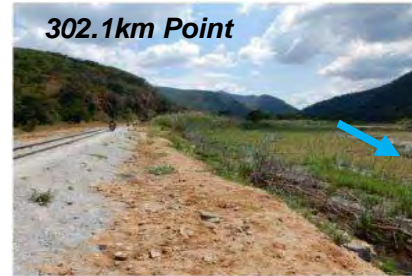
**Station: From KM302 to KM303**      **Sheet No.: CH- KM 302**

2-18	Damaged Record, if any (year/month)	One Culvert and Gabion(400 m) had been washed out by a flood in 2014.

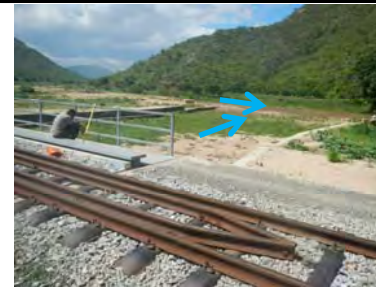
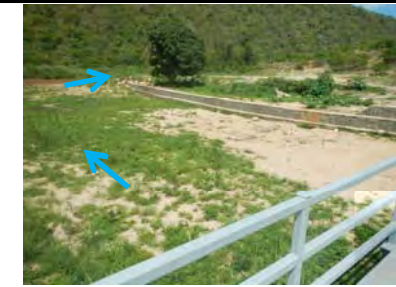
2-18	Damaged Record, if any (year/month)	The bridge of the right tributary had washed out by a flood in 2010. A new bridge had been completed in 2014 and the railroad line had been moved to the
2-19	Reason of	Flood flow overtopped the bridge
2-20	Pattern of Riverbed
