Inventory Sheet for River/Channel

Station: From KM305 to KM306 **Sheet No.: CH- KM 305**

1. General			
1-1	Name of Inspector	T. Kawaguchi ,, Hussein , Abiud	
1-2	Organization of Inspector	River Group D	
1-3	Date/Time of Inspection	Dec. 4, 2014	
1-4	Location	Lat	6° 43' 38" 05"
1-5		Long	36° 50' 33" 85"

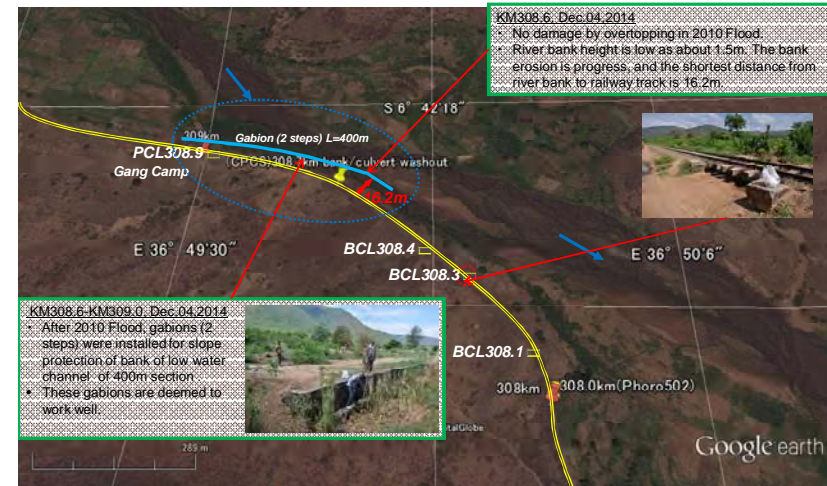
Location

2-18	Damaged Record, if any (year/month)	After damaged by 2010 flood, 2 steps of gabions were constructed.	
2-19	Reason of	Bank erosion	
2-20	Pattern of Riverbed	Rising of riverbed in long distance

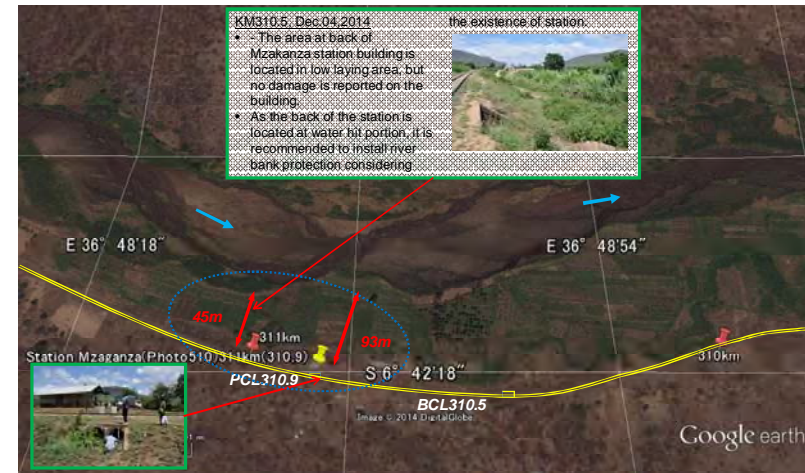
Location

2-18	Damaged Record, if any (year/month)	Bank erosion is progressive, but no serious flood damage is reported.
2-19	Reason of	
2-20	Pattern of Riverbed	Rising of riverbed in long distance

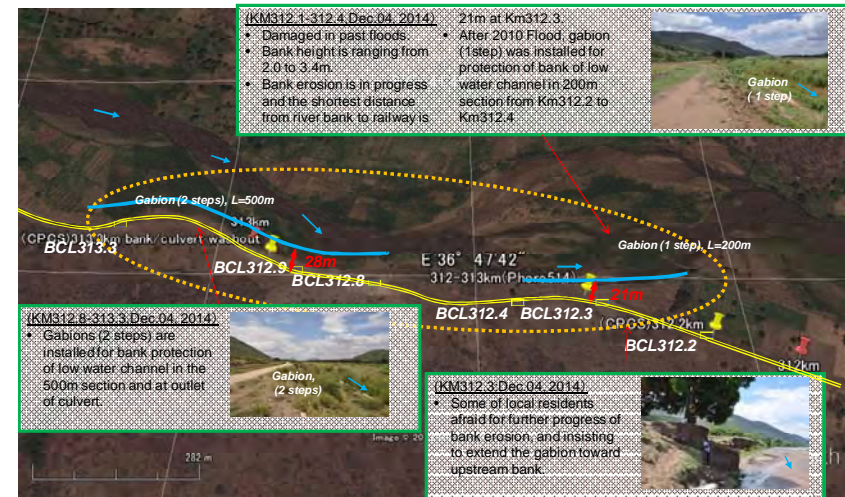
Location

2-18	Damaged Record, if any (year/month)	Progress of erosion to railway side
2-19	Reason of	bank erosion
2-20	Pattern of Riverbed

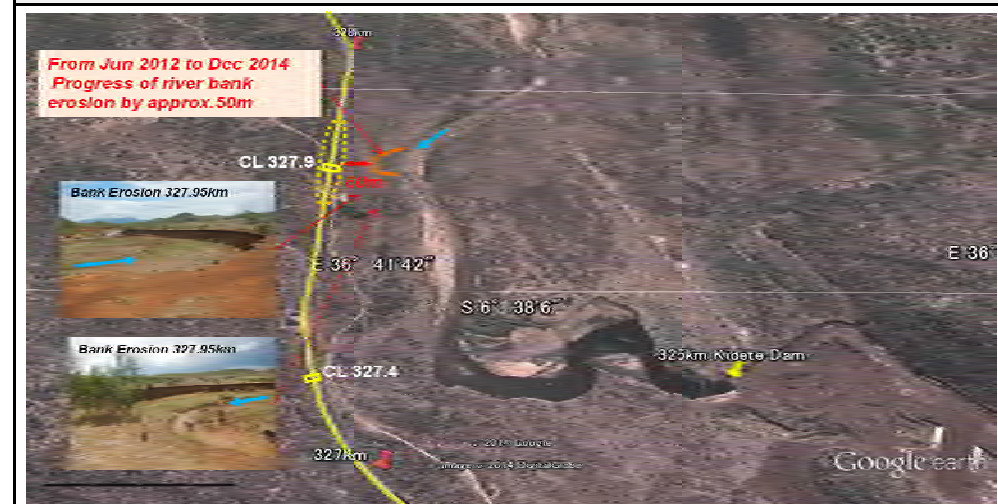
Location

2-18	Damaged Record, if any (year/month)	Notable riverbank corrosion has been occurred at 327.95 km point of the water colliding front. About 50m corrosion has been advancing during two years and a half between present
2-19	Reason of	Bank Erosion
2-20	Pattern of Riverbed

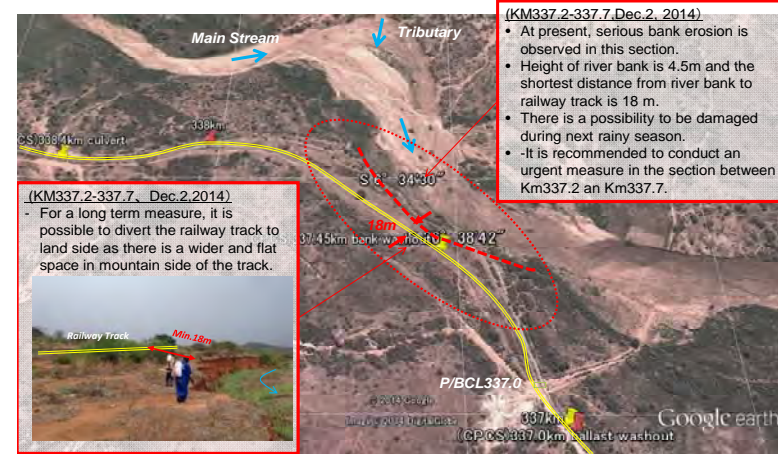
Location

(KM337.2-337.7, Dec.2, 2014)

- At present, serious bank erosion is observed in this section.
- Height of river bank is 4.5m and the shortest distance from river bank to railway track is 18 m.
- There is a possibility to be damaged during next rainy season.
- It is recommended to conduct an urgent measure in the section between Km337.2 and Km337.7.

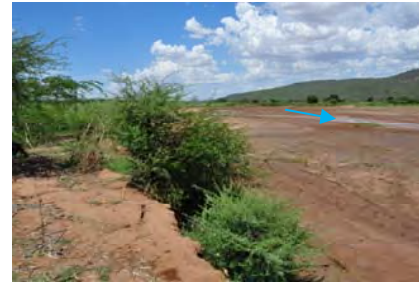
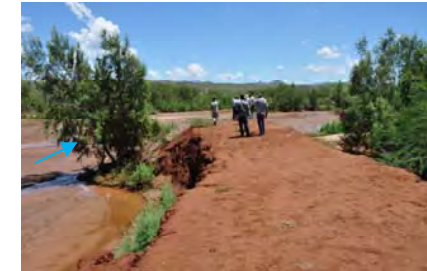
2-1	Length of Objective Area	300m, a Guide dike	
2-2	Nos. of River	none	
2-3	River Channel Alignment	meandering	
2-4	River Cross Section	compound section	
2-5	River Width	Wf: m, Wr: approx.300 m	
		Bl: m, Bc:50 m, Br: m	
2-6	Riverbed Slope	Gentle	
2-7	Riverbed Material	Material	Sand
2-8	River Bank	Bank Height	Hb:2.5 m
2-9		Side Slope	Sl: 1v: , Sr: 1v: (vertical)
2-10		Vegetation	Grass
2-11	Estimated Flow Velocity	normal: m/s, flood	m/s
2-12	Characteristic of environmental condition of river channel	Riverside forests, Sandbar, Pool, shoal, fishes, etc	
2-13	Land Use	none	
2-14	Soil Type	Red	
2-15	Topography	left: ← ,right →	
2-16	Structures/Houses, road	none	
2-17	Location of Railway	d=116m

2-18	Damaged Record, if any (year/month)	none	
2-19	Reason of	Bank erosion	
2-20	Pattern of Riverbed	Rising of riverbed in long distance

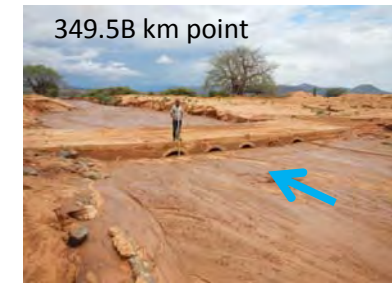
Photo Downstream

2-18	Damaged Record, if any (year/month)	Culverts of the railroad have been deposited by the sediment in the tributary MASUWALA RIVER, and river flow prevention has been occurred . The railroad bank has been scored by the
2-19	Reason of	Flood flow overtopped railway track
2-20	Pattern of Riverbed

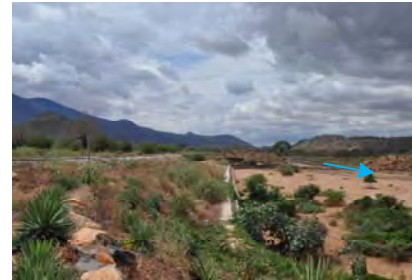
Photo Upstream

2. Characteristics of Physical Condition of River Channel			
2-1	Length of Objective Area	KM354.9-355.2	
2-2	Nos. of River	Gabion, culvert (1), bridge(1)	
2-3	River Channel Alignment	Straight, water hit area	
2-4	River Cross Section	compond	
2-5	River Width	Wf: m, Wr:300-600 m	
		Bl: m, Bc: m, Br: m	
2-6	Riverbed Slope	Gentle	
2-7	Riverbed Material	Material	Sand
2-8	River Bank	Bank Height	Hb: 4.0 - 5.3m
2-9		Side Slope	Sl: 1v: , Sr: 1v:
2-10		Vegetation	none
2-11	Estimated Flow Velocity	normal: 0 m/s, flood	m/s
2-12	Characteristic of environmental condition of river channel	Riverside forests, Sandbar, Pool, shoal, fishes, etc	
2-13	Land Use	none	
2-14	Soil Type	yellow color soil	
2-15	Topography	left: ← ,right →	
2-16	Structures/Houses, road	none	
2-17	Location of Railway	d=22mpkm355.1	
2-18	Damaged Record, if any (year/month)	After 2010 flood, gabion were insatalled. Boulders are delivered from Gulwe, and sands are extracte neare site.

2-19	Reason of	Bank erosion & overflow	
2-20	Pattern of Riverbed

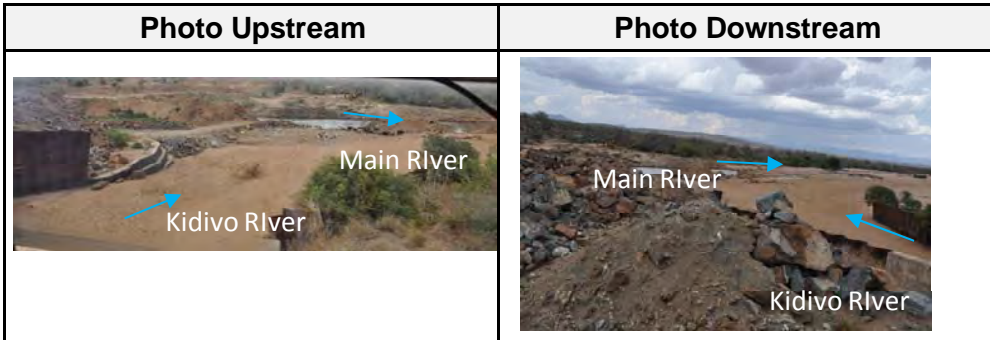
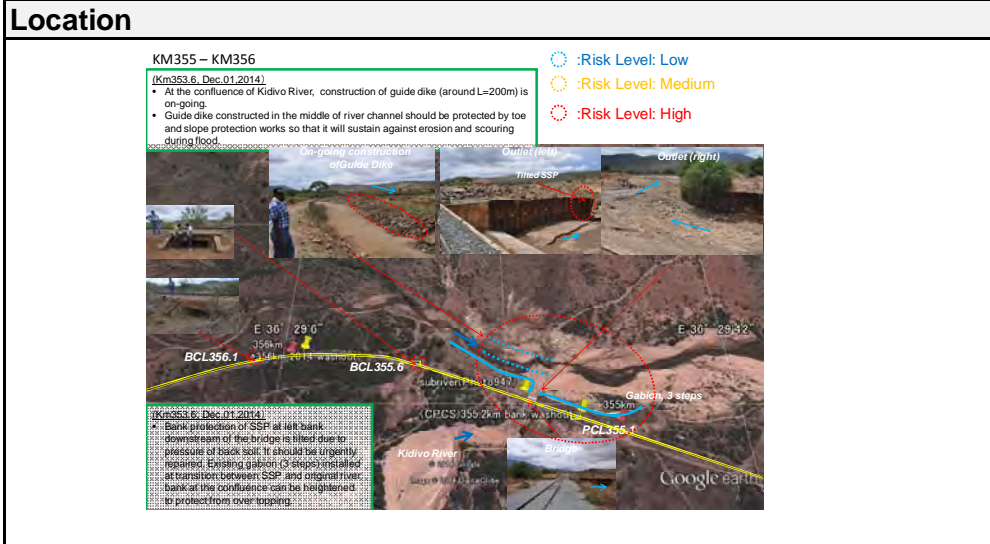
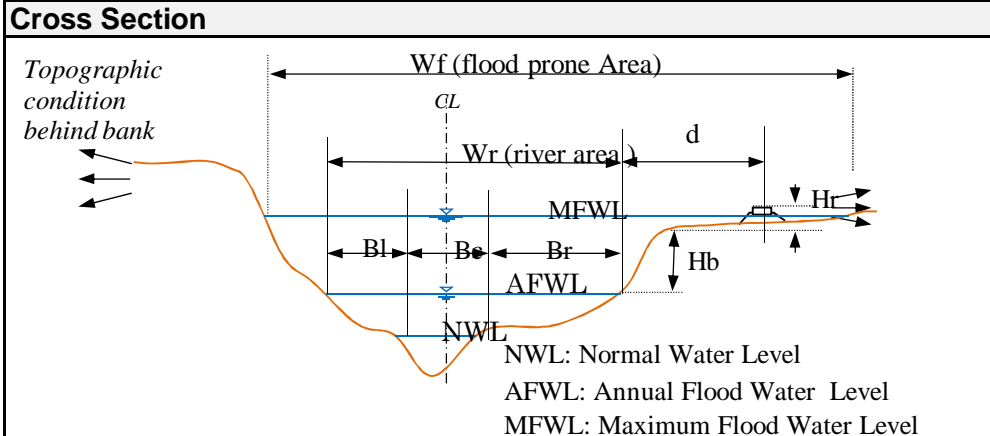
2. Characteristics of Physical Condition of River Channel		
2-1	Length of Objective Area	300m, Km355.2-Km355.5
2-2	Nos. of River	
2-3	River Channel Alignment	Straight
2-4	River Cross Section	
2-5	River Width	Wf: m, Wr: m Bl: m, Bc: m, Br: m
2-6	Riverbed Slope	Gentle
2-7	Riverbed Material	Material: Sand
2-8	River Bank	Bank Height: Hl: m
2-9		Side Slope: Sl: 1v: , Sr: 1v:
2-10		Vegetation: Tall grass
2-11	Estimated Flow Velocity	normal: m/s, flood m/s
2-12	Characteristic of environmental condition of river channel	Riverside forests, Sandbar, Pool, shoal, fishes, etc
2-13	Land Use	none
2-14	Soil Type	Laterite
2-15	Topography	left: ← , right →
2-16	Structures/Houses, road	none
2-17	Location of Railway	d=28.6m@ Km355.2
2-18	Damaged Record, if any (year/month)	Steel sheet pile and gabion (3 steps) are installed for protection of left and right banks of outlet channel at confluence of Kidivo River.
2-19		Reason of

2-20	Pattern of Riverbed	siltation at confluence
