## **APPENDIX F**

### **INVENTORY SHEET OF CULVERT**

## Inventory Sheet for Culvert

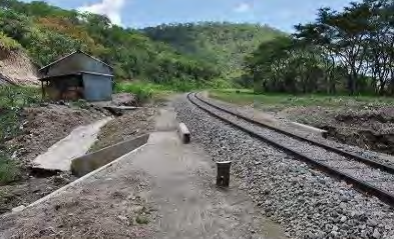
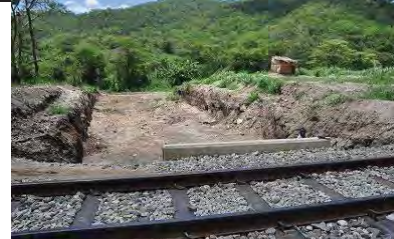
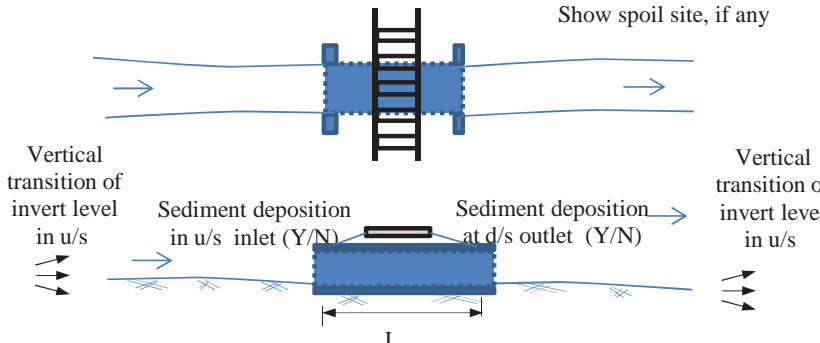
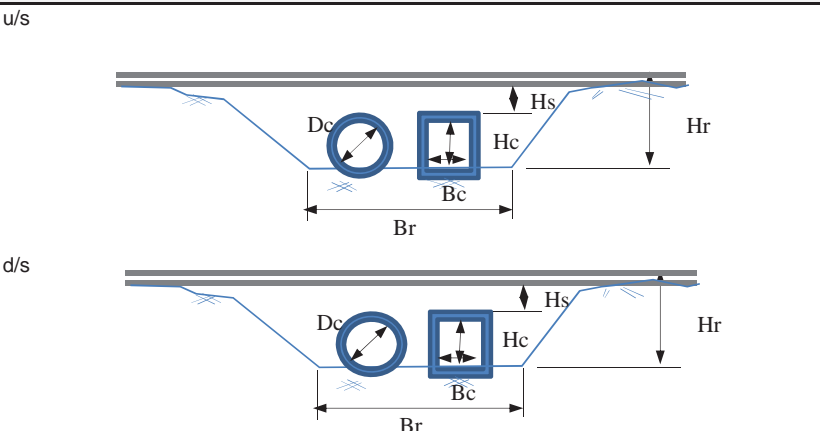
<b>Station: at KM 293/0</b>		<b>Sheet No.: BCL293.0</b>	
<b>1. General</b>			
1-1	Name of Inspector	T.Fukuda, Mr.Kido, Mr.Philipo	
1-2	Organization of Inspector	B	
1-3	Date/Time of Inspection	DEC 5 2014 1207	
1-4	Location	Lat	0645'43.9"
1-5		Long	036°56'06.6"
1-6	Elevation	n/a	
<b>2. Characteristics of Physical Condition of Culvert</b>			
2-1	Length of Culvert	n/a	
2-2	Shape of Cross Section	Rectangular × 1	
2-3	Flow Area	Height	Hc = 1.8m
2-4		Width	Bc = 2.0m
2-5		Other	WL = 3.6m, Hs = 0.3m
2-6	Connecting Channel	Height	n/a
2-7		Width	n/a
2-8		Side Slope	n/a
2-9	Type of Culvert	Concrete	
2-10	Riverbed	Material	n/a
2-11	Sediment deposition	u/s	Y, 10%
2-12		d/s	Y, 10%
2-13	Topography	u/s: ↘ ,d/s: →	
2-14	Land Use	n/a	
2-15	Structures/Houses, road	n/a	
<b>3. Damaged Flood Records</b>			
3-1	(Year/Month)	(Type)	(Reason,etc.)
	2010	Flood	Overtop

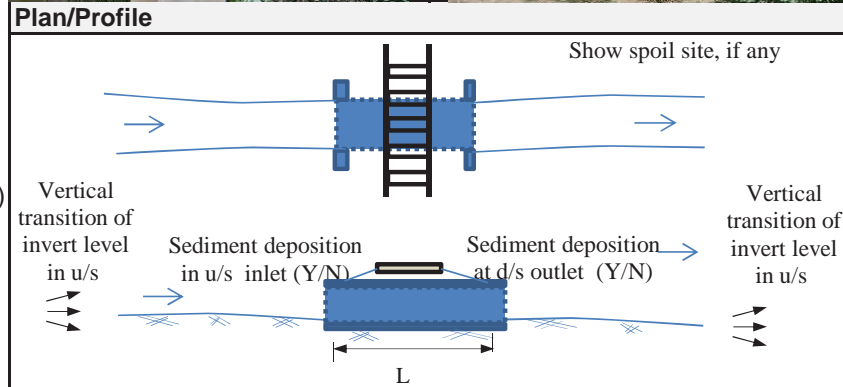
**Station: at KM 293/1**      **Sheet No.: BCL293.1**

3-1	(Year/Month)	(Type)	(Reason,etc.)
	2010(2008?)	Flood	Overtop, wash out of bridge
	1998	Flood	Overtop, wash out of bridge

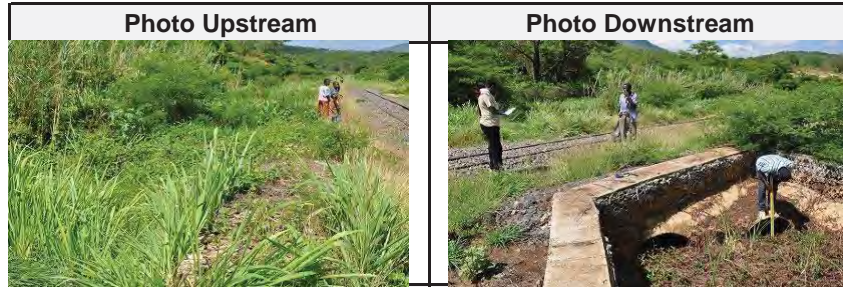
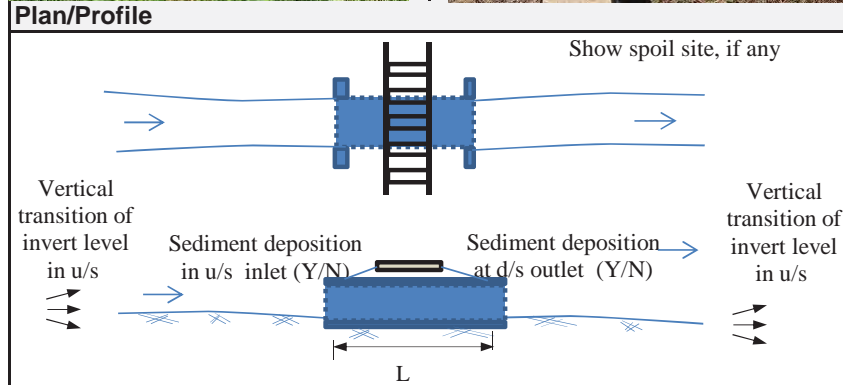
<b>Station: at KM 294/2</b>		<b>Sheet No.: PCL294.2</b>	
<b>1. General</b>			
1-1	Name of Inspector	T.Fukuda, Mr.Kido, Mr.Philipo	
1-2	Organization of Inspector	B	
1-3	Date/Time of Inspection	DEC 5 2014 1045	
1-4	Location	Lat	0645'34.4"
1-5		Long	036°55'25.9"
1-6	Elevation	n/a	
<b>2. Characteristics of Physical Condition of Culvert</b>			
2-1	Length of Culvert	n/a	
2-2	Shape of Cross Section	Circle x 2	
2-3	Flow Area	Height	n/a
2-4		Width	n/a
2-5		Other	d = 0.95m, Hs = 0.9m
2-6	Connecting Channel	Height	n/a
2-7		Width	n/a
2-8		Side Slope	n/a
2-9	Type of Culvert	Concrete	
2-10	Riverbed	Material	n/a
2-11	Sediment deposition	u/s	Y, 80%
2-12		d/s	Y, 80?
2-13	Topography	u/s: → ,d/s →	
2-14	Land Use	n/a	
2-15	Structures/Houses, road	n/a	
<b>3. Damaged Flood Records</b>			
3-1	(Year/Month)	(Type)	(Reason,etc.)
	2010?	washed out	overtop

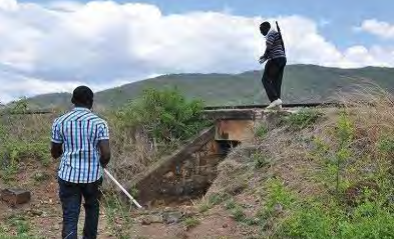
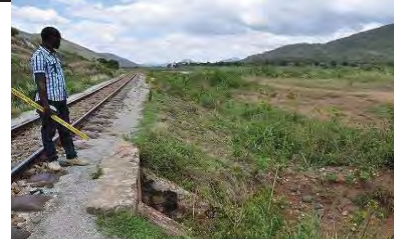
<b>Station: at KM 312/2</b>		<b>Sheet No.: BCL312.2</b>	
<b>1. General</b>			
1-1	Name of Inspector	T.Fukuda, Mr.Kido, Mr.Philipo	
1-2	Organization of Inspector	B	
1-3	Date/Time of Inspection	DEC 4 2014 1225	
1-4	Location	Lat	0642'02.8"
1-5		Long	03647'53.0"
1-6	Elevation	n/a	
<b>2. Characteristics of Physical Condition of Culvert</b>			
2-1	Length of Culvert	n/a	
2-2	Shape of Cross Section	Rectangular × 1	
2-3	Flow Area	Height	Hc= 1.35m
2-4		Width	Bc= 1.0m
2-5		Other	WL=2.0m, Hs=0.5m
2-6	Connecting Channel	Height	n/a
2-7		Width	n/a
2-8		Side Slope	n/a
2-9	Type of Culvert	Concrete	
2-10	Riverbed	Material	n/a
2-11	Sediment deposition	u/s	Y, 0%
2-12		d/s	Y, 0%
2-13	Topography	u/s: → ,d/s →	
2-14	Land Use	n/a	
2-15	Structures/Houses, road	n/a	
<b>3. Damaged Flood Records</b>			
3-1	(Year/Month)	(Type)	(Reason,etc.)
	?	damaged on	gaion is insatalled along the bank

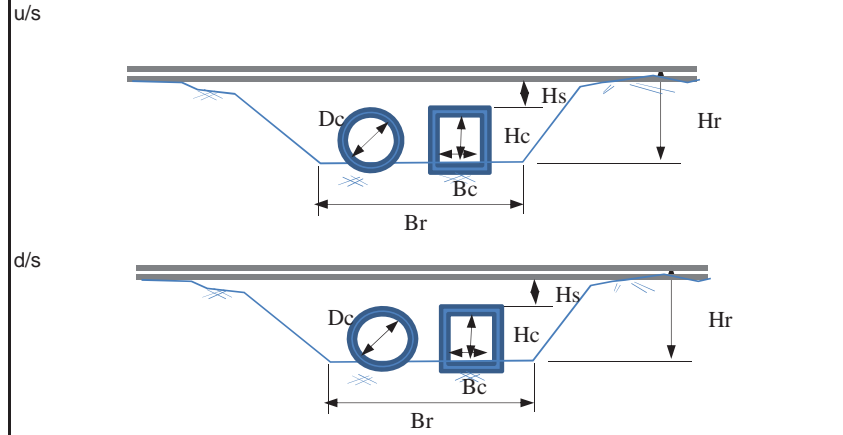
**Station: at KM 313/4**      **Sheet No.: BCL313.3**

3-1	(Year/Month)	(Type)	(Reason,etc.)
	?	washout	?

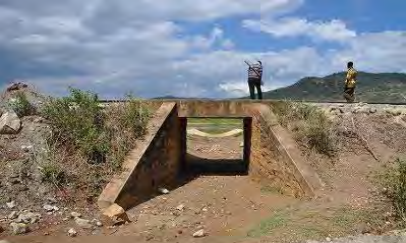
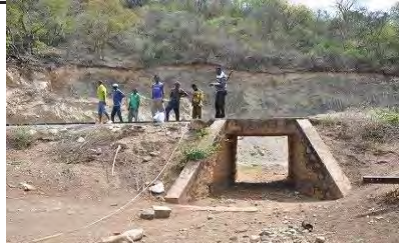
<b>Station: at KM 314/9</b>		<b>Sheet No.: BCL314.9</b>	
<b>1. General</b>			
1-1	Name of Inspector	T.Fukuda, Mr.Kido, Mr.Philipo	
1-2	Organization of Inspector	B	
1-3	Date/Time of Inspection	DEC 4 2014 1420	
1-4	Location	Lat	0641'34.3"
1-5		Long	036°46'30.5"
1-6	Elevation	n/a	
<b>2. Characteristics of Physical Condition of Culvert</b>			
2-1	Length of Culvert	n/a	
2-2	Shape of Cross Section	Rectangular × 1	
2-3	Flow Area	Height	Hc= 1.8m
2-4		Width	Bc= 2.0m
2-5		Other	WL=3.0m, Hs= 0.35m
2-6	Connecting Channel	Height	n/a
2-7		Width	n/a
2-8		Side Slope	n/a
2-9	Type of Culvert	Concrete	
2-10	Riverbed	Material	n/a
2-11	Sediment deposition	u/s	Y, 10%
2-12		d/s	Y, 10%
2-13	Topography	u/s: → ,d/s →	
2-14	Land Use	n/a	
2-15	Structures/Houses, road	n/a	
<b>3. Damaged Flood Records</b>			
3-1	(Year/Month)	(Type)	(Reason,etc.)
	n/a	overtop	n/a

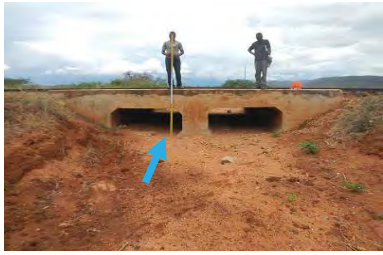
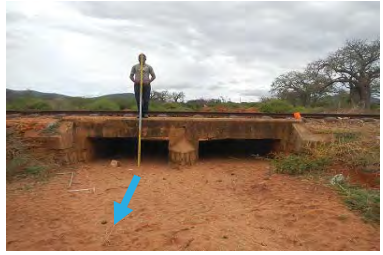
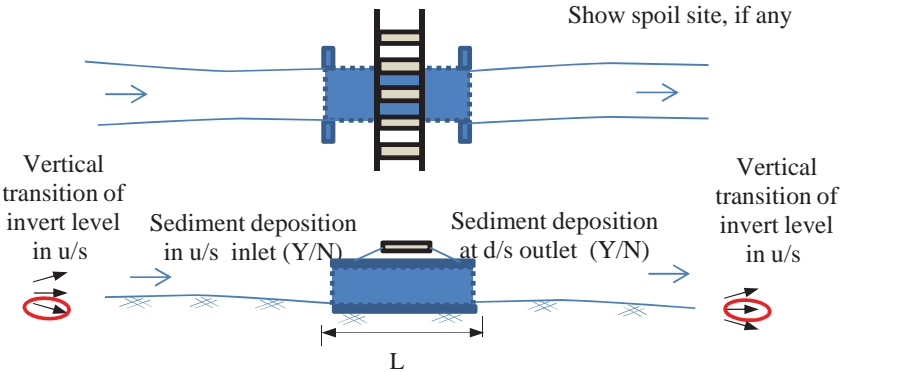
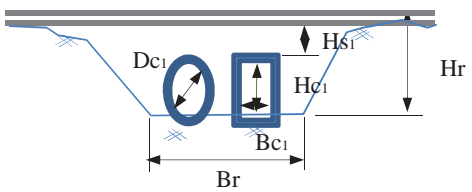
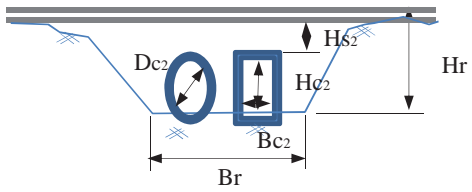
Station: at KM 349.4 A		Sheet No.: BCL 349.4A	
<b>1. General</b>			
1-1	Name of Inspector	T. Kawaguchi , Hussein , Abiud	
1-2	Organization of Inspector	JICA Study Team	
1-3	Date/Time of Inspection	2014/2/12	
1-4	Location	Lat 06° 32' 00" 94'''	
1-5		Long 036° 33' 21" 55'''	
1-6	Elevation		
<b>2. Characteristics of Physical Condition of Culvert</b>			
2-1	Length of Culvert	5.0 m	
2-2	Shape of Cross Section	Square:(2) Rectangular: Circle:	
2-3	Flow Area	Height Hc1 = 0.8 m , Hc2 = 0.8 m	
2-4		Width Bc1 = 1.5 m , Bc2 = 1.5 m	
2-5		Other Hs1 = 0.5 m , Hs2 = 0.5 m	
2-6	Connecting Channel	Height	
2-7		Width	
2-8		Side Slope	
2-9	Type of Culvert	Concrete	
2-10	Riverbed	Material Silty sand	
2-11	Sediment deposition	u/s Heavy ( 50% rate)	
2-12		d/s Heavy ( 50% rate)	
2-13	Topography	u/s: , d/s:	
2-14	Land Use		
2-15	Structures/Houses, road		
<b>3. Damaged Flood Records</b>			
3-1	(Year/Month)	(Type)	(Reason,etc.)

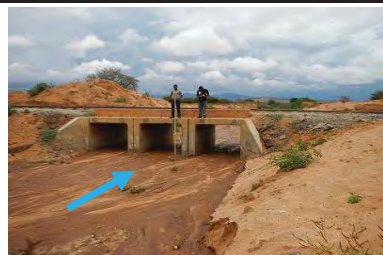
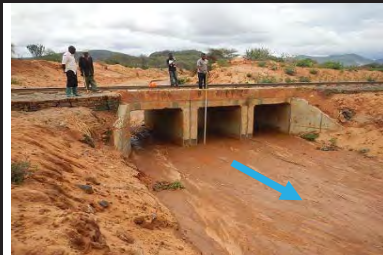
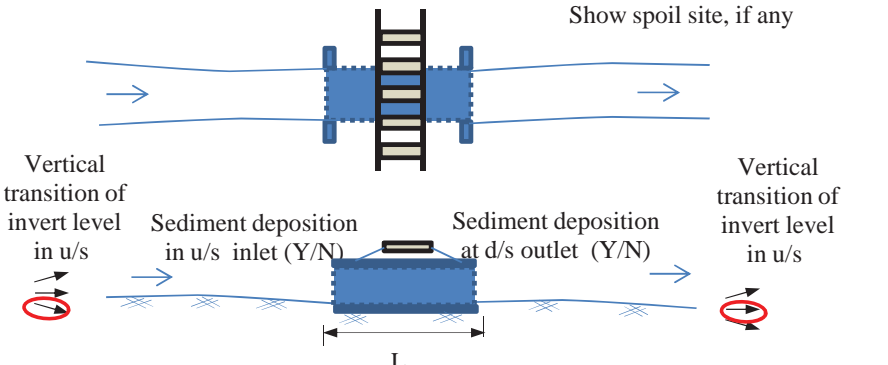
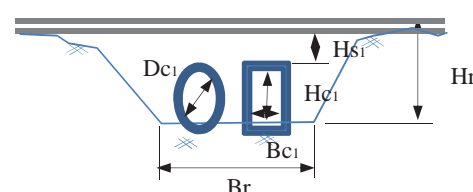
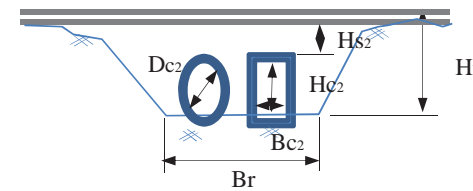
<b>Station: at KM 349.4B</b>		<b>Sheet No.: BCL 349.4B</b>	
<b>1. General</b>			
1-1	Name of Inspector	T. Kawaguchi , Hussein , Abiud	
1-2	Organization of Inspector	JICA Study Team	
1-3	Date/Time of Inspection	2014/2/12	
1-4	Location	Lat	06° 31' 41" 17"
1-5		Long	036° 32' 54" 70"
1-6	Elevation		
<b>2. Characteristics of Physical Condition of Culvert</b>			
2-1	Length of Culvert	5.0 m	
2-2	Shape of Cross Section	Square:(3) Rectangular: Circle:	
2-3	Flow Area	Height	Hc1 = 1.7 m , Hc2 = 1.7 m
2-4		Width	Bc1 = 2.0 m , Bc2 = 2.0 m
2-5		Other	Hs1 = 1.0 m , Hs2 = 1.0 m
2-6	Connecting Channel	Height	
2-7		Width	
2-8		Side Slope	
2-9	Type of Culvert	Concrete	
2-10	Riverbed	Material	Silty sand
2-11	Sediment deposition	u/s	Light ( 30% rate)
2-12		d/s	Light ( 30% rate)
2-13	Topography	u/s:  , d/s:	
2-14	Land Use		
2-15	Structures/Houses, road		
<b>3. Damaged Flood Records</b>			
3-1	(Year/Month)	(Type)	(Reason,etc.)

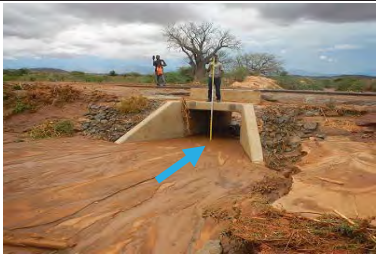
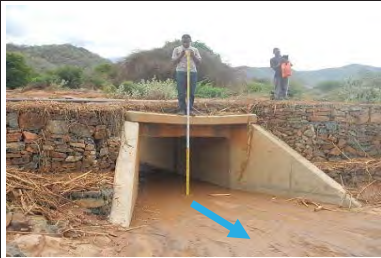
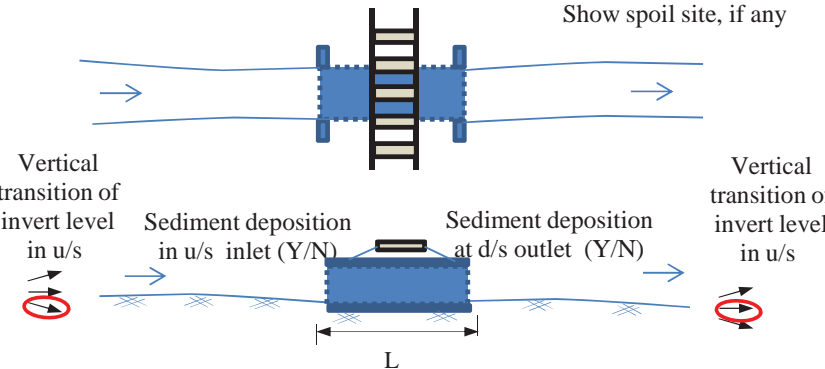
<b>Station: at KM 349.6B</b>		<b>Sheet No.: BCL 349.6B</b>	
<b>1. General</b>			
1-1	Name of Inspector	T. Kawaguchi , Hussein , Abiud	
1-2	Organization of Inspector	JICA Study Team	
1-3	Date/Time of Inspection	2014/2/12	
1-4	Location	Lat	06° 31' 37" 36 ""
1-5		Long	036° 32' 49" 49""
1-6	Elevation		
<b>2. Characteristics of Physical Condition of Culvert</b>			
2-1	Length of Culvert	6.0 m	
2-2	Shape of Cross Section	Square:(1) Rectangular: Circle:	
2-3	Flow Area	Height	Hc1 = 1.1 m , Hc2 = 1.2 m
2-4		Width	Bc1 = 2.0 m , Bc2 = 2.0 m
2-5		Other	Hs1 = 0.3 m , Hs2 = 0.3 m
2-6	Connecting Channel	Height	
2-7		Width	
2-8		Side Slope	
2-9	Type of Culvert	Concrete	
2-10	Riverbed	Material	Silty sand
2-11	Sediment	u/s	Light ( 30% rate)
2-12	deposition	d/s	Light ( 30% rate)
2-13	Topography	u/s:  , d/s:	
2-14	Land Use		
2-15	Structures/Houses, road		
<b>3. Damaged Flood Records</b>			
3-1	(Year/Month)	(Type)	(Reason,etc.)

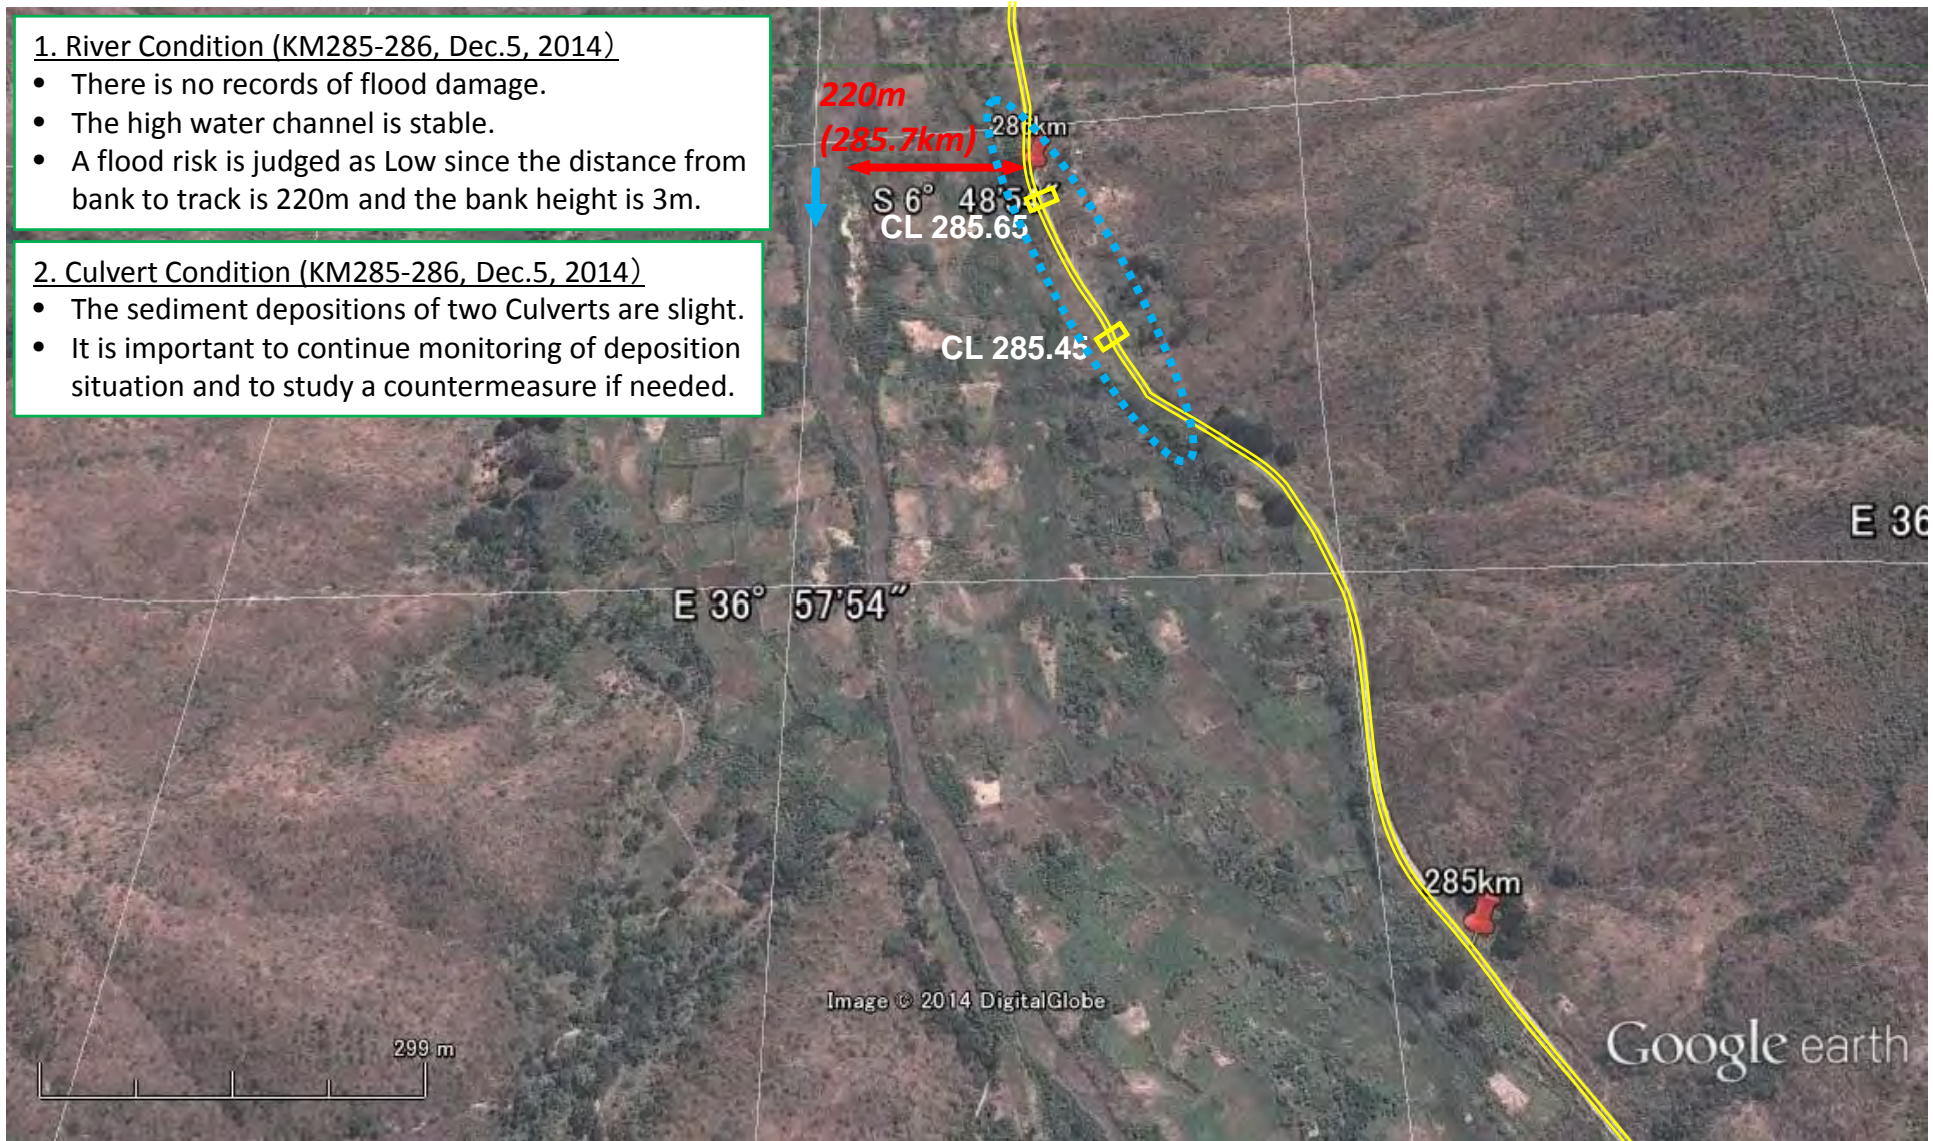
H-4

- 1. River Condition (KM285-286, Dec.5, 2014)**
  - There is no records of flood damage.
  - The high water channel is stable.
  - A flood risk is judged as Low since the distance from bank to track is 220m and the bank height is 3m.
- 2. Culvert Condition (KM285-286, Dec.5, 2014)**
  - The sediment depositions of two Culverts are slight.
  - It is important to continue monitoring of deposition situation and to study a countermeasure if needed.

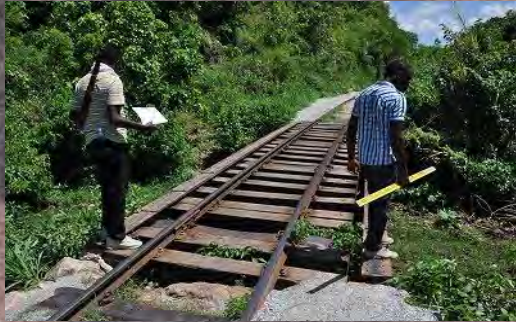
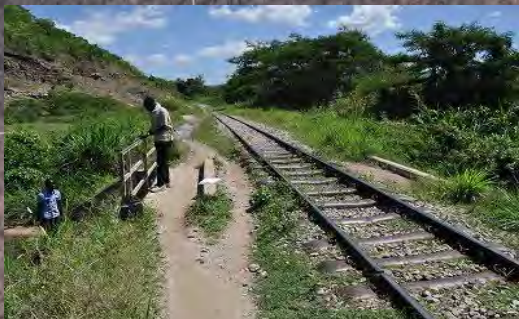
KM290-KM291, December 5, 2014  
" At present, the section is relatively safe because of diversion of the track and shifting of river course to opposite bank.

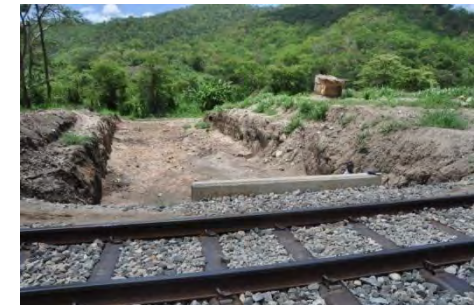
## KM292.9, December 5, 2014

- By 2010 Flood, the box culvert at KM292.9 was damaged due to overtopping of flood from the left upstream of the bridge. At present, it was restored together with the bridge.

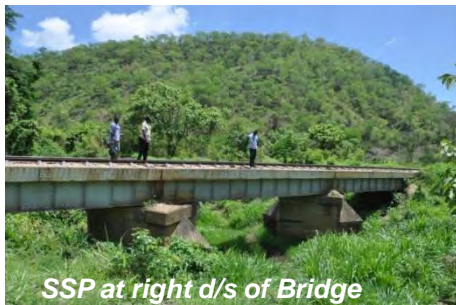
## Km292.6, December 5, 2014

- “ A Bridge (L=31.8m with 3 spans) at KM292.6
- “ Steel sheet piles (L=14m) were driven for the river bank protection of the right downstream of the bridge.
- “ It is recommended to conduct maintenance and rehabilitation of the bridge and slope protection in long term plan.

SSP at right d/s of Bridge

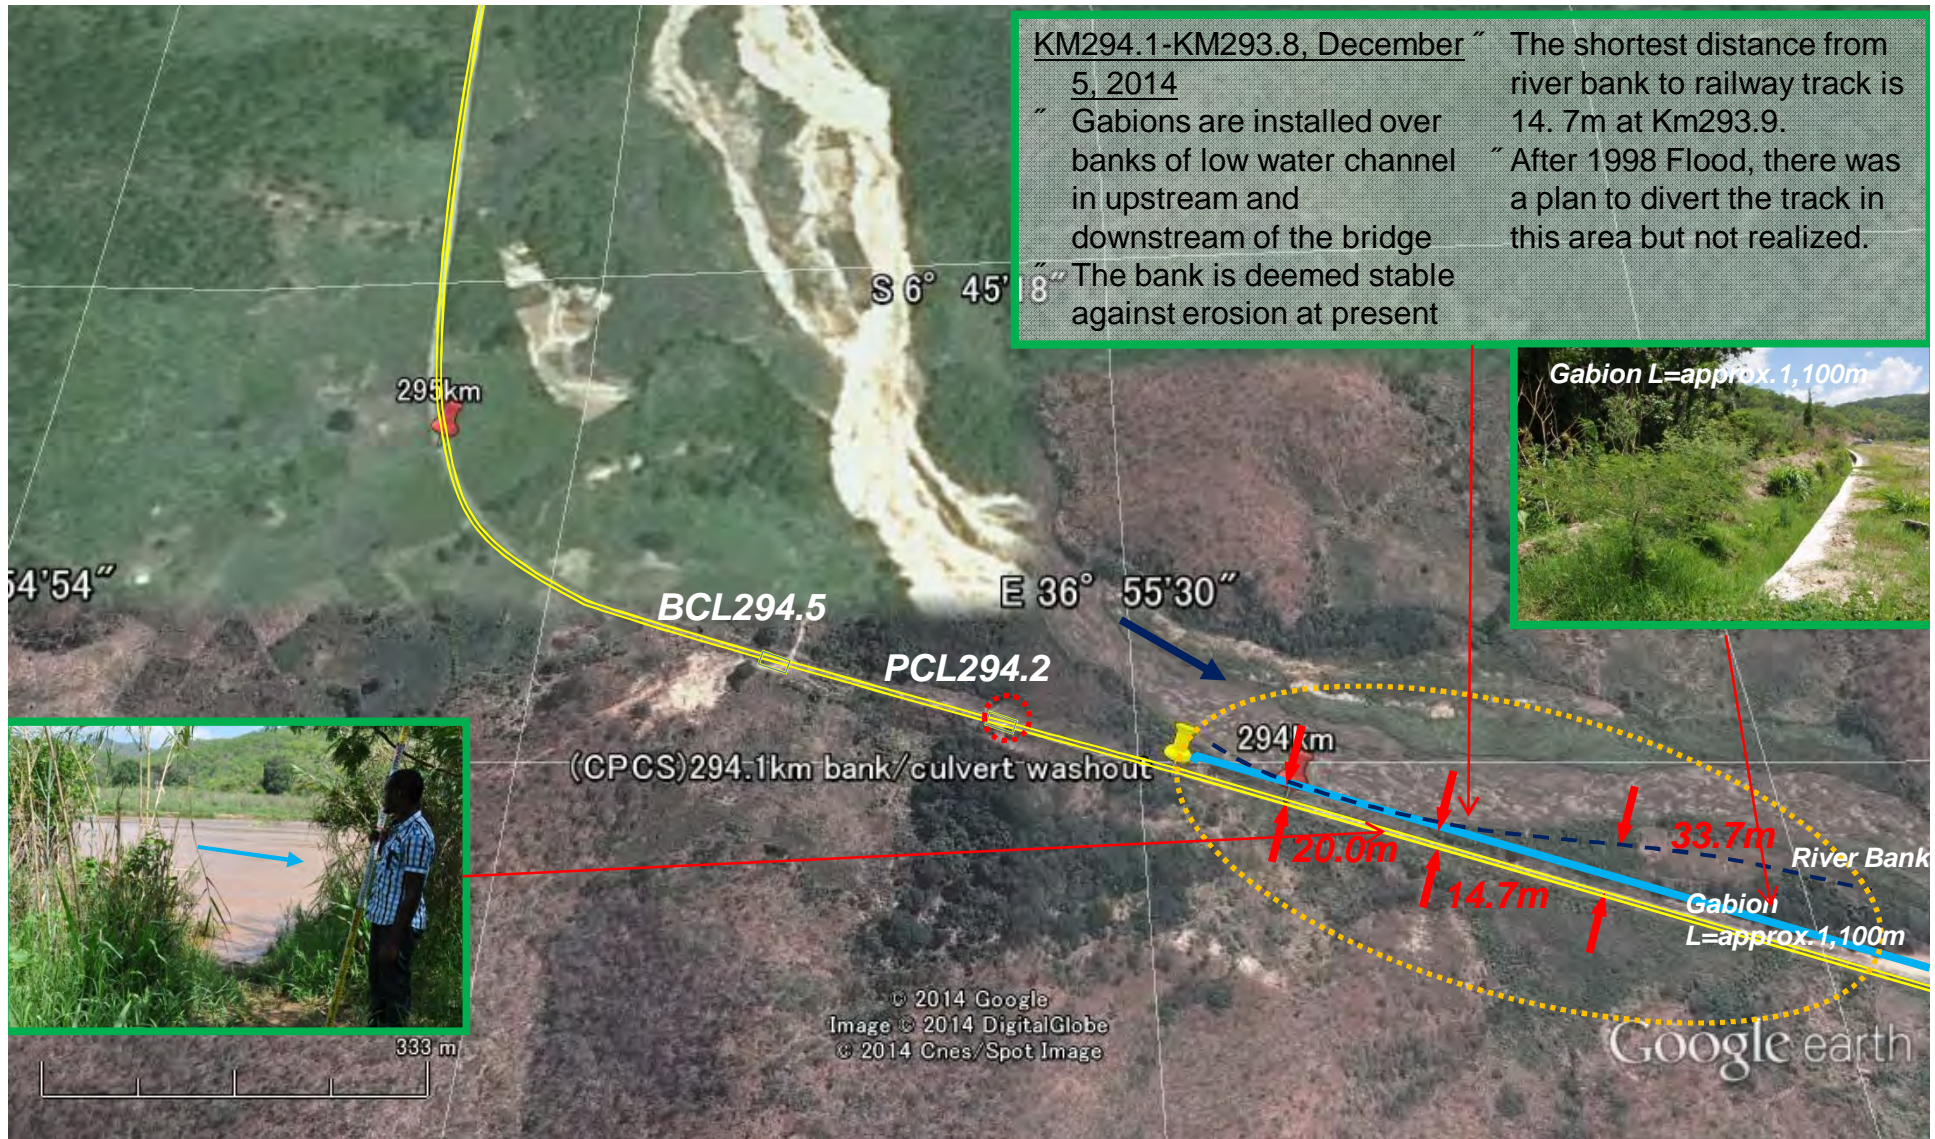
# KM300 – Km301

- The left bank at 300.5km point is colliding front section.
- Monitoring the distance from bank to track and Culverts sediment deposition situation is recommended.

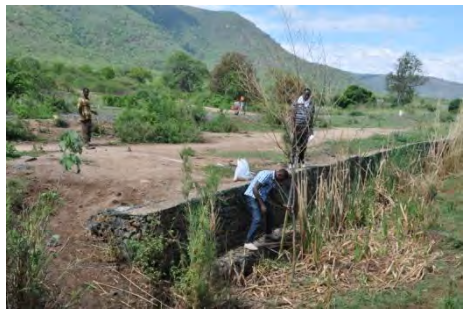
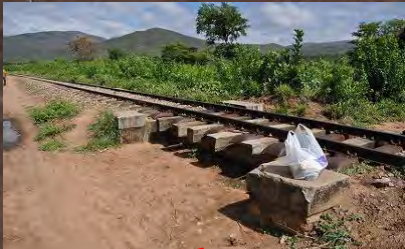
**KM308.6-KM309.0, Dec.04,2014**

- After 2010 Flood, gabions (2 steps) were installed for slope protection of bank of low water channel of 400m section .
- “ These gabions are deemed to work well.

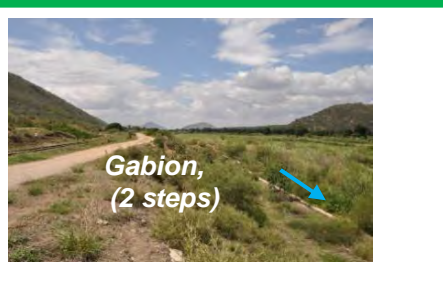
(KM312.8-313.3, Dec.04, 2014)  
 " Gabions (2 steps) are installed for bank protection of low water channel in the 500m section and at outlet of culvert.

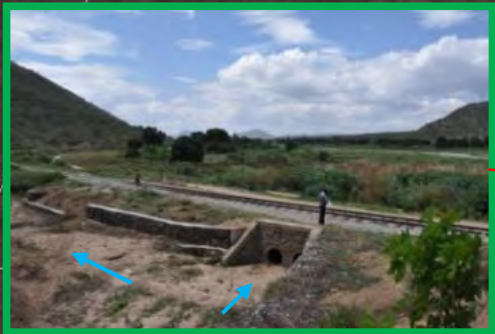
(KM313.3, Dec. 04, 2014)

- ~ A small tributary joins to mainstream
- ~ A culvert had been damaged and washed out. After that, the outlet of culvert was restored and reinforced by installation of gabion and apron.

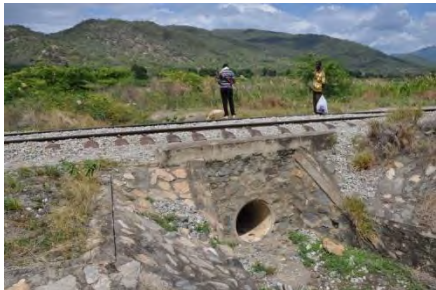
(KM314.3, Dec.4, 2014)

- At the upstream of the culvert (BCL311.1) step of stone pitching are installed. for drainage of a local tributary,
- The shortest distance from river bank to railway track is 19m. The river bank with 4.4m in height s protected by wide flood plain of 100m in width with dense vegetations.

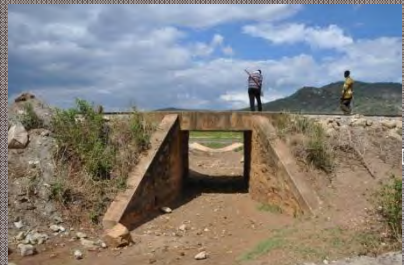
(KM314.9, Dec.4, 2014)

- The shortest distance from river bank (H5m) to railway track is 32m.
- A new culvert will be installed at upstream of this section as a part of on-going restoration work in this area

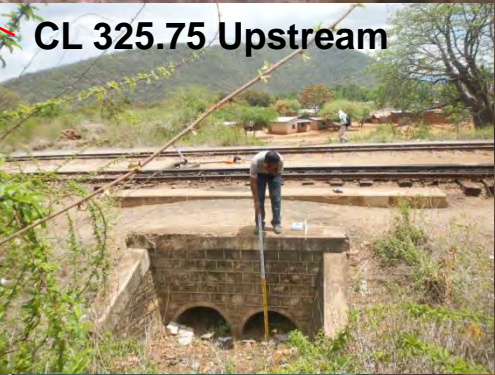
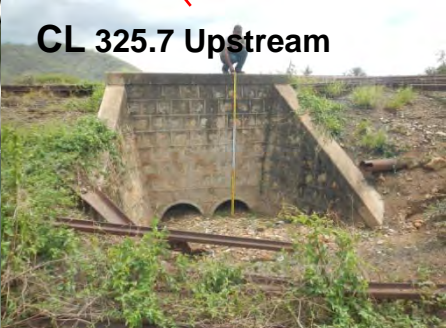
- Three pipe culverts have been deposited by sediment due to shortage of flow capacity.
- It is necessary to work on the removal sediment or rebuilding from pipe to box culvert as urgent countermeasures.

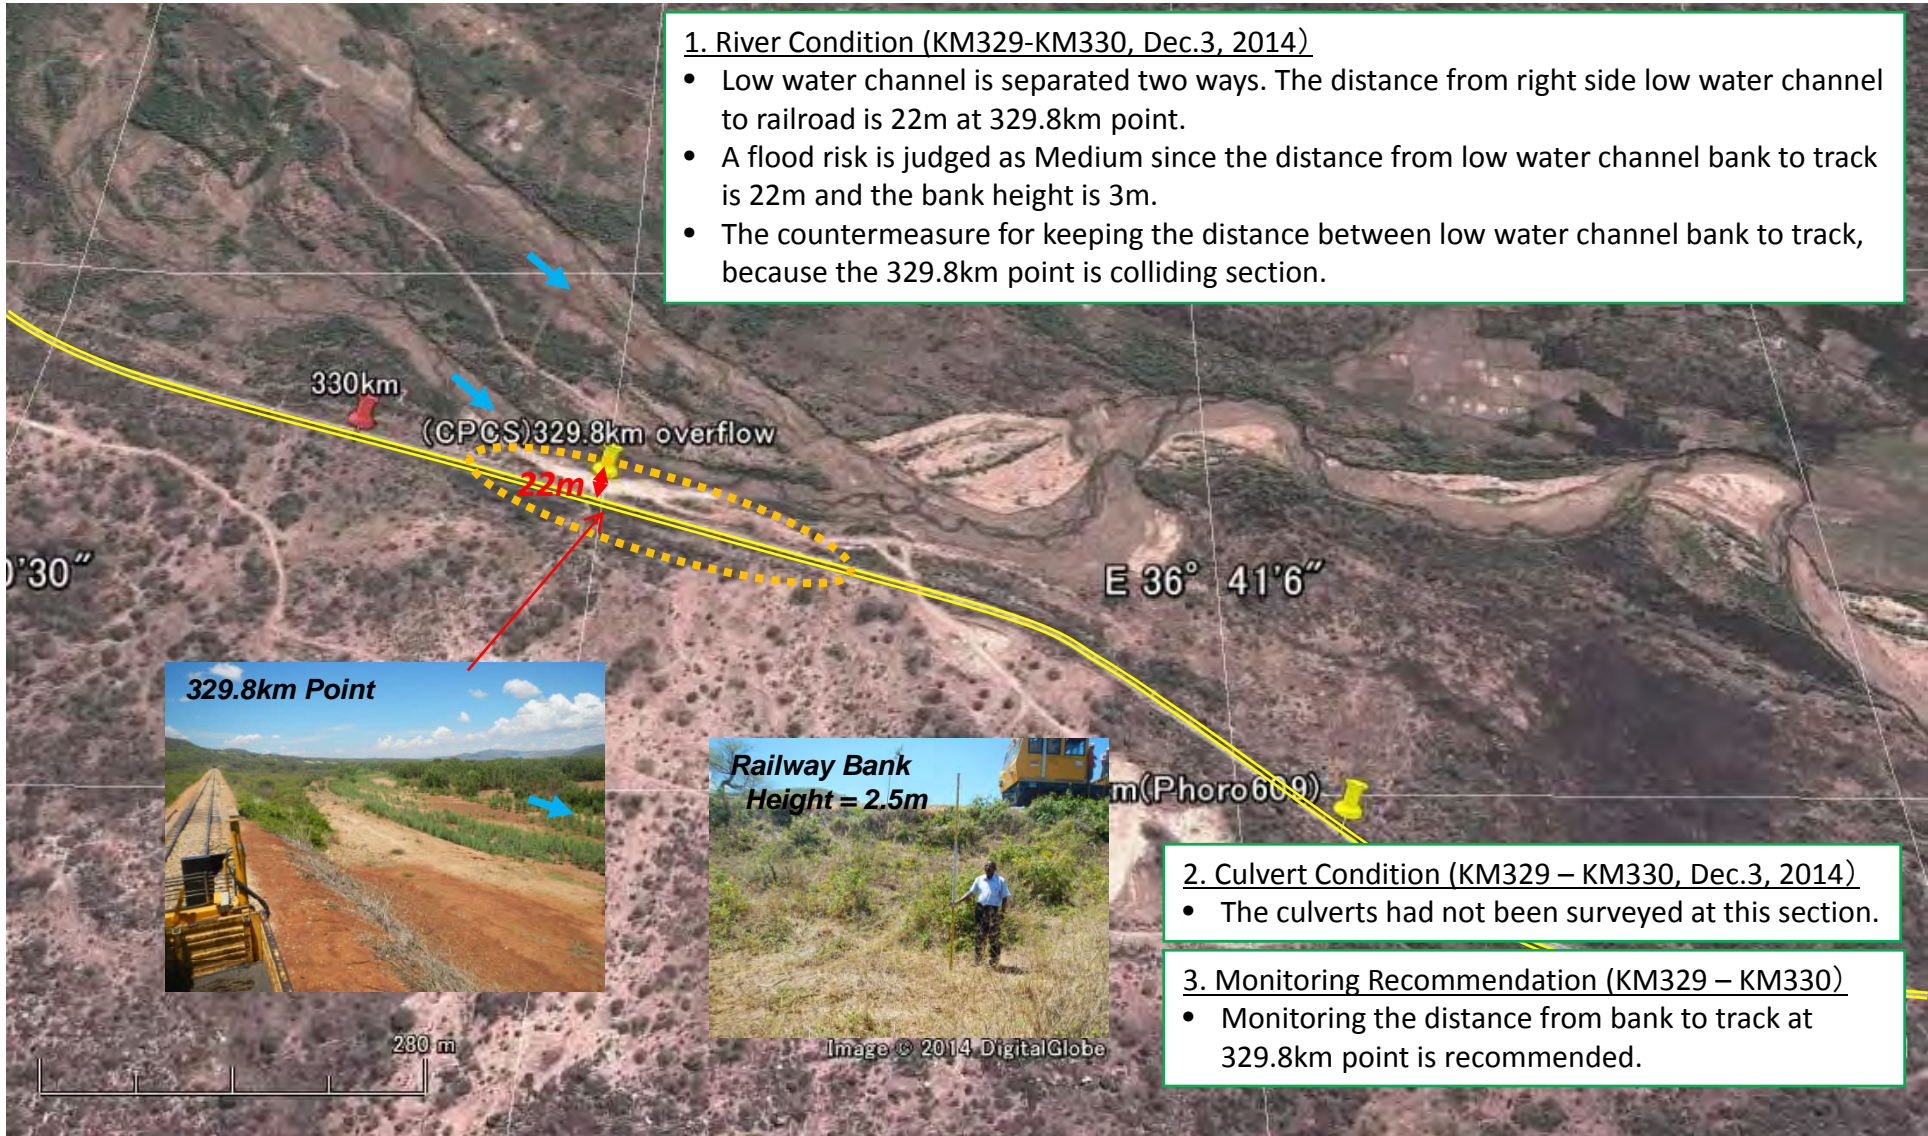
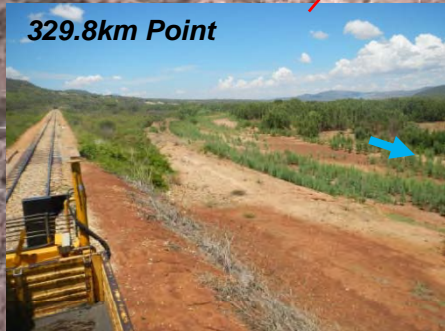
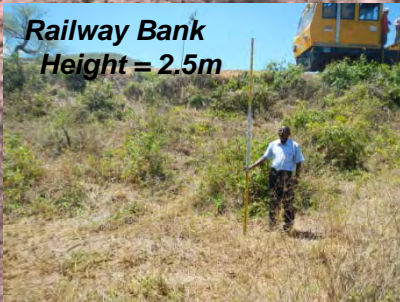
1. River Condition (KM329-KM330, Dec.3, 2014)

- Low water channel is separated two ways. The distance from right side low water channel to railroad is 22m at 329.8km point.
- A flood risk is judged as Medium since the distance from low water channel bank to track is 22m and the bank height is 3m.
- The countermeasure for keeping the distance between low water channel bank to track, because the 329.8km point is colliding section.

- Monitoring the distance from bank to track at 329.8km point is recommended.

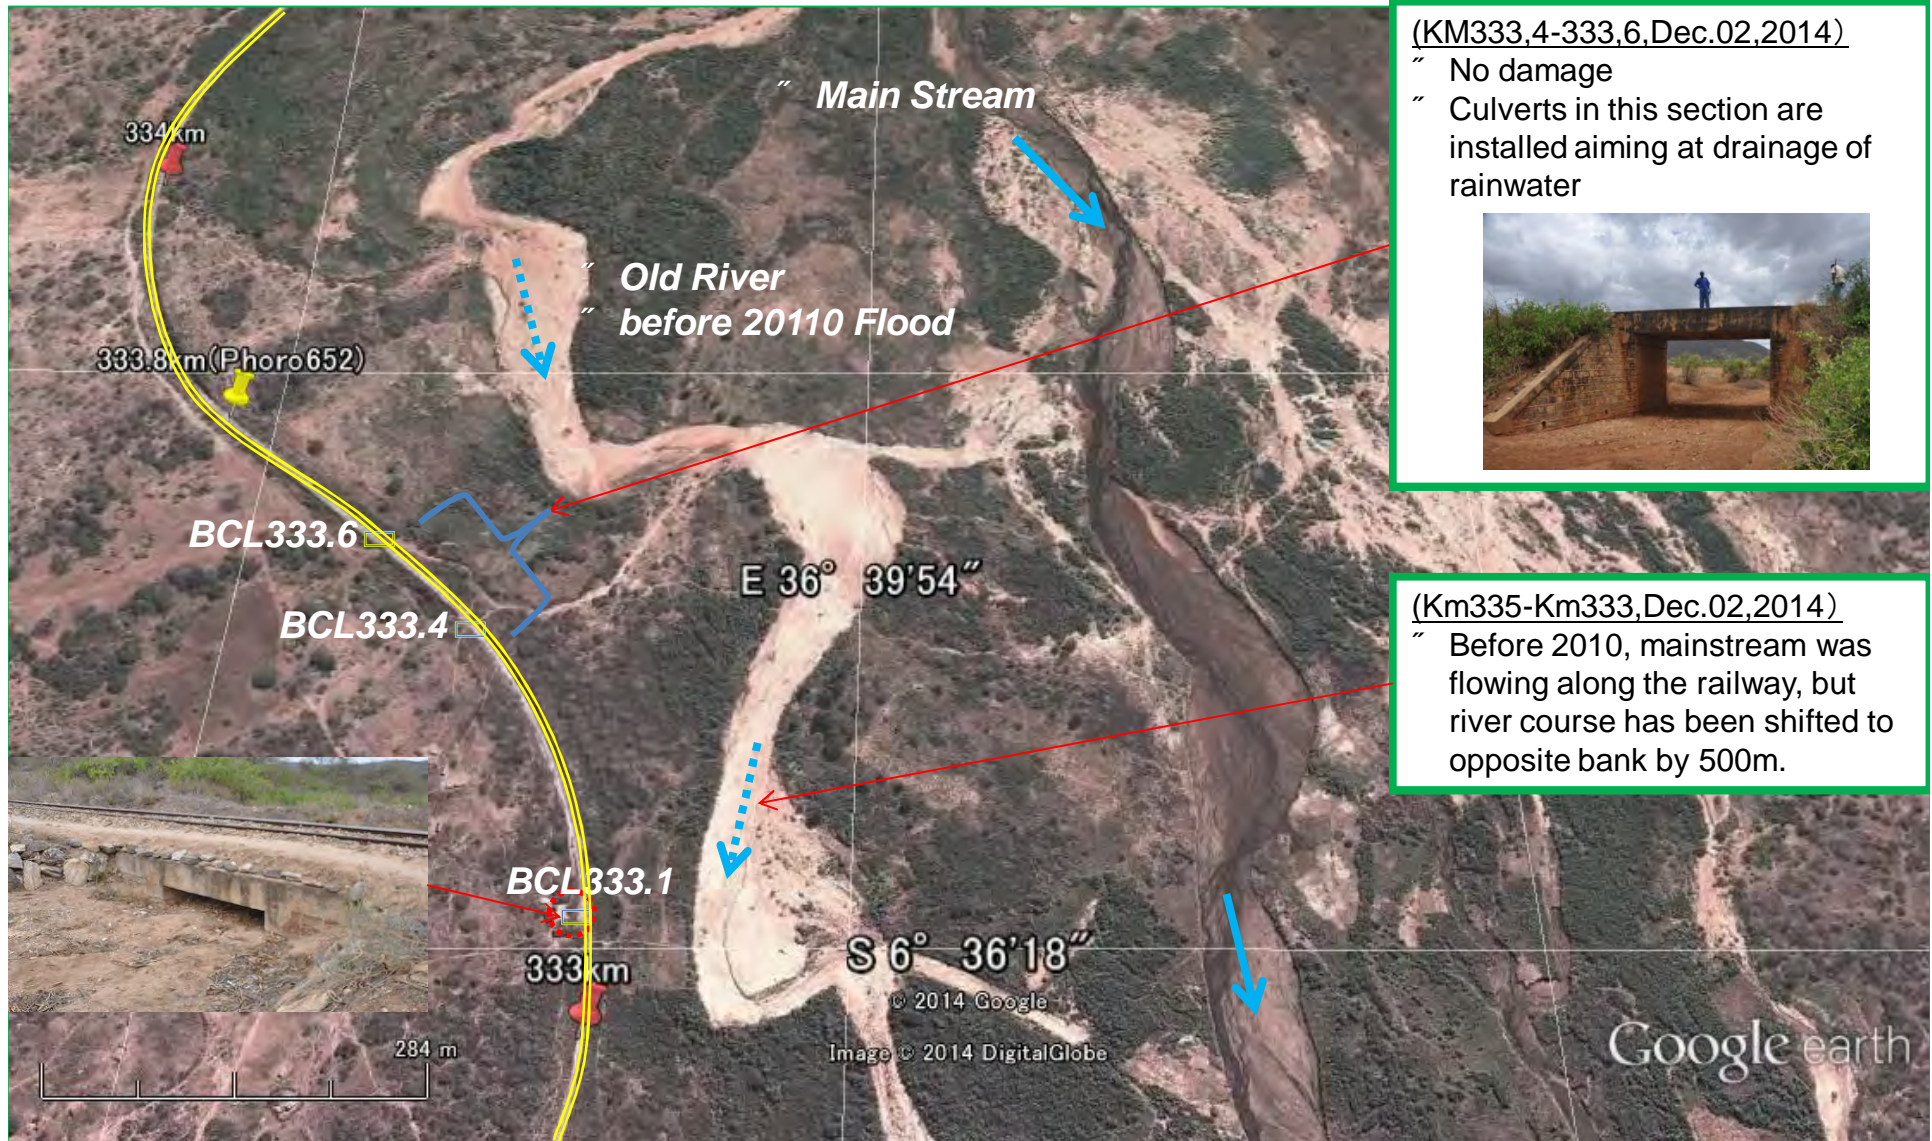
(KM333,4-333,6,Dec.02,2014)

- “ No damage
- “ Culverts in this section are installed aiming at drainage of rainwater

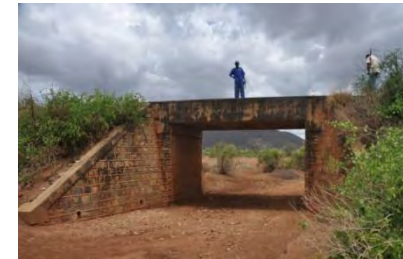
(Km335-Km333,Dec.02,2014)

- “ Before 2010, mainstream was flowing along the railway, but river course has been shifted to opposite bank by 500m.

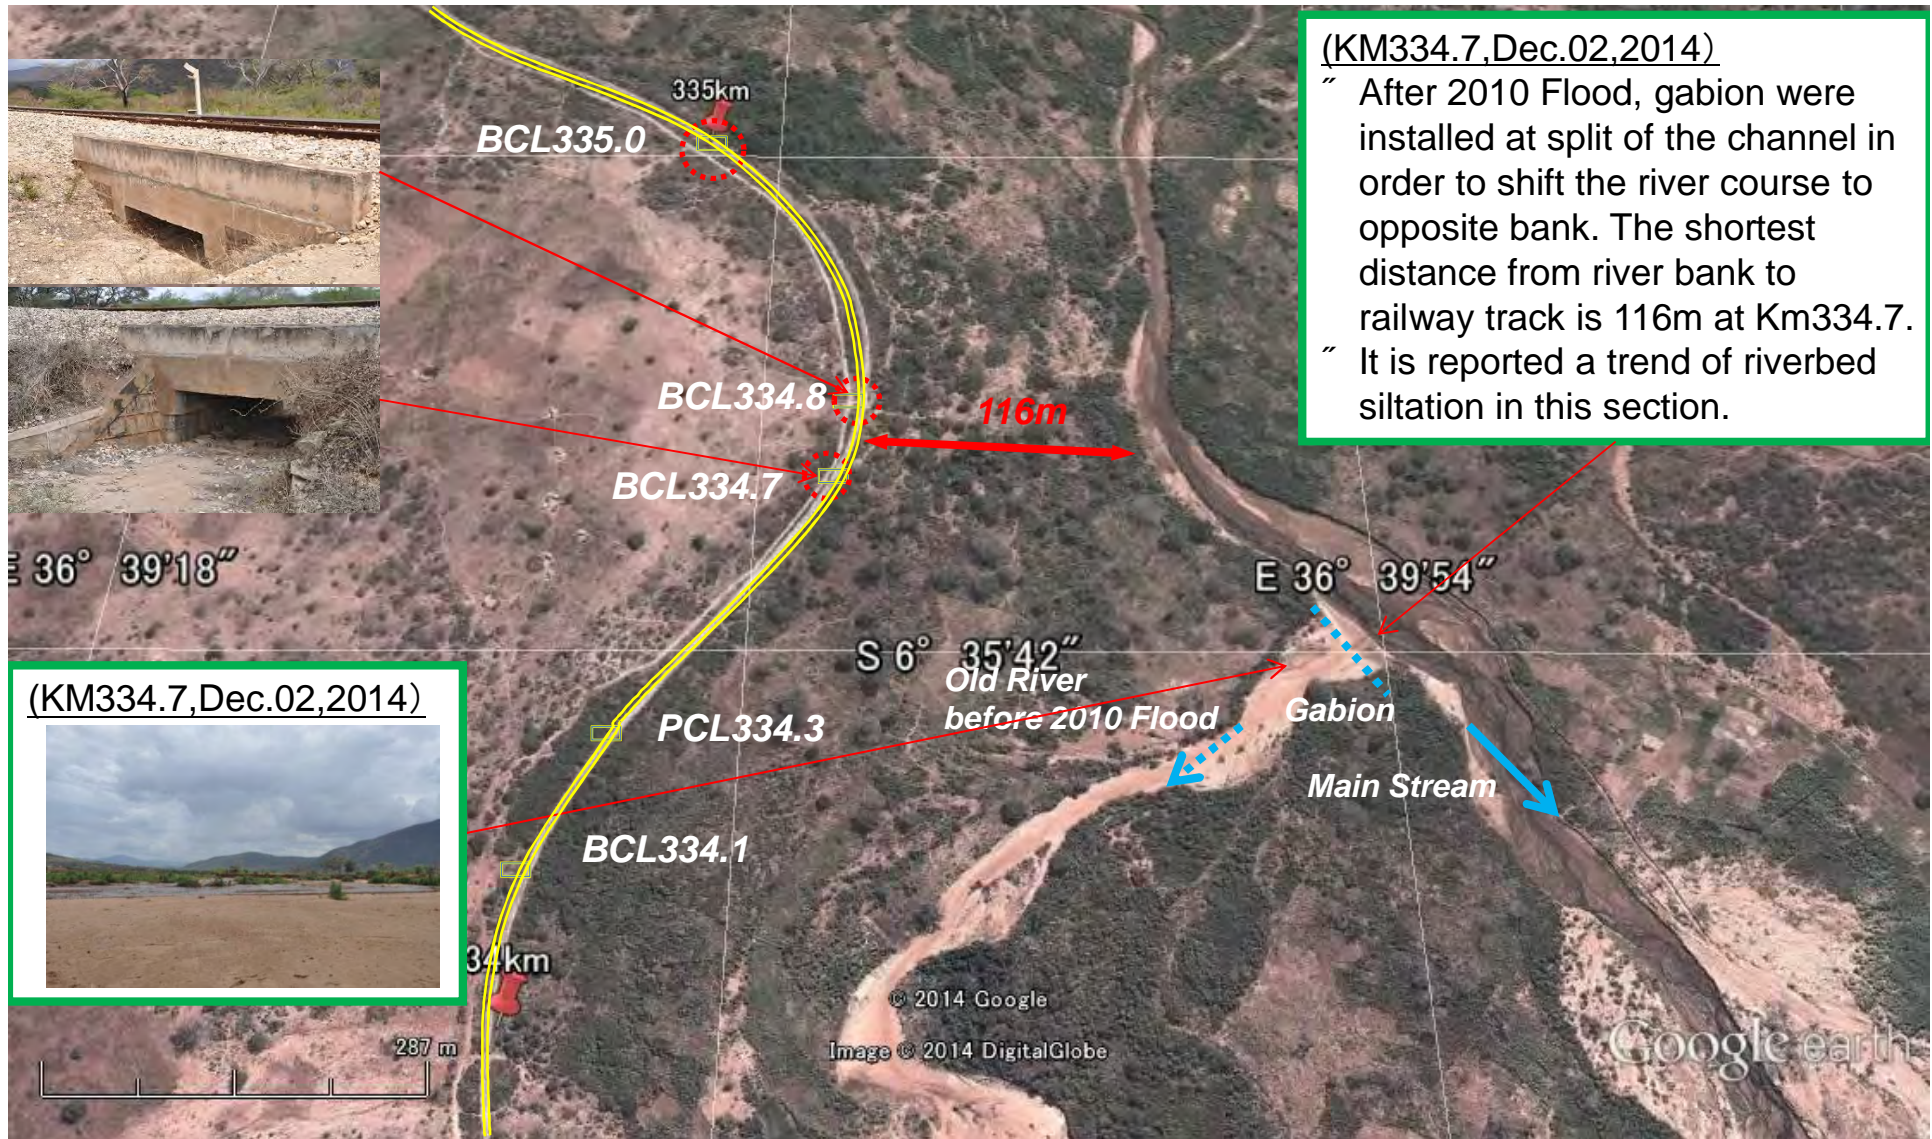
(KM334.7, Dec.02, 2014)  
 " After 2010 Flood, gabion were installed at split of the channel in order to shift the river course to opposite bank. The shortest distance from river bank to railway track is 116m at Km334.7.  
 " It is reported a trend of riverbed siltation in this section.

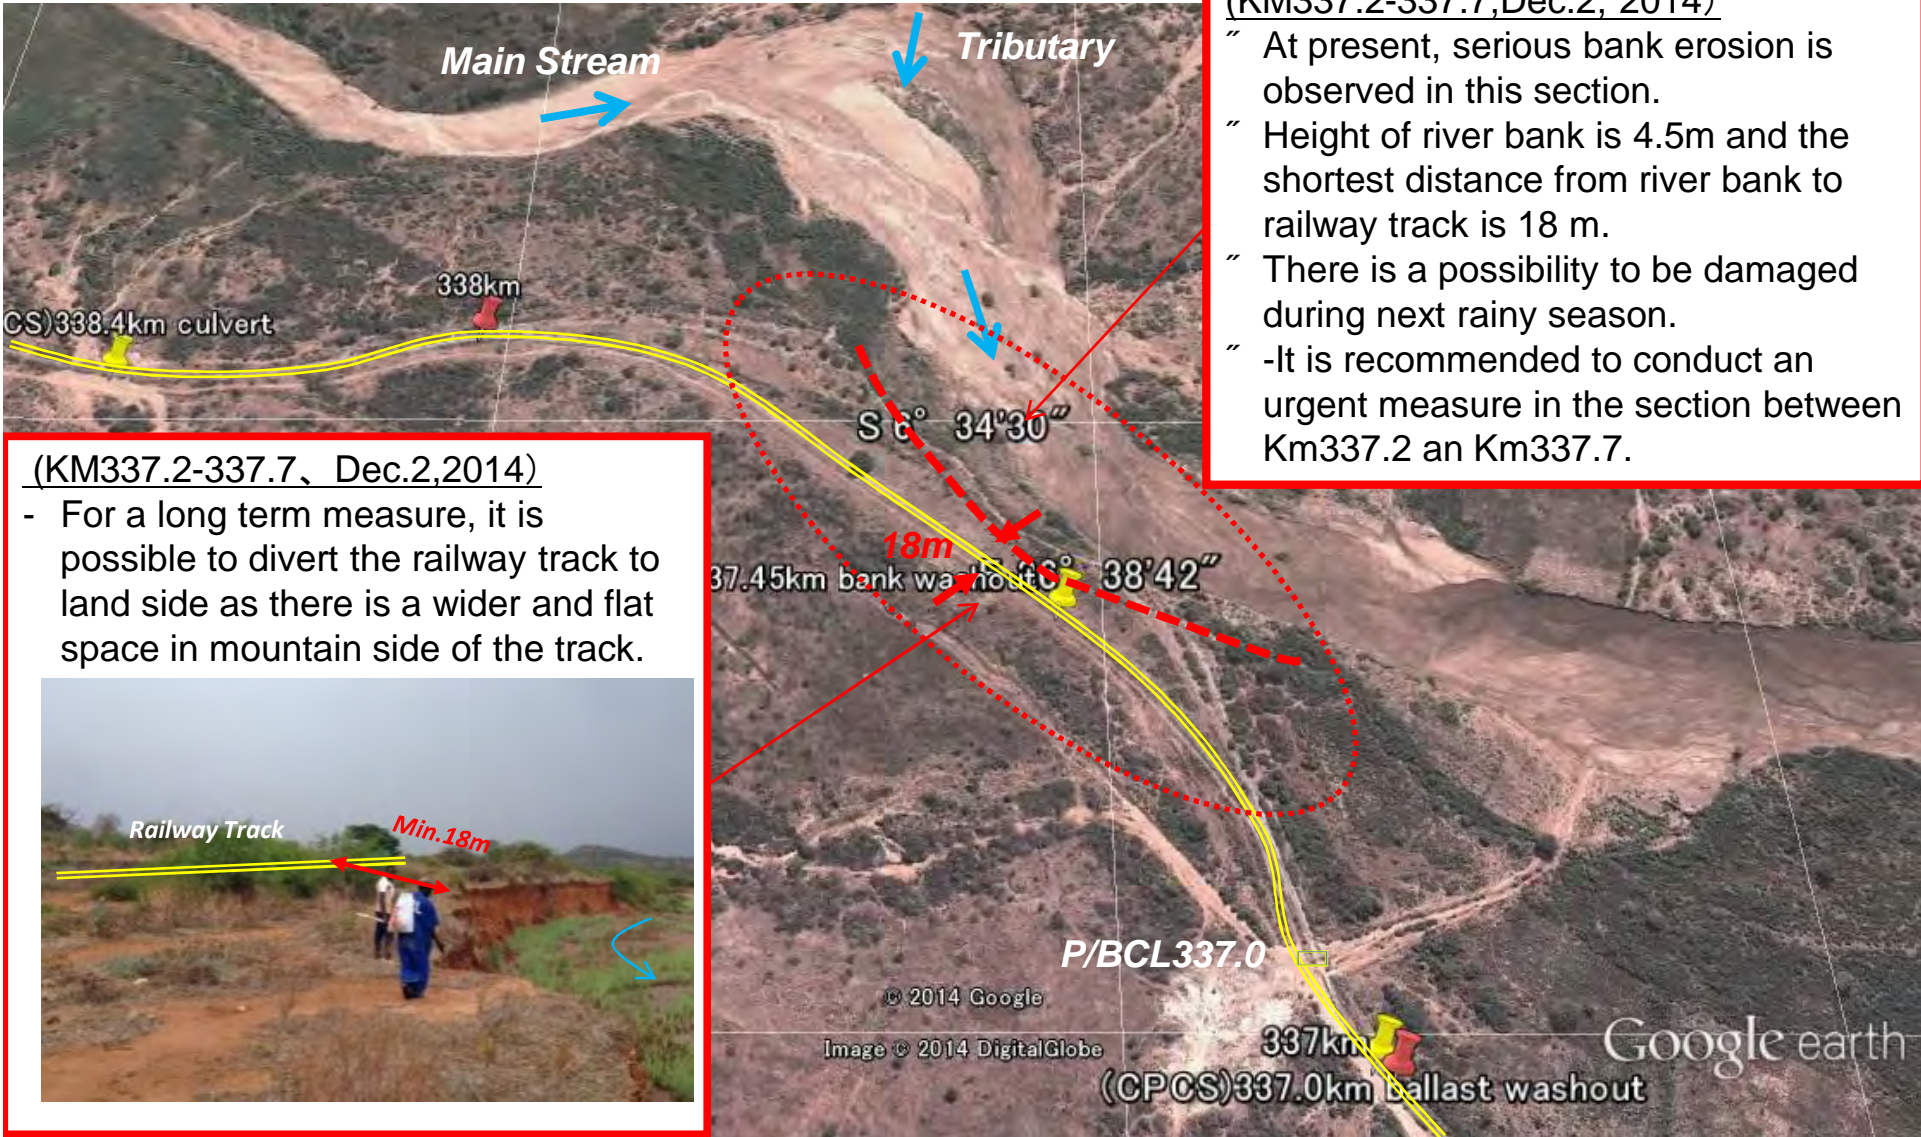
(KM337.2-337.7, Dec.2,2014)

- " At present, serious bank erosion is observed in this section.
- " Height of river bank is 4.5m and the shortest distance from river bank to railway track is 18 m.
- " There is a possibility to be damaged during next rainy season.
- " -It is recommended to conduct an urgent measure in the section between Km337.2 an Km337.7.

- For a long term measure, it is possible to divert the railway track to land side as there is a wider and flat space in mountain side of the track.
