## **APPENDIX F**

### **INVENTORY SHEET OF CULVERT**

## Inventory Sheet for Culvert

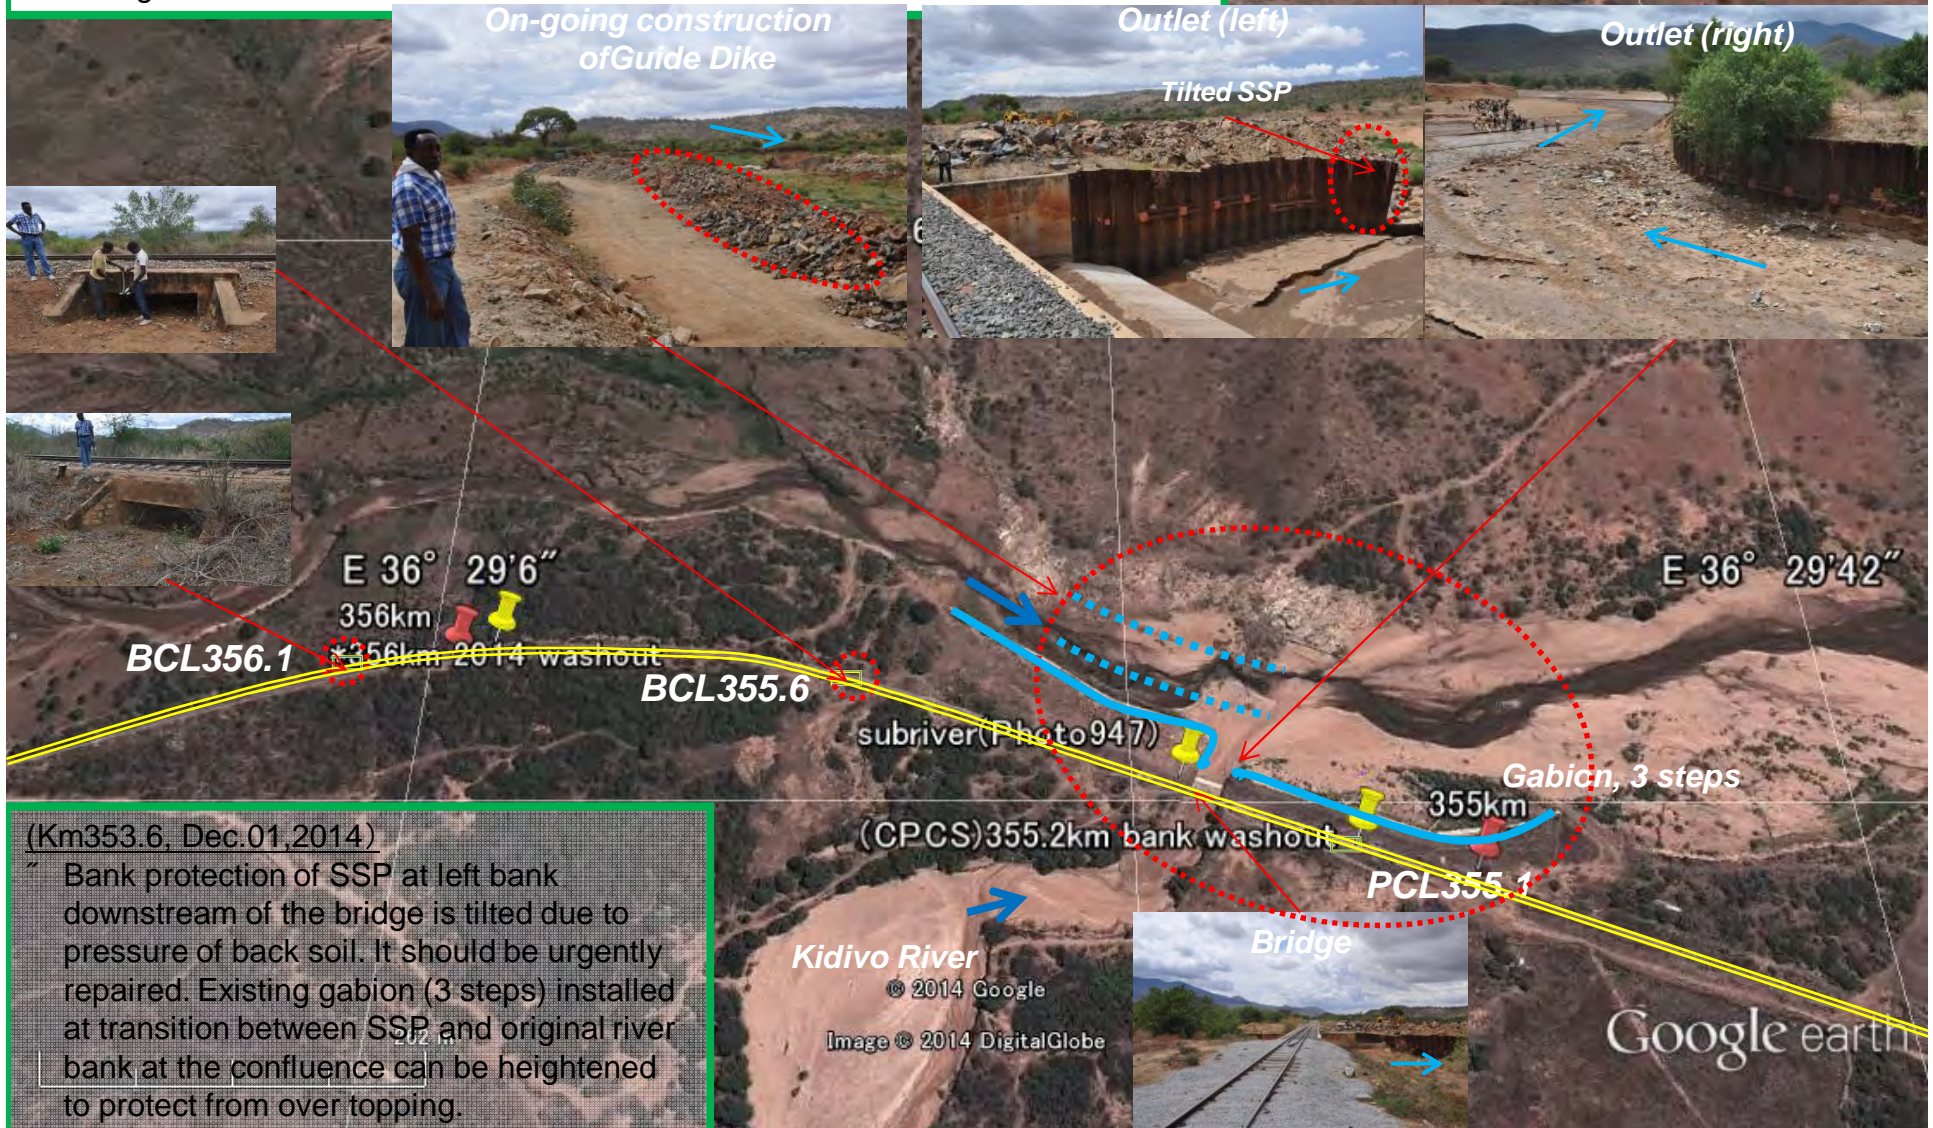
(Km353.6, Dec.01,2014)

- Bank protection of SSP at left bank downstream of the bridge is tilted due to pressure of back soil. It should be urgently repaired. Existing gabion (3 steps) installed at transition between SSP and original river bank at the confluence can be heightened to protect from over topping.
