Chapter 3 Field Investigations

3.1 Basin Overview (Helicopter Survey)

3.2 River Survey

Chapter 4 Summary of Present Conditions and Issues of Flood Control and Basin Management in Nadi River

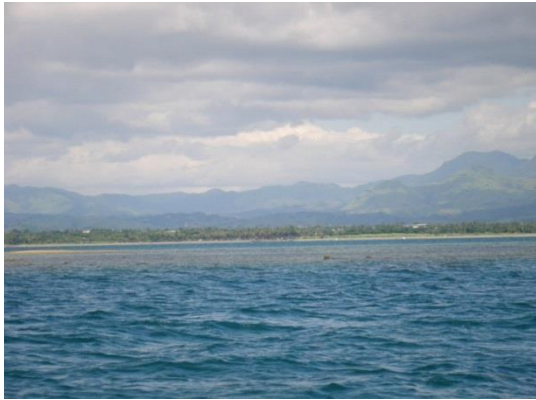
Picture1-1 Malan Cay,the situation under low tide
Photo taken in 24 Jan, 2015

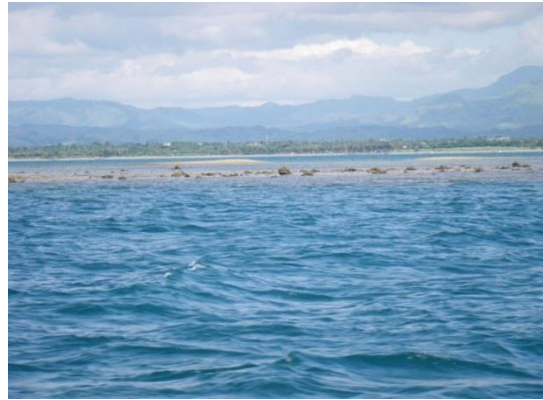
Picture1-2 Malan Cay, the situation under high tide
Photo taken in 24 Jan, 2015

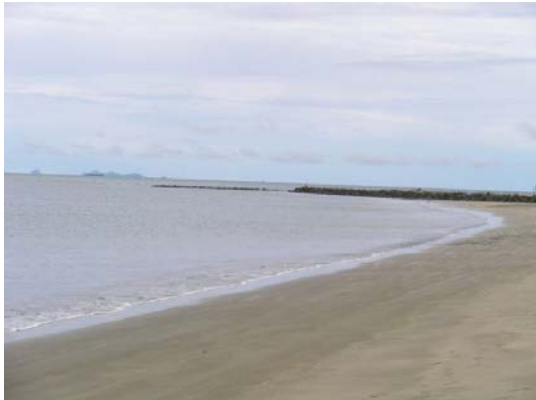
Picture2-1 Stone Jetty at Denarau Sheraton

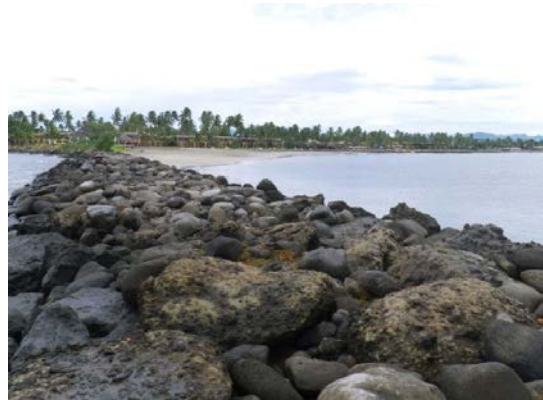
Picture2-2 Stone Jetty at Denarau Sheraton
