Data Collection Survey on Urban Building Safety in the People's Republic of Bangladesh

Final Report (Appendices)

JAPAN INTERNATIONAL COOPERATION AGENCY (JICA)

Preliminary inspection sheet for the seismic capacity of a building

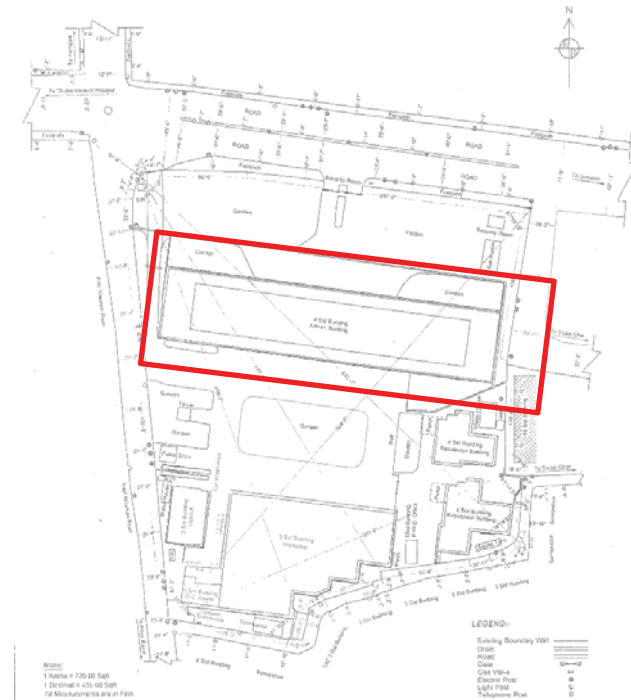
Figure Lay out plan of Siddique Bazar

Inspection results		
Deterioration(cracking, rusting, deflection and others)	<input type="checkbox"/> None <input checked="" type="checkbox"/> Existent : (cracking, rusting of rebar)	
Irregular structure (Mass, Torsion, Weak/Soft story)	<input type="checkbox"/> None <input checked="" type="checkbox"/> Existent : (Change in effective mass)	
Constraints on seismic retrofit work	Temporary buildings or the replacement facility will be required.	
Additional facilities/Fence	Wall height is 2m. If the boundary walls fall down, it may block the passage vehicles.	
Others	Three story building with expansions (small intervals)	
Comments		
<p>High-rise buildings exist in the near distance. Road in front is constantly jammed.</p> <p>It is impossible in the common seismic retrofitting method of construction to adapt due to realistic usability.</p>

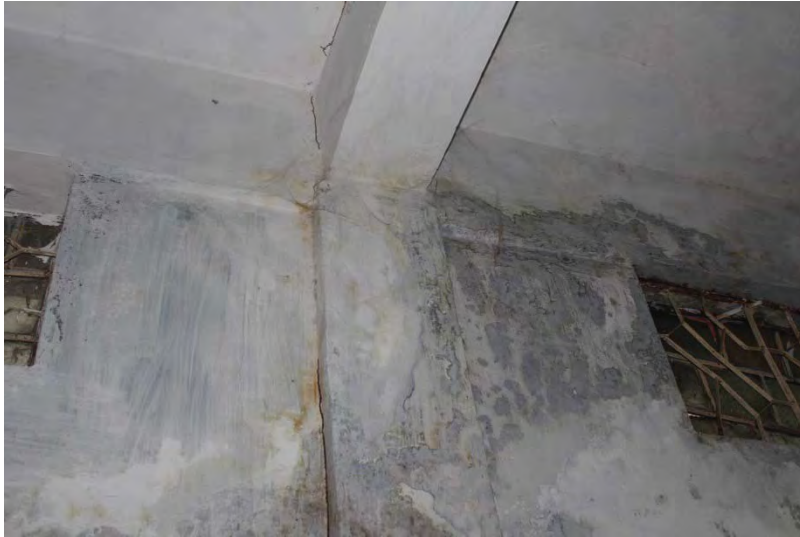
Location	-	
Occupation	<input checked="" type="checkbox"/> Fire station <input type="checkbox"/> school <input type="checkbox"/> Hospital <input type="checkbox"/> Others ()	
Structural type	<input checked="" type="checkbox"/> RC <input type="checkbox"/> BRICK <input type="checkbox"/> RC+BRICK <input type="checkbox"/> Others	
Foundation structural type	<input type="checkbox"/> Pile(m) <input type="checkbox"/> Spread <input checked="" type="checkbox"/> Unknown	
Number of stories	3-story	
Year of completion	1974 (Duration:40 years)	
Total floor/building area	Unknown/Unknown	
Surrounding terrain	-	
Additional facilities	<input type="checkbox"/> None <input checked="" type="checkbox"/> Existent	
Fence	<input type="checkbox"/> None <input checked="" type="checkbox"/> Existent	
Inspection results		
Deterioration(cracking, rusting, deflection and others)	<input type="checkbox"/> None <input checked="" type="checkbox"/> Existent : (cracking, rusting of rebar)

Degradation situation

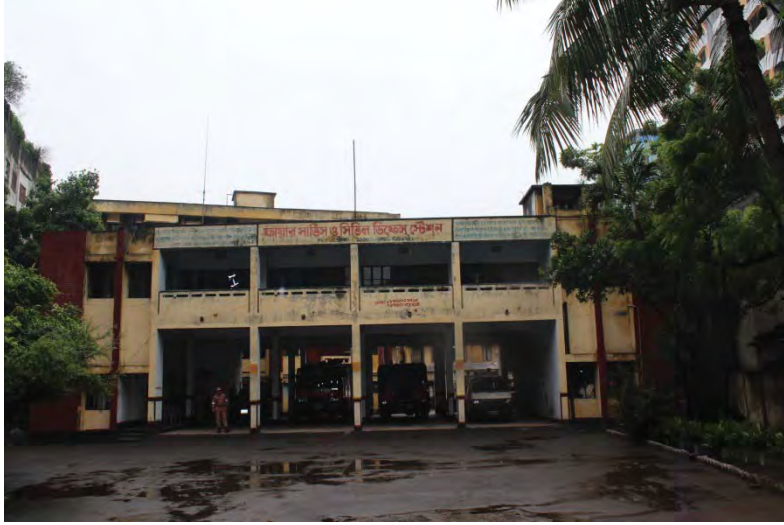
Front side

Inspection results		
Deterioration(cracking, rusting, deflection and others)	<input type="checkbox"/> None <input checked="" type="checkbox"/> Existent :(carbonation)	
Irregular structure (Mass, Torsion, Weak/Soft story)	<input checked="" type="checkbox"/> None <input type="checkbox"/> Existent :	
Constraints on seismic retrofit work	-	
Additional facilities/Fence	The seismic capacity of residences is low.	
Others	Some high-rise building adjacent. There is a possibility that the neighboring building collapse	
Comments		
<p>The building and the area are not suitable to be set as the emergency centers on disaster. It is needed to seek alternative facilities.</p> <p>There are residences of the employees, which the seismic capacity is low. The human resources in disaster are spoiled.</p>

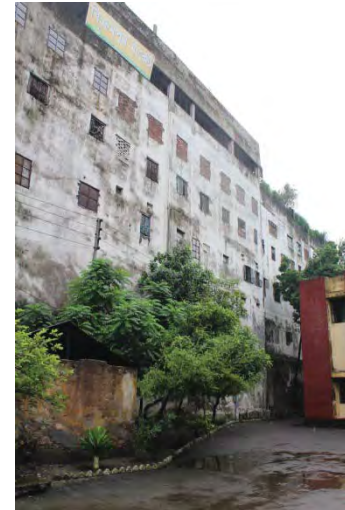
Adjacent building

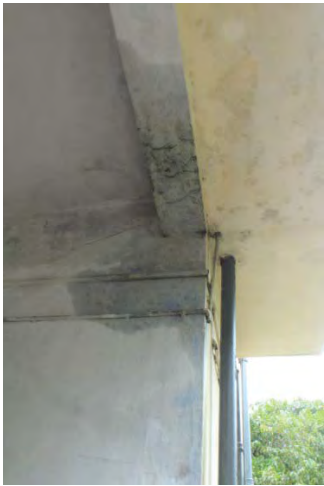
Reinforcing-bars possibly be corroded judging from the status of the building frame, which has been exposed to water. But the explosion of concrete is currently not observed.

Degradation situation

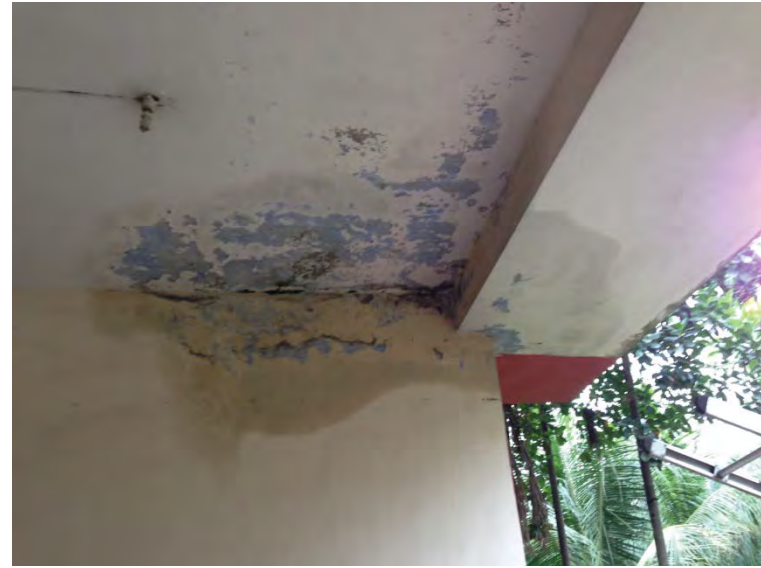
Inspection results		
Deterioration(cracking, rusting, deflection and others)	<input type="checkbox"/> None <input checked="" type="checkbox"/> Existent :(cracking)	
Irregular structure (Mass, Torsion, Weak/Soft story)	<input type="checkbox"/> None <input checked="" type="checkbox"/> Existent : Change in effective mass	
Constraints on seismic retrofit work	-	
Additional facilities/Fence	-	
Others	-	
Comments		
Reinforcing-bars possibly be corroded judging from the status of the building frame, which has been exposed to water. But the explosion of concrete is currently not observed.

Degradation situation

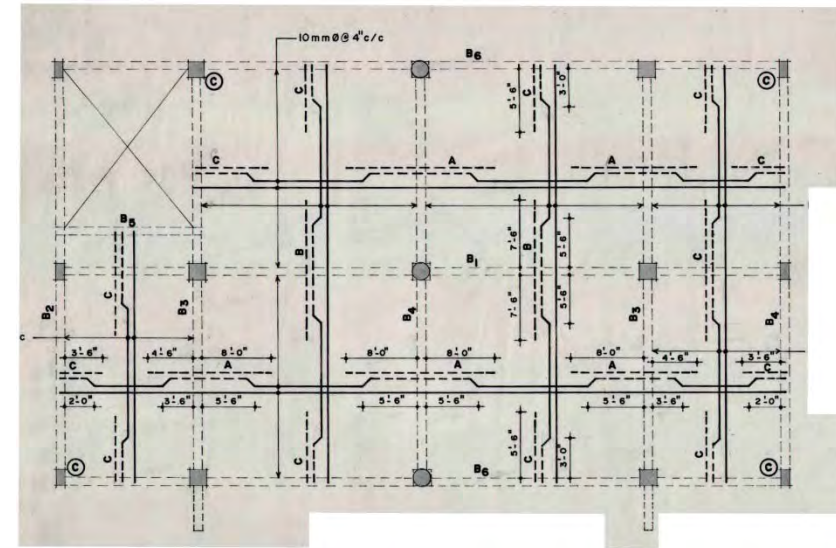
Figure Framing Plan

Irregular structure (Mass, Torsion, Weak/Soft story)	<input type="checkbox"/> None <input checked="" type="checkbox"/> Existent : Change in effective mass
Constraints on seismic retrofit work	-
Additional facilities/Fence	The fence is less likely to turn over.
Others	Road in front is narrow, and there are many week buildings in the area.

The building and the area are not suitable to be set as the emergency centers on disaster. It is needed to seek alternative facilities.
The important factor is 1.25 of the current BNBC. New BNBC requires 1.50. The seismic capacity is lower than the one required by the New BNBC.

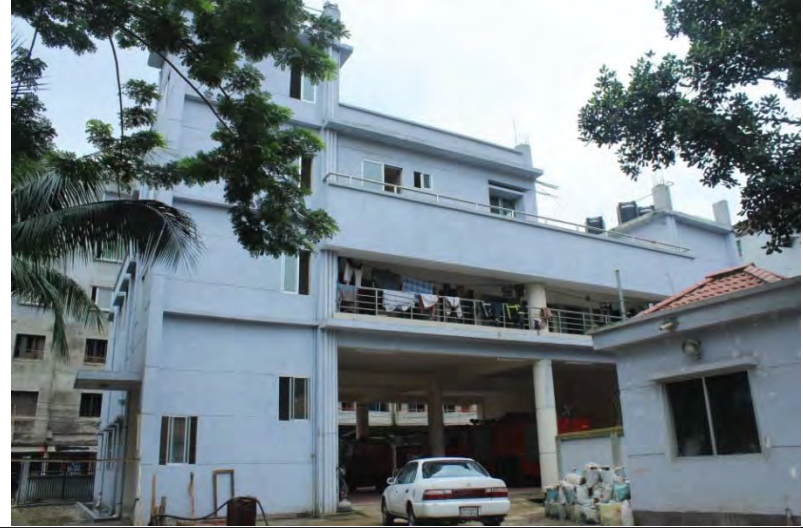
Degradation situation

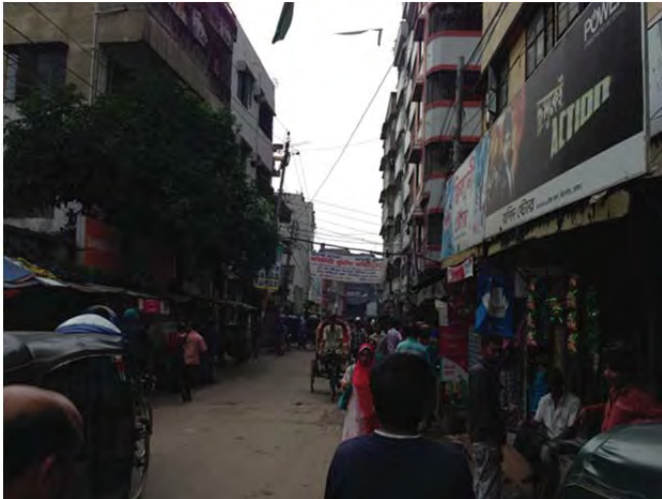
Road in front of the fire station.

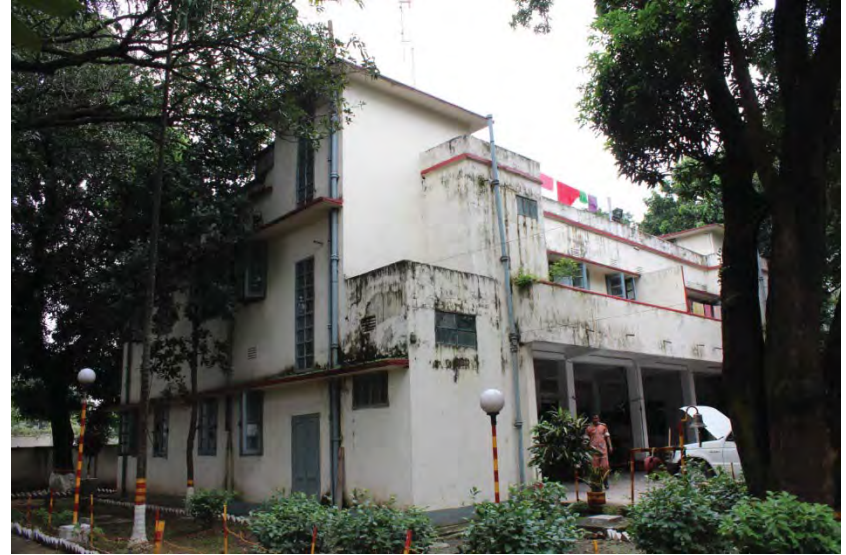
Front side

Deterioration(cracking, rusting, deflection and others)	<input type="checkbox"/> None <input checked="" type="checkbox"/> Existent : Corrosion of existing main reinforcing-bar	
Irregular structure (Mass, Torsion, Weak/Soft story)	<input checked="" type="checkbox"/> None <input type="checkbox"/> Existent : -	
Constraints on seismic retrofit work	-	
Additional facilities/Fence	The fence is less likely to turn over.	
Others	-	
Comments

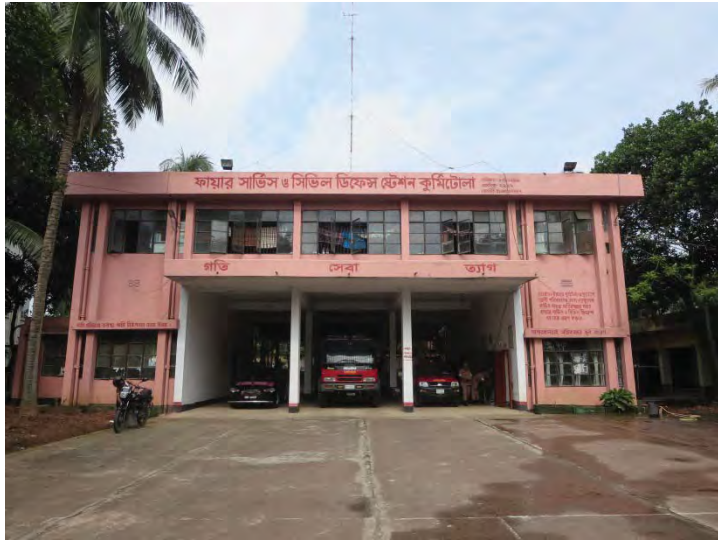
Front side

Outline information	
Name	⑦Kurmitola (Type A)
Location	-
Occupation	<input checked="" type="checkbox"/> Fire station <input type="checkbox"/> School <input type="checkbox"/> Hospital <input type="checkbox"/> Others ()
Structural type	<input type="checkbox"/> RC <input type="checkbox"/> BRICK <input checked="" type="checkbox"/> RC+BRICK <input type="checkbox"/> Others
Foundation structural type	<input type="checkbox"/> Pile(m) <input checked="" type="checkbox"/> Spread <input type="checkbox"/> Unknown
Number of stories	2-story
Year of completion	1980(Duration:34years)
Total floor/building area	573 m ² , 298 m ²
Surrounding terrain	-
Additional facilities	<input type="checkbox"/> None <input checked="" type="checkbox"/> Existent (Dormitory, etc.)
Fence	<input type="checkbox"/> None <input checked="" type="checkbox"/> Existent
Inspection results	
Deterioration(cracking, rusting, deflection and others)	<input type="checkbox"/> None <input checked="" type="checkbox"/> Existent : Corrosion of existing reinforcing-bar

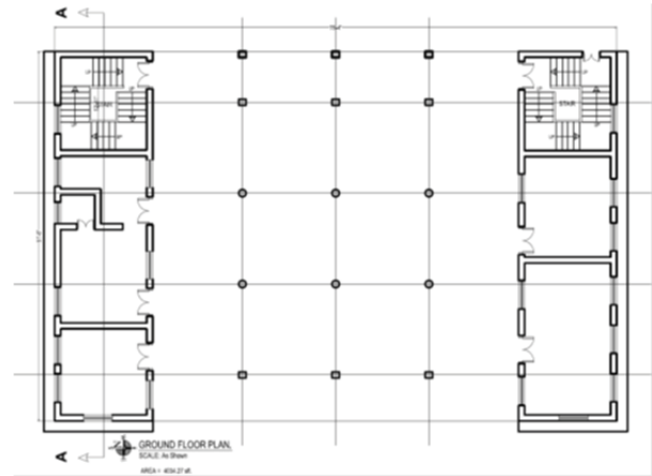
Figure Plan of grand floor

The dormitory made of brick is significantly deteriorated and has an eccentricity caused by the training-tower.

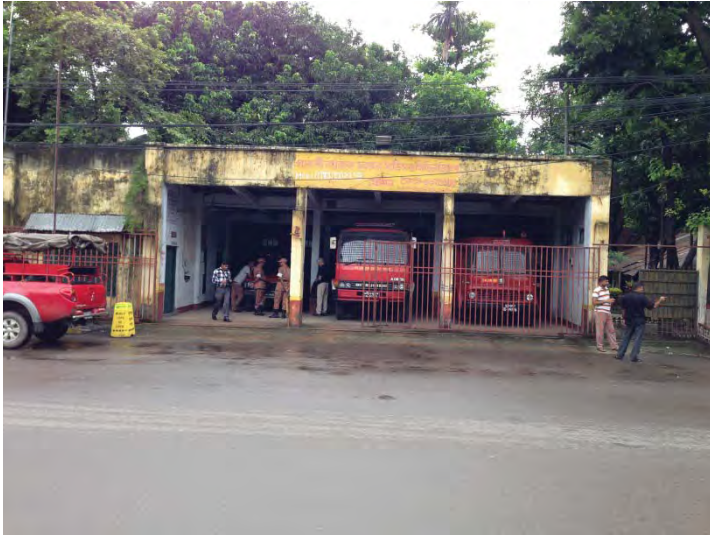
Front side

Deterioration(cracking, rusting, deflection and others)	<input type="checkbox"/> None <input checked="" type="checkbox"/> Existent : Corrosion of existing main reinforcing-bar in columns	
Irregular structure (Mass, Torsion, Weak/Soft story)	<input checked="" type="checkbox"/> None <input type="checkbox"/> Existent : -	
Constraints on seismic retrofit work	-	
Additional facilities/Fence	-	
Others	BUET owns land.	
Comments		
Approval of BUET is necessary to rebuild this fire station, because BUET owns land.

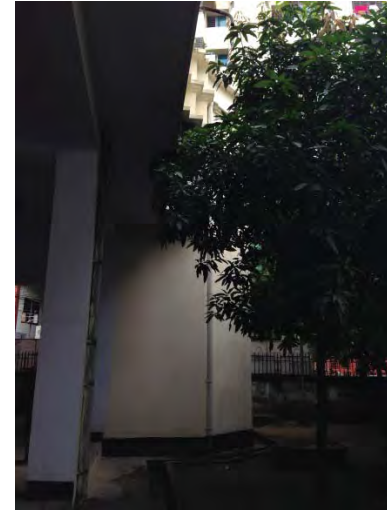
Back side

Irregular structure (Mass, Torsion, Weak/Soft story)	<input type="checkbox"/> None <input checked="" type="checkbox"/> Existent : left-right asymmetry
Constraints on seismic retrofit work	The site is narrow.
Additional facilities/Fence	Vertical shape of dormitory is overhang.
Others	Road in front is narrow, and there are many week buildings in the area.
Comments	
It does not appear to be the suitable area to set a stronghold of activities in the event of an earthquake

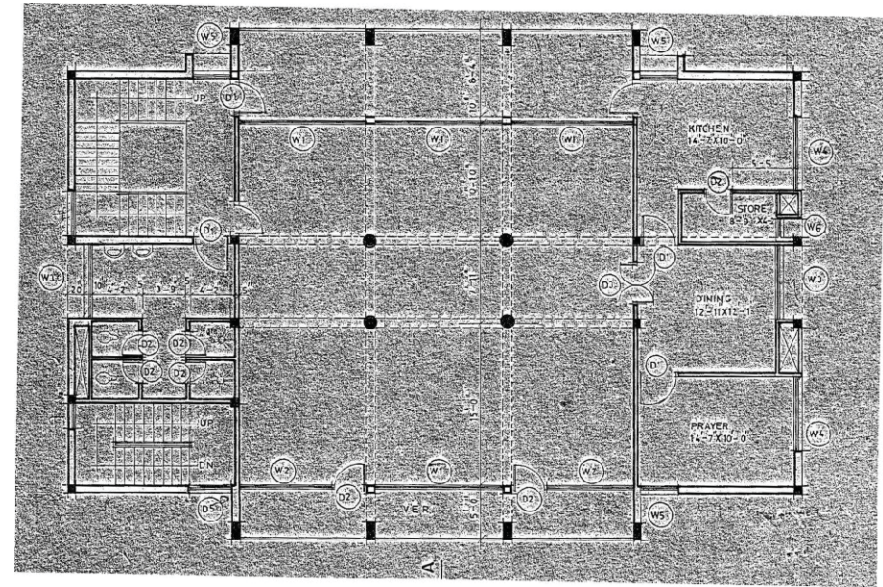
Figure Plan of ground floor

Irregular structure (Mass, Torsion, Weak/Soft story)	<input type="checkbox"/> None <input checked="" type="checkbox"/> Existent : Vertical set back
Constraints on seismic retrofit work	-
Additional facilities/Fence	-
Others

Section area of column is small. One-way depth of column is small.

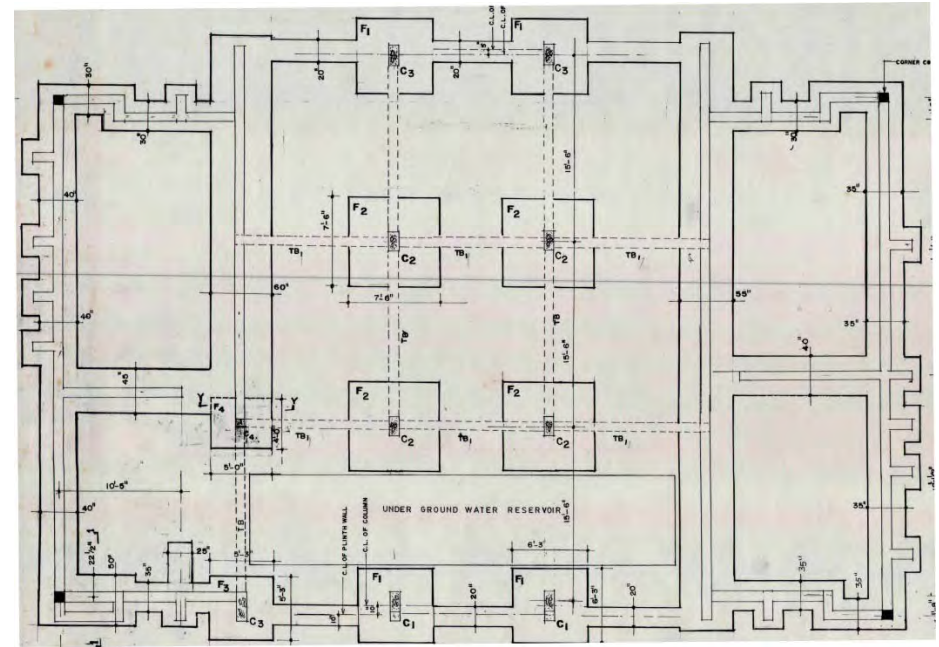
Figure Foundation Plan

Outline information	
Name	⑭ Baridhara (Type B)
Location	-
Occupation	<input checked="" type="checkbox"/> Fire station <input type="checkbox"/> School <input type="checkbox"/> Hospital <input type="checkbox"/> Others ()
Structural type	<input type="checkbox"/> RC <input type="checkbox"/> BRICK <input checked="" type="checkbox"/> RC+BRICK <input type="checkbox"/> Others
Foundation structural type	<input type="checkbox"/> Pile(m) <input checked="" type="checkbox"/> Spread <input type="checkbox"/> Unknown
Number of stories	2-story
Year of completion	2004(Duration:10years)
Total floor/building area	Unknown/282 m ²
Surrounding terrain	-
Additional facilities	<input type="checkbox"/> None <input checked="" type="checkbox"/> Existent (Family quarter, etc.)
Fence	<input type="checkbox"/> None <input checked="" type="checkbox"/> Existent (Height is 1.5m)
Inspection results	
Deterioration(cracking, rusting, deflection and others)	<input type="checkbox"/> None <input checked="" type="checkbox"/> Existent : Cracking with settlement of building.

Irregular structure (Mass, Torsion, Weak/Soft story)	<input type="checkbox"/> None <input checked="" type="checkbox"/> Existent: Height of each floor is different significantly
Constraints on seismic retrofit work	-
Additional facilities/Fence	Even if the walls fall down, that would not be a major problem for the rescue activities.
Others	-

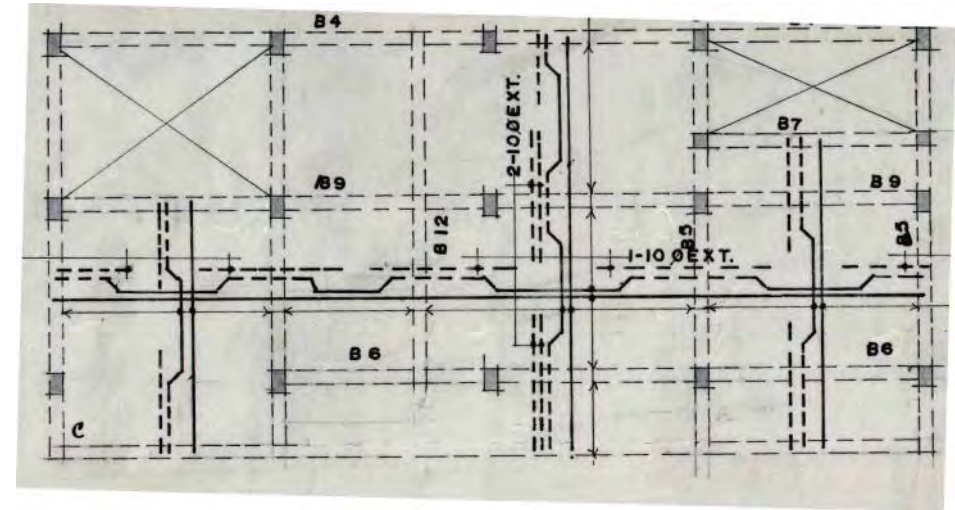
Figure Structural Plan

Deterioration(cracking, rusting, deflection and others)	<input checked="" type="checkbox"/> None <input type="checkbox"/> Existent :
Irregular structure (Mass, Torsion, Weak/Soft story)	<input type="checkbox"/> None <input checked="" type="checkbox"/> Existent: Change in effective mass
Constraints on seismic retrofit work	-
Additional facilities/Fence	Check whether the water storage tank withstands the earthquake.
Others	-

The important factor is 1.25 of the current BNBC. New BNBC requires 1.50. The seismic capacity is lower than the one required by the New BNBC.
Land subsidence observed in the surrounding area.

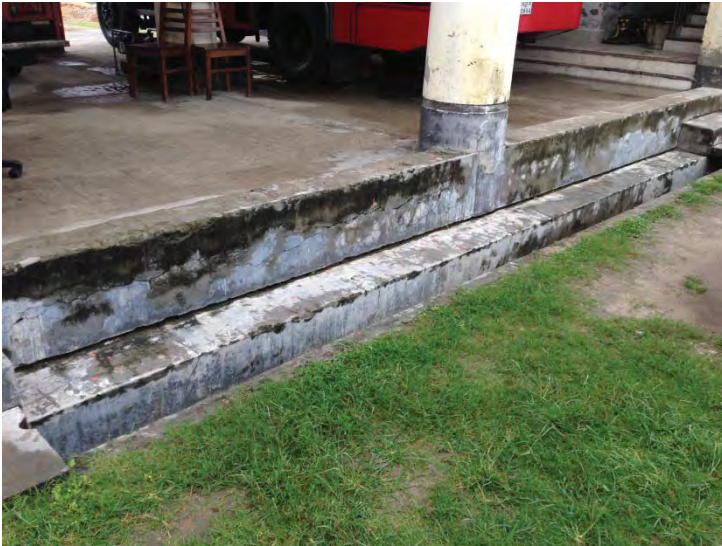
Land subsidence

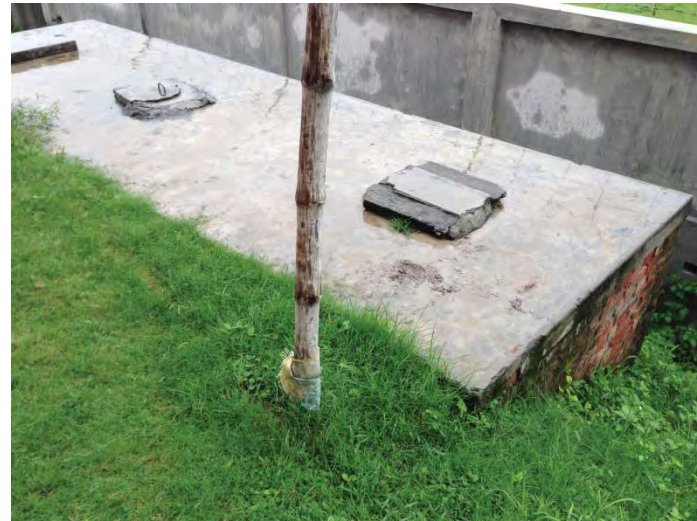
the water storage

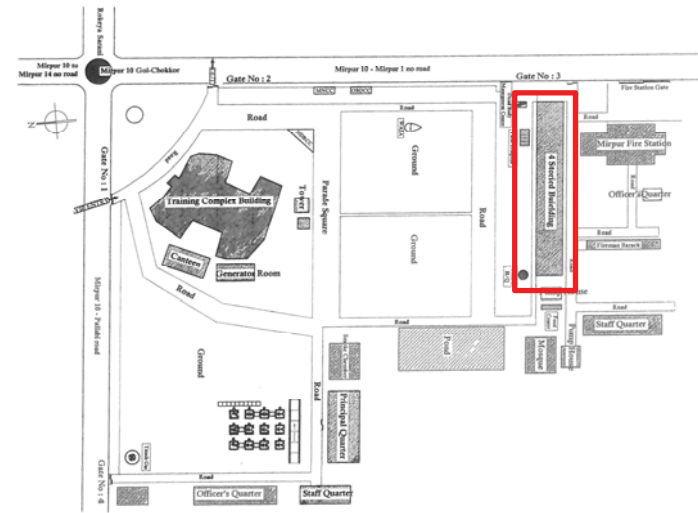
Figure Lay out plan of Training complex Mirpur

The west part of extend building does not need seismic retrofit, because the design is based on BNBC.

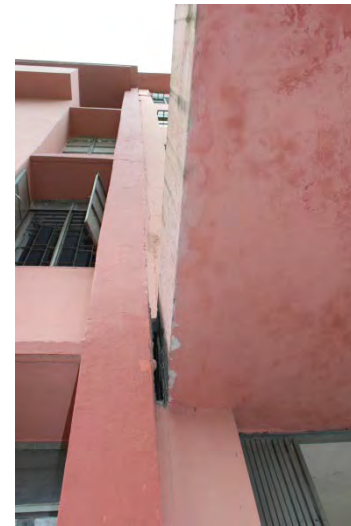
Deterioration(cracking, rusting, deflection and others)	<input type="checkbox"/> None <input checked="" type="checkbox"/> Existent :Cracking
Irregular structure (Mass, Torsion, Weak/Soft story)	<input checked="" type="checkbox"/> None <input type="checkbox"/> Existent:
Constraints on seismic retrofit work	-
Additional facilities/Fence	-
Others	Three story building with expansions (small intervals)

Expansion joint
