**FOLLOW-UP COOPERATION STUDY  
ON  
THE BRIDGE DESIGN  
(COUNTERPART TRAINING FOR THE SUEZ  
CANAL BRIDGE PROJECT)**

**FINAL REPORT**

**JAPAN INTERNATIONAL COOPERATION AGENCY**

**ORIENTAL CONSULTANTS GLOBAL CO., LTD.  
CHODAI CO., LTD.**

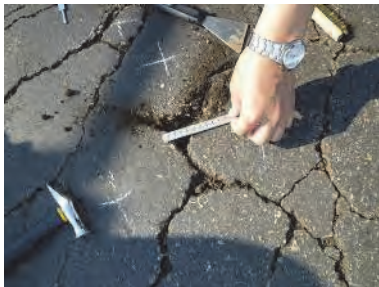
Photo1.2.1      Detailed  
Inspection for damaged  
pavement

In order to confirm the detailed condition of cracks, evident six damaged locations were selected and drilled to remove the pavement of 6 m length × 4 m width for each location. The maximum crack width was 40 mm, and cracks of more than 10 mm width penetrated the base course layer. Where the maximum crack width was 40 mm, the asphalt pavement was partially separated from

The core sampling test (100 mm diameter) of six damaged locations revealed that cracks completely penetrated the pavement and the bonding layer was not functioning properly. It was determined that the cracks were caused by passage of overloaded vehicles under uncontrolled axle load limitations soon after the bridge inauguration. The crack width and depth developed further due to insufficient repair measures by GARBLT. Moreover, rainwater penetrated these cracks and the waterproof performance in the bonding layer was lost. This deterioration resulted in more crack development.

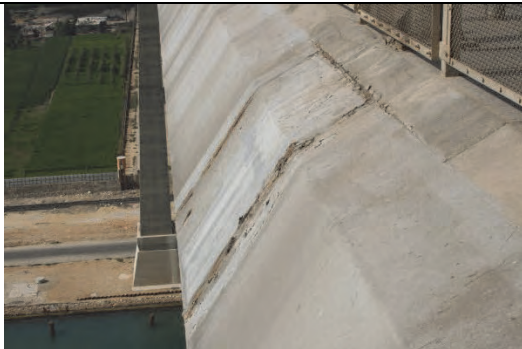
The condition of the bridge deck is good partly because of the scarce rain, the good paint, etc. But one severe corrosion was found. It is on the fairing. The fairing is not a structural member so that the bridge will not collapse even if a small part of the fairing disappeared. But it is strongly recommended to remove the rust and repaint the surface immediately.

Site welded fairing part is severely corroded.

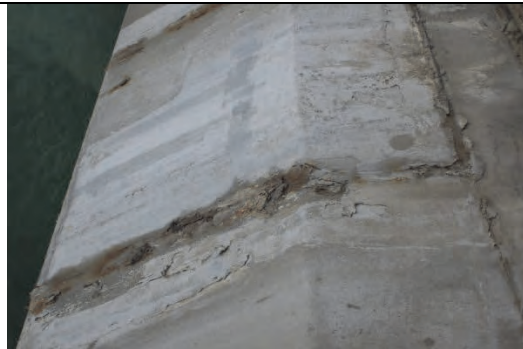
Corrosion. The fairing is not a structural member but it is better to remove the rust and repaint immediately.

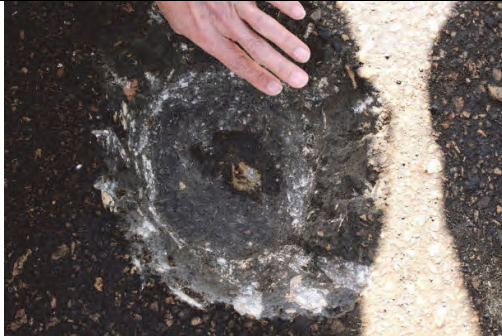
3. Condition of pavement was quite good and no rust was observed on the deck surface. The yellow color shows the Zinc Chromate.

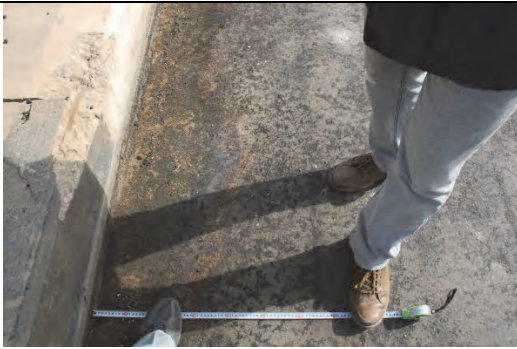
The welding line of R4 U-rib below the steel deck, which is 64cm apart from the curb is visible on the left of the brown shoes.

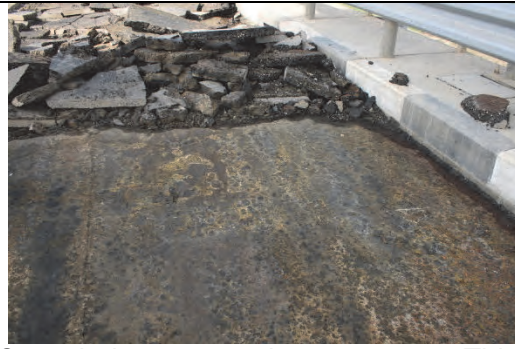
Corroded area near the west tower. This may be worst corroded.

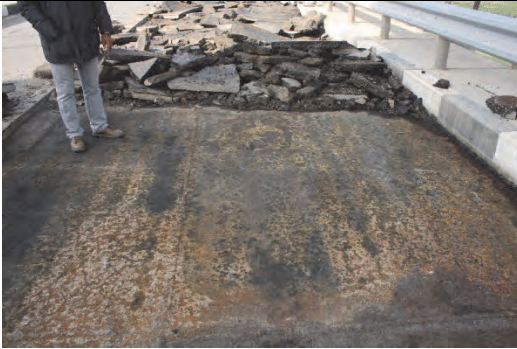
Corrosion near the west tower and on the North Lane.

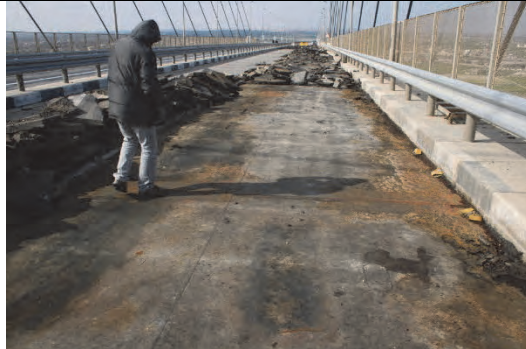
The corroded areas are on both sides which are below the cracked pavement areas. The center area is healthier.

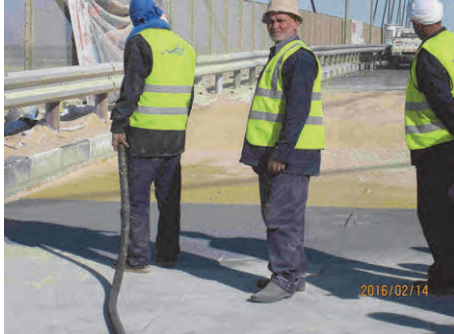
Sand blasting and painting of primer started February 13rd from center of bridge to west side. Sand blasting takes so much time, so GARBLT and ACE consultant ask SAMCO to increase sand blast machines and workers.

1. Work of sand blasting

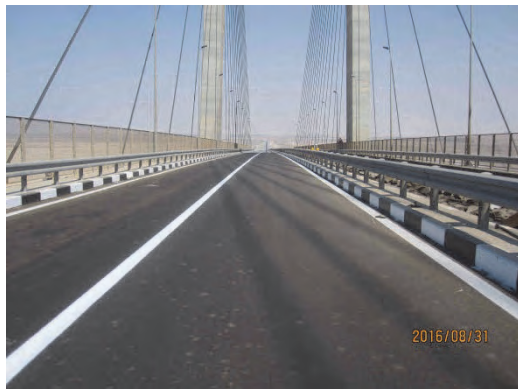
The condition of the pavement looks very good.

The surface of pavement of North Side.

Monitoring of the pavement must be implemented constantly.

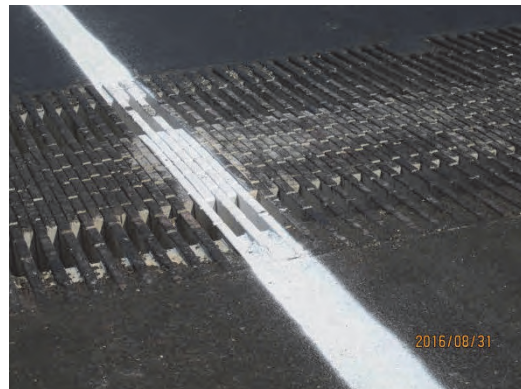
The pavement around expansion joint of East end.

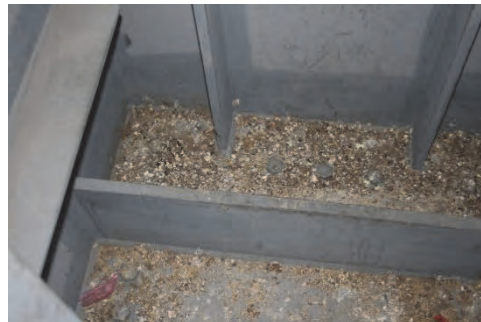
6. Entrance of Box Girder. Bird droppings. This should be removed.

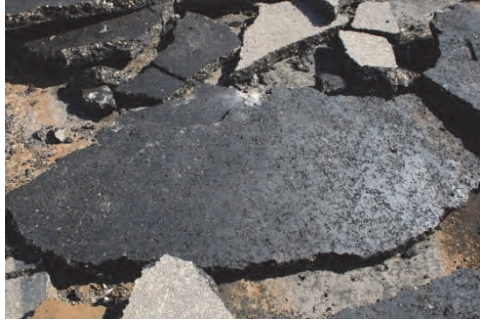
3. Removed pavement of North Lane, west side span. Back side of pavement. This black color indicates healthy adhesion to steel deck.

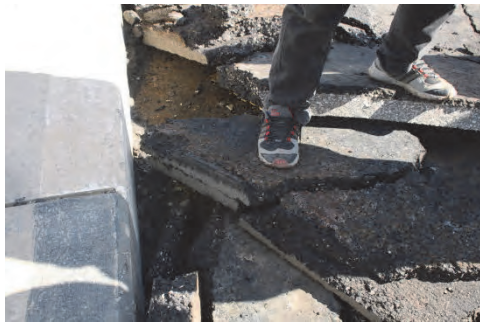
5. North side curb and some rust of steel deck plate is seen.

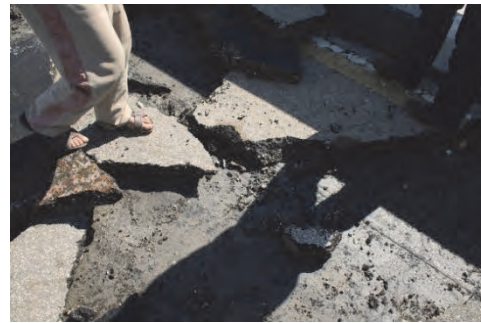
6. Steel deck near center median. No rust is seen here.

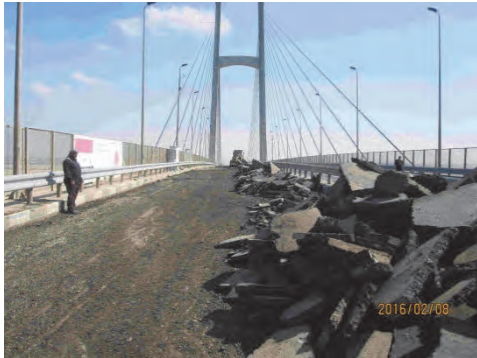
1. Removal of pavement on east side.

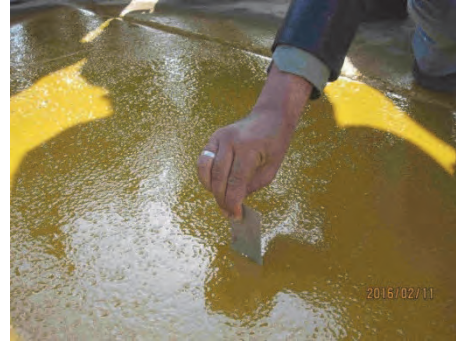
6. Measurement of thickness; A little too thick, so it will be reduced more totargeted 0.05mm on actual stage.

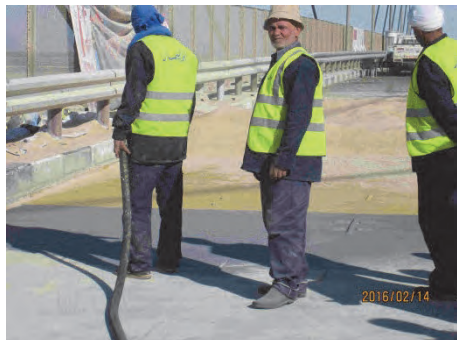
1. Work of sand blasting

Sand blasting takes so long, so that Mr.Ahmed(GARBLT) and ACE consultant ask SAMCO to increase sand blast machines and workers.

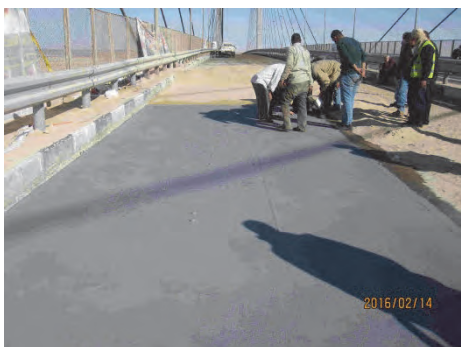
5. After sand blasting

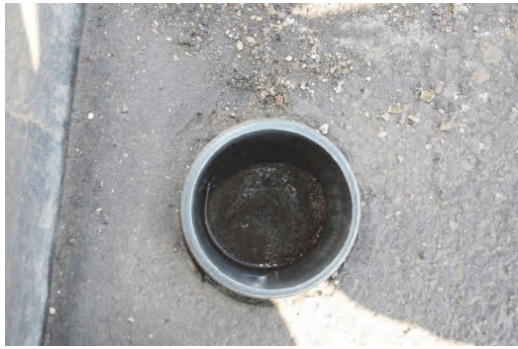
1. P11, Some water is observed and the bottom surface is swollen.

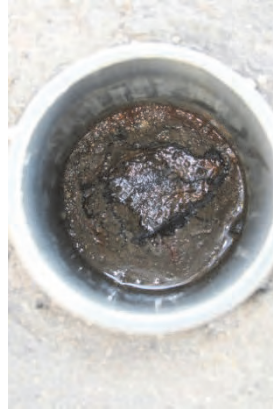
2. P11, bottom surface is broken by hand and rusty deck plate appeared.

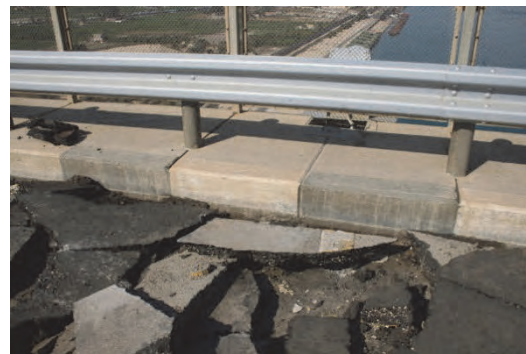
6. P13, Removed pavement and a cap on pavement.

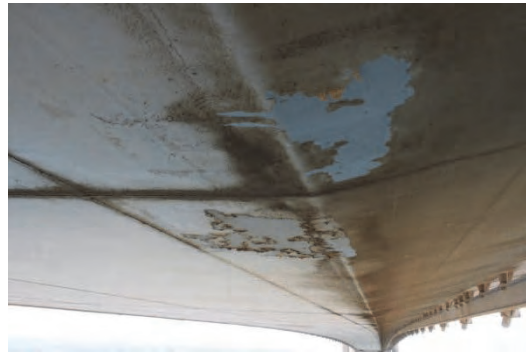
2. The same kind of rust as Photo 24. The all surfaces are covered by very fine sand, which may include salt particles.

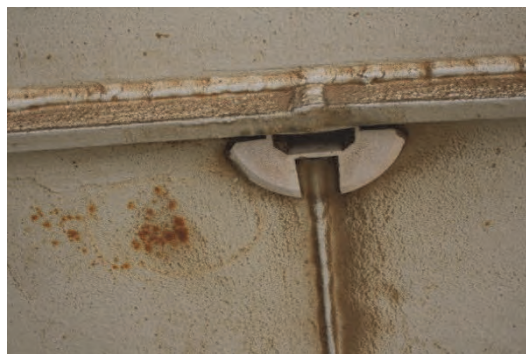
4. Some rust near site welding. Bottom plate is also site welded.

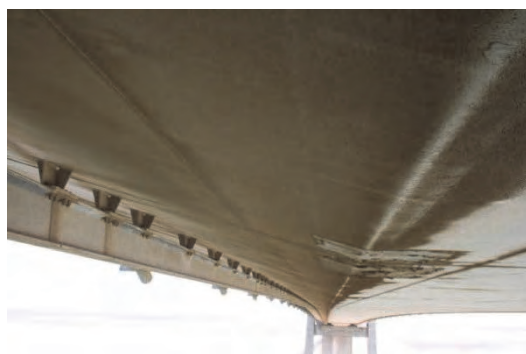
6. Sand covered bottom plate

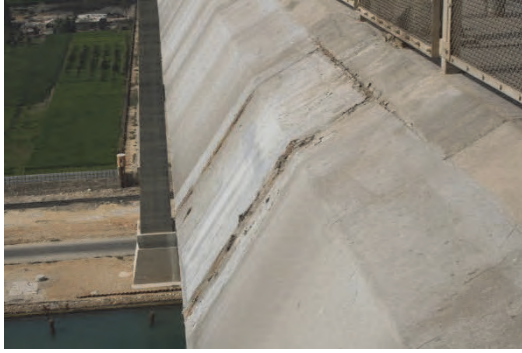
7. Site welded fairing part is severely corroded.

The condition of the bridge deck is good partly because of the scarce rain, the good paint, etc. But one severe corrosion was found. It is on the fairing. The fairing is not a structural member so that the bridge will not collapse even if a small part of the fairing disappeared. But it is strongly recommended to remove the rust and repaint the surface immediately. Although it seems that the engineers do not inspect the bridge so often, they know the places of rust very well.
