**PREPARATORY SURVEY
ON
HYDROPOWER PLANTS REHABILITATION PROJECT
IN
THE REPUBLIC OF THE UNION OF MYANMAR**

FINAL REPORT

November 2016

Japan International Cooperation Agency

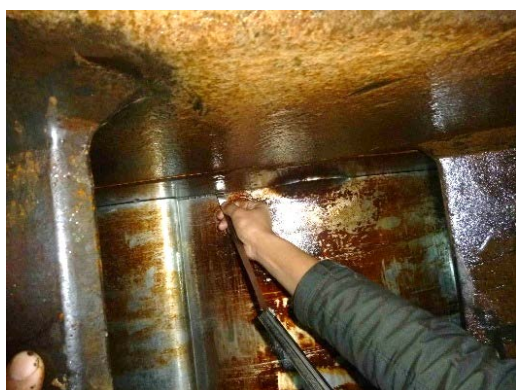
(1) Gap measurement

Gaps between the upper and lower portion of guide vanes are measured as samples. The measured gap is averagely 0.6 - 0.7mm. This value clearly exceeds the design value of 0.3mm. (Photo 4.1-1 (1)).

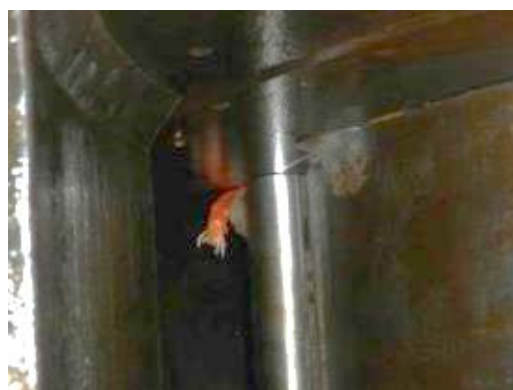
(2) Foreign materials at the side gap

Some guide vanes tuck down small floating foreign materials at the gap portions. But it is not an irregular issue. (Photo 4.1-1 (2)).

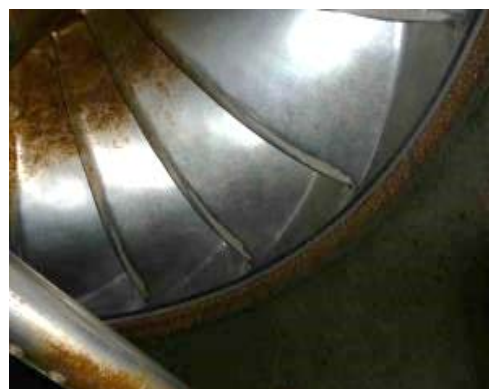
(1) Runner outlet portion

a) Runners of both units are eroded by the cavitation at the outlet portions of the runner vane on the suction surface. There are partially deeply eroded portions (the maximum depth of 3 - 5mm) and countermeasures such as replace or repair work are necessary in the near future. (Photo 4.1-3 (1))

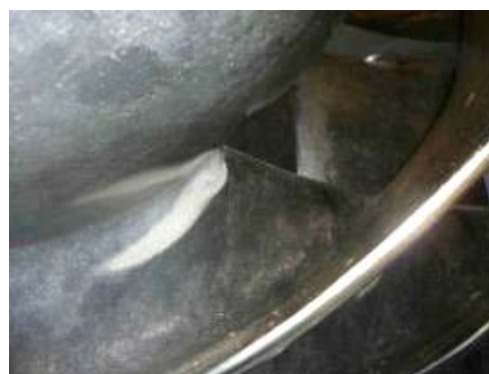
(2) Runner inlet portion

b) Near the connection point with runner band (shroud) on the suction surface of runner vane root and the adjacent area of runner band (shroud), there are eroded portions by cavitation on every runner vanes of both units of #1 and #2. There are partially deeply damaged portions (the maximum depth of 5 - 8mm) and countermeasures such as replace or repair work are necessary in the near future. (Photo 4.1-3 (2))

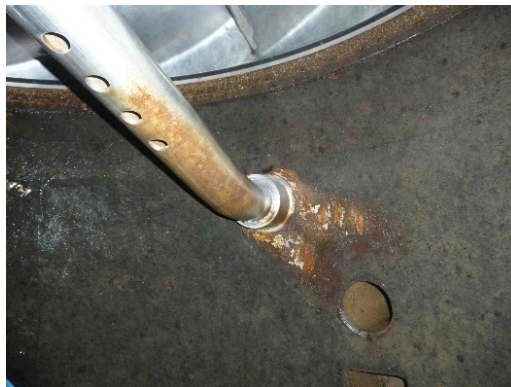
(1) Runner bottom and air pipe

There are portions slightly eroded by cavitation on the inner face of draft tube downstream side of the connecting portion with the air supply pipes. It is expected to be repaired by grinding off the rough surfaces in the future. (Photo 4.1-4 (1))

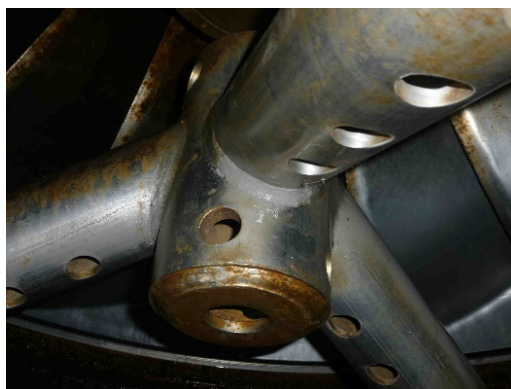
(2) Air pipes (tripod type)

The air supply pipes in the upper draft tube, tripod type, to prevent large water pressure fluctuation during turbine partial load operation had no apparent damage. (Photo 4.1-4 (2))

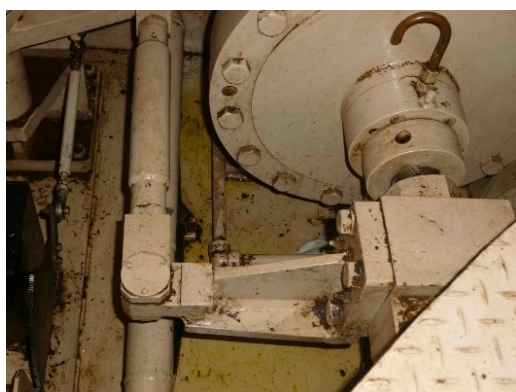
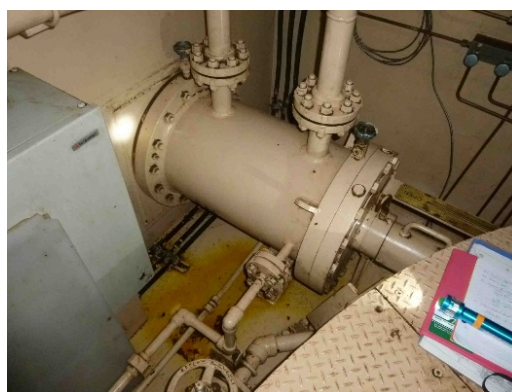
Photo 4.1-5 Around Guide Vane Servomotors (Unit-#2)

The guide vane servomotors themselves and related components, including the guide ring and the connecting link, etc., have no apparent defect. But, oil leakage was found from the flange connections of pressure oil piping near the servomotor. The oil leakage was found at both unit of #1 and #2. (Photo 4.1-5)

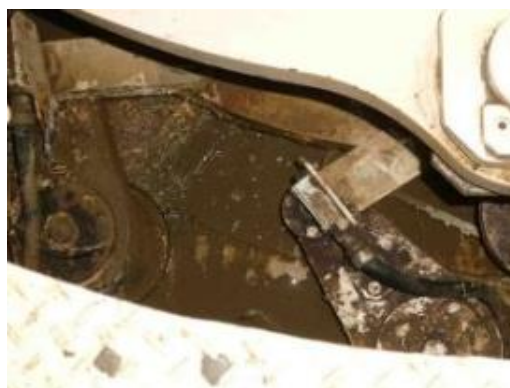
(1) Guide vane operating mechanism

by a film of mud which was contained in water from the penstock. That condition is unfavorable for long satisfactory turbine operation. (Photo 4.1-6 (1))

There was no experience of shear pin breakage at unit #1 and #2, according to the plant staff. On the other hand, although limit switches of the alarm for the shear-pin breakage have often troubles, there are no spare parts at present. (Photo 4.1-6 (1))

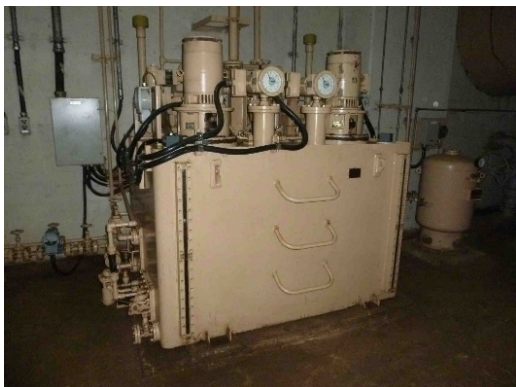
(1) Oil sump tank and related components

b) Oil Sump Tank (Photo 4.1-8 (1))

- (a) There are symptoms of the deterioration at unloader valves, one of very important components.
- (b) There is slight oil leakage from the flange connection with pressure oil pipe at unit-#2.
- (c) Aging deterioration of relays, meters, gauges and the local control panels is predicted.

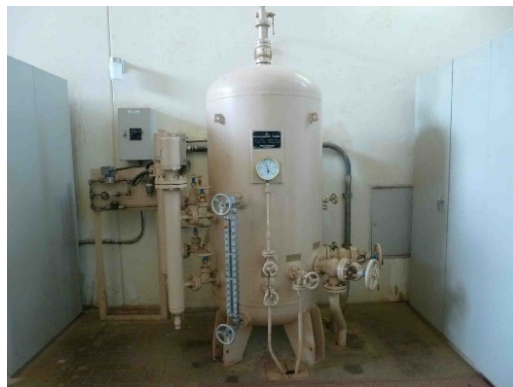
(2) Oil pressure tank set

- (a) A pressure relay is operated manually as a results, not operated automatically, due to its breakdown.
- (b) It is supposed that reliability of the function of safety valve is decreased due to the aging deterioration.
- (c) The aging deterioration of relays, meters, gauges and the local control panels is predicted.

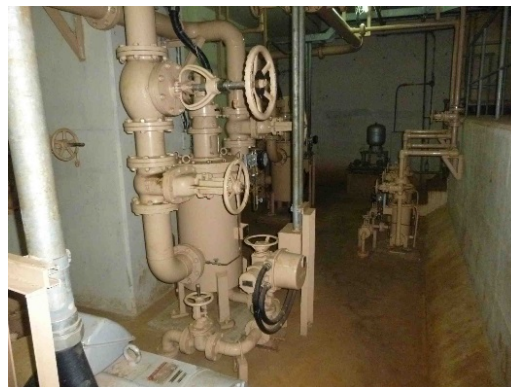
(1) Automatic water strainers
(Regular use and backup)

b) Automatic Strainer (3 units in total) (Photo 4.1-9 (1))

It is predicted that reliability of motor-driven automatic water strainers is decreased due to the aging deterioration at “motor and gear box”s.

The inside of strainers was cleaned and maintained periodically, once two months, by station staff by dismantling the major components. No damage of internal components/parts was confirmed by the staff.

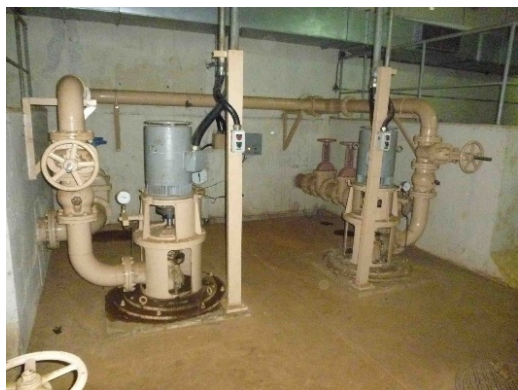
(1) Water drainage pumps for the drainage pit (regular use and backup)

a) Dewatering Pump (2 units, regular use and back-up) (Photo 4.1-11 (1))

The deterioration of the insulation of motors for dewatering is predicted. Reliability of the system including all electrical devices/components such as the local control panel is seemed to decrease.

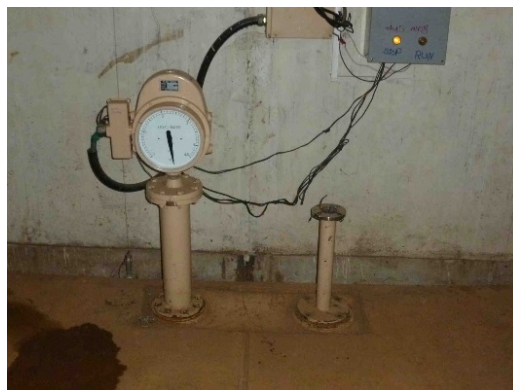
(2) Water level gauge/detector for the drainage pit

- (a) Water level gauging equipment, a gauge and a detector, has not been functioned due to the troubles. The damaged detector was removed already by station staff. (Photo 4.1-11 (2))
- (b) Due to these troubles, as a result the dewatering pumps are operated manually, not automatically, at present.

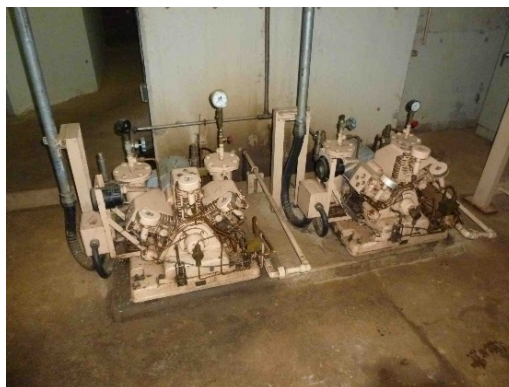
(1) Air compressor set (regular use and backup)

a) Air Compressor (2 units, regular use and back) (Photo 4.1-12 (1))

Deterioration of insulation of the motors for the air compressors is supposed. Reliability of the system including gauges and electrical devices such as the local control panel is seemed to decrease. The air compressors are located near the inlet valve where is in humid condition. Thus, the redesign of arrangement of the system and the replacement of all related components is needed.

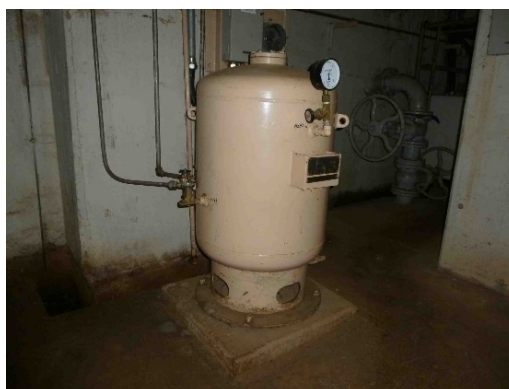
(2) Pressure air tank set

b) Air-pressure Tank (Photo 4.1-12 (2))

Aging deterioration of safety valve, gauges and accessories is predicted. The location of the tank set is to be redesigned according to the new location of the air compressor sets

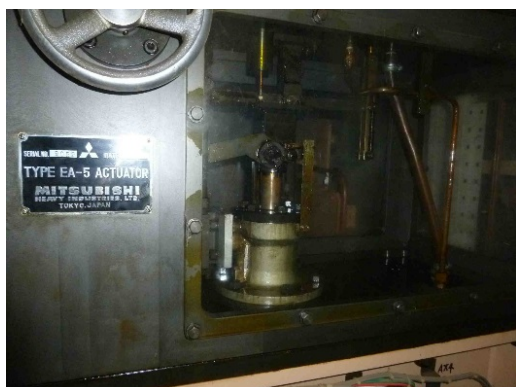
(1) Governor actuator portion in governor control panel

- a) The mechanical portion of the actuator are covered with deteriorated grease and oil and it is predicted to cause operational failures. (Photo 4.1-13 (1))
- b) Metal ablation powder is around Cam mechanism portion. It will cause troubles in the function of position detection of the governor system.

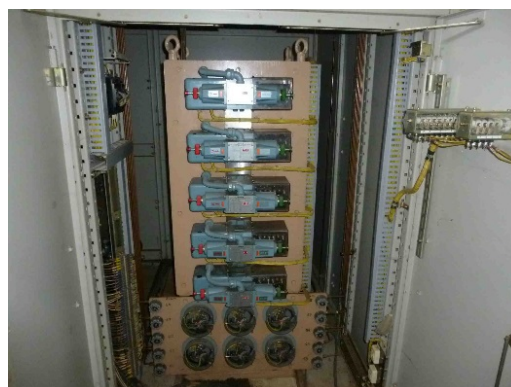
(2) Solenoid valves in turbine control panel

- a) Solenoid valves are deteriorated by aging and it will cause troubles in the control of oil pressure. (Photo 4.1-13 (2))
 - b) The display function of each meter in the panel is considered to be deteriorated by aging.
- 7) **Turbine Flow Meter** (Photo 4.1-14)

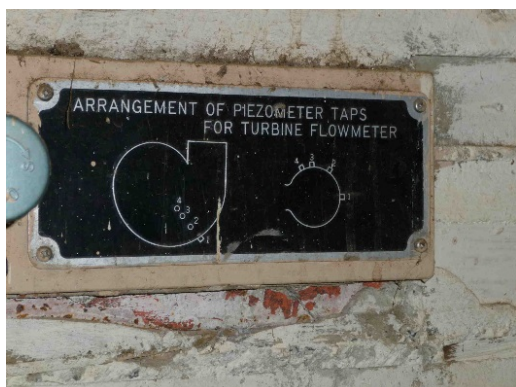
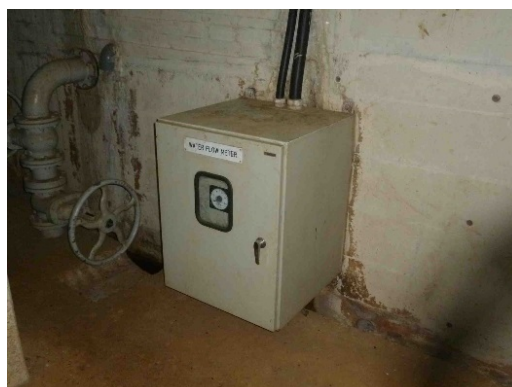
The turbine flowmeters, using piezometer taps, of both units are broken and out of use.

Monitoring system of turbine flow rate by alternative method was requested to the JICA Survey Team by the station manager.

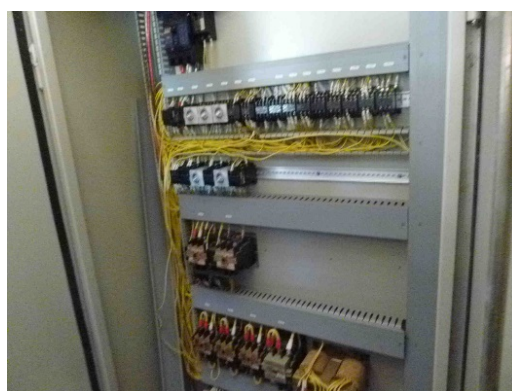
(2) Electrical parts in the control panel of main crane

On the other hand, it is predicted that function of electrical equipment such as motor, relay, breaker, etc. is decreased due to the aging deterioration. (Photo 4.1-15 (2))

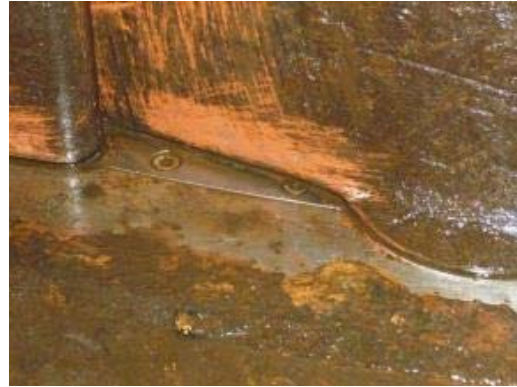
(2) Bottom portion of guide vane

The surface of guide vanes had no apparent damage. (Photo 4.1-17)

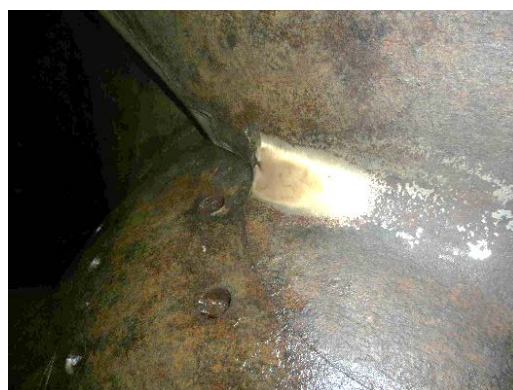
(2) Root disk of runner vane

suction surfaces in upstream side. The portions have the pear skin surface, but the damage is not serious. (Photo 4.1-19 (2))

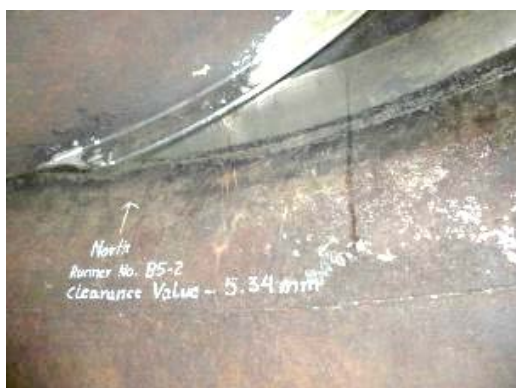
(3) Gap at runner vane periphery

- c) Gaps between the outer periphery of runner vanes and the inner surface of the discharge ring are measured. Gaps of the vane have the values of minimum 0.6mm and maximum 5.3mm. This variation is remarkably large. It is supposed that aging of overall equipment has been developed. It is necessary to adjust these gaps in the future. (Photo 4.1-19 (3)).
- d) Circumferential abrasion signatures are observed at a portion of the inner face of the discharge ring. However the relation with the large variation of runner vane gaps mentioned in 3) is not clear. (Photo 4.1-19 (4)).

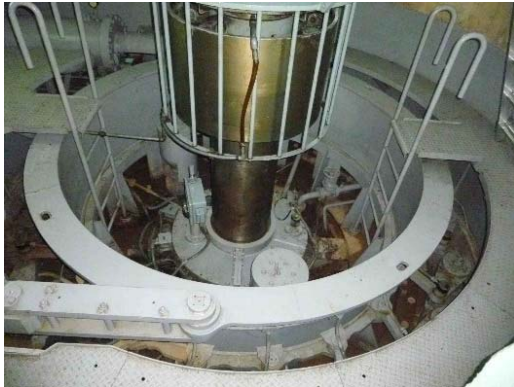
(1) Overview in the turbine pit

The conditions in the turbine pit including the upper surface of head cover were relatively clear in general in spite of the long turbine operation of about 30 years. No oil leakage was found around the guide vane servomotors and its pressure oil piping. (Photo 4.1-20 (1))

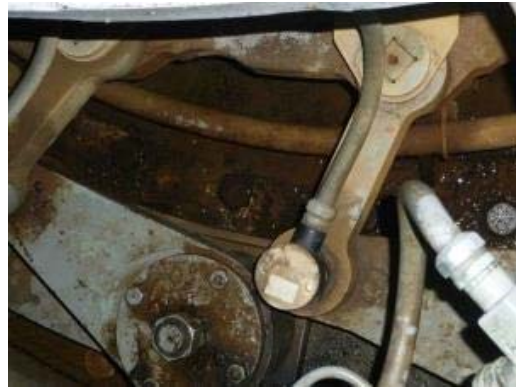
(2) Shear pin breakage detector

According to the interviews with station staffs, shear pin breakage detectors had some malfunctions up to now. (Photo 4.1-20 (2))

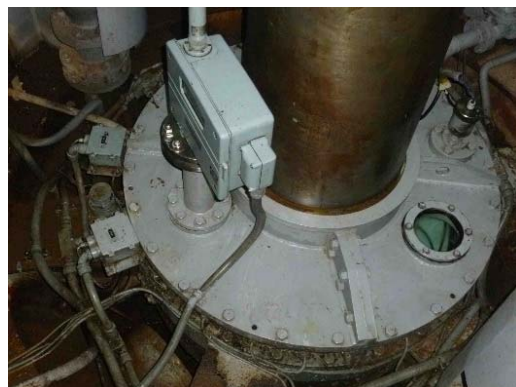
(2) Oil level detector and devices

- a) The oil level detection relay at the turbine bearing has sometimes troubles (unit-2). (Photo 4.1-21 (2))
- b) Generally speaking, it is predicted that aging deterioration of relays, gauges and other electrical devices have been developed. (Photo 4.1-22)

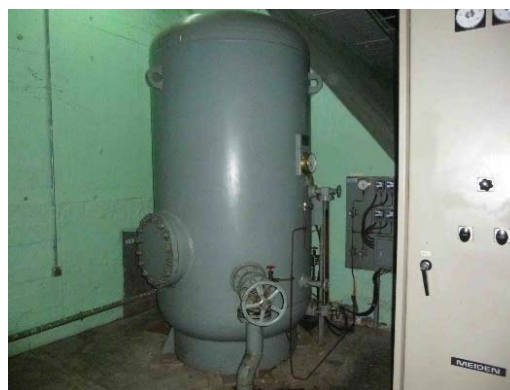
(2) Pressure oil tank set

- (a) It is predicted that reliability of the function of all electrical/mechanical components including pressure relay and the safety valve is decreased due to the aging deterioration.
- (b) It is difficult to read the value of the oil gauge (sight glass) of oil tank due to the grim of deteriorated oil.

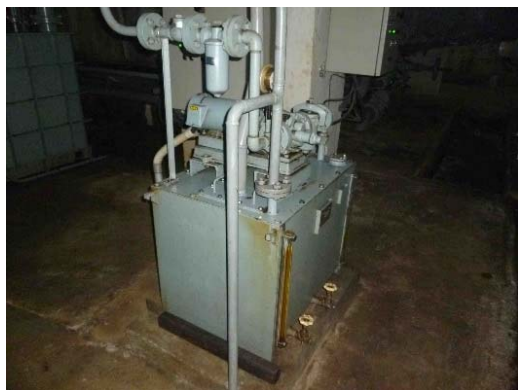
(1) Leakage oil tank set

The oil feeding pump is on the leakage oil tank. Aging deterioration of insulation for motors is predicted.

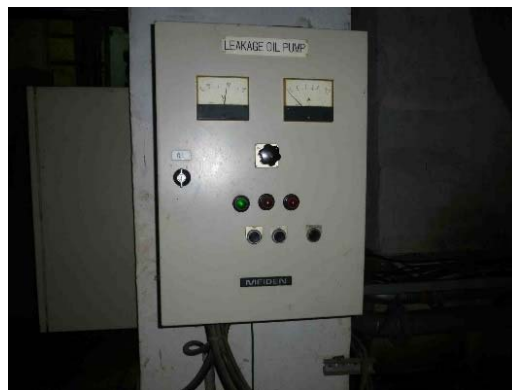
(2) Local control panel

c) Electrical Parts at Operation Panel (Photo 4.1-24 (2))

It is predicted that reliability of the function of electric parts is decreased due to the aging deterioration.

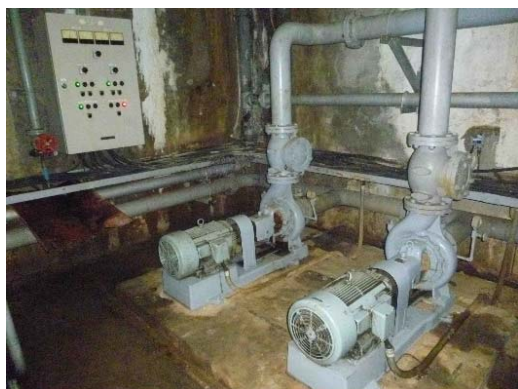
(1) Cooling water pumps

Deterioration of insulation of the motors for cooling water pumps is predicted. Reliability of the system is seemed to decrease.

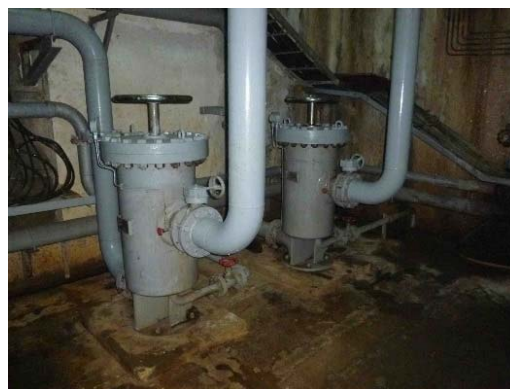
(2) Main water strainers

It is impossible to remove foreign materials at the inner water filter easily due to its mechanical structure and is necessary to dismantle the strainer parts to remove the foreign materials currently. The motor-driven system by the automatic control is expected to be installed for stable operation of the plant. (Photo 4.1-25 (2))

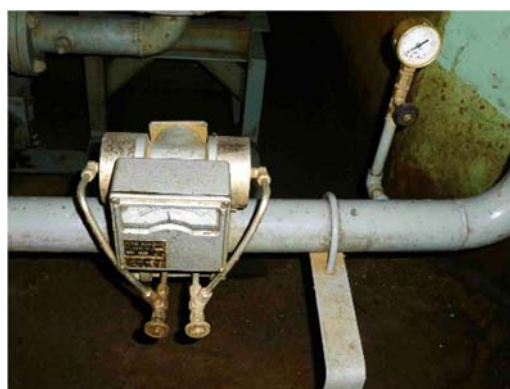
(2) Flowmeter at cooling water pipe

- (a) Generally speaking, it is supposed that reliability of the function of instrumentation equipment is decreased. There are no spare parts.
- (b) Flow meters of air cooling equipment for generators of each unit are broken.
- (c) Turbine flow meter of unit-1 inside the transmitter box sometimes has troubles. (The flow meter is equipped in the local panel shown in Photo 4.1-26 (1))
- (d) Flow meters at the main pipe of cooling water system for oil cooling equipment of Unit-1 are broken. (Photo 4.1-26 (2))

Meanwhile, the readings of these meters can be observed only on site and the additional remote monitoring system is requested to be installed by the plant manager.

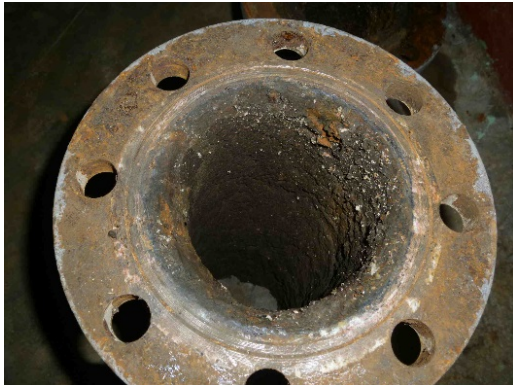
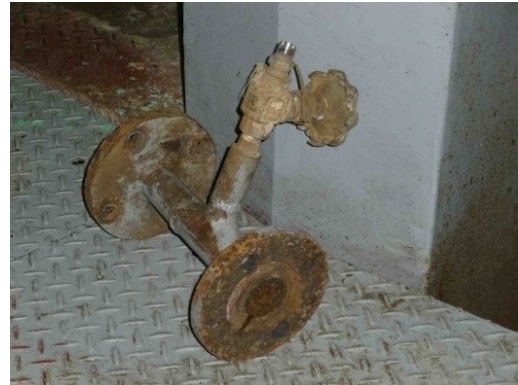
- (a) Internal inspection for water piping at the outlet of cooling water pump and at air cooling equipment for generators is implemented by dismantling the pipe pieces. As a result, mixing layer of rust and mud of approx. 5.0 - 6.0 mm thickness is deposited on the pipe wall. Thus, the rust and mud layer is surely supposed to be deposited in all water piping. (Photo 4.1-27 (1))
- (b) Photo 4.1-27 (2) shows a piece of small pipes used for water pressure meters/relays in the turbine pit after dismantling for the inspection. Thick rust layer was deposited on the internal surface and the outer surface of the pipe was corroded.

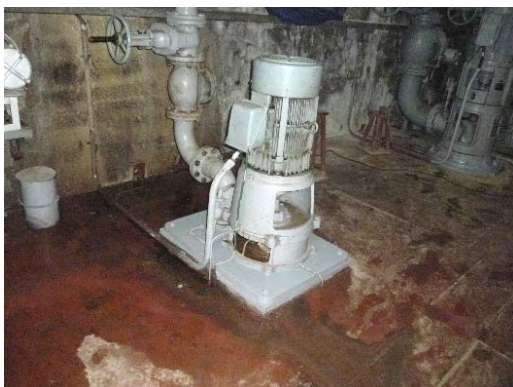
(1) Drainage pumps for powerhouse water leakage pit

a) Dewatering Pump for Powerhouse Water Leakage Pits (2 units, regular use and back-up) (Photo 4.1-28 (1))

One of two units is damaged (the shaft vibration due to the damage of the bearings). Reliability of another unit is seemed to be decreased due to the deterioration of the insulation of motors and the deterioration of mechanical parts of the pump.

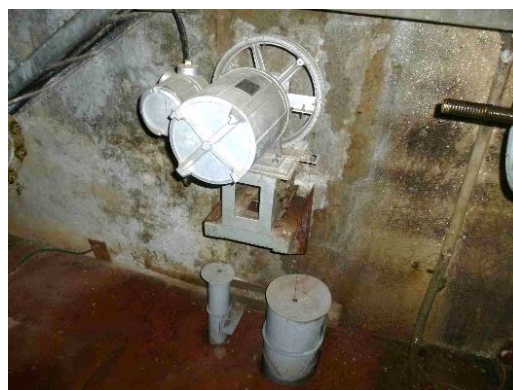
(2) Water level detector for drainage pit

Currently, the detectors of water level for dewatering pits are not in troubles. However, these are also predicted to be in aging and deteriorated conditions. (Photo 4.1-29 (2))

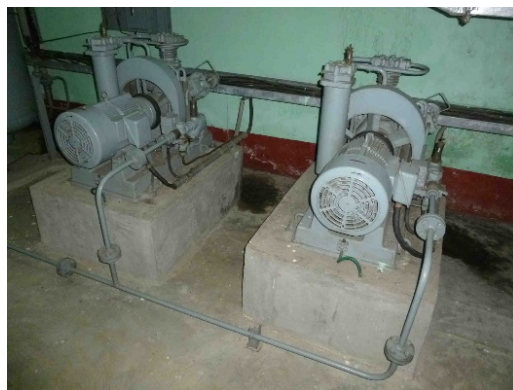
(2) Air compressor

Deterioration of insulation of the motor for the air compressor is supposed. Reliability of the system is seemed to decrease. (Photo 4.1-30 (2))

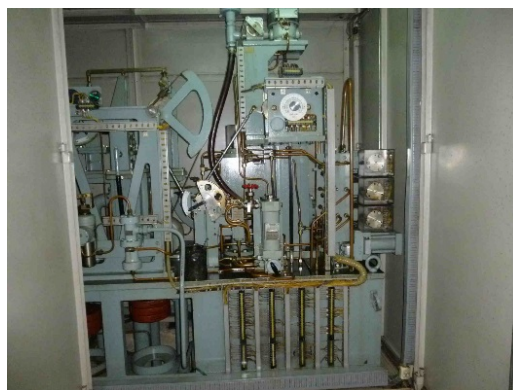
(2) Governor actuator portion

- a) Mechanical portions of the actuator are covered with deteriorated grease and oil and it is predicted to prevent smooth movement of mechanical parts and cause operational failures. (Photo 4.1-31 (2))

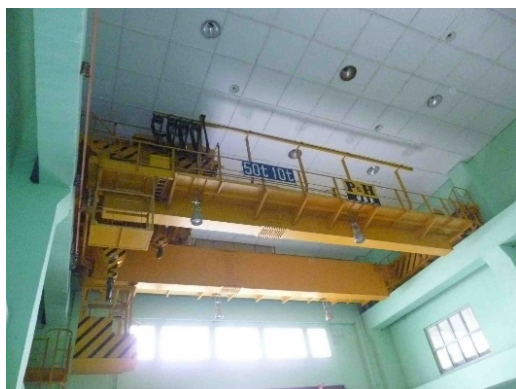
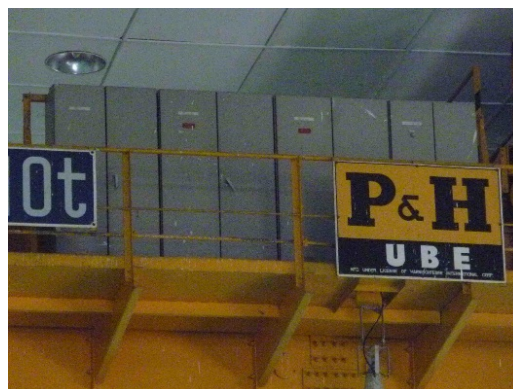
- a) It is predicted that function of electrical equipment such as (motor, relay and breaker) is decreased due to the aging deterioration. During the inspection, there was a trouble of related electrical control system for the main 50 ton hook and the operation for hoisting up/down was implemented manually using the local panel. Although this trouble was already repaired tentatively by the change of wiring terminal location, similar troubles are surely predicted to occur in all electrical equipment.
- b) Squeak mechanical noise sounded when the operation test of gantry, trolley and hooks were executed. Grease/oil lubrication for the mechanical parts such as reduction gears and the bearings may be insufficient for lack of maintenance.

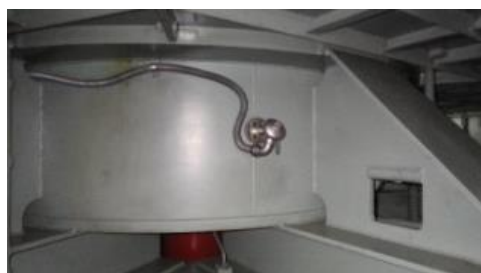
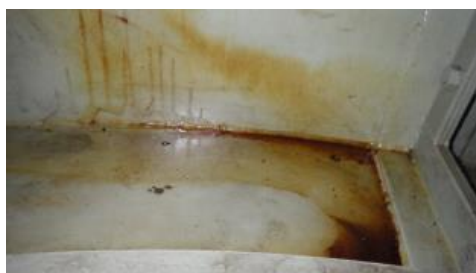
Oil Leakage on Upper Bracket

There is oil leakage at the surface of upper bracket from the upper bearing oil tank. There is also oil leakage from the tank due to the crack at welding points of upper bracket of No. 1 unit (Photo 5.1-2).

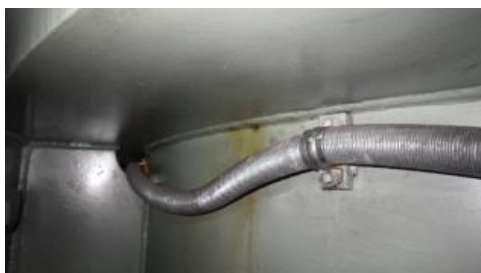
Photo 5.1-2 Upper Bracket

Oil Leakage from Welding Line

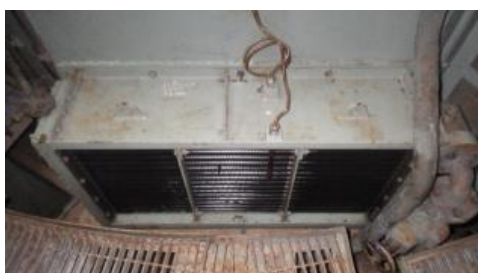
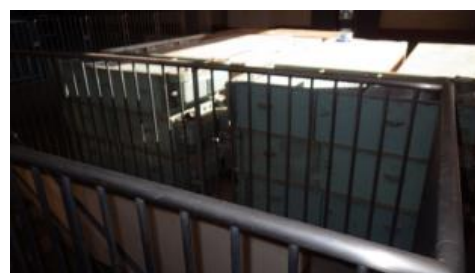
Photo 5.1-3 Air Cooler

There have been frequent troubles of the leakage at air coolers. Total twelve spare parts of the air cooler had been installed at first but currently only six parts are stored (Photo 5.1-3).

Air Cooler (Installed)

Spares (6 unit)

The air coolers shall be replaced, and appropriate numerical spare parts shall be provided.

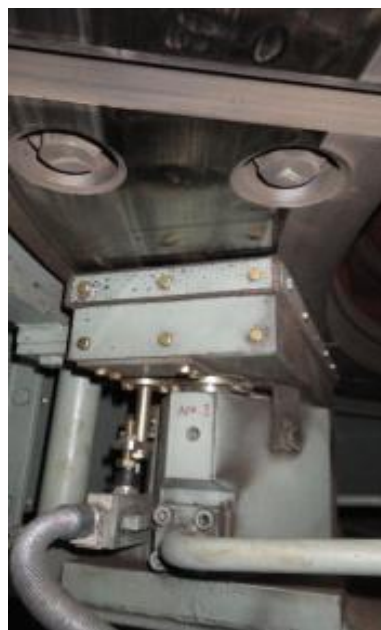
Photo 5.1-4 Brake System

Brake ring is damaged by the slide scaring. Decrease of the reliability due to the deterioration of braking control equipment may cause the burning accident of bearing in the shutdown procedures of turbine and generators (Photo 5.1-4).

Brake

Brake jack and brake ring system shall be replaced.

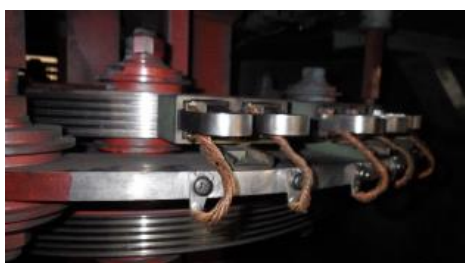
There is slight roughness at the surface of slip rings. Inside of the collector ring cover is coated by carbon powder of brush. In addition, oil from the upper bearing oil tank is splattered around collector rings (Photo 5.1-6).

Roughness at Surface of Slip Ring
and Carbon Brush Powder

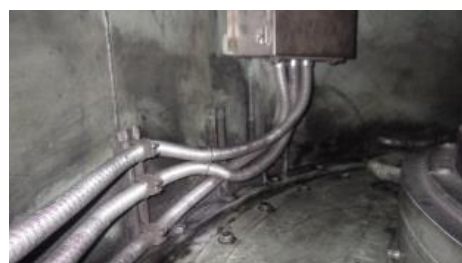
Photo 5.1-6 Collector

Inside of the Collector Ring Cover

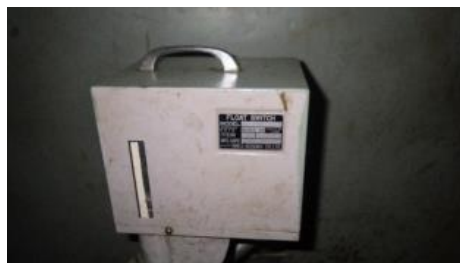
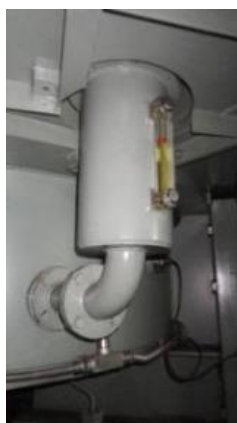
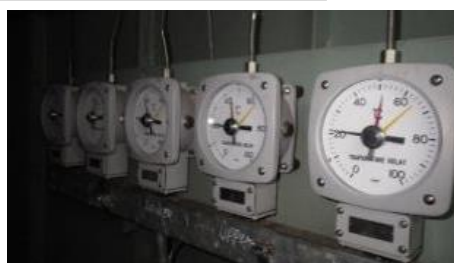
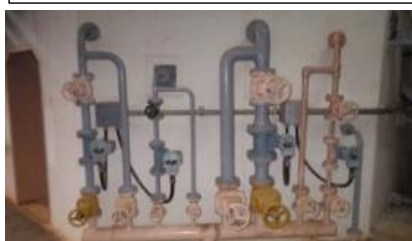
Photo 5.1-7 Electric Relays

Regarding electric relays (cooling water discharge, oil level and bearing temperature), scale of lower bearing oil level meter cannot be read. It may be the decrease of reliability due to the deterioration of each relay and cause some serious accidents of turbine and generators (Photo 5.1-7).

Oil Gauge at Lower Bearing

The relays (cooling water discharge, oil level and bearing temperature) shall be replaced as consumable parts of overhaul work.

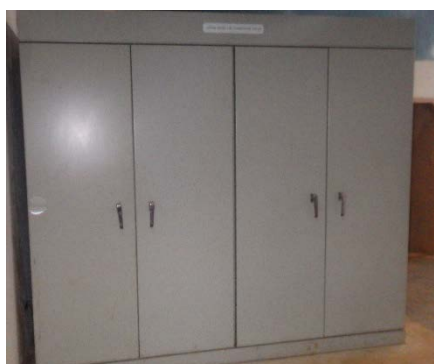
Photo 5.1-8 CO₂ Fire Fighting System

CO₂ firefighting system for the generators have never been maintained. The system have not been maintained. The system is not functional (Photo 5.1-8).

Firefighting system is necessary for the generators. It is recommended that portable fire extinguishers should be considered as countermeasure of the existing CO₂ firefighting system.

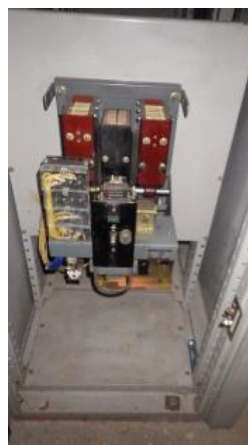
Photo 5.1-9 FCB (Field Circuit Breakers)

FCB (installed)

There have been many troubles in FCB. Spare parts of them have been already finished up as of now. If serious troubles occur in them in the future, turbine and generators cannot operate (Photo 5.1-9).

The excitation system shall be replaced from existing static system to brushless system for reliable operation and minimum maintenance. And AVR (Automatic Voltage Regulator), including the excitation transformer, shall be also replaced to new digital type.

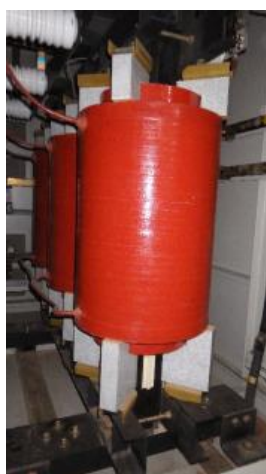
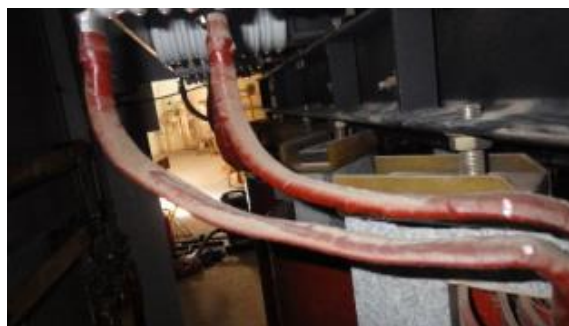
Photo 5.1-10 Excitation Transformer

Coating at the lead of exciters is partially come off due to the aged deterioration. There are damages including main conductors.

Polluted Lead

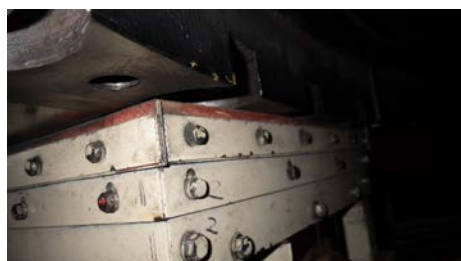
Hotspots by the unbalance of the brake are observed. Splash protection materials of brake powder at Unit-2 are partially disappeared. Splash protection materials of brake powder at Unit-1 are partially in touch with the brake ring. Reliability is supposed to decrease due to the deterioration of brake control equipment. It may cause the burning accident of bearing in the shutdown process of turbine and generator (Photo 5.1-13).

Unit-1
Splash protection materials of brake powder are partially in touch with the brake ring

Brake jack and brake ring system shall be replaced.

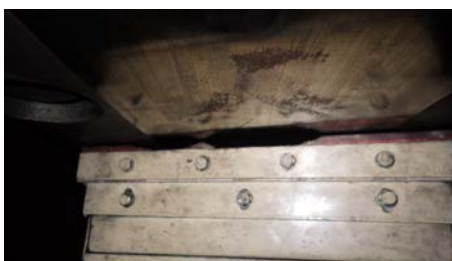
Photo 5.1-13 Brake System

Unit-2
Hotspot and Disappearance of Splash Protection Materials

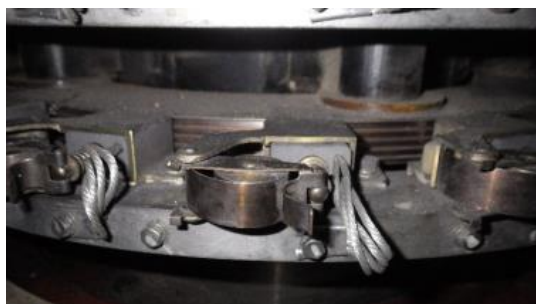
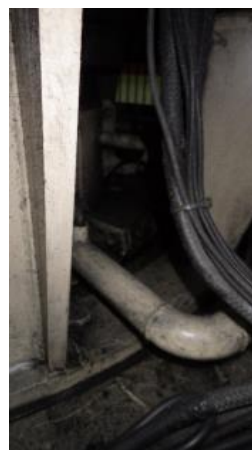
Photo 5.1-14 Collector

Carbone brush powder is splashed around the slip ring. There are no spare parts for Carbone brush produced by original manufacturers and brush made by Indian manufacture is currently used. Oil from the oil tank of the upper bearing is splashed around the collector ring. Surface of the lower slip ring of Unit-2 is slightly rough (Photo 5.1-14).

Carbone Brush Powder
Slight Roughness at Lower Slip Ring
Oil Leakage from Upper Bearing

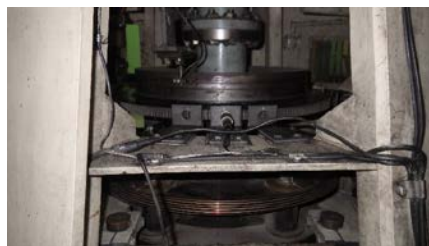
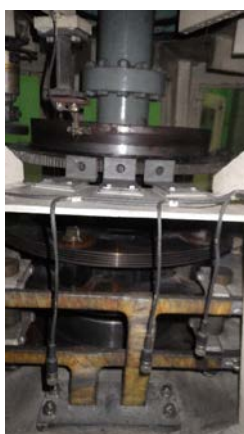
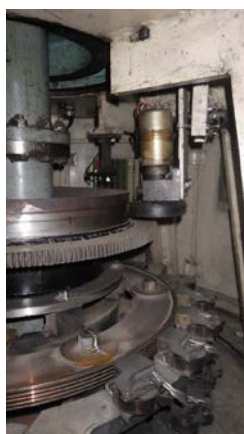
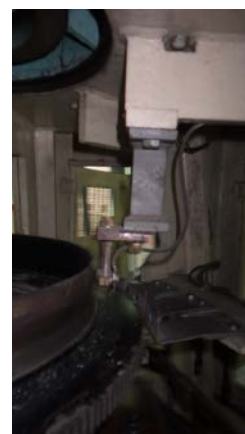
Photo 5.1-15 Speed Signal Generator

Pulse pickup sensors for the velocity detector are in troubles (4 of 6 parts in Unit 1 and 3 of 6 for Unit-2). In addition, mechanical speed switch and earthing brush are also in troubles in both Units. If troubles of the sensor happen, it is assumed that the turbine and generator can't operate (Photo 5.1-15).

Sensor of Unit-1 (Two in Troubles)

Sensor of Unit-1 (Three in Troubles)

The existing speed signal generator and mechanical speed switch shall be replaced to new digital type on the top part of generator.

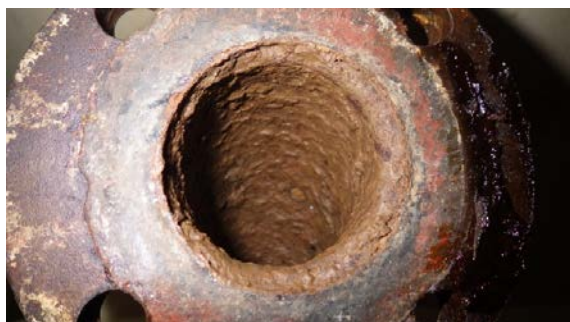
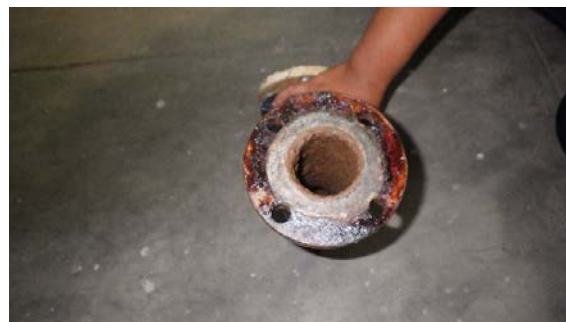
Photo 5.1-16 Cooling Water Piping for Air Cooler

Inside of the cooling water piping for air cooling system is slightly coated with the rust and mud (Photo 5.1-16).

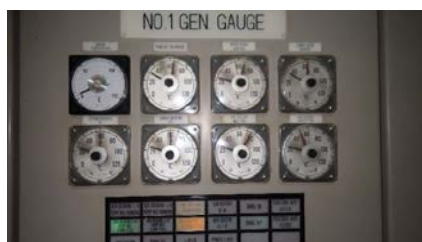
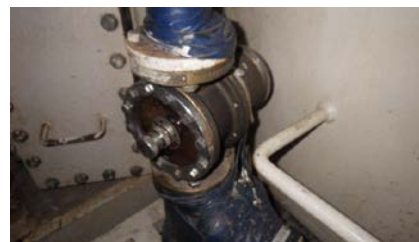
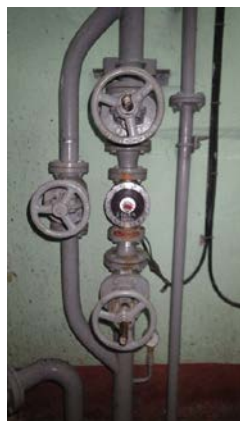
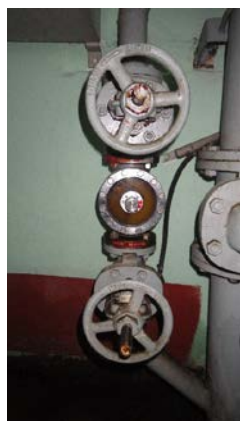
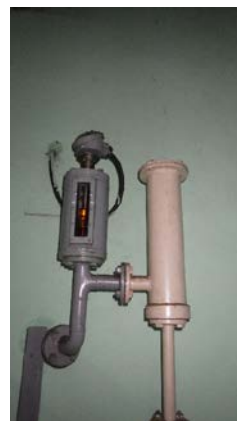
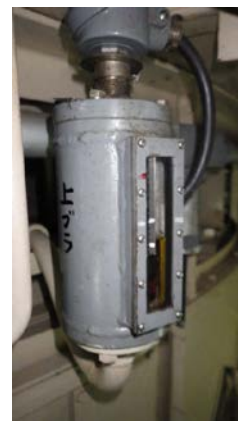
Photo 5.1-20 Relays

Regarding relays (Discharge, Oil and Temperature), the dial temperature gauge installed at the generator gauge panel has the trouble. Most of flow meters (Oil and Water) are not functioned. It is also difficult to judge whether the equipment is in proper operation or not. Oil gauge for the bearing can't be read. Reliability is supposed to decrease due to the deterioration of relays. It may cause serious accidents of turbine and generator (Photo 5.1-20).

Trouble of Indicator of
Dial Temperature Gauge

Flow Meter of Cooling Water
(Electric Wire is unconnected)

Flow Meter of Oil and Water
(Value is Unread)

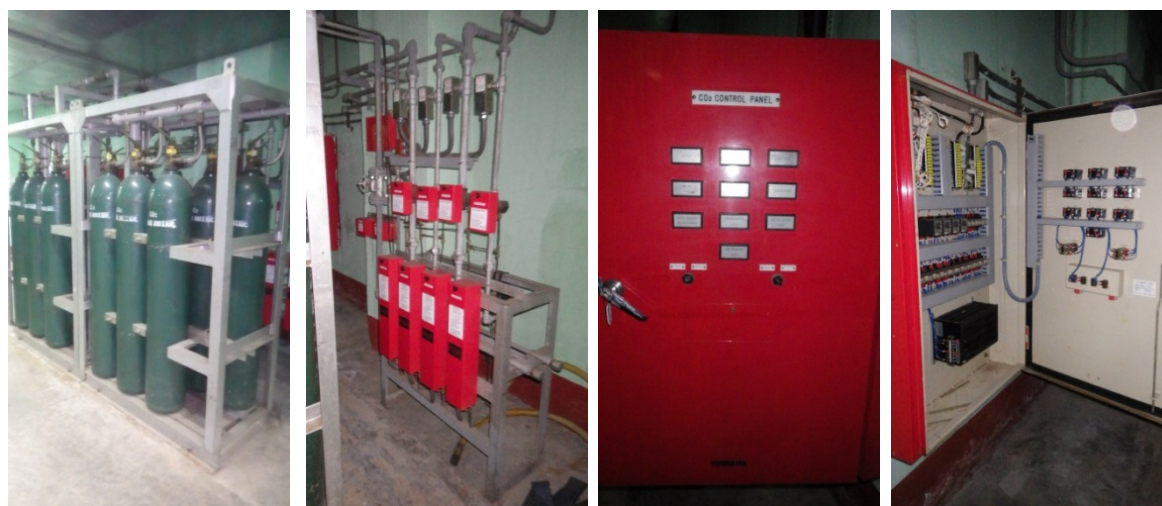
Photo 5.1-21 CO₂ Fire Fighting System

CO₂ firefighting system is for the generators have never been maintained. The system have not been maintained. The system is not functional (Photo 5.1-21).

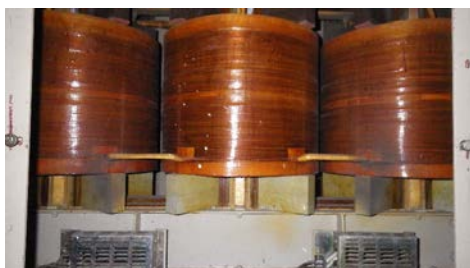
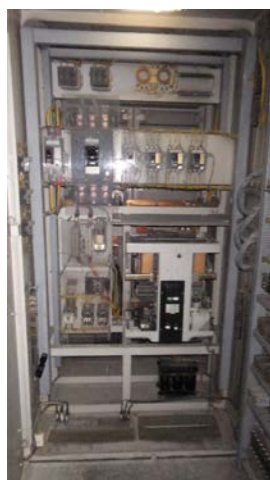
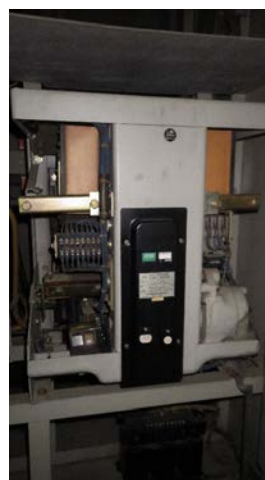
Photo 5.1-22 *Exciters*

There are no spare parts for FCB. In the case of troubles, turbine and generator can't operate. Although excitation transformers don't have troubles, but reliability is supposed to decrease due to the deterioration (Photo 5.1-22).

FCB (no Spare Parts)

The excitation system shall be replaced from existing static system to brushless system for reliable operation and minimum maintenance. And AVR, including the excitation transformer, shall be also replaced to new digital type.

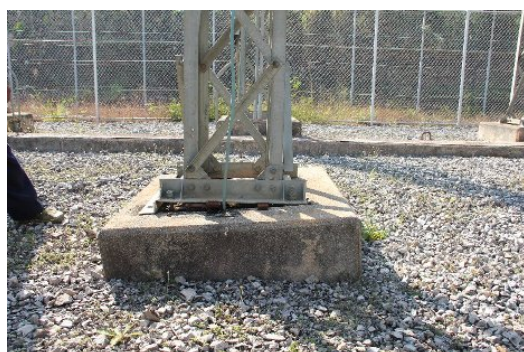
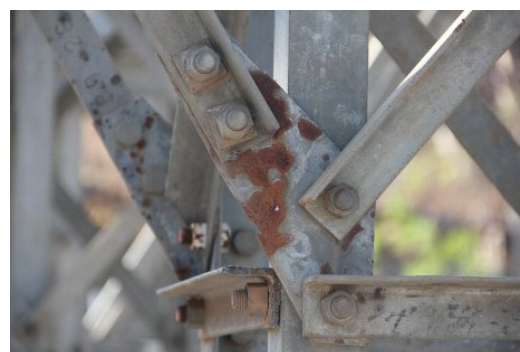
Photo 7.1-2 132 kV Switchgear

The foundations of surge arrester in phase B has been settled down to the ground. Even though temporary treatment for the base plate of supporting structures has been conducted, it may incur the collapse of surge arresters.

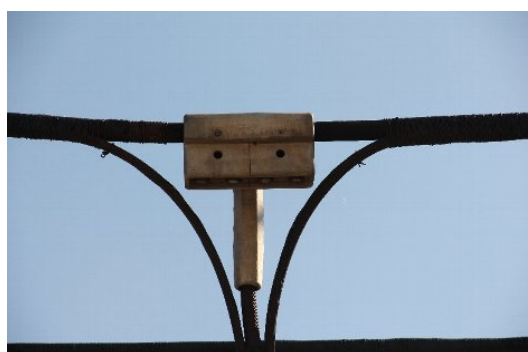
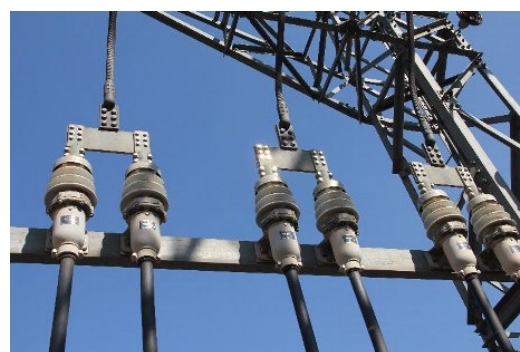
Photo 7.1-3 11 kV Busbar and Cable Clamp

HDCC (hard-drawn copper conductor) 1000 mm² has been installed in 11 kV busbar, however, the maximum current capacity is not enough. Additionally, since the damages by overheat on the cable clamps in order to connect 11 kV busbar and main transformer are appeared due to the loose connection. Temporary treatment by bypass conductor has been conducted.

Therefore, it is required to replace new conductors which have more capacity such as ASCR (Aluminum Conductor Steel Reinforced) 1,520mm², etc. Furthermore, corresponding to replacement the 11 kV busbar conductor, cable head and cable clamp shall also be replaced.

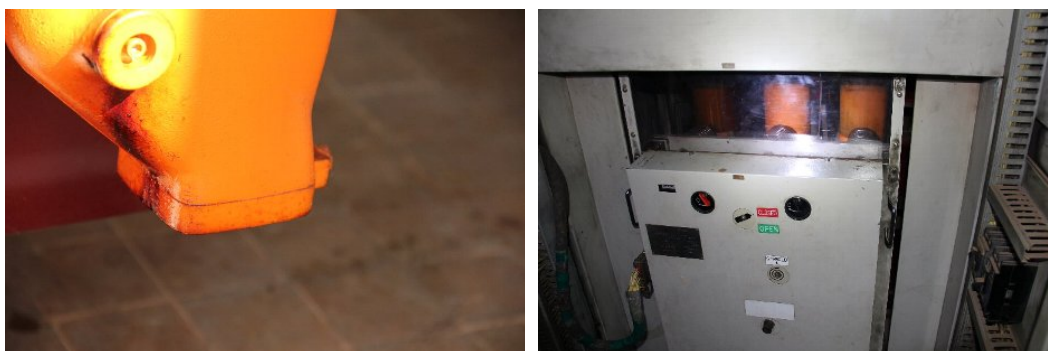
Photo 7.1-4 11 kV Switchgear (LOCCB)

Although LOCCB (low oil content circuit breakers) have been applied in 11 kV main and local cubicles, there is some oil leakage from LOCCB. Some troubles such as flash over in LOCCB has been reported for five times at Unit 1 circuit. Additionally, the size of the cubicle for 11 kV is quite large compared with the current standard design.

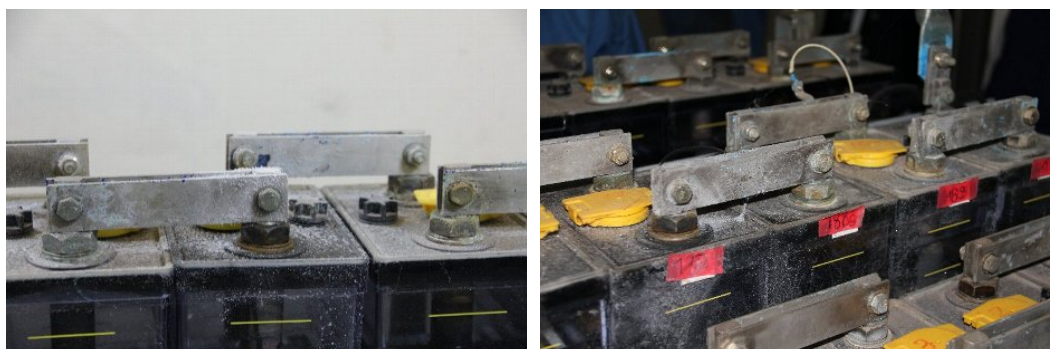
Photo 7.1-5 DC Batteries

DC batteries have never been replaced after operation of power station. Therefore the level of electrolytic solution in DC batteries is quite low because the leakage of it has been occurred. Additionally, the green rust development is founded on the termination of each batteries due to the no cover.

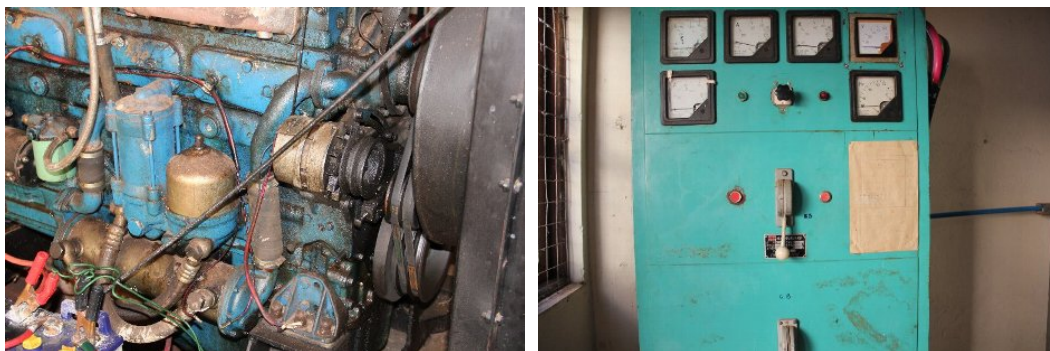
Photo 7.1-6 EDG**(15) Transmission Line Control Panels**

The operating conditions of EDG are quite bad due to the aging, the oil leakage and low quality. Additionally, EDG is not fixed to the foundation due to no anchor bolts though there is hole for anchor bolts at base plate.

In addition to the above, there is no meter for checking the power factor and watt-hour, etc. in the control panel.

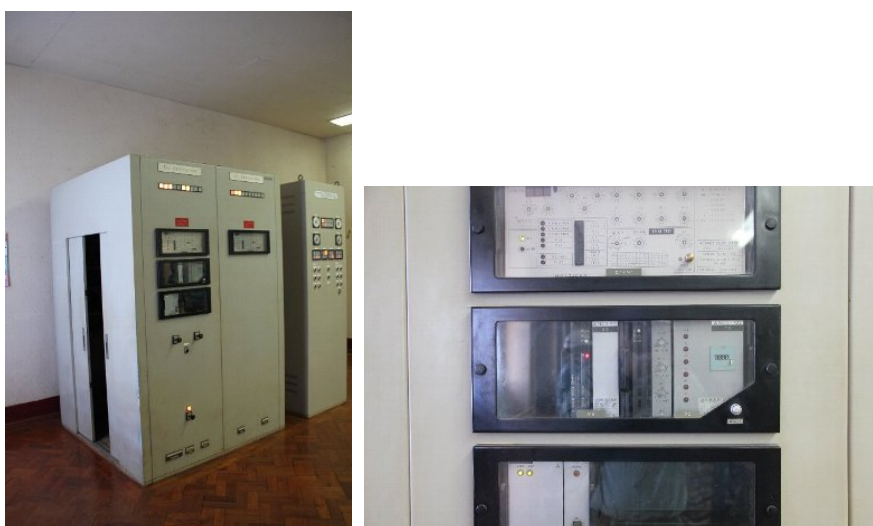
Photo 7.1-7 Transmission Line Protection Panel

In current design for line protection panel in Myanmar, distance relay as main protection and over current and grounding fault relay as back-up protection is applying. However, line protection panels for transmission line between Baluchaung No.1 and Baluchaung No.2 HPPs have only distance relay.

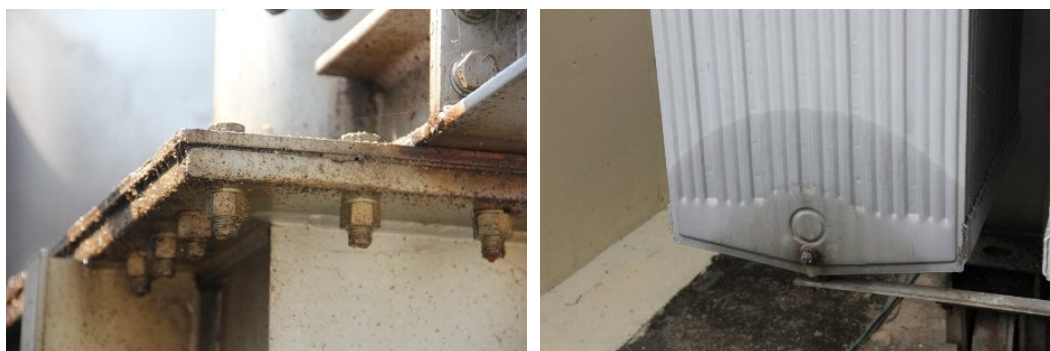
Photo 7.1-8 Main Transformers

There is remarkable oil leakage at the tank, gasket and radiator, etc. in all units. And, there is some rust development in local control panels.

There is no vibrations and abnormal noise in main transformers under the normal operation.

As the result of checking the ordinary maintenance records, the trip of the main transformers circuit by high oil temperature has not been confirmed.

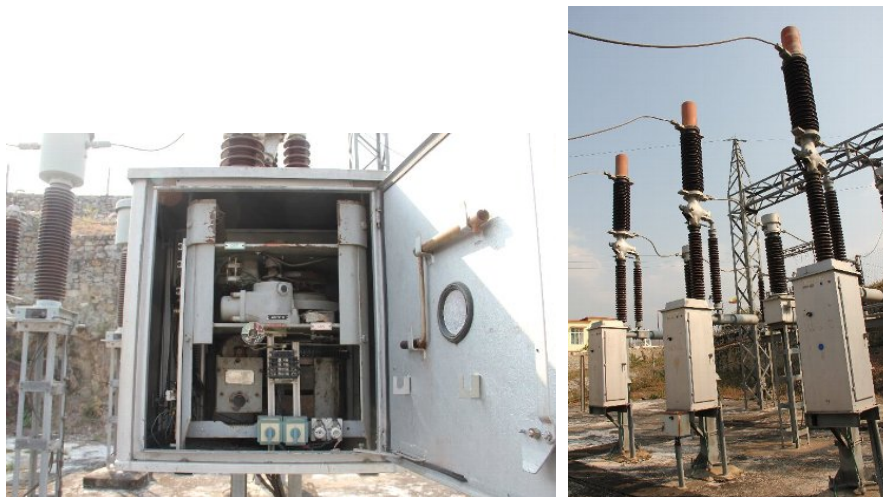
Photo 7.1-9 132 kV Switchgear

Operating conditions of disconnectors are good even under the on-load disconnection. And also, there is no deterioration in insulators, blade and contact parts.

The current transformers in Sedawgyi substation have not been replaced until now. 132 kV red phase current transformer of the Kyaukpahtoe S/S circuit was burnt in 2007 and was replaced.

The voltage for both transmission lines is not able to be measured due to the failure of secondary windings in capacitor voltage transformers.

The counter value of surge arresters on the main transformer side is differed vastly with respect to each phase. Thus, it is considerable the counter is not operating correctly.
