**PREPARATORY SURVEY
ON
HYDROPOWER PLANTS REHABILITATION PROJECT
IN
THE REPUBLIC OF THE UNION OF MYANMAR**

FINAL REPORT

November 2016

Japan International Cooperation Agency

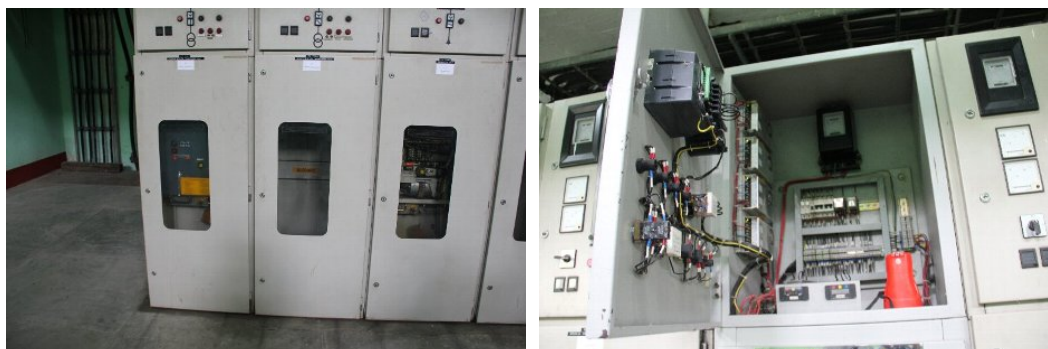
Photo 7.1-10 11 kV Switchgear

Insulator which supports the terminal between 11 kV busbar and 11 kV cable for one phase was modified because it had insulation failure.

There is insulation deterioration of 11 kV cables by aging.

11 kV switchgear panel for irrigation feeder have been replaced to new one because flash over had happened on OCB.

There is no method for receiving the power from 132 kV system.

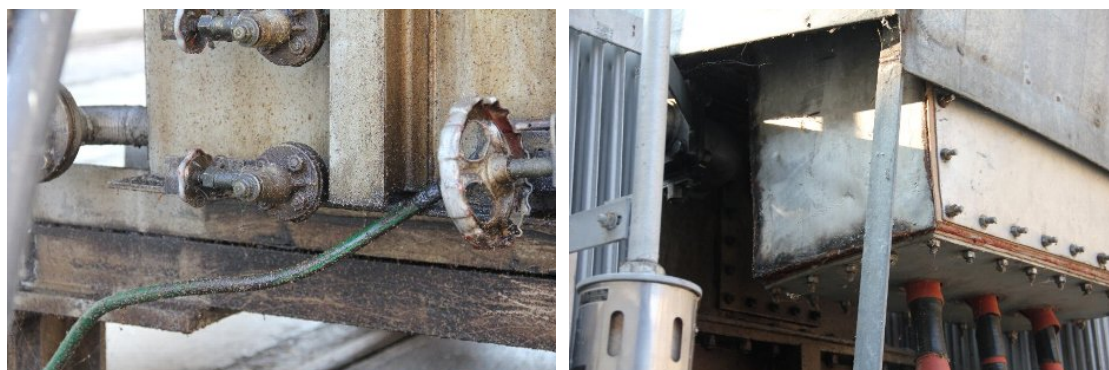
Photo 7.1-11 11/11 kV Tie Transformer

There is remarkable oil leakage at the tank, gasket and radiator, etc. 11 kV bushing has been reinforced due to the flashover.

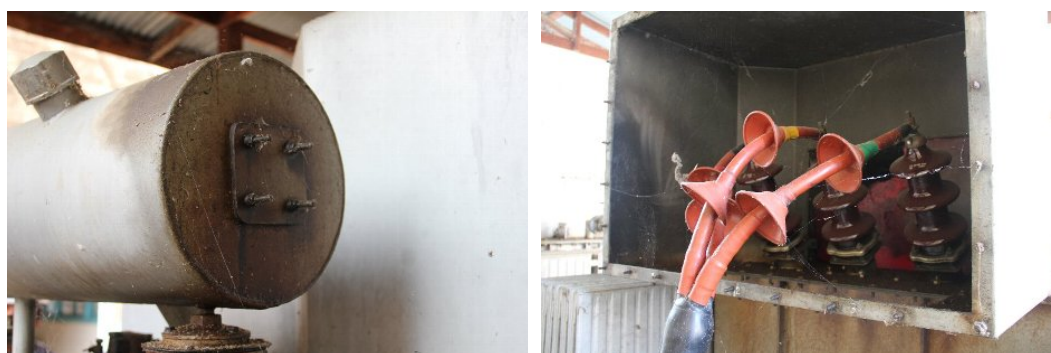
Photo 7.1-12 Station Service Transformers

There is remarkable oil leakage at the tank, gasket, conservator and radiator, etc. in all units. Low voltage bushing has been reinforced due to insulation failure by the flashover.

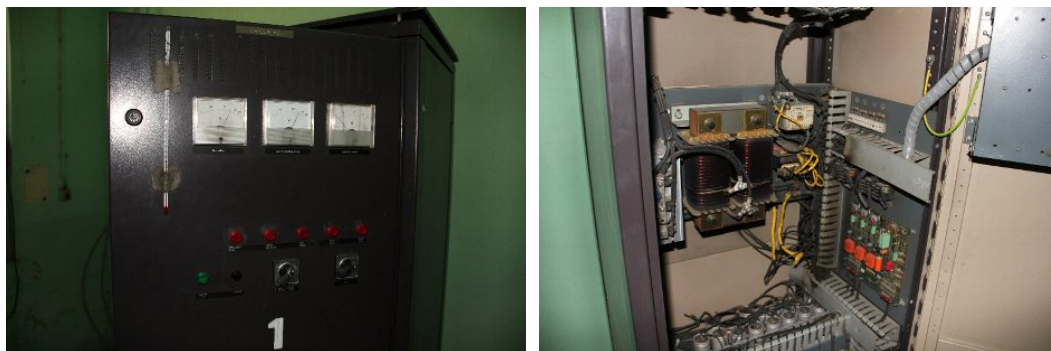
Photo 7.1-13 DC Battery Charger

There is noise in both panels and the temperature of the panels is rising without opening the front door.

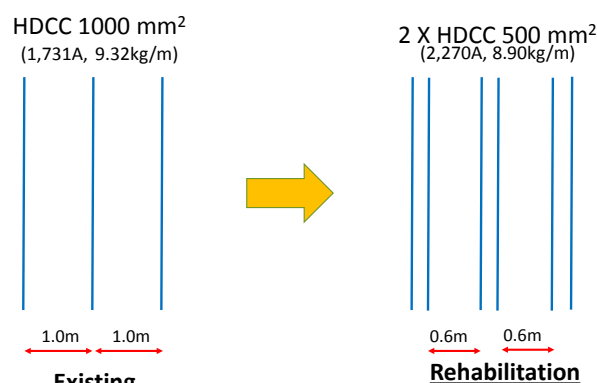
Fig. 7.3-1 Comparison of Conductor for 11 kV Busbar in Baluchaung No.1 HPP

The existing conductor for 11 kV busbar is a HDCC 1,000 mm² and its continuous current carrying capacity is 1,731 A at its permissible operating temperature of 90°C against rated current capacity of 1,627 A under normal generating operation. It is recommended to replace conductor to 2 × HDCC 500mm² which has 2,270 A under 90°C condition, in order to secure the surplus current for abnormal operation. In addition, gantry structure for 11 kV busbar is not necessary to replace because weight of 2 × HDCC 500 mm² is lighter than HDCC 1,000 mm². Furthermore, after replacement to 2 × HDCC 500 mm², the insulation clearance of 11 kV busbar will be secured as shown in the following figure:

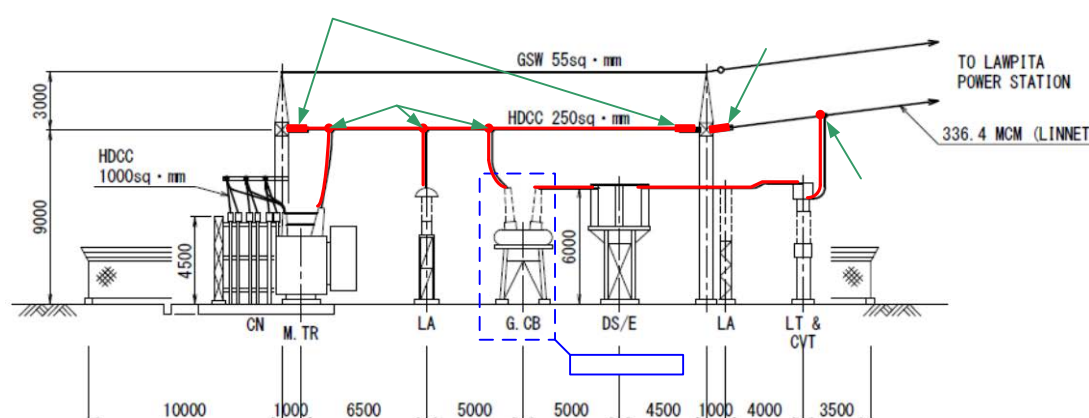
Fig. 7.3-2 Replacement Area for 132 kV Busbar in Baluchaung No.1 HPP

132 kV busbar conductor, related insulator strings and accessories such as cable clamps and connection wire, etc. shall be replaced to new one due to the aged deterioration. The conductor size of 132 kV busbar will be replaced to HDCC 250 mm² same as the existing one. Replacement area for 132 kV busbar is shown as follows:
