ANNEXES

ANNEX 4

REHABILITATION OF TURBINE AND AUXILIARY EQUIPMENT

- (1) Check List (Baluchaung No.1 Hydropower Plant)
- (2) Check List (Sedawgyi Hydropower Plant)
- (3) Measurement on the Clearance of Mechanical Components (Baluchaung No.1 Hydropower Plant)
- (4) Measurement on the Clearance of Mechanical Components (Sedawgyi Hydropower Plant)

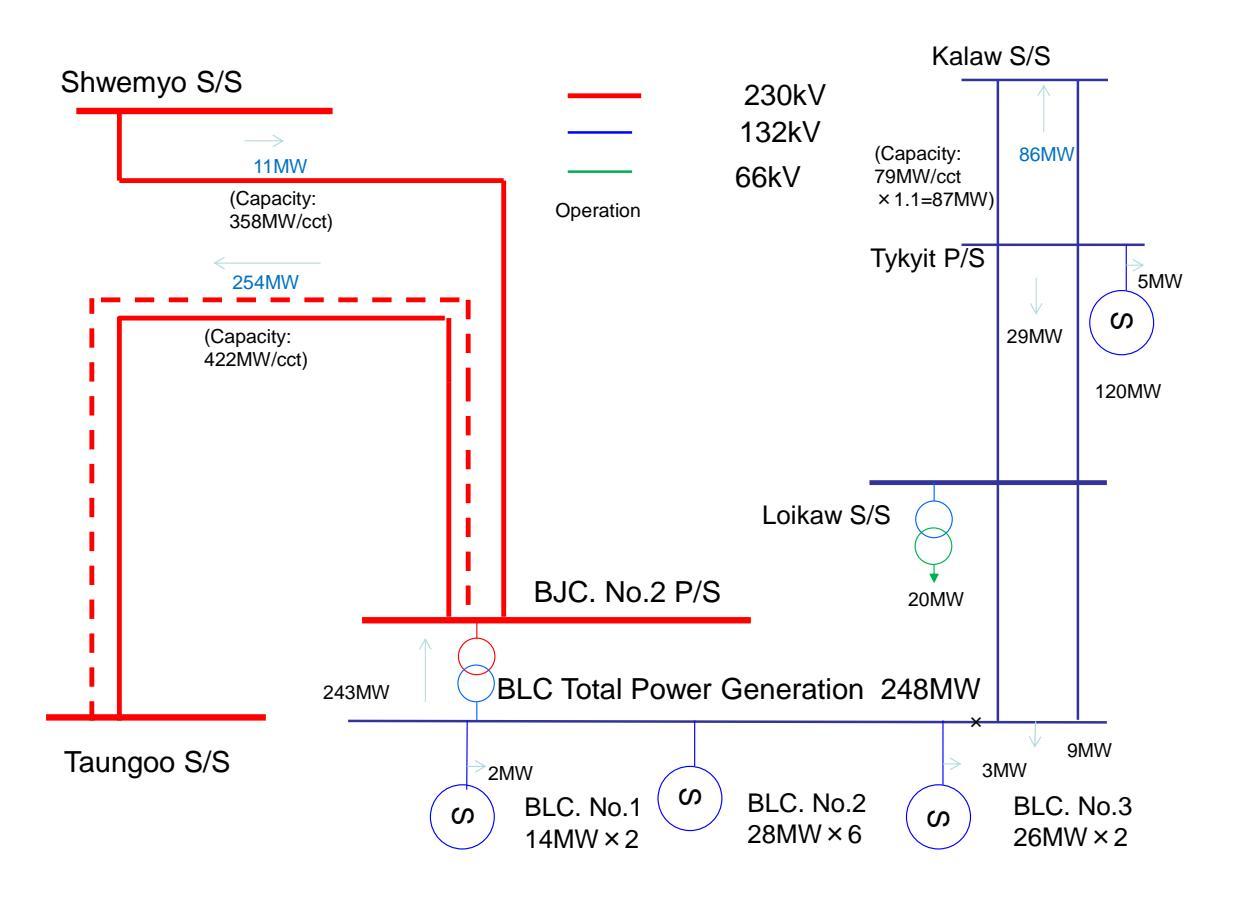
Fig. 11.2-1 Scenario A for Power System surrounding Baluchaung

In this scenario, the existing 230kV T/L (795MCM (Drake) single bundle, single circuit, 154.5km) is scrapped and new 230kV T/L (795MCM (Drake) double bundle, double circuit, 159km) for new 500kV Taungoo S/S is built. The new T/L route is almost same as the existing T/L route, so land acquisition issue is few. And the generation power of Baluchang P/S is directly transmitted to Yangon area via Taungoo S/S, so the power system loss is decreased.

But along the 230kV T/L route for Taungoo S/S, the issue of land mine exists. In the interview with PTP (Department of Power Transmission Project) in MEPE, the existing T/L for Taungoo S/S has the tower fences in which land mines are buried for defense the towers from the destroyers. In order to scrap and built the T/L for Taungoo S/S, it is necessary to survey and eliminate the land mines by support of Ministry of Defense. But peace agreement should be done before that, so just now it is very difficult to proceed Scenario A.

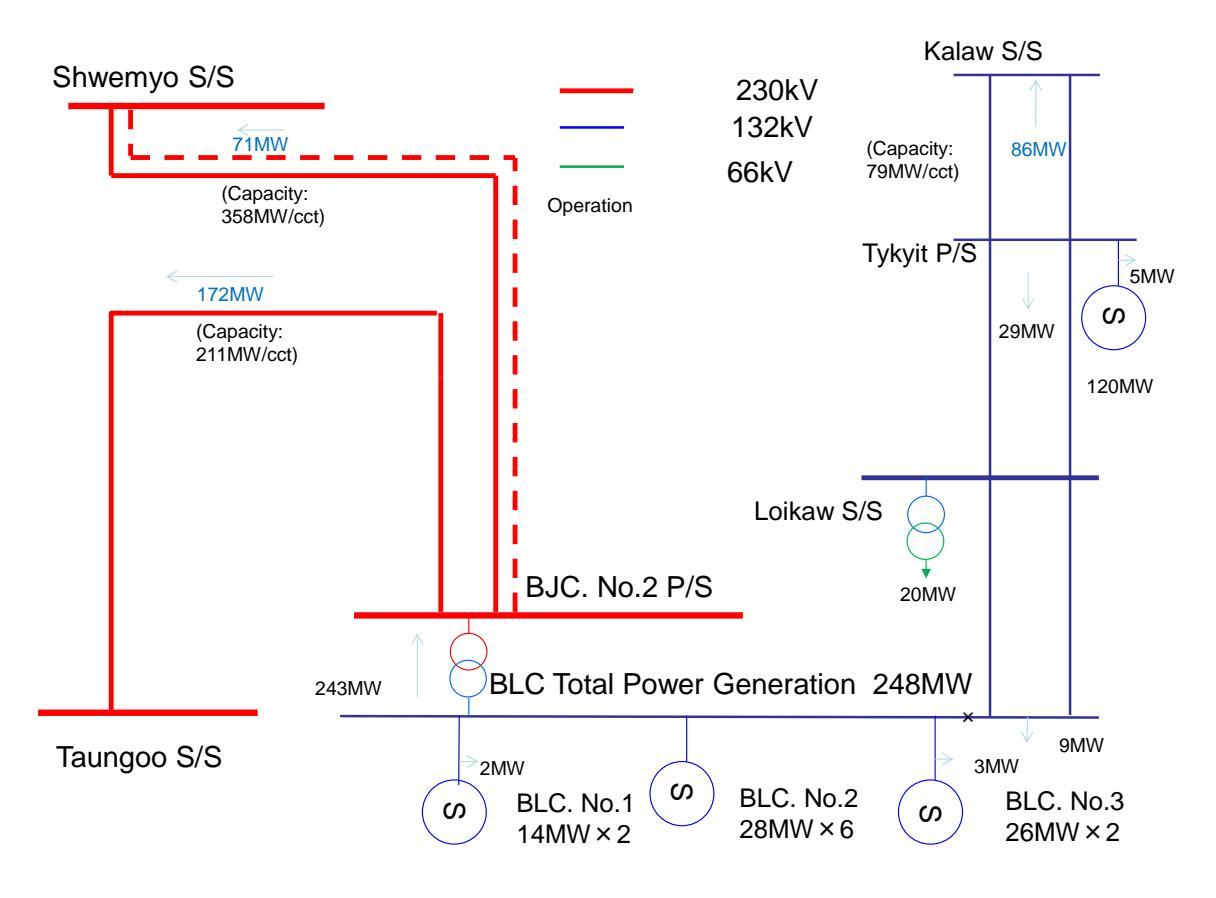
Fig.11.2-2 Scenario B for Power System surrounding Baluchaung

In this scenario, the expansion 230kV T/L (605MCM (Duck) double bundle, single circuit, 193.1km) for Shwemyo S/S is built near the existing 230kV T/L (605MCM (Duck) double bundle, single circuit, 193.1km), which will start the operation soon in 2016. This scenario can avoid the issue of land mine such as Scenario A, but the length of the T/L is 34km longer than Scenario A and the generation power of Baluchaung P/S in transmitted to Yangon area via Shwemyo S/S, so the power system loss is more than Scenario A. Moreover, in the interview with MEPE, the existing T/L for Shwemyo S/S is the newest T/L, it is very difficult to propose another T/L for Shwemyo S/S just now.

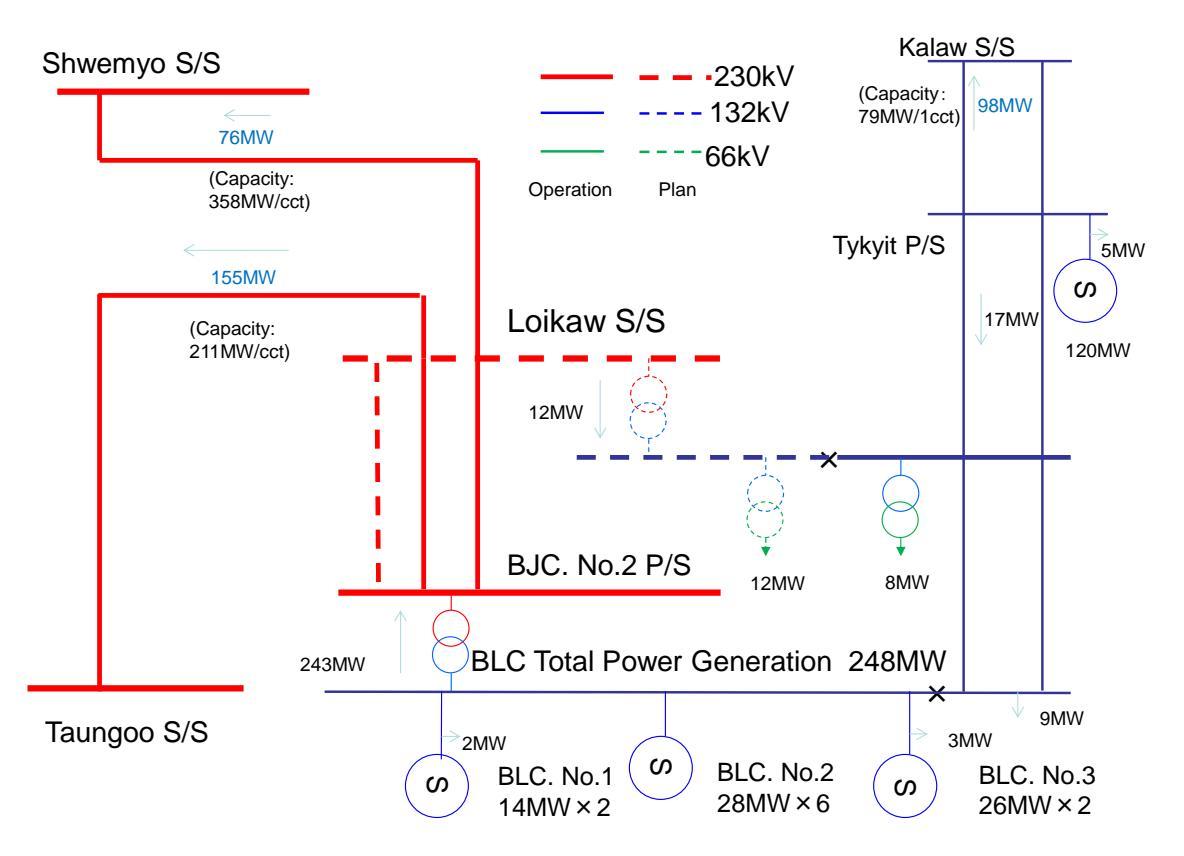
Fig. 11.2-3 Scenario C for Power System surrounding Baluchaung

In this Scenario, the existing 132kV Loikaw S/S, which is the nearest substation to Baluchaung P/S, is upgraded to 230kV substation, the existing 230kV T/L for Taungoo S/S and for Shwemyo are connected to upgraded 230kV Loikaw S/S, and one more 230kV T/L around 20km length between Baluchaung No.2 P/S and Loikow P/S, is built.

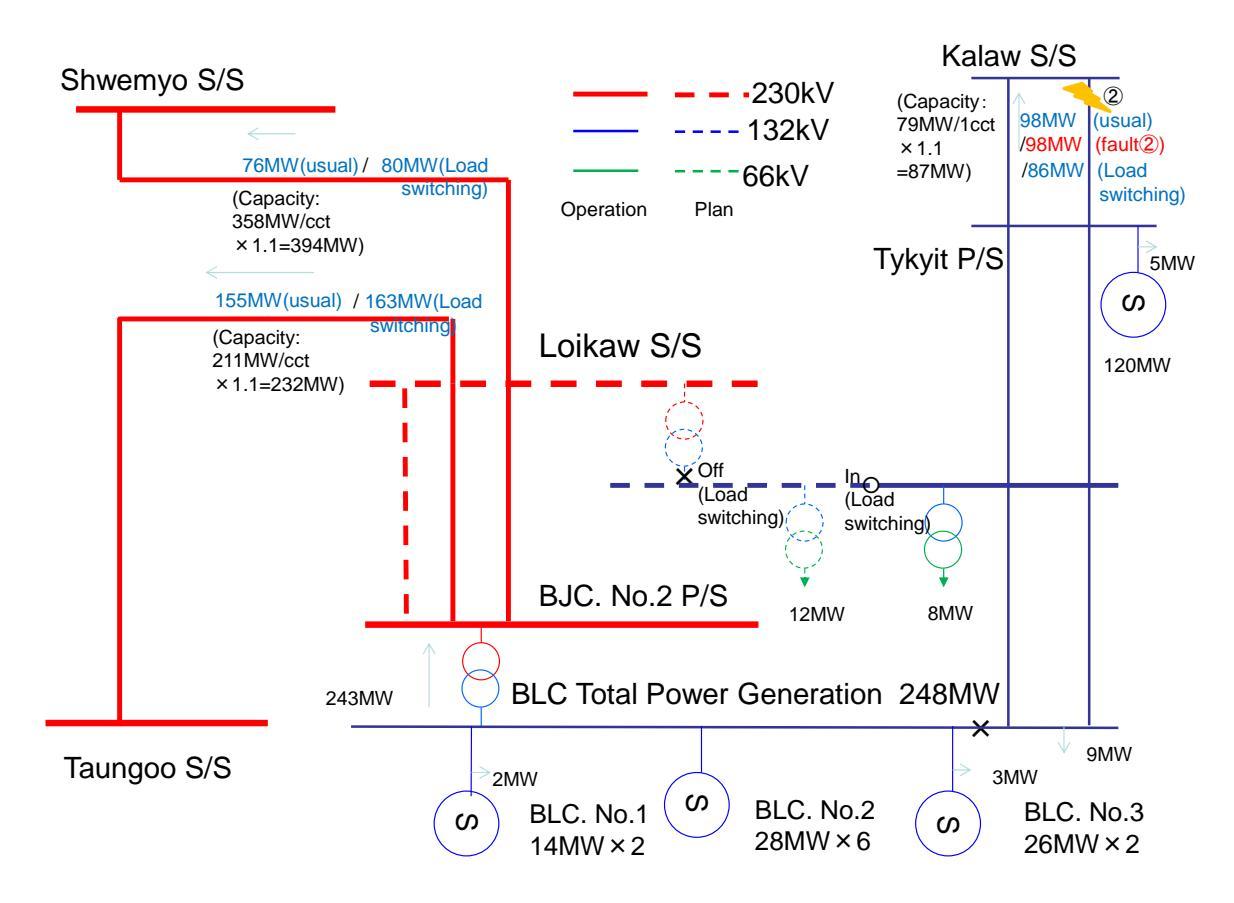
Fig. 11.2-5 Effect 2 on Scenario C

On the other hand, when one 132kV T/L between Tykyit P/S and Kalaw S/S is tripped by fault, the power flow 98MW of the other 132kV T/L between Tykyit P/S and Kalaw S/S is over the transmission capacity 87MW at the time point of the fault. But by switching the part of Loikaw S/S load 12MW to Tykyit P/S system side, the power flow 86MW is under the transmission capacity 87MW (Effect 2).

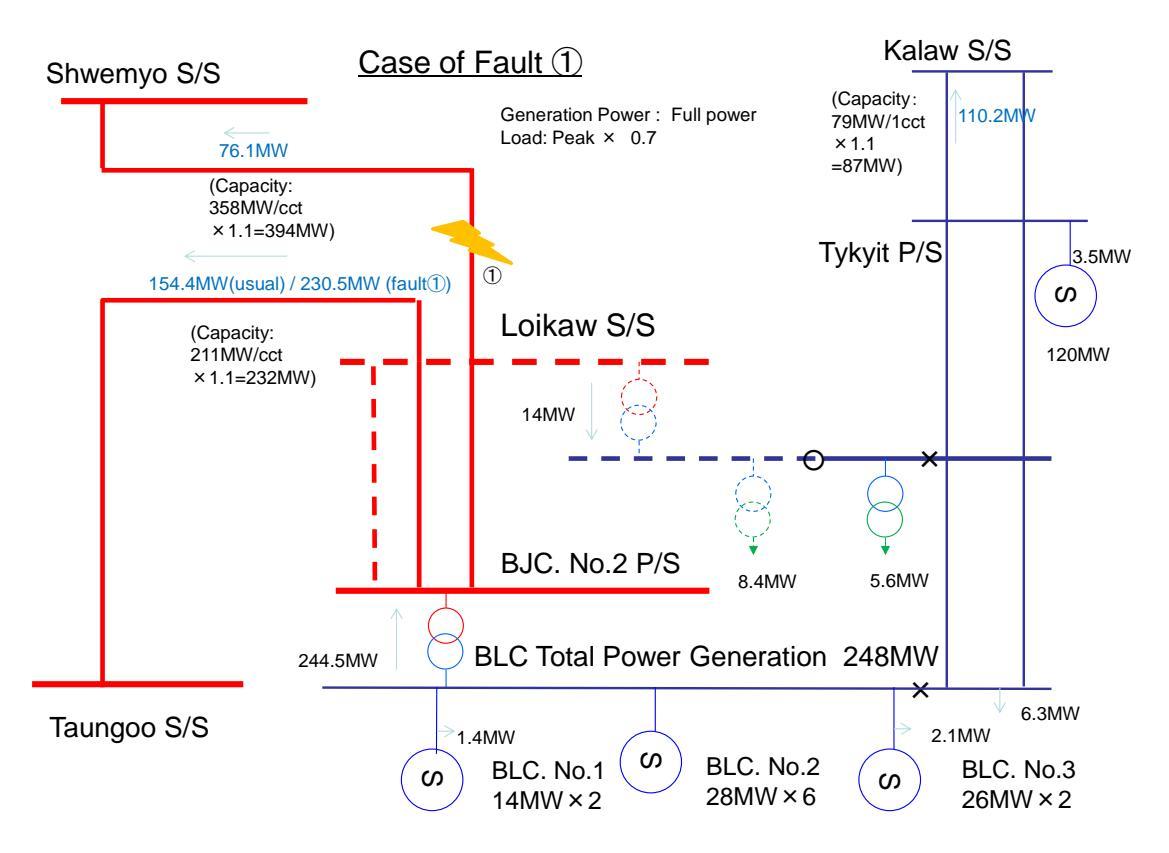
Fig. 11.2-8 Off Peak Power Flow 1 (at night in dry season of May) in Scenario C

In Scenario C, when the 230kV T/L between Loikaw S/S and Shwemyo S/S is tripped by fault, the power flow 230.5MW of the 230kV T/L between Loikaw S/S and Taungoo S/S is under the transmission capacity 232MW (Fig.11.2-8).

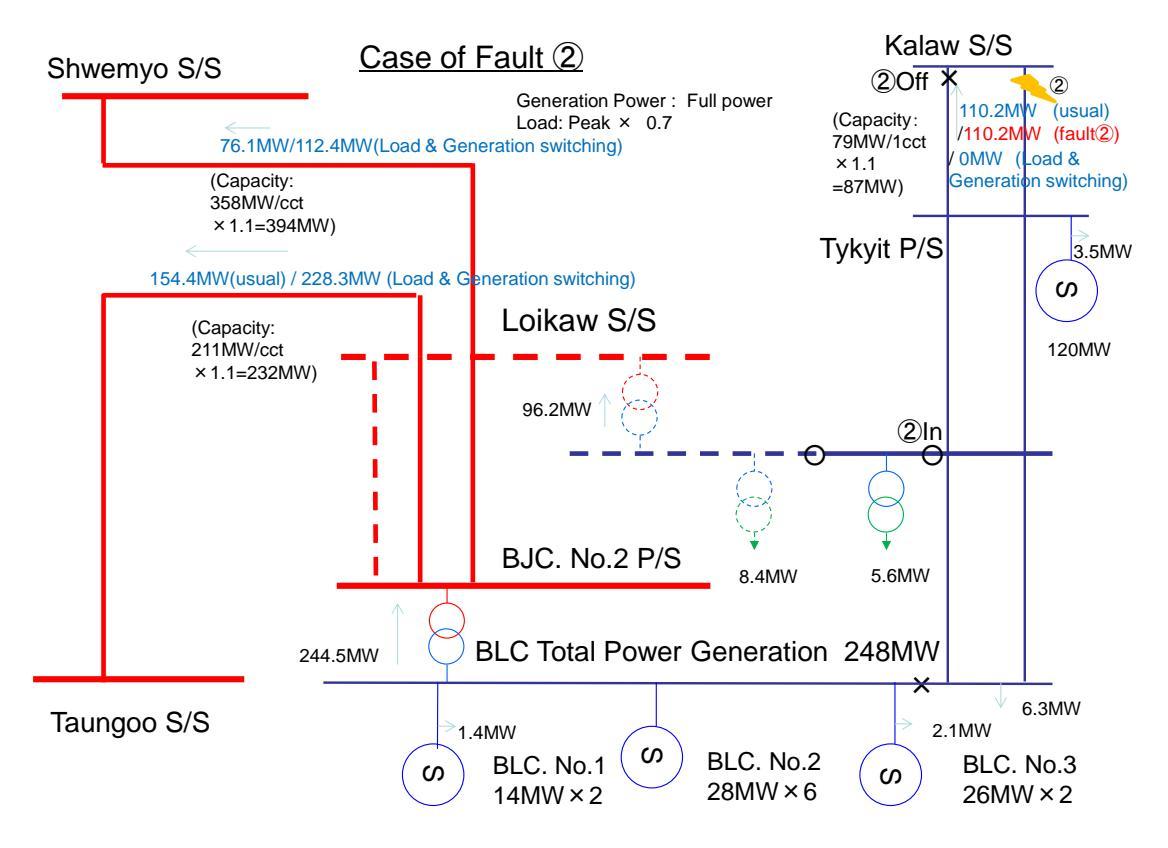
Fig. 11.2-9 Off Peak Power Flow 2 (at night in dry season of May) in Scenario C

On the other hand, when one 132kV T/L between Tykyit P/S and Kalaw S/S is tripped by fault, the power flow 110.2MW of the other 132kV T/L between Tykyit P/S and Kalaw S/S is over the transmission capacity 87MW. But by switching the generation power of Tykyit P/S to 230kV power system side via Loikaw S/S, there is no bottle neck T/L (Fig.11.2-9).

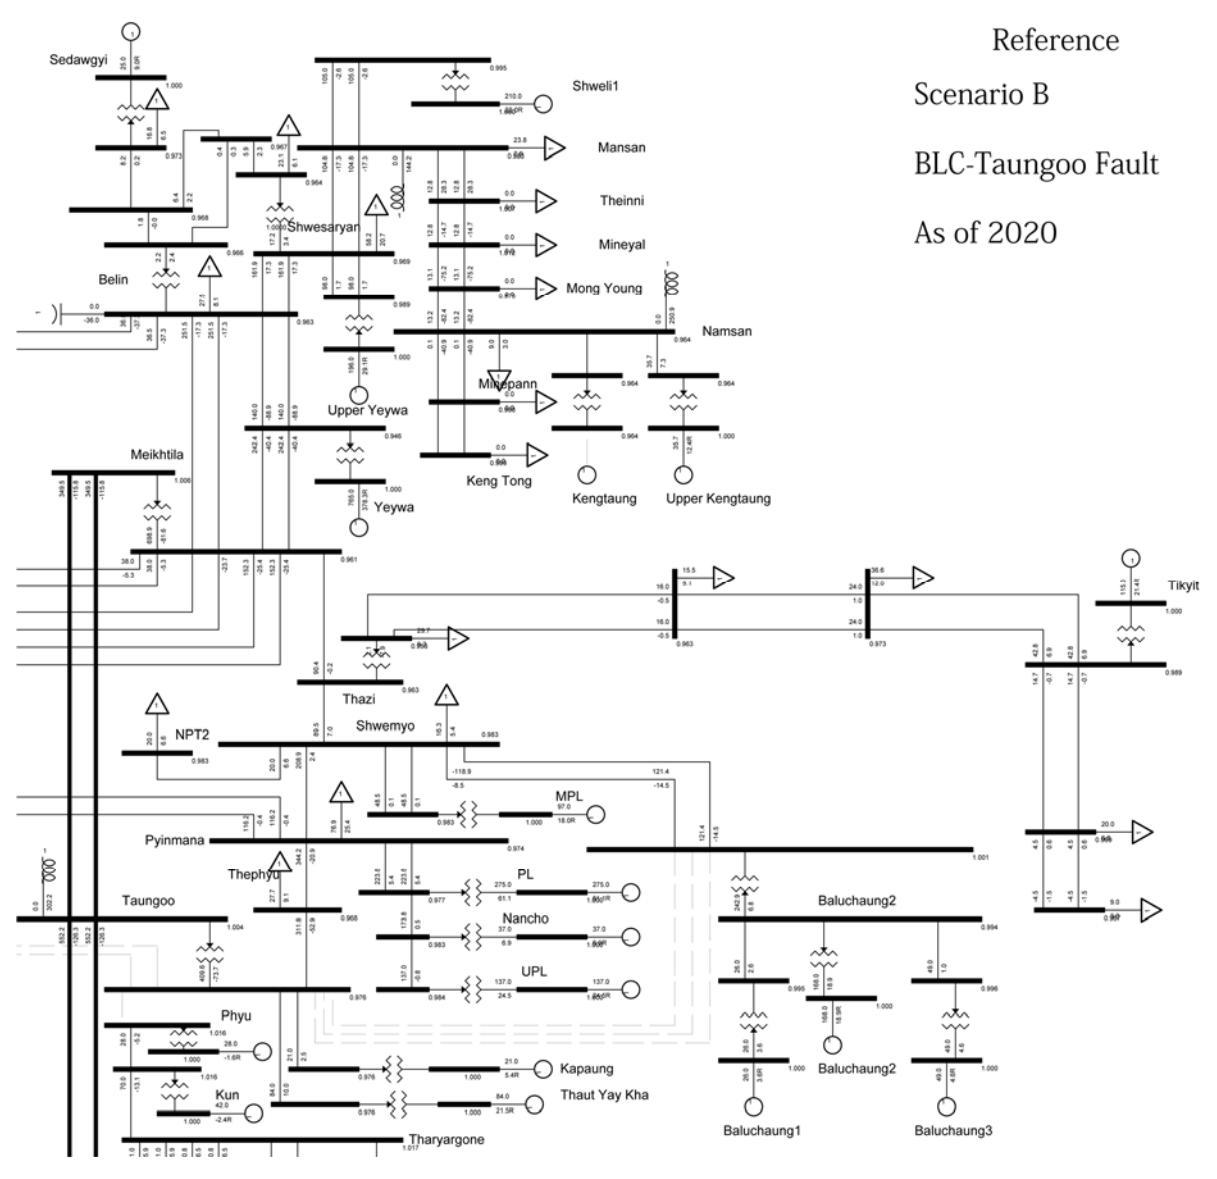
Fig.11.3-4 Power Flow in Scenario B: Baluchaung - Tangoo Fault as of 2020

For reference, power flow of Scenario B in the case of the 230kV T/L fault between Baluchaung No.2 P/S and Taungoo S/S is shown in Fig.11.3-4, where the generation power of Baluchaung P/S is transmitted to Yangon area via Shwemyo S/S and the power flow situation is very strict in total power system, but there is no bottleneck T/L.

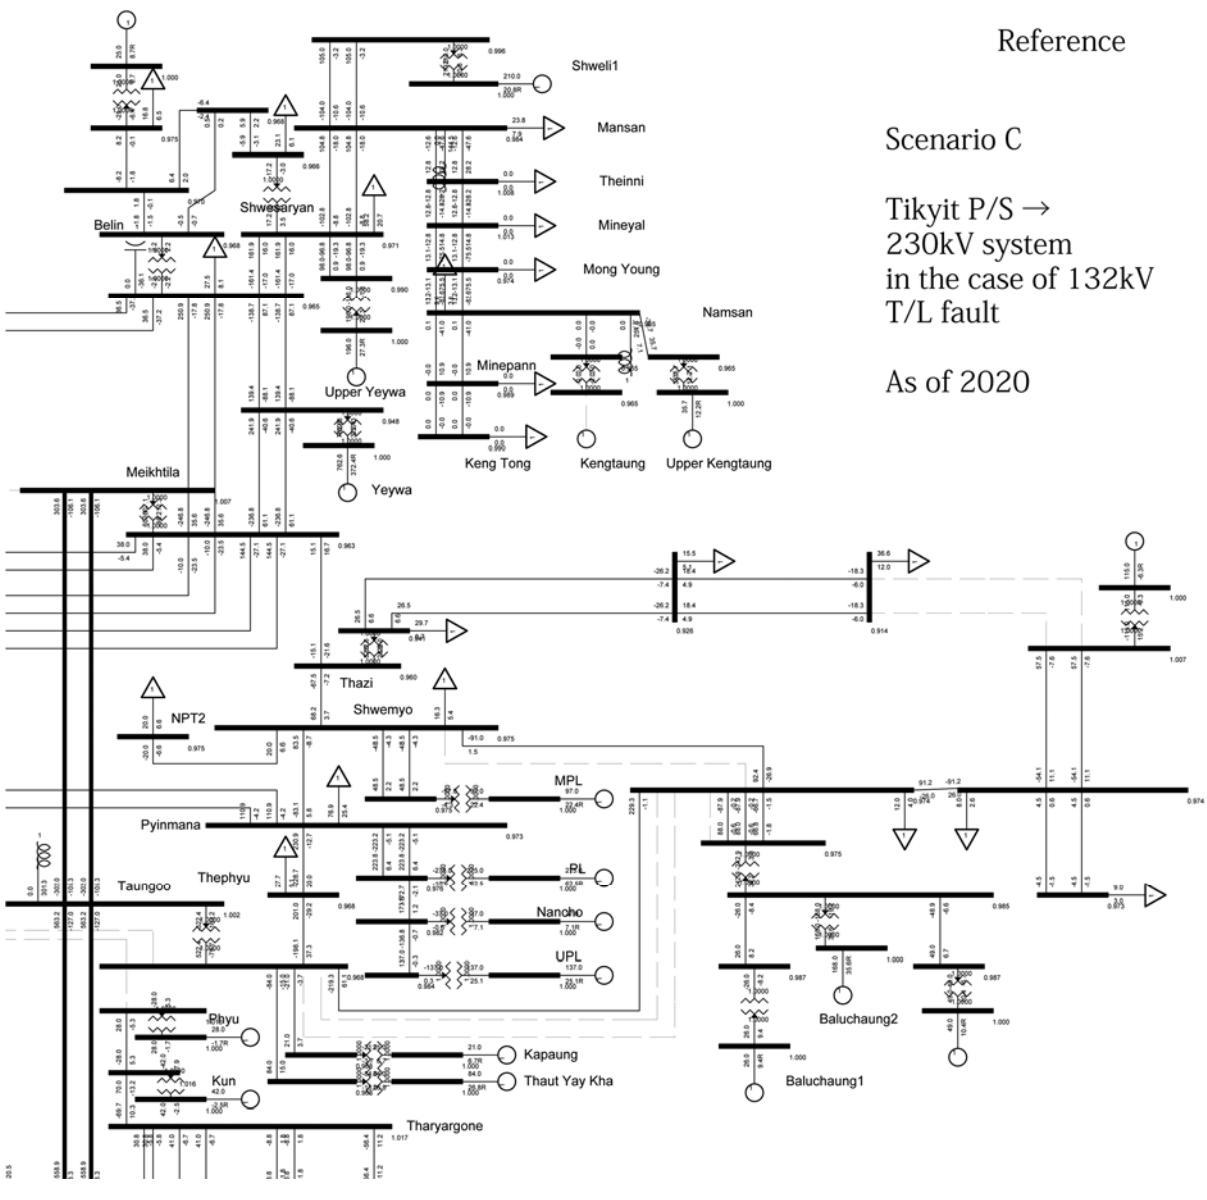
Fig.11.3-5 Power Flow in Scenario C: 132kV T/L Fault as of 2020

For more reference, power flow of Scenario C in case of one 132kV T/L fault between Tykyit P/S and Kalaw S/S is shown in Fig.11.3-5, where the generation power of Tykyit P/S is transmitted to 230kV system via Loikaw S/S and there is no issue in the view point of power flow.
