Original Data Sheet by  
RGSB  
in Beni-Suef

**Data Sheet for the minor Structure**      **From 1/ For intake,**  
**Regulator, Tail escape**

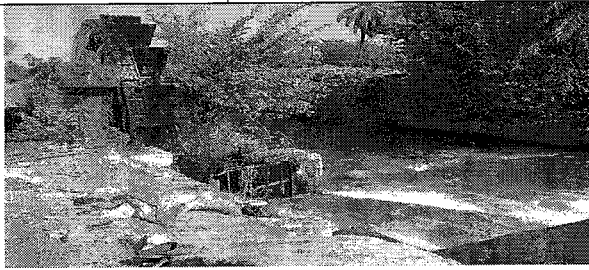
3) Crest L(m)	21.54	4) Crest Width (m)	8.078
5) max.Water L (m)	22.08	6) Bed level d.s (m)	19.65
7) Structure condition / Excellent , Good , Bad , Already Expire			Bad
