CHAPTER 5 REPAIR OF CONCRETE STRUCTURE

5.1 Planning of Concrete structure repair

5.2 Case of Concrete structure repair

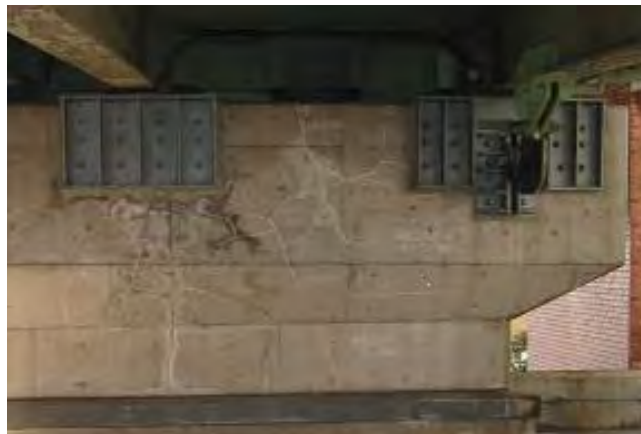
Photo 5.2.1.1 Concrete crack on pier

There are alligator cracks or multiple numbers of linear cracks on the sides of concrete piers, and their width is more than 0.3mm (Photo 5.2.1.1). If this situation remains untreated, corrosion of reinforcements is in danger of progressing. As a result, spalling and decrease of concrete strength might occur in the future (Fig. 5.2.1.1).

Though there are some possible causes of the damage such as dry shrinkage during construction, it is difficult to identify to the one.

However, since many similar cracks exist in multiple directions and locations, the excessive external load from overloading vehicles can be excluded.

Concrete cracks are filled with epoxy resin injection (**Photo 5.2.1.2**).

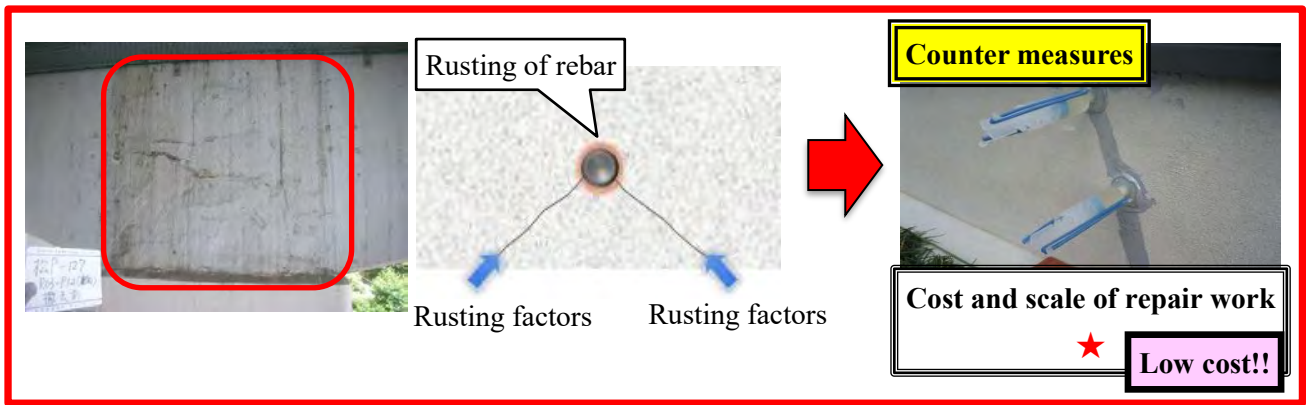
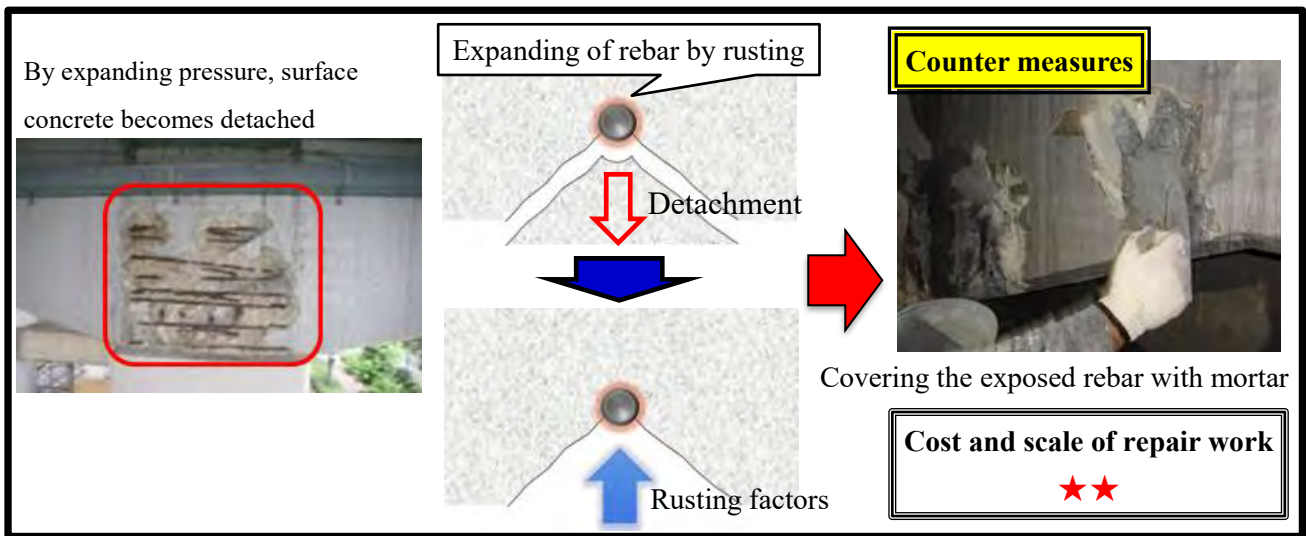
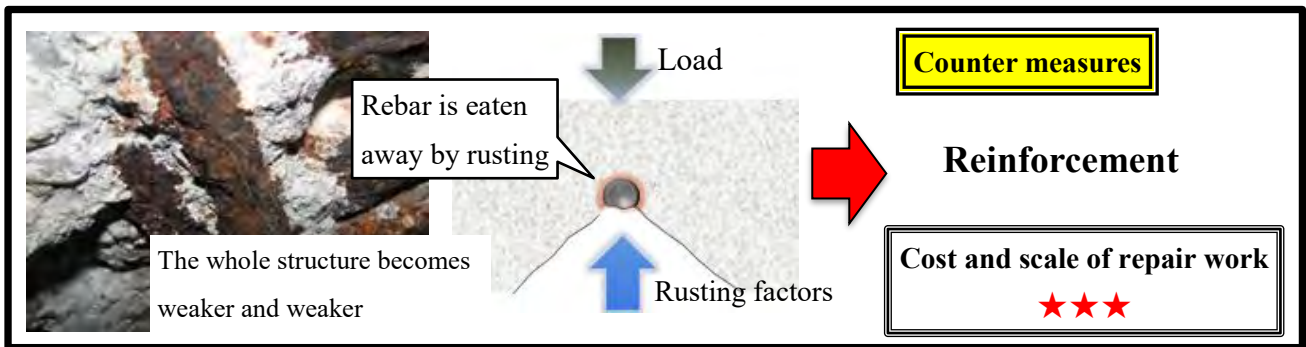
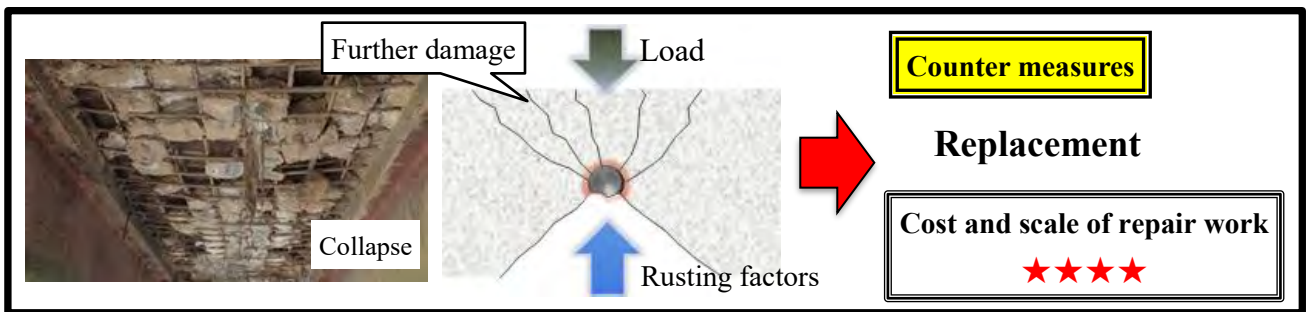
Fig. 5.2.1.3 Progress of concrete crack

The cost of resin injection method for concrete crack repairing is relatively less expensive than other method (**Fig 5.2.1.3**). In case that the cause of the concrete cracks is not caused by external loading, repair budget is saved in the long run by this simple and reasonable method while the degree of cracks remains small.

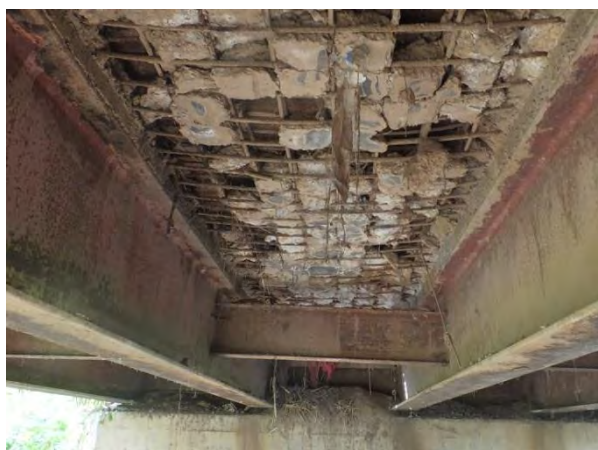
Photo 5.2.2.5 Collapsing bridge

There are numbers of cracks on the slab, and their width is more than 0.6mm. If this situation remains untreated, this crack will progress. As a result, spalling and decrease of concrete strength might occur and this bridge will collapse in the future (**Photo 5.2.2.5**).

It is a possibility of fatigue crack by overloading from the following reasons.

- These cracks occur in transverse direction.
- When overloaded vehicles pass, the vibration of the slab is large.
- There are many cracks near axle of vehicle.

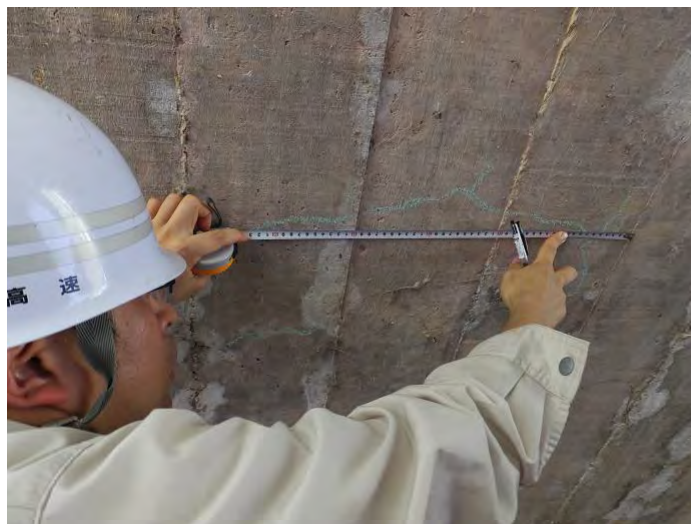
Photo 5.2.2.6 Measure the reinforcing range

In addition, by hammering inspection, we check detached sections and remove them. We measure the reinforcing range and record it on the expansion plan. (Photo 5.2.2.6)

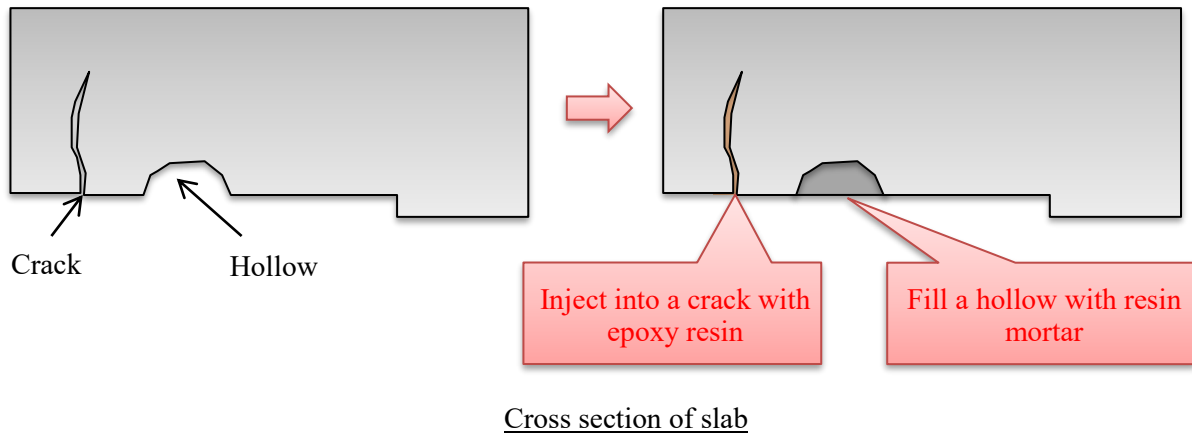
Fig. 5.2.2.2 Crack and hollow repair

The oversight of hollows and cracks causes bad bonding.

Therefore if there is lacking parts and the hollows in concrete, it must be repair by resin mortar. And if there is crack wider than 0.3mm, it must be repair by epoxy resin (Fig. 5.2.2.2, Photo 5.2.2.7).

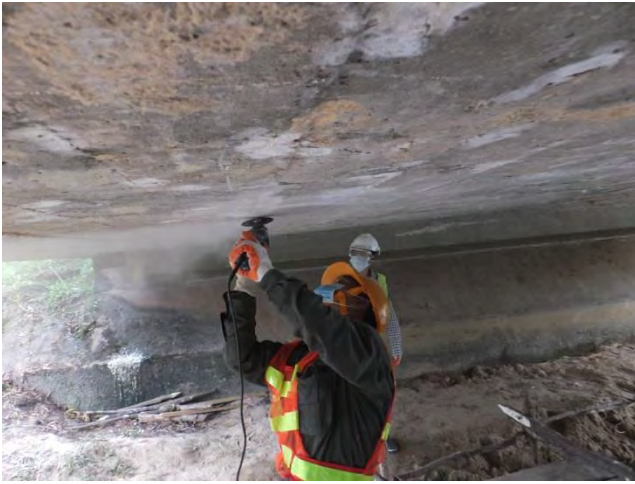
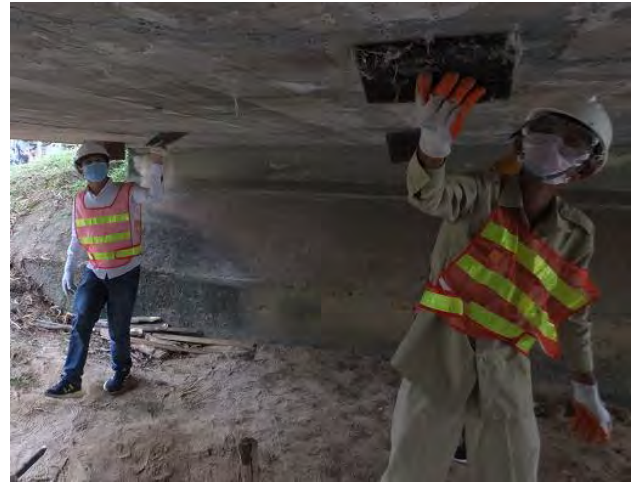
Photo 5.2.2.8 Surface Preparation

Surface difference in level or edge of the corner causes bad bonding and break of carbon fiber.

Therefore, surface difference is flattened on the concrete surface by disk grinder (**Photo 5.2.2.8(a)**) (less than 1mm difference in level) or put resin mortar (larger than 30mm in radius).

And such as mortar, oil and dust are removed to expose the sound concrete by a disk grinder or a wire brush and a polishing scrubbing (**Photo 5.2.2.8(b)**).

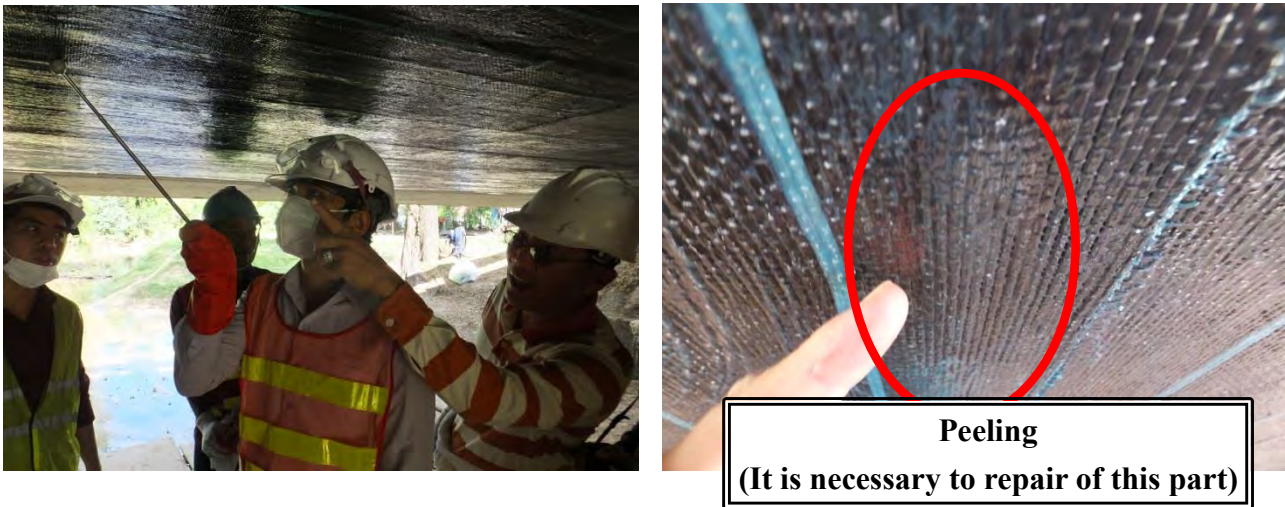
Photo 5.2.2.34 Confirmation of pushing out air bubbles

Before applying impregnating resin of 2nd CFC layer, it is needed to confirm of pushing out air bubbles of 1st CFC layer (**Photo 5.2.2.34**).

If the peeling is found, it is necessary to repair of this part < Reference: 4-2 >.

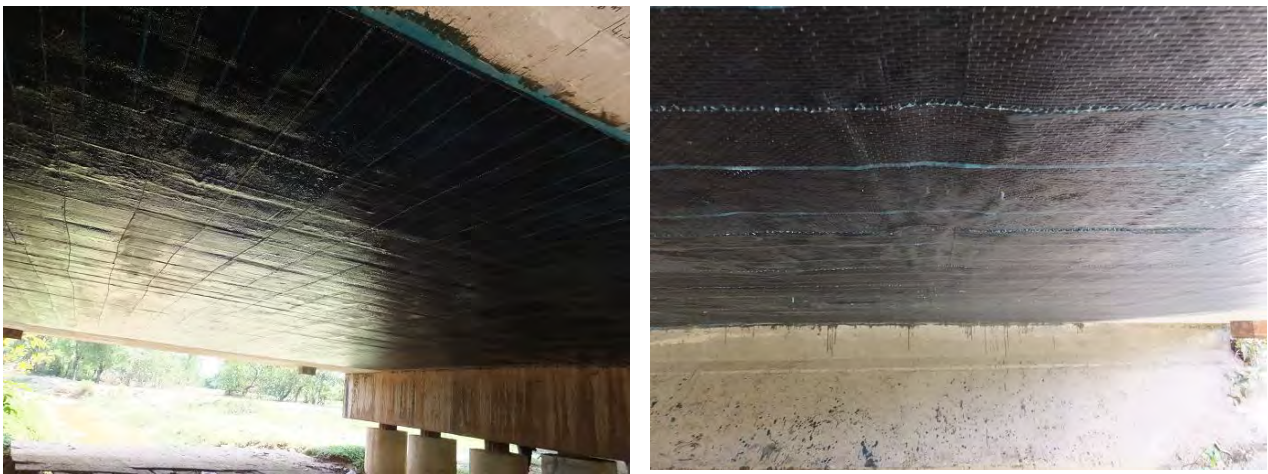
Photo 5.2.2.38 Completion

The completion status of this repair method is shown to **Photo 5.2.2.38**.

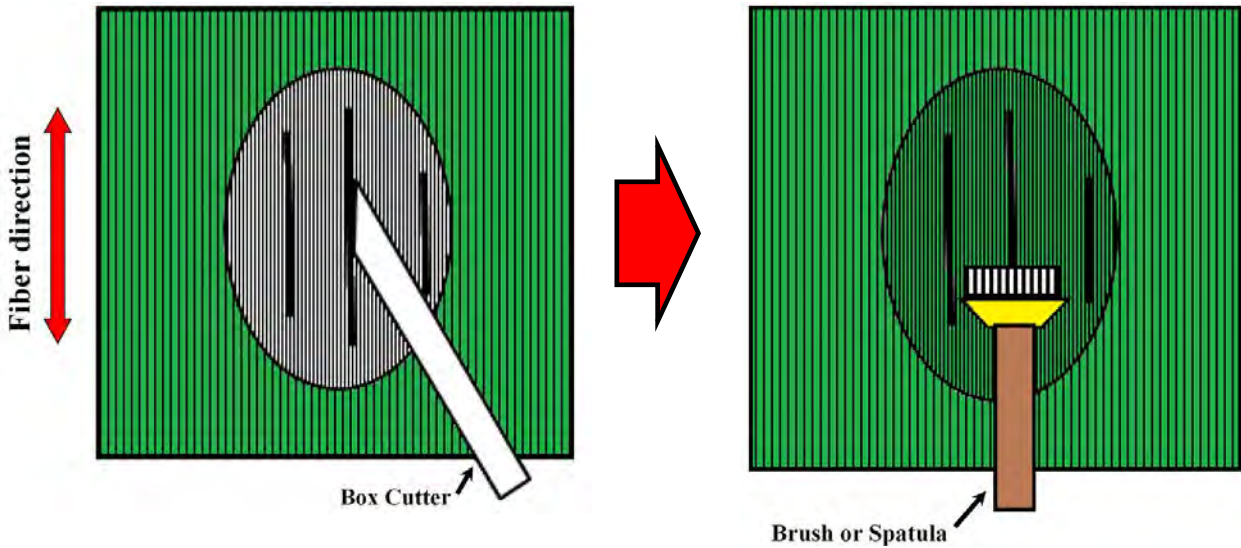
Fig 5.2.2.15 Repairing at the initial curing

If the peeling of CFC is found out after completion of reinforcement work, it should be repaired partially.

a) Repairing at the initial curing (Fig 5.2.2.15)

- 1) It is cut several locations into the fiber direction on the surface by using box cutter.
- 2) 'Impregnating resin' is applied from the surface by using a brush or spatula.

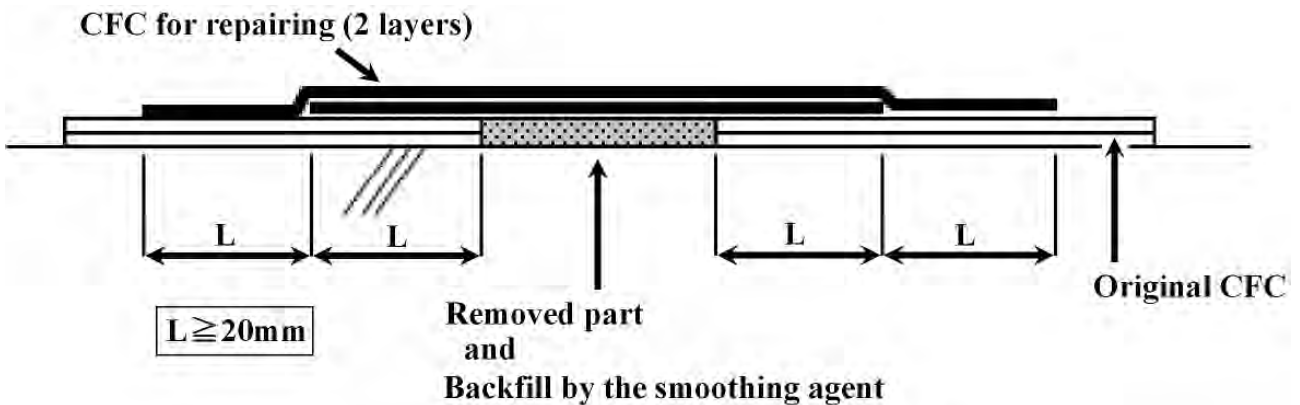
Fig 5.2.2.16 Repairing at the initial curing

If the peeling of CFC is found out after completely cured, it should be cut open and patched.

b) Repairing after completely cured (Fig 5.2.2.16)

- 1) The failure part is removed carefully.
- 2) It is backfilled by the smoothing agent.
- 3) CFC patch is overlapped with impregnation resin. (CFC patch is same number of layer as the original CFC)

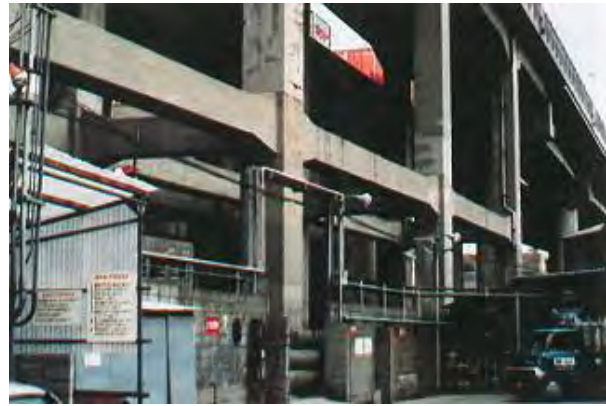
Photo 5.2.3.1 General view of damaged part

Concrete pieces were damaged to exfoliate from the column of rigid frame (**Photo 5.2.3.1**).

The pier columns were made much higher than other columns to cross over the elevated railroad. It is speculated, in such a height, that conditions caused improper concrete placement, coarse aggregate segregation, and insufficient compaction.

Corrosion on RE-bars initiated because of the existence of honeycomb in concrete, insufficient thickness of covering concrete where cracks generate, ingress of rainwater. Such corrosion is understood to have caused the exfoliation and dropping of concrete.

In heavily exfoliated area, the honeycomb repairs with mortar had been experienced. Some of these repair patches caused exfoliation probably due to difference in material properties or vibration.

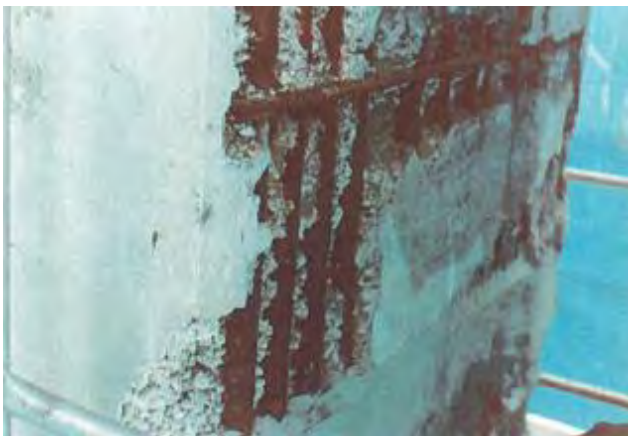
Photo 5.2.3.2 Concrete flake-off

Through the hammer-tapping off the damaged concrete, corrosion on the RE-bars and rust float were observed along the hoop (**Photo 5.2.3.2** and **Photo 5.2.3.3**).

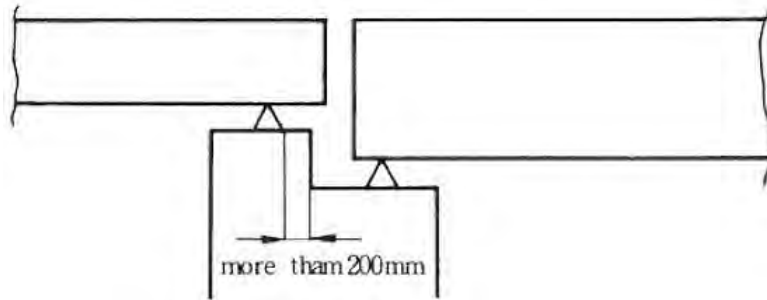
Fig. 5.2.4.2 Required seat length

(3) The current design standard requires the seat length not to be less than 200mm for the staggered beam (Fig.5.2.4.2). In this condition, the staggered beam exhibits strong enough against the shearing force.

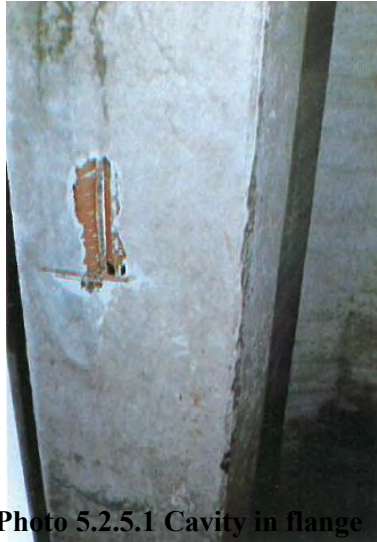
PC girder (Post-tensioned or Pre-stressed Concrete) was found to have cavity at a mid-span part in a lower flange (**Photo 5.2.5.1**). The hammer-tapping around the cavity broke off the concrete cover in about 30cm×100cm area exposed sheaths (**Photo 5.2.5.2**).

Photo 5.2.5.1 Cavity in flange

The damaged area and its surroundings had concrete paste. The possible cause was understood as insufficient compaction of concrete and lack of cover concrete thickness for the sheaths.

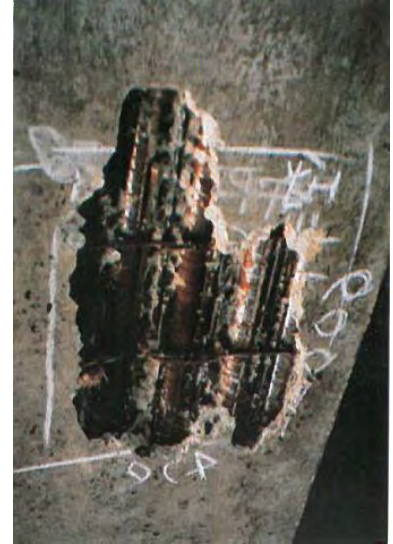
Photo 5.2.5.2 Condition after
hammer-tapping

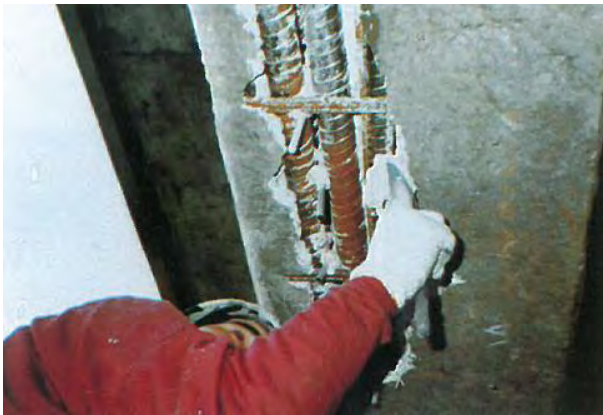
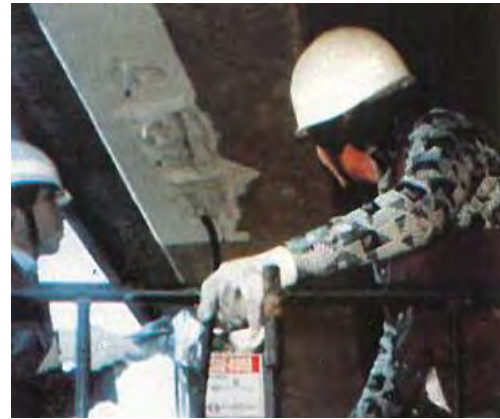
Photo 5.2.5.3 Damage repair

The repair was performed without traffic suspension, and it was structurally doubtful if such repair was applied for pre-stressed concrete. In this case, insufficient fabrication workmanship of the main girder caused the defect. From now on, therefore, it is required to be much more careful for the sheaths arrangement and concrete quality control, especially of compaction, of the girder fabrication.

Repair was carried out first by hammering and removing the damaged concrete, then by placing a putty sealant, and lastly by filling the cavity with epoxy resin mortar (**Photo 5.2.5.3**).

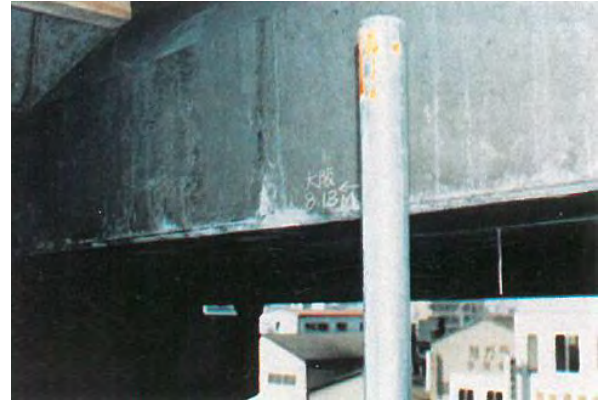
Efflorescence flowed out from the lower flange at a mid-span of the posttensioned pre-stressed concrete girder, its deposit hanging like icicles from the lower flange (**Photo 5.2.6.1**).

Photo 5.2.6.1 Deposit of free hanging like icicles

(5) The cause for the damage was insufficient grouting work of sheath at the construction stage and subsequent rainwater.

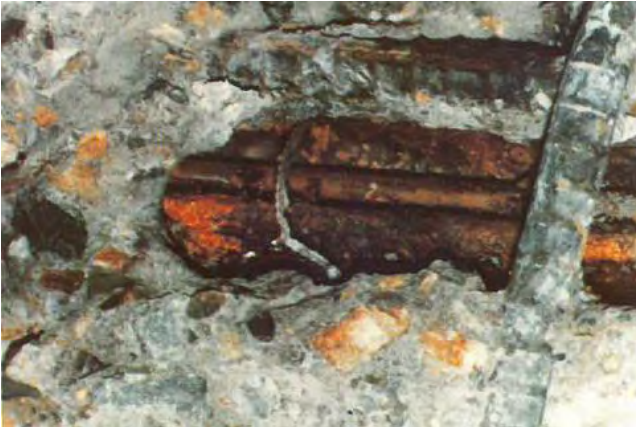
Photo 5.2.6.2 Steel wire exposed by hammering

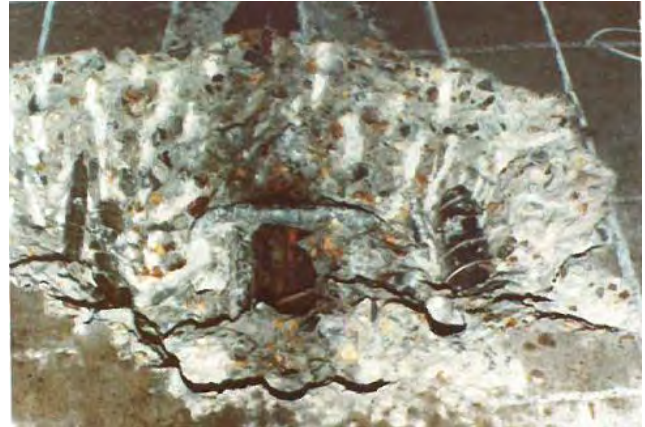
Photo 5.2.6.3 Lower flange after chipping-off

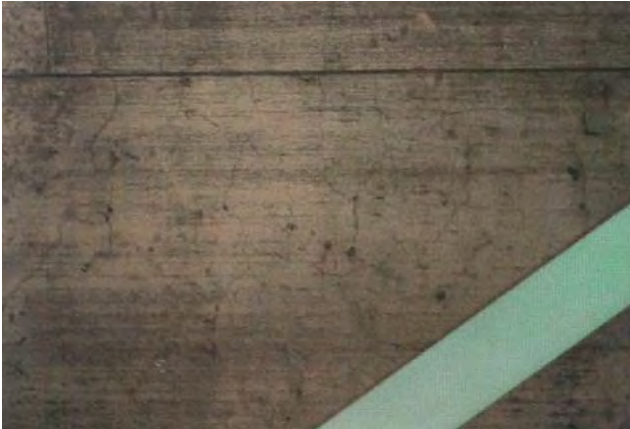
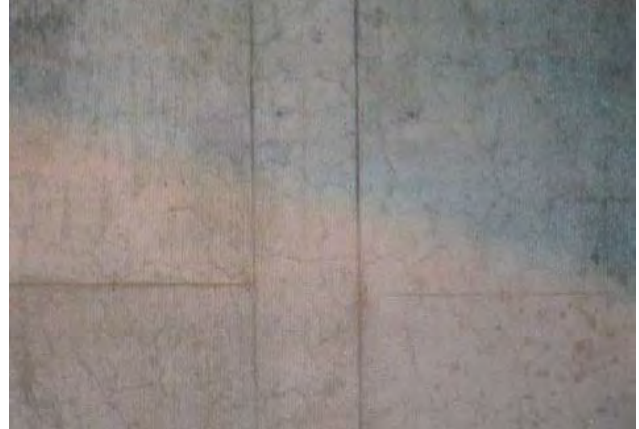
Honeycomb (or carapace shell) patterned cracking, 0.1mm-0.3mm, grew in the soffit of slab concrete (Photo 5.2.7.1 and Fig. 5.2.7.1).

The cracks clustering area exhibited square pattern. From measurement, the cracking density was $7.5\text{mm}^2\text{-}10\text{mm}^2$ (Table 5.2.7.1).

Photo 5.2.7.1 Crack on the slab

According to the criteria of slab damage, the slab needs to be repaired through the reinforcement method to restore its function, and if possible enhancement of rigidity was preferred.

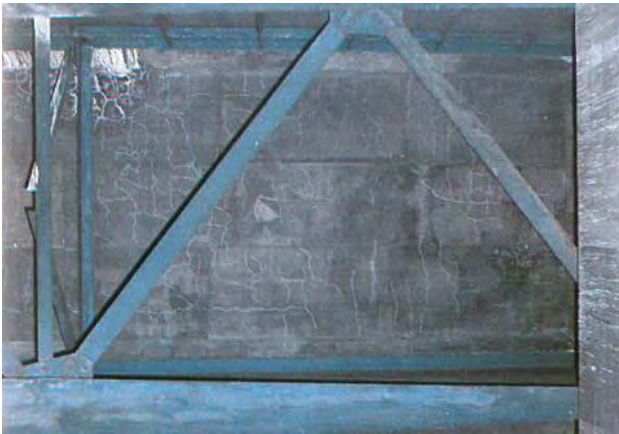
The concrete slab underside surface got cracked (**Photo 5.2.8.1**). In this damage, afterward, efflorescence flowed out from nearby slab haunch and the concrete spalled partially (**Photo 5.2.8.2**), inflicting distress on the pavement (**Photo 5.2.8.3**).

Photo 5.2.8.1 Crack on the slab

The regular periodical inspection in November 1980 revealed this damage, ranked as level A in damage degree (Photo 5.2.8.1). This damage, thereafter, developed to level AA by 31 August 1981 (Photo 5.2.8.2).

To avoid endangering the vehicles under such conditions, it was decided to suspend the traffic temporarily and to reconstruct the slab partially with reinforcement by the Epoxy Bonded Steel Plate Method.

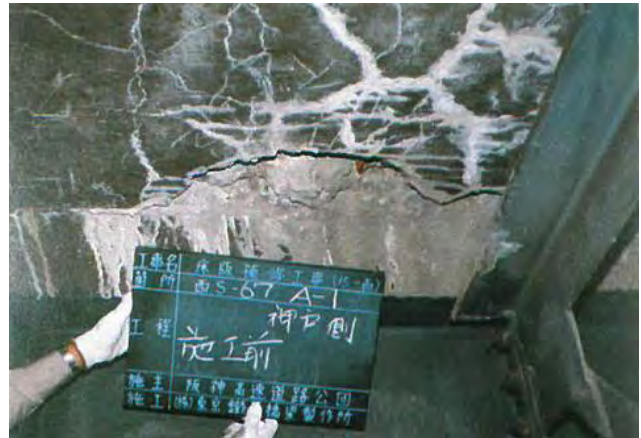
Photo 5.2.8.2 Concrete spall at the slab

Like this case, the crack-penetrated slab degraded at an unexpected speed. Inspection with appropriate “prediction” is important.

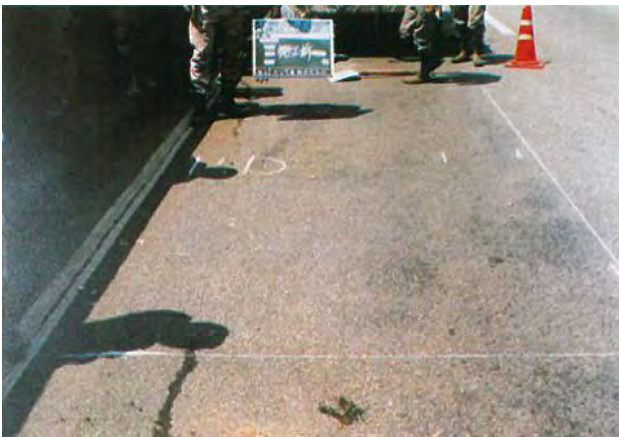
Photo 5.2.8.3 Pavement distress due to slab concrete damage

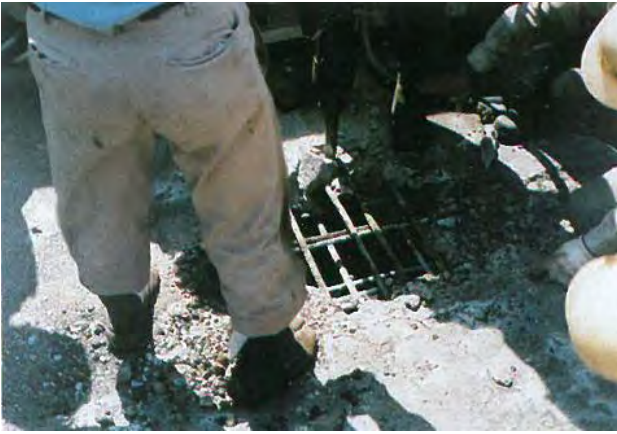
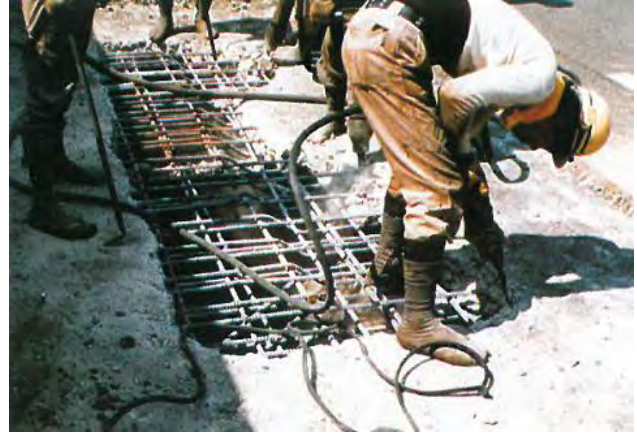
Photo 5.2.8.4 Slab concrete being chipped off

The heavily damaged portion had penetrated cracks. Lime liberated due to rain water ingress, deposited on the slab soffit, and caused aggregate spalling (**Photo 5.2.8.4**).

- (1) Convert epoxy bonded steel plate method to slab reconstruction formwork with additional reinforcement.
- (2) Decide and cut out the reconstruction area (**Photo 5.2.8.4**), removing the pavement, chipping off the heavily damaged concrete (**Photo 5.2.8.4**).
- (3) Reinforce sound portion with the epoxy bonded steel plate method. As for reconstructed portion, the steel plate with bent-up bars served dual-purposes (**Fig. 5.2.8.1**), serving as a form for concrete placement and as slab reinforcement.

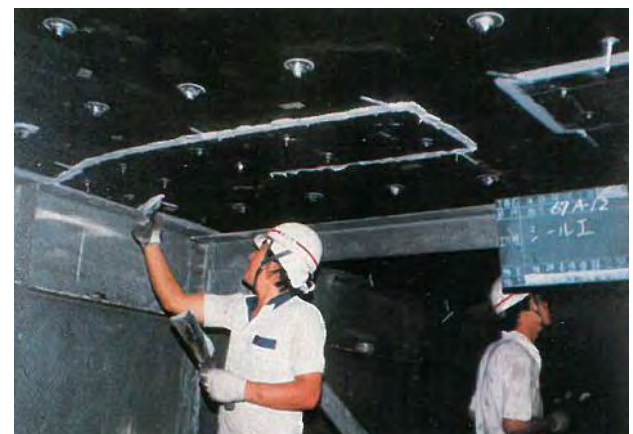
Photo 5.2.8.9 Injection pipes and sealing are installed

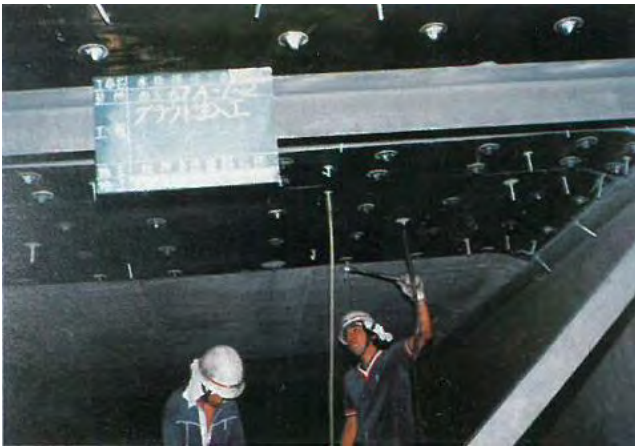
Photo 5.2.8.10 Resin injection

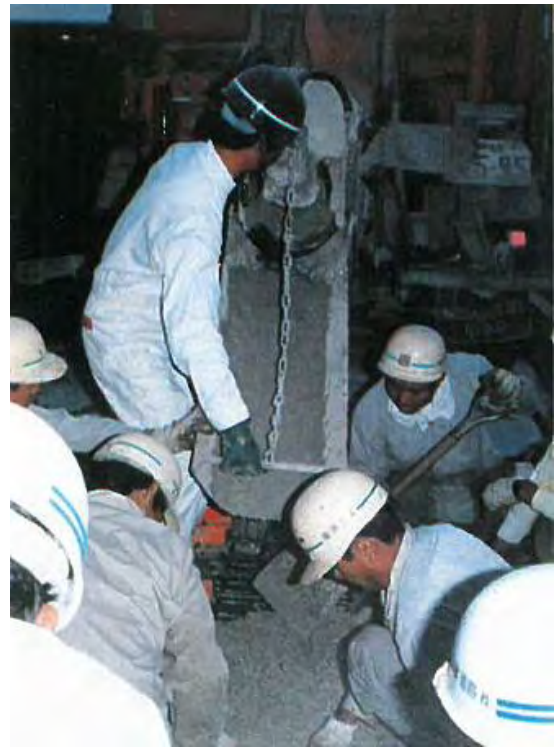
Photo 5.2.8.11 Placing concrete

- (4) Concrete with ultra-high-strength cement, using field mixing to place concrete (**Photo 5.2.8.11**).
- (5) To cure the placed concrete for about 4 hours, checking with the completed dimension (**Photo 5.2.8.12**).

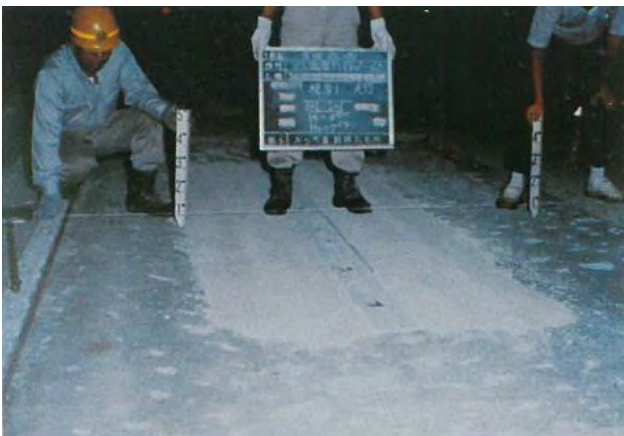
Photo 5.2.8.12 Checking re-concrete work

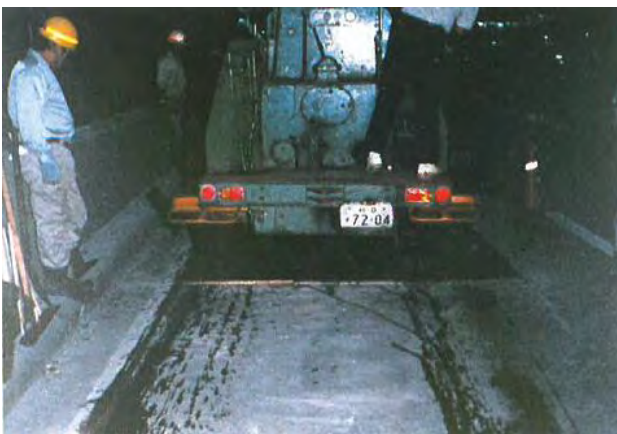
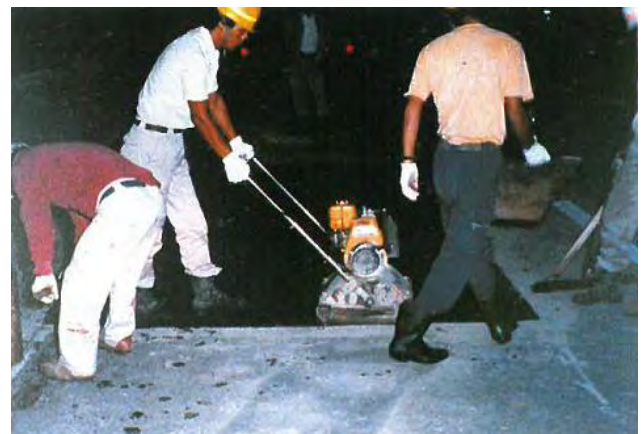
Photo 5.2.8.13 Pavement being placed and compacted

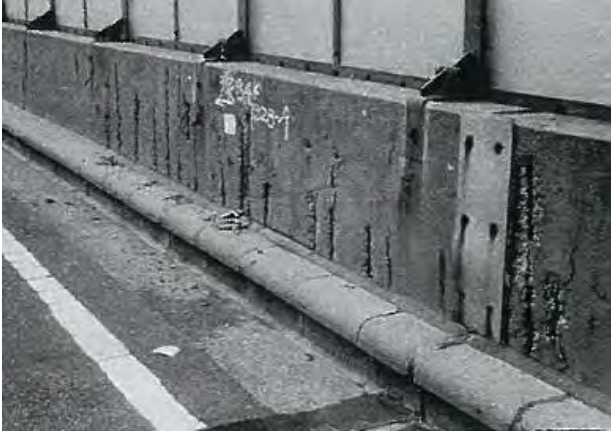
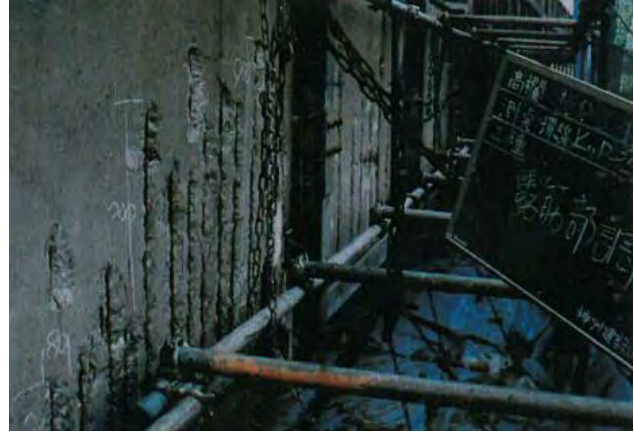
Photo 5.2.9.1 Damaged railing

D13 (Diameter 13mm) main reinforcement is used in concrete railing, got corroded and expanded out the cover concrete to spall at the main bar spacing (Photo 5.2.9.1).

The RE-bars arrangement in concrete railing is designed to have 30 mm distance between the bar center and concrete surface and to have 23.5mm clear cover. However, the actual construction is understood not to have designed value due to sorts of errors, etc. related to its construction work. From this, the carbon dioxide had the concrete neutralized, reinforcement bar corroded to expand and spall the concrete itself.

This type of damage took place in a wide area of the Expressway's existing railing.

The exposed RE-bars received the repairs by application of epoxy-resin-base coating and toweling (Photo 5.2.9.2), finishing by brushing and rolling of acrylic resin (Fig.5.2.9.1).

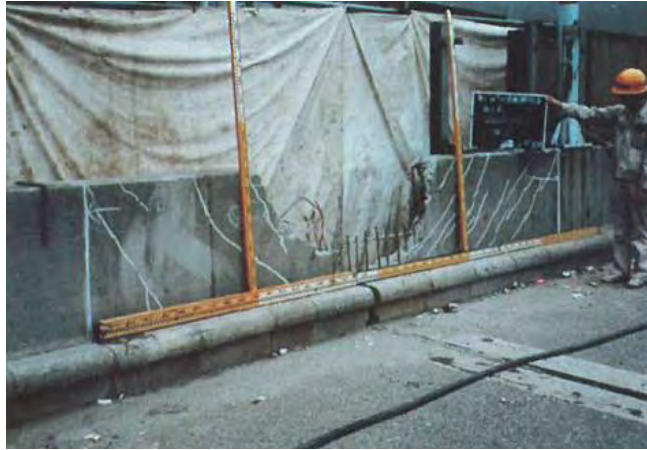
Four vehicles running on the overtaking lane hit on one after another. The tail-end cargo vehicle steered to the left and collided with the concrete railing at an acute angle.

The collision damaged the railing and its concrete fell (Photo 5.2.10.1).

Photo 5.2.10.1 Damage condition (Case 1)

The damage, broke through RC railing wall, caused falling of 1.7m concrete lump downward from the Expressway.

Although crack in the concrete railing spread over 4.45m in length, the concrete slabs underside surface was intact.

- 1) Chipping concrete of the damaged portion.
- 2) Repairing and assembly of reinforcement.
- 3) Placing of super quick strength concrete.
- 4) Installing of blocks.
- 5) Finishing of repair.

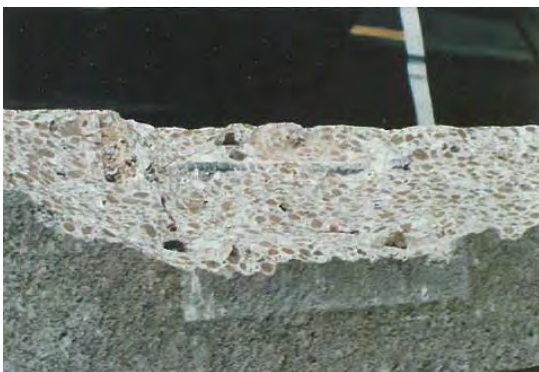
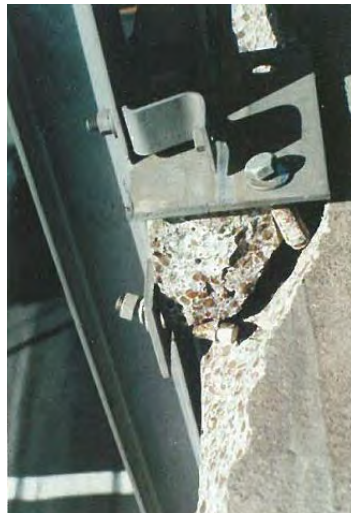
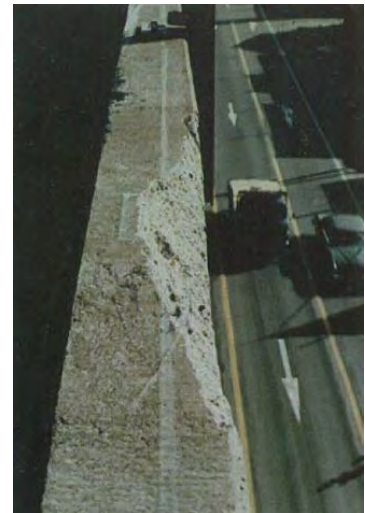
The lightweight concrete railing was damaged as if it were shaved with sharp cutlery (**Photo 5.2.10.6**).

Photo 5.2.10.6 Damage condition (Case 4)

- 1) Chipping concrete of the damaged portion.
- 2) Repairing and assembly of reinforcement.
- 3) Placing of super quick strength concrete.
- 4) Installing of curb blocks.
- 5) Finishing of repair.

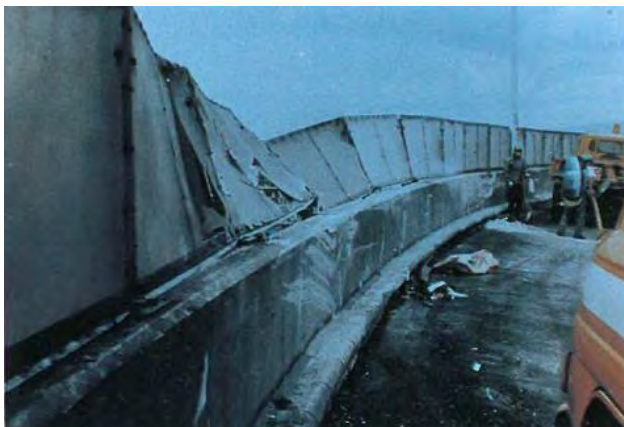
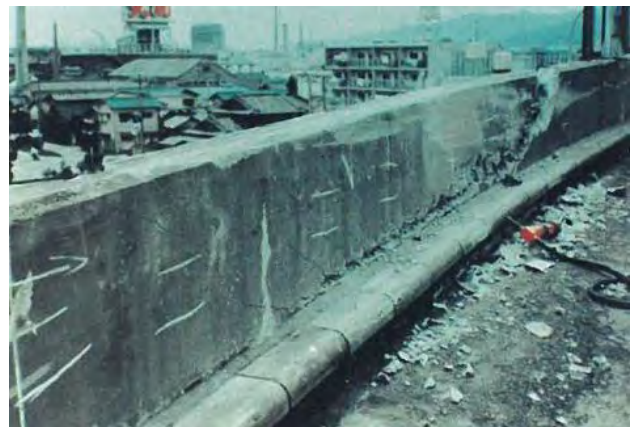
Due to vehicle collision, the curved concrete railing was damaged for about 5m long (Photo 5.2.10.8).

Photo 5.2.10.8 Damage condition (Case 5)

The cause for such a large scale damaged was excessive loading caused by vehicle collision.

- 1) Chipping concrete of the damaged portion.
- 2) Repairing and assembly of reinforcement.
- 3) Placing of super quick strength concrete.
- 4) Installing of curb blocks.
- 5) Finishing of repair.

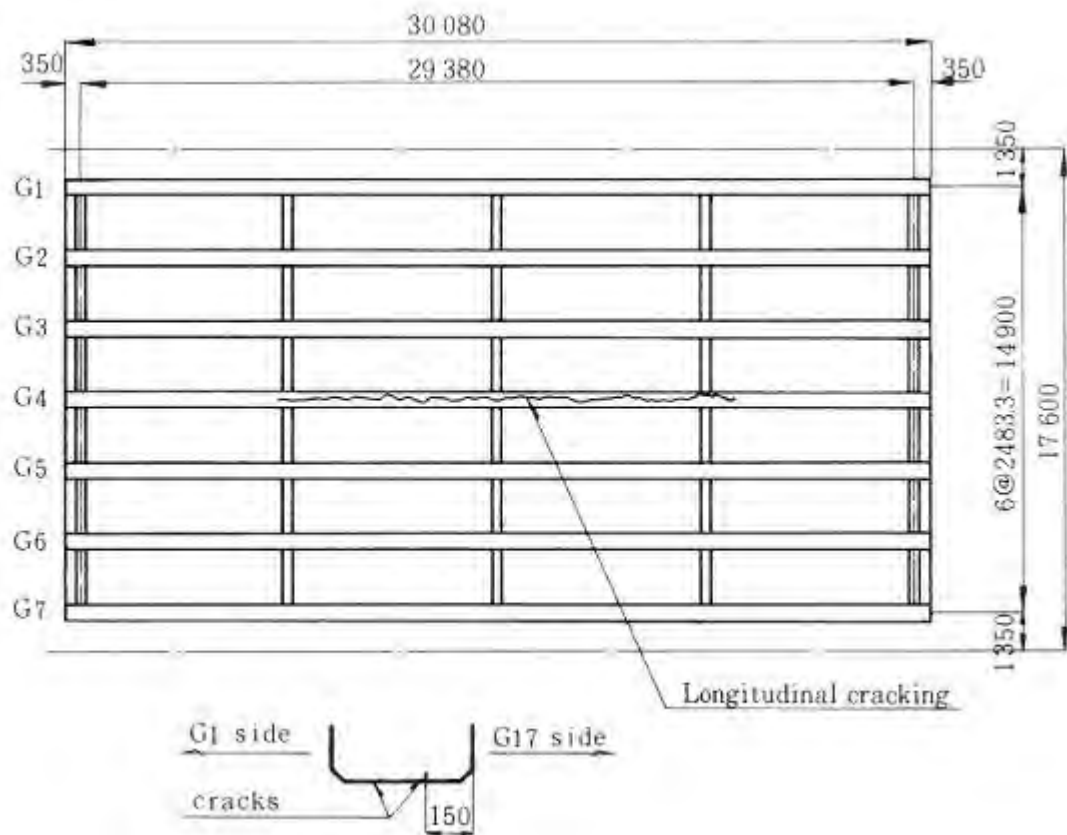
Fig. 5.2.11.1 Cracked position

G4, the central girder, had crack of 0.5mm-1.0mm wide and approximately 18m long in its mid-span lower flange (Fig. 5.2.11.1).

Two cracks spread in the longitudinal direction, dividing 60cm-wide lower flange into trisections and trace of efflorescence at places. The ultrasonic detector measured the estimated crack depth as 6cm to 10cm.

To prevent corrosion from starting on reinforcement and PC cables, sealing to the cracks of 0.2mm and larger width was implemented through injection pipes positioned at 20cm interval along the cracking line.

The repair was completed with the injection of epoxy resin grouts with pressure of about 0.2kg/m² and with the surface finishing.

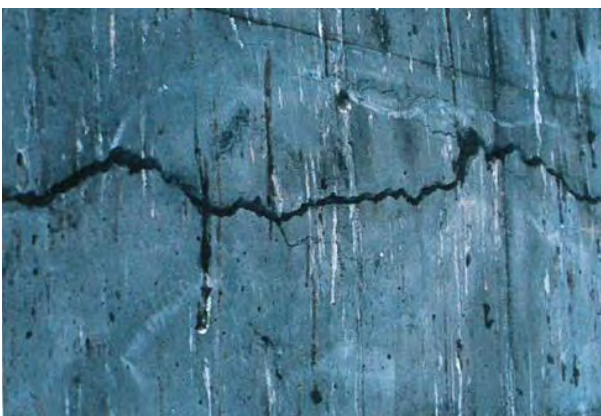
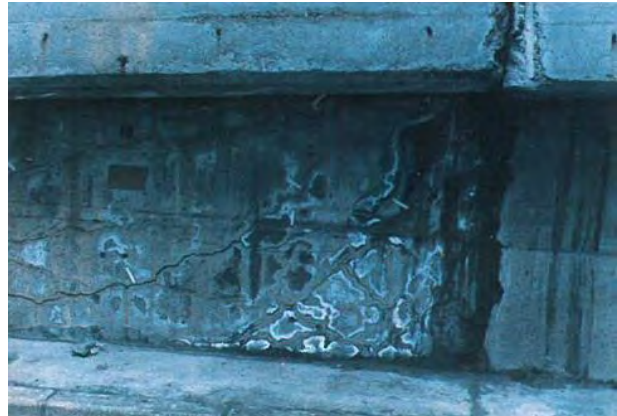
The widest crack (Photo 5.2.12.1) was 4 to 5 mm in width, located in the position where the column reinforcement terminates at the beam center.

Photo 5.2.12.1 Crack caused by alkali-aggregate reaction

As **Fig. 5.2.12.2** shows, each side of cracks of the beam surface had about 4mm dislocation. Except for this cracks, other cracks were not deep and stayed within the cover concrete according to the random core sampling. This type of cracking was found out also in the abutment and its core samples are shown in **Photo 5.2.12.1**.

Presently, single conceivable repair method is the waterproof of existing concrete structure to eliminate one of the aforementioned three factors. Available single method is surface coating after injection of flexible epoxy resins of high elongation type into cracks to shut out the moisture ingress.

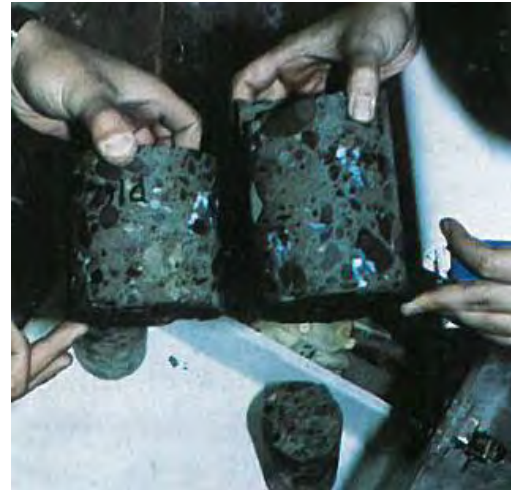
Photo 5.2.12.2 Surface observation by core sample

This type of cracking, dislocation in the concrete surface, was caused by concrete expansion. The surface of cores sampled from the beam was carefully observed (**Photo 5.2.12.2**) in pursuit of the cause of the concrete expansion.

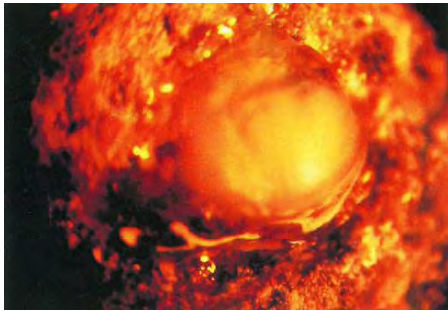
(a) Gel exudation from aggregate

Powdered x-ray analyzing and deflective microscopic observation of mineral composition in the aggregate of sampled core revealed the presence of reactive minerals. From such outcome of observation, it was concluded that the damage was caused by alkali-aggregate reaction.

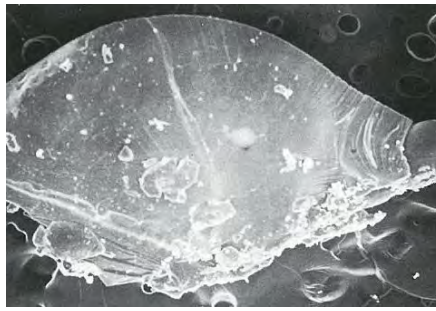
(b) Exuded gel observed with Scanning Electron Microscope

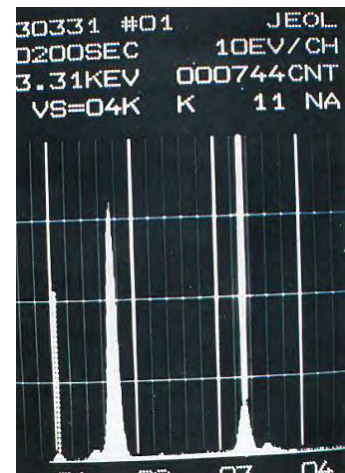
(c) X-ray intensity spectrum by elements exuded gel

Photo 5.2.12.4 Exudation of gel around each ring

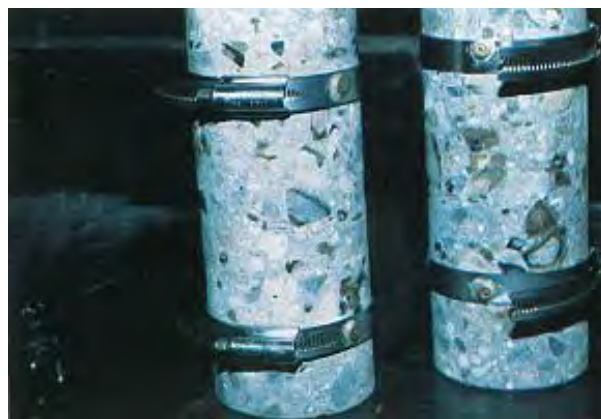
Photo 5.2.12.5 Sampled cores banded for change of perimeter measurement

A considerable elongation (expansion) was recorded through the measuring of variation of perimeter after core boring (Photo 5.2.12.5).

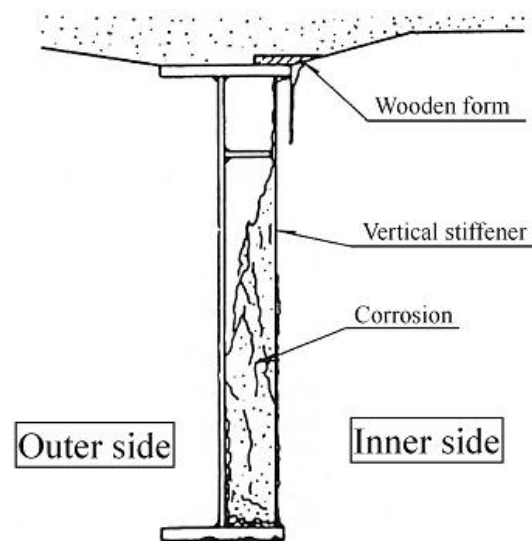
Fig. 6.2.1.1 Condition for corrosion

Based on a thickness measurement by ultrasonic tester, the corrosion was judged as serious and it was confirmed that decrease of the thickness is by 5.2mm for the lower flange compared to the original design (Web: 9mm, lower flange: 16mm to 19mm). Also, a large amount of water leakage was found at the floor slab over the corroded area and a large amount of efflorescence had been deposited on the lower flange (**Fig.6.2.1.1**).

Also, some of the wooden form which had accidentally come into the wrong position was left in the slab concrete during the construction (**Fig. 6.2.1.1** and **Photo 6.2.1.3**). It is assumed that the deterioration had developed as follows.

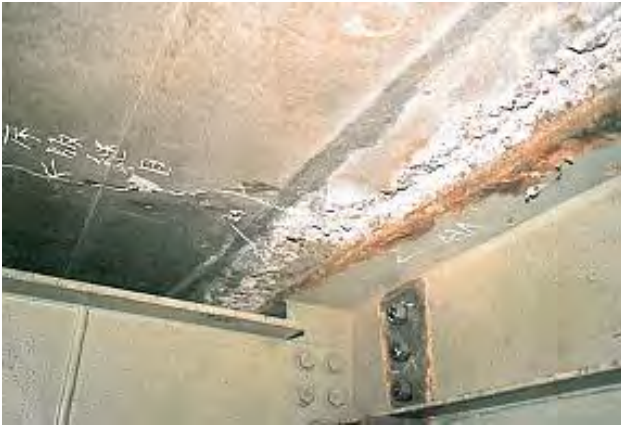
It is assumed that deterioration was caused by the water leakage from the construction joint of slab concrete which was insufficiently treated, and that rainwater has gradually leaked to the lower flange for a long period of time as shown in **Photo 6.2.1.2**.

Photo 6.2.1.2 Water leakage from the construction joint of slab concrete

Careful attention for preventing rainwater leakage from road surface shall be given to construction joints of the slab concrete and expansion joint because rainwater leakage develops serious corrosion on the steel girder.

If the areas become rusty, action to stop the water leakage shall be immediately taken. Also, at the same time, partial re-painting shall be performed, if necessary.

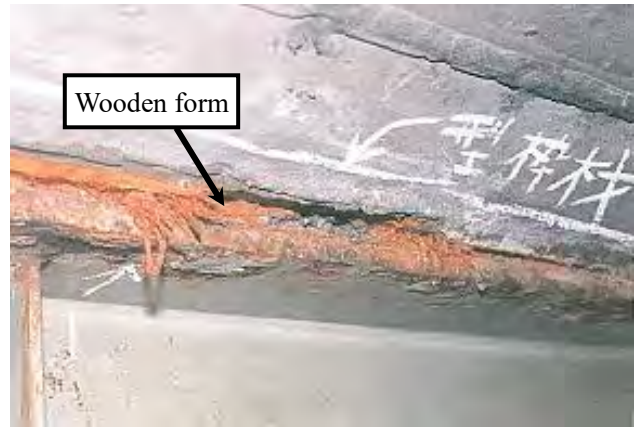
Photo 6.2.1.3 Wooden form which was left in the slab concrete

Rainwater with efflorescence coming through the slab concrete was stored around the wooden form and immersed out whenever traffic passed through. This efflorescence accumulated on the lower flange, and kept the area wet all the time. Therefore, deterioration had developed.

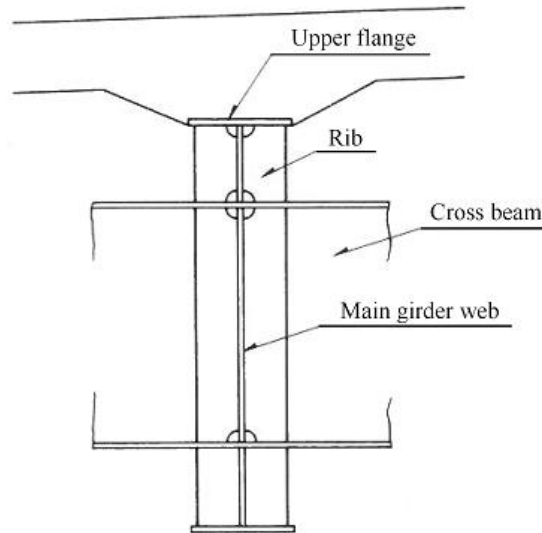
Fig. 6.2.2.2 Structural members

- (1) Large bending moment three times bigger than the allowable stress was observed at the rib plate and top of the vertical stiffener. Also, composite force of bending and shearing was observed at the jammed part welded with the rib plate and upper flange of the vertical stiffener (**Fig. 6.2.2.2, Fig. 6.2.2.3**).
