CHAPTER 5 REPAIR OF CONCRETE STRUCTURE

5.1 Planning of Concrete structure repair

5.2 Case of Concrete structure repair

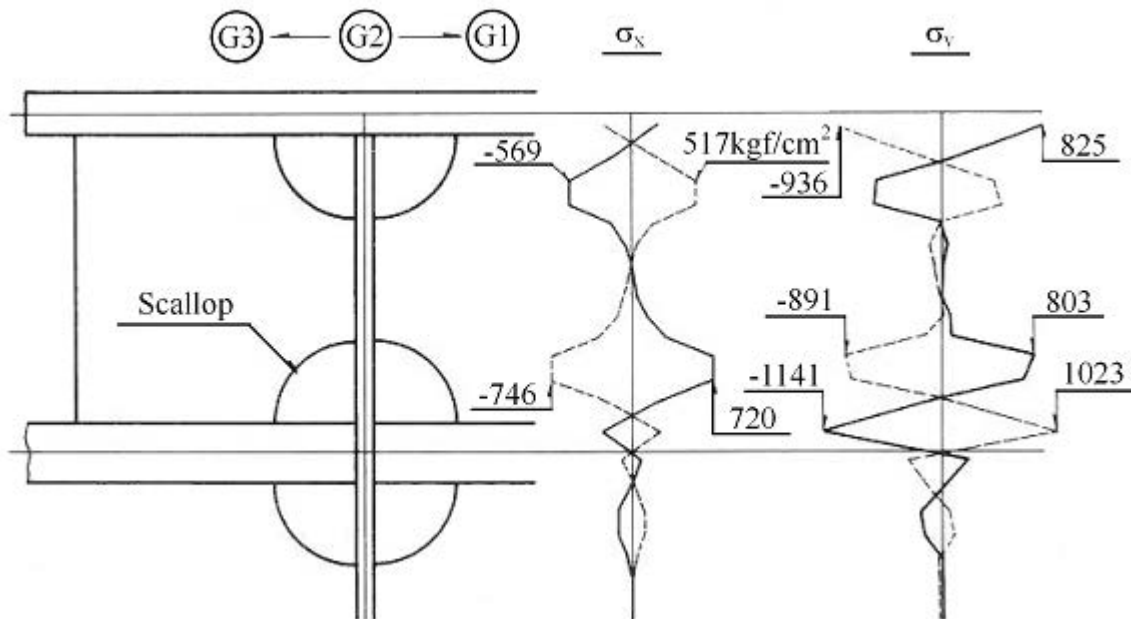
- (1) Large bending moment three times bigger than the allowable stress was observed at the rib plate and top of the vertical stiffener. Also, composite force of bending and shearing was observed at the jammed part welded with the rib plate and upper flange of the vertical stiffener (**Fig. 6.2.2.2, Fig. 6.2.2.3**).

Fig. 6.2.2.3 Stress diagram on the web

- (2) The stress on the web of main girder is disturbed at the scallop and has a great influence on flow of stress.
- (3) The weld part exhibits bending. It is caused by structural members, such as upper flange, web of the main girder, rib plate and vertical stiffener.

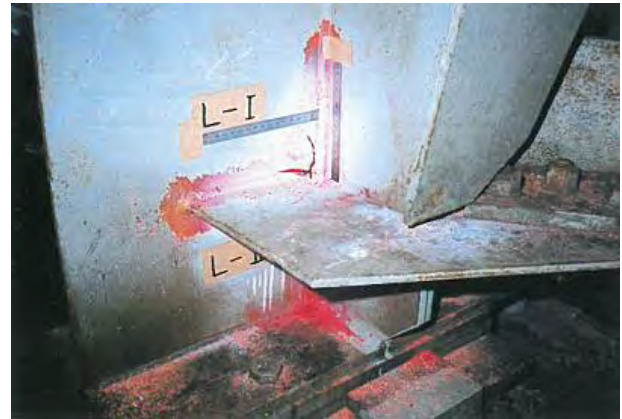
The cracks shown in Fig.6.2.3.1 and Photo 6.2.3.1 were found on both welded parts of the main girder web and vertical stiffener connected with gusset for a lateral bracing at the end of the main girder, around the support, in the simple steel girder bridge.

Photo 6.2.3.1 Condition of crack

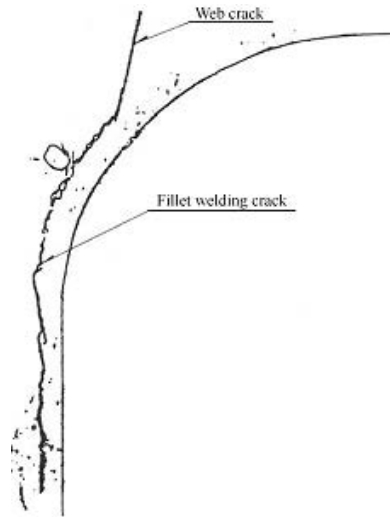
A crack was found on the steel web and on the fillet welding area of lower flange at the hunched main girder as shown in **Photos 6.2.4.1**. Magnetic particle test revealed the crack dimension is in full size as shown in **Fig. 6.2.4.1**.

Fig. 6.2.4.1 Crack dimension in full scale drawing

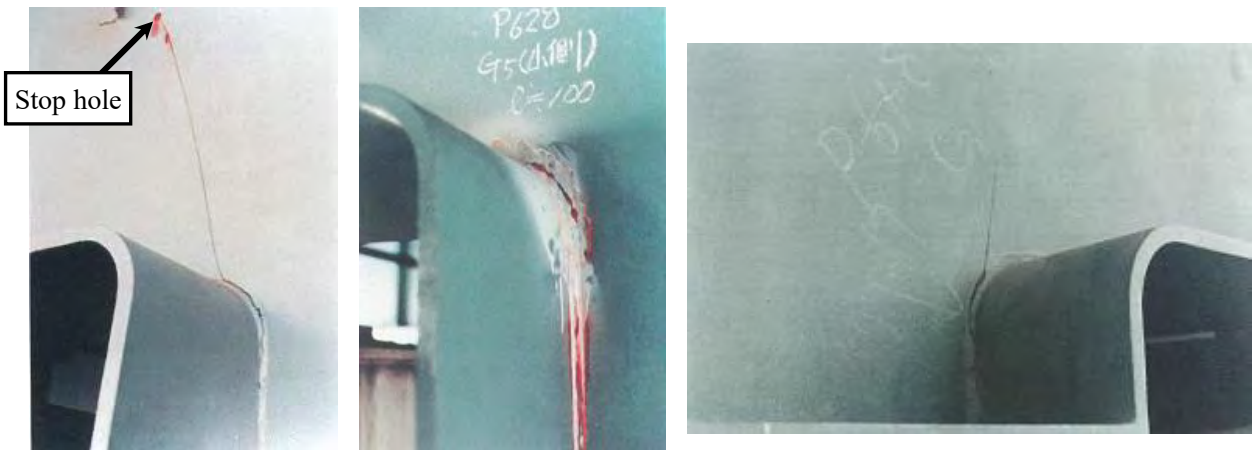
Photo 6.2.4.1 Crack on steel girder

This bridge, simple composite girder bridge which consists of 6 main I-girders, has been operating for 13 years. In survey of the other I-girders on the same bridge, cracks were found at four places of fillet welding area on the middle girders. Also, similar kinds of cracks were found on the same type of three other bridges, including two cracks which expanded from the welded area to the web.

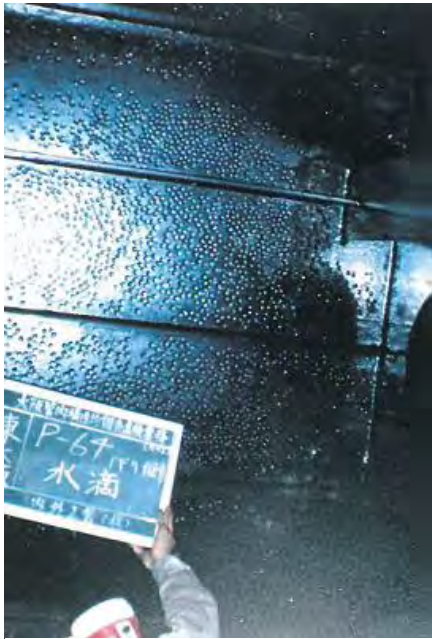
A serious corrosion due to an intensive dew condensation occurred in a steel pier as shown in **Photo 6.2.5.1**. In a steel pier, sometimes paint-missing fault (usually 2-layer coat with tar epoxy must be applied) occurred because of tight condition. Rust due to dew condensation inside of the pier as shown in **Photo 6.2.5.1(b)**.

(a) Remarkable dew condensation

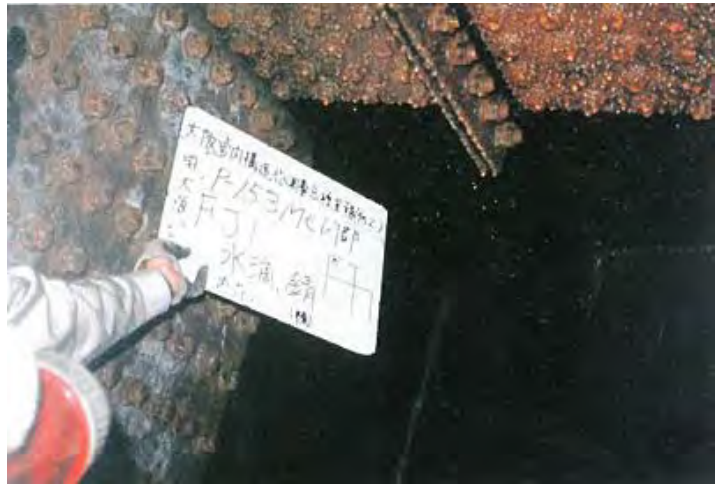
(b) Corrosion status (No painting)

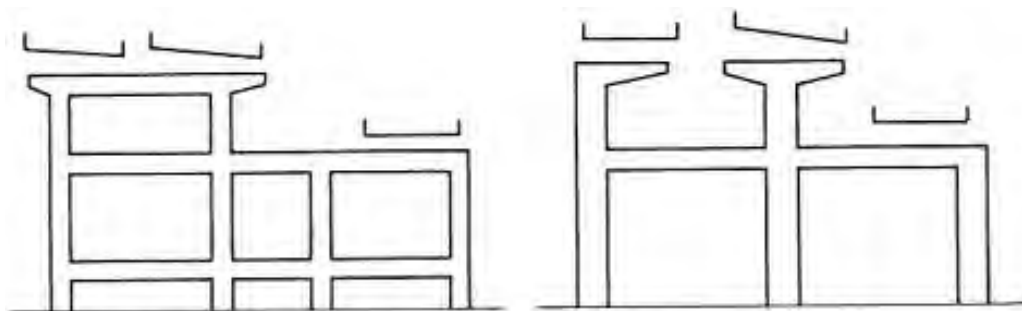
Fig. 6.2.5.1 Steel pier sectional diagrams

This kind of examples can be found out more often in structures with complicated shapes as shown in **Fig. 6.2.5.1**. The primary factors are assumed that the air circulation in the sealed area is not smooth because of its complicated shape, so dew condensation is introduced on the steel surface due to the temperature difference between inside and outside of structures.
