Republic of Mauritius
Landslide Management Unit: LMU, Ministry of Public
Infrastructure and Land Transport: MPI

TECHNICAL COOPERATION PROJECT : LANDSLIDE ADVISER FOR MAURITIUS

FINAL REPORT

February 2018

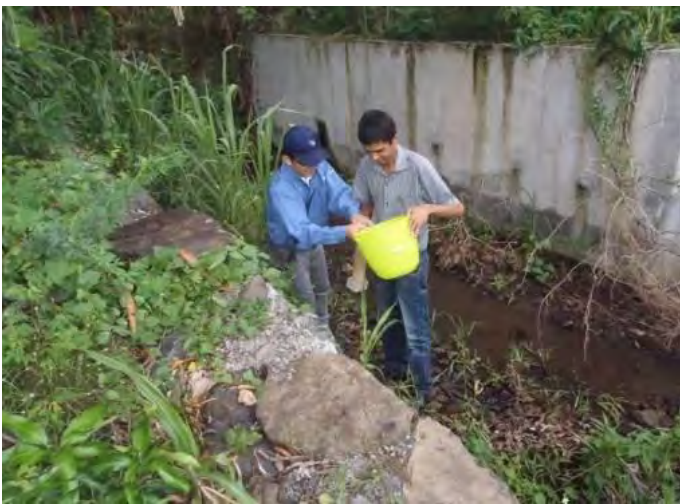
Measuring at the horizontal drainage constructed under the Previous Project, Chitrakoot

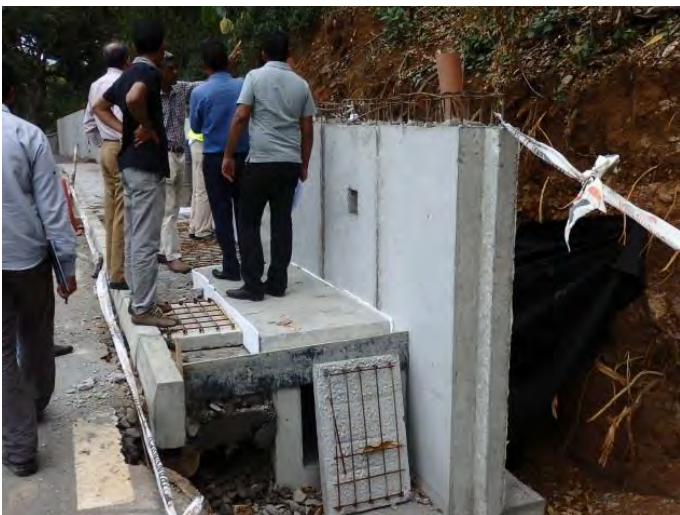
Construction of retaining wall at a place of possible slope failures, Batelage

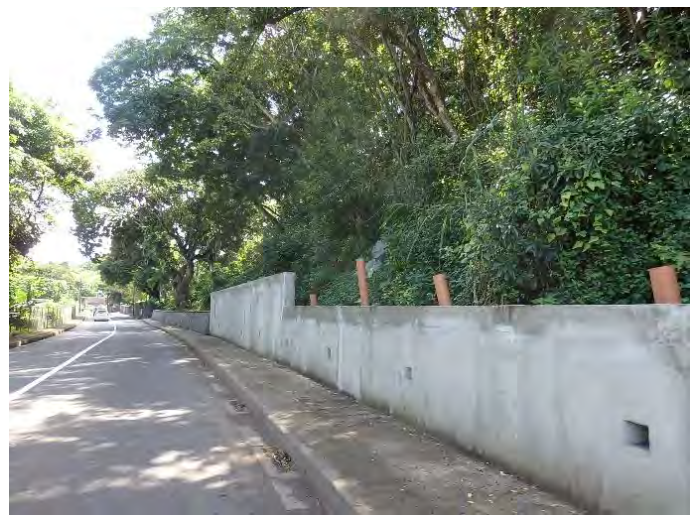
Completed countermeasure work, Batelage

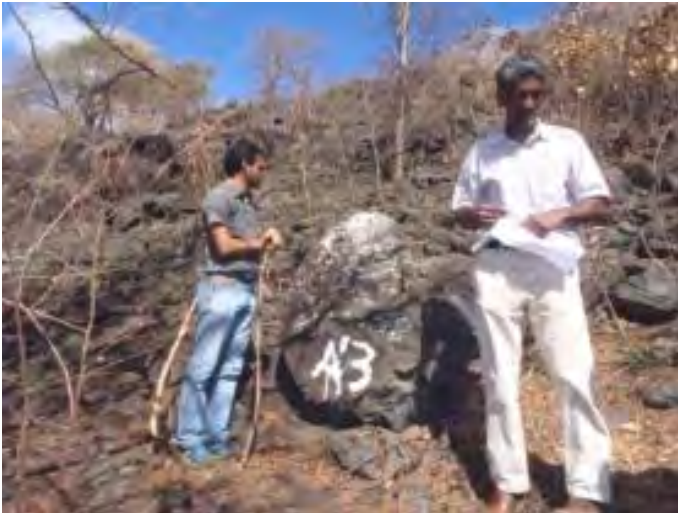
Specification of unstable rocks, evaluation, and numbering, Signal Mountain

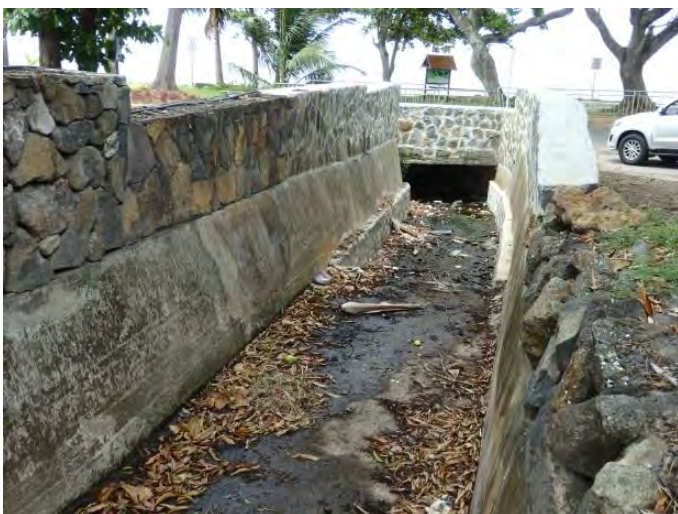
Countermeasure work for debris flow, Baie du Cap

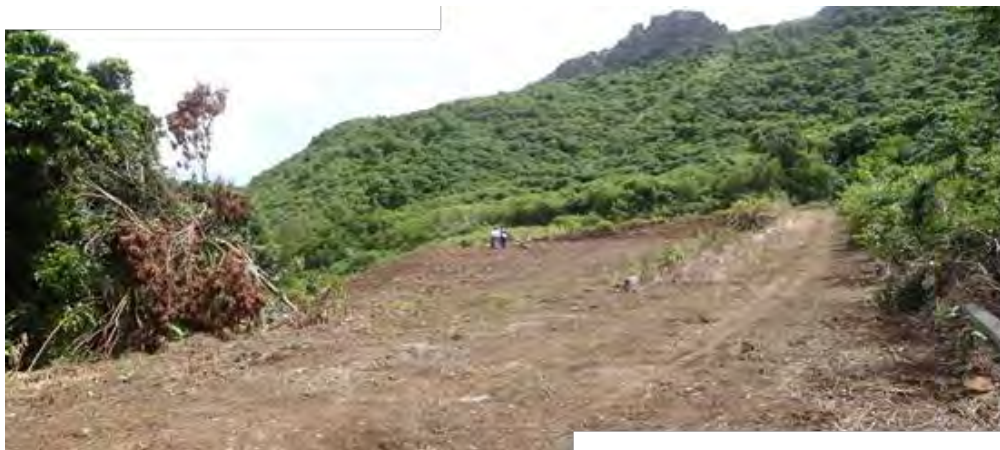
Photo 3.2.1 Panoramic view of survey site (Source: JET)

Cases in Moka Region and Mount Ory are typical examples. One of the target slopes is located along the M 1 motorway between Port Louis and Phoenix, where the colluvial deposit slope (talus) in the lower part of a steep slope was designed and developed without permission. The other slope is a little distance from the M 1 motorway, and its geological characteristics are similar with the previous site.

- Both of these sites have already been developed.
- The angle of land before the development is thought to be more than 20 degrees.
- The valley side of the slopes might cause landslides. The mountain sides of the slopes were so steep that they were likely to cause rock fall disasters.
- Development can make the slopes unstable.

Since the development at the slopes with gradients of more than 20 % is forbidden, a preliminary review system based on PPG needs to be established according to which District and Municipal Councils will give administrative approval or denial for development. After

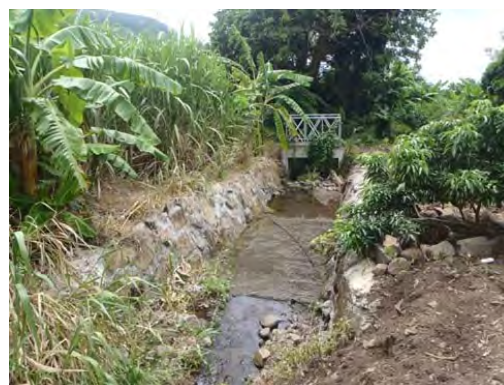
Photo 4 View of landslide countermeasure, upgrade drainage, UD-2, 08th March 2016
(Source: JET)

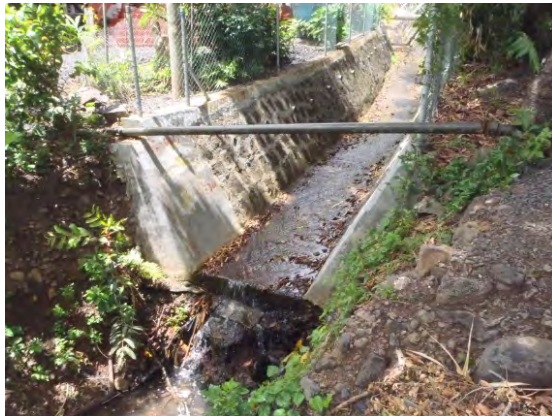
Although there was no rainfall because the weather was clear when site inspection was carried out on 6 March 2017, the quantity of flow of the drainage through RUD-1 was around 200 litres a minute. According to the photo taken during the rainy season in 2015 (refer to Photo 4), the flow of the drainage through RUD-1 was estimated to be around 1 or 2 m³ a second during heavy rain.

Photo 3 End part of the Reinforced Upgrade Drainage, RUD-1, March 2017

The flow of the drainage was around 200 litres a minute. (Source: JET)

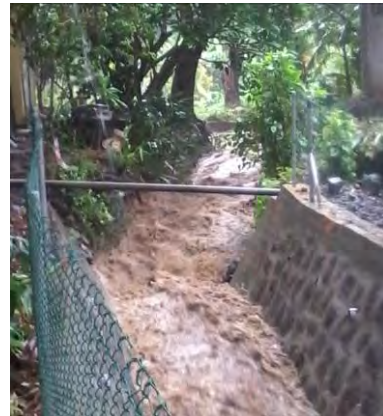
Photo 4 End part of the Reinforced Upgrade Drainage, RUD-1, during the rainy season in January 2015 (Source: JET)
