Work plan for evaluation of the landslide countermeasure in Chitrakoot

Slope inventory

MPI and JET have visited 18 sites of slope failures, rock falls, and debris flows, and surveyed the current conditions of each slope during this project. As a result of the investigation of the 18 sites, slope investigation sheets and a slope inventory were made by MPI and JET.

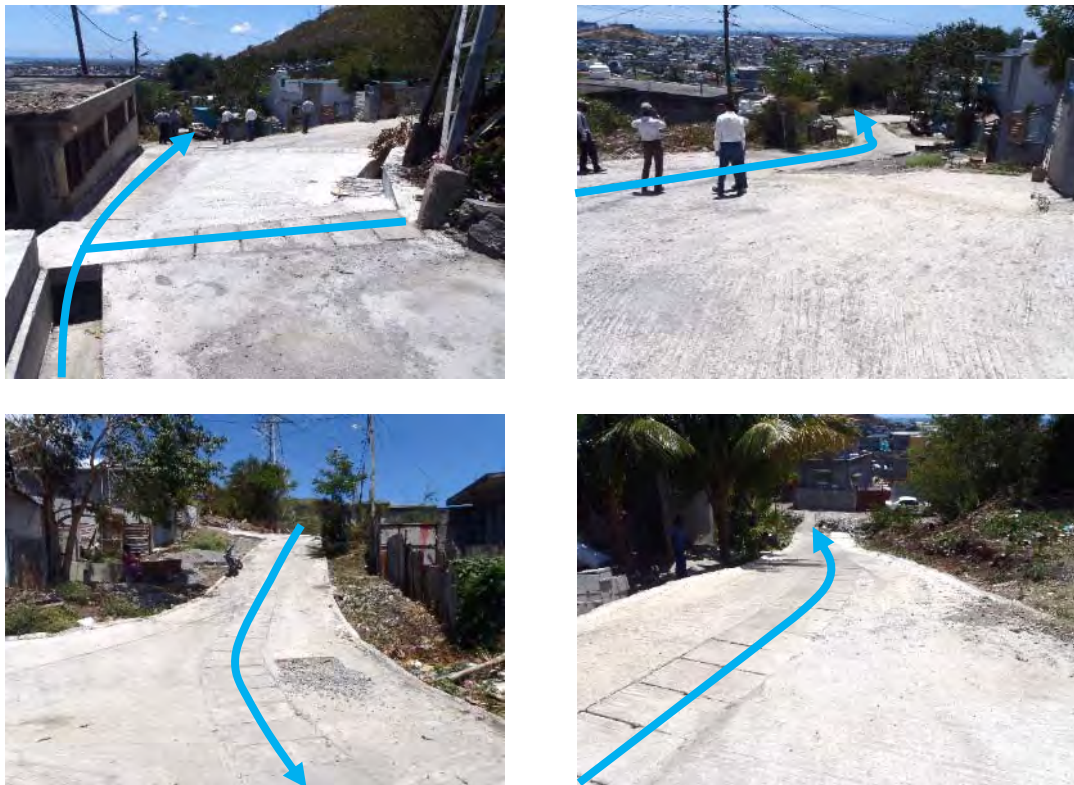
Figure 2 Surface drainage system in Valle Pitot, 12th Oct 2017 (Source: JET)

Vallee Pitot was a representative pilot site of a landslide danger area in the previous JICA project. And the geological investigation was carried out by MPI in 2015. Based on the result of the landslide investigation, the surface drainage system had been constructed as the landslide countermeasure by MPI and RDA in 2017, and the effect of that will be expected in the future.

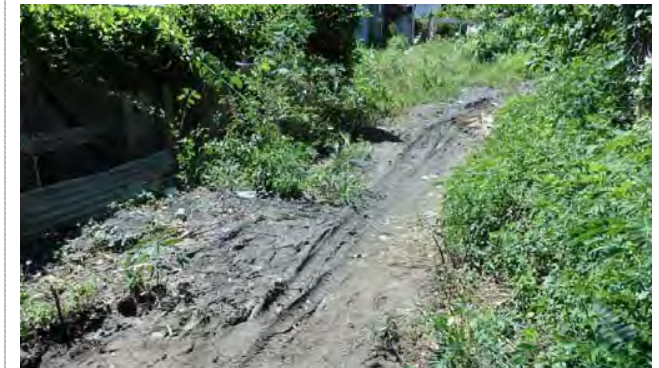
Photo-6 Opposite side of the road is facing to the inlet and river. Flash flood from the slope behind the house, which flowed down to the yard and to the road.

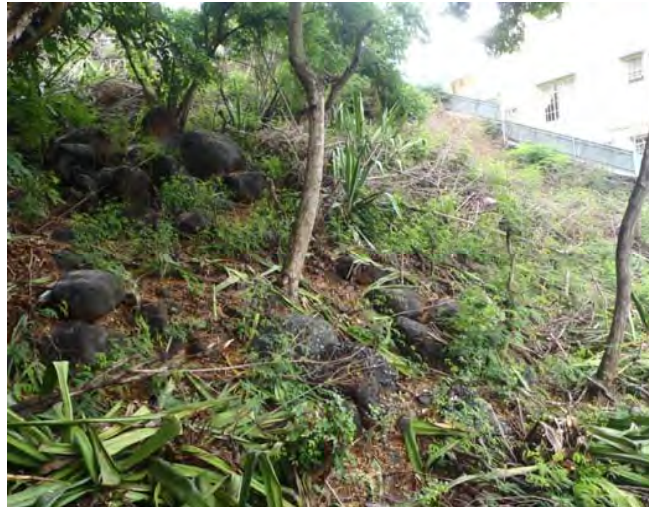
Unstable big boulders in the steep slope

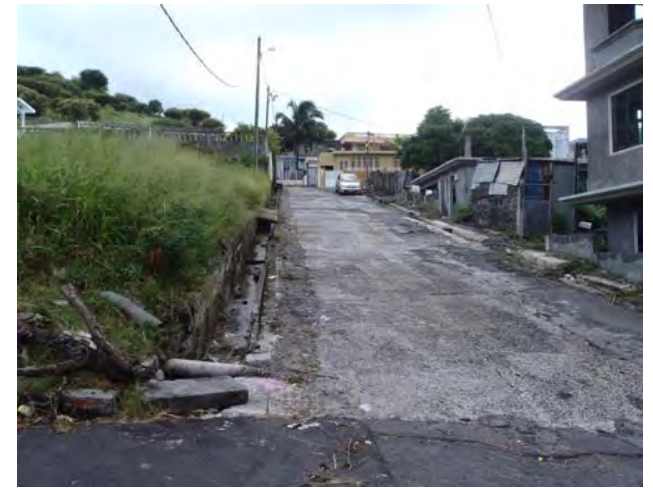
Existing Drainage of Road Side
No damage by landslide is found on the existing open drains.

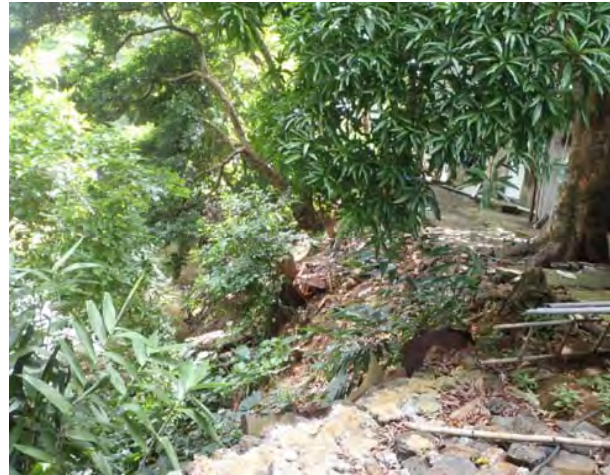
Unstable river bank slope behind a house

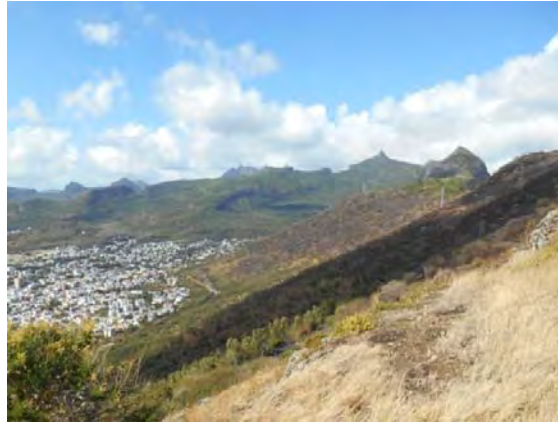
Photo-2 Full view from the road end. All section of the road is on the slope. Wide area is burned by wild fire.

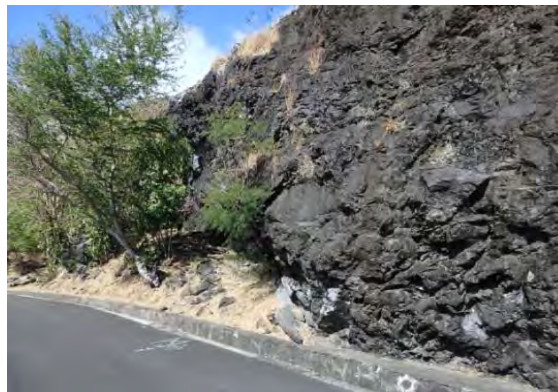
Photo-5 Cut slope with overhang. Middle part of the cut slope is cracky basalt. That part has been eroded selectively, and consequently, slope become over hang. The slope is planed to protect by fixing concrete.

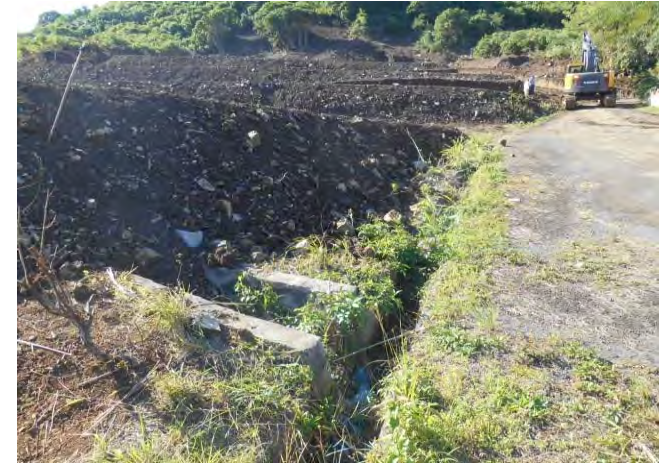
Photo-3 Lower part of the development area. Drainage of the road and slope are buried by debris.

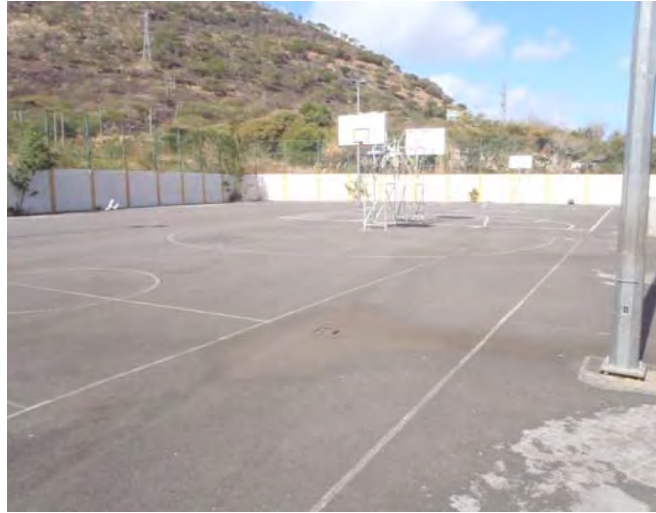
Planning area for the extension of Dr J.B.DAVID SSS
(The current conditions are basketball courts)

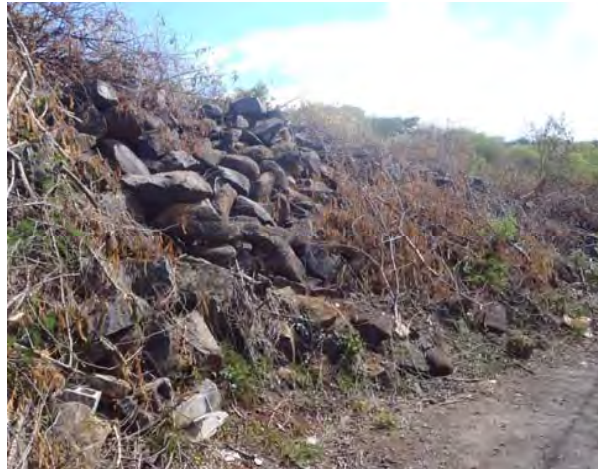
Unstable big boulders at toe of the slope

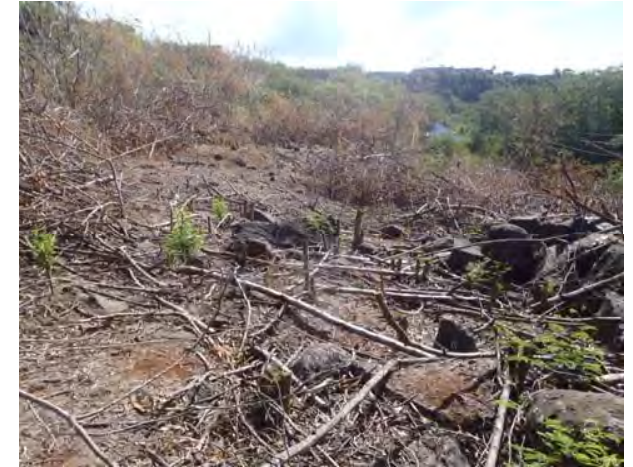
View of the top part of the slope

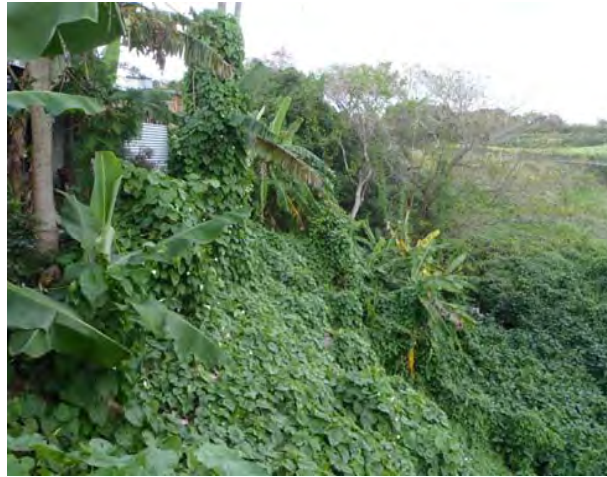
- > There is a river behind a house, and the phenomenon of this site is slope failure of the river banks.
- > Erosion at the bottom of the slope behind the house has progressed and is likely to affect the houses along the riverside.
- > In addition, the drainage from the houses and the rainwater flowing down the cliff from the road accelerates erosion of the cliff.
- > The two houses are situated close to the cliff, and the distance from a house to the cliff is only 2m.
- > The two houses are at high-risk of disaster caused by the erosion of the cliff in the area.
- > It is recommended that a countermeasure, such as the relocation of the inhabitants of the two

Unstable river bank slope behind a house

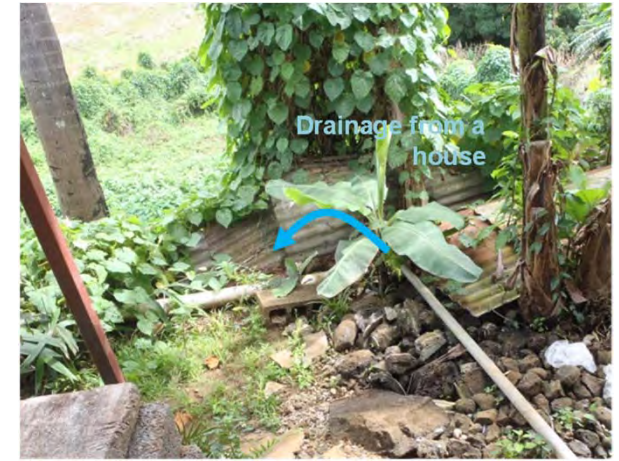
Drainage from a house accelerates erosion of the cliff

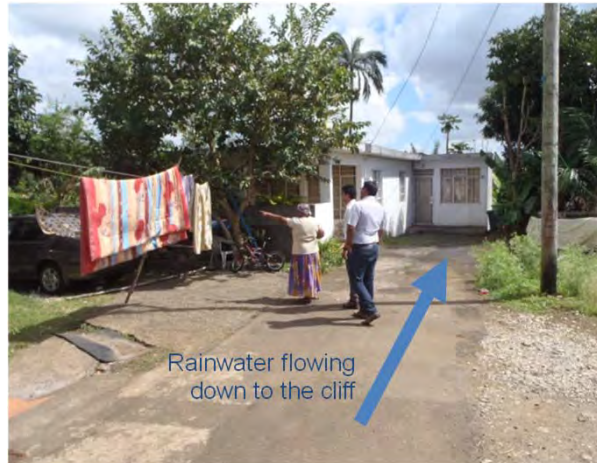
Rainwater flowing down the cliff from the road accelerates erosion of the cliff.

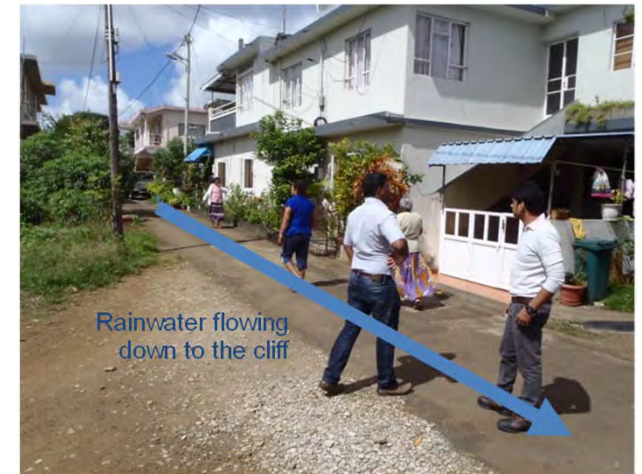
Rainwater flowing down the cliff from the road accelerates erosion of the cliff.
