## **APPENDIX 5.9**

# **Existing station Building Conditions**

## Investigation of Station Building

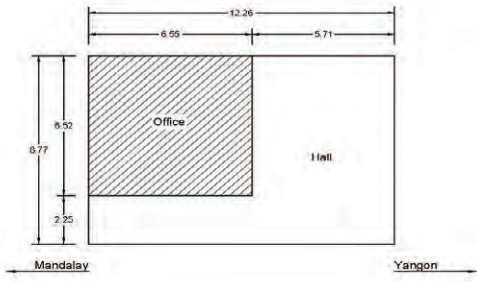
Station No.	39	Line Name	Yangon – Mandalay Line	Date of Survey	5/7/2017		
Station Name	KYEDAW						
Existing Station Building	Kilopost	276.5	Mileage	171.75			
	Access Road	<input checked="" type="radio"/> Yes <input type="radio"/> No	Age of Building	Over 50 years			
	Story of Building	( 1 ) Story Building	Total Floor Area	About 109 m <sup>2</sup>			
	Type of Main Structure (Check <input type="radio"/> )	<input checked="" type="radio"/> Brick with RC • Wood • Other(    )	Finish Material	Roof	<input checked="" type="radio"/> Corrugated Steel sheet • Roof Tiles • RC • Asbestos Fibre Cement		
	Other Structure	Wall		<input checked="" type="radio"/> Brick <input type="radio"/> Wood	Wall	<input checked="" type="radio"/> Paint	
		Column		<input checked="" type="radio"/> Brick <input type="radio"/> Wood	Column	<input checked="" type="radio"/> Paint	
		Beam		Wood <input checked="" type="radio"/> RC <input type="radio"/> Steel	Floor	<input checked="" type="radio"/> Concrete    • Wood

Electric system (Check <input type="radio"/> )	<input checked="" type="radio"/> Retract from outside • Solar System • Generator	Water Supply (Check <input type="radio"/> )	<input checked="" type="radio"/> Water Well (    ) • Waterwork • None			
	Condition of Main Structure	Main Damage Type & Rank*		Condition of Finish Material	Main Damage Type & Rank*		
		D	<input checked="" type="radio"/> Crack (10 mm) • Settlement • Inclination		D	<input checked="" type="radio"/> Water Leak <input checked="" type="radio"/> Peel Off (Roof, Ceiling, Wall, Colum )	
General Evaluation	• Usual <input checked="" type="radio"/> Poor • Severe	Remarks	No passenger and freight. No toilet. 1 cable room and 1 generator room.				
Photograph

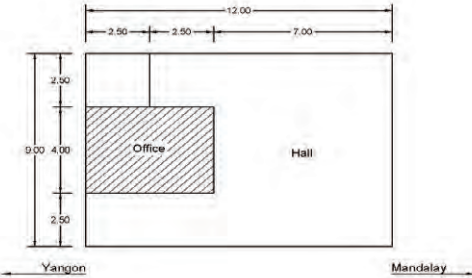
Station No.	45	Line Name	Yangon – Mandalay Line	Date of Survy	16/5/2017		
Station Name	THARGAYA						
Existing Station Building	Kilopost	314.5		Mileage	195.25		
	Access Road	<input checked="" type="radio"/> Yes    No		Age of Building	Over 100 years		
	Story of Building	( 1 ) Story Building		Total Floor Area	About 108 m <sup>2</sup>		
	Type of Main Structure (Check <input type="radio"/> )	<input type="radio"/> Brick with RC <input checked="" type="radio"/> Wood <input type="radio"/> Other(    )		Finish Material	Roof	<input checked="" type="radio"/> Corrugated Steel sheet <input type="radio"/> Roof Tiles <input type="radio"/> RC <input type="radio"/> Asbestos Fibre Cement	
	Other Structure	Wall	Brick		<input checked="" type="radio"/> Wood	Wall	• Paint
		Column	Brick		<input checked="" type="radio"/> Wood	Column	• Paint
		Beam	<input checked="" type="radio"/> Wood		RC    Steel	Floor	<input checked="" type="radio"/> Concrete    •Wood

Electric system (Check <input type="radio"/> )	<input checked="" type="radio"/> Retract from outside <input type="radio"/> Solar System <input type="radio"/> Generator		Water Supply (Check <input type="radio"/> )	<input type="radio"/> Water Well (    ) <input type="radio"/> Waterwork <input type="radio"/> None		
	Condition of Main Structure	Main Damage Type & Rank*		Condition of Finish Material	Main Damage Type & Rank*		
		<b>B</b>	<input type="radio"/> Crack (    mm) <input type="radio"/> Settlement <input type="radio"/> Inclination		<b>B</b>	<input type="radio"/> Water Leak <input type="radio"/> Peel Off (Roof, Ceiling, Wall, Colum )	
General Evaluation	<input checked="" type="radio"/> Usual <input type="radio"/> Poor <input type="radio"/> Severe		Remarks	No toilet room.			
Photograph

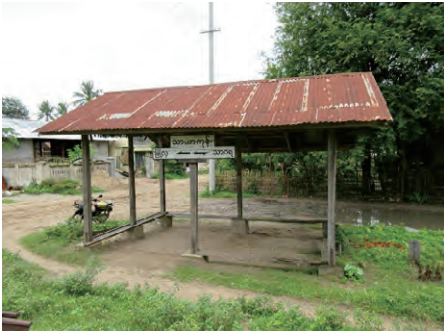
Station No.	46	Line Name	Yangon – Mandalay Line	Date of Survey	5/7/2017		
Station Name	THARYARGON						
Existing Station Building	Kilopost	318.5		Mileage	197		
	Access Road	Yes <input type="radio"/> No <input checked="" type="radio"/>		Age of Building	Over 100 years		
	Story of Building	( 1 ) Story Building		Total Floor Area	About 19 m <sup>2</sup>		
	Type of Main Structure (Check <input type="radio"/> )	<input type="checkbox"/> Brick with RC <input checked="" type="checkbox"/> Wood <input type="checkbox"/> Other(     )		Finish Material	Roof	<input checked="" type="checkbox"/> Corrugated Steel sheet <input type="checkbox"/> Roof Tiles <input type="checkbox"/> RC <input type="checkbox"/> Asbestos Fibre Cement	
		Other Structure	Wall		Brick    Wood	Wall	<input type="checkbox"/> Paint
			Column		Brick <input checked="" type="radio"/> Wood	Column	<input type="checkbox"/> Paint
			Beam		<input checked="" type="radio"/> Wood    RC    Steel	Floor	<input type="checkbox"/> Concrete <input type="checkbox"/> Wood

Electric system (Check <input type="radio"/> )	<input type="checkbox"/> Retract from outside <input type="checkbox"/> Solar System <input type="checkbox"/> Generator		Water Supply (Check <input type="radio"/> )	<input type="checkbox"/> Water Well (     ) <input type="checkbox"/> Waterwork <input checked="" type="radio"/> None		
	Condition of Main Structure	Main Damage Type & Rank*		Condition of Finish Material	Main Damage Type & Rank*		
		C	<input type="checkbox"/> Crack (     mm) <input type="checkbox"/> Settlement <input type="checkbox"/> Inclination		C	<input type="checkbox"/> Water Leak <input type="checkbox"/> Peel Off (Roof, Ceiling, Wall, Colum )	
General Evaluation	<input checked="" type="radio"/> Usual <input type="checkbox"/> Poor <input type="checkbox"/> Severe		Remarks				
Photograph

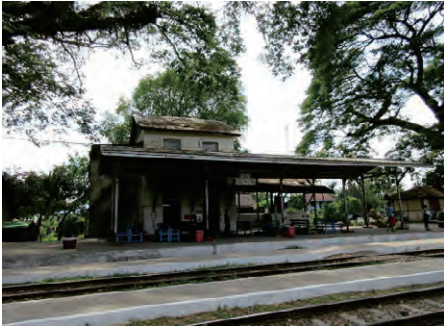
Station No.	47	Line Name	Yangon – Mandalay Line	Date of Survey	16/5/2017			
Station Name	MYOHLA							
Existing Station Building	Kilopost	324		Mileage	201.25			
	Access Road	<input checked="" type="radio"/> Yes    No		Age of Building	Over 100 years			
	Story of Building	( 2 ) Story Building		Total Floor Area	About 150 m <sup>2</sup>			
	Type of Main Structure (Check <input type="radio"/> )	<input checked="" type="radio"/> Brick with RC • Wood • Other(    )		Finish Material	Roof	<input checked="" type="radio"/> Corrugated Steel sheet • Roof Tiles • RC • Asbestos Fibre Cement		
	Other Structure	Wall	<input checked="" type="radio"/> Brick    Wood		Wall	<input checked="" type="radio"/> Paint		
		Column	<input checked="" type="radio"/> Brick    Wood		Column	<input checked="" type="radio"/> Paint		
		Beam	<input checked="" type="radio"/> Wood    RC    Steel		Floor	<input checked="" type="radio"/> Concrete    • Wood

Electric system (Check <input type="radio"/> )	<input checked="" type="radio"/> Retract from outside • Solar System • Generator		Water Supply (Check <input type="radio"/> )	• Water Well (    ) • Waterwork <input checked="" type="radio"/> None			
	Condition of Main Structure	Main Damage Type & Rank*			Condition of Finish Material		Main Damage Type & Rank*	
		D	• Crack (    mm) • Settlement • Inclination		D		<input checked="" type="radio"/> Water Leak <input checked="" type="radio"/> Peel Off (Roof, Ceiling, Wall, Colum )	
General Evaluation	• Usual <input checked="" type="radio"/> Poor • Severe		Remarks		No toilet room(Only staff).			
Photograph

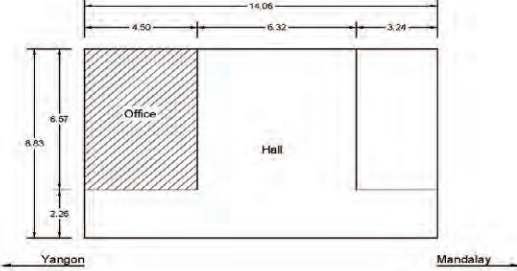
Electric system (Check <input type="radio"/> )	<ul style="list-style-type: none"> <li><input checked="" type="radio"/> Retract from outside</li> <li>▪ Solar System</li> <li>▪ Generator</li> </ul>		Water Supply (Check <input type="radio"/> )	<ul style="list-style-type: none"> <li><input checked="" type="radio"/> Water Well ( Mortar )</li> <li>▪ Waterwork</li> <li>▪ None</li> </ul>		
	Condition of Main Structure	Main Damage Type & Rank*			Condition of Finish Material	Main Damage Type & Rank*	
		F	<ul style="list-style-type: none"> <li><input checked="" type="radio"/> Crack (10mm)</li> <li><input type="radio"/> Settlement</li> <li><input type="radio"/> Inclination</li> </ul>			C	<ul style="list-style-type: none"> <li><input checked="" type="radio"/> Water Leak</li> <li><input checked="" type="radio"/> Peel Off (Roof, Ceiling, Wall, Colum )</li> </ul>
General Evaluation	<ul style="list-style-type: none"> <li>▪ Usual</li> <li>▪ Poor</li> <li><input checked="" type="radio"/> Severe</li> </ul>		Remarks	No toilet room. About 7 passengers/day and a little freight(sometime).

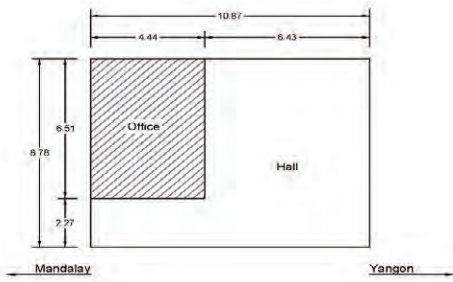
Beam	<input checked="" type="radio"/> Wood    RC    Steel		Floor	<input checked="" type="radio"/> Concrete    • Wood	
	Electric system (Check <input type="radio"/> )	<ul style="list-style-type: none"> <li><input checked="" type="radio"/> Retract from outside</li> <li>• Solar System</li> <li>• Generator</li> </ul>		Water Supply (Check <input type="radio"/> )	<ul style="list-style-type: none"> <li><input checked="" type="radio"/> Water Well ( Mortar )</li> <li>• Waterwork</li> <li>• None</li> </ul>		
	Condition of Main Structure	Main Damage Type & Rank*			Condition of Finish Material	Main Damage Type & Rank*	
		D	<ul style="list-style-type: none"> <li><input checked="" type="radio"/> Crack (10mm)</li> <li>• Settlement</li> <li>• Inclination</li> </ul>			D	<ul style="list-style-type: none"> <li><input checked="" type="radio"/> Water Leak</li> <li><input checked="" type="radio"/> Peel Off (Roof, Ceiling, Wall, Colum )</li> </ul>

General Evaluation	<ul style="list-style-type: none"> <li>• Usual</li> <li><input checked="" type="radio"/> Poor</li> <li>• Severe</li> </ul>		Remarks	No toilet room. About 70 passengers/day and a little freight(sometime). 1 cable and 1 generator			
Photograph

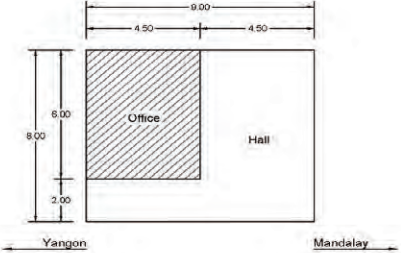
Station No.	52	Line Name	Yangon – Mandalay Line	Date of Survey	16/5/2017		
Station Name	PYAYWUN						
Existing Station Building	Kilopost	353.5		Mileage	219.17		
	Access Road	<input checked="" type="radio"/> Yes    No		Age of Building	Over 100 years		
	Story of Building	( 1 ) Story Building		Total Floor Area	About 120 m <sup>2</sup>		
	Type of Main Structure (Check <input type="radio"/> )	<input checked="" type="radio"/> Brick with RC • Wood • Other(    )		Finish Material	Roof	<input checked="" type="radio"/> Corrugated Steel sheet • Roof Tiles • RC • Asbestos Fibre Cement	
	Other Structure	Wall	<input checked="" type="radio"/> Brick    Wood		Wall	<input checked="" type="radio"/> Paint	
		Column	<input checked="" type="radio"/> Brick    Wood		Column	<input checked="" type="radio"/> Paint	
		Beam	Wood		<input checked="" type="radio"/> RC	Steel	<input checked="" type="radio"/> Concrete    • Wood
	Electric system (Check <input type="radio"/> )	<input checked="" type="radio"/> Retract from outside • Solar System • Generator		Water Supply (Check <input type="radio"/> )	<input checked="" type="radio"/> Water Well (    ) • Waterwork • None

Condition of Main Structure	Main Damage Type & Rank*		Condition of Finish Material	Main Damage Type & Rank*		
		F	<input checked="" type="radio"/> Crack (10mm) <input checked="" type="radio"/> Settlement • Inclination		D	<input checked="" type="radio"/> Water Leak <input checked="" type="radio"/> Peel Off (Roof, Ceiling, Wall, Colum )	
General Evaluation	• Usual • Poor <input checked="" type="radio"/> Severe		Remarks	No toilet room.			
Photograph

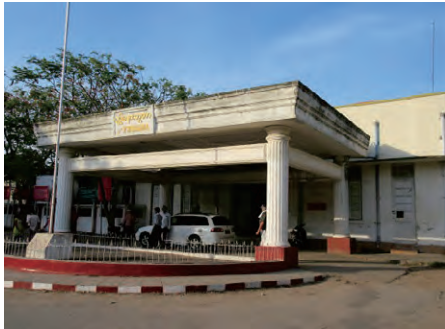
Beam	Wood		<input checked="" type="radio"/> RC	Steel	<input checked="" type="radio"/> Concrete <input type="radio"/> Wood
	Electric system (Check <input type="radio"/> )	<input checked="" type="radio"/> Retract from outside <input type="radio"/> Solar System <input type="radio"/> Generator		Water Supply (Check <input type="radio"/> )	<input checked="" type="radio"/> Water Well (         ) <input type="radio"/> Waterwork <input type="radio"/> None		
	Condition of Main Structure	Main Damage Type & Rank*			Condition of Finish Material	Main Damage Type & Rank*	
		D	<input checked="" type="radio"/> Crack (5mm) <input type="radio"/> Settlement <input type="radio"/> Inclination			D	<input checked="" type="radio"/> Water Leak <input checked="" type="radio"/> Peel Off (Roof, Ceiling, Wall, Colum )
General Evaluation	<input type="radio"/> Usual <input checked="" type="radio"/> Poor <input type="radio"/> Severe		Remarks		Front of station plaza.

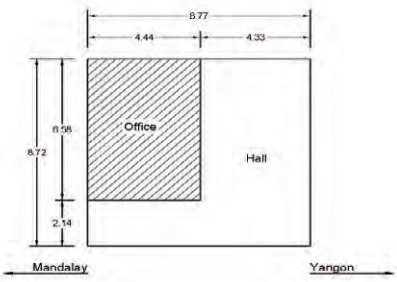
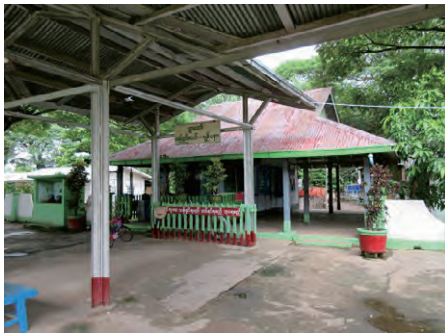
Station No.	54	Line Name	Yangon – Mandalay Line	Date of Survey	5/7/2017		
Station Name	YWADAW						
Existing Station Building	Kilopost	370		Mileage	230		
	Access Road	<input checked="" type="radio"/> Yes    No		Age of Building	Over 100 years		
	Story of Building	( 1 ) Story Building		Total Floor Area	About 78 m <sup>2</sup>		
	Type of Main Structure (Check <input type="radio"/> )	<input type="radio"/> Brick with RC <input checked="" type="radio"/> Wood <input type="radio"/> Other(    )		Finish Material	Roof	<input checked="" type="radio"/> Corrugated Steel sheet <input type="radio"/> Roof Tiles <input type="radio"/> RC <input type="radio"/> Asbestos Fibre Cement	
		Other Structure	Wall		<input checked="" type="radio"/> Brick    Wood	Wall	<input checked="" type="radio"/> Paint
			Column		Brick <input checked="" type="radio"/> Wood    RC	Column	<input checked="" type="radio"/> Paint
			Beam		<input checked="" type="radio"/> Wood    RC    Steel	Floor	<input checked="" type="radio"/> Concrete <input type="radio"/> Wood

Electric system (Check <input type="radio"/> )	<input checked="" type="radio"/> Retract from outside <input type="radio"/> Solar System <input type="radio"/> Generator		Water Supply (Check <input type="radio"/> )	<input checked="" type="radio"/> Water Well ( Tube ) <input type="radio"/> Waterwork <input type="radio"/> None		
	Condition of Main Structure	Main Damage Type & Rank*		Condition of Finish Material	Main Damage Type & Rank*		
		C	<input checked="" type="radio"/> Crack (6mm) <input checked="" type="radio"/> Settlement <input type="radio"/> Inclination		B	<input type="radio"/> Water Leak <input type="radio"/> Peel Off (Roof, Ceiling, Wall, Colum )	
General Evaluation	<input checked="" type="radio"/> Usual <input type="radio"/> Poor <input type="radio"/> Severe		Remarks	About 5 passengers/day and 2times freight/month. 1 toilet and 1 cable room.			
Photograph

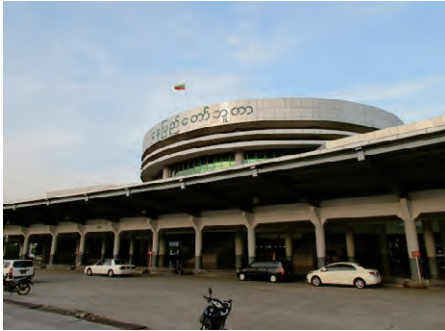
Station No.	55	Line Name	Yangon – Mandalay Line	Date of Survey	16/5/2017		
Station Name	NAYPYITAW						
Existing Station Building	Kilopost	375		Mileage	232		
	Access Road	<input checked="" type="radio"/> Yes    No		Age of Building	Over 8 years		
	Story of Building	( 2 ) Story Building		Total Floor Area	About 2500 m <sup>2</sup>		
	Type of Main Structure (Check <input type="radio"/> )	<input type="radio"/> Brick with RC <input type="radio"/> Wood <input checked="" type="radio"/> Other( RC )		Finish Material	Roof	<input checked="" type="radio"/> Corrugated Steel sheet <input type="radio"/> Roof Tiles <input type="radio"/> RC <input type="radio"/> Asbestos Fibre Cement	
	Other Structure	Wall	<input checked="" type="radio"/> Brick    Wood		Wall	<input checked="" type="radio"/> Paint	
		Column	Brick    Wood <input checked="" type="radio"/> RC		Column	<input checked="" type="radio"/> Paint	
		Beam	Wood <input checked="" type="radio"/> RC    Steel		Floor	<input checked="" type="radio"/> Concrete with stone tile

Electric system (Check <input type="radio"/> )	<input checked="" type="radio"/> Retract from outside <input type="radio"/> Solar System <input type="radio"/> Generator		Water Supply (Check <input type="radio"/> )	<input type="radio"/> Water Well (         ) <input type="radio"/> Waterwork <input type="radio"/> None		
	Condition of Main Structure	Main Damage Type & Rank*		Condition of Finish Material	Main Damage Type & Rank*		
		<b>B</b>	<input type="radio"/> Crack (     mm) <input type="radio"/> Settlement <input type="radio"/> Inclination		<b>B</b>	<input type="radio"/> Water Leak <input checked="" type="radio"/> Peel Off (Roof, Ceiling, Wall, Colum )	
General Evaluation	<input checked="" type="radio"/> Usual <input type="radio"/> Poor <input type="radio"/> Severe		Remarks	About 5 passengers/day and 2times freight/month. 1 toilet and 1 cable room.			
Photograph

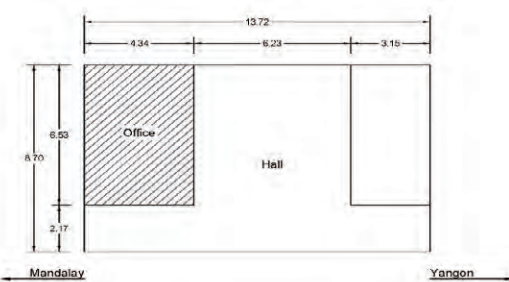
Beam	<input checked="" type="radio"/> Wood <input type="radio"/> RC <input type="radio"/> Steel		Floor	<input checked="" type="radio"/> Concrete <input type="radio"/> Wood	
	Electric system (Check <input type="radio"/> )	<input checked="" type="radio"/> Retract from outside <input type="radio"/> Solar System <input type="radio"/> Generator		Water Supply (Check <input type="radio"/> )	<input checked="" type="radio"/> Water Well ( Tube ) <input type="radio"/> Waterwork <input type="radio"/> None		
	Condition of Main Structure	Main Damage Type & Rank*			Main Damage Type & Rank*		
		D	<input checked="" type="radio"/> Crack (6mm) <input checked="" type="radio"/> Settlement <input type="radio"/> Inclination		C	<input checked="" type="radio"/> Water Leak <input type="radio"/> Peel Off (Roof, Ceiling, Wall, Colum )	
General Evaluation	<input type="radio"/> Usual <input checked="" type="radio"/> Poor <input type="radio"/> Severe		Remarks	About 100 passengers/day and freight(sometime). No toilet. 1 cable room and 1 store

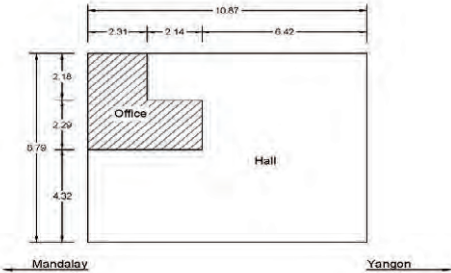
Beam		<input checked="" type="radio"/> Wood <input type="radio"/> RC <input type="radio"/> Steel	Floor	<input checked="" type="radio"/> Concrete    • Wood	
	Electric system (Check <input type="radio"/> )	<ul style="list-style-type: none"> <li><input checked="" type="radio"/> Retract from outside</li> <li>• Solar System</li> <li>• Generator</li> </ul>	Water Supply (Check <input type="radio"/> )	<ul style="list-style-type: none"> <li>• Water Well (            )</li> <li>• Waterwork</li> <li><input checked="" type="radio"/> None</li> </ul>			
	Condition of Main Structure	Main Damage Type & Rank*		Condition of Finish Material	Main Damage Type & Rank*		
		F	<ul style="list-style-type: none"> <li><input checked="" type="radio"/> Crack (10mm)</li> <li><input checked="" type="radio"/> Settlement</li> <li><input checked="" type="radio"/> Inclination 5°</li> </ul>		D	<ul style="list-style-type: none"> <li><input checked="" type="radio"/> Water Leak</li> <li><input checked="" type="radio"/> Peel Off (Roof, Ceiling, Wall, Colum )</li> </ul>

General Evaluation	<ul style="list-style-type: none"> <li>• Usual</li> <li>• Poor</li> <li><input checked="" type="radio"/> Severe</li> </ul>	Remarks	About 40 passengers/day and no freight. No toilet. 1 cable and 1 generator				
Photograph

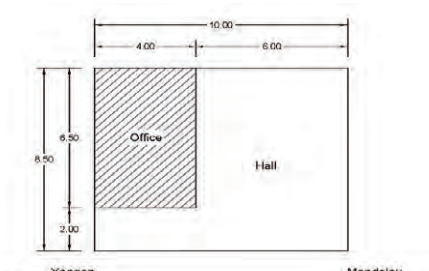
Station No.	58	Line Name	Yangon – Mandalay Line	Date of Survey	15/5/2017		
Station Name	SINBYUGYUN						
Existing Station Building	Kilopost	392	Mileage	243-1/2			
	Access Road	<input checked="" type="radio"/> Yes <input type="radio"/> No	Age of Building	Over 100 years			
	Story of Building	( 1 ) Story Building	Total Floor Area	About 120 m <sup>2</sup>			
	Type of Main Structure (Check <input type="radio"/> )	<input checked="" type="radio"/> Brick with RC • Wood • Other(    )	Finish Material	Roof	<input checked="" type="radio"/> Corrugated Steel sheet • Roof Tiles • RC • Asbestos Fibre Cement		
	Other Structure	Wall		<input checked="" type="radio"/> Brick <input type="radio"/> Wood	Wall	<input checked="" type="radio"/> Paint	
		Column		<input checked="" type="radio"/> Brick <input type="radio"/> Wood <input type="radio"/> RC	Column	<input checked="" type="radio"/> Paint	
		Beam		Wood <input checked="" type="radio"/> RC <input type="radio"/> Steel	Floor	<input checked="" type="radio"/> Concrete    • Wood

Electric system (Check <input type="radio"/> )	• Retract from outside <input checked="" type="radio"/> Solar System • Generator	Water Supply (Check <input type="radio"/> )	• Water Well (    ) • Waterwork <input checked="" type="radio"/> None			
	Condition of Main Structure	Main Damage Type & Rank*		Condition of Finish Material	Main Damage Type & Rank*		
		F	<input checked="" type="radio"/> Crack (10mm) • Settlement • Inclination		D	<input checked="" type="radio"/> Water Leak <input checked="" type="radio"/> Peel Off (Roof, Ceiling, Wall, Colum )	
General Evaluation	• Usual • Poor <input checked="" type="radio"/> Severe		Remarks	No toilet.			
Photograph

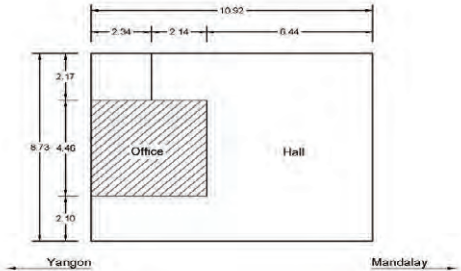
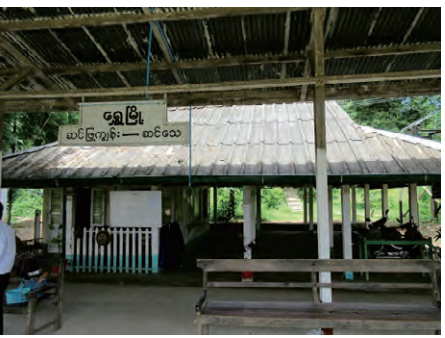
Beam		<input checked="" type="radio"/> Wood    RC    Steel	Floor	<input checked="" type="radio"/> Concrete <input type="radio"/> Wood
	Electric system (Check <input type="radio"/> )	<input checked="" type="radio"/> Retract from outside <input type="radio"/> Solar System <input type="radio"/> Generator		Water Supply (Check <input type="radio"/> )	<input checked="" type="radio"/> Water Well ( Tube ) <input type="radio"/> Waterwork <input type="radio"/> None		
	Condition of Main Structure	Main Damage Type & Rank*		Condition of Finish Material	Main Damage Type & Rank*		
		D	<input checked="" type="radio"/> Crack (10mm) <input checked="" type="radio"/> Settlement <input checked="" type="radio"/> Inclination 3°		C	<input checked="" type="radio"/> Water Leak <input type="radio"/> Peel Off (Roof, Ceiling, Wall, Colum )	
General Evaluation	<input type="radio"/> Usual <input checked="" type="radio"/> Poor <input type="radio"/> Severe		Remarks	No toilet.About 70-80passengers/day and no freight.1 cable rm,1 generator rm and 1 wireless rm.

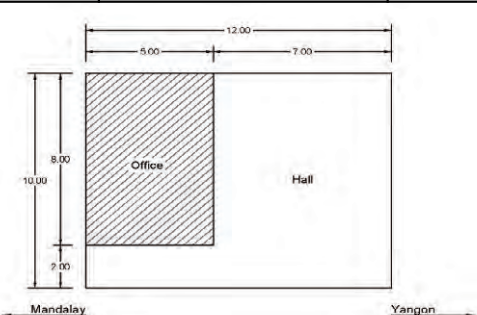
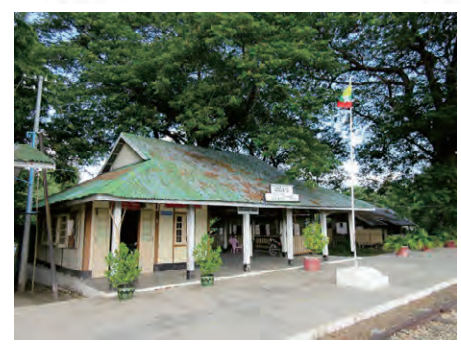
Station No.	60	Line Name	Yangon – Mandalay Line	Date of Survey	15/5/2017		
Station Name	SINTHE						
Existing Station Building	Kilopost	404		Mileage	251		
	Access Road	<input checked="" type="radio"/> Yes <input type="radio"/> No		Age of Building	Over 100 years		
	Story of Building	( 1 ) Story Building		Total Floor Area	About 150 m <sup>2</sup>		
	Type of Main Structure (Check <input type="radio"/> )	<ul style="list-style-type: none"> <li>• Brick with RC</li> <li><input checked="" type="radio"/> Wood</li> <li>• Other(    )</li> </ul>		Finish Material	Roof	<input checked="" type="radio"/> Corrugated Steel sheet • Roof Tiles • RC • Asbestos Fibre Cement	
	Other Structure	Wall	Brick <input checked="" type="radio"/> Wood		Wall	<input checked="" type="radio"/> Paint	
		Column	Brick <input checked="" type="radio"/> Wood    RC		Column	<input checked="" type="radio"/> Paint	
		Beam	<input checked="" type="radio"/> Wood    RC    Steel		Floor	<input checked="" type="radio"/> Concrete    • Wood

Electric system (Check <input type="radio"/> )	<input checked="" type="radio"/> Retract from outside • Solar System • Generator		Water Supply (Check <input type="radio"/> )	<input checked="" type="radio"/> Water Well (    ) • Waterwork • None		
	Condition of Main Structure	Main Damage Type & Rank*		Condition of Finish Material	Main Damage Type & Rank*		
		<b>B</b>	<ul style="list-style-type: none"> <li>• Crack (    mm)</li> <li>• Settlement</li> <li>• Inclination</li> </ul>		<b>B</b>	<ul style="list-style-type: none"> <li>• Water Leak</li> <li>• Peel Off (Roof, Ceiling, Wall, Colum )</li> </ul>	
General Evaluation	<input checked="" type="radio"/> Usual • Poor • Severe		Remarks	No toilet.			
Photograph

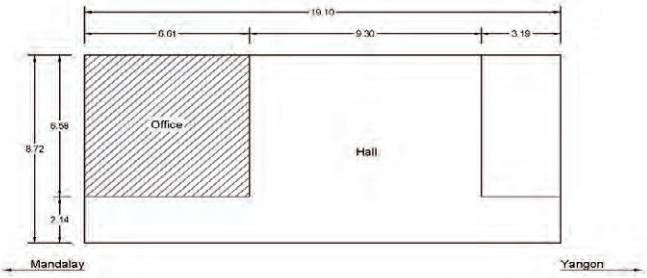
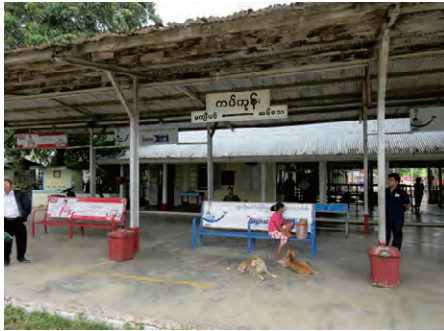
Electric system (Check <input type="radio"/> )	<input checked="" type="radio"/> Retract from outside <input type="radio"/> Solar System <input type="radio"/> Generator		Water Supply (Check <input type="radio"/> )	<input checked="" type="radio"/> Water Well ( Mortar ) <input type="radio"/> Waterwork <input type="radio"/> None		
	Condition of Main Structure	Main Damage Type & Rank*		Condition of Finish Material	Main Damage Type & Rank*		
		C	<input checked="" type="radio"/> Crack ( 8mm) <input type="radio"/> Settlement <input type="radio"/> Inclination		B	<input type="radio"/> Water Leak <input type="radio"/> Peel Off (Roof, Ceiling, Wall, Colum )	
General Evaluation	<input checked="" type="radio"/> Usual <input type="radio"/> Poor <input type="radio"/> Severe		Remarks	No toilet. About 350passengers/day and 4ton/day freight. 1 cable rm and 1generator			
Photograph

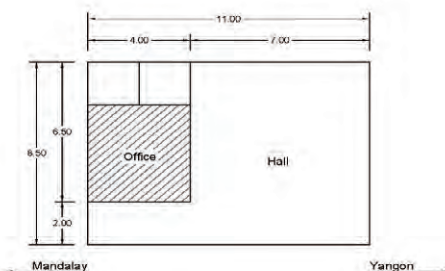
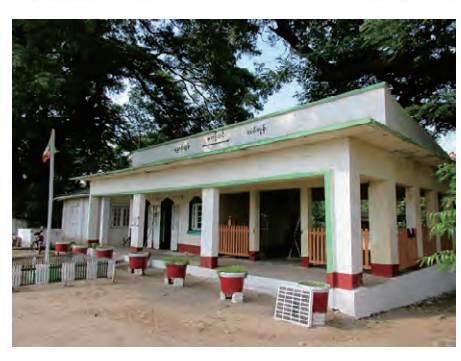
Electric system (Check <input type="radio"/> )	<input checked="" type="radio"/> Retract from outside • Solar System • Generator	Water Supply (Check <input type="radio"/> )	<input checked="" type="radio"/> Water Well (    ) • Waterwork • None			
	Condition of Main Structure	Main Damage Type & Rank*		Condition of Finish Material	Main Damage Type & Rank*		
		D	• Crack ( mm ) • Settlement • Inclination		C	• Water Leak • Peel Off (Roof, Ceiling, Wall, Colum )	
General Evaluation	• Usual <input checked="" type="radio"/> Poor • Severe		Remarks	No toilet.			
Photograph

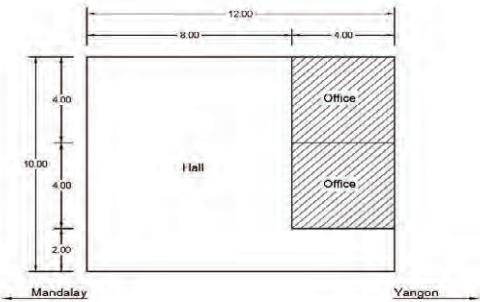
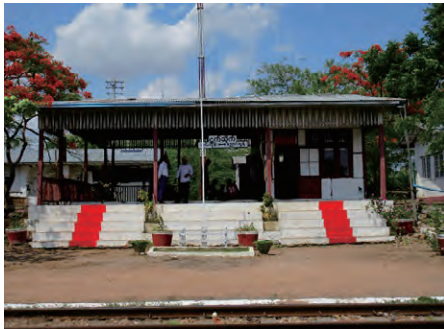
Electric system (Check <input type="radio"/> )	<input checked="" type="radio"/> Retract from outside <input type="radio"/> Solar System <input type="radio"/> Generator		Water Supply (Check <input type="radio"/> )	<input type="radio"/> Water Well (    ) <input type="radio"/> Waterwork <input checked="" type="radio"/> None		
	Condition of Main Structure	Main Damage Type & Rank*		Condition of Finish Material	Main Damage Type & Rank*		
		<b>B</b>	<input type="radio"/> Crack (    mm) <input type="radio"/> Settlement <input type="radio"/> Inclination		<b>B</b>	<input type="radio"/> Water Leak <input type="radio"/> Peel Off (Roof, Ceiling, Wall, Colum )	
General Evaluation	<input checked="" type="radio"/> Usual <input type="radio"/> Poor <input type="radio"/> Severe		Remarks	No toilet.			
Photograph

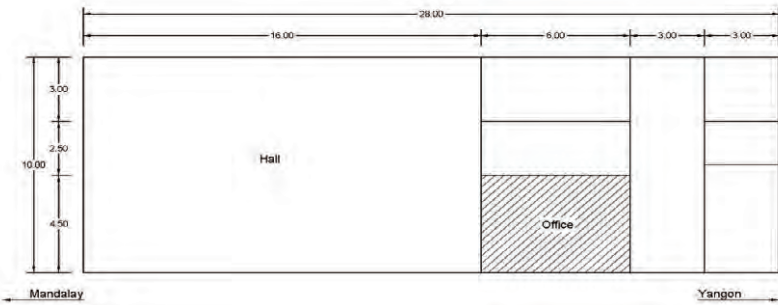
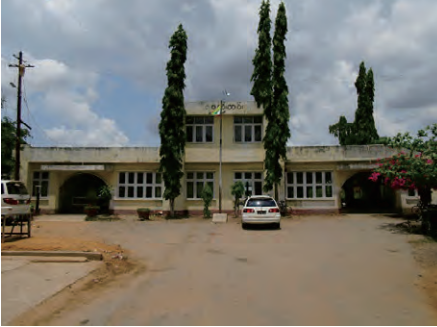
Beam	Wood		<input checked="" type="radio"/> RC    Steel		Floor
	Electric system (Check <input type="radio"/> )	<input checked="" type="radio"/> Retract from outside <ul style="list-style-type: none"> <li>• Solar System</li> <li>• Generator</li> </ul>		Water Supply (Check <input type="radio"/> )	<input checked="" type="radio"/> Water Well (Breaking Pump) <ul style="list-style-type: none"> <li>• Waterwork</li> <li>• None</li> </ul>		
	Condition of Main Structure	Main Damage Type & Rank*		Condition of Finish Material	Main Damage Type & Rank*		
		C	<ul style="list-style-type: none"> <li>• Crack ( mm)</li> <li>• Settlement</li> <li>• Inclination</li> </ul>		D	<input checked="" type="radio"/> Water Leak <input checked="" type="radio"/> Peel Off (Roof, Ceiling, Wall, Colum )	
General Evaluation	<ul style="list-style-type: none"> <li>• Usual</li> <li><input checked="" type="radio"/> Poor</li> <li>• Severe</li> </ul>		Remarks

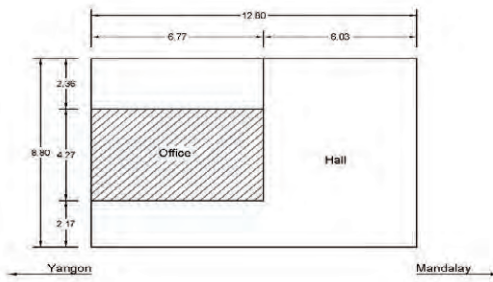
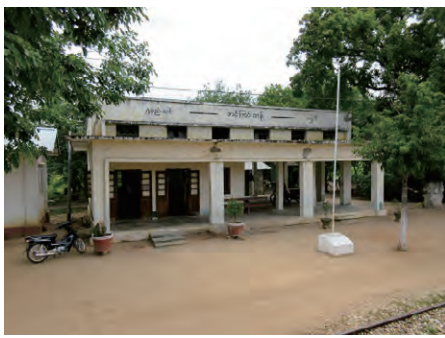
Beam		Wood <input checked="" type="radio"/> RC <input type="radio"/> Steel	Floor	<input checked="" type="radio"/> Concrete <input type="radio"/> Wood	
	Electric system (Check <input type="radio"/> )	<input type="radio"/> Retract from outside <input checked="" type="radio"/> Solar System <input type="radio"/> Generator	Water Supply (Check <input type="radio"/> )	<input checked="" type="radio"/> Water Well ( Mortar ) <input type="radio"/> Waterwork <input type="radio"/> None			
	Condition of Main Structure	Main Damage Type & Rank*		Condition of Finish Material	Main Damage Type & Rank*		
		F	<input checked="" type="radio"/> Crack ( 10mm ) <input checked="" type="radio"/> Settlement <input type="radio"/> Inclination		D	<input checked="" type="radio"/> Water Leak <input checked="" type="radio"/> Peel Off (Roof, Ceiling, Wall, Colum )	
General Evaluation	<input type="radio"/> Usual <input type="radio"/> Poor <input checked="" type="radio"/> Severe		Remarks	No toilet. No passenger and freight. 1 cable rm and 1 generator rm.

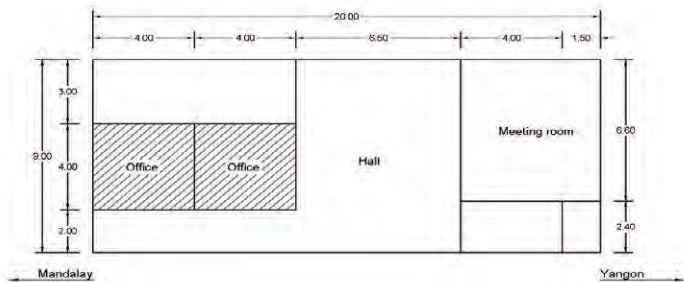
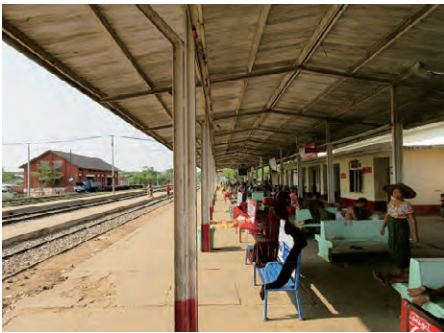
Electric system (Check <input type="radio"/> )	<input checked="" type="radio"/> Retract from outside <input type="radio"/> Solar System <input type="radio"/> Generator		Water Supply (Check <input type="radio"/> )	<input checked="" type="radio"/> Water Well (         ) <input type="radio"/> Waterwork <input type="radio"/> None		
	Condition of Main Structure	Main Damage Type & Rank*			Main Damage Type & Rank*		
		C	<input checked="" type="radio"/> Crack ( 5 mm ) <input type="radio"/> Settlement <input type="radio"/> Inclination		C	<input checked="" type="radio"/> Water Leak <input type="radio"/> Peel Off (Roof, Ceiling, Wall, Colum )	
General Evaluation	<input checked="" type="radio"/> Usual <input type="radio"/> Poor <input type="radio"/> Severe		Remarks	Public toilet pay 100MMK.			
Photograph

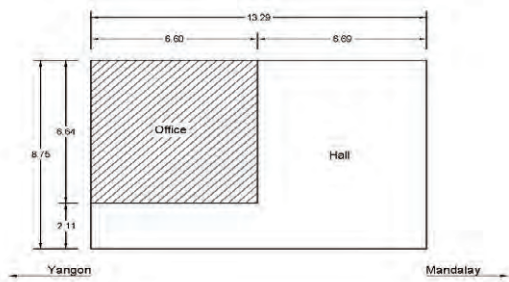
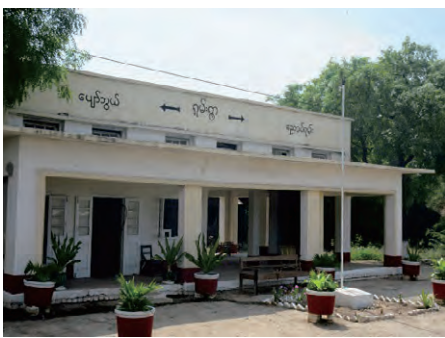
Electric system (Check <input type="radio"/> )	• Retract from outside <input checked="" type="radio"/> Solar System • Generator	Water Supply (Check <input type="radio"/> )	<input checked="" type="radio"/> Water Well ( Mortar ) • Waterwork • None			
	Condition of Main Structure	Main Damage Type & Rank*		Condition of Finish Material	Main Damage Type & Rank*		
		F	<input checked="" type="radio"/> Crack ( 5 mm ) • Settlement • Inclination		C	<input checked="" type="radio"/> Water Leak • Peel Off (Roof, Ceiling, Wall, Colum )	
General Evaluation	• Usual • Poor <input checked="" type="radio"/> Severe	Remarks	No toilet. About 15passengers/day and no freight. 1 cable rm and 1 generator				
Photograph

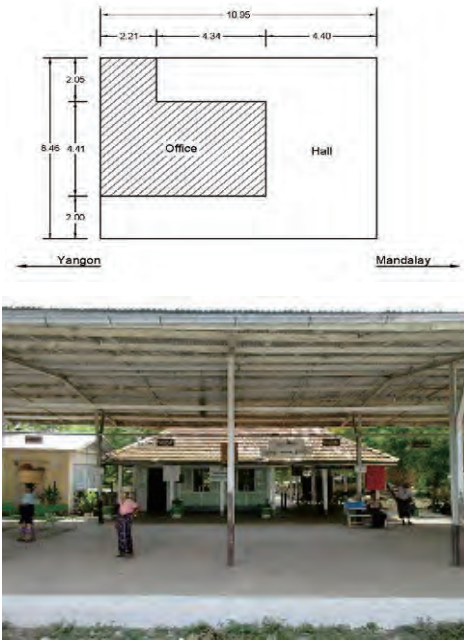
Beam	<input checked="" type="radio"/> Wood <input type="radio"/> RC <input type="radio"/> Steel		Floor	<input checked="" type="radio"/> Concrete <input type="radio"/> Wood	
	Electric system (Check <input type="radio"/> )	<input checked="" type="radio"/> Retract from outside <input type="radio"/> Solar System <input type="radio"/> Generator		Water Supply (Check <input type="radio"/> )	<input checked="" type="radio"/> Water Well ( Pump ) <input type="radio"/> Waterwork <input type="radio"/> None		
	Condition of Main Structure	Main Damage Type & Rank*		Condition of Finish Material	Main Damage Type & Rank*		
		D	<input checked="" type="radio"/> Crack ( 5 mm ) <input type="radio"/> Settlement <input checked="" type="radio"/> Inclination 2°		D	<input checked="" type="radio"/> Water Leak <input checked="" type="radio"/> Peel Off (Roof, Ceiling, Wall, Colum )	
General Evaluation	<input type="radio"/> Usual <input checked="" type="radio"/> Poor <input type="radio"/> Severe		Remarks	No toilet. About 90passengers/day and 200viss/day freight. 1 cable rm and 1 generator

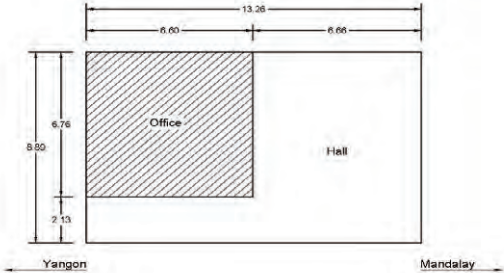
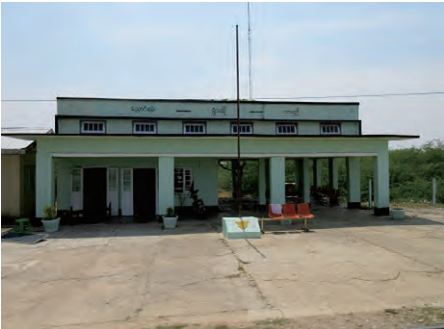
Beam		Wood <input checked="" type="radio"/> RC <input type="radio"/> Steel	Floor	<input checked="" type="radio"/> Concrete <input type="radio"/> Wood	
	Electric system (Check <input type="radio"/> )	<input type="radio"/> Retract from outside <input type="radio"/> Solar System <input checked="" type="radio"/> Generator	Water Supply (Check <input type="radio"/> )	<input type="radio"/> Water Well (    ) <input type="radio"/> Waterwork <input checked="" type="radio"/> None			
	Condition of Main Structure	Main Damage Type & Rank*		Condition of Finish Material	Main Damage Type & Rank*		
		F	<input checked="" type="radio"/> Crack ( 7mm ) <input type="radio"/> Settlement <input type="radio"/> Inclination		F	<input checked="" type="radio"/> Water Leak <input checked="" type="radio"/> Peel Off (Roof, Ceiling, Wall, Colum )	
General Evaluation	<input type="radio"/> Usual <input type="radio"/> Poor <input checked="" type="radio"/> Severe		Remarks	About 15passengers/day and no freight. 1 toilet, 1 cable rm and 1 generator rm.

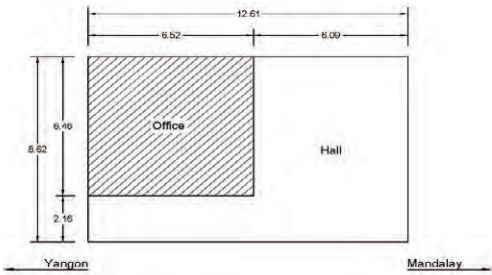
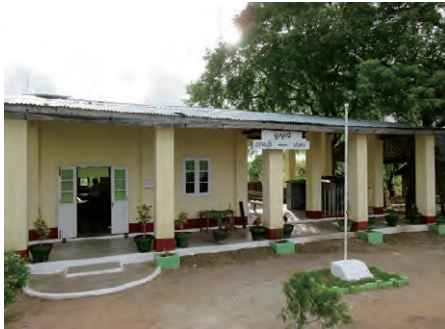
Beam	<input checked="" type="radio"/> Wood		<input type="radio"/> RC <input type="radio"/> Steel	Floor	<input checked="" type="radio"/> Concrete <input type="radio"/> Wood
	Electric system (Check <input type="radio"/> )	<input type="radio"/> Retract from outside <input checked="" type="radio"/> Solar System <input type="radio"/> Generator		Water Supply (Check <input type="radio"/> )	<input type="radio"/> Water Well (    ) <input type="radio"/> Waterwork <input checked="" type="radio"/> None		
	Condition of Main Structure	Main Damage Type & Rank*		Condition of Finish Material	Main Damage Type & Rank*		
		C	<input checked="" type="radio"/> Crack ( 6mm) <input type="radio"/> Settlement <input type="radio"/> Inclination		B	<input type="radio"/> Water Leak <input type="radio"/> Peel Off (Roof, Ceiling, Wall, Colum )	
General Evaluation	<input checked="" type="radio"/> Usual <input type="radio"/> Poor <input type="radio"/> Severe		Remarks	About 2passengers/day and no freight. No toilet. 1 cable rm.

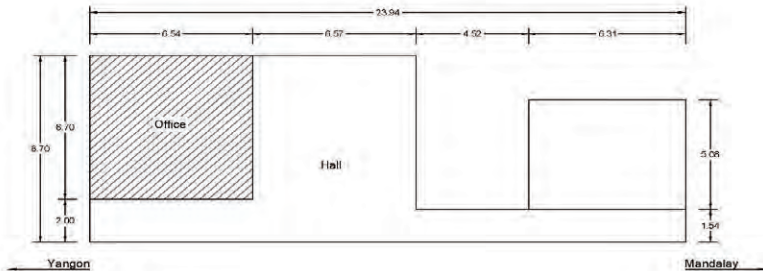
Electric system (Check <input type="radio"/> )	<input checked="" type="radio"/> Retract from outside • Solar System • Generator		Water Supply (Check <input type="radio"/> )	• Water Well (    ) • Waterwork <input checked="" type="radio"/> None		
	Condition of Main Structure	Main Damage Type & Rank*		Condition of Finish Material	Main Damage Type & Rank*		
		F	<input checked="" type="radio"/> Crack ( 6mm) • Settlement • Inclination		D	<input checked="" type="radio"/> Water Leak <input checked="" type="radio"/> Peel Off (Roof, Ceiling, Wall, Colum )	
General Evaluation	• Usual • Poor <input checked="" type="radio"/> Severe		Remarks	About 30passengers/day and a little freight.No toilet. 1 cable rm,1 generator rm and 2shop rm.			
Photograph

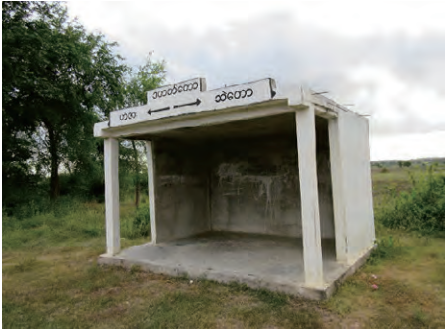
Electric system (Check <input type="radio"/> )	• Retract from outside • Solar System • Generator	Water Supply (Check <input type="radio"/> )	• Water Well ( ) • Waterwork <input checked="" type="radio"/> None			
	Condition of Main Structure	Main Damage Type & Rank*		Condition of Finish Material	Main Damage Type & Rank*		
		<b>B</b>	• Crack ( mm) • Settlement • Inclination		<b>B</b>	• Water Leak • Peel Off (Roof, Ceiling, Wall, Colum )	
General Evaluation	<input checked="" type="radio"/> Usual • Poor • Severe		Remarks				
Photograph

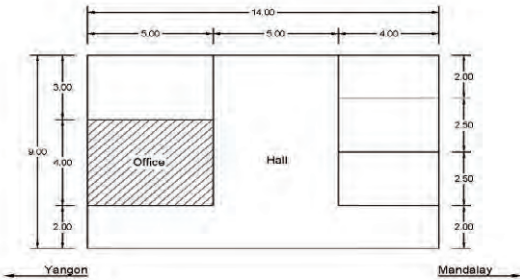
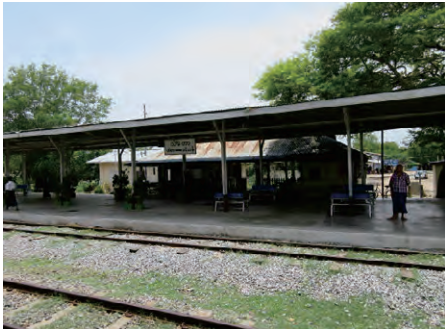
Electric system (Check <input type="radio"/> )	<input checked="" type="radio"/> Retract from outside <input type="radio"/> Solar System <input type="radio"/> Generator		Water Supply (Check <input type="radio"/> )	<input checked="" type="radio"/> Water Well (    ) <input type="radio"/> Waterwork <input type="radio"/> None		
	Condition of Main Structure	Main Damage Type & Rank*			Condition of Finish Material	Main Damage Type & Rank*	
		<b>B</b>	<input type="radio"/> Crack (    mm) <input type="radio"/> Settlement <input type="radio"/> Inclination			<b>B</b>	<input type="radio"/> Water Leak <input type="radio"/> Peel Off (Roof, Ceiling, Wall, Colum )
General Evaluation	<input checked="" type="radio"/> Usual <input type="radio"/> Poor <input type="radio"/> Severe		Remarks	Public toilet.			
Photograph

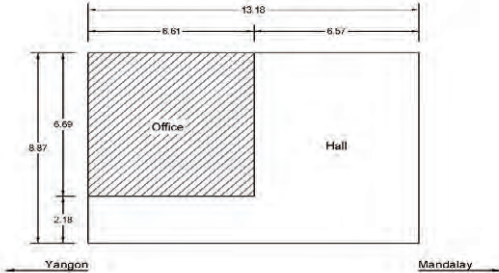
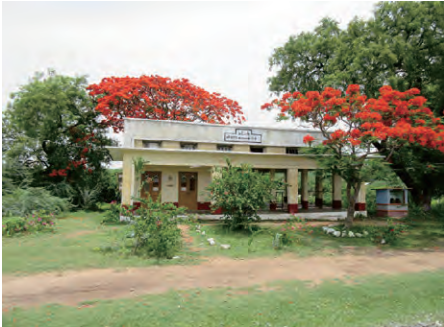
Electric system (Check <input type="radio"/> )	<input checked="" type="radio"/> Retract from outside • Solar System • Generator	Water Supply (Check <input type="radio"/> )	• Water Well ( ) • Waterwork <input checked="" type="radio"/> None			
	Condition of Main Structure	Main Damage Type & Rank*		Condition of Finish Material	Main Damage Type & Rank*		
		F	<input checked="" type="radio"/> Crack ( 10mm) <input checked="" type="radio"/> Settlement <input checked="" type="radio"/> Inclination		D	<input checked="" type="radio"/> Water Leak <input checked="" type="radio"/> Peel Off (Roof, Ceiling, Wall, Colum )	
General Evaluation	• Usual • Poor <input checked="" type="radio"/> Severe	Remarks	About 15passengers/day and 5–10boxes/day freight. No toilet. No cable rm.				
Photograph

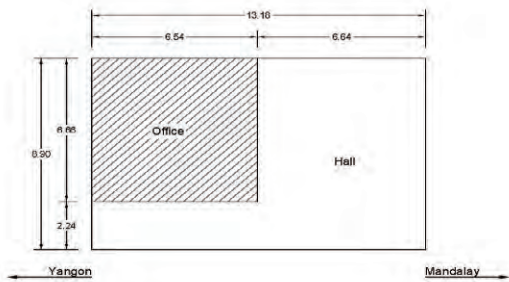
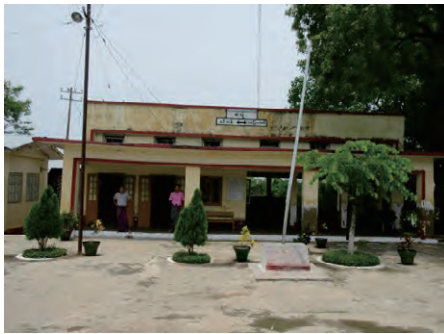
Electric system (Check <input type="radio"/> )	<input checked="" type="radio"/> Retract from outside • Solar System • Generator	Water Supply (Check <input type="radio"/> )	<input checked="" type="radio"/> Water Well ( Mortar ) • Waterwork • None			
	Condition of Main Structure	Main Damage Type & Rank*		Condition of Finish Material	Main Damage Type & Rank*		
		F	<input checked="" type="radio"/> Crack ( 6mm) • Settlement • Inclination		C	<input checked="" type="radio"/> Water Leak • Peel Off (Roof, Ceiling, Wall, Colum )	
General Evaluation	• Usual • Poor <input checked="" type="radio"/> Severe	Remarks	About 40passengers/day and 400viss/day freight. No toilet. 1 cable rm and 1 generator				
Photograph

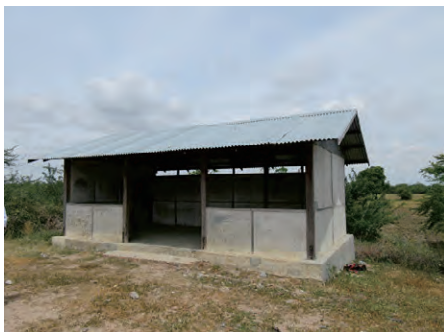
Beam		<input checked="" type="radio"/> Wood    RC    Steel	Floor	<input checked="" type="radio"/> Concrete    ▪ Wood	
	Electric system (Check <input type="radio"/> )	<ul style="list-style-type: none"> <li>▪ Retract from outside</li> <li>▪ Solar System</li> <li>▪ Generator</li> </ul>	Water Supply (Check <input type="radio"/> )	<ul style="list-style-type: none"> <li>▪ Water Well (            )</li> <li>▪ Waterwork</li> <li><input checked="" type="radio"/> None</li> </ul>			
	Condition of Main Structure	Main Damage Type & Rank*		Condition of Finish Material	Main Damage Type & Rank*		
		B	<ul style="list-style-type: none"> <li>▪ Crack (    mm)</li> <li>▪ Settlement</li> <li>▪ Inclination</li> </ul>		B	<ul style="list-style-type: none"> <li>▪ Water Leak</li> <li>▪ Peel Off (Roof, Ceiling, Wall, Colum )</li> </ul>	
General Evaluation	<input checked="" type="radio"/> Usual <ul style="list-style-type: none"> <li>▪ Poor</li> <li>▪ Severe</li> </ul>		Remarks

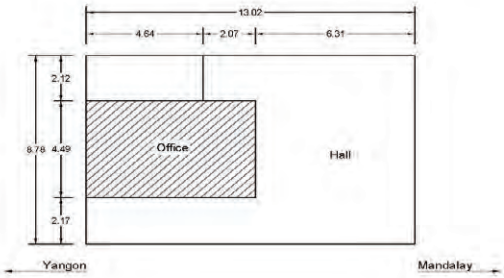
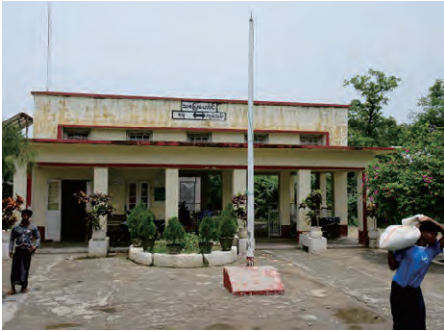
Electric system (Check <input type="radio"/> )	• Retract from outside <input checked="" type="radio"/> Solar System • Generator	Water Supply (Check <input type="radio"/> )	<input checked="" type="radio"/> Water Well ( Tube    ) • Waterwork • None			
	Condition of Main Structure	Main Damage Type & Rank*		Condition of Finish Material	Main Damage Type & Rank*		
		<b>B</b>	• Crack (    mm) • Settlement • Inclination		<b>C</b>	<input checked="" type="radio"/> Water Leak • Peel Off (Roof, Ceiling, Wall, Colum )	
General Evaluation	<input checked="" type="radio"/> Usual • Poor • Severe		Remarks	About 20passengers/day and no freight. 1 toilet rm,1 cable rm and 1 generator rm.			
Photograph

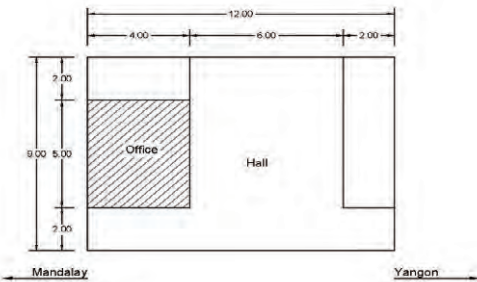
Photograph

Beam		<input checked="" type="radio"/> Wood <input type="radio"/> RC <input type="radio"/> Steel	Floor	<input checked="" type="radio"/> Concrete <input type="radio"/> Wood	
	Electric system (Check <input type="radio"/> )	<input checked="" type="radio"/> Retract from outside <input type="radio"/> Solar System <input type="radio"/> Generator	Water Supply (Check <input type="radio"/> )	<input checked="" type="radio"/> Water Well ( Pump ) <input type="radio"/> Waterwork <input type="radio"/> None			
	Condition of Main Structure	Main Damage Type & Rank*		Condition of Finish Material	Main Damage Type & Rank*		
		D	<input checked="" type="radio"/> Crack ( 10mm ) <input type="radio"/> Settlement <input type="radio"/> Inclination		B	<input type="radio"/> Water Leak <input type="radio"/> Peel Off ( Roof, Ceiling, Wall, Colum )	
General Evaluation	<input type="radio"/> Usual <input checked="" type="radio"/> Poor <input type="radio"/> Severe		Remarks	No toilet.

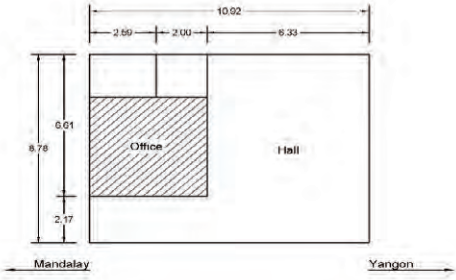
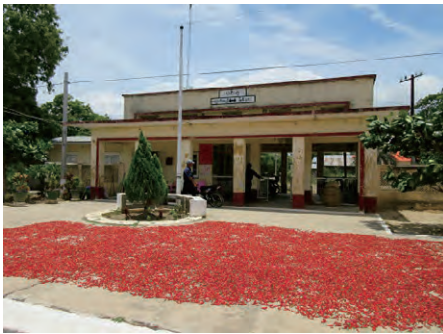
Station No.	84	Line Name	Yangon – Mandalay Line	Date of Survey	7/7/2017		
Station Name	MINZU						
Existing Station Building	Kilopost	567	Mileage	352-1/2			
	Access Road	<input checked="" type="radio"/> Yes <input type="radio"/> No	Age of Building	Over 100 years			
	Story of Building	( 1 ) Story Building	Total Floor Area	About 97 m <sup>2</sup>			
	Type of Main Structure (Check <input type="radio"/> )	<input checked="" type="radio"/> Brick with RC • Wood • Other(    )	Finish Material	Roof	<input checked="" type="radio"/> Corrugated Steel sheet • Roof Tiles • RC • Asbestos Fibre Cement		
	Other Structure	Wall		<input checked="" type="radio"/> Brick <input type="radio"/> Wood	Wall	<input checked="" type="radio"/> Paint	
		Column		<input checked="" type="radio"/> Brick <input type="radio"/> Wood <input type="radio"/> RC	Column	<input checked="" type="radio"/> Paint	
		Beam		Wood <input checked="" type="radio"/> RC <input type="radio"/> Steel	Floor	<input checked="" type="radio"/> Concrete    • Wood

Electric system (Check <input type="radio"/> )	<input checked="" type="radio"/> Retract from outside • Solar System • Generator	Water Supply (Check <input type="radio"/> )	• Water Well (    ) <input type="radio"/> Waterwork • None			
	Condition of Main Structure	Main Damage Type & Rank*		Condition of Finish Material	Main Damage Type & Rank*		
		F	<input checked="" type="radio"/> Crack ( 5 mm ) • Settlement • Inclination		F	<input checked="" type="radio"/> Water Leak <input checked="" type="radio"/> Peel Off (Roof, Ceiling, Wall, Colum )	
General Evaluation	• Usual • Poor <input checked="" type="radio"/> Severe		Remarks	No toilet. About 10passengers/day and a little freight sometime. 1 cable rm and 1 generator			
Photograph

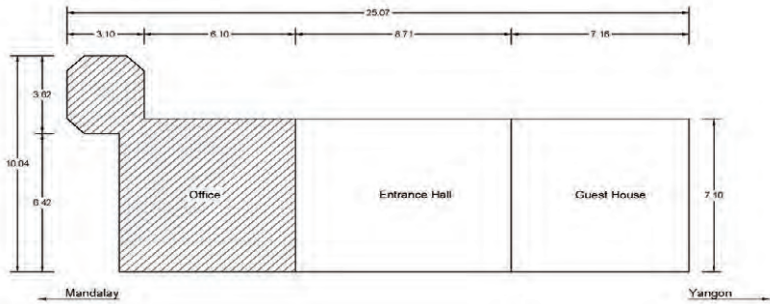
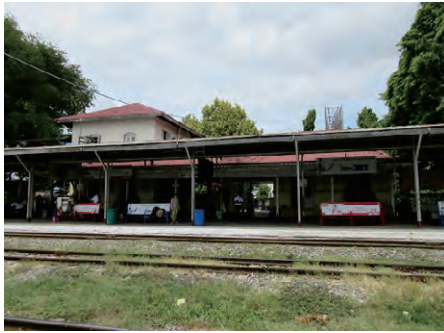
Station No.	85	Line Name	Yangon – Mandalay Line	Date of Survey	7/7/2017		
Station Name	KYAUKSE						
Existing Station Building	Kilopost	578		Mileage	359-1/4		
	Access Road	<input checked="" type="radio"/> Yes    No		Age of Building	Over 100 years		
	Story of Building	( 2 ) Story Building		Total Floor Area	About 174 m <sup>2</sup>		
	Type of Main Structure (Check <input type="radio"/> )	<input type="radio"/> Brick with RC <input checked="" type="radio"/> Wood <input type="radio"/> Other(    )		Finish Material	Roof	<input checked="" type="radio"/> Corrugated Steel sheet <input type="radio"/> Roof Tiles <input type="radio"/> RC <input type="radio"/> Asbestos Fibre Cement	
	Other Structure	Wall	<input checked="" type="radio"/> Brick    Wood		Wall	<input checked="" type="radio"/> Paint	
		Column	Brick		<input checked="" type="radio"/> Wood    RC	Column	<input checked="" type="radio"/> Paint
		Beam	<input checked="" type="radio"/> Wood    RC    Steel		Floor	<input checked="" type="radio"/> Concrete <input type="radio"/> Wood

Electric system (Check <input type="radio"/> )	<input checked="" type="radio"/> Retract from outside <input type="radio"/> Solar System <input type="radio"/> Generator		Water Supply (Check <input type="radio"/> )	<input type="radio"/> Water Well (    ) <input checked="" type="radio"/> Waterwork <input type="radio"/> None		
	Condition of Main Structure	Main Damage Type & Rank*			Condition of Finish Material	Main Damage Type & Rank*	
		C	<input checked="" type="radio"/> Crack ( 5mm) <input type="radio"/> Settlement <input type="radio"/> Inclination			B	<input type="radio"/> Water Leak <input type="radio"/> Peel Off (Roof, Ceiling, Wall, Colum )
General Evaluation	<input checked="" type="radio"/> Usual <input type="radio"/> Poor <input type="radio"/> Severe		Remarks	About 130passengers/day and 2600viss/day freight. 6 toilet rm,1 cable rm,2 generator rm and 1 guest rm.			
Photograph

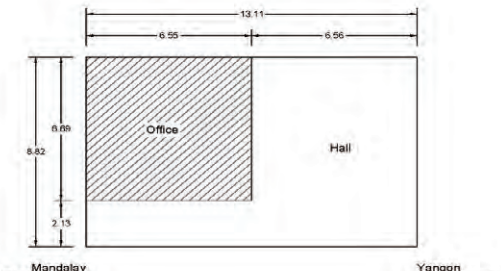
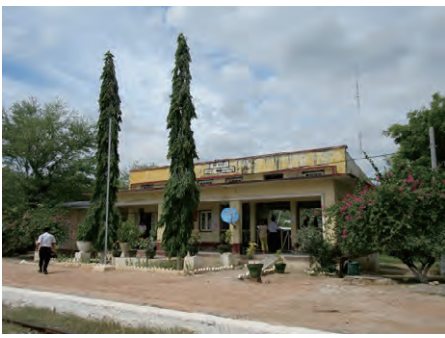
Station No.	86	Line Name	Yangon – Mandalay Line	Date of Survey	7/7/2017		
Station Name	BELIN						
Existing Station Building	Kilopost	585	Mileage	363-1/2			
	Access Road	<input checked="" type="radio"/> Yes <input type="radio"/> No	Age of Building	Over 100 years			
	Story of Building	( 1 ) Story Building	Total Floor Area	About 118m <sup>2</sup>			
	Type of Main Structure (Check <input type="radio"/> )	<input checked="" type="radio"/> Brick with RC • Wood • Other(    )	Finish Material	Roof	<input checked="" type="radio"/> Corrugated Steel sheet • Roof Tiles • RC • Asbestos Fibre Cement		
	Other Structure	Wall		<input checked="" type="radio"/> Brick <input type="radio"/> Wood	Wall	<input checked="" type="radio"/> Paint	
		Column		<input checked="" type="radio"/> Brick <input type="radio"/> Wood <input type="radio"/> RC	Column	<input checked="" type="radio"/> Paint	
		Beam		Wood <input checked="" type="radio"/> RC <input type="radio"/> Steel	Floor	<input checked="" type="radio"/> Concrete    • Wood

Electric system (Check <input type="radio"/> )	<input checked="" type="radio"/> Retract from outside • Solar System • Generator	Water Supply (Check <input type="radio"/> )	<input checked="" type="radio"/> Water Well ( Mortar ) • Waterwork • None			
	Condition of Main Structure	Main Damage Type & Rank*		Condition of Finish Material	Main Damage Type & Rank*		
		D	<input checked="" type="radio"/> Crack ( 8mm) • Settlement • Inclination		B	• Water Leak • Peel Off (Roof, Ceiling, Wall, Colum )	
General Evaluation	• Usual <input checked="" type="radio"/> Poor • Severe	Remarks	About 10passengers/day and stone & cement freight. 1 toilet rm,1 cable rm and 1 generator rm.				
Photograph

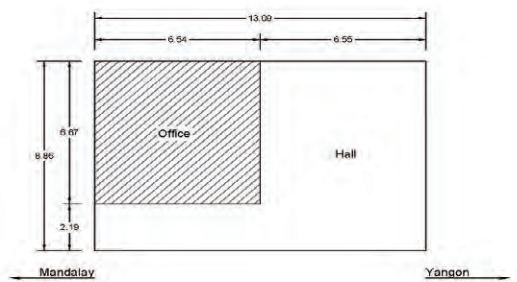
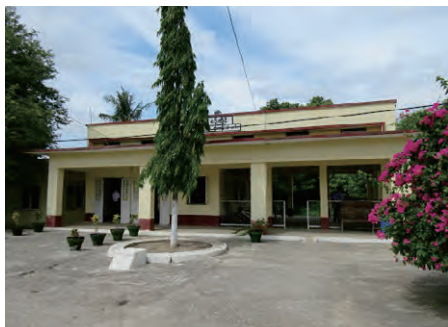
Photograph

Beam		Wood <input checked="" type="radio"/> RC <input type="radio"/> Steel	Floor	<input checked="" type="radio"/> Concrete    • Wood	
	Electric system (Check <input type="radio"/> )	<input checked="" type="radio"/> Retract from outside • Solar System • Generator	Water Supply (Check <input type="radio"/> )	<input checked="" type="radio"/> Water Well ( Mortar ) <input type="radio"/> Waterwork <input type="radio"/> None			
	Condition of Main Structure	Main Damage Type & Rank*		Condition of Finish Material	Main Damage Type & Rank*		
		F	<input checked="" type="radio"/> Crack (4 mm) <input type="radio"/> Settlement <input type="radio"/> Inclination		B	<input type="radio"/> Water Leak <input type="radio"/> Peel Off (Roof, Ceiling, Wall, Colum )	
General Evaluation	<input type="radio"/> Usual <input type="radio"/> Poor <input checked="" type="radio"/> Severe		Remarks	About 3passengers/day and no freight. 1 toilet rm,1 cable rm and 1 generator rm.

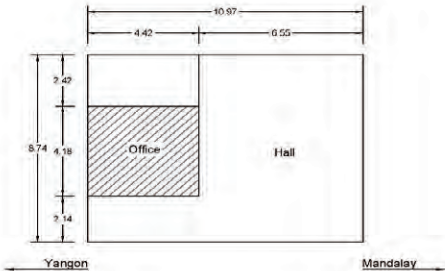
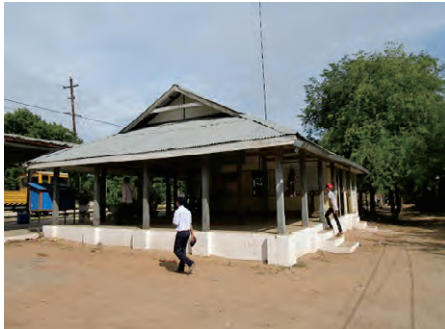
Station No.	88	Line Name	Yangon – Mandalay Line	Date of Survey	7/7/2017		
Station Name	PALEIK						
Existing Station Building	Kilopost	602		Mileage	374-1/4		
	Access Road	<input checked="" type="radio"/> Yes    No		Age of Building	Over 100 years		
	Story of Building	( 1 ) Story Building		Total Floor Area	About 97 m <sup>2</sup>		
	Type of Main Structure (Check <input type="radio"/> )	<input type="radio"/> Brick with RC <input checked="" type="radio"/> Wood <input type="radio"/> Other(    )		Finish Material	Roof	<input checked="" type="radio"/> Corrugated Steel sheet <input type="radio"/> Roof Tiles <input type="radio"/> RC <input type="radio"/> Asbestos Fibre Cement	
	Other Structure	Wall	<input checked="" type="radio"/> Brick    Wood		Wall	<input checked="" type="radio"/> Paint	
		Column	Brick		<input checked="" type="radio"/> Wood    RC	Column	<input checked="" type="radio"/> Paint
		Beam	<input checked="" type="radio"/> Wood    RC    Steel		Floor	<input checked="" type="radio"/> Concrete <input type="radio"/> Wood

Electric system (Check <input type="radio"/> )	<input checked="" type="radio"/> Retract from outside <input type="radio"/> Solar System <input type="radio"/> Generator		Water Supply (Check <input type="radio"/> )	<input checked="" type="radio"/> Water Well ( Mortar ) <input type="radio"/> Waterwork <input type="radio"/> None		
	Condition of Main Structure	Main Damage Type & Rank*			Condition of Finish Material	Main Damage Type & Rank*	
		B	<input checked="" type="radio"/> Crack ( 5mm) <input type="radio"/> Settlement <input type="radio"/> Inclination			B	<input type="radio"/> Water Leak <input type="radio"/> Peel Off (Roof, Ceiling, Wall, Colum )
General Evaluation	<input checked="" type="radio"/> Usual <input type="radio"/> Poor <input type="radio"/> Severe		Remarks	About 30passengers/day and 200viss/day freight. 1 toilet rm and 1 cable rm.			
Photograph
