## **APPENDIX 5.9**

# **Existing station Building Conditions**

## Investigation of Station Building

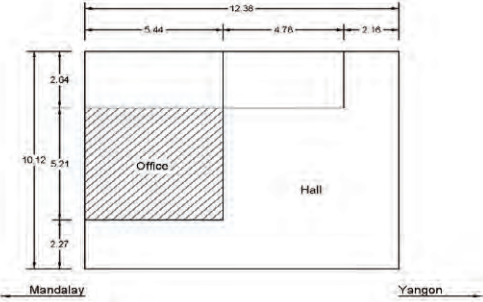
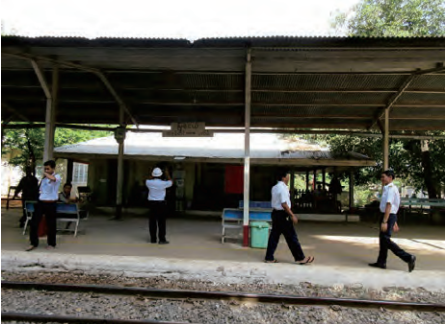
Station No.	89	Line Name	Yangon – Mandalay Line	Date of Survy	7/7/2017		
Station Name	MYITNGE						
Existing Station Building	Kilopost	607		Mileage	377-3/4		
	Access Road	<input checked="" type="radio"/> Yes    No		Age of Building	Over 50 years		
	Story of Building	( 1 ) Story Building		Total Floor Area	About 126 m <sup>2</sup>		
	Type of Main Structure (Check <input type="radio"/> )	<input type="radio"/> Brick with RC <input checked="" type="radio"/> Wood <input type="radio"/> Other(    )		Finish Material	Roof	<input checked="" type="radio"/> Corrugated Steel sheet <input type="radio"/> Roof Tiles <input type="radio"/> RC <input type="radio"/> Asbestos Fibre Cement	
		Other Structure	Wall		<input checked="" type="radio"/> Brick    Wood	Wall	<input checked="" type="radio"/> Paint
			Column		Brick <input checked="" type="radio"/> Wood    RC	Column	<input checked="" type="radio"/> Paint
			Beam		<input checked="" type="radio"/> Wood    RC    Steel	Floor	<input checked="" type="radio"/> Concrete <input type="radio"/> Wood

Electric system (Check <input type="radio"/> )	<input checked="" type="radio"/> Retract from outside <input checked="" type="radio"/> Solar System <input type="radio"/> Generator		Water Supply (Check <input type="radio"/> )	<input type="radio"/> Water Well ( Mortar ) <input checked="" type="radio"/> Waterwork <input type="radio"/> None		
	Condition of Main Structure	Main Damage Type & Rank*		Condition of Finish Material	Main Damage Type & Rank*		
		<b>B</b>	<input checked="" type="radio"/> Crack ( 5mm) <input type="radio"/> Settlement <input type="radio"/> Inclination		<b>B</b>	<input type="radio"/> Water Leak <input type="radio"/> Peel Off (Roof, Ceiling, Wall, Colum )	
General Evaluation	<input checked="" type="radio"/> Usual <input type="radio"/> Poor <input type="radio"/> Severe		Remarks	About 20passengers/day and 200viss/day freight. 1 toilet rm and 1 cable rm.			
Photograph

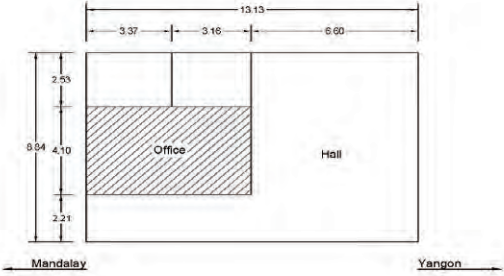
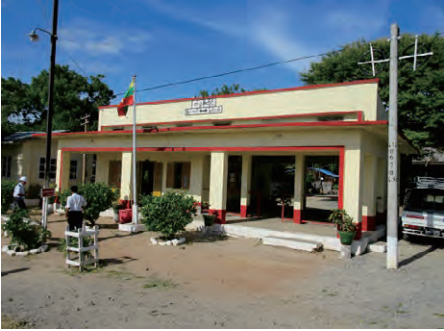
Station No.	90	Line Name	Yangon – Mandalay Line	Date of Survey	7/7/2017		
Station Name	TAGUNDAING						
Existing Station Building	Kilopost	611.5	Mileage	380-1/2			
	Access Road	<input checked="" type="radio"/> Yes    No	Age of Building	Over 100 years			
	Story of Building	( 1 ) Story Building	Total Floor Area	About 117 m <sup>2</sup>			
	Type of Main Structure (Check <input type="radio"/> )	<input checked="" type="radio"/> Brick with RC • Wood • Other(    )	Finish Material	Roof	<input checked="" type="radio"/> Corrugated Steel sheet • Roof Tiles • RC • Asbestos Fibre Cement		
	Other Structure	Wall		<input checked="" type="radio"/> Brick    Wood	Wall	<input checked="" type="radio"/> Paint	
		Column		<input checked="" type="radio"/> Brick    Wood    RC	Column	<input checked="" type="radio"/> Paint	
		Beam		Wood <input checked="" type="radio"/> RC    Steel	Floor	<input checked="" type="radio"/> Concrete    • Wood

Electric system (Check <input type="radio"/> )	<input checked="" type="radio"/> Retract from outside • Solar System • Generator	Water Supply (Check <input type="radio"/> )	<input checked="" type="radio"/> Water Well ( Tube    ) • Waterwork • None			
	Condition of Main Structure	Main Damage Type & Rank*		Condition of Finish Material	Main Damage Type & Rank*		
		F	<input checked="" type="radio"/> Crack ( 10mm) • Settlement • Inclination		C	<input checked="" type="radio"/> Water Leak • Peel Off (Roof, Ceiling, Wall, Colum )	
General Evaluation	• Usual • Poor <input checked="" type="radio"/> Severe		Remarks	About 20passengers/day and 12viss/day freight. No toilet rm and 1 cable rm.			
Photograph

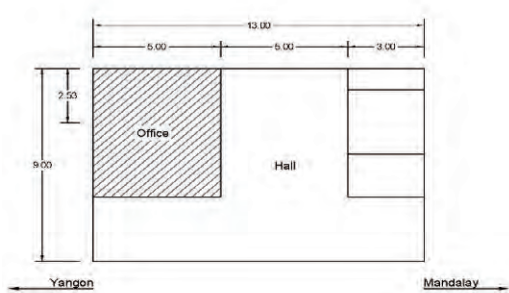
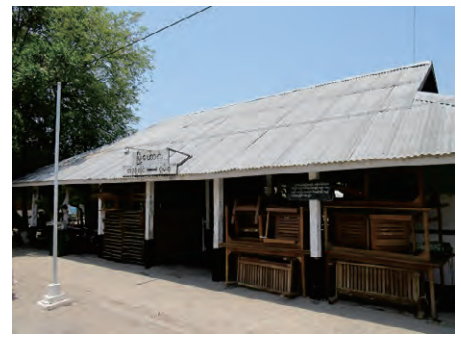
Station No.	91	Line Name	Yangon – Mandalay Line	Date of Survey	22/5/2017		
Station Name	MYOHAUNG						
Existing Station Building	Kilopost	616		Mileage	382-3/4		
	Access Road	<input checked="" type="radio"/> Yes    No		Age of Building	Over 100 years		
	Story of Building	( 1 ) Story Building		Total Floor Area	About 120 m <sup>2</sup>		
	Type of Main Structure (Check <input type="radio"/> )	<input type="radio"/> Brick with RC <input checked="" type="radio"/> Wood <input type="radio"/> Other(    )		Finish Material	Roof	<input checked="" type="radio"/> Corrugated Steel sheet <input type="radio"/> Roof Tiles <input type="radio"/> RC <input type="radio"/> Asbestos Fibre Cement	
		Other Structure	Wall		<input checked="" type="radio"/> Brick    Wood	Wall	<input checked="" type="radio"/> Paint
			Column		Brick <input checked="" type="radio"/> Wood    RC	Column	<input checked="" type="radio"/> Paint
			Beam		<input checked="" type="radio"/> Wood    RC    Steel	Floor	<input checked="" type="radio"/> Concrete <input type="radio"/> Wood

Electric system (Check <input type="radio"/> )	<input checked="" type="radio"/> Retract from outside <input type="radio"/> Solar System <input type="radio"/> Generator		Water Supply (Check <input type="radio"/> )	<input checked="" type="radio"/> Water Well ( Pump ) <input type="radio"/> Waterwork <input type="radio"/> None		
	Condition of Main Structure	Main Damage Type & Rank*		Condition of Finish Material	Main Damage Type & Rank*		
		<b>B</b>	<input type="radio"/> Crack (    mm) <input type="radio"/> Settlement <input type="radio"/> Inclination		<b>B</b>	<input type="radio"/> Water Leak <input type="radio"/> Peel Off (Roof, Ceiling, Wall, Colum )	
General Evaluation	<input checked="" type="radio"/> Usual <input type="radio"/> Poor <input type="radio"/> Severe		Remarks	Toilet for staff.			
Photograph

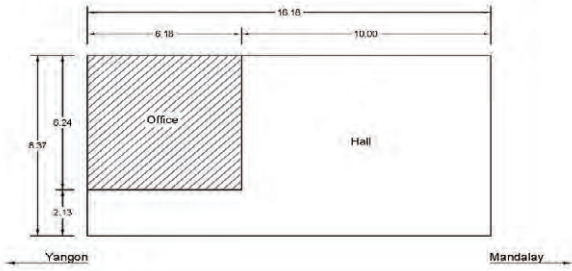
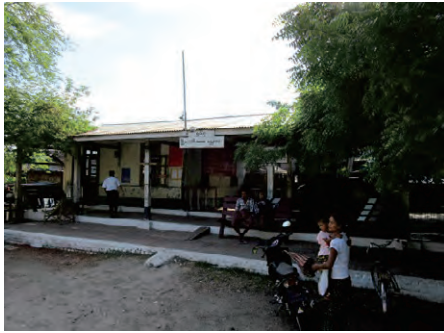
Station No.	92	Line Name	Yangon – Mandalay Line	Date of Survey	7/7/2017		
Station Name	SHANZU						
Existing Station Building	Kilopost	617.5	Mileage	384			
	Access Road	<input checked="" type="radio"/> Yes <input type="radio"/> No	Age of Building	Over 50 years			
	Story of Building	( 1 ) Story Building	Total Floor Area	About 136 m <sup>2</sup>			
	Type of Main Structure (Check <input type="radio"/> )	<input checked="" type="radio"/> Brick with RC • Wood • Other(    )	Finish Material	Roof	<input checked="" type="radio"/> Corrugated Steel sheet • Roof Tiles • RC • Asbestos Fibre Cement		
	Other Structure	Wall		<input checked="" type="radio"/> Brick <input type="radio"/> Wood	Wall	<input checked="" type="radio"/> Paint	
		Column		Brick <input checked="" type="radio"/> Wood <input type="radio"/> RC	Column	<input checked="" type="radio"/> Paint	
		Beam		<input checked="" type="radio"/> Wood <input type="radio"/> RC <input type="radio"/> Steel	Floor	<input checked="" type="radio"/> Concrete    • Wood

Electric system (Check <input type="radio"/> )	<input checked="" type="radio"/> Retract from outside • Solar System • Generator	Water Supply (Check <input type="radio"/> )	• Water Well (    ) • Waterwork <input checked="" type="radio"/> None			
	Condition of Main Structure	Main Damage Type & Rank*		Condition of Finish Material	Main Damage Type & Rank*		
		D	<input checked="" type="radio"/> Crack ( 6mm) • Settlement • Inclination		C	<input checked="" type="radio"/> Water Leak • Peel Off (Roof, Ceiling, Wall, Colum )	
General Evaluation	• Usual <input checked="" type="radio"/> Poor • Severe	Remarks	No toilet. About 10–15passengers/day.				
Photograph

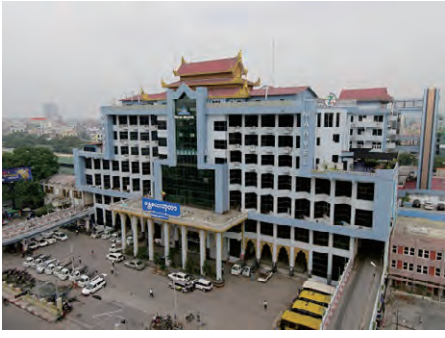
Photograph

Beam	Wood <input checked="" type="radio"/> RC    Steel		Floor	<input checked="" type="radio"/> Concrete <input type="radio"/> Wood	
	Electric system (Check <input type="radio"/> )	<input checked="" type="radio"/> Retract from outside <input type="radio"/> Solar System <input type="radio"/> Generator		Water Supply (Check <input type="radio"/> )	<input checked="" type="radio"/> Water Well ( Pump ) <input type="radio"/> Waterwork <input type="radio"/> None		
	Condition of Main Structure	Main Damage Type & Rank*		Condition of Finish Material	Main Damage Type & Rank*		
		<b>B</b>	<input type="checkbox"/> Crack (    mm) <input type="checkbox"/> Settlement <input type="checkbox"/> Inclination		<b>C</b>	<input checked="" type="radio"/> Water Leak <input type="checkbox"/> Peel Off (Roof, Ceiling, Wall, Colum )	
General Evaluation	<input checked="" type="radio"/> Usual <input type="radio"/> Poor <input type="radio"/> Severe		Remarks
