## **APPENDIX 5.9**

### **Existing station Building Conditions**

## Investigation of Station Building

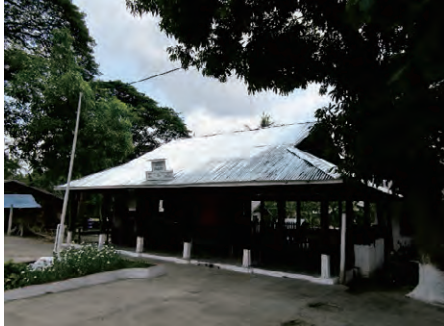
Station No.	45	Line Name	Yangon – Mandalay Line	Date of Survy	16/5/2017		
Station Name	THARGAYA						
Existing Station Building	Kilopost	314.5		Mileage	195.25		
	Access Road	<input checked="" type="radio"/> Yes    No		Age of Building	Over 100 years		
	Story of Building	( 1 ) Story Building		Total Floor Area	About 108 m <sup>2</sup>		
	Type of Main Structure (Check <input type="radio"/> )	<input type="radio"/> Brick with RC <input checked="" type="radio"/> Wood <input type="radio"/> Other(    )		Finish Material	Roof	<input checked="" type="radio"/> Corrugated Steel sheet <input type="radio"/> Roof Tiles <input type="radio"/> RC <input type="radio"/> Asbestos Fibre Cement	
	Other Structure	Wall	Brick		<input checked="" type="radio"/> Wood	Wall	• Paint
		Column	Brick		<input checked="" type="radio"/> Wood	Column	• Paint
		Beam	<input checked="" type="radio"/> Wood		RC    Steel	Floor	<input checked="" type="radio"/> Concrete    •Wood

Electric system (Check <input type="radio"/> )	<input checked="" type="radio"/> Retract from outside <input type="radio"/> Solar System <input type="radio"/> Generator		Water Supply (Check <input type="radio"/> )	<input type="radio"/> Water Well (    ) <input type="radio"/> Waterwork <input type="radio"/> None		
	Condition of Main Structure	Main Damage Type & Rank*		Condition of Finish Material	Main Damage Type & Rank*		
		<b>B</b>	<input type="checkbox"/> Crack (    mm) <input type="checkbox"/> Settlement <input type="checkbox"/> Inclination		<b>B</b>	<input type="checkbox"/> Water Leak <input type="checkbox"/> Peel Off (Roof, Ceiling, Wall, Colum )	
General Evaluation	<input checked="" type="radio"/> Usual <input type="radio"/> Poor <input type="radio"/> Severe		Remarks	No toilet room.			
Photograph

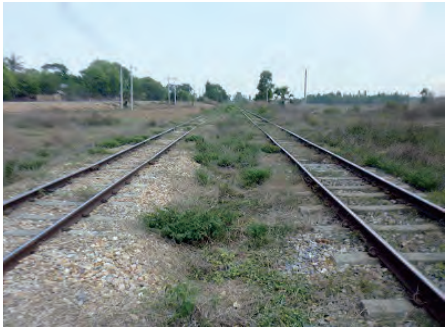
Station No.	50	Line Name	Yangon – Mandalay Line	Date of Survey	16/5/2017		
Station Name	HTEININN						
Existing Station Building	Kilopost	344.5		Mileage	214		
	Access Road	Yes	No	Age of Building			
	Story of Building	( ) Story Building		Total Floor Area	About m <sup>2</sup>		
	Type of Main Structure (Check O)	<ul style="list-style-type: none"> <li>▪ Brick with RC</li> <li>▪ Wood</li> <li>▪ Other( )</li> </ul>		Finish Material	Roof	<ul style="list-style-type: none"> <li>▪ Corrugated Steel sheet</li> <li>▪ Roof Tiles</li> <li>▪ RC</li> <li>▪ Asbestos Fibre Cement</li> </ul>	
		Other Structure	Wall		Brick	Wood	▪ Paint
			Column		Brick	Wood	▪ Paint
			Beam		Wood	RC	Steel
	Electric system (Check O)	<ul style="list-style-type: none"> <li>▪ Retract from outside</li> <li>▪ Solar System</li> <li>▪ Generator</li> </ul>		Water Supply (Check O)	<ul style="list-style-type: none"> <li>▪ Water Well ( )</li> <li>▪ Waterwork</li> <li>▪ None</li> </ul>

Condition of Main Structure	Main Damage Type & Rank*		Condition of Finish Material	Main Damage Type & Rank*		
			<ul style="list-style-type: none"> <li>▪ Crack ( mm)</li> <li>▪ Settlement</li> <li>▪ Inclination</li> </ul>			<ul style="list-style-type: none"> <li>▪ Water Leak</li> <li>▪ Peel Off (Roof, Ceiling, Wall, Colum )</li> </ul>	
General Evaluation	<ul style="list-style-type: none"> <li>▪ Usual</li> <li>▪ Poor</li> <li>▪ Severe</li> </ul>		Remarks	Dismantled.			
Photograph

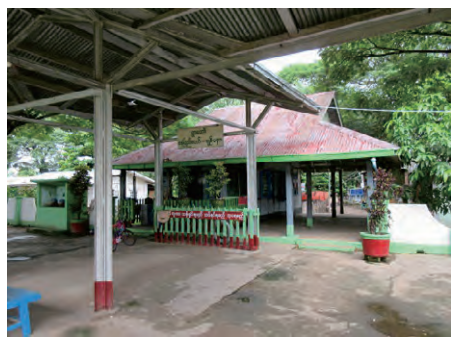
Station No.	54	Line Name	Yangon – Mandalay Line	Date of Survey	5/7/2017		
Station Name	YWADAW						
Existing Station Building	Kilopost	370		Mileage	230		
	Access Road	<input checked="" type="radio"/> Yes    No		Age of Building	Over 100 years		
	Story of Building	( 1 ) Story Building		Total Floor Area	About 78 m <sup>2</sup>		
	Type of Main Structure (Check <input type="radio"/> )	<input type="radio"/> Brick with RC <input checked="" type="radio"/> Wood <input type="radio"/> Other(    )		Finish Material	Roof	<input checked="" type="radio"/> Corrugated Steel sheet <input type="radio"/> Roof Tiles <input type="radio"/> RC <input type="radio"/> Asbestos Fibre Cement	
		Other Structure	Wall		<input checked="" type="radio"/> Brick    Wood	Wall	<input checked="" type="radio"/> Paint
			Column		Brick <input checked="" type="radio"/> Wood    RC	Column	<input checked="" type="radio"/> Paint
			Beam		<input checked="" type="radio"/> Wood    RC    Steel	Floor	<input checked="" type="radio"/> Concrete <input type="radio"/> Wood

Electric system (Check <input type="radio"/> )	<input checked="" type="radio"/> Retract from outside <input type="radio"/> Solar System <input type="radio"/> Generator		Water Supply (Check <input type="radio"/> )	<input checked="" type="radio"/> Water Well ( Tube ) <input type="radio"/> Waterwork <input type="radio"/> None		
	Condition of Main Structure	Main Damage Type & Rank*		Condition of Finish Material	Main Damage Type & Rank*		
		C	<input checked="" type="radio"/> Crack (6mm) <input checked="" type="radio"/> Settlement <input type="radio"/> Inclination		B	<input type="radio"/> Water Leak <input type="radio"/> Peel Off (Roof, Ceiling, Wall, Colum )	
General Evaluation	<input checked="" type="radio"/> Usual <input type="radio"/> Poor <input type="radio"/> Severe		Remarks	About 5 passengers/day and 2times freight/month. 1 toilet and 1 cable room.			
Photograph

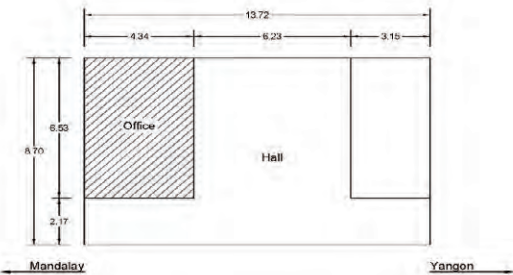
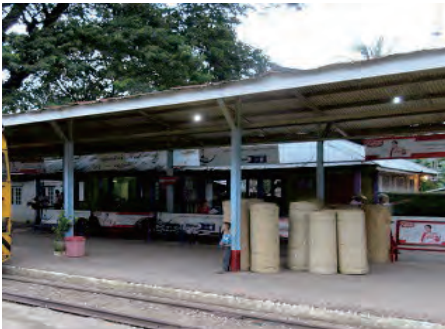
Beam		<input checked="" type="radio"/> Wood <input type="radio"/> RC <input type="radio"/> Steel	Floor	<input checked="" type="radio"/> Concrete <input type="radio"/> Wood	
	Electric system (Check <input type="radio"/> )	<input checked="" type="radio"/> Retract from outside <input type="radio"/> Solar System <input type="radio"/> Generator	Water Supply (Check <input type="radio"/> )	<input checked="" type="radio"/> Water Well ( Tube ) <input type="radio"/> Waterwork <input type="radio"/> None			
	Condition of Main Structure	Main Damage Type & Rank*		Condition of Finish Material	Main Damage Type & Rank*		
		D	<input checked="" type="radio"/> Crack (6mm) <input checked="" type="radio"/> Settlement <input type="radio"/> Inclination		C	<input checked="" type="radio"/> Water Leak <input type="radio"/> Peel Off (Roof, Ceiling, Wall, Colum )	
General Evaluation	<input type="radio"/> Usual <input checked="" type="radio"/> Poor <input type="radio"/> Severe	Remarks	About 100 passengers/day and freight(sometime). No toilet. 1 cable room and 1 store

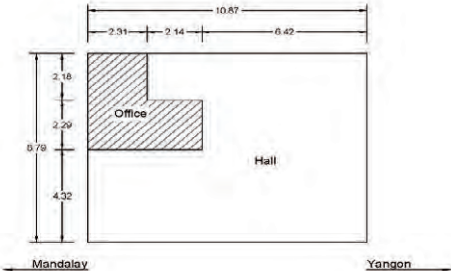
Beam		<input checked="" type="radio"/> Wood <input type="radio"/> RC <input type="radio"/> Steel	Floor	<input checked="" type="radio"/> Concrete <input type="radio"/> Wood	
	Electric system (Check <input type="radio"/> )	<ul style="list-style-type: none"> <li><input checked="" type="radio"/> Retract from outside</li> <li>• Solar System</li> <li>• Generator</li> </ul>	Water Supply (Check <input type="radio"/> )	<ul style="list-style-type: none"> <li>• Water Well ( )</li> <li>• Waterwork</li> <li><input checked="" type="radio"/> None</li> </ul>			
	Condition of Main Structure	Main Damage Type & Rank*		Condition of Finish Material	Main Damage Type & Rank*		
		F	<ul style="list-style-type: none"> <li><input checked="" type="radio"/> Crack (10mm)</li> <li><input checked="" type="radio"/> Settlement</li> <li><input checked="" type="radio"/> Inclination 5°</li> </ul>		D	<ul style="list-style-type: none"> <li><input checked="" type="radio"/> Water Leak</li> <li><input checked="" type="radio"/> Peel Off (Roof, Ceiling, Wall, Colum )</li> </ul>

General Evaluation	<ul style="list-style-type: none"> <li>• Usual</li> <li>• Poor</li> <li><input checked="" type="radio"/> Severe</li> </ul>	Remarks	About 40 passengers/day and no freight. No toilet. 1 cable and 1 generator				
Photograph

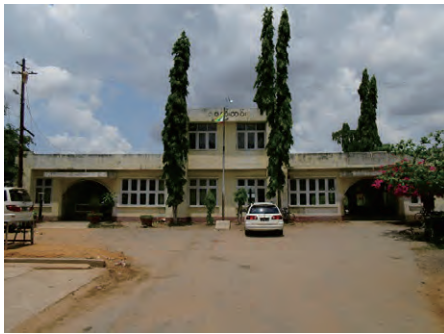
Electric system (Check <input type="radio"/> )	<input checked="" type="radio"/> Retract from outside <input type="radio"/> Solar System <input type="radio"/> Generator		Water Supply (Check <input type="radio"/> )	<input checked="" type="radio"/> Water Well (Breaking Pump) <input type="radio"/> Waterwork <input type="radio"/> None		
	Condition of Main Structure	Main Damage Type & Rank*		Condition of Finish Material	Main Damage Type & Rank*		
		C	<input type="radio"/> Crack ( mm) <input type="radio"/> Settlement <input type="radio"/> Inclination		D	<input checked="" type="radio"/> Water Leak <input checked="" type="radio"/> Peel Off (Roof, Ceiling, Wall, Colum )	
General Evaluation	<input type="radio"/> Usual <input checked="" type="radio"/> Poor <input type="radio"/> Severe		Remarks				
Photograph

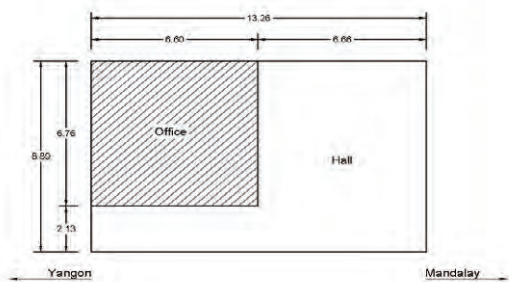
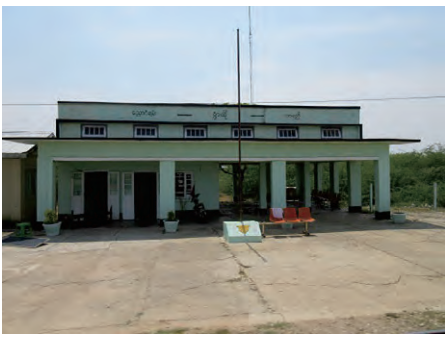
Beam		Wood <input checked="" type="radio"/> RC <input type="radio"/> Steel	Floor	<input checked="" type="radio"/> Concrete <input type="radio"/> Wood	
	Electric system (Check <input type="radio"/> )	<input type="radio"/> Retract from outside <input type="radio"/> Solar System <input checked="" type="radio"/> Generator	Water Supply (Check <input type="radio"/> )	<input type="radio"/> Water Well (    ) <input type="radio"/> Waterwork <input checked="" type="radio"/> None			
	Condition of Main Structure	Main Damage Type & Rank*		Condition of Finish Material	Main Damage Type & Rank*		
		F	<input checked="" type="radio"/> Crack ( 7mm ) <input type="radio"/> Settlement <input type="radio"/> Inclination		F	<input checked="" type="radio"/> Water Leak <input checked="" type="radio"/> Peel Off (Roof, Ceiling, Wall, Colum )	
General Evaluation	<input type="radio"/> Usual <input type="radio"/> Poor <input checked="" type="radio"/> Severe		Remarks	About 15passengers/day and no freight. 1 toilet, 1 cable rm and 1 generator rm.

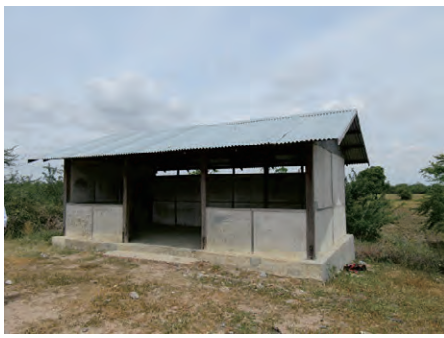
Beam		<input checked="" type="radio"/> Wood    RC    Steel	Floor	<input checked="" type="radio"/> Concrete    ▪ Wood	
	Electric system (Check <input type="radio"/> )	<ul style="list-style-type: none"> <li>▪ Retract from outside</li> <li>▪ Solar System</li> <li>▪ Generator</li> </ul>	Water Supply (Check <input type="radio"/> )	<ul style="list-style-type: none"> <li>▪ Water Well (            )</li> <li>▪ Waterwork</li> <li><input checked="" type="radio"/> None</li> </ul>			
	Condition of Main Structure	Main Damage Type & Rank*		Condition of Finish Material	Main Damage Type & Rank*		
		<b>B</b>	<ul style="list-style-type: none"> <li>▪ Crack (    mm)</li> <li>▪ Settlement</li> <li>▪ Inclination</li> </ul>		<b>B</b>	<ul style="list-style-type: none"> <li>▪ Water Leak</li> <li>▪ Peel Off (Roof, Ceiling, Wall, Colum )</li> </ul>	
General Evaluation	<ul style="list-style-type: none"> <li><input checked="" type="radio"/> Usual</li> <li>▪ Poor</li> <li>▪ Severe</li> </ul>		Remarks

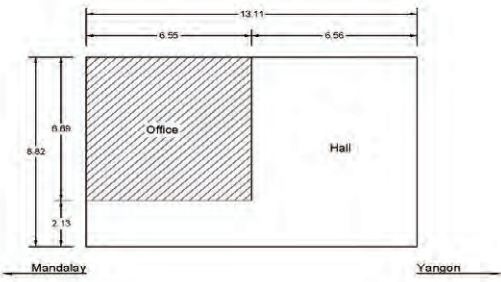
Electric system (Check <input type="radio"/> )	<input checked="" type="radio"/> Retract from outside • Solar System • Generator		Water Supply (Check <input type="radio"/> )	<input checked="" type="radio"/> Water Well ( Mortar ) • Waterwork • None		
	Condition of Main Structure	Main Damage Type & Rank*		Condition of Finish Material	Main Damage Type & Rank*		
		D	<input checked="" type="radio"/> Crack ( 8mm) • Settlement • Inclination		B	• Water Leak • Peel Off (Roof, Ceiling, Wall, Colum )	
General Evaluation	• Usual <input checked="" type="radio"/> Poor • Severe		Remarks	About 10passengers/day and stone & cement freight. 1 toilet rm,1 cable rm and 1 generator rm.			
Photograph

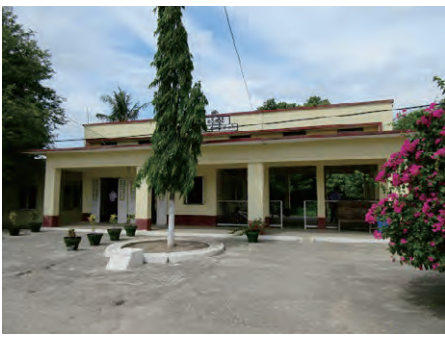
Beam		Wood <input checked="" type="radio"/> RC <input type="radio"/> Steel	Floor	<input checked="" type="radio"/> Concrete    • Wood	
	Electric system (Check <input type="radio"/> )	<input checked="" type="radio"/> Retract from outside • Solar System • Generator	Water Supply (Check <input type="radio"/> )	<input checked="" type="radio"/> Water Well ( Mortar ) <input type="radio"/> Waterwork <input type="radio"/> None			
	Condition of Main Structure	Main Damage Type & Rank*		Condition of Finish Material	Main Damage Type & Rank*		
		F	<input checked="" type="radio"/> Crack (4 mm) <input type="radio"/> Settlement <input type="radio"/> Inclination		B	<input type="radio"/> Water Leak <input type="radio"/> Peel Off (Roof, Ceiling, Wall, Colum )	
General Evaluation	<input type="radio"/> Usual <input type="radio"/> Poor <input checked="" type="radio"/> Severe		Remarks	About 3passengers/day and no freight. 1 toilet rm,1 cable rm and 1 generator rm.
