Bridge Condition Survey Rout 13N in Vientiane Province

The Project of Improvement of Road Management Capability in Lao PDR Report

## Appendix 2-17 Concept Design Report for Rehabilitation Project of National Road No. 9

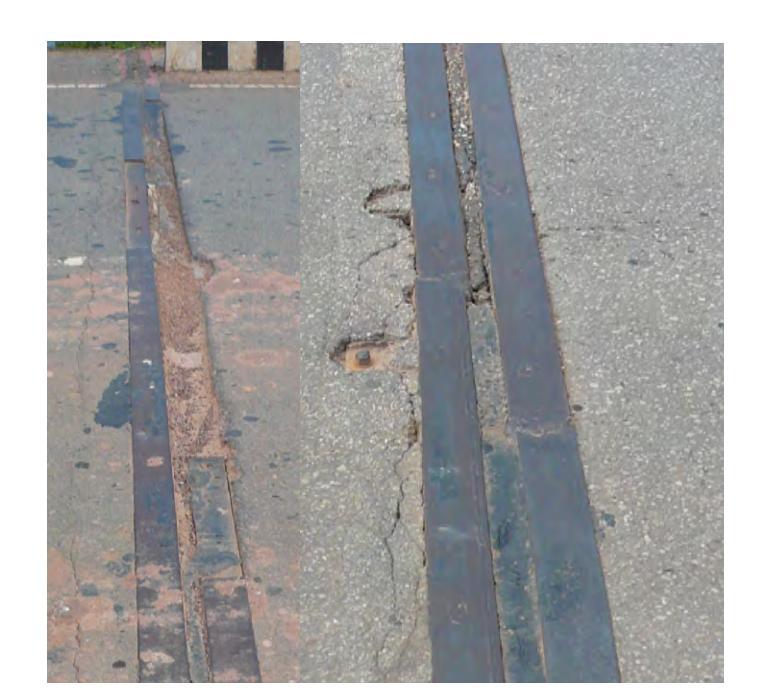
Problems-and-Causes-:--

ความเสียหายจากเหล็กยึด **B**สียหายเนื่องจากสมอยึด ธะดับของเหล็กทั้งสองข้าง ไม่เสมอกัน เกิดการรับ แรงกระแทกด้านใดด้าน หนึ่งมากกว่า-

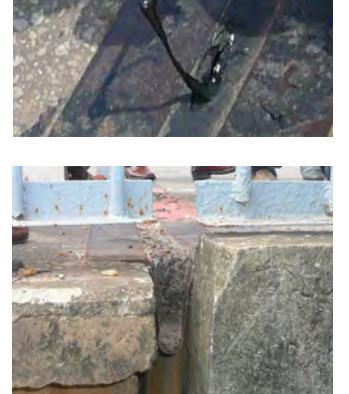
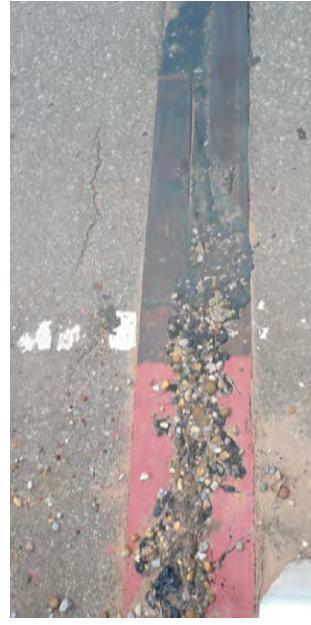
Problems-and-Causes-:--BGap-is-blocked-bygravels-=-no-Gap-

ความเสียหายจากการที่ช่อง ว่างมีสิ่งกีดขวางการ เคลื่อนตัว-

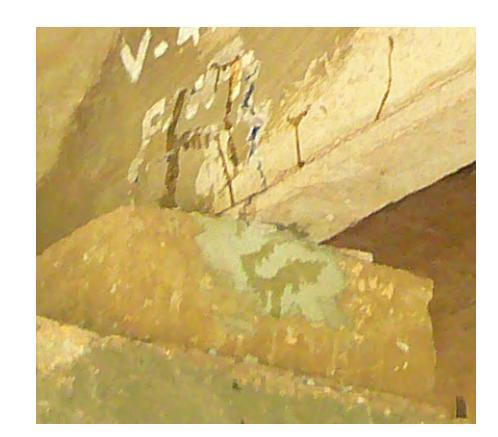
BursOng-in-Bearing-area BBursOng-caused-by-insufficient-bearingarea. BWrong-alignment-(only-one-girder-

fail),-not-same-leveling-for-all-girder.-BBearing-is-too-rigid-for-impact-loadand-wrong-alignment.-

รอยร้าวของคานเนื่องจากพื้นที่ในการรับแรงน้อยเกินไป Bอาจเกิดเนื่องจากระดับคานตัวที่แตกต่ำกว่าทำให้น้ำหนักมากกว่า Bตัวรับน้ำหนักไม่มีความยืดหยุ่นในการรับแรงกระแทก-

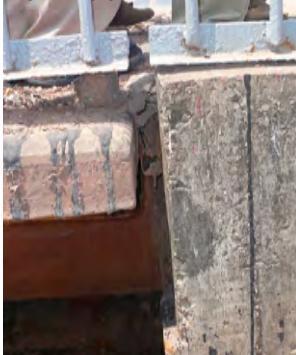
Same-Problem-as-the-firstbridge-caused-seriousmotorbike-accident-

ปัญหาเหมือนกับที่แรก ทำให้เกิดอุบัติเหตุกับ มอเตอร์ไซด์-

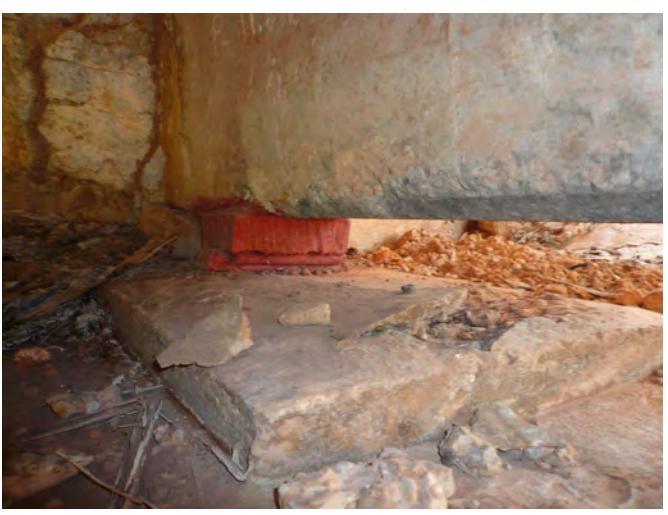
HOUAY TABONGPHETH BRIDGE

Problems-of-water-leakagecrack-start-underneathbearing-and-expand-bysteel-corrosion-

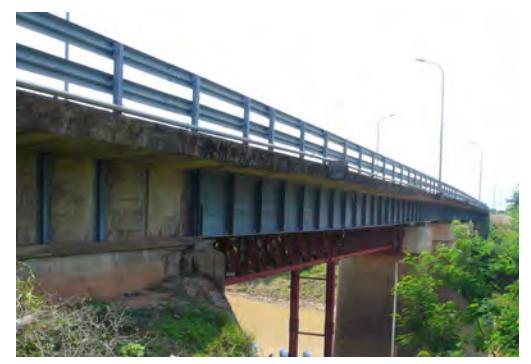
Water-leakage-and-gapblocked-

น้ำรั่วที่รอยต่อและรอย ต่อไม่สามารถเคลื่อน ตัวได้-

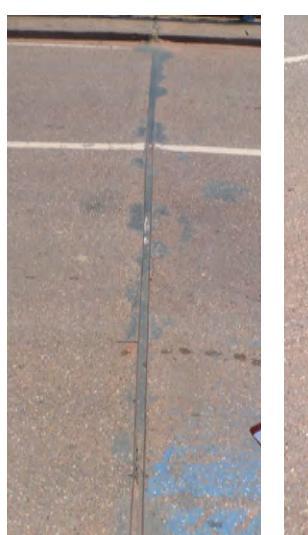
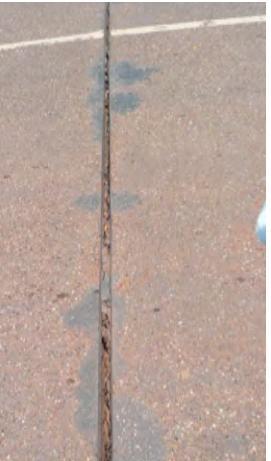
Expansion-Joints-Fixed-side-

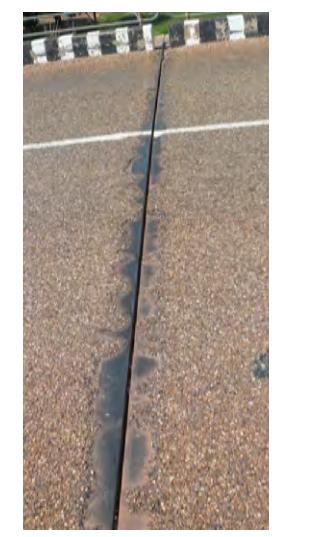
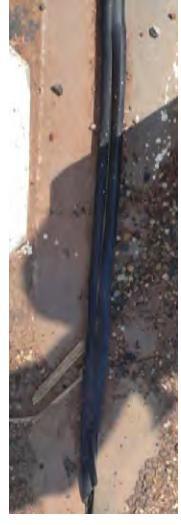
# Fixed-side-

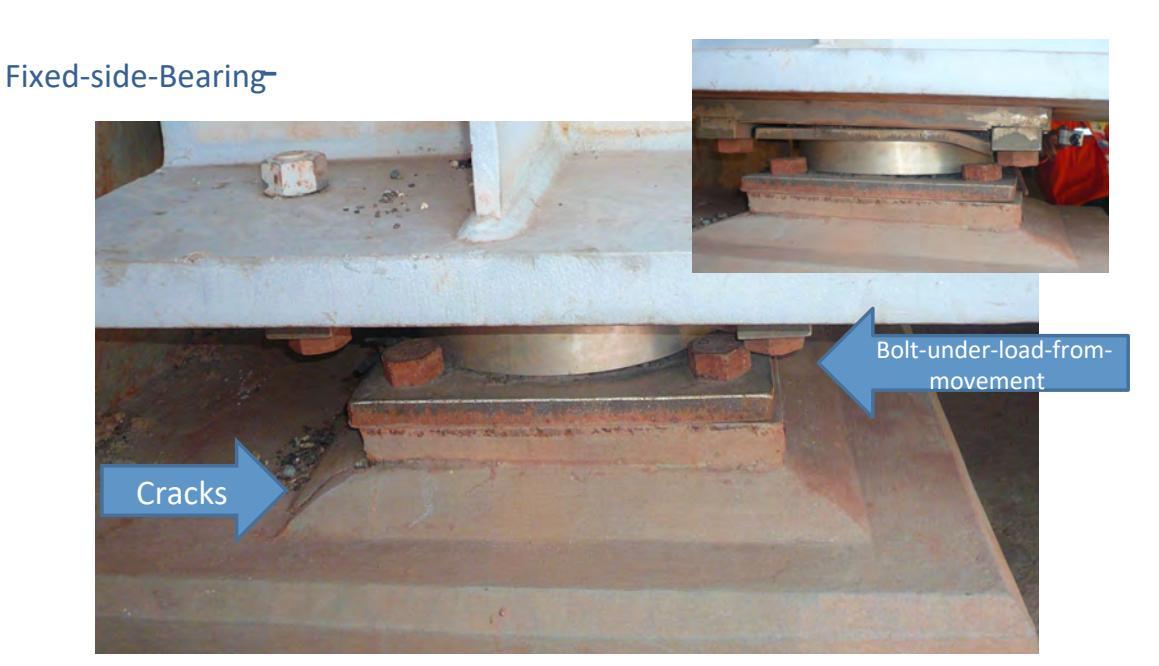
Bearing-on--Fixed-Side<del>-</del>

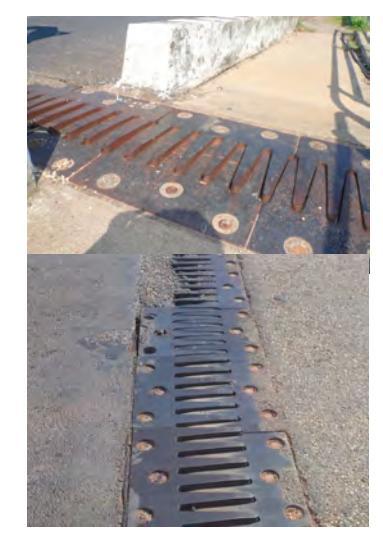
Gap-is-too-small-

# ช่องว่างแคบเกินไป-

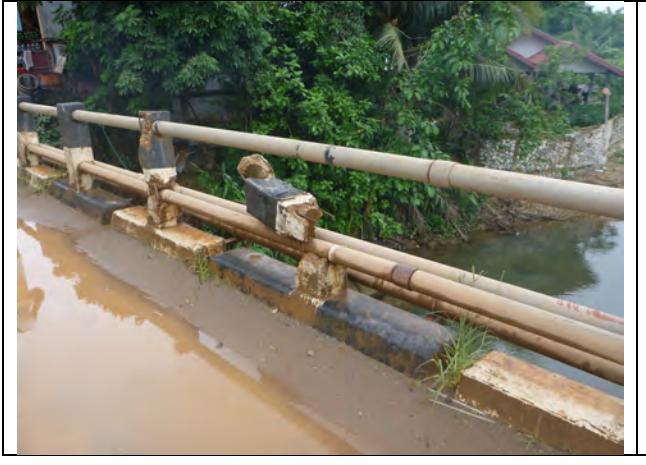
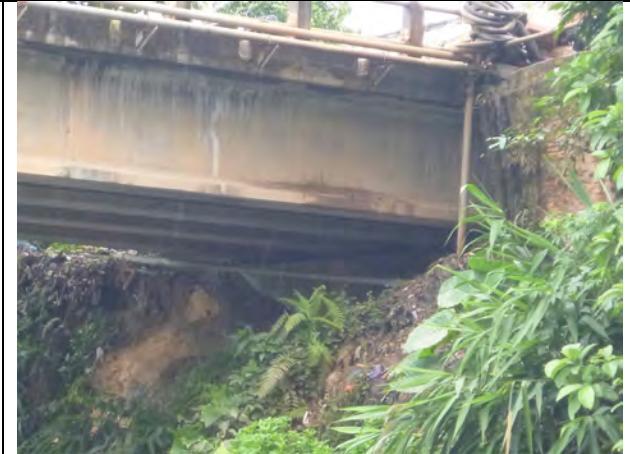
# Bridge Condition Survey

As the result, bridge structure itself such as main girders, Piers, still have a good condition. However, Expansion joint, Bridge surface, parapets on bridge, especially bridge surface and parapets on bridge had a significant damage which is need to be repair as soon as possible. Also maintenance (Cleaning) surround drainage, abutment, fill in front of bridge and bearing, which is main cause of damage in the future. (Appendix 2: Visual Inspection sheet)

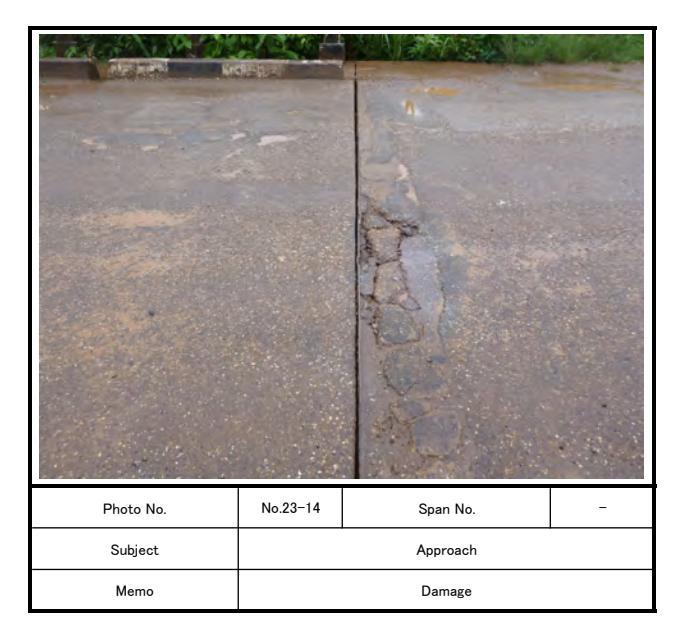
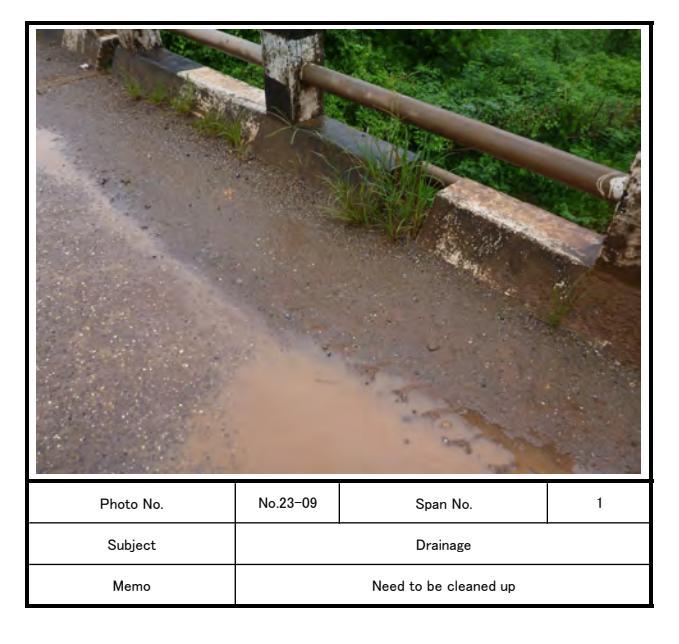
Parapets on Bridge

Damage, Progess of Corrosion

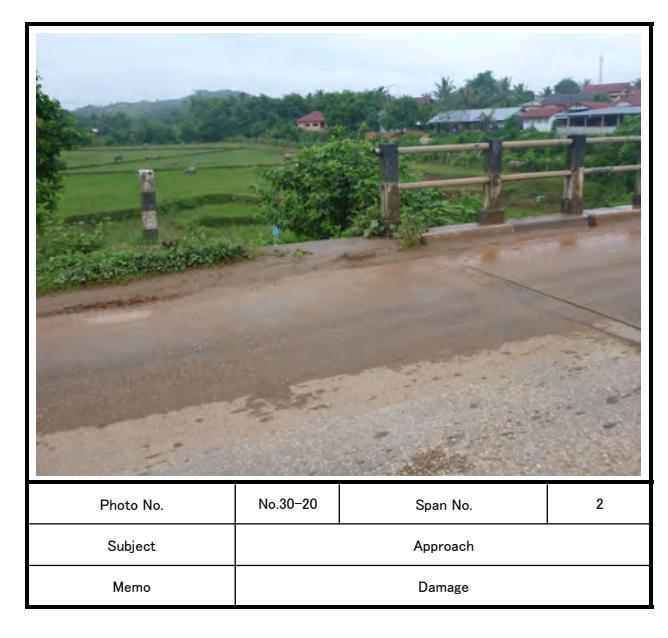
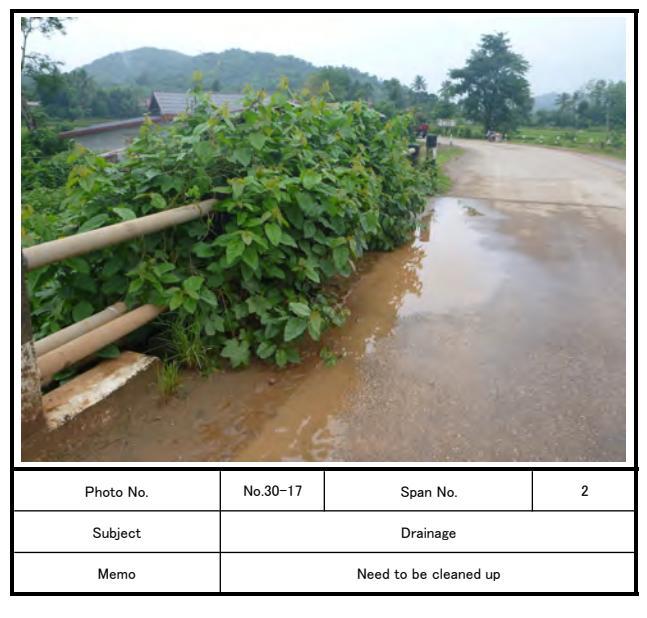
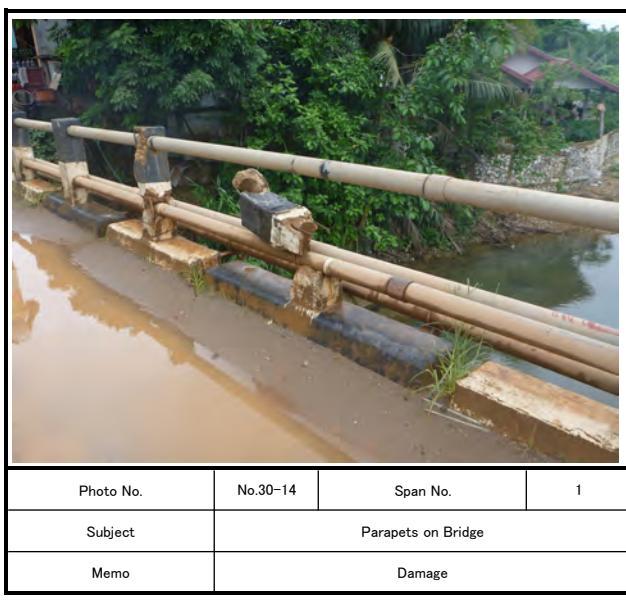
Minor Damage

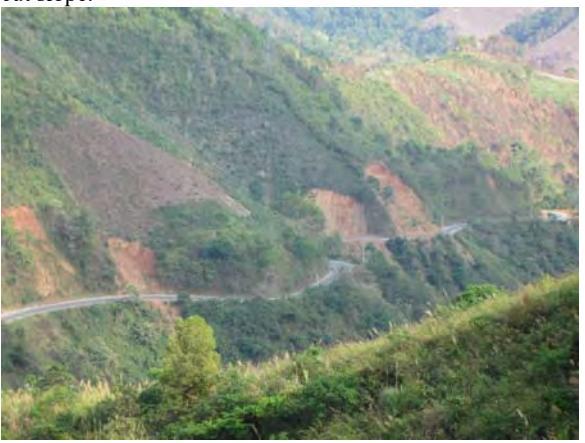
The slope gradient (1:0.5) would be too steep for such large cut slope.

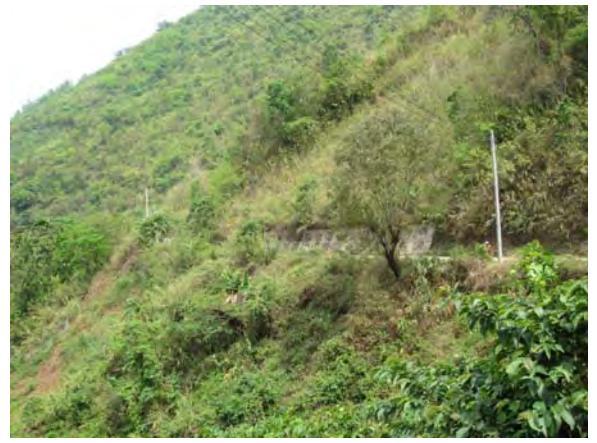
All of the debris of shallow failure was not removed so that secondary failure would be caused after heavy rain.

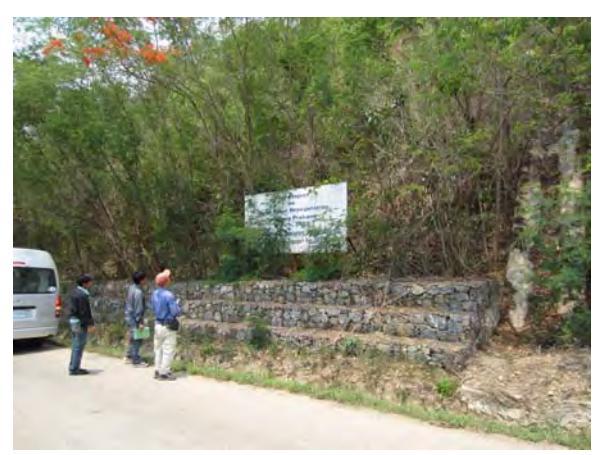
Gabion boxes were often used for protection of fill slope on NR13N. The basements of the gabions were not properly supported by rock or compacted soil so that many erosions under gabion were observed.

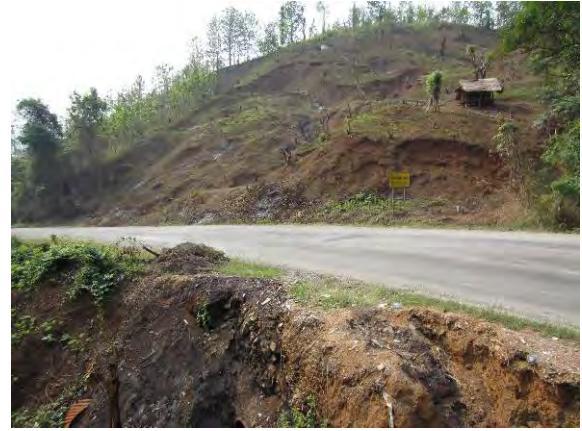
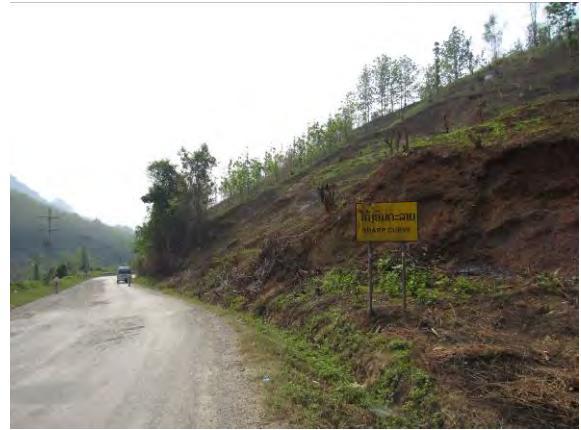
SITE-2: KM327 Slope failure type:

(Backslope) Shallow failure and no rocks on the slope, (Foreslope) Fill slope failure due to not enough fill compaction

(Backslope) Re-cutting of the slope and rounding, installation of slope drainage, slope protection with vegetation, (Foreslope) Retaining wall, vegetation

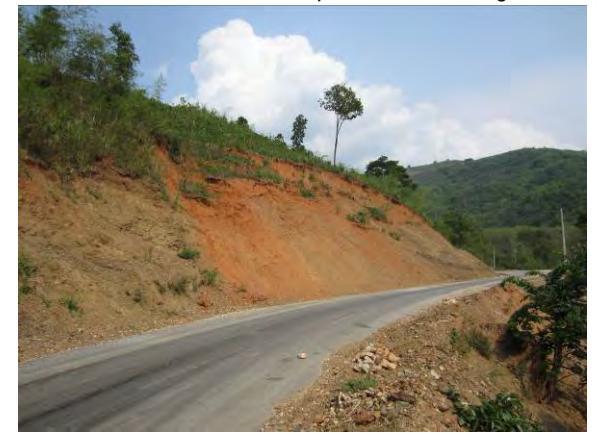
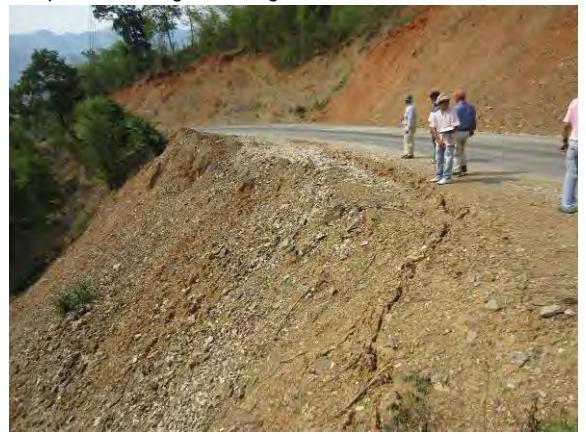
#### SITE-3: KM311-312 (WP-376)

Slope failure type: Possible countermeasures: (Foreslope) Fill slope failure due to luck of roadside drainage (Foreslope) Retaining wall, roadside/slope drainage

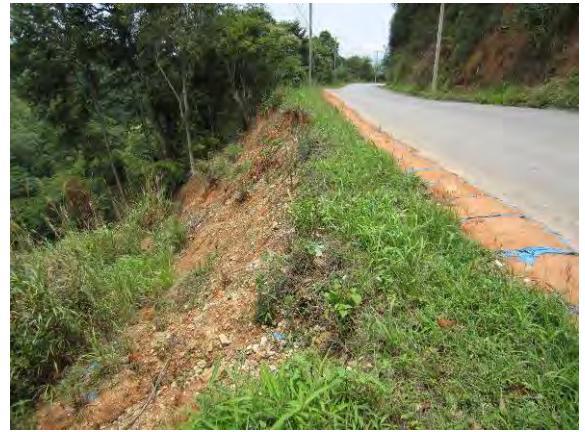
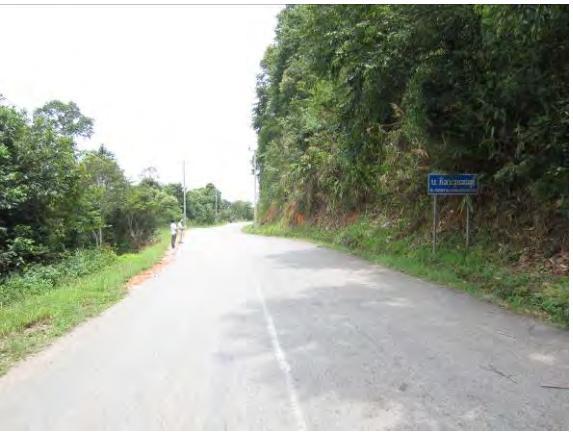
#### SITE-4: KM278-279 (WP-587)

Slope failure type: Possible countermeasures: (Backslope) Shallow failure (Volcanic Rock, some gullies) (Backslope) Mitigate erosion with rounding, vegetation and check dam

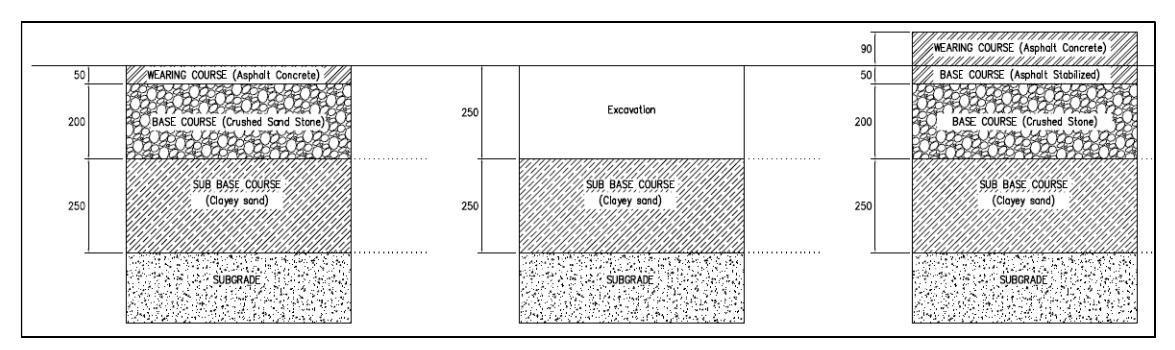
Figure 4.1.1 Spot Replacement (A) (applied for moderate damege)

2 types of spot replacement works are designed for the project as shown in Figure 4.1.1 and 4.1.2. Type (A) will be applied in case that the damage affects up to base course but sub-base course still keeps the soundness. On the other hand, Type (B) will be applied in case that damage reaches up to sub-base course. Quantity of only Type (B) is calculated for the estimate because the cost of Type (B) is higher than Type (A). The quantity will be converted to Type (A) by the Contractor in case that the observed damage is not so severe at the construction stage.
