添付資料 9-6
工事完了証明書

1. Name of Consulting Service Assignment	The Pilot Project for Landslide and Rock fall mitigation works (Lot 1) under the Technical Cooperation for Landslide Mitigation Project
2. Performance Period	28/01/2016 – 28/07/2018
3. Contract Amount	LKR 38,268,930.00 (Final confirmed price: LKR 37,361,900.36)
4. Name of Contractor	ELS Construction (Pvt) Ltd
5. Progress of Work	As per progress report
6. Amount Payable by this Inspection	LKR 10,437,206.77
7. Note	Work progress in the report is 97.51% (Rs. 33,923,186.36) which is the progress percentage to the contract amount without contingency (10%). After this inspection on the completion of the work, defect liability period commences at the date of issuance and approval of Certificate of Completion for one year. The contractor should submit Maintenance Security to JICA for the defect liability.

CERTIFICATE OF PRACTICAL COMPLETION

Defects Liability Certificate

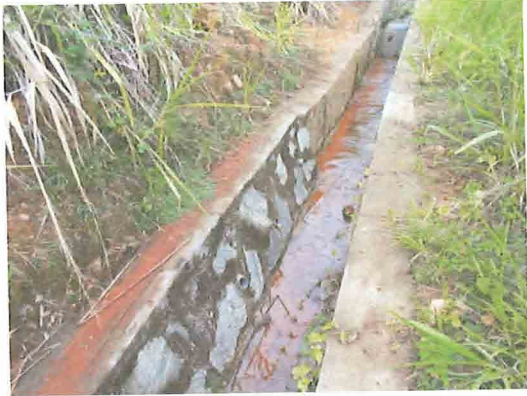
Photo 1: Erosion has been corrected (Loc.2)

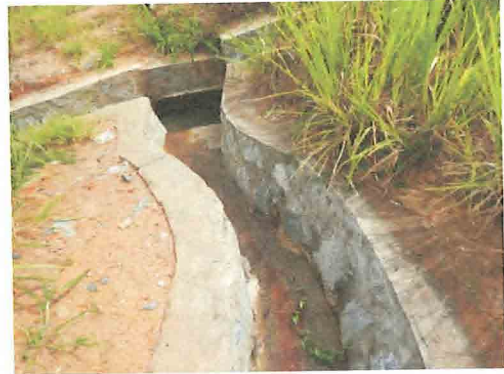
Photo 2: Erosion has been corrected (Loc.1)

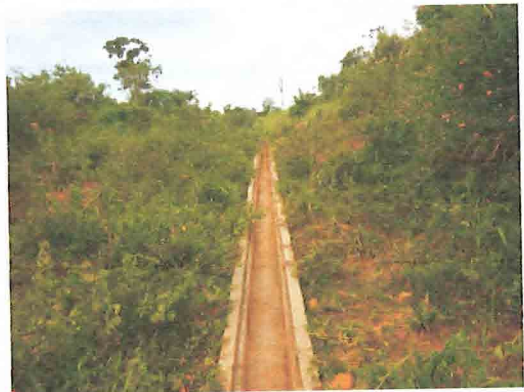
Photo 6: Rocks have been removed (Loc.12)

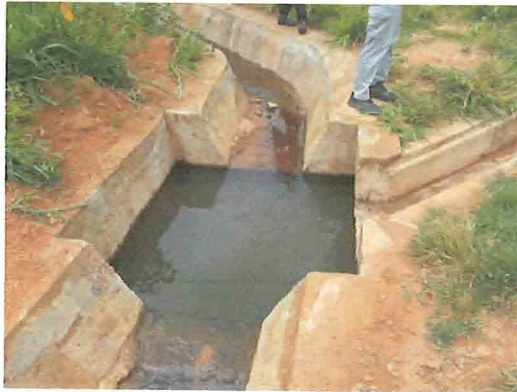
Photo 7: Soils have been removed (Loc.8)

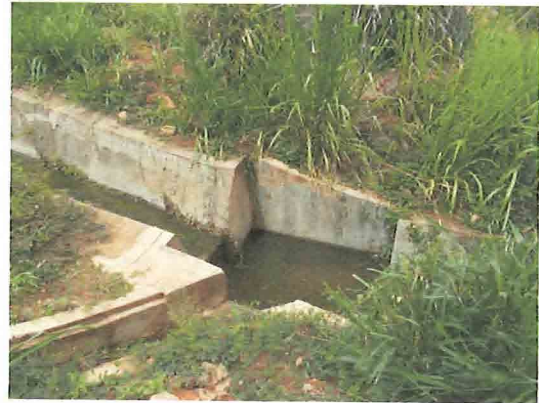
Photo 8: Soils have been removed (Loc.9)

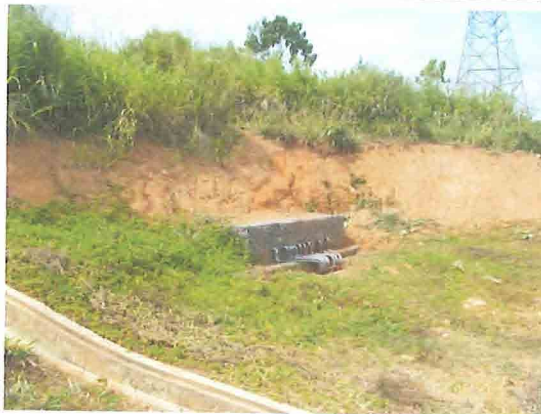
Photo 11: Soils have been removed (D.P.6)

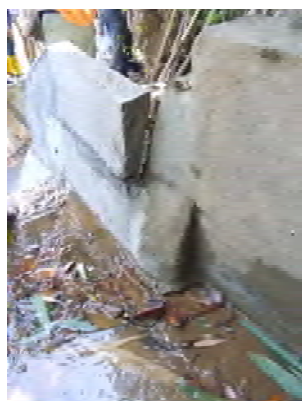
Photo 3: The ditch lower part of the pit has not been constructed properly. After the inspection, it has been corrected.(Loc. 3)

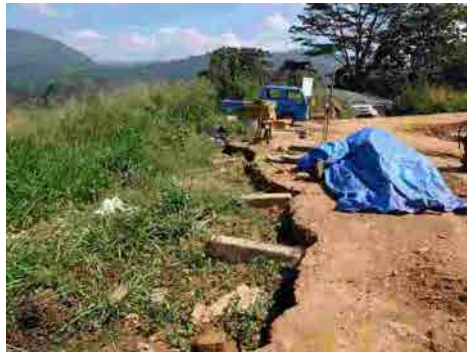
During the construction period of the pilot project, small landslides occurred at drilling points No.1 and 4 due to cutting/ excavation for installation of horizontal drilling platforms in Badulusirigama, Badulla. Finally, reshaping and additional gabion works were conducted for stabilization of the slopes and regarding No.4, even the location of the drilling point was changed.

Cracks at the shoulder of the slope caused by cutting work (Point No.4)

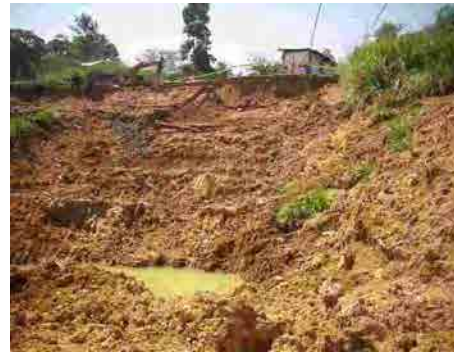
Whole picture of the small landslide (Point No.4)

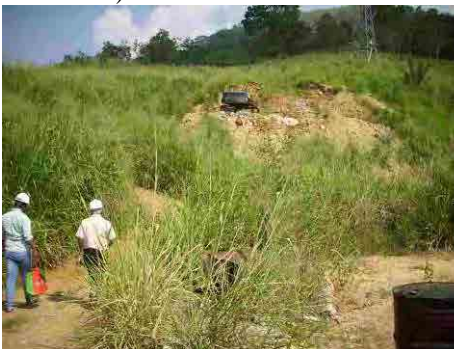
Embankment at the middle of the slope (Point No.1)

Photo 4.1 Small landslide caused by cutting work

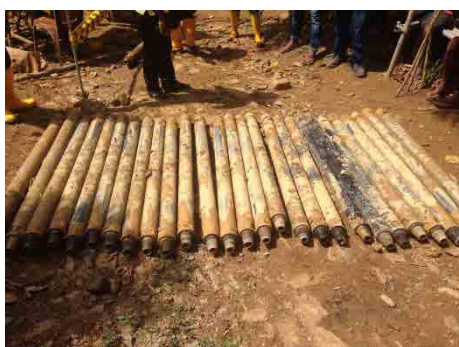
ロッドの数量による掘削深度の確認
(1.7m/ロッド×27本=45.9m : 設計 45m)

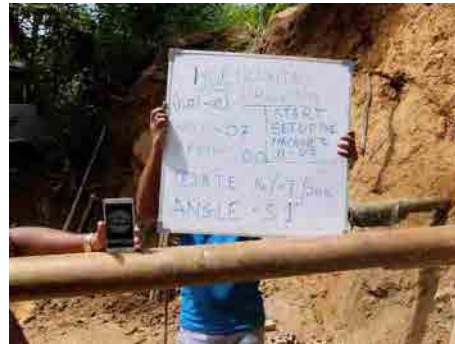
No.7: 掘削角度の確認
(5.1° , 設計 : 5°)

現地視察実施中に No.8 の PVC パイプの挿入を行っていたため、ホワイトボードに必要な情報を記載して写真撮影を行い、管理を行うことを指導した。また、No.8 完了後、No.7 の掘削準備を行ったため、同様に写真による管理の指導を行った。

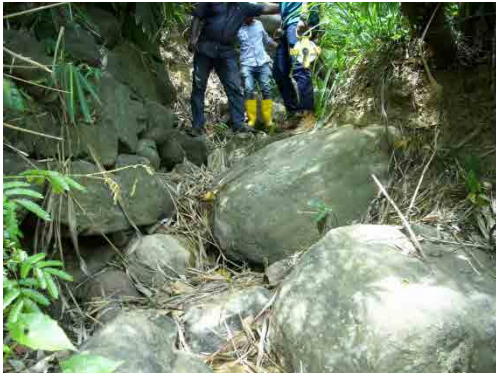
水路工予定箇所の露岩

下部小規模ダムの接続形状と水路工沿いの巨礫破碎、除去に関するプロポーザルについて施工業者からプロポーザルが提出されていたため、この 2 点に関する現地立会いを実施した。ダム接続部については既設のダムの機能を損なわないようにすることと、提案区間の延長と断面形状を確認した。巨礫除去に関しては礫の分布箇所を確認したが、プロポーザ

ルでは礫の具体的な破碎方法がわかりにくく、作業単価のみが示されていたので全体数量および変更金額がわかるような書類を提出するように指導した。

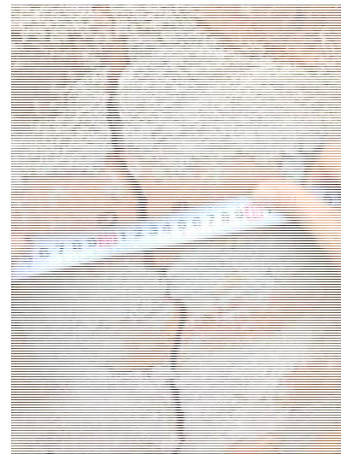
5月に発生したクラックの状況

現地視察実施中には水平ボーリング No.3 のケーシング抜管をおこなっており、掘削については残り 2 孔であった。5 月に変状が発生した上部の家屋については、その後のモニタリングにおいて変状の進行がないことを確認した。計測点の釘の逸失が確認されたので、マーキングをおこない今後も変状の進行について確認を行えるようし、週 1 回の定期的な観測を行うように指導した。水路工については掘削作業を実施中であった。

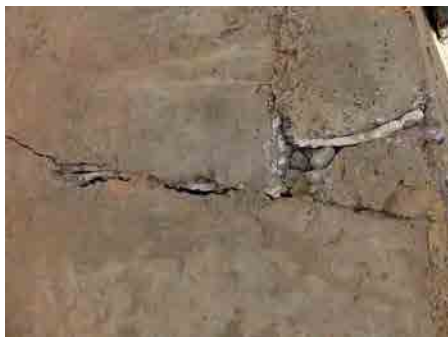
目地の施工不良

コントラクターは出来形として Type D (450 - 450)を延長 100m 計上してきた。このうち上流の 20m+20m 区間 (計 40m) は上に示す水路内に捨コンが放置された状態になっていたため、除去するまでは出来形として承認しないこととした。また、下流側の 60m 区間については、写真に示すように、目地の施工不良、及び目地の亀裂が 3箇所確認された。このため、目地の前後 1m 区間については修復を行うこととし、計 3m 区間については修復後承認することとして、残り 57m を出来形として承認した。

a については、亀裂が発生している箇所があり、修復が必要である。

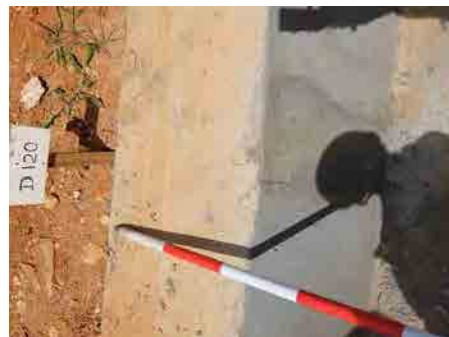
目地の位置に発生した亀裂

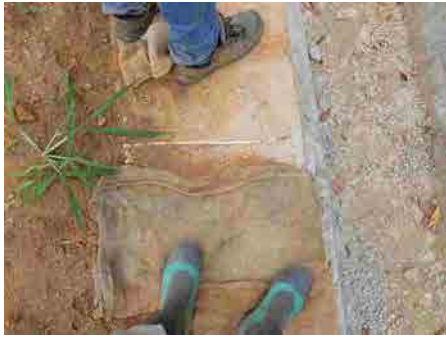
水路工内に放置された捨てコン

b については、コンクリートを除去し、水路内に所定の断面を確保する必要がある。

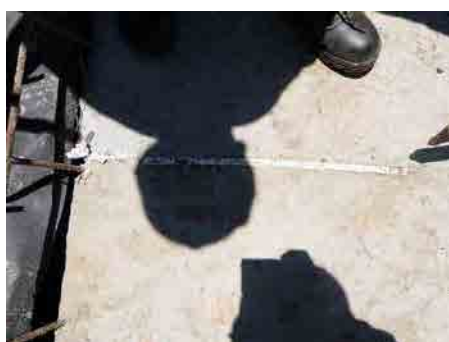
b については、目地が **20m** 間隔で設置されていない。設置されている箇所でも施工が不良となっている、等が確認された。目地の適切な設置と、不適切な設置の箇所では、再設置が必要である。

目地の施工不良

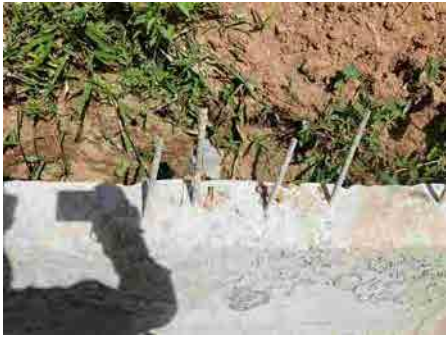
鉄筋の不整配置

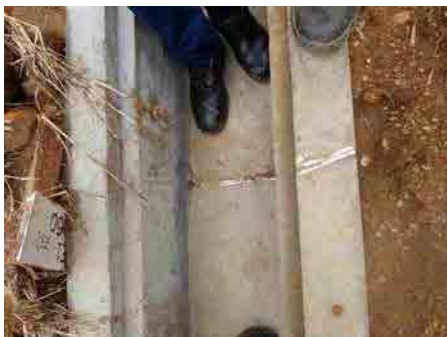
a については、先月指摘した亀裂が発生している箇所については修復済みであったため、今回 3m 分を承認した。ただし、今回も E タイプ (300-300) の施工箇所で 3 箇所不適切な箇所があったため、3m 分減とした。

目地の施工不良

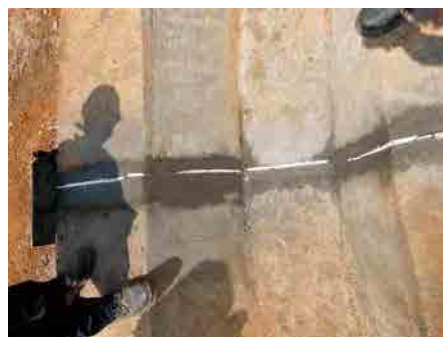
b については、先月指摘した箇所については、修復されていたが、視察前日の豪雨により土砂が流入して全体を確認することができなかつたため、20m 分は土砂撤去後に確認を行うこととした。ただし、E タイプの施工箇所で 1 箇所不適切な部分があったため、1m 分減とした。

再施工された目地

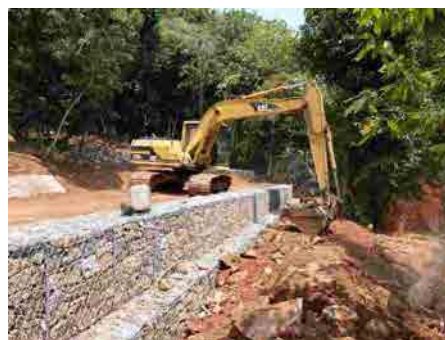
以前は、破碎した岩塊を所定の形状にまとめて数量の確認を行っていたが、数量が増えてきたため、管理が総量を把握できるような管理ではなくなっていた。が、既に今月は破碎した岩塊を布団カゴに詰めて、布団カゴを設置しているため、布団カゴの数量を破碎した岩塊の数量とすることとした。以降も、出来形数量で検査を行うことをコントラクターと確認を行った。なお、布団カゴは 10 月から設置開始したため、9 月の出来形には含まれない。布団カゴの数量は 198m³ であるため、岩塊の破碎も同量とした。

布団カゴの設置状況

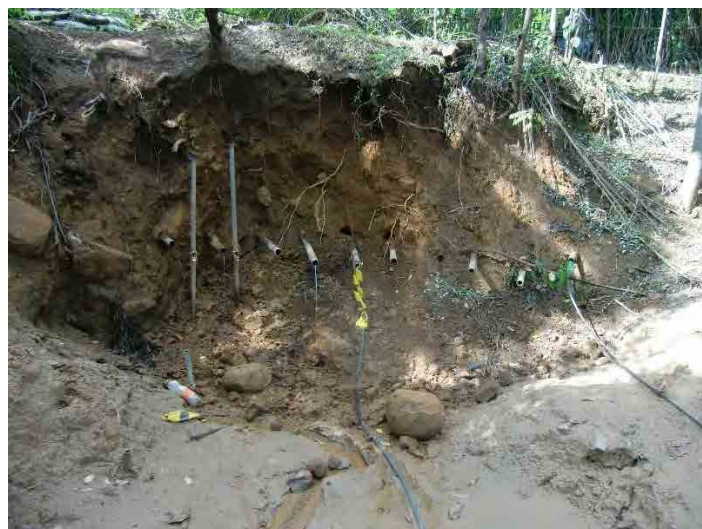
孔名	No.1	No.2	No.3	No.4	No.5
流量	0	1.47	0	0.61	0.16
孔名	No.6	No.7	No.8	No.9	No.10
流量	0	1.17	0	0.18	1.49

合計、約 4 リットル/毎分の集水をしており、所定の排水効果が期待される。

ボーリング集水状況

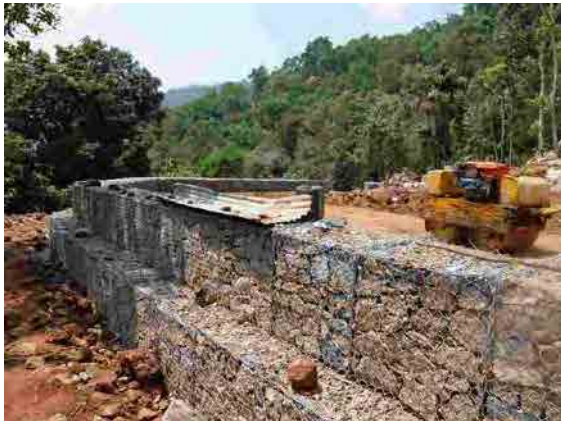
布団カゴの施工状況(9月)

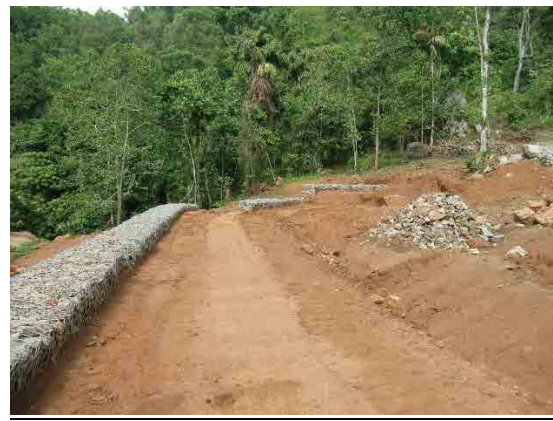
布団カゴ及び盛土の施工状況(10月)

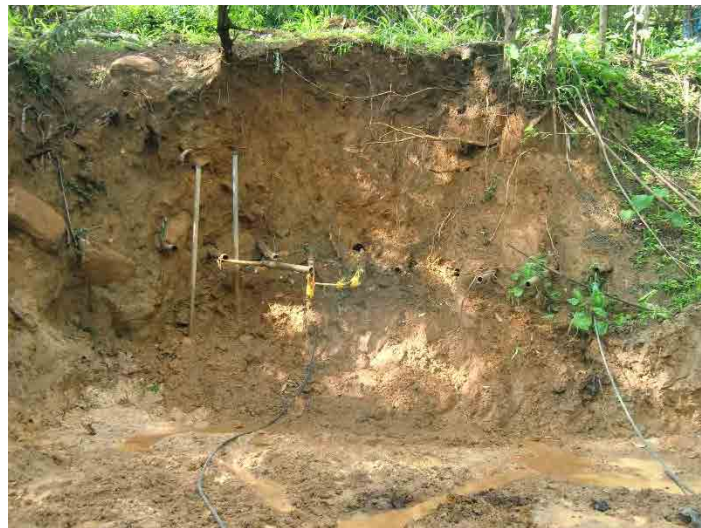
孔名	No.1	No.2	No.3	No.4	No.5
流量	0	1.41	0	0.60	1.29
孔名	No.6	No.7	No.8	No.9	No.10
流量	0	0	0	0	1.82

合計、約5.1リットル/毎分の集水をしており、所定の排水効果が期待される。

ボーリング集水状況

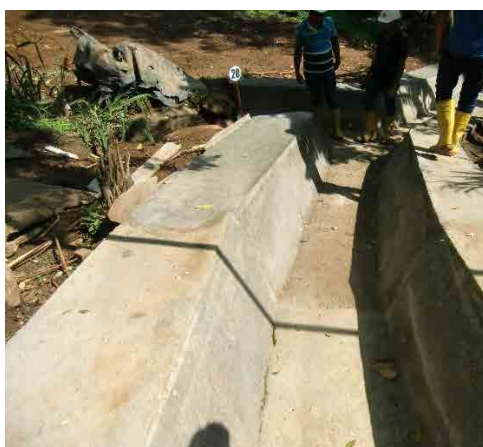
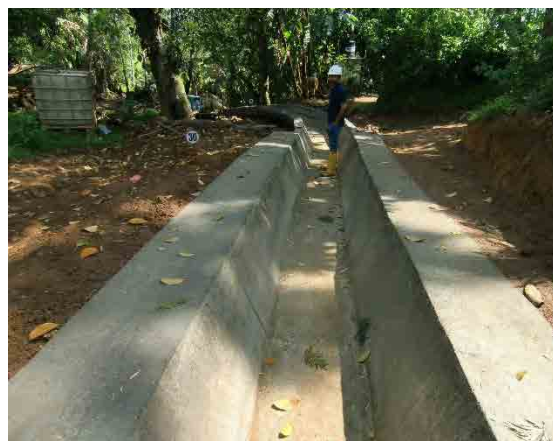
a, b については、NBRO ジオテク部門のマドランガ氏が、定期的に確認・指導を行っており、11月も15日、25日に現地確認・指導を行っており、現地の修復対応はほぼ終了しており。修復完了・確認区間より、順次、出来高として計上しており、11月分も水路工掘削、コンクリート打設につき、施工完了区間の数量計上を行った。

水路工施工状況(施工完了)

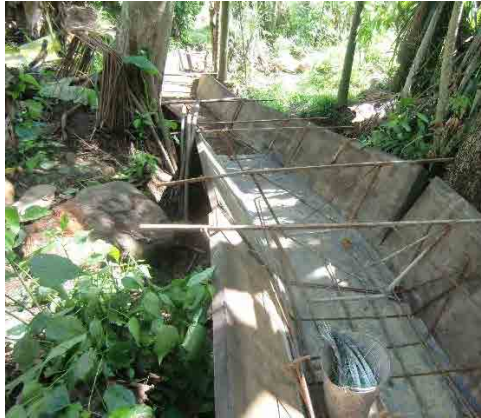
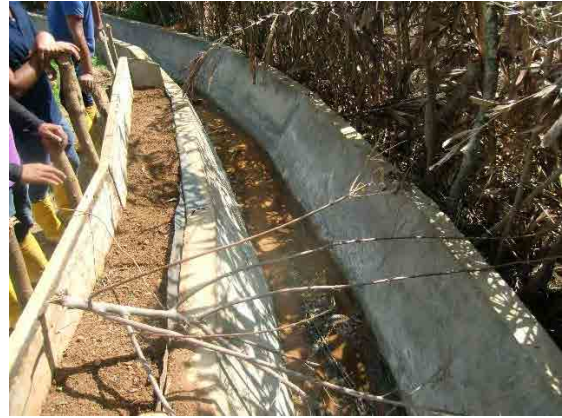
水路工施工状況(施工中)

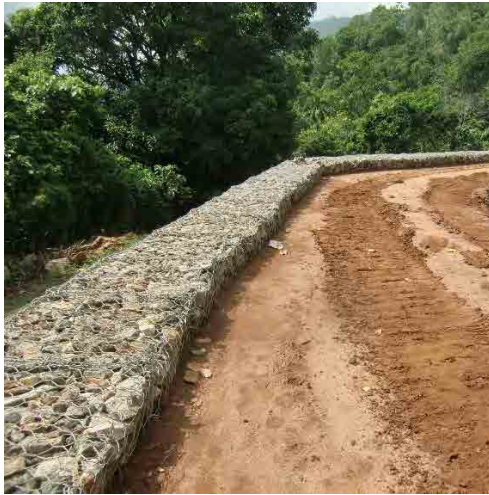
布団カゴの施工状況(11月)

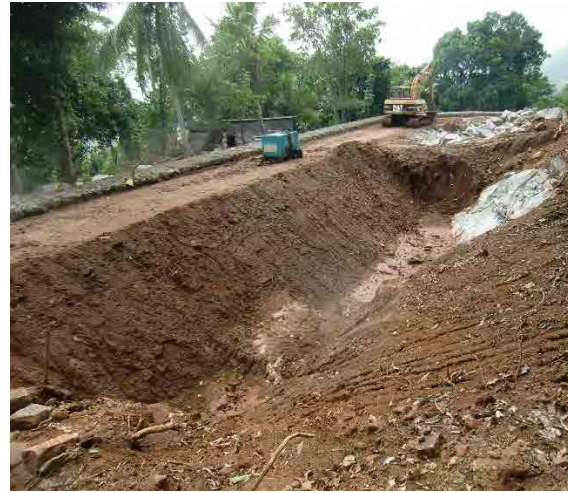
ピット掘削の状況(11月)

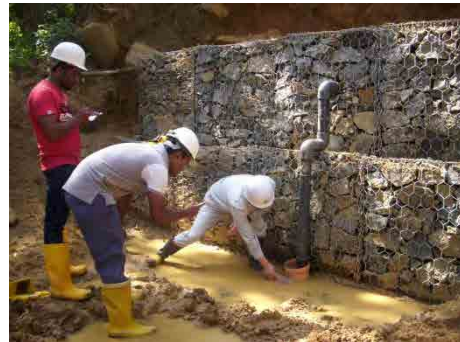
削孔およびパイプ挿入は 11 月までに完了しており、孔口部のガビオン工が施工され出来高計上 (10 m³) がなされた。水平ボーリングからは継続して良好な地下水排水状況を示しており、10 孔を合計した排水量は 90/分であった。12 月下旬には連続した降雨日があったことから、前月の約 50/分から大きく増加したとみられる。

ボーリング集水量計測状況

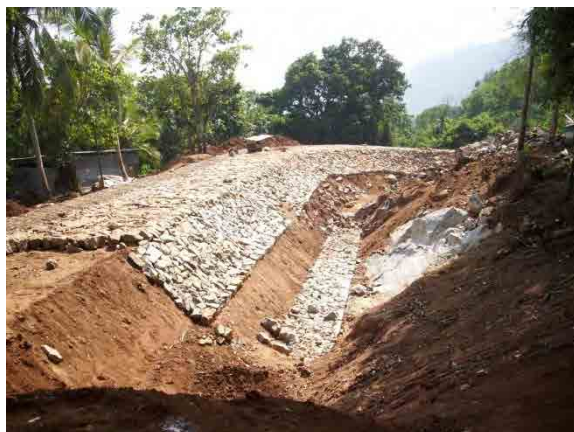
盛土工および表面被覆工

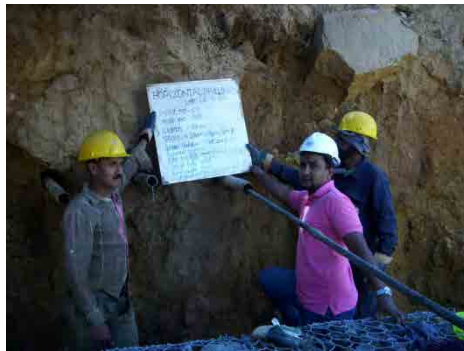
Point 5(BH-5)の削孔深度確認を2月13日に行なった。全9孔ともに計画延長の60mを超過しており、累計掘削延長540mを1月出来形数量として承認した。排水量は9孔計で2ℓ/minであった。

水平ボーリング施工延長確認

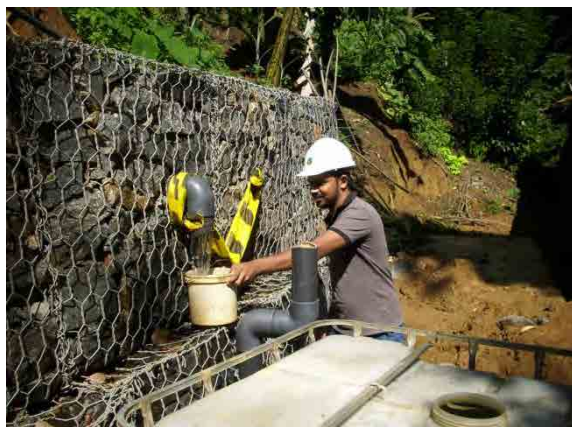
水平ボーリング工からは継続して地下水排出が確認されており、10孔を合計した排水量は1月31日で360ℓ/分、2月15日の計測値で500ℓ/分を超えるものであった。2/15の前夜にはかなりの集中した降雨が見られたことから過剰な地下水が効率的に排出されているものと考えられる。水平ボーリング工からの排水については、地元住民から水平ボーリング排水を利用したいとの要望を受け、中途にマンホールをセットしたうえでφ160mmのポリエチレン管で接続する方式の採用が承認済みであり施工準備段階である。また、各パイプが布団カゴ工背面で接続され、布団カゴ工前面には1本のパイプしか出てきていない状況にある。The Engineer から、維持管理のためにパイプ前面で結合されるべきと提案がなされ、コントラクターから修正されたレターが提出された。本件については修正工事案が承認されており施工準備中である。

ボーリング集水量計測状況

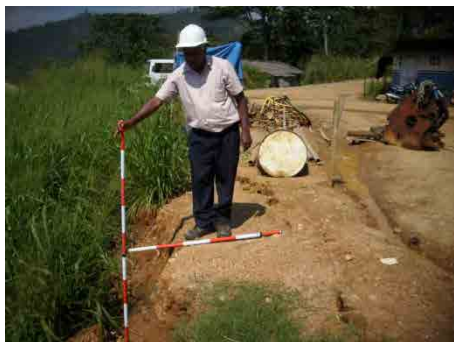
2 月提出の活動報告において記載済みであるが、現地事務所前の盛土縁辺部に 1/26 に豪雨に伴い亀裂が発生し、土塊の移動が生じ水平ボーリング Point No.4 が土砂で埋まった状況となっている。コントラクターは盛土部分を整形し斜面の安定を確保してから水平ボーリング工の施工を行う予定である。また、施工済みの水平ボーリング PointNo.1 の背後斜面も幅 15m、長さ 20m 程度の地すべり現象を生じており不安定な状況である。以上 2 か所の安定化に関わる対応について併せてコントラクターからレターが発出される予定である。

現場事務所前の段差

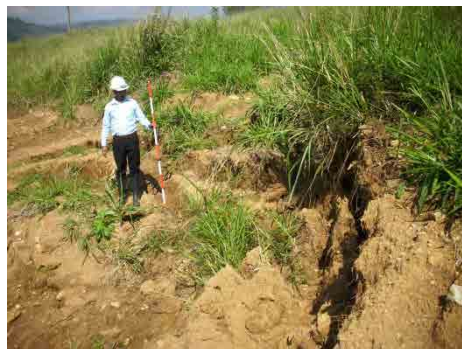
Point 1 背後斜面の段差

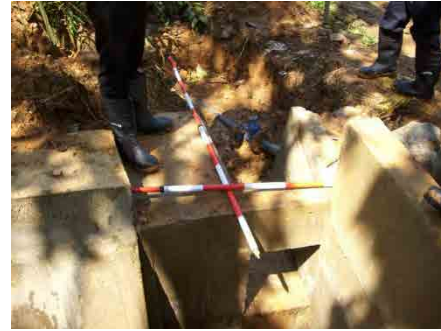
最下部 TypeA 水路の流末は別事業による側溝工事区間との接続をおこなえるように集水柵を The Engineer の承認により施工中であったが、上水道利用のパイプが近傍に埋設されていることが確認されたため接続延長を必要最小限として施工を完了した。この出来形に応じて改めて変更数量協議をおこなう予定である。

TypeA 流末接続柵(既設水道パイプ確認)

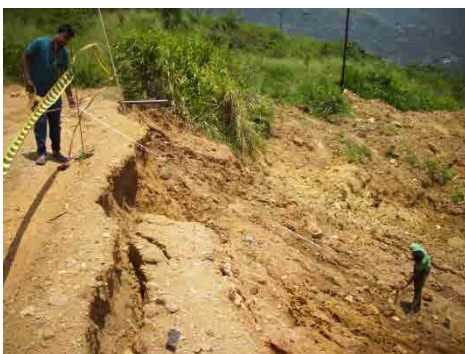
2 月提出の活動報告において記載済みであるが、現地事務所前の盛土縁辺部に 1/26 に豪雨に伴い亀裂が発生し、土塊の移動が生じ水平ボーリング PointNo.4 が土砂で埋まった状況となっていた。コントラクターは変動した盛土部分を整形し斜面の安定を確保してから水平ボーリング工の施工準備を実施していたが、4 月 19 日に軽微な土砂移動を生じ削孔予定のコンクリートベース基面が土砂で埋没した。この現象に対応して NBRO と現地状況確認をおこない、削孔位置を平面的に約 30m、(標高差約 - 6m) TypeD の水路工方向にシフトし改めて再掘削を開始する方針とした。また、同箇所での安定化を確認する目的で単管パイプと鉄筋棒によって簡易な伸縮変動計測点を設け、定期的なモニタリングを行うように指導をおこなった。

現場事務所前の段差計測

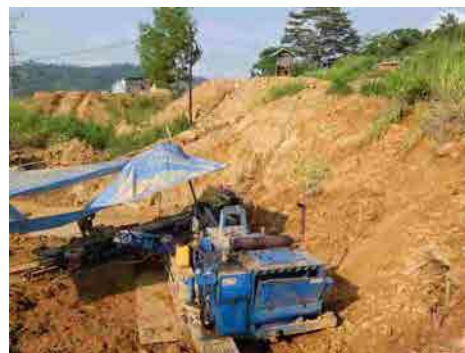
4月提出の活動報告において記載済みであるが、現地事務所前の盛土縁辺部に1/26に豪雨に伴い亀裂が発生し、土塊の移動が生じ水平ボーリング Point No.4 が土砂で埋まった状況となっていた。コントラクターは変動した盛土部分を整形し斜面の安定を確保してから水平ボーリング工の施工準備を実施していたが、4月19日に軽微な土砂移動を生じ削孔予定のコンクリートベース基面が土砂で埋没した。

No.1 よりボーリングが開始され、余掘りを含めて64m掘削したが、先端部分の孔壁が崩壊しPVCパイプが58mまでしか挿入できない状況であった。その後、洗浄等によって回復し61mまで挿入したとのことである。来月以降に数量の確認を行う。

なお、4月の活動時に同箇所の変動状況を確認する目的で単管パイプと鉄筋棒によって簡易な伸縮変動計測点を設け、定期的なモニタリングを行うように指導を行っている。観測点設置以降は特に変動は無く、今回の測定によっても変動は確認されなかった。

Point No.4 ボーリング施工箇所全景

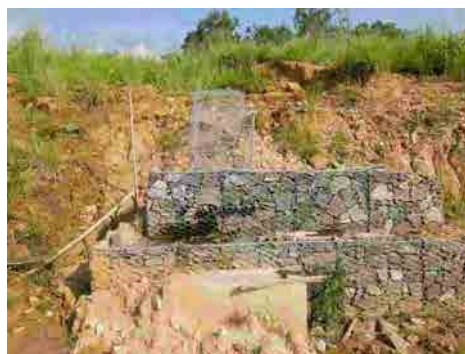
先月までに報告済みであるが、施工済みの水平ボーリング Point No.1 の背後斜面も幅15m、長さ20m程度の地すべり現象を生じ、不安定な状況となっており、さらに背後斜面からの湧水の浸出が恒常的に認められた。この現象を放置すると Point No.1 周辺の不安定化が進行することが懸念されたため、水路工の施工によって湧水を既設の水路工に導くことが NBRO の指導により計画された。現時点では地表面を仮掘削して水路工のラインを設定し、ある程度の湧水を既設水路工に導いている。なお、Point No.1 の向かって左側端部は前述の湧水の流下影響により不安定化が進行している。この部分については布団カゴ工を延長することで対応が計画されている。以上の状況は、先月から大きな変化はないものと考えられる。

Point No.1 ボーリング施工箇所全景

なお、No.1 孔からの排水量は、約 0.6ℓ/min であり、その他の孔からはほとんど排水は認められない。

上記の斜面安定化に関わる対応については、まとめてコントラクターからレターを提出するように依頼した。

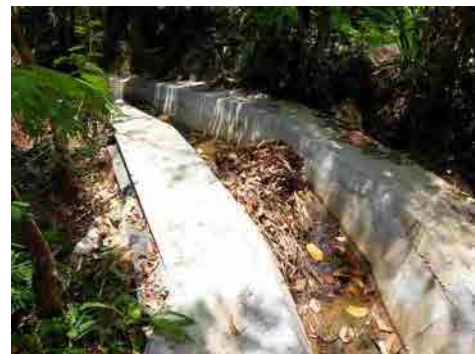
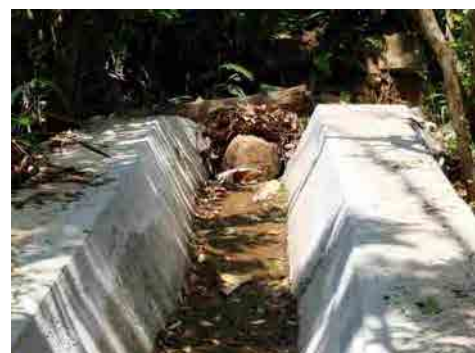
以上より、完成検査後特に大きな異常は生じていないと判断されるが、③の堆積物については今後増加が予想されることや瑕疵検査期間内においてさらに大きな降雨の影響を受けることも予想されるので、定期的な水路工清掃の指導、継続的な監視、モニタリングが必要である。NBROの地すべりモニタリングや巡回結果についても確認を行う必要がある。

水路に溜まった枯葉等 (上流から)

水路に溜まった枯葉等 (下流から)

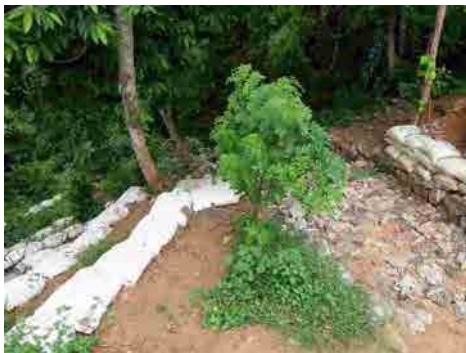
水路工側部に設置された土のう
(上方より)

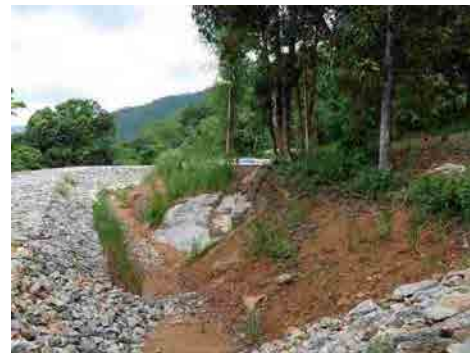
②については表層の侵食に対応して植栽工が実施されており、植生が徐々に成長しつつある状況である。

植栽工の状況

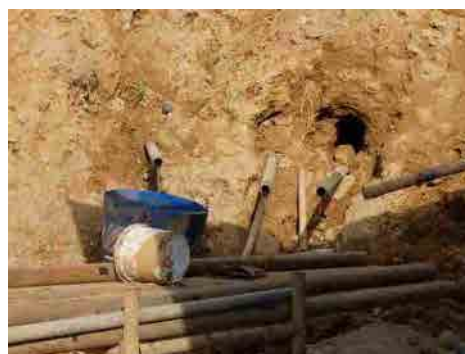
Point No.4 ボーリング工からの集水状況

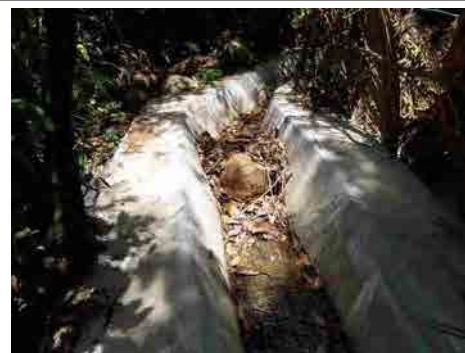
③については柵内に土砂や植物等の堆積が確認されたが、集水柵の機能は保たれている。ただし、水路に落石があり、石に枯葉や枝が引っかかっている

水路に溜まった枯葉等（下流側から）

る箇所がそのままの状況であることが確認された。

以上より、完成検査後特に大きな異常は生じていないと判断されるが、③の堆積物については今後増加が予想されることや瑕疵検査期間内においてさらに大きな降雨の影響を受けることも予想されるので、定期的な水路工清掃の指導、継続的な監視、モニタリングが必要である。NBROの地すべりモニタリングや巡回結果についても確認を行う必要がある。

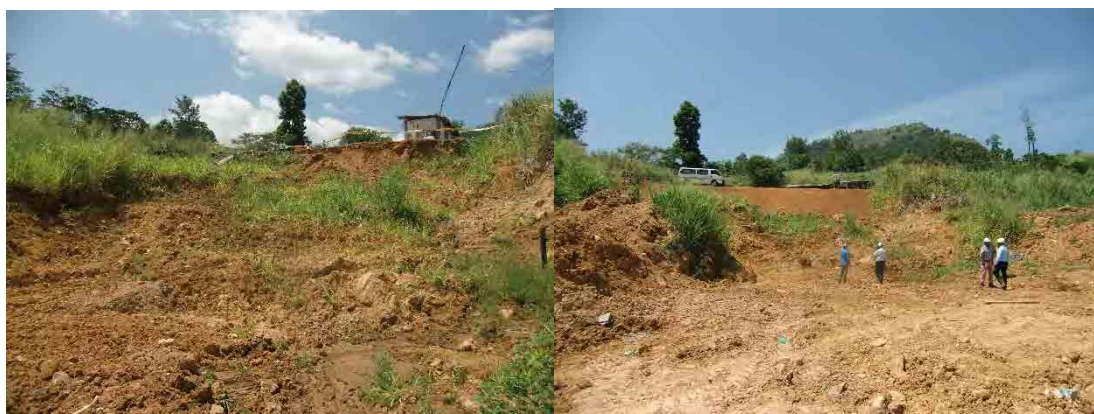
BH-4(旧)の急斜面の状況(施工前)

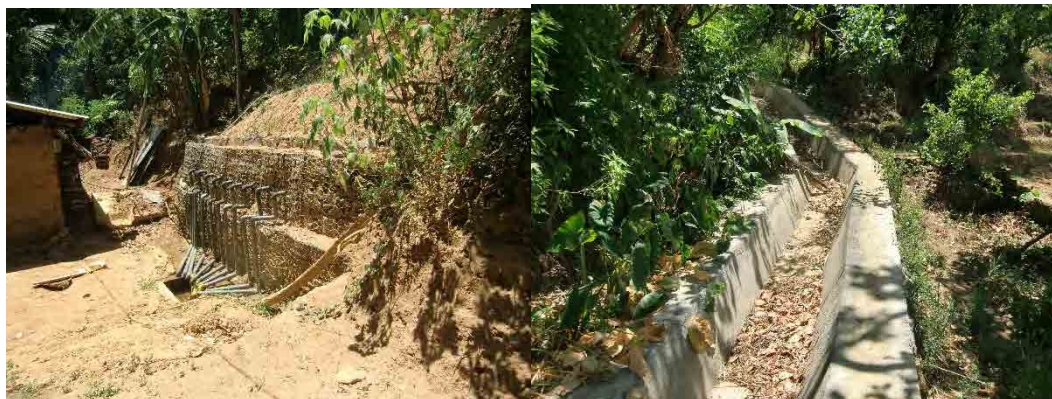
- ① については先月までと同様に、特に石などが置かれ減勢がなされた様子はいかがいかなかったが、施工完了後に特に豪雨もなく、大量の流水による影響は確認されなかった。
- ② についても先月までと同様に、完成検査翌日に処理がなされていることを確認済みであり、その後特に変化はない。
- ③ については水路や桝内に土砂や植物等の堆積が確認されたが、通水機能は保たれている。施工後特に豪雨を経っていないため、堆積状況には特に変化はない模様だが、今後の豪雨による通水機能には、現段階では大きな影響はない程度と思われる。

水路工施工状況(水路内に植物が堆積)

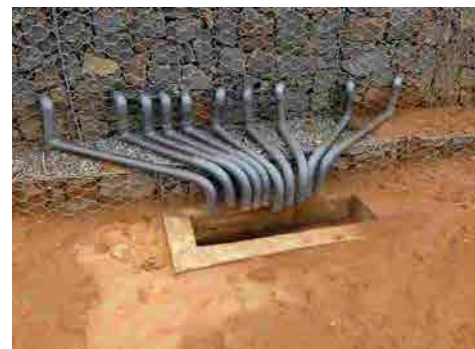
Point No.6 の柵に土砂が流入している状況

Point No.1 で、背後斜面から土砂が侵食されて流出している状況にある。前回、亀裂が確認された箇所が小規模なすべりを発生していることが確認された。また、Point No.6では、集水柵に土砂が流入し、ほぼ閉塞状態にある。土砂の撤去等に関する計画をコントラクターが提出する予定となっている。

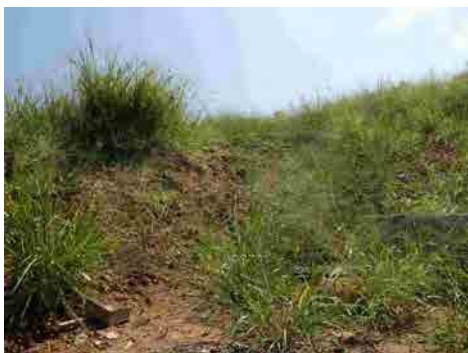
Point No.1 背後斜面の状況

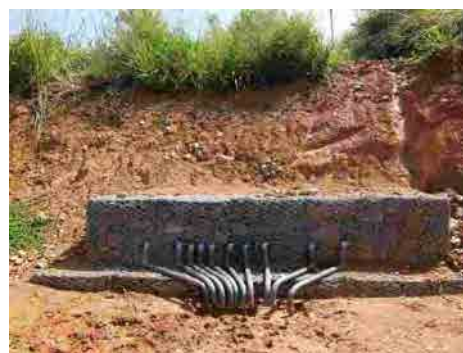
Point No.6 の柵に土砂が流入し
ほぼ埋塞している状況

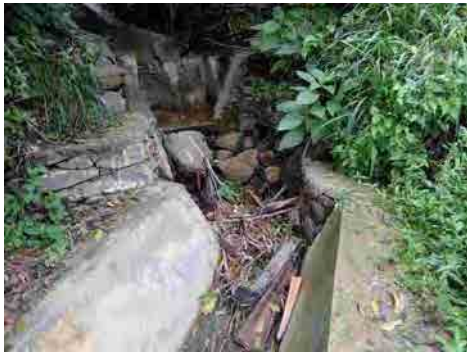
樹下部のコンクリート打設が実施されていない箇所と流木等による閉塞状況

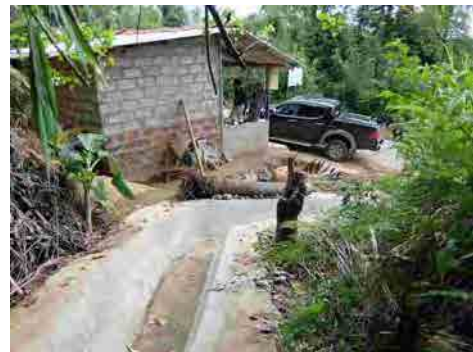
道路上部の水路工で豪雨時に表流水があふれる現象が確認された。水路が急角度で屈曲していることによるものと考えられる。住民は、石や木材等で表流水を防いでいる状況にある。

水路の越流箇所

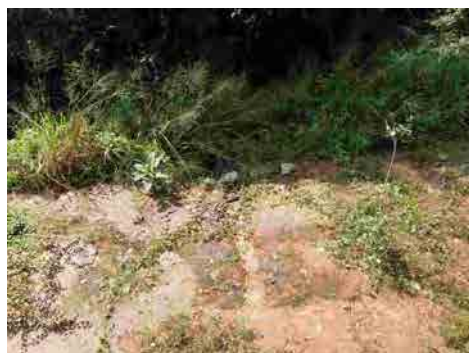
前回同様に布団カゴ工前面の盛土部分の法肩に、小規模な侵食が確認された。亀裂は雨水

等の影響で消滅したようである。また、カスケード水路工が流水により、一部石が移動している状況が確認された。前回からはほとんど変化は無い。

盛土部法肩の状況 (左)

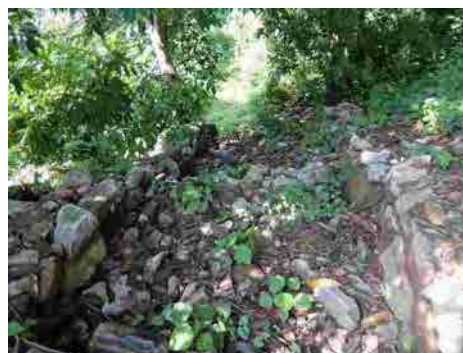
水路工の状況

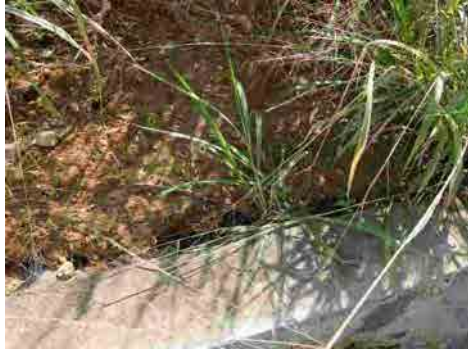
上部斜面における水路側部の侵食状況

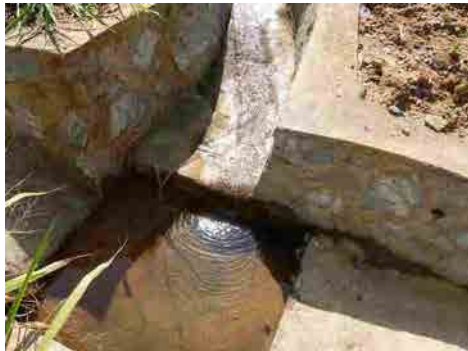
また、最上流部の集水桝 No.1 に、上部水路から水が流入してきているが、下流に流出していない状況が確認された。集水桝中に設置された水抜きパイプから、水が外部に排出されているようである。さらに水抜きパイプを通して外部に出た水は、水路へ再度漏水として流入してきている状況にある。

集水柵への流入の状況

水抜きパイプを閉塞して、漏水を防ぐことが必要と考えられる。

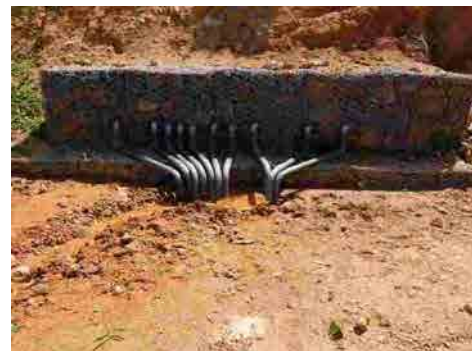
Point No.6 の柵に土砂が流入し埋塞している状況

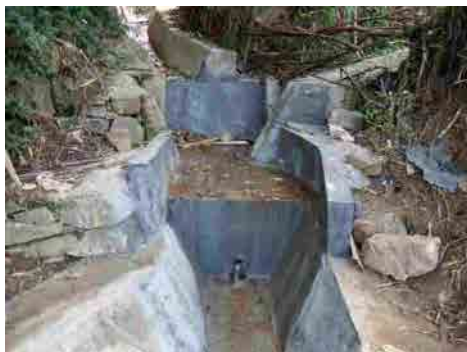
その他の箇所についても補修は行われているが、特に漏水箇所については、今回は水路内の流量が多く、漏水箇所が確認できない状態にあった。

樹下部の水路工の補修後の状況

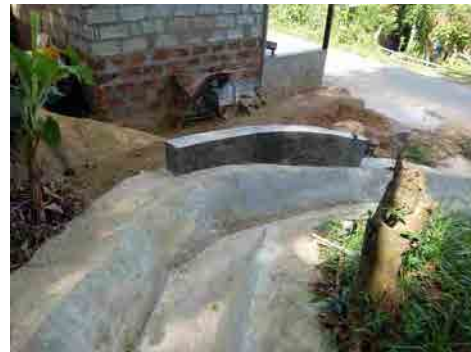
また、道路上部の水路工で豪雨時に表流水があふれる現象が確認された。水路が急角度で屈曲していることによるものと考えられる。この場所についても、コントラクターが水路工上部にコンクリート壁を建設して、対策を行っているが、実際にこの延長で問題が無いか、降雨時の確認が必要となると思われる。

水路の越流箇所

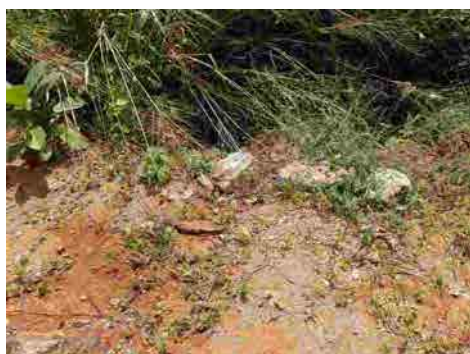
前回同様に布団カゴ工前面の盛土部分の法肩に、小規模な侵食が確認された。亀裂は乾燥収縮の影響で大量に確認された。降雨に伴う土砂の移動ではないため、特に問題は無い。ただし、今後も確認していく必要はある。また、カスケード水路工が流水により、一部石が移動している状況が確認された。前回からはほとんど変化は無い。

盛土部法肩の状況

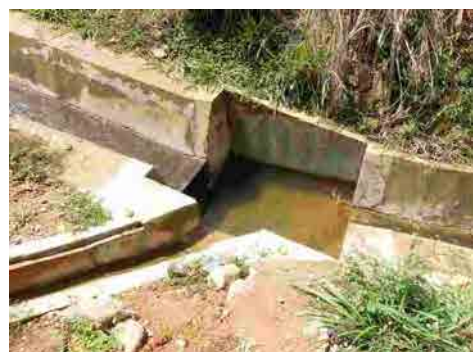
集水柵の土砂撤去後の状況

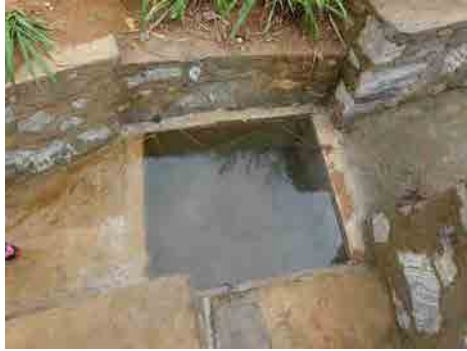
集水柵補修後の状況

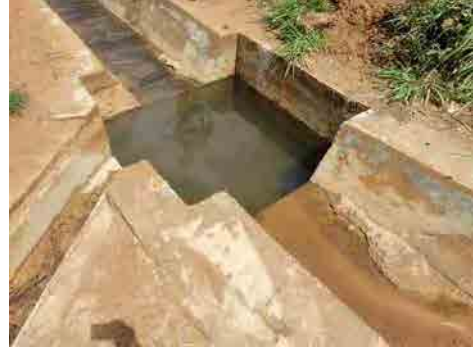
集水柵土砂撤去後の状況

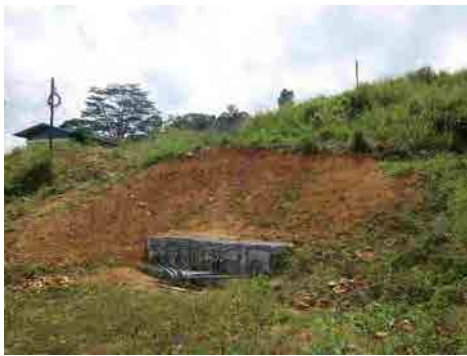
Point No.4 背後斜面の整形状況

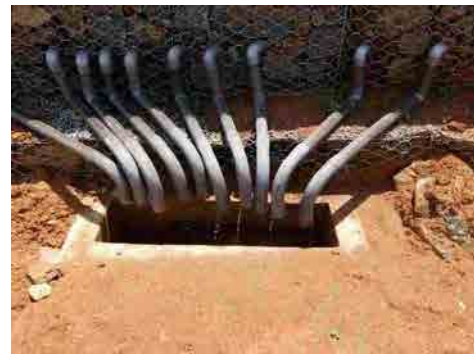
No.6 集水ボーリングの土砂撤去後

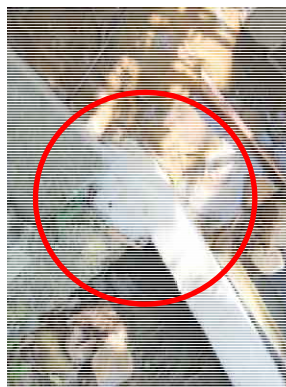
その他の箇所についても補修は行われているが、特に漏水箇所については、検査時にも水路内の流量が多く、漏水箇所が確認できない状態にあった。漏水箇所については、**Final Report** に、乾期に漏水箇所の確認を行い、必要に応じて補修を行うこと、と提言として記載した。

検査後の補修状況

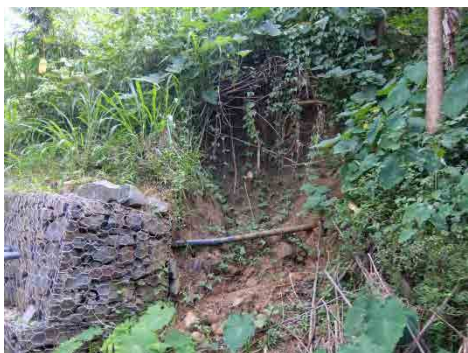
布団カゴ右側の崩壊の状況

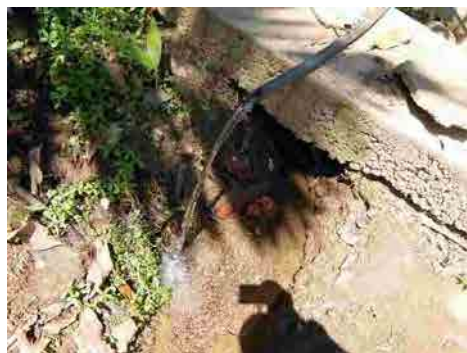
また、住民の要望により、水路に穴を開け農業用の水を水田に引くことが出来るようになっており、検査時にも穴から水を取得している状況が確認された。ただし、水田まで素掘りの水路で水を引いているため、地表水が地すべり地内に再浸透してしまう可能性がある。したがって、素掘り箇所にビニールシートを敷くか、パイプ等を用いて、地下に浸透しないような工夫を行うことを、**Final Report** で提言を行った。

水路から地すべり地内に素掘り水路で水を流している状況

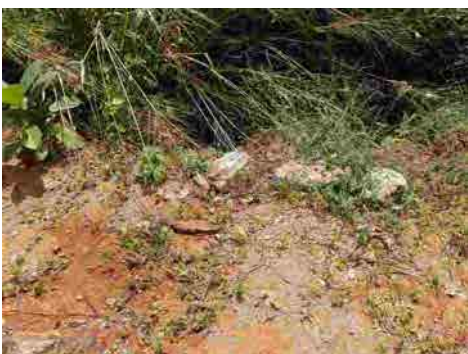
前回同様に布団カゴ工前面の盛土部分の法肩に、小規模な侵食が確認された。亀裂は特に確認されなかった。また、カスケード水路工が流水により、一部石が移動している状況が確認された。前回からはほとんど変化は無い。

盛土部法肩の状況

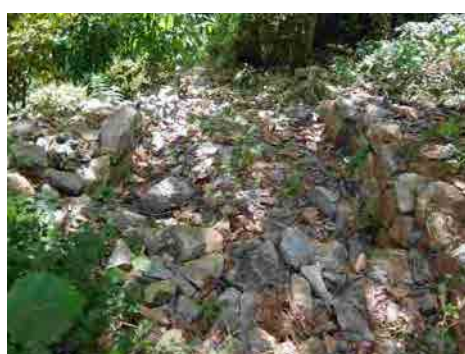
水路工の状況

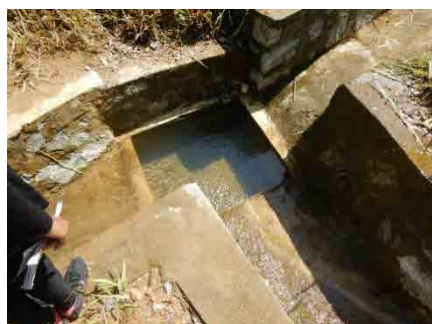
2017年7月26日の完成検査が実施された。現在は瑕疵担保期間中であるが、NBROにより定期的に集水桝に溜まった土砂の取り除き等が実施されており、水路の効果は適切に維持されている。

最上部の集水桝に堆砂は生じていない

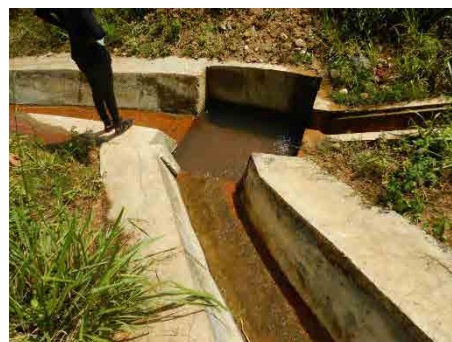
NBRO が定期的に堆砂の除去を実施している。

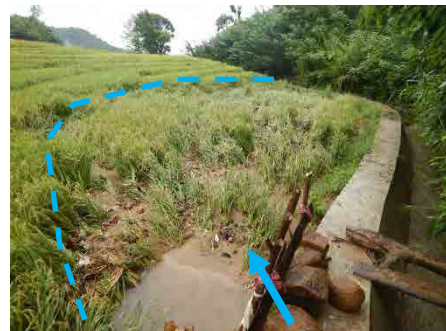
水路が急角度で屈曲している2箇所（Location No.14およびNo.15）において、水路の流水が豪雨時にあふれる現象が確認された。Location No.14については、コントラクターが水路工上部にコンクリート壁を建設して、対策を行っているが、降雨時にはその壁の横から流水が飛び出していることが確認された。Location No.15では水田に被害が生じているため、今後、水路にコンクリート製の蓋をして固定する等の対策が必要である。

水路からの越流による水田の被害
(Location No.15)

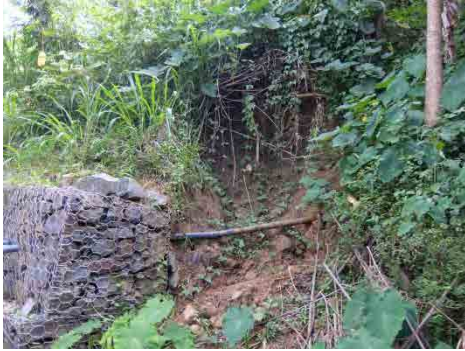
布団カゴ工右側の斜面に2018年1月29日の豪雨によって、幅1-2m程度の小崩壊が発生した。この崩壊は、豪雨によって発生した自然災害であり、コントラクターの瑕疵となっていない。NBROとコントラクターと協議を行い、布団カゴの追加を追加する予定であるが予算の確保で時間を要している。

布団カゴ右側の崩壊の状況

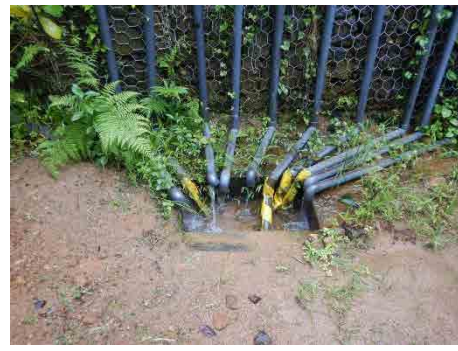
2018年5月21日の点検時には、右下写真のように多量の排水が認められ、横ボーリングの効果が確認された。

横ボーリングの排水機能が維持されている

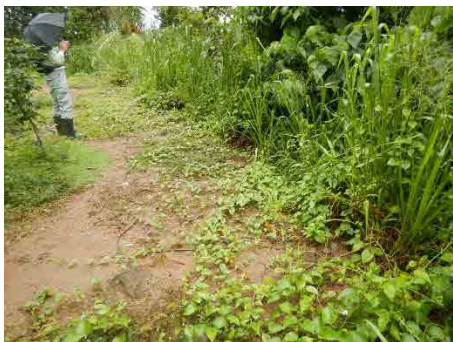
布団カゴ工前面の盛土部分の法肩の小規模な侵食がこれまでのモニタリングで確認されている。今回の点検で浸食の拡大などは認められなかった。また、カスケード水路工部分に変化も認められなかった。

盛土部法肩の状況 (変化なし)

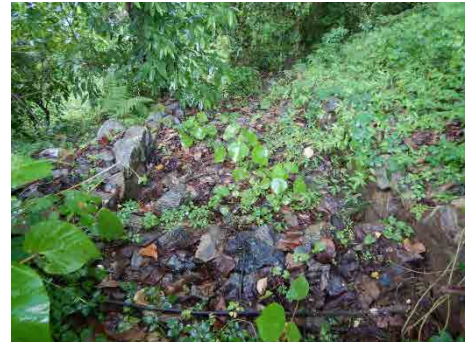
水路工の状況 (変化なし)

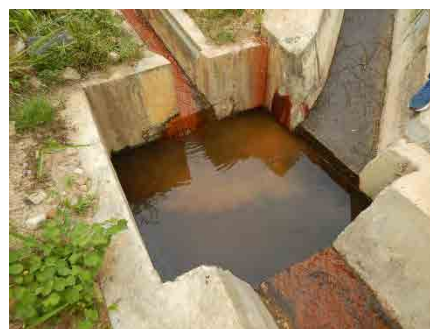
NBRO が定期的に堆砂の除去を実施している。

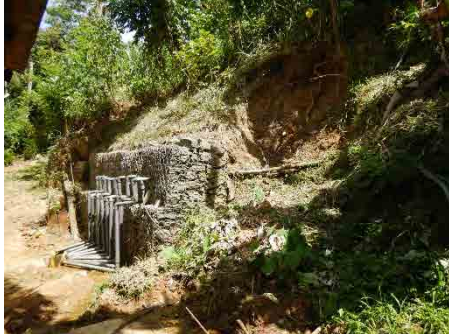
布団カゴ工右側の斜面に2018年1月29日の豪雨によって、幅1-2m程度の小崩壊が発生した。この崩壊は、豪雨によって発生した自然災害であり、コントラクターの瑕疵となっていない。NBROとコントラクターと協議を行い、布団カゴの追加を追加する予定であるが予算の確保で時間を要している。

布団カゴ右側の崩壊の状況

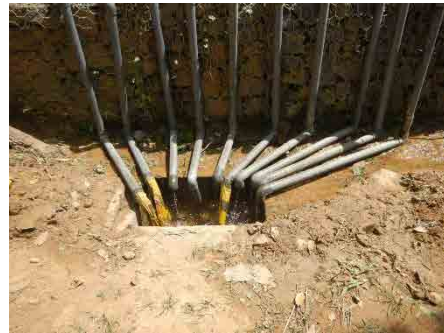
横ボーリングの排水機能が維持されている

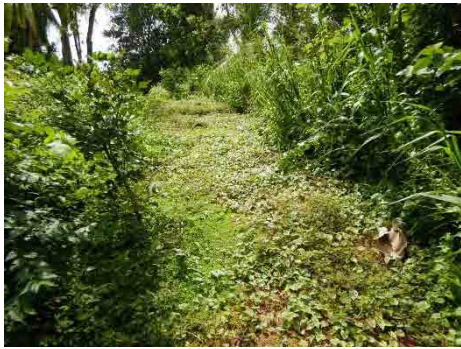
布団カゴ工前面の盛土部分の法肩の小規模な侵食がこれまでのモニタリングで確認されている。今回の点検で浸食の拡大などは認められなかった。また、カスケード水路工部分に変化も認められなかった。

盛土部法肩の状況（変化なし）

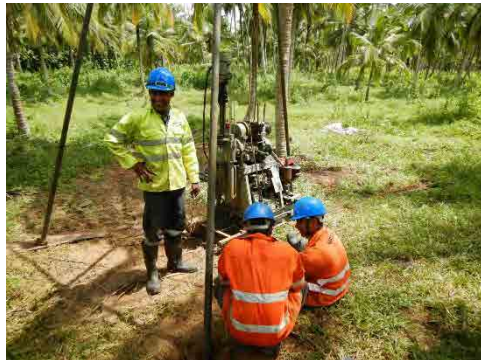
これまでと同様、ボーリングマシンは特に問題なく稼働している。また、作業現場は整理整頓が行き届いており、機械類も適切に維持管理されている。ボーリングマシンについては熟練のオペレーターが運転しており、定期的にメンテナンスを実施しているとのことであった。

ボーリングマシンの使用状況

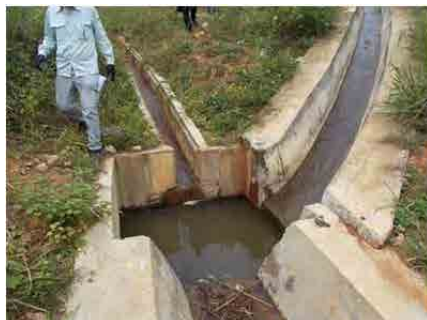
2017年7月26日に完成検査が実施された。瑕疵担保期間中はNBROにより定期的に集水枠に溜まった土砂の取り除き等が実施されており、水路の効果は適切に維持されている。

土砂は除去されている

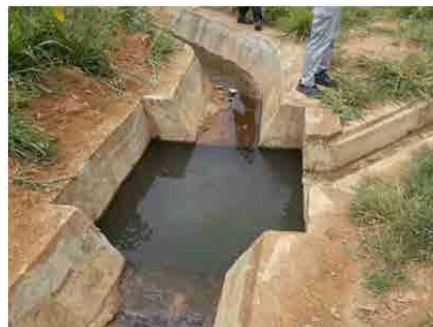
土砂は除去されている

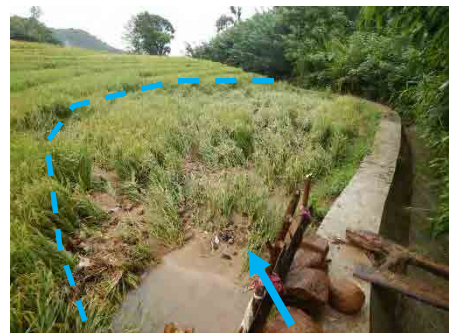
水路が急角度で屈曲している 2 箇所 (Location No.14 および No.15) において、水路の流水が豪雨時にあふれる現象が確認された。Location No.14 については、コントラクターが水路工上部にコンクリート壁を建設して、対策を行っているが、降雨時にはその壁の横から流水が越流していることが確認された。Location No.15 では水田に被害が生じているため、今後、水路にコンクリートの蓋を設置する等の対策が必要である。対策方針については、NBRO、コンサルタントチーム、コントラクターとで現地で協議済みであるが、雨期の状況を見て最終的に対策を決定することとした。

水路からの越流による水田の被害
(Location No.15) 2018 年 5 月の状況

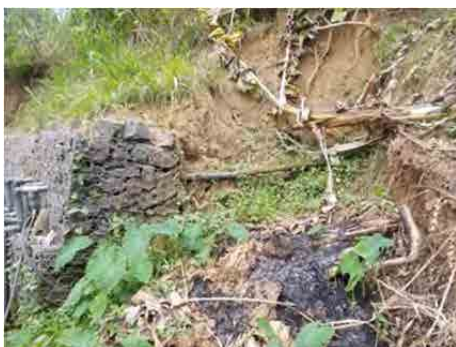
布団カゴ工右側の斜面に 2018 年 1 月 29 日の豪雨によって、幅 1-2m 程度の小崩壊が発生した。この崩壊は、豪雨によって発生した自然災害であり、コントラクターの瑕疵となっていない。NBRO とコントラクターと協議を行い、布団カゴの追加を追加する予定であるが予算の確保で時間を要している。

布団カゴ右側の崩壊の状況

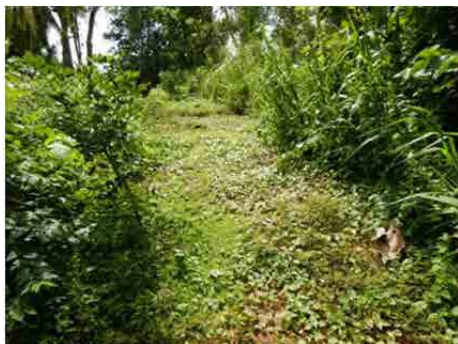
布団カゴ工前面の盛土部分の法肩の小規模な侵食がこれまでのモニタリングで確認されている。今回の点検で侵食の拡大などは認められなかった。また、カスケード水路工部分に変化も認められなかった。

盛土部法肩の状況（変化なし）

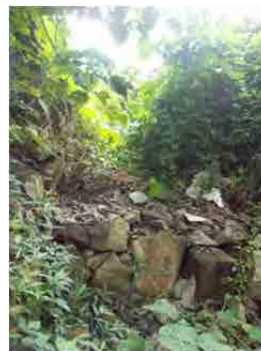
水路工の状況（変化なし）

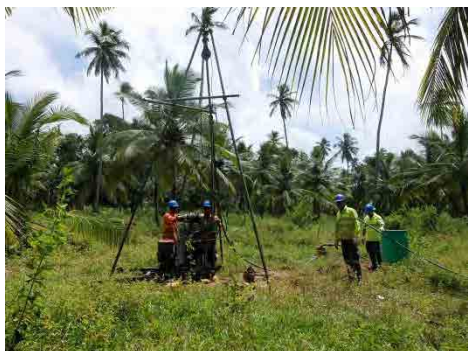
これまでと同様、ボーリングマシンは特に問題なく稼働している。また、作業現場は整理整頓が行き届いており、機械類も適切に維持管理されている。ボーリングマシンについては熟練のオペレーターが運転しており、定期的にメンテナンスを実施しているとのことであった。なお、マシンに貼られた JICA シールが古くなっていたため、今回新しいものに貼り直した。

ボーリングマシンの使用状況

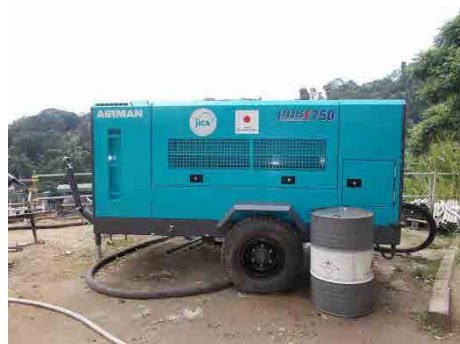
7月の点検でもコンプレッサーも問題なく稼働していることを確認した。また、NBRO の施工監理技術者により日々のコンプレッサーの稼働記録と点検チェックシートが記入されていることを確認した。

キャンディ看護学校で稼働中のコンプレッサー
