Appendix 8-6

Certificate of completion
of the pilot site

1. Name of Consulting Service Assignment	The Pilot Project for Landslide and Rock fall mitigation works (Lot 1) under the Technical Cooperation for Landslide Mitigation Project
2. Performance Period	28/01/2016 – 28/07/2018
3. Contract Amount	LKR 38,268,930.00 (Final confirmed price: LKR 37,361,900.36)
4. Name of Contractor	ELS Construction (Pvt) Ltd
5. Progress of Work	As per progress report
6. Amount Payable by this Inspection	LKR 10,437,206.77
7. Note	Work progress in the report is 97.51% (Rs. 33,923,186.36) which is the progress percentage to the contract amount without contingency (10%). After this inspection on the completion of the work, defect liability period commences at the date of issuance and approval of Certificate of Completion for one year. The contractor should submit Maintenance Security to JICA for the defect liability.

Certificate of defect liability period
of the pilot sites

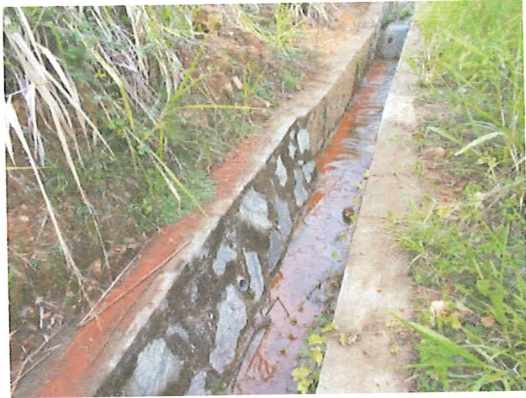
Photo 1: Erosion has been corrected (Loc.2)

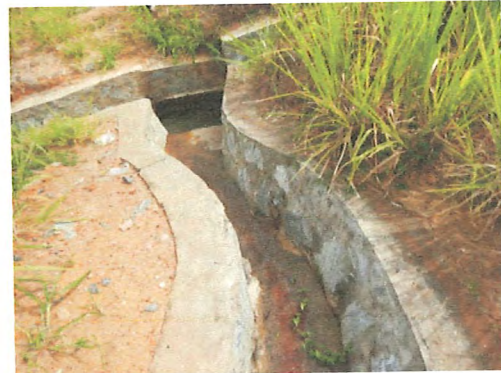
Photo 2: Erosion has been corrected (Loc.1)

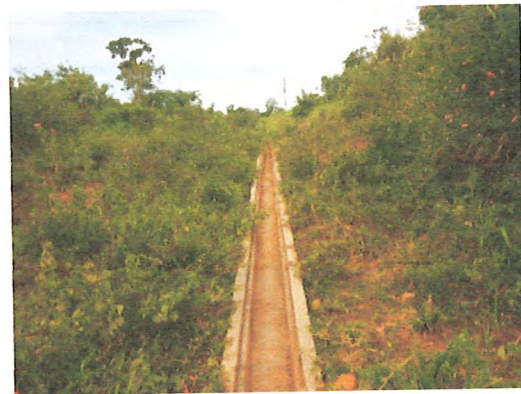
Photo 6: Rocks have been removed (Loc.12)

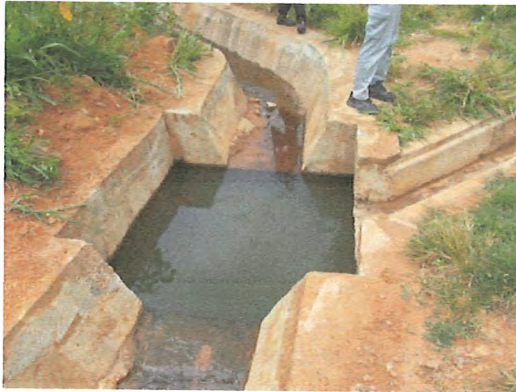
Photo 7: Soils have been removed (Loc.8)

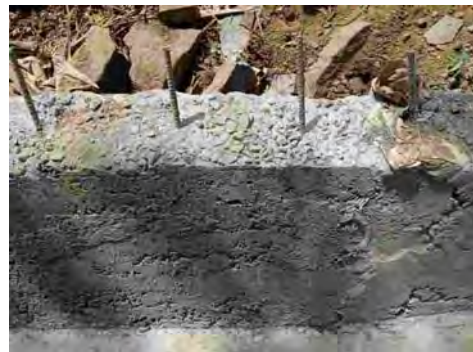
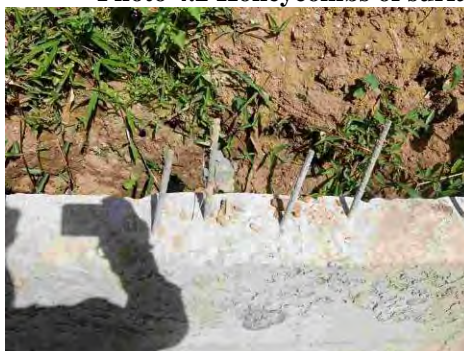
The concrete grade of the surface drainage ditch should be more than 25 grade. Otherwise, honeycombs could appear on the surface of the ditch. (see Photo 4.2) The main cause was the concrete grade and insufficient compaction with vibrator might be a cause of the honeycombs. Therefore more than a concrete grade 25 should be used for the surface drainage ditch in order to avoid such honeycombs. Also distribution of reinforce steel bars should follow the original design in order to keep the quality stipulated in the standard in Sri Lanka and the contract document (see Photo 4.3) .

Photo 4.3 Spacing of steel bars do not follow the design (already corrected)

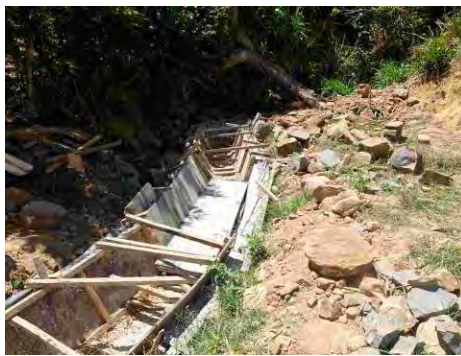
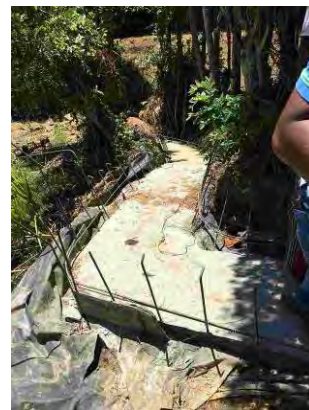
Photo 4.4 Sudden curves of ditch (already corrected)

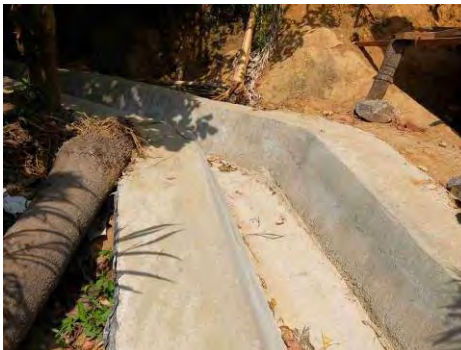
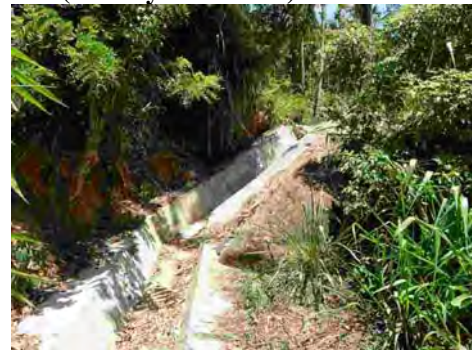
Photo 4.5 Sudden curves of ditch

sometimes it could be difficult to follow the original design. Topographic surveys should be conducted before the construction works along the planned surface drainage ditch line and usually a cross section should be surveyed almost every 20m along the ditch line in the shop drawings. Therefore sometimes it could be difficult to follow the original drawings because the topographic survey cannot cover all of the cross sections along the ditch line. If there are so many changes of gradient of slope or sudden change of direction of stream, the Contractor shall submit a proposal of proper ditch works and an approval from the Engineer should be required. If necessary, additional cross sections should be surveyed depending on the topography along the planned ditch line in the shop drawings. (see Photo 4.4) After the discussion, these sudden curves were corrected in the pilot project. However, some parts have not been corrected completely, and sometimes water overflows at the steep slope and sudden curves. To construct such a steep slope and sudden curve should be avoided in order to avoid overflow at the sudden curve points. (see Photo 4.5) Sometimes land use was a problem to construct ditches as the original design land owners don't allow their land to be used for ditches. In this case, before the construction works, sufficient explanation and discussion should be conducted with land owners to obtain the land owner's agreement.

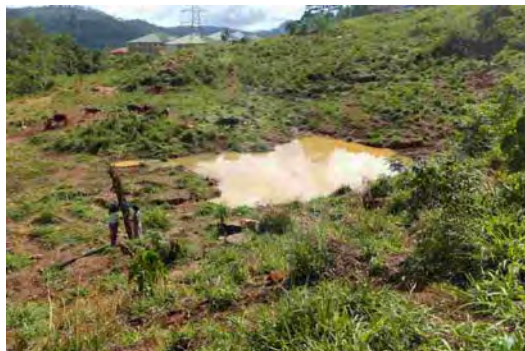
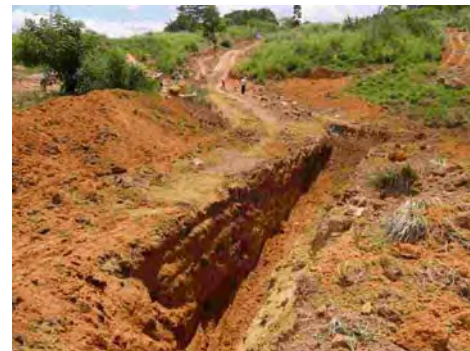
Photo 4.6 Pond before the construction (left) During the construction (right)

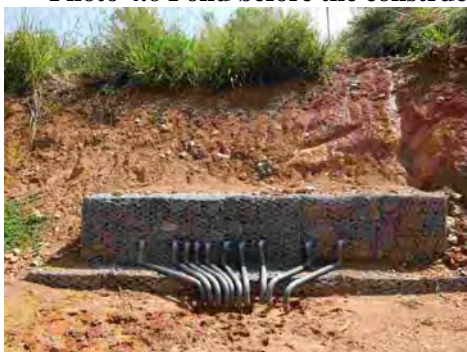
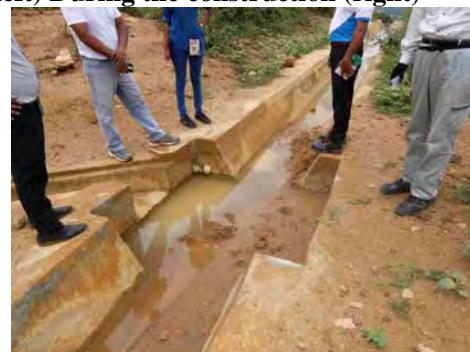
Photo 4.6 After the construction Pits are filled by soils

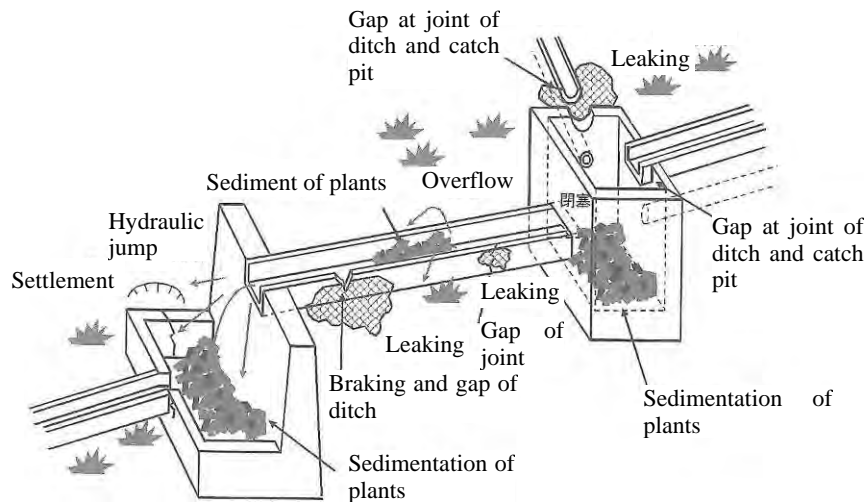
Figure 5.1 Damages along surface drainage ditch

Deterioration in functioning of the surface drainage ditch is caused by alteration or corrosion of materials by aging such as sunshine, rainfall and so on, deformation by gaps in the joints, deformation or damage by landslide movement and earth pressure or blockage by collapse or soil flowing into the ditch or plants, and erosion along the ditch by overflow or leaking.

Especially ditches installed at scarp or cracks of landslides tend to generate gaps in the

joints, it should be important to check areas that tend to cause phenomena such as landslide movements.

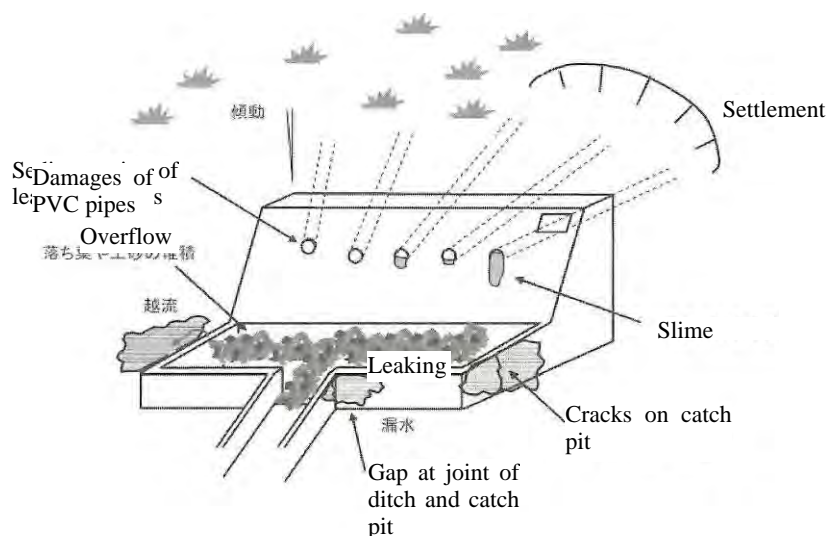
Figure 5.2 Damages at horizontal drainage drilling

Blockage by bacteria, algae and soils included in groundwater and penetration by roots of plants tend to occur. Deterioration of PVC pipes by water quality and damage such as cracks and gaps are sometimes found. Examples of deterioration of horizontal drainage are shown in Fig. 5.2.

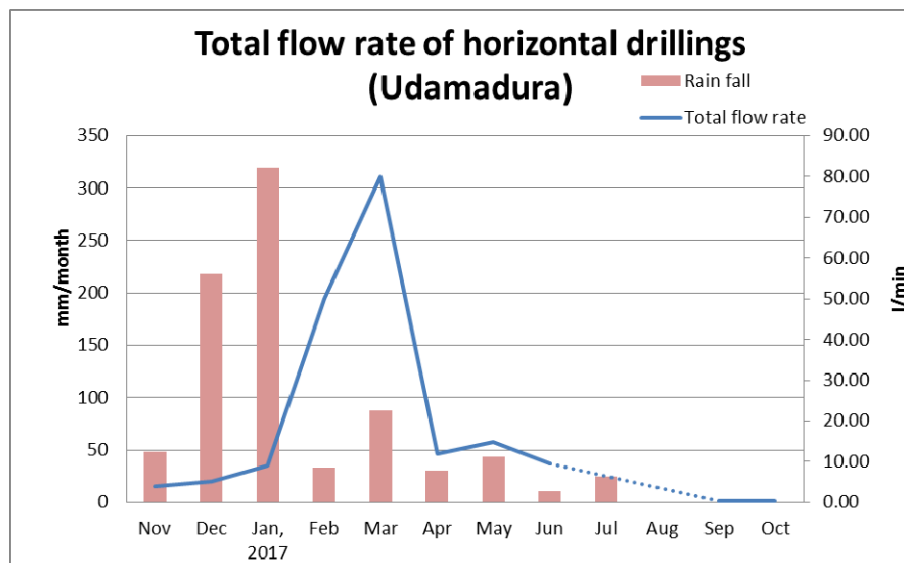
Figure 5.3 Water flow rate of horizontal drillings in Nuwara Eliya

When monitoring is conducted, the water flow rate should be measured in order to check the function of horizontal drainage drilling. Figure 5.3 shows the water flow rate in 2016 and 2017 in Nuwara Eliya. The water flow rate should be compared with the data, and if the water flow rate is less than the data considering rain fall data, washing and cleaning of drainage holes might be conducted. Attention should be paid that the data of the water flow rate was only once a month, but the rain fall data was cumulative data of daily rain fall. Therefore the water flow data could be a reference.

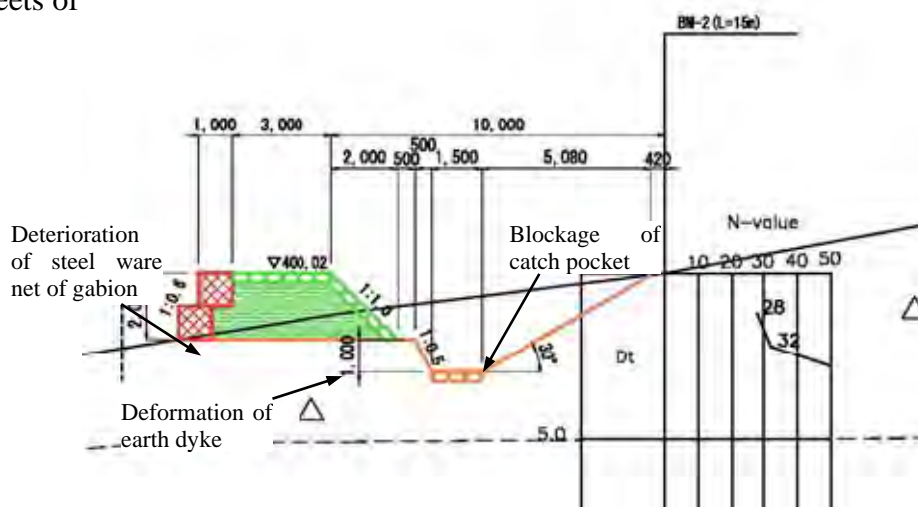
Deterioration of steel wire of the gabion, deformation of embankment and blockage of the catch pocket should be checked for the earth dyke countermeasures against rock fall. Examples of deterioration or damage of the earth dyke are shown in Fig. 5.4. Monitoring sheets of

Figure 5.4 Damages at earth dyke (Source: JICA Consultant Team)

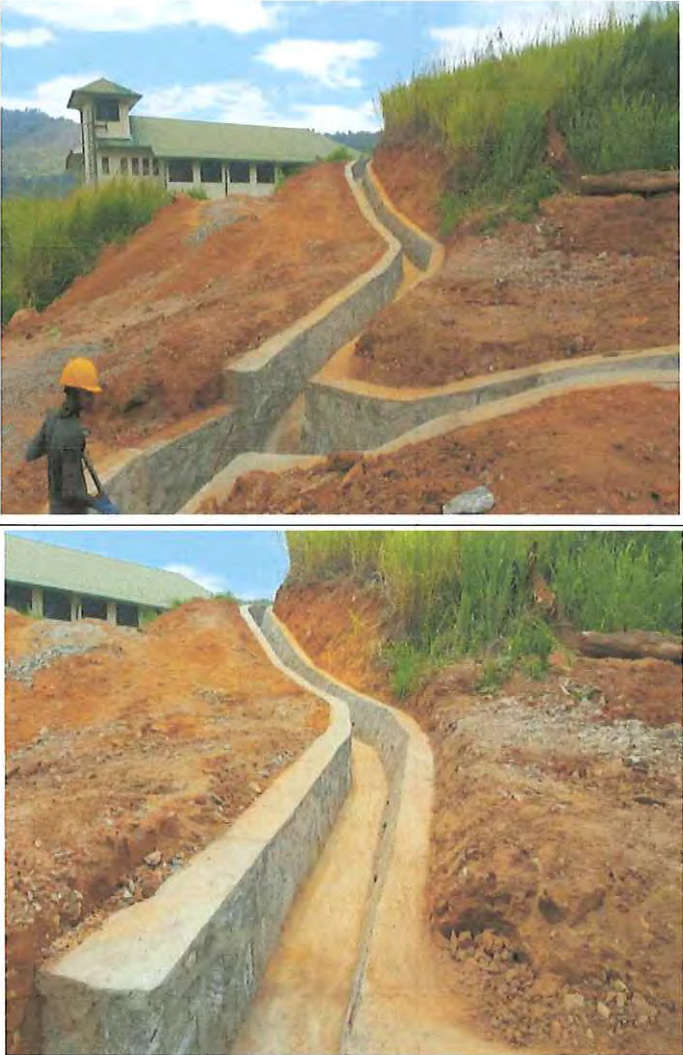
3. Observations on Environmental Noncompliance
3.1 Landslide mitigation work in Badulusirigama

Date inspected	Noncompliance Status	Photograph
12/07/2017	No any Noncompliance was observed during site visit.

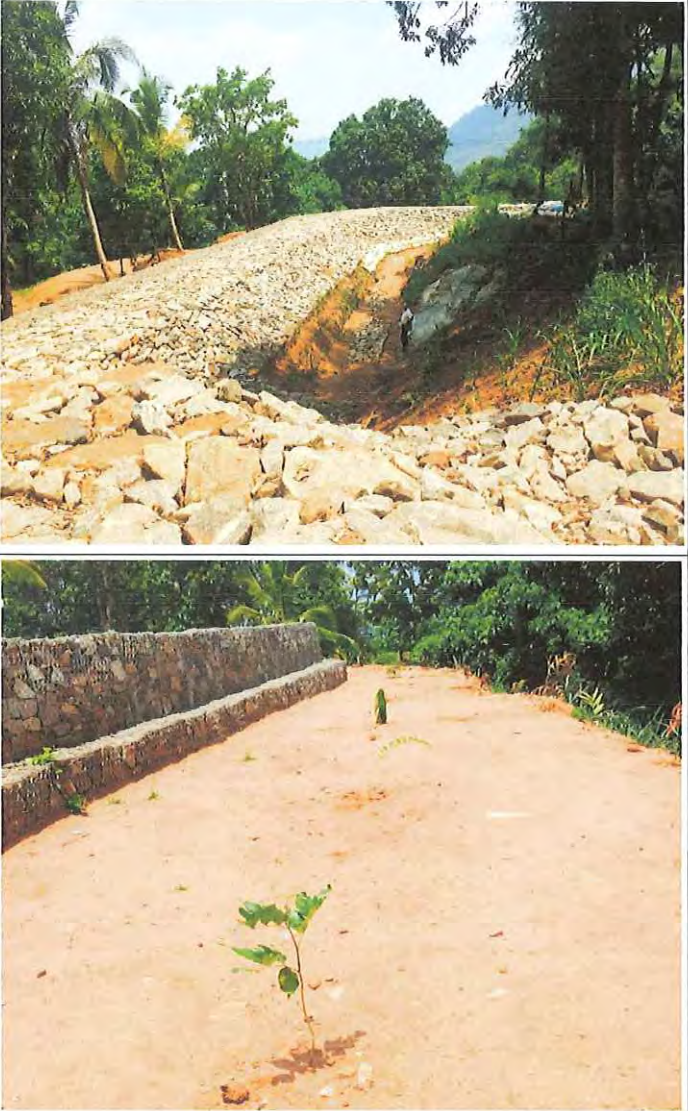
3.2 Landslide mitigation work in Alagumale

Date inspected	Noncompliance Status	Photograph
11/07/2017	No any Noncompliance was observed during site visit.

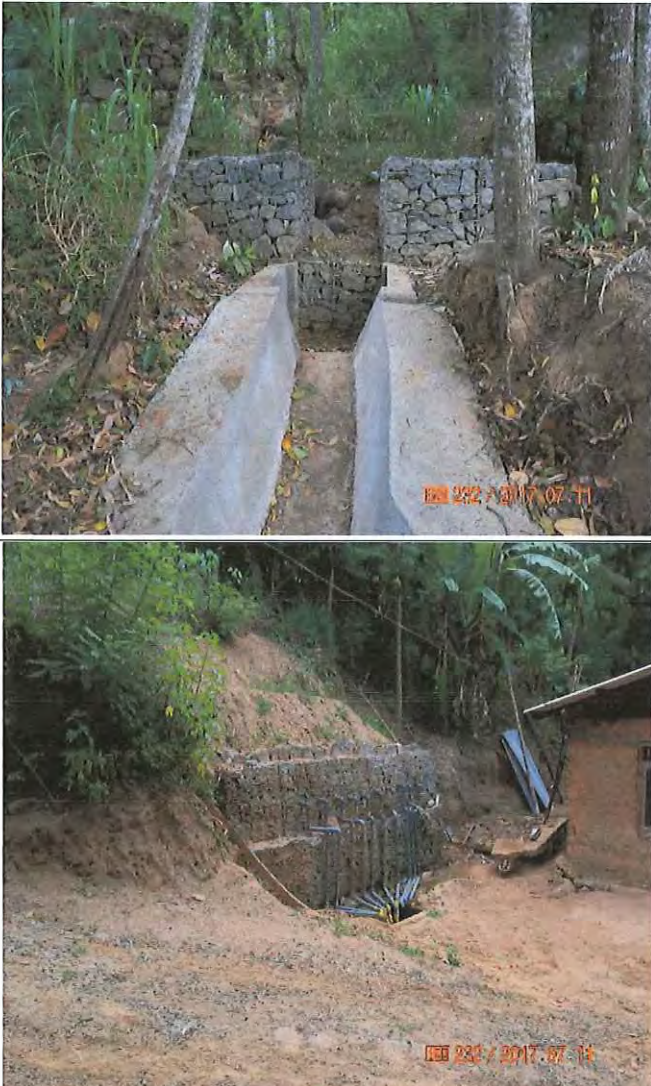
3.3 Landslide mitigation work in Udamadura

Date inspected	Noncompliance Status	Photograph
11/07/2017	No any Noncompliance was observed during site visit.
