APPENDIX-3

SITE SURVEY FOR OVER HEAD TRANSMISSION LINE

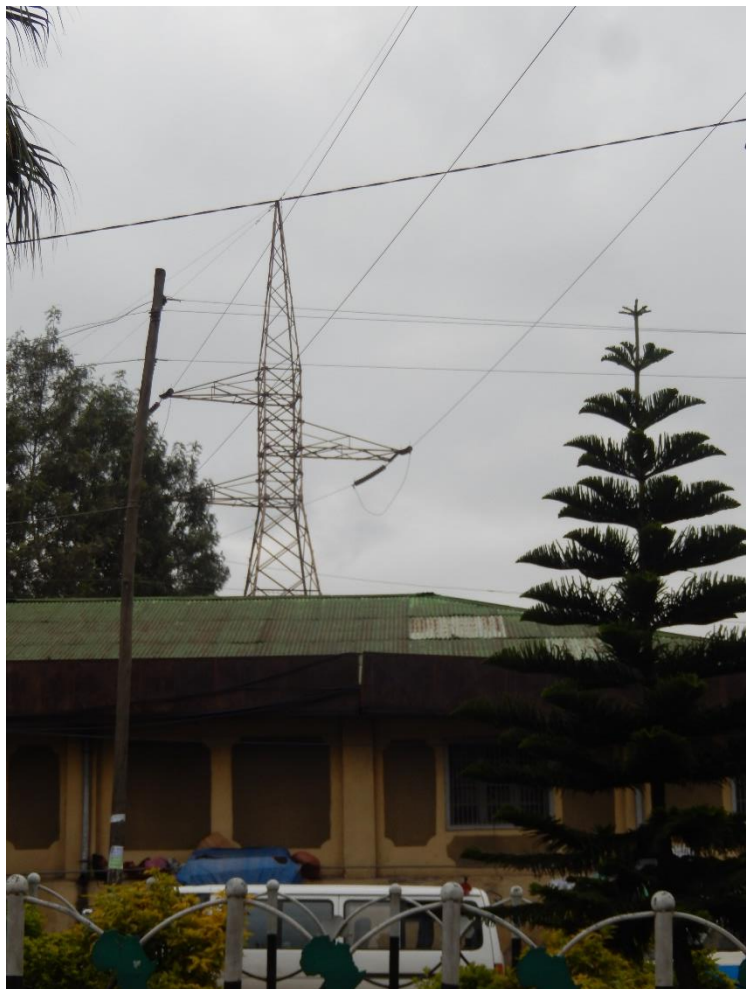
T-01 views from Main Road.
T-01 is dead-end tower to Addis Center Substation

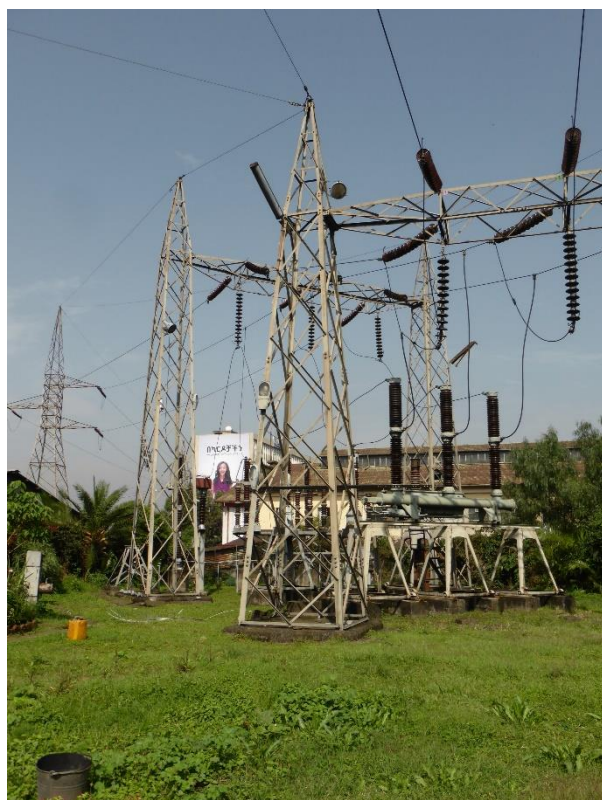
Addis Center Substation at 7th July 2017.
A Plan for Substation modification is considered.

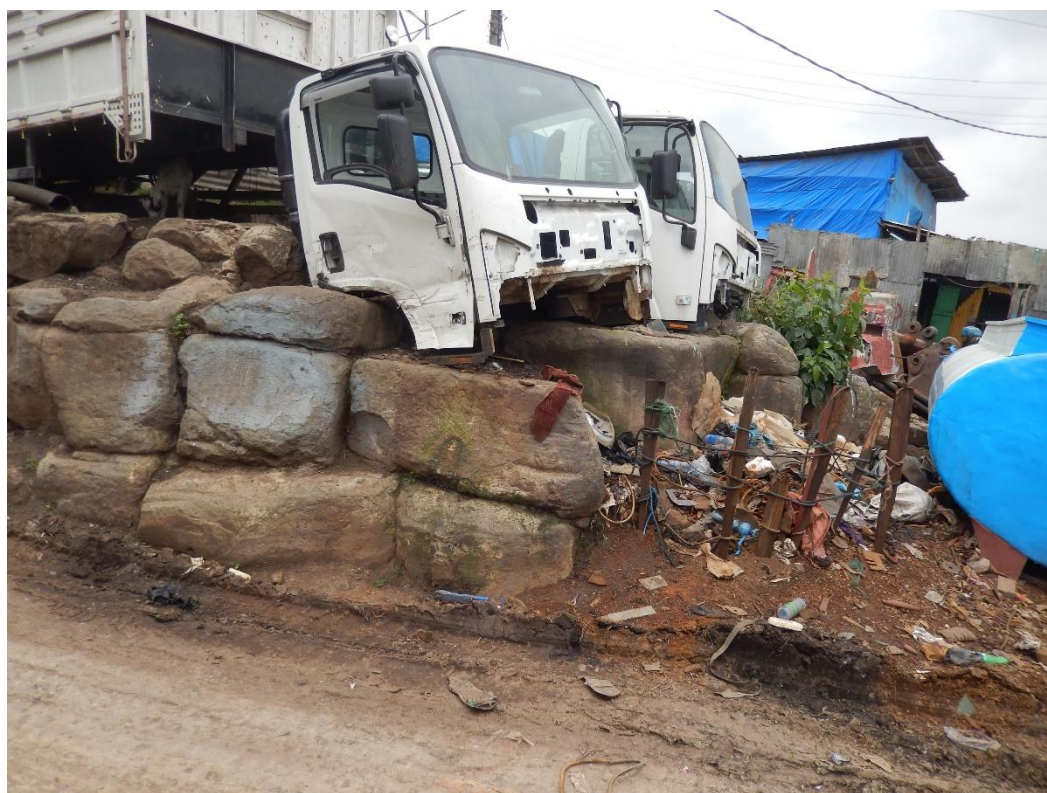
T20 on the slope toward existing road. Here will be end of new construction road

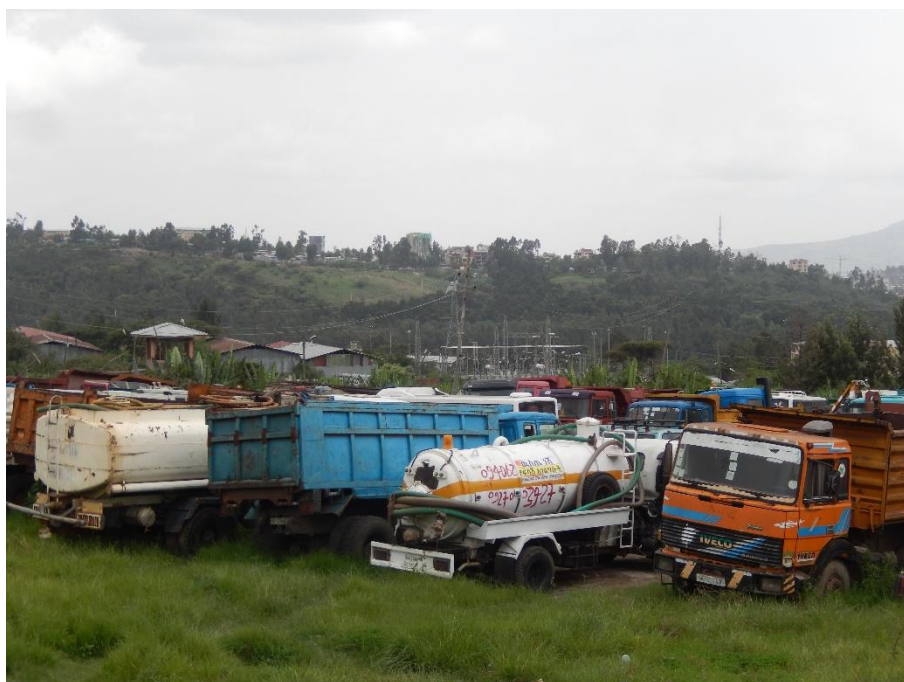
Gofa Substation
Front : Parkings for vehicle under corridor

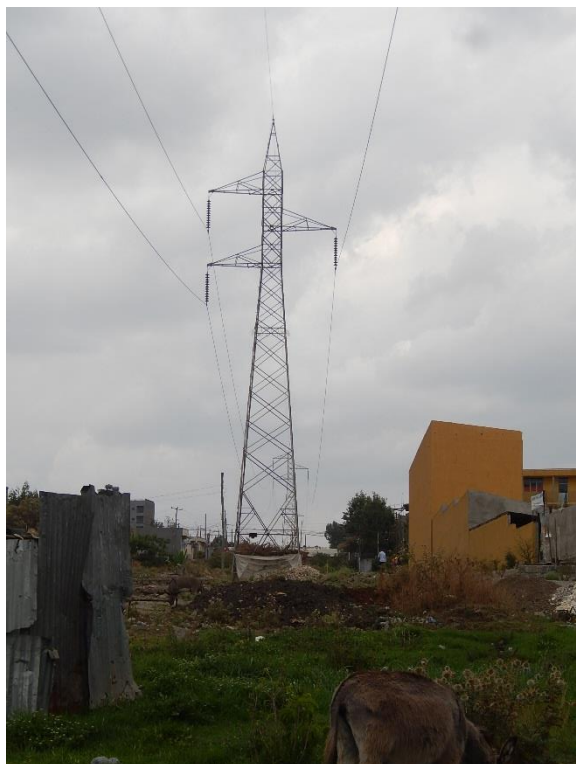
T 30
DSCN0540 T30 from T 29 side

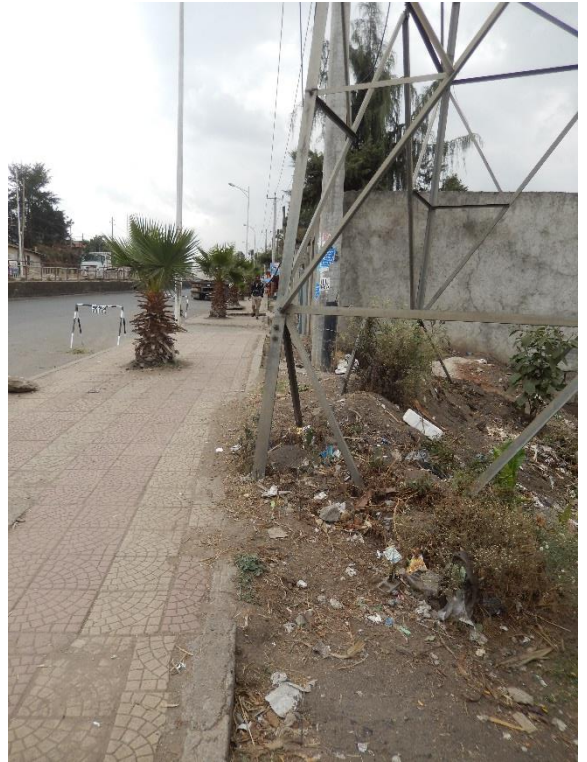
T 31
DSCN0529 T31 Tower Legs are located in road edges.

Tower T31 is located in narrow space and beside road. Special tower and foundation shall be designed.

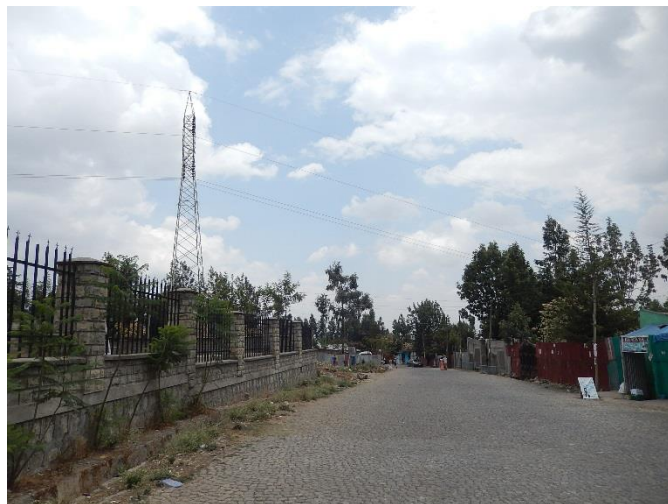
T33
DSCN0499 T33 from side 100m. Heavy weight span due to ground profile level toward T34.

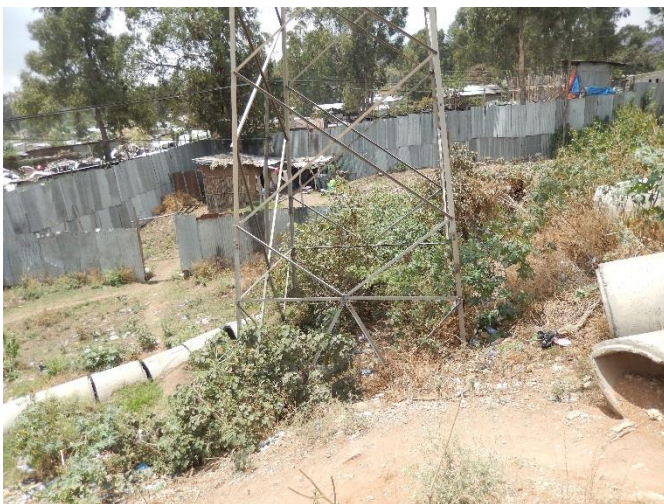
T 34
DSCN0485 T34 beside road. Water drain pipes for road are installed beside tower foundation.

Elevation of road become much higher than tower foundation level, during embankment work for construction of road.

T34 become a section tower as T33 has a large weight span and T34 stand beside main road.

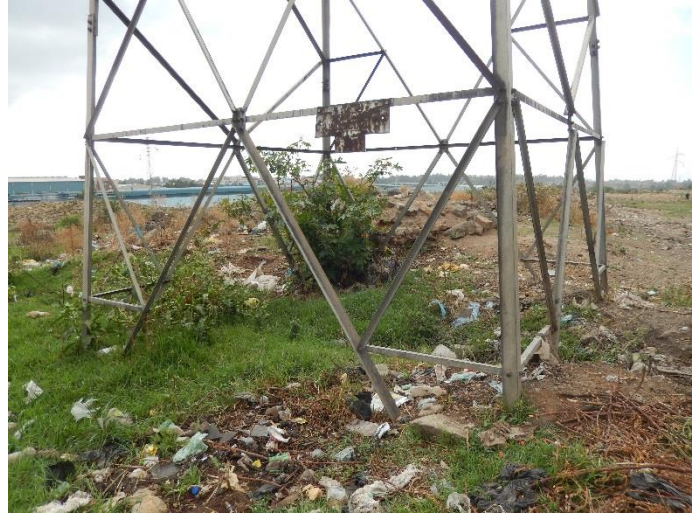
T35
Ground elevation level become higher than original ground due to embankment by construction of new industrial factory area.

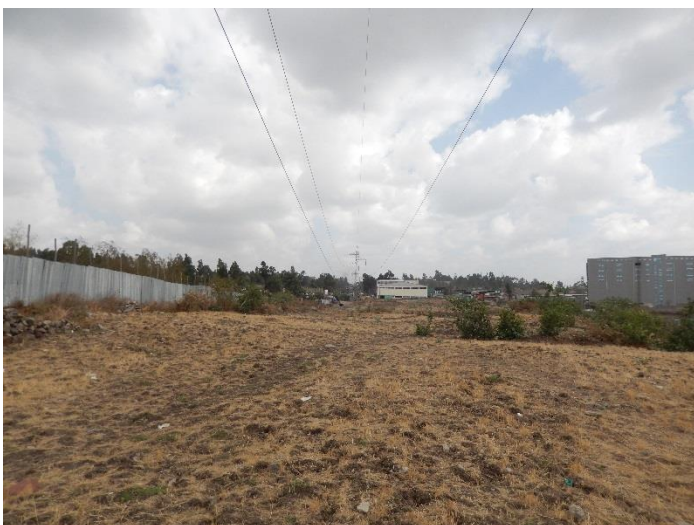
T 35
DSCN0715 T35 from T36 side. Surrounding area of ROW (Corridor) become a part of industrial area, The elevation of the arear has been level up by embankment works.

Industrial development works are on progress from T 34 toward Kaliti-I substation. Original foundation levels were below existing ground level.

The ground level will be more higher when development the surrounding area will be commenced

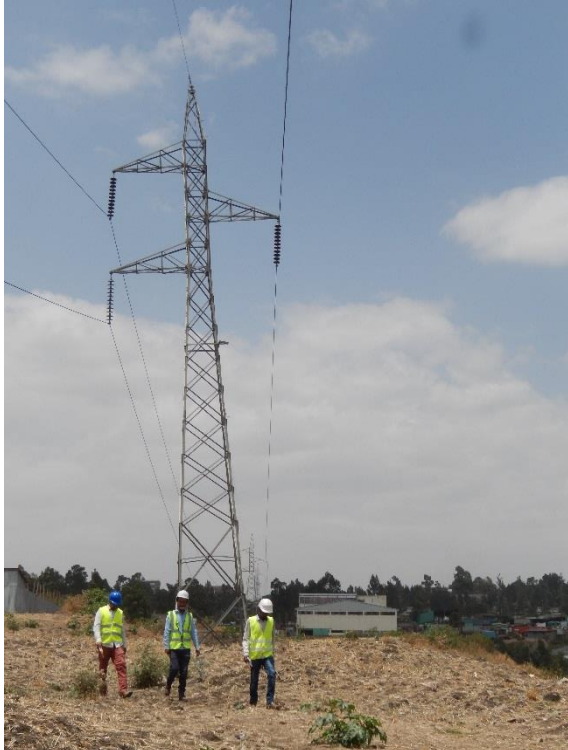
T 36
DSCN0906 T36 from T37 side.

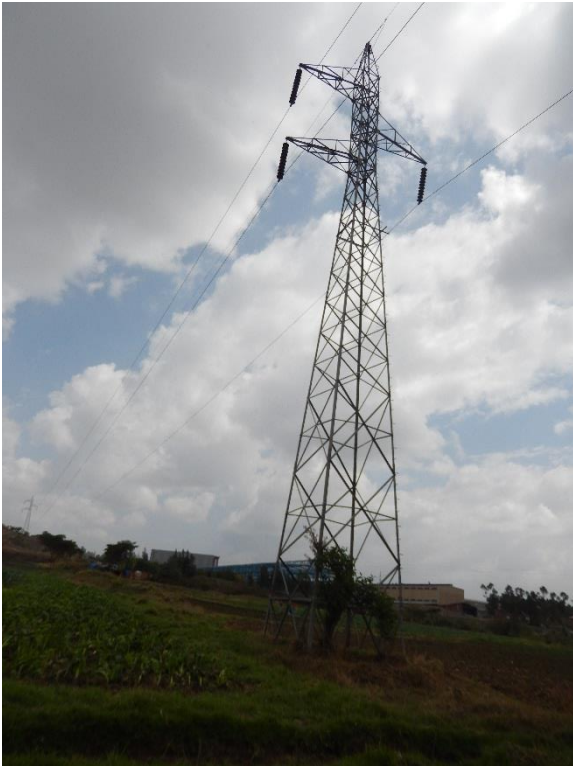
T 37
DSCN0739 T37 from T38 side .
T 36 could see at far end.

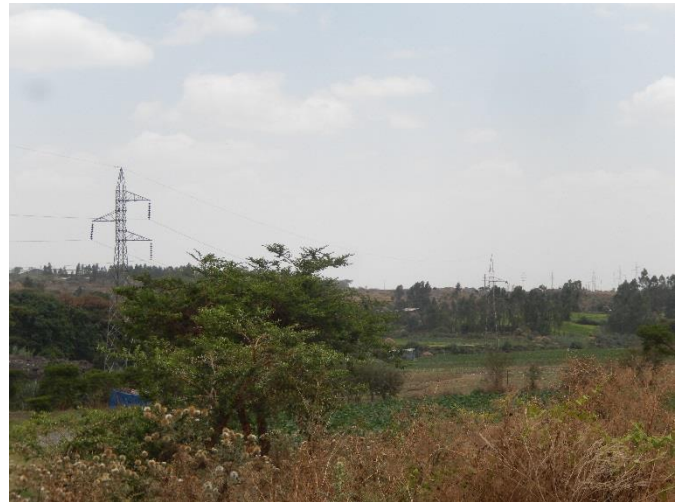
T37
DSCN0913 T37 is located in vegetable garden where
is a small stream river beside. This area may not be
industrial area in future.

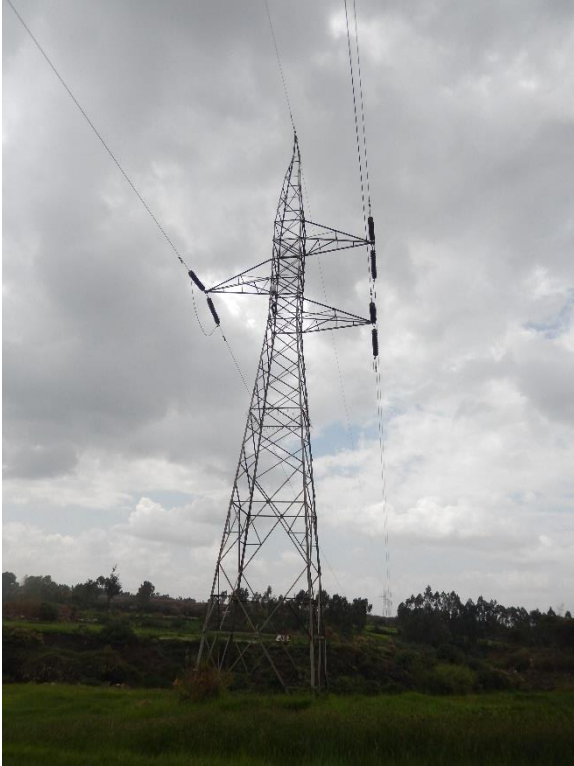
T 38
DSCN0744 T38 from T37 side.
Tension tower with OPGW Joint Box.
The deviation angle is small.

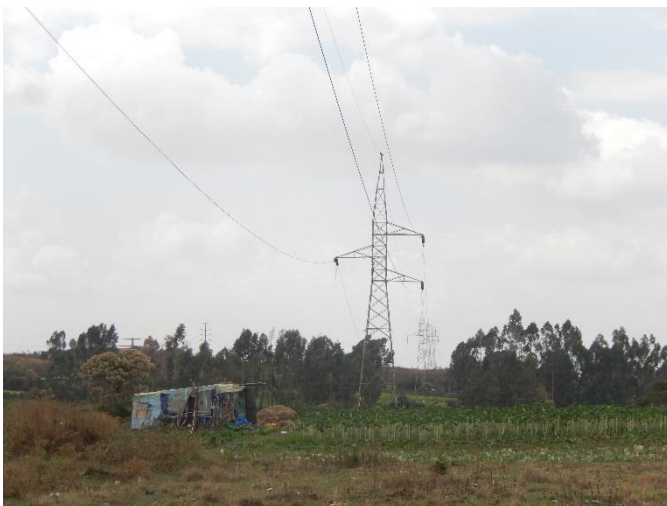
T 38
DSCN0741 T38 from T37.
Transmission line Kaliti-I to Nefas Silk is run in parallel with this ADC to Kaliti-I

Ground wire (GW) was replaced by OPGW in last 10 years.

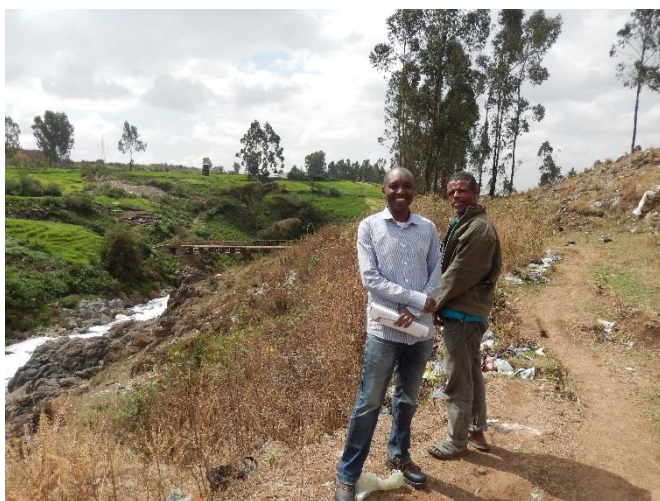
T 39
DSCN0759 Access Bridge.
Mr Samuel : Strategy & Investment Department leads the site survey.

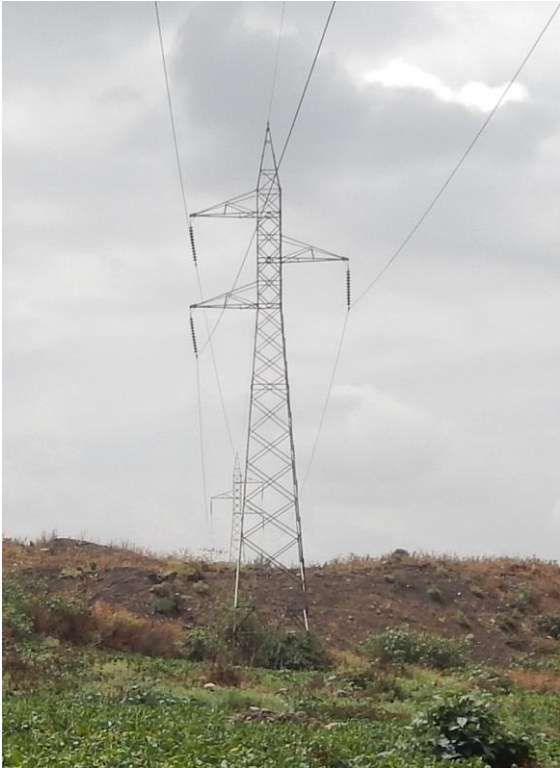
T 40
DSCN0772 T40 from T39 side.
The Conductor is inclined due to
transposition.

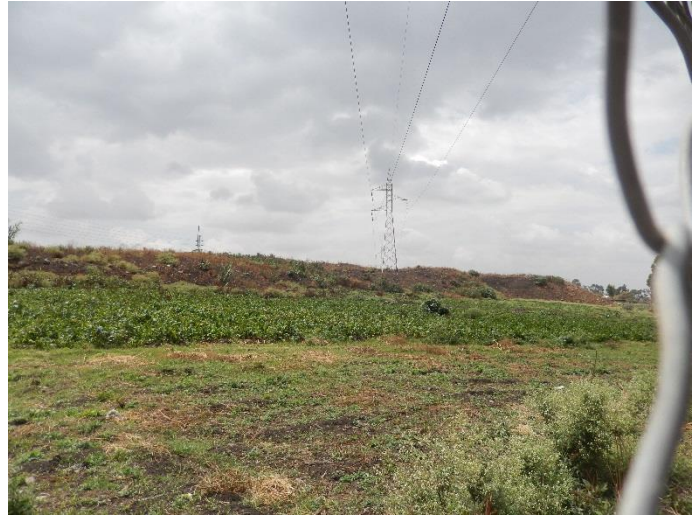
T40
DSCN0772 T40 from T39 side. Tower is located
inside the water treatment area with boundary fence.

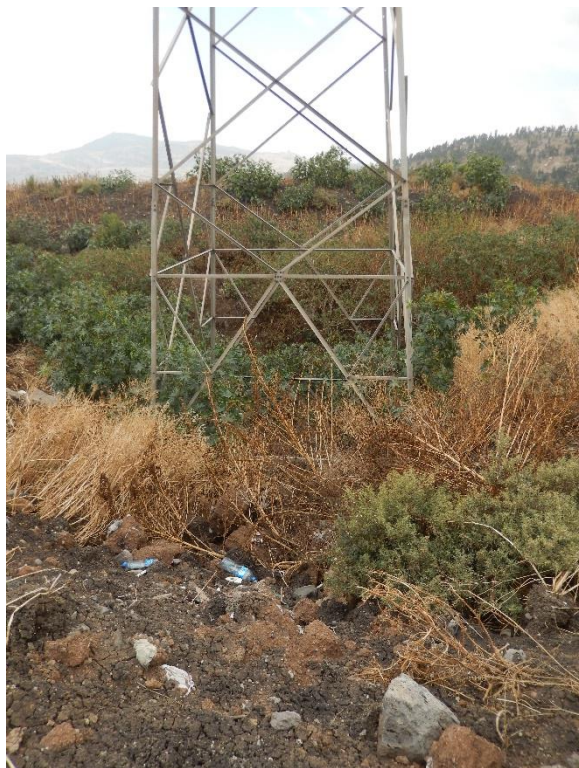
T 40
DSCN0773 T41 foundation.
Embankment works were done around tower site/

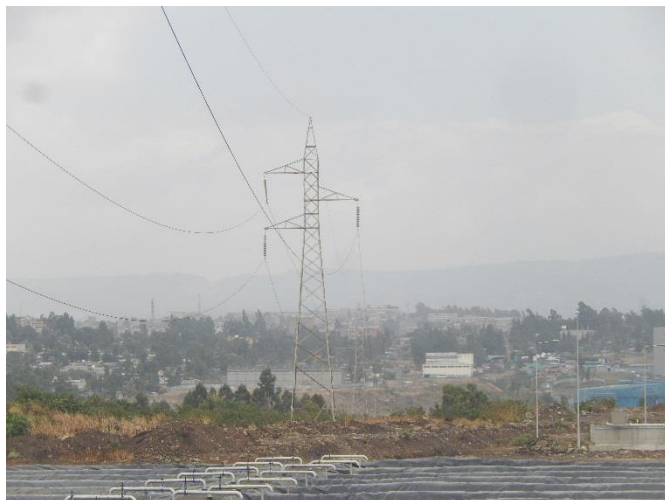
T41
DSCN0785 T41 from T42 side.
Transmission line pass the area of water treatment.
An access road is belonging to water treatment.
ROW (Corridor) is not so clear, but no houses.

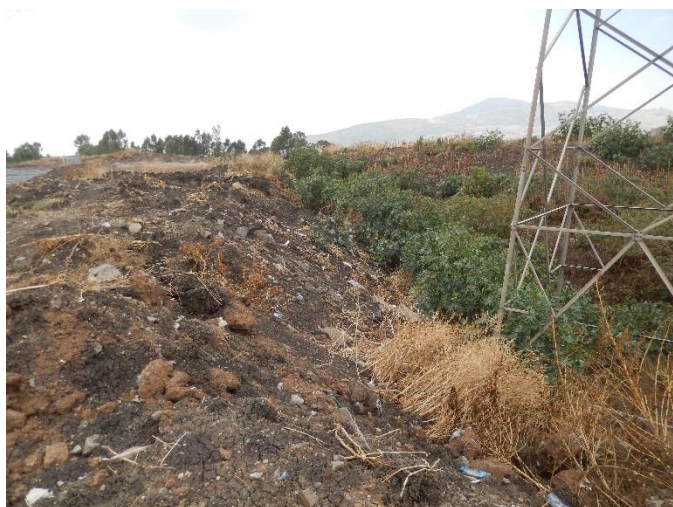
T 41
DSCN0775 T41 foundation level is much lower than
existing ground level of water treatment facility.

Tower is located at edge of embankment for development area which is used as water treatment.

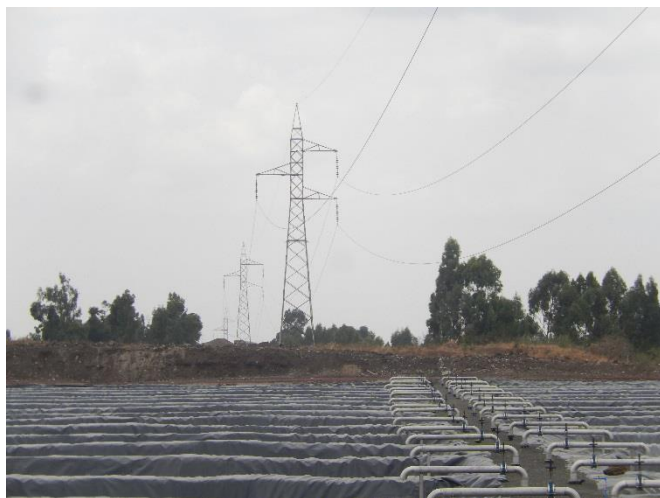
T42
DSCN0778 T42 from T41
Transmission line pass the area of water treatment.
An access road is belonging to water treatment.
ROW (Corridor) is not so clear, but no houses.

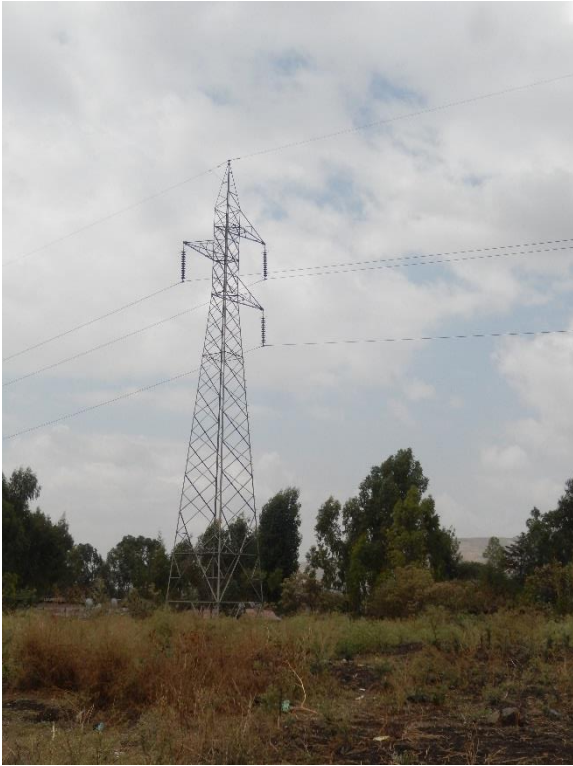
T 43
DSCN0791 T43 side residential houses.
Hoses are constructed under ROW (Corridor)
after T 42 water treatment area.

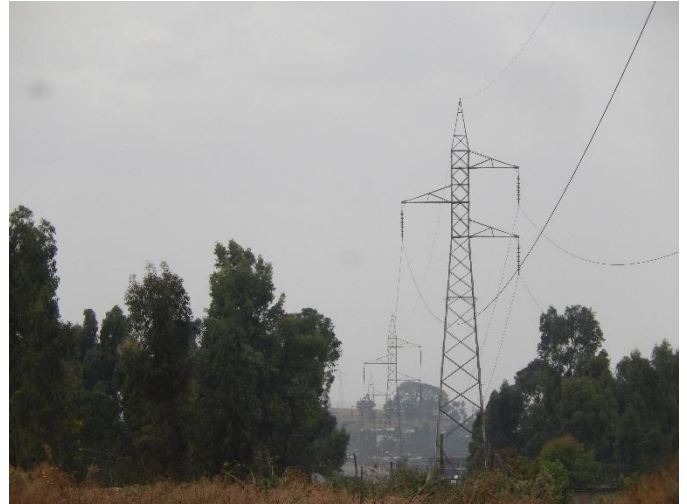
T43
DSCN0788 T43 from T42
Along the fence for water treatment, many houses are
constructed. ROW (Corridor is disappeared).

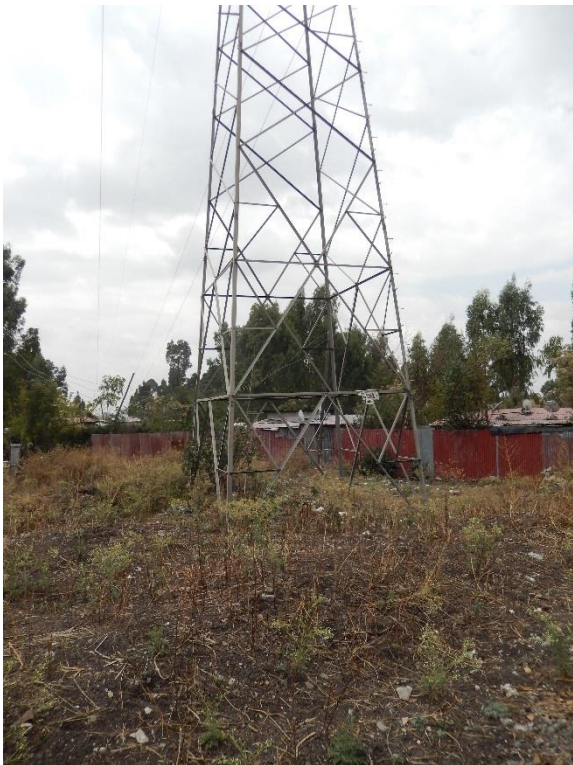
T 43
DSCN0792 T43 beside houses.

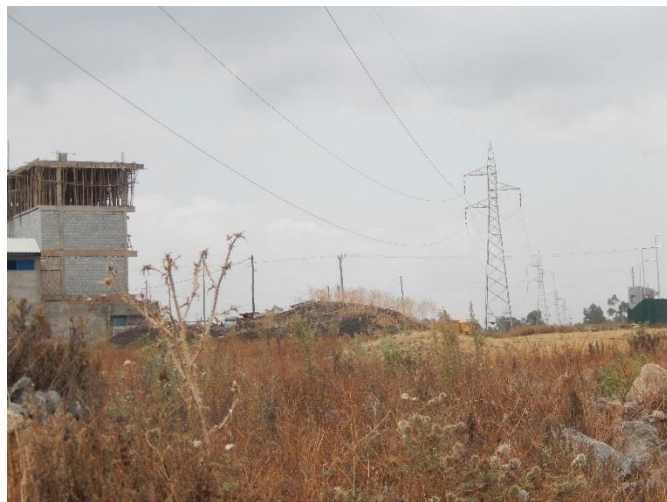
T47
DSCN0814 A view from T47 to T46.
ROW (Corridor) is maintained.
New factories are constructed out side the ROW.

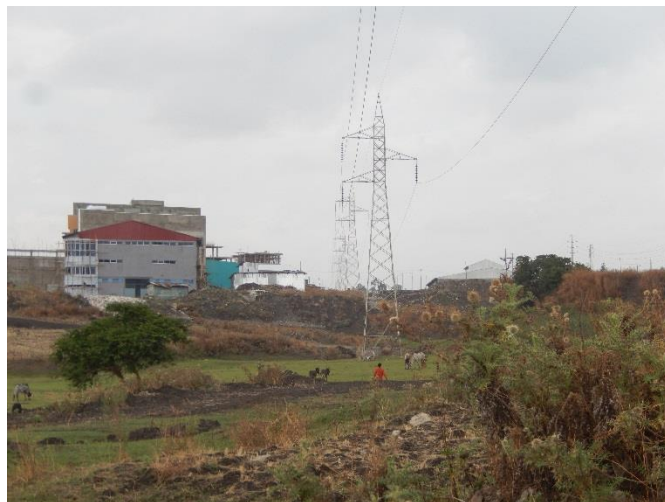
T48
DSCN0826 T48 from 49
Plates for tower cross arm are missing

Plates for cross arms are disappeared at compressed steel members.

The remedial works shall be arranged.

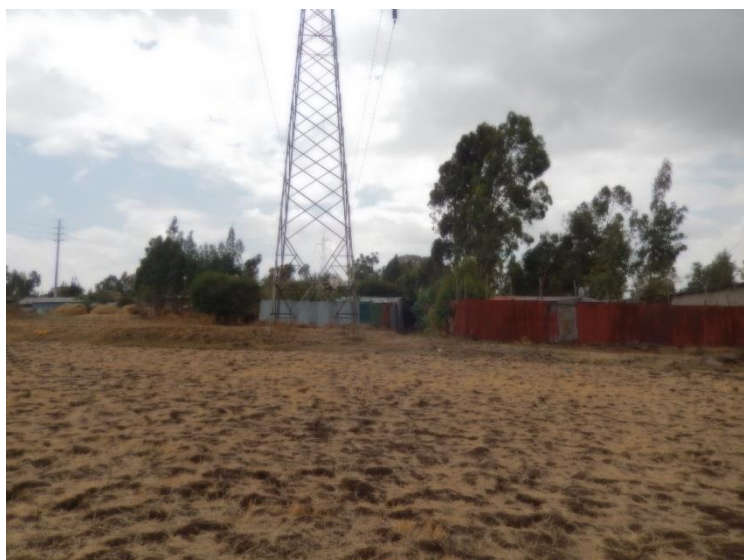
DSCN0838 T51 bottom
Residential houses are existed between T51 to T52.

Many houses between T 51 and T52
This area is suitable for industrial area as
the short distance national road.

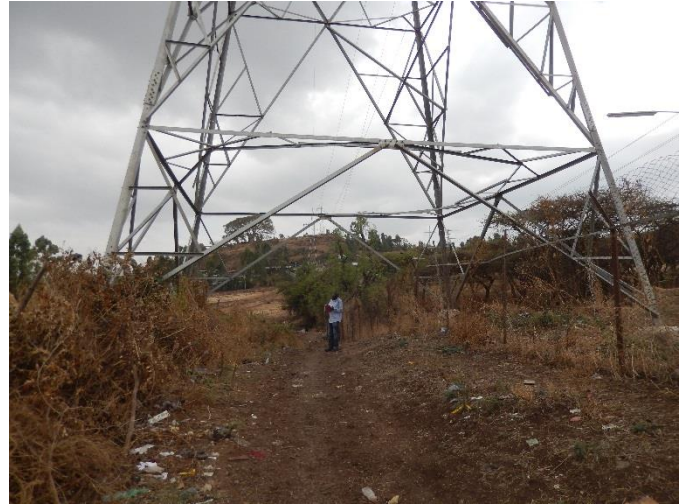
T 54
DSCN0863 T54 bottom
Two legs are located out side the Kaliti-I Substation.

The tower erection is not completed yes as many steels are missing condition.

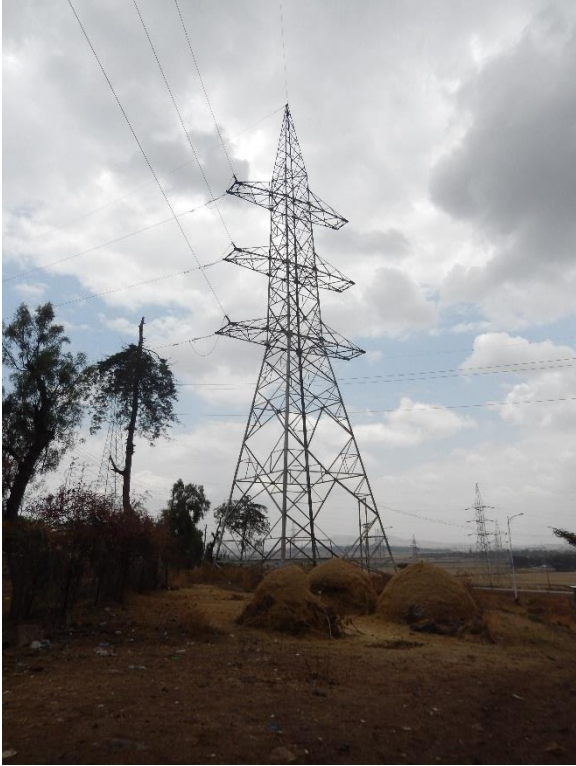
T 55
DSCN0866 T55 from T54
220kV Dead end tower.

T 55 is Ideadend tension tower for 220kV 2cct. Only one (1) cct was applied for ADC to Kaliti-I 132kV transmission line.

The tower erection is not completed yes as many steels are missing condition.

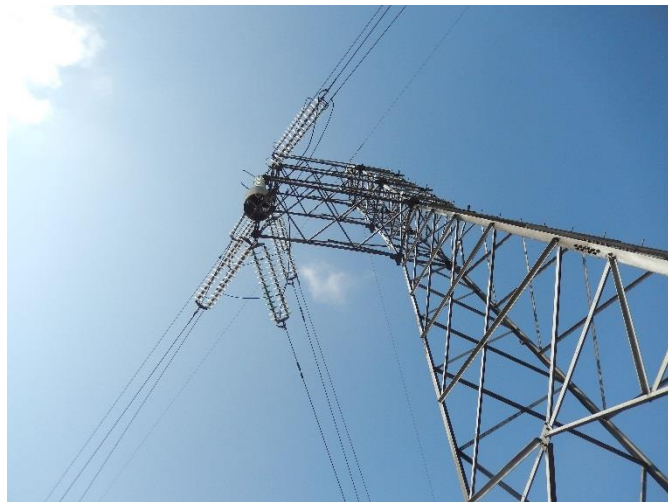
T 62
DSCN0454 Kaliti-I to Cotebie Transmission Line

Remarks
Foundation for all four legs are
damaged due to soil pressure from
surface.

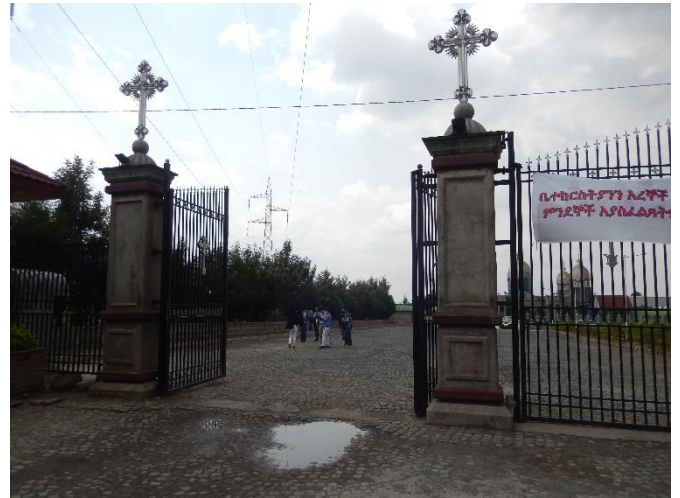
T 67
DSCN0367 New Tower will be located 30-40 meter
front of existing tower T67.

Remarks
New Cable Termination Tower will
be constructed by replacing T 67.

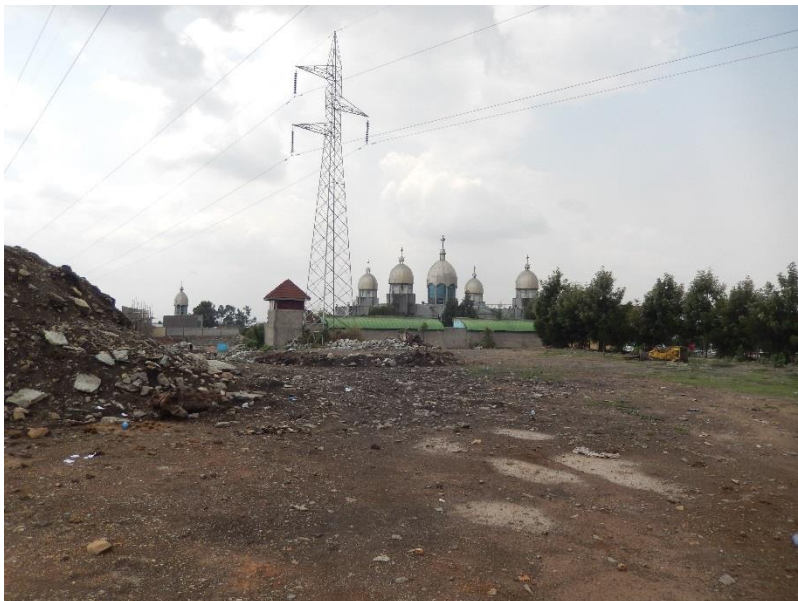
DSCN0379 T67 Second 132kV TL is just beside T67.
