APPENDIX-3

SITE SURVEY FOR OVER HEAD TRANSMISSION LINE

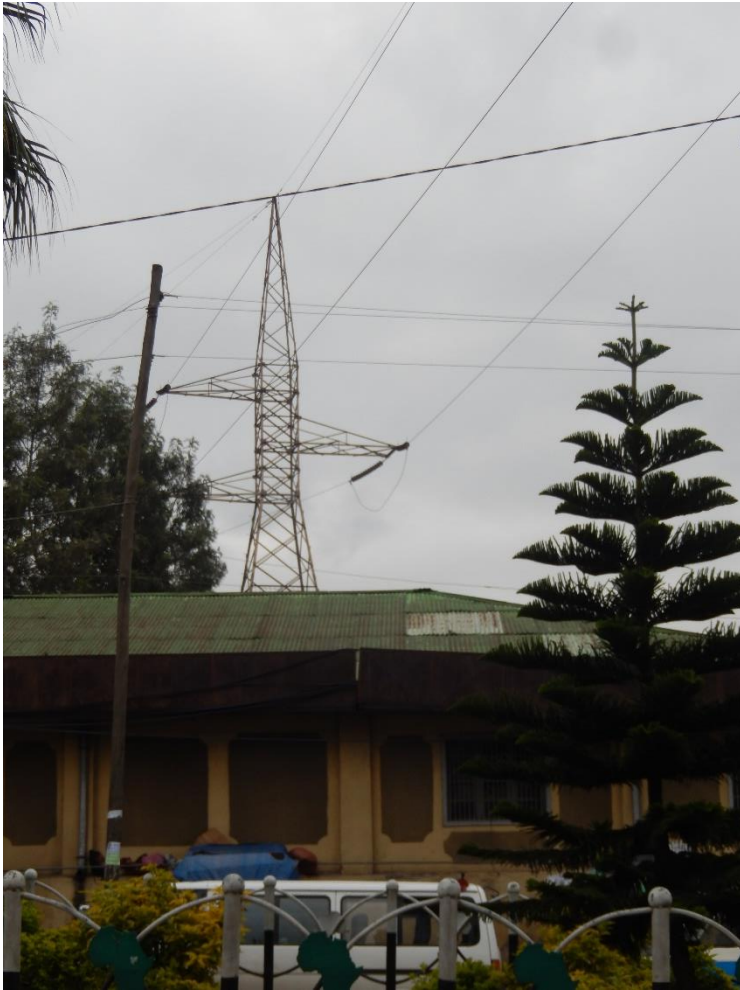
T-01 views from Main Road.
T-01 is dead-end tower to Addis Center Substation

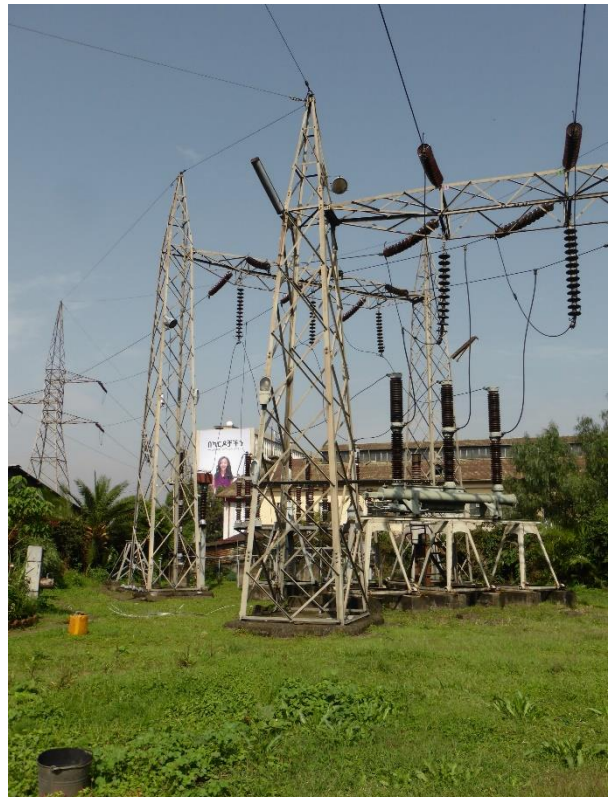
Addis Center Substation at 7th July 2017.
A Plan for Substation modification is considered.

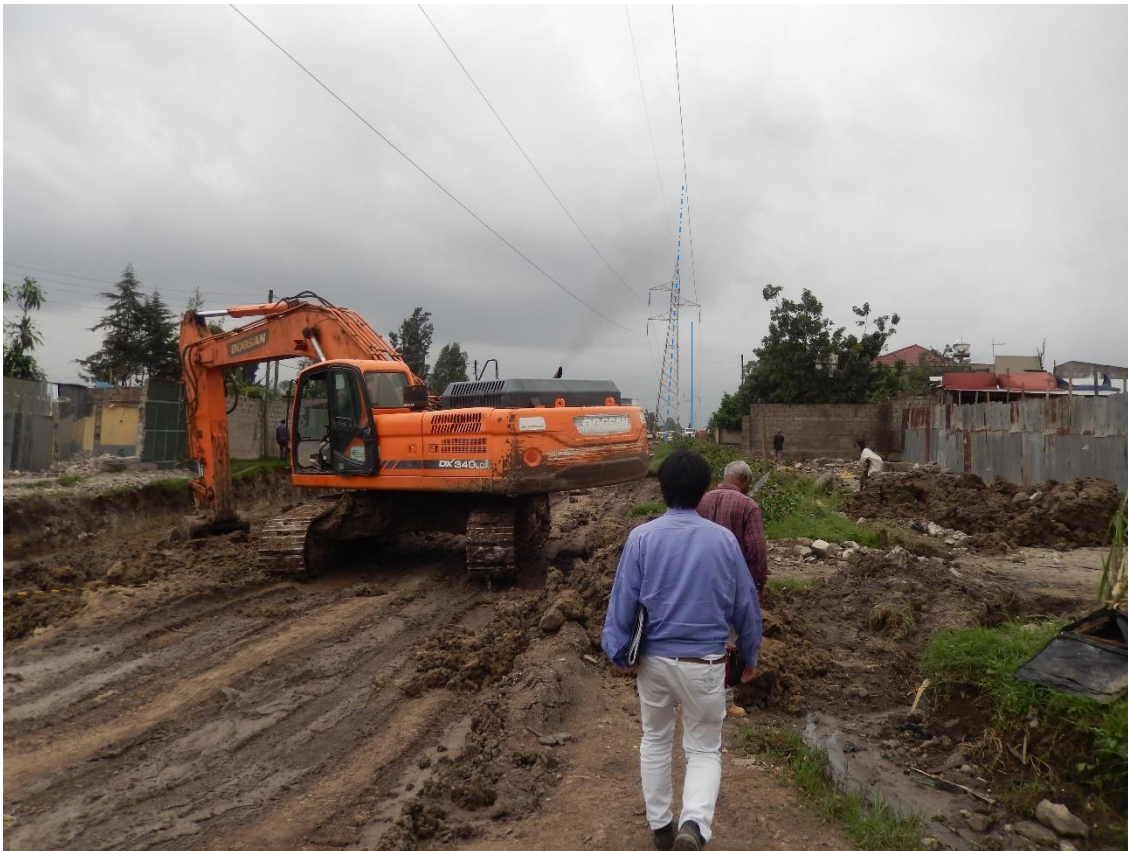
Obstruction houses on right side has been removed now.
Tower 17 is damaged by construction and slightly declined.

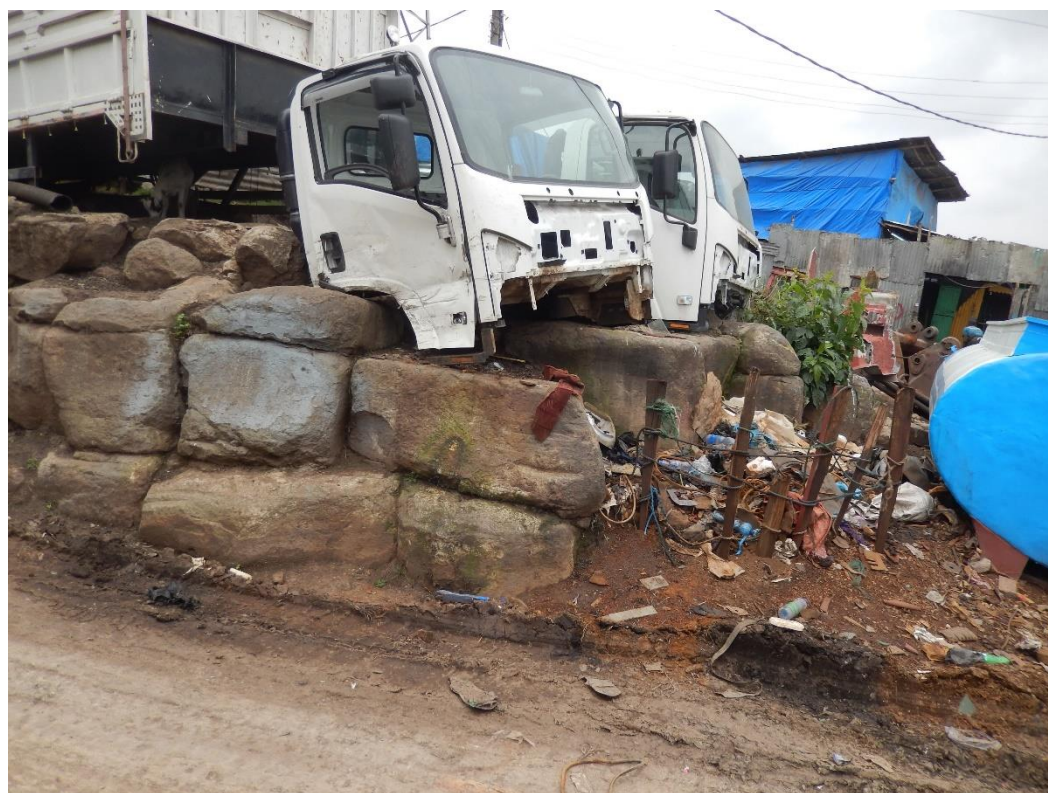
T20 on the slope toward existing road. Here will be end of new construction road

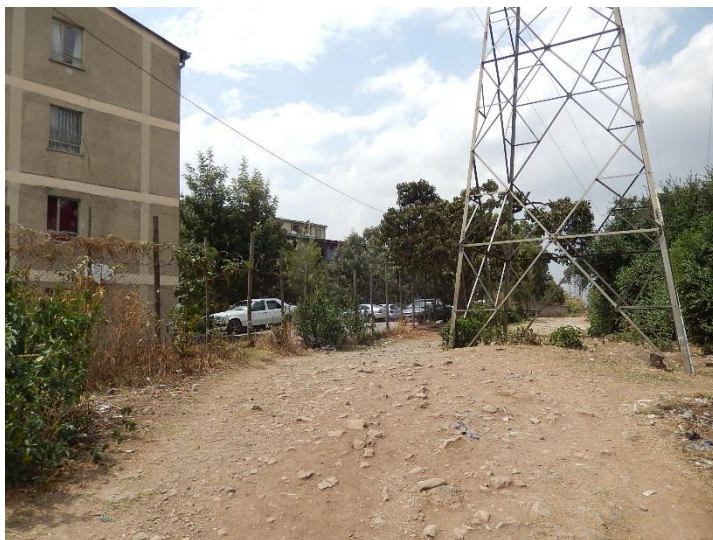
T 25
DSCN0592 T25 near existing road and fence

A road for residential peoples are passed beside the T25. A house and apartment admonitory are constructed beside tower location.

T 25 is angle deviation tower, a new lattice type tower will be constructed on the same location of existing T25.

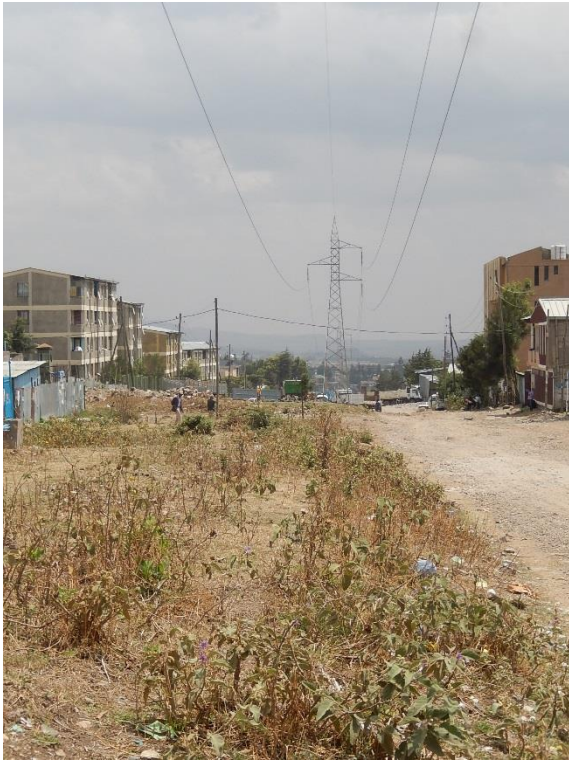
T 27
DSCN0572 T27 from T26 side

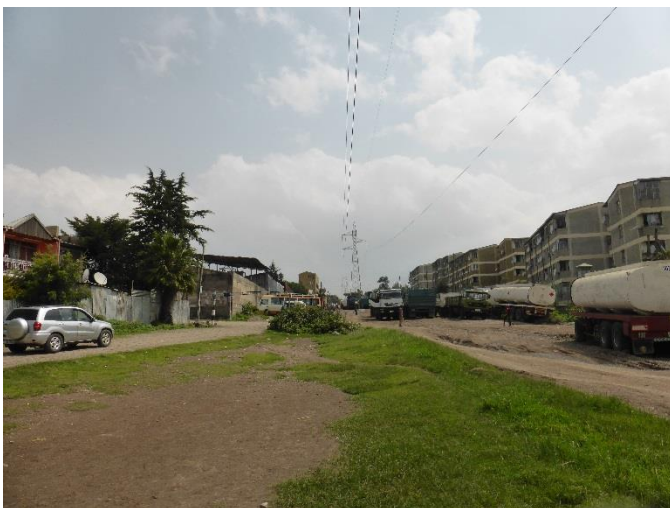
T 26
DSCN0574 T26 from T27 side ROW house

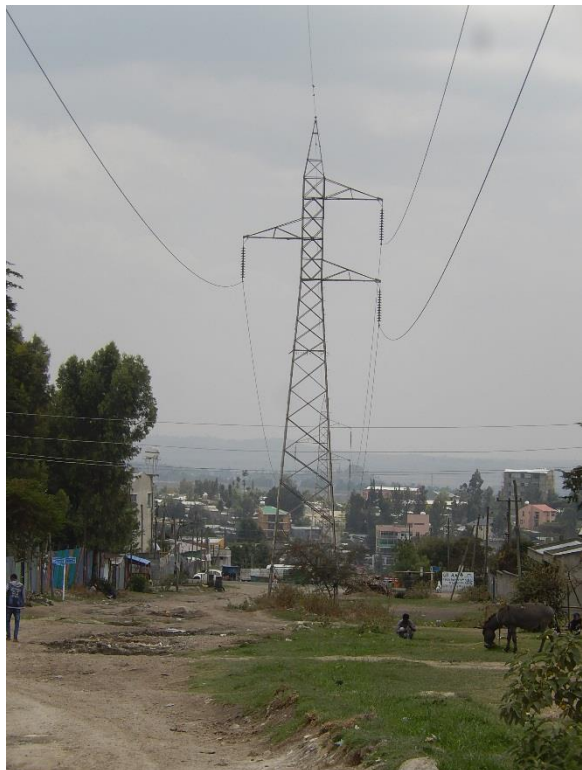
T 28
DSCN0561 T28 from T27 side

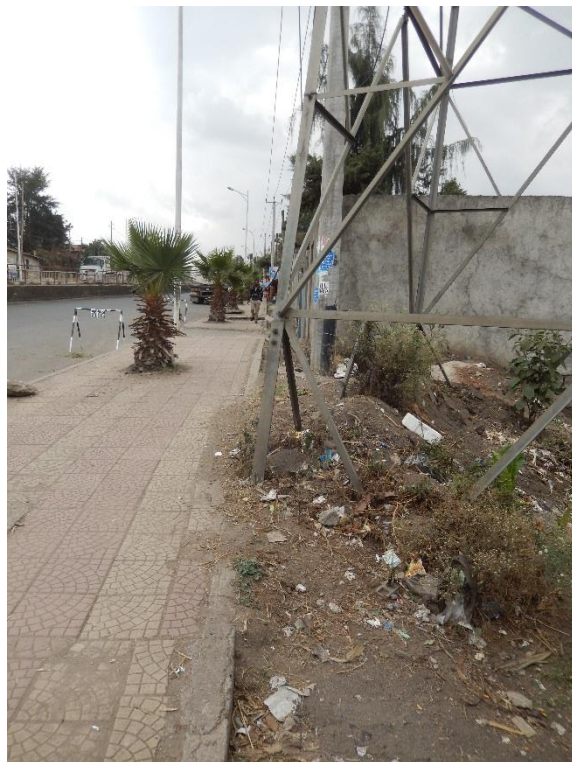
T 31
DSCN0529 T31 Tower Legs are located in road edges.

Tower T31 is located in narrow space and beside road. Special tower and foundation shall be designed.

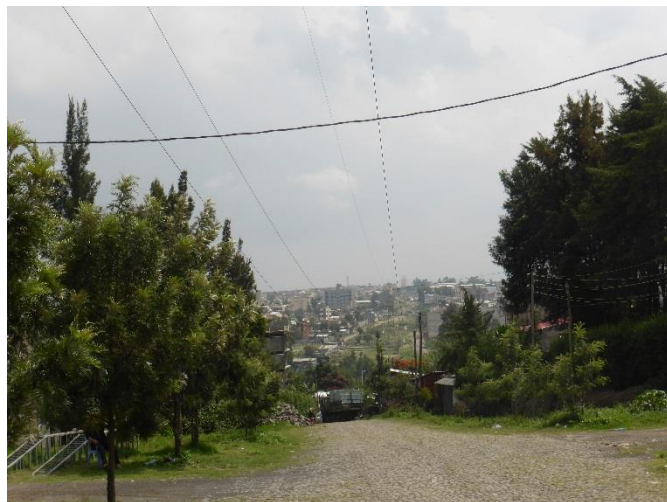
ROW (Corridor) between T 31 and T32
P1130596 T32 view toward T31, many residential houses are existing.

Many residential houses between T31 and T33.

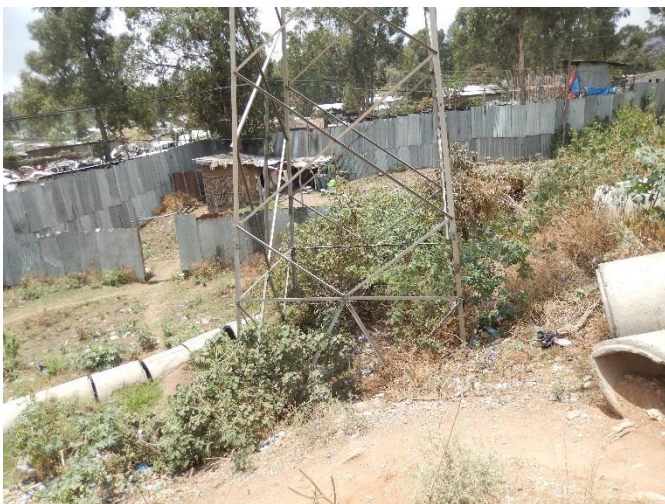
T 34
DSCN0485 T34 beside road. Water drain pipes for road are installed beside tower foundation.

T34 become a section tower as T33 has a large weight span and T34 stand beside main road.

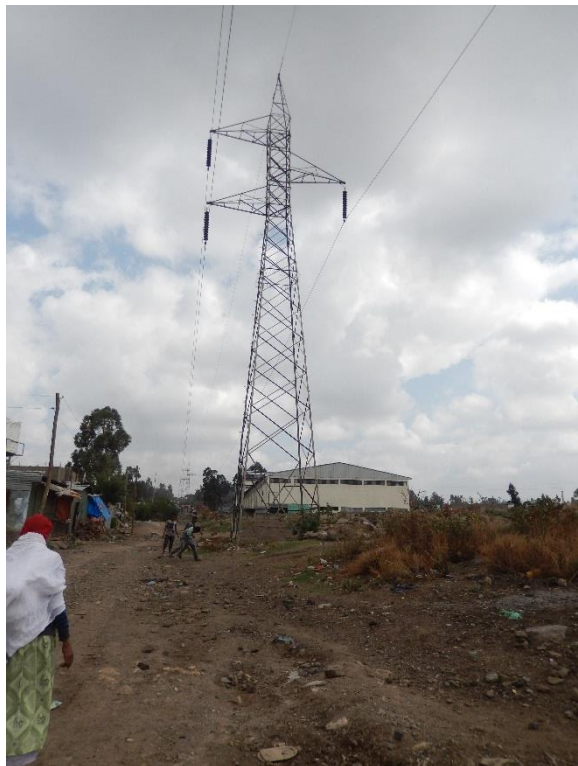
T 35
DSCN0708 T35 from T 36 side.

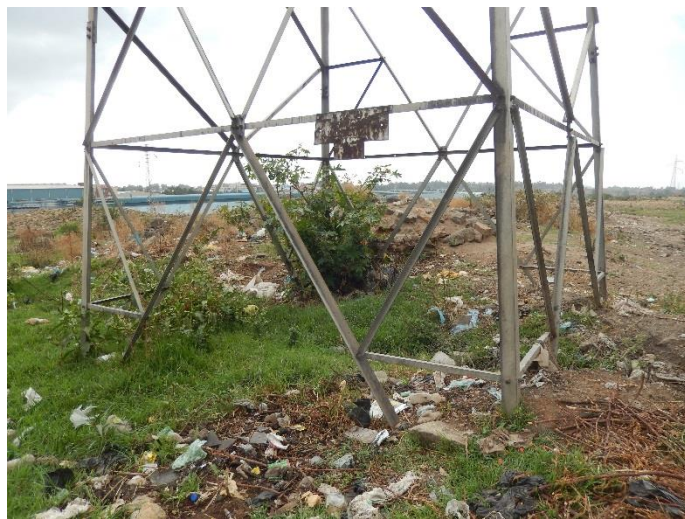
T35
Ground elevation level become higher than original ground due to embankment by construction of new industrial factory area.

Industrial development works are on progress from T 34 toward Kaliti-I substation. Original foundation levels were below existing ground level.

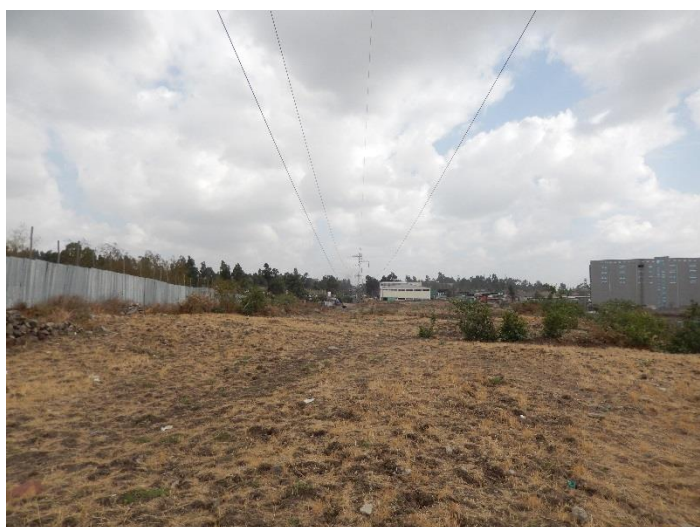
T 35
DSCN0715 T35 from T36 side. Surrounding area of ROW (Corridor) become a part of industrial area, The elevation of the arear has been level up by embankment works.

The ground level will be more higher when development the surrounding area will be commenced

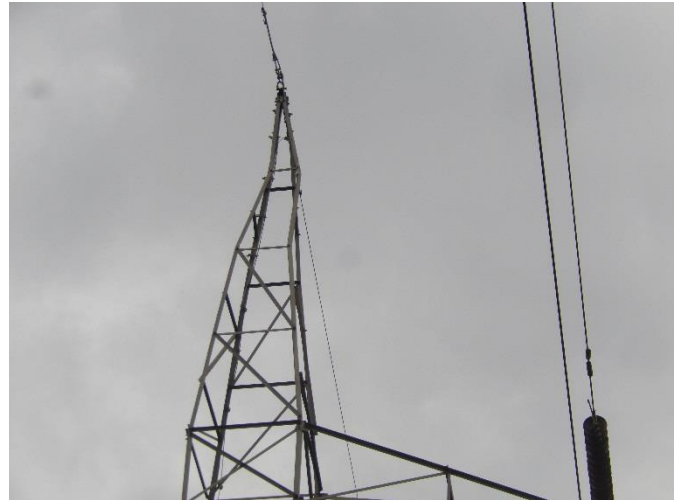
T38
DSCN0743 T38 Ground Wire arm was damaged and bend. Arm can be callapes in any time.

The damage 33, 36 and 38 are so critical and remedial works required as soon as possible.

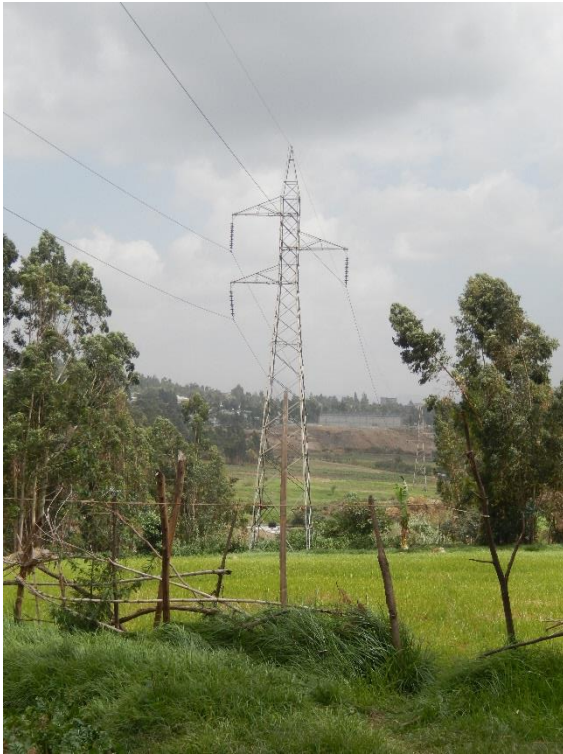
T 39
DSCN0768 T39 from T40.
T 39 – 40 -41 is transposition tower.

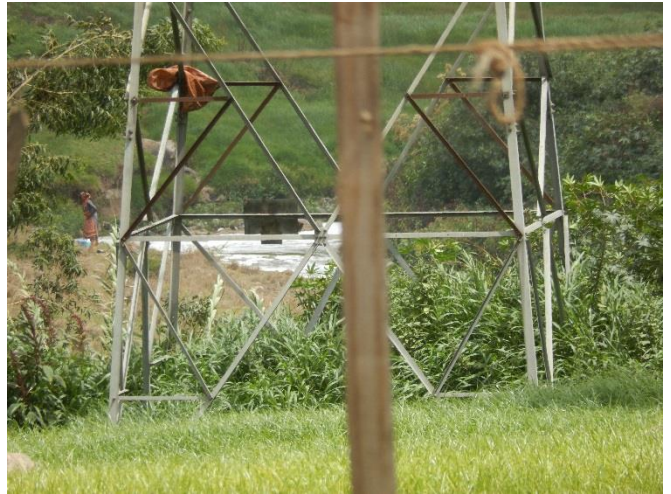
T39
DSCN0770 T39 & river.
Access bridge to cross river is for light weight only.
Vehicle is not accepted to cross.

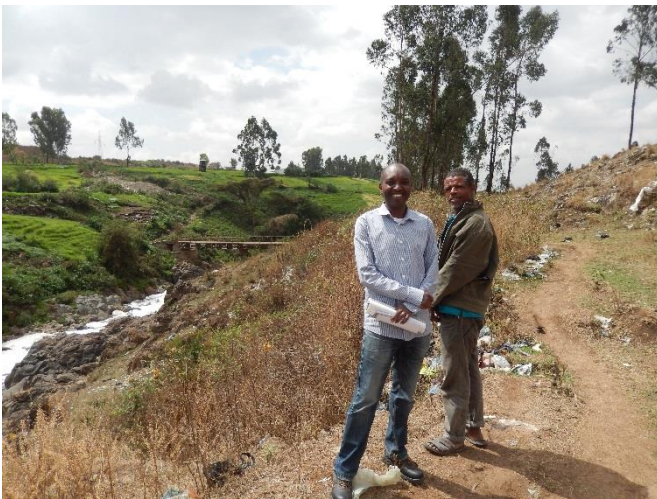
T 39
DSCN0759 Access Bridge.
Mr Samuel : Strategy & Investment Department leads the site survey.

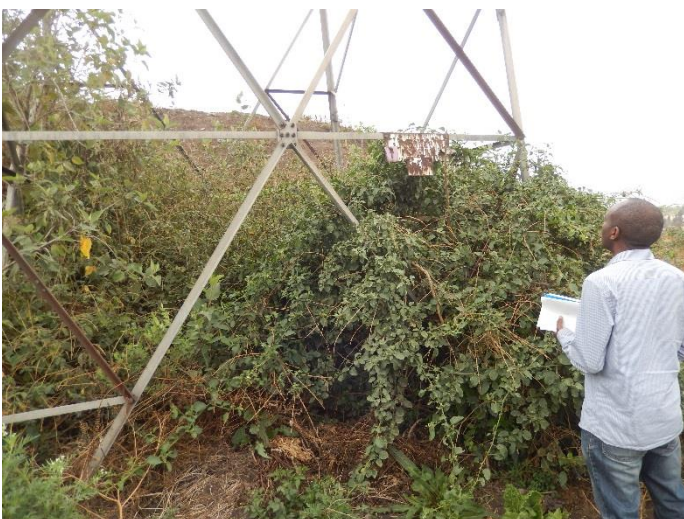
T 40
DSCN0761 T40 Bottom Embankment

Tower T40 is located at edge of embankment for development area which is used as water treatment.

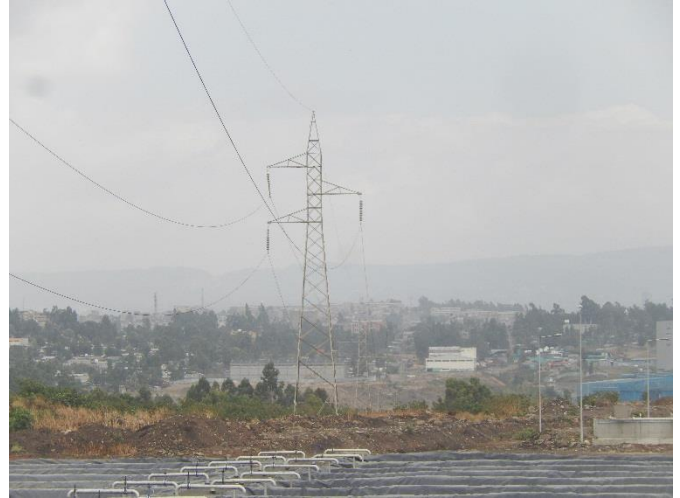
T41
DSCN0785 T41 from T42 side.
Transmission line pass the area of water treatment.
An access road is belonging to water treatment.
ROW (Corridor) is not so clear, but no houses.

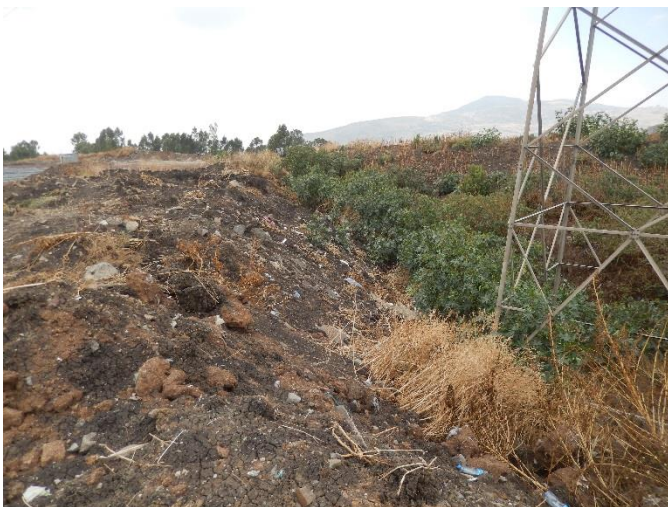
T 41
DSCN0775 T41 foundation level is much lower than
existing ground level of water treatment facility.

Tower is located at edge of embankment for development area which is used as water treatment.

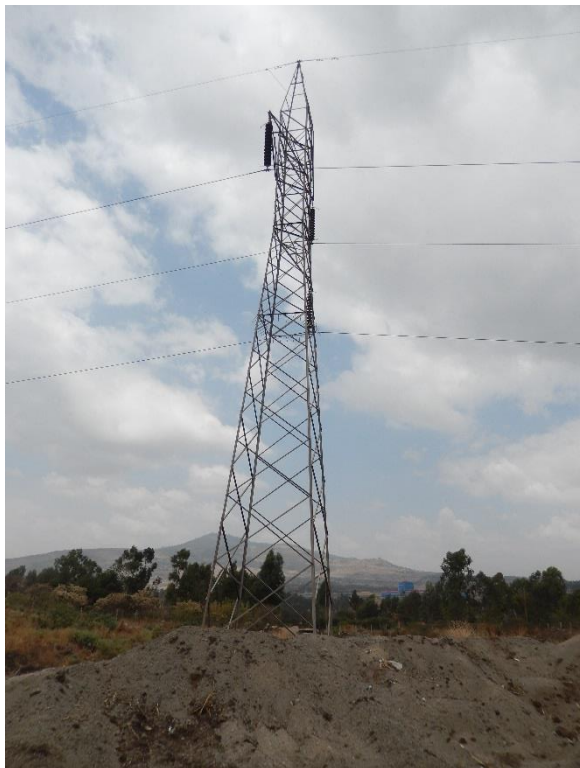
T 42
DSCN0783 T42.
Embankment works were done around tower site/

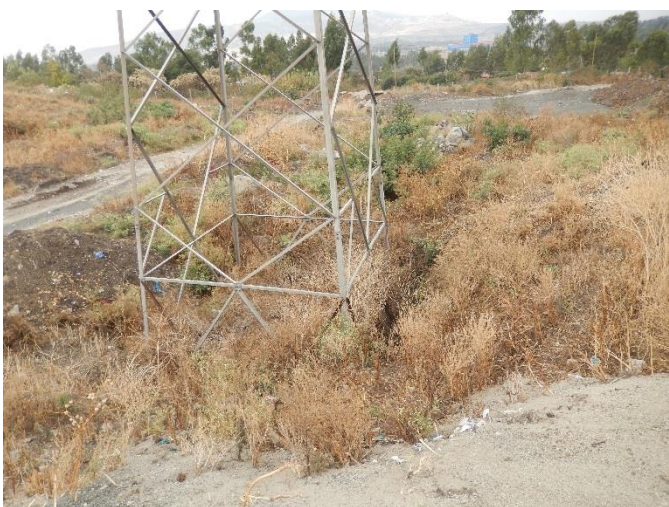
T 42
DSCN0784 T42 bottom
T42 foundation level is much lower than exiting ground level of water treatment facility.

Tower is located at edge of embankment for development area which is used as water treatment.

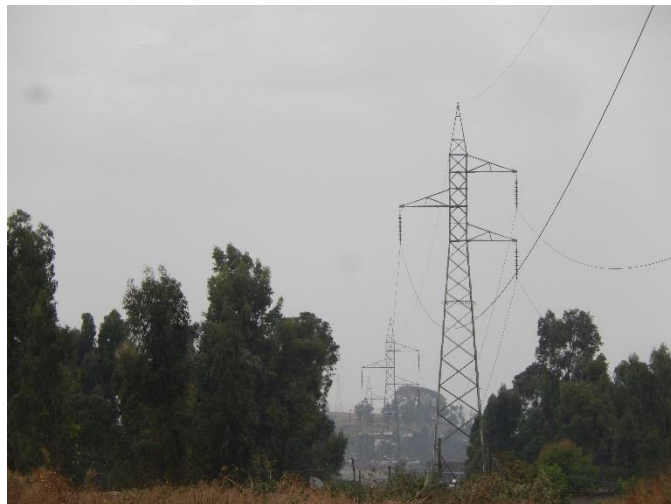
T43
DSCN0788 T43 from T42
Along the fence for water treatment, many houses are
constructed. ROW (Corridor is disappeared).

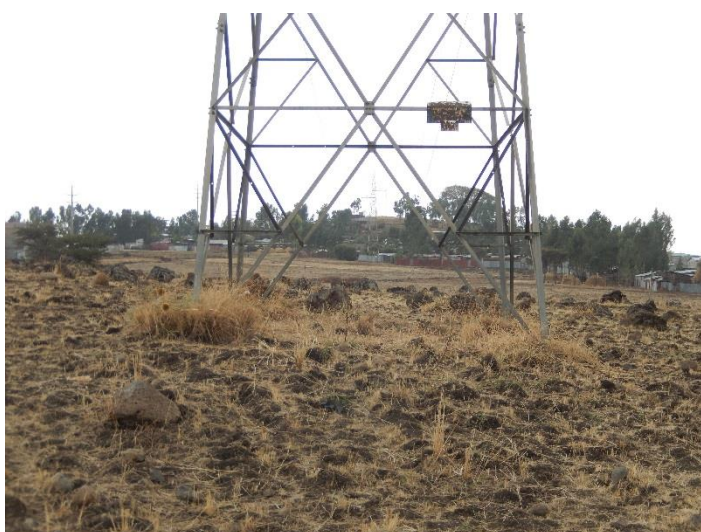
DSCN0833 T50 bottom
Residential houses are existed toward T51.

Many houses between T 50 and T51
This area is suitable for industrial area as
the short distance national road.

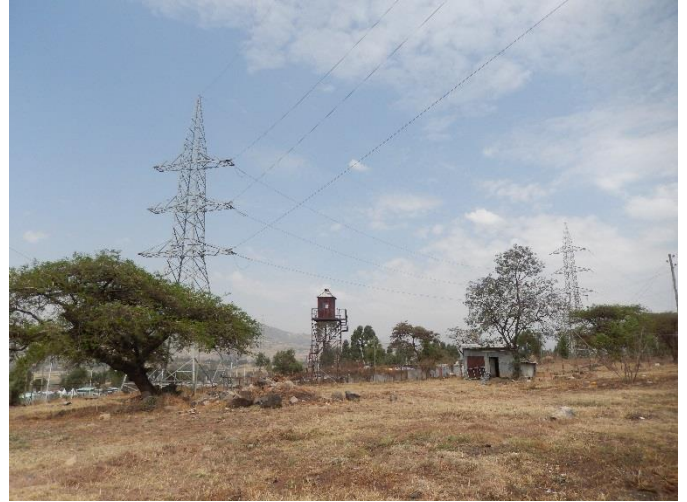
T 55
DSCN0953 T55 from inside Kaliti-I substation.

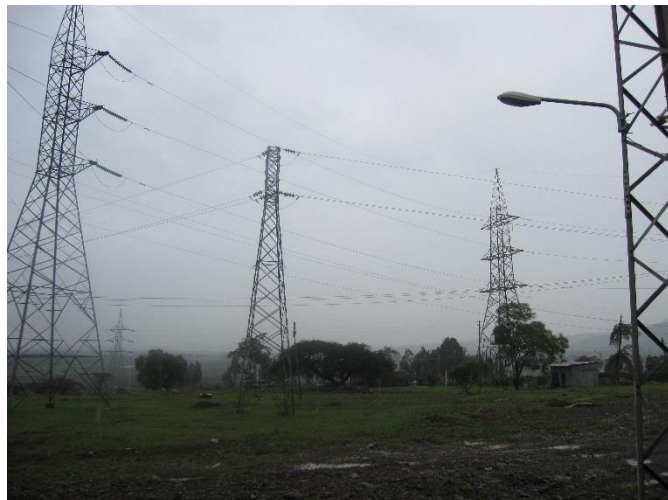
T 56
IMG_1244 down lead to gantry from T56 & T55

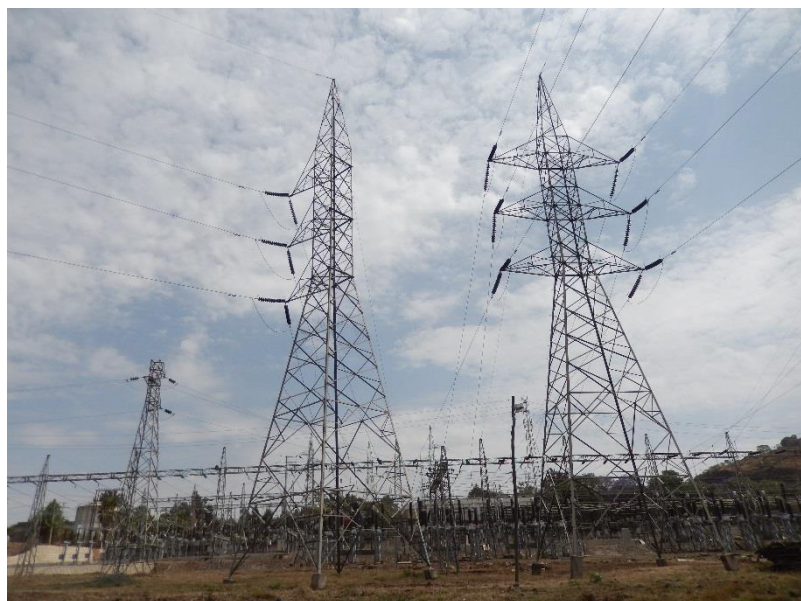
DSCN0960 T56 to gantry of Kaliti-I substation.

Tower 56 was new number.
Original tower number was T54
having 90 degree angle to T 53 (no
tower T 54 and T55).

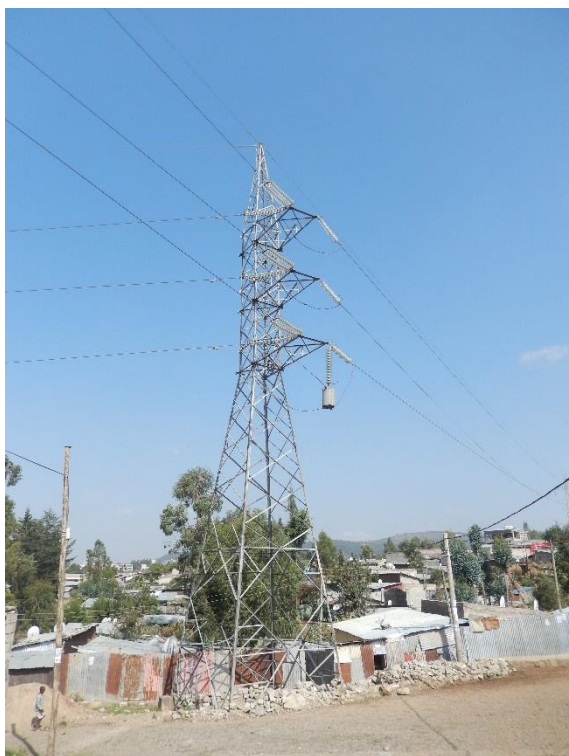
T 62
DSCN0444 T-Branch to Weregenu
Substation

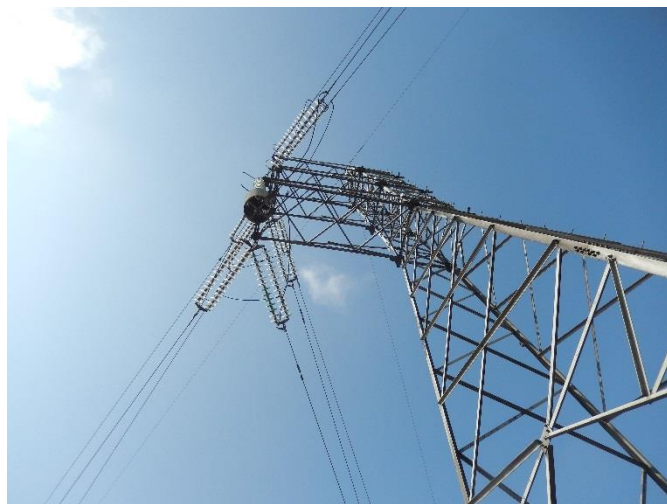
T 62
DSCN0454 Kaliti-I to Cotebie Transmission Line

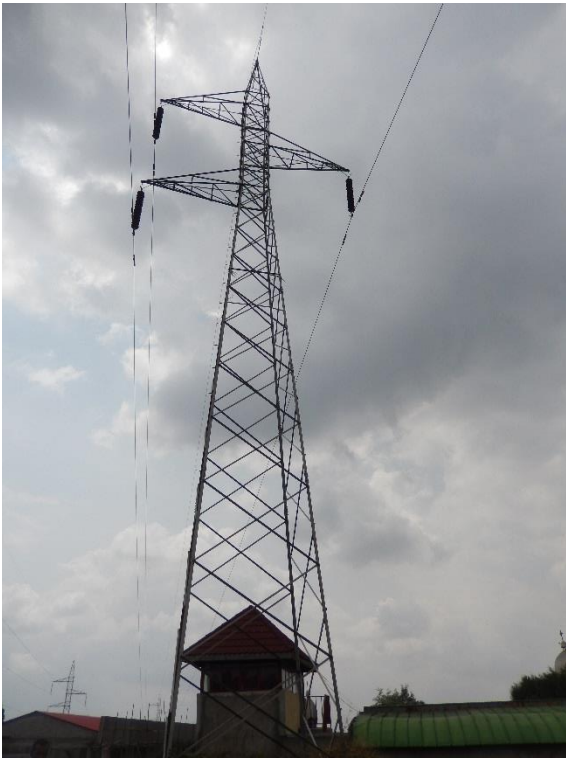
T 67
DSCN0387 New T-Branch to Weregenu
Substation

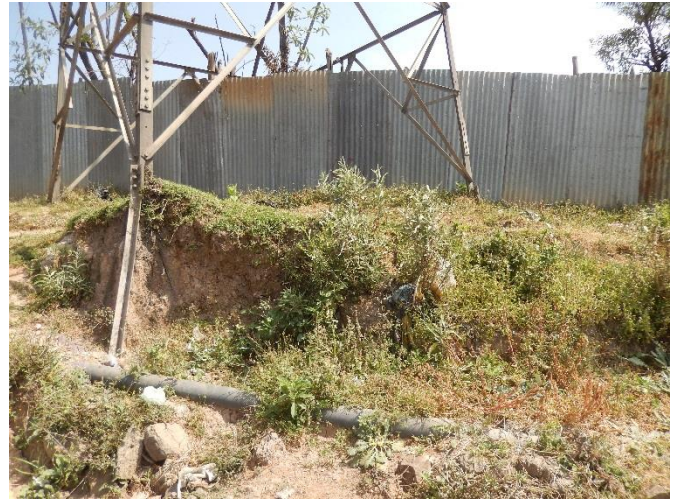
T52 Kaliti – Sebeta
Existing Foundation
Two steel angles were used for each leg to support tower
