Final Report on Building Inventory, Damage and Seismic Intensity Survey for the JICA Aided the Project for Assessment of Earthquake Disaster Risk for the Kathmandu Valley in Nepal

Ref. No. R7011/JICA/015

National Society for Earthquake Technology-Nepal (NSET)

February 2016

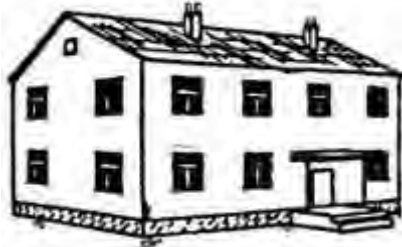
<p>Grade 1: Negligible to slight damage</p>	<p>Structural damage : No Non-structural damage: Slight</p> <ul style="list-style-type: none"> • Hair-line cracks in very few walls. • Fall of small pieces of plaster only. • Fall of loose stones from upper parts of buildings in very few cases.

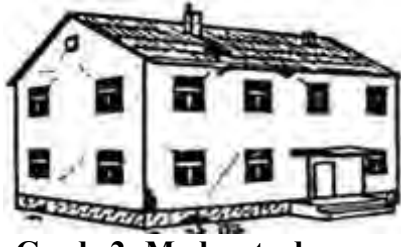
<p>Grade 2: Moderate damage</p>	<p>Structural damage : Slight Non-structural damage: Moderate</p> <ul style="list-style-type: none"> • Cracks in many walls. • Fall of fairly large pieces of plaster. • Partial collapse of chimneys.

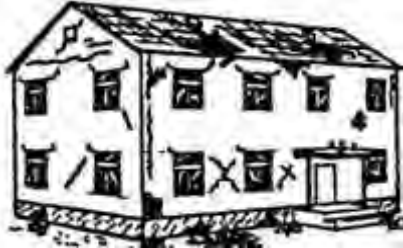
<p>Grade 3: Substantial to heavy damage</p>	<p>Structural damage: Moderate Non-structural damage: Heavy</p> <ul style="list-style-type: none"> • Large and extensive cracks in most walls. • Roof tiles detach. • Chimneys fracture at the roof line; failure of individual non-structural elements (partitions, gable walls).

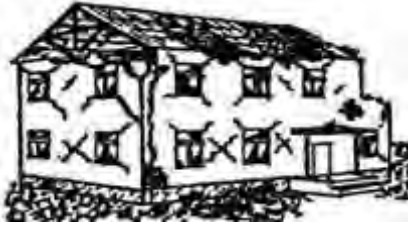
<p>Grade 4: Very heavy damage</p>	<p>Structural damage: Heavy Non-structural damage: Very heavy</p> <p>Serious failure of walls; partial structural failure of roofs and floors.</p>

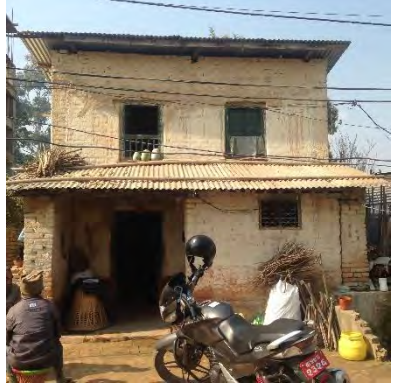
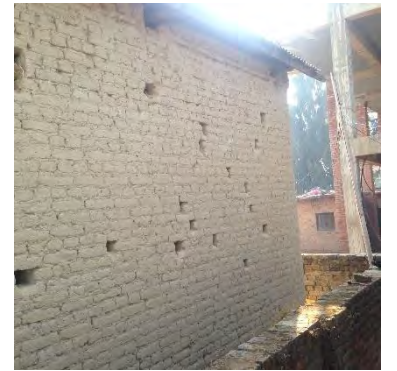
- Shear cracks along the door window openings.
- More than 5 mm cracks were seen in the corners of the walls.

- Third story was damaged heavily due to Gorkha earthquake.
- Third story was removed and only two was present
- The observed damage grade is DG3 according to damage classification by EMS 98. (refer Annex 1 for damage grade information)

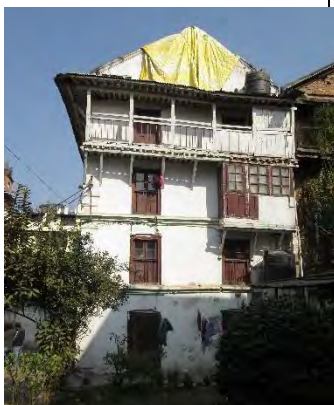
- Spalling of mud plaster
- Shear cracks along the door window openings.
- More than 5 mm cracks were seen in the corners of the walls.
- Attic was greatly damaged.

- The observed damage grade is DG3 according to damage classification by EMS 98. (Refer Annex 1 for damage grade information).

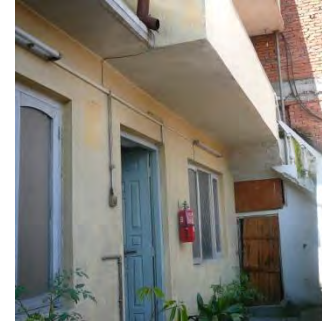
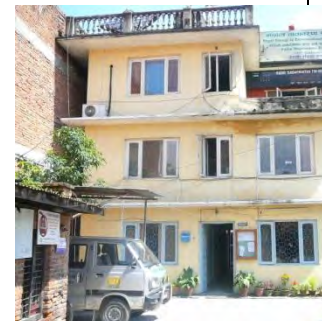
No damage was observed due to Gorkha Earthquake.

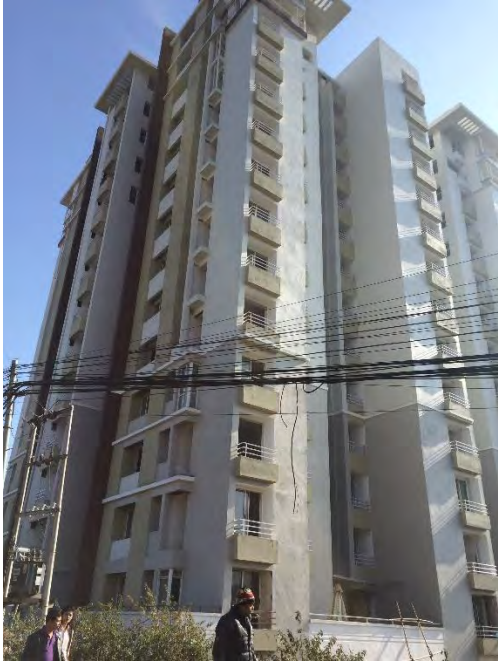
Moderate to severe cracks were observed after Gorkha Earthquake. But, the damage were already been repaired when we started this survey. The damage can be classified as DG2 according to EMS-98.

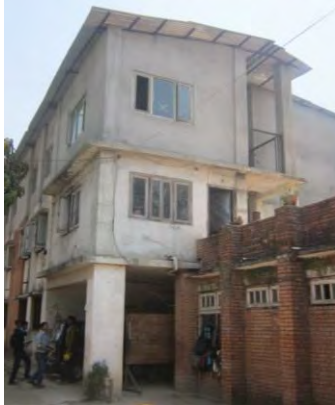
No damages were seen in the building.

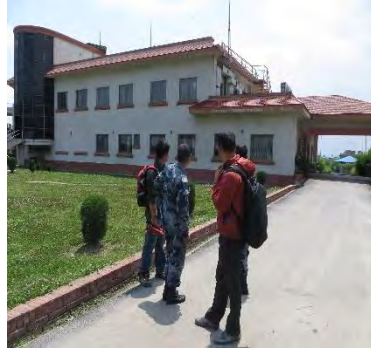
No damage was seen due to the Gorkha earthquake.
