**INDONESIA LIGHTNING PROTECTION  
DESIGN SURVEY  
FOR  
VESSEL TRAFFIC SERVICE EQUIPMENT  
REGARDING  
TECHNICAL COOPERATION PROJECT ON  
ENHANCING OF VESSEL TRAFFIC SERVICE  
SYSTEM MANAGEMENT CAPACITY  
IN  
INDONESIA

FINAL REPORT**

**MARCH 2013**

**ORIENTAL CONSULTANTS CO., LTD. (OC)  
JAPAN AIDS TO NAVIGATION ASSOCIATION (JANA)**

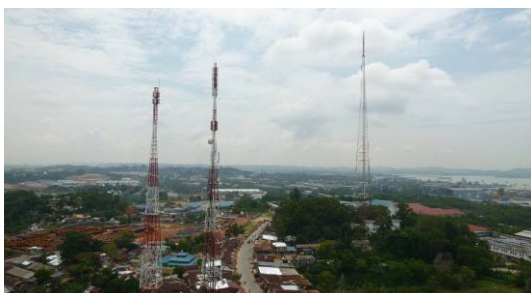
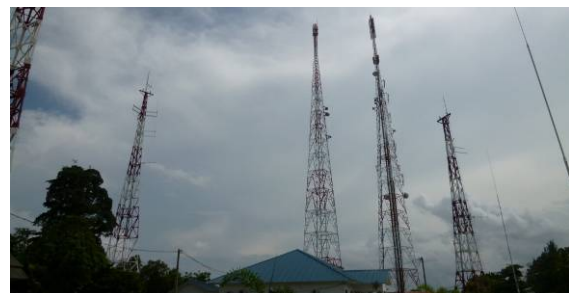
**Photo 2-8 Steel Towers in the Surrounding Area of VTS Center**

There are several steel towers near Batu Ampar VTS Center. Among these, there are two (2) towers owned and managed by Batam TV. The tower heights are 70 m and 80 m. The towers are owned by the TV company; however, other TV companies and telecommunication companies such as Media Link, ANTV, TV1, Telekomsel, Smart Friend, etc. use these towers on a contract basis for data communication.

**(1) : Steel Towers near VTS Center**

**(2) : Steel Towers beside VTS Center**

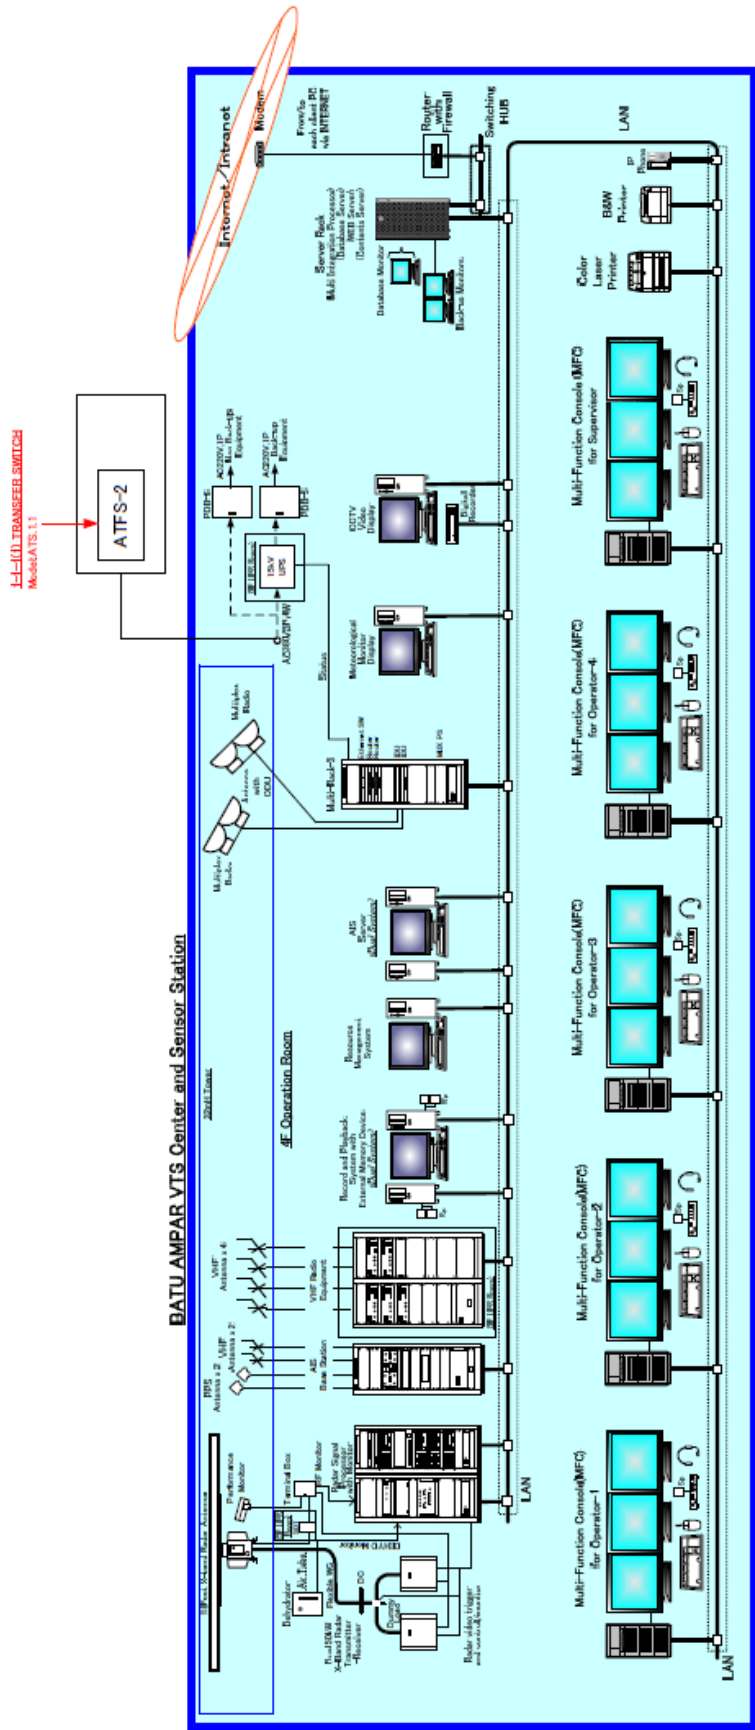
Figure 3-1 General Plan of Equipment Repair for Batu Ampar VTS Center

During the Survey, DGST informed the Survey Team that automatic switching devices between the PLN and backup generator were damaged due to lightning that occurred at the end of November 2012.

Based on the Survey, it was found that the automatic switch did not function after the lightning, but on the other hand, VTS equipment was not damaged.

After the lightning, automatic switching between commercial power (PLN) and the backup generator did not function because the switching control unit was damaged. In addition, lamps in the MEH office and the garden in front of the office were blown out by the strike.

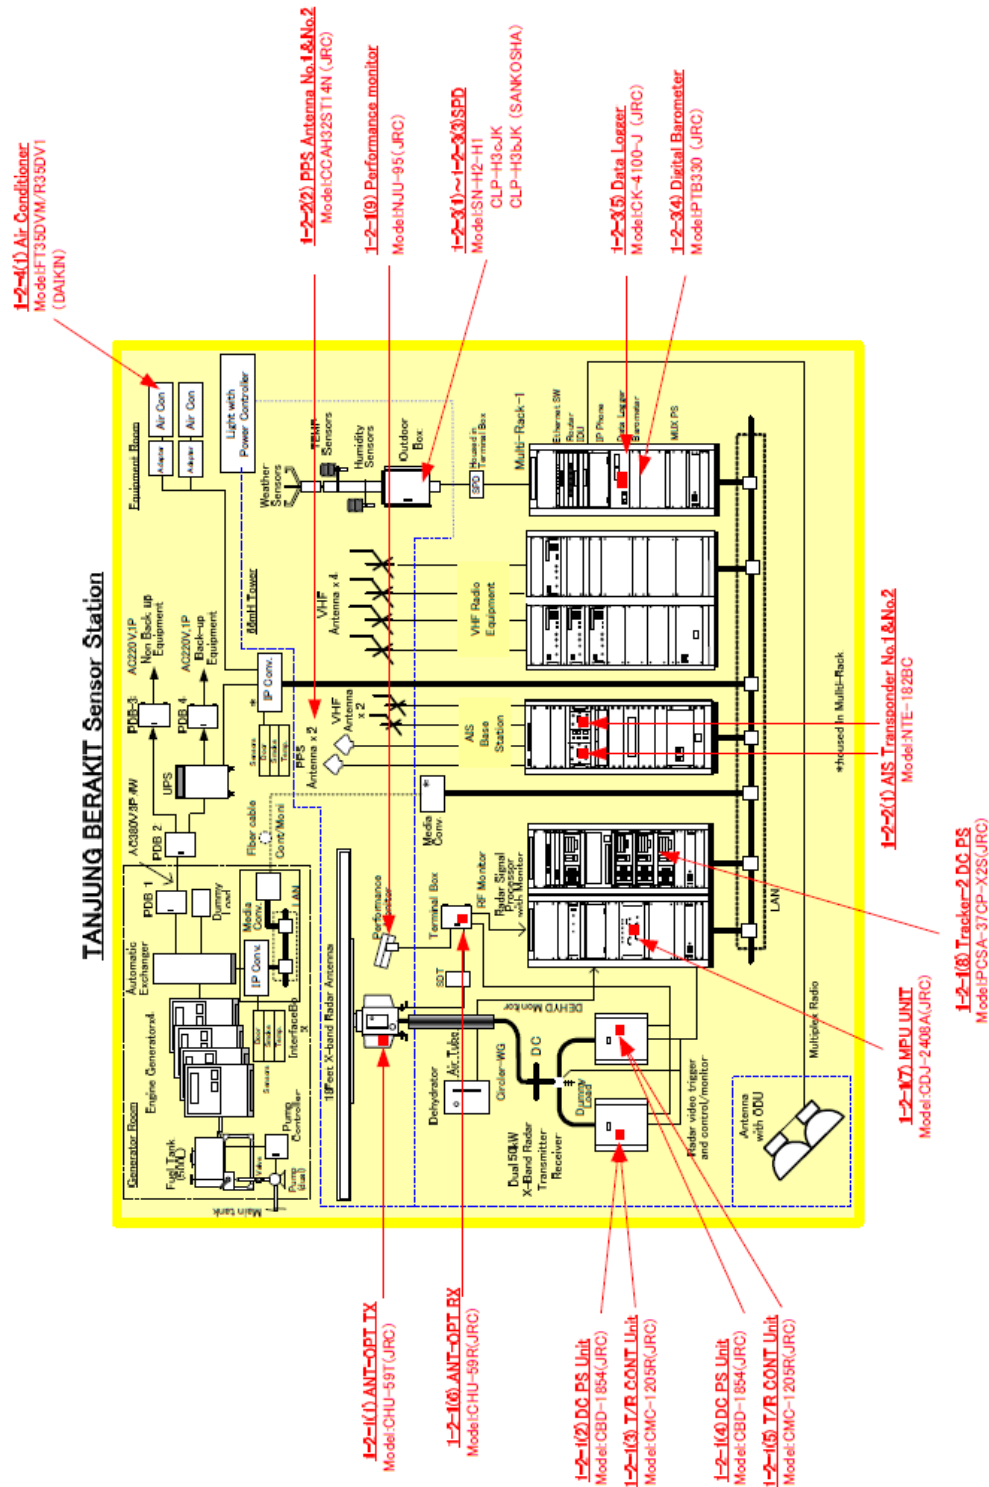
Figure 3-6 General Plan of Equipment Repair for Tanjung Berakit

Damage was found in the radar system, CCTV camera system and air conditioner.

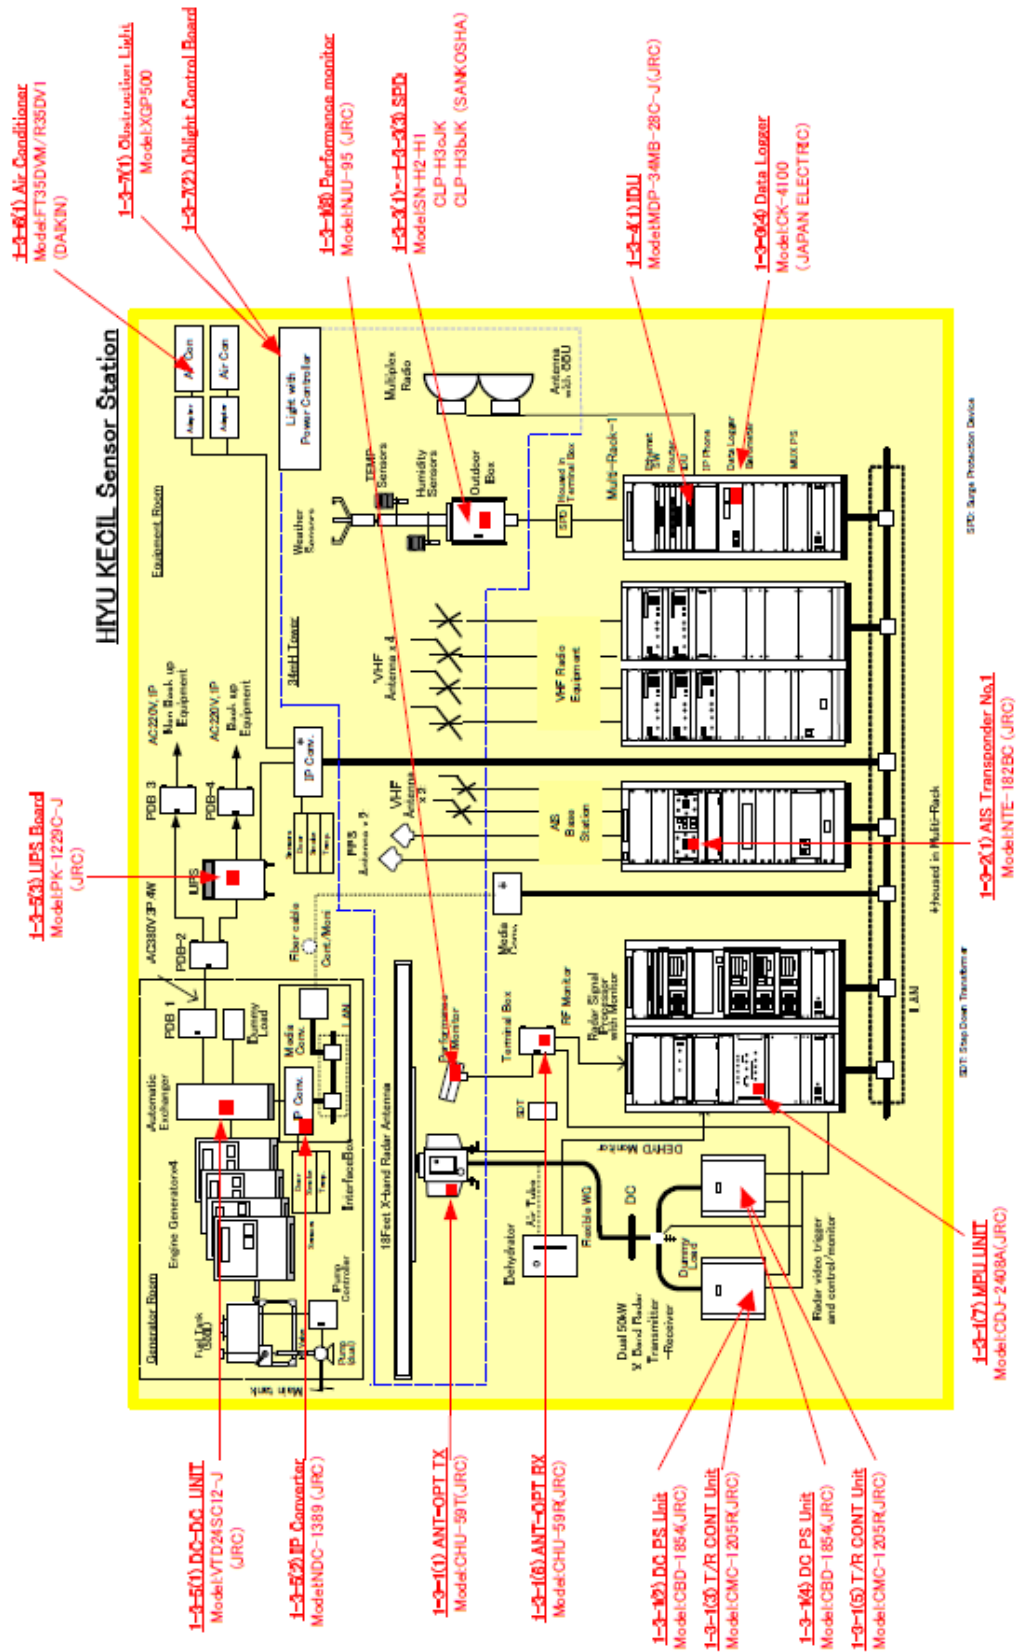
Figure 3-12 General Plan of Equipment Repair for Hiyu Kecil

The radar system, AIS base station equipment, meteorological observation devices, UPS system, multiplex communication devices, air conditioner, aviation obstruction lights and fuel supply pump system were damaged by lightning. Burning in the equipment rack was also found.

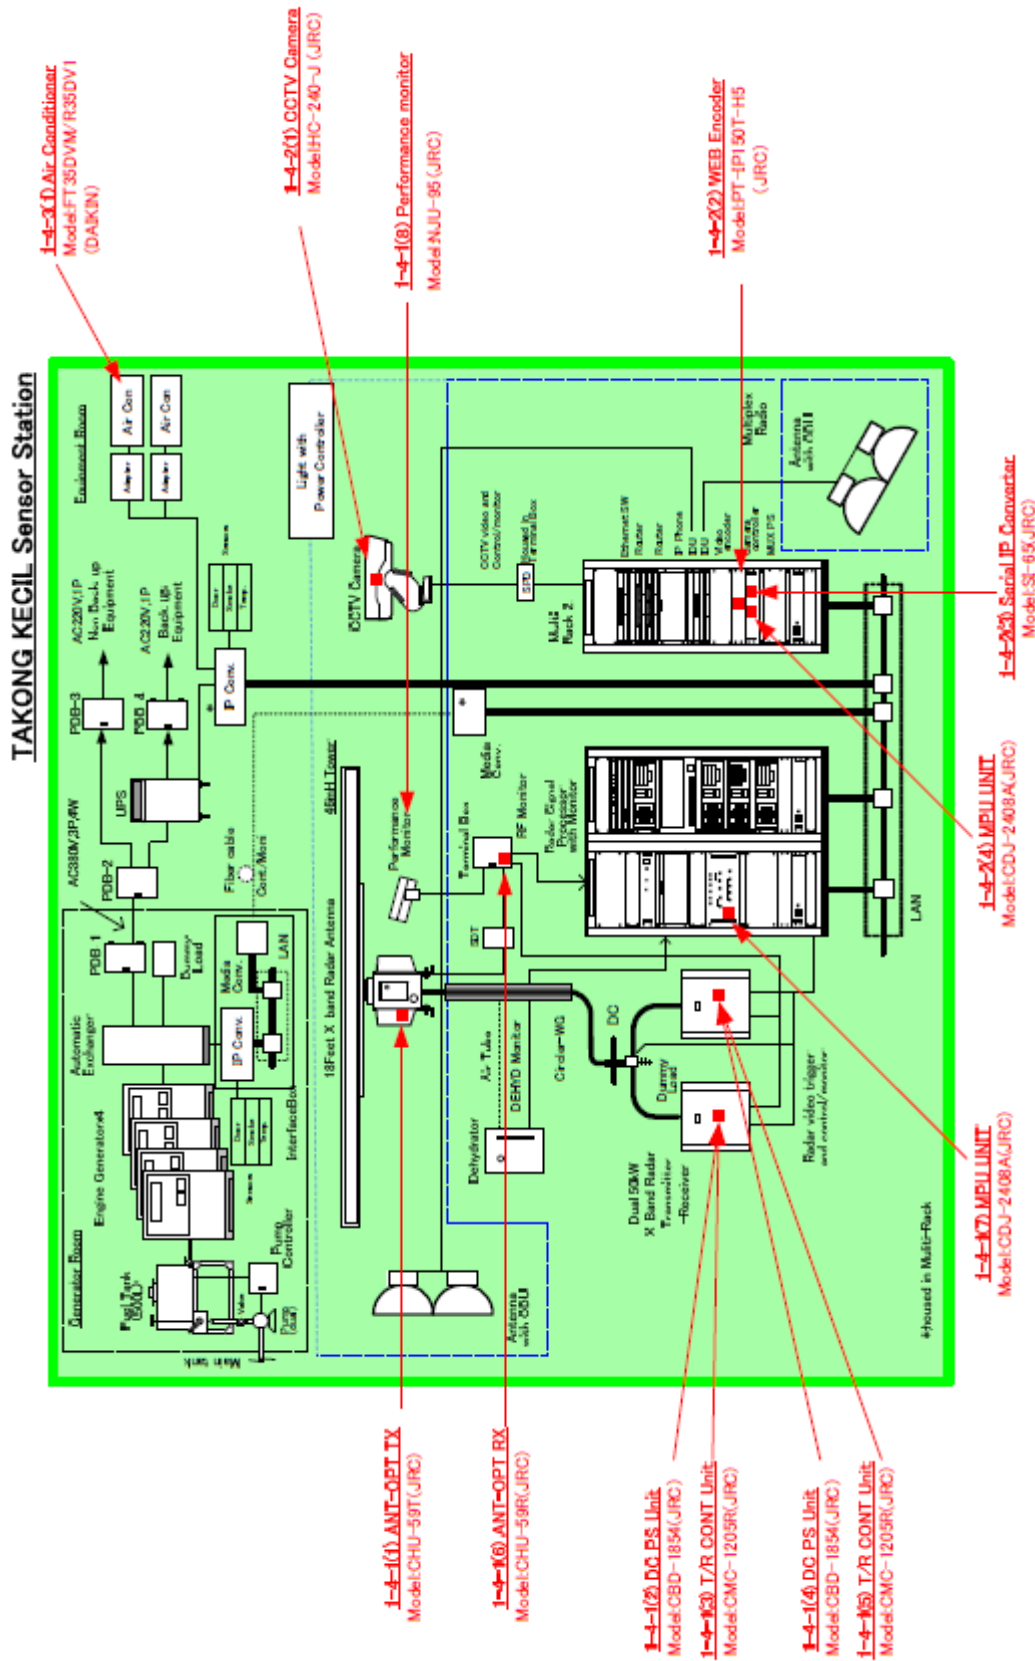
Figure 3-17 General Plan of Equipment Repair for Takong Kecil

The radar system, AIS base station equipment, meteorological observation devices and air conditioner were damaged by lightning.
