# FOLLOW-UP COOPERATION ON THE PROJECT FOR FLOOD FORECASTING AND WARNING SYSTEM IN HIGH ATLAS AREA

# FOLLOW-UP COOPERATION REPORT

JULY 2015

JAPAN INTERNATIONAL COOPERATION AGENCY (JICA) CTI ENGINEERING INTERNATIONAL CO., LTD.

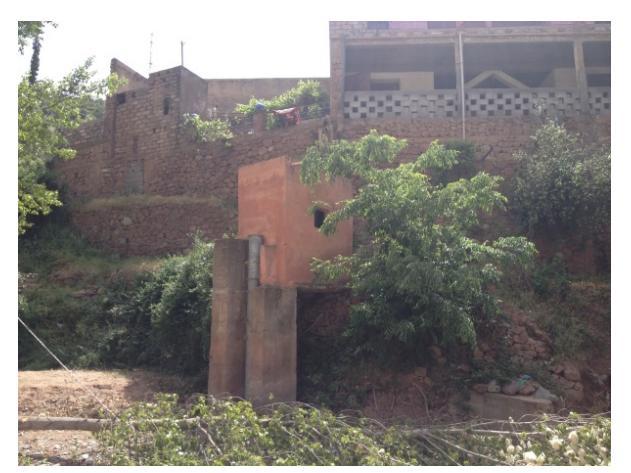
Before Commencement of Work

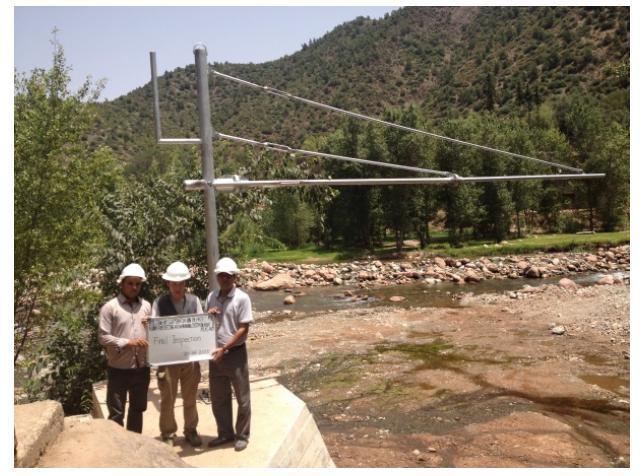
30th June Final Inspection

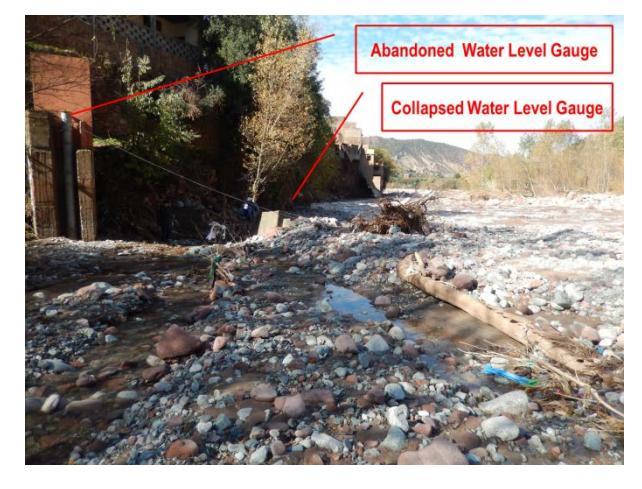
Photo 2.3.1 Location of Reconstruction Site

As seen in Photos 2.3.1 and 2.3.2, the site is far from the main stream and there is no water at ordinary time. Therefore, it is necessary to guide river water to the water level gauge by excavating the river bed. This river excavation work is supposed to be implemented by the Moroccan side in accordance with the S/W (Scope of Work) dated April 7, 2015 and the Minutes of Meetings on the Inception Report dated May 12, 2015.

The Consultant (CTII) conducted a preliminary survey in March 2015 and found four candidate sites near the Aghbalou Station. Table 2.3.1 compares the four sites. The Consultant proposed the site of old and abandoned water level gauge just behind the destroyed gauge as the most appropriate site (refer to Photos 2.3.1 and 2.3.2). The old gauge have been broken and left unused for more than 10 years. Since this site needs no land acquisition, construction work could be commenced immediately. Behind the abandoned water level gauge there appears rock, which could support the concrete foundation/substructure of the new gauge to make it durable against even a 100-year flood.

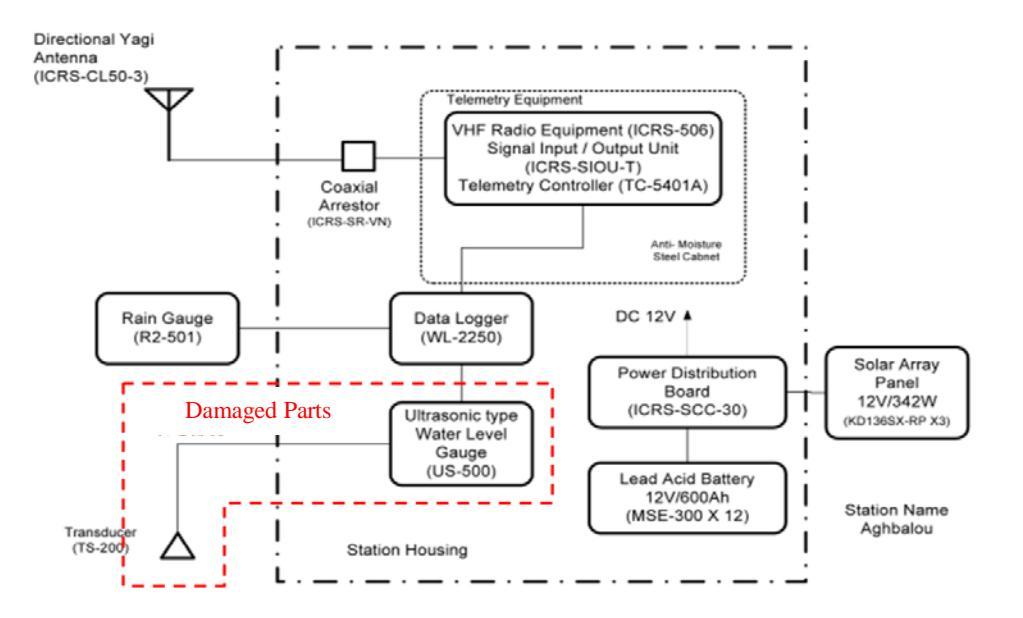
Figure 2.3.3 Component of Existing Equipment in Aghbalou Station

The configuration of the existing equipment at the Aghbalou Station is shown in Figure 2.3.3. The water level gauge is mainly composed of a transducer with a thermometer transmitter (TS-200) and its main unit (US-500). According to the preliminary survey by the Consultant in March 2015, the transducer and connection cable between the transducer and the main unit were totally damaged by the flood.

It is necessary to newly procure the same transducer and cable for the restoration. Regarding the main unit that might have been damaged, the Consultant got approval from DRPE and took it to Japan for checking and adjustment in March 2015. The main unit would be brought back to Morocco after the repair/adjustment in Japan and installed again where it was before, in the follow-up cooperation.
