**THE FOLLOW-UP COOPERATION STUDY
ON THE PROJECT FOR WATER SUPPLY
IN AFAR REGION IN THE FEDERAL
DEMOCRATIC REPUBLIC OF ETHIOPIA**

FINAL REPORT

February 2016

**JAPAN INTERNATIONAL COOPERATION AGENCY
KOKUSAI KOGYO CO., LTD.**

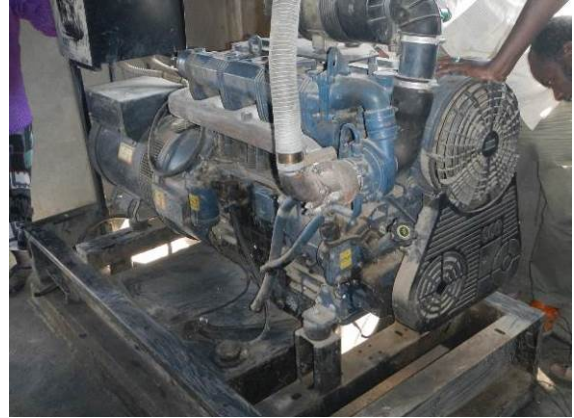
Figure 1-4 Existing generator

The AWRB reported that the pumping discharge of a production well, which was constructed by the previous grant aid, was reduced, and therefore a well development and pumping test were carried out in the Study. A submersible pump installed by the previous grant aid was replaced by the AWRB because it was out of order in 2010. Thereafter, the broken submersible pump was replaced with another pump (18.5 kW). However, the pump was not fulfilling its function due to a failure with the impeller. The flow meter and compound gauge of the pump unit were working. The generator had not been used since the facility was electrified with commercial power in 2013.

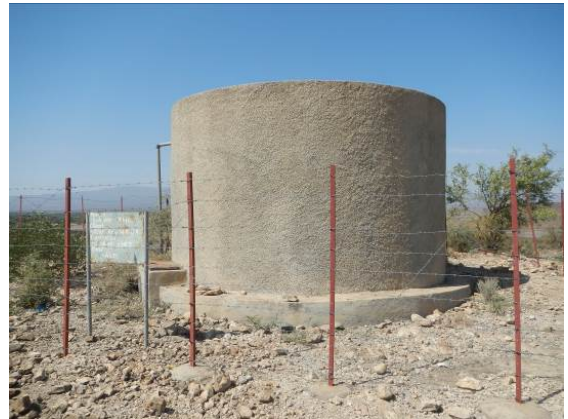
Figure 1-5 Existing reservoir

An existing reservoir of 50 m³ was working properly.

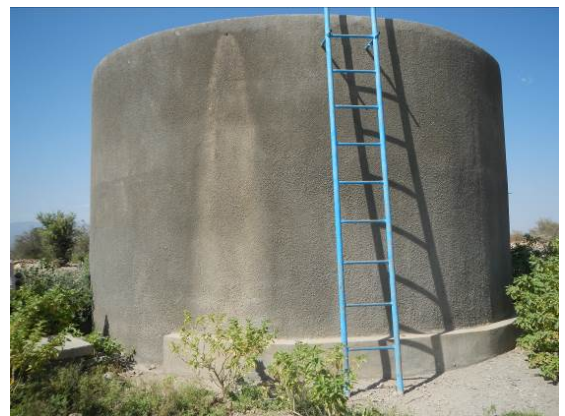
Figure 1-6 Reservoir

A reservoir of 100 m³, which was constructed by the previous grant aid, was working properly.

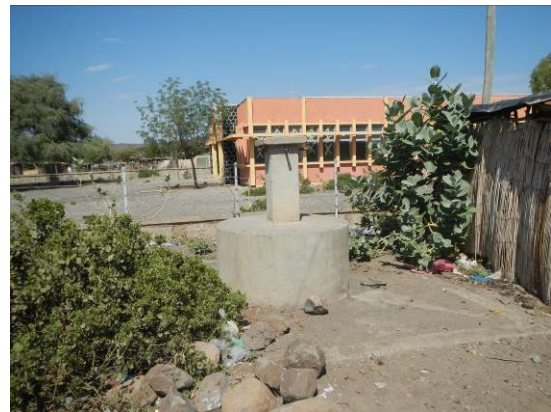
Figure 1-8 Existing public fountain No.2

Existing public fountain No.2 had not been used since the water supply through private connections was disseminated in the service area.

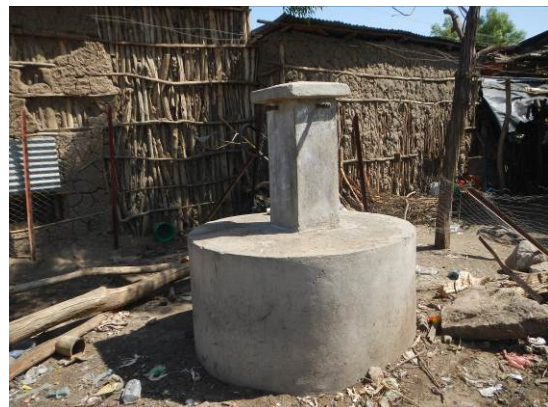
Figure 1-9 Existing public fountain No.3

Existing public fountain No.3 had not been used since the water supply through private connections was disseminated in the service area.

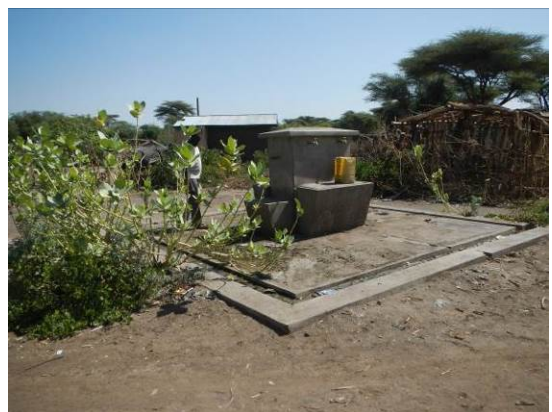
Figure 1-12 Public fountain No.2

Public fountain No.2, which was constructed by the previous grant aid, was working, and the flow meter and a gate valve were working.

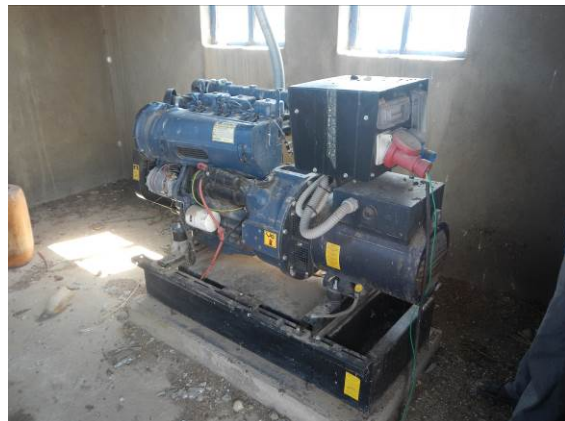
Figure 1-15 Generator

A submersible pump installed by the previous grant aid had also not been used and was left in the well since its last use in 2012. The pump was confirmed to not work in the Study. In addition, thread connections of riser pipes were damaged by corrosion. The flow meter and compound gauge of the pump unit were not working. A generator installed by the previous grant aid was not working due to a malfunction in the alternator, and therefore was no longer in use at the time of inspection.

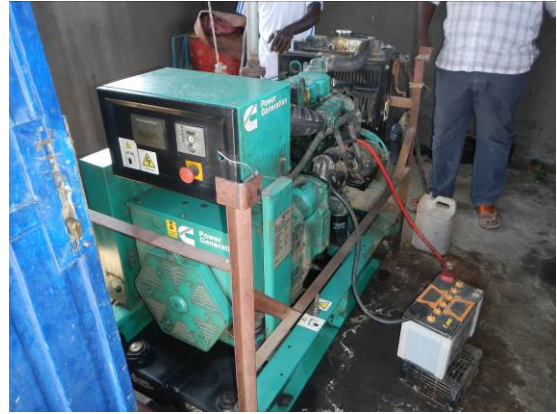
Figure 1-17 Generator

The submersible pump installed by the previous grant aid was working. A flow meter and a compound gauge of the pump unit were not working. The generator installed by the previous grant aid malfunctioned and was replaced by the AWRB in 2014. The replaced generator was working properly.

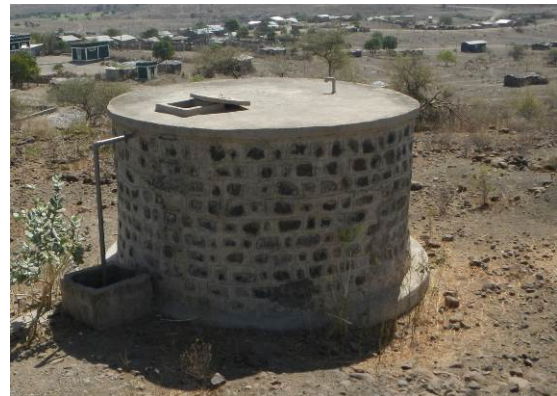
Figure 1-18 Existing reservoir

An existing reservoir of 50 m³ had not been used since the existing well ceased to supply water in 2015.

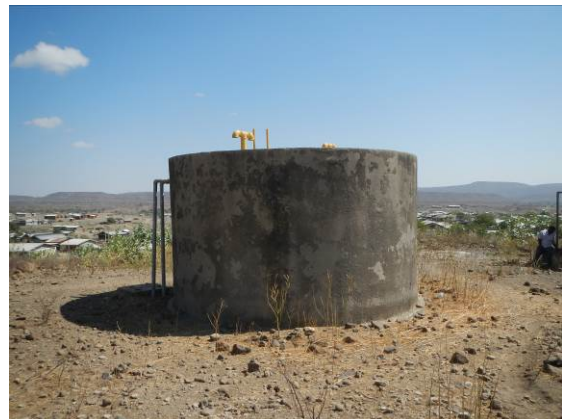
Figure 1-19 Reservoir

A reservoir of 50 m³, which was constructed by the previous grant aid, was working properly.

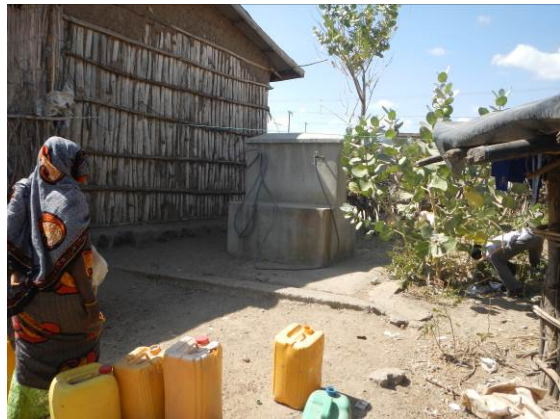
Figure 1-21 Existing public fountain No.2

Existing public fountain No.2, on private land, was working. The flow meter and a gate valve were also working.

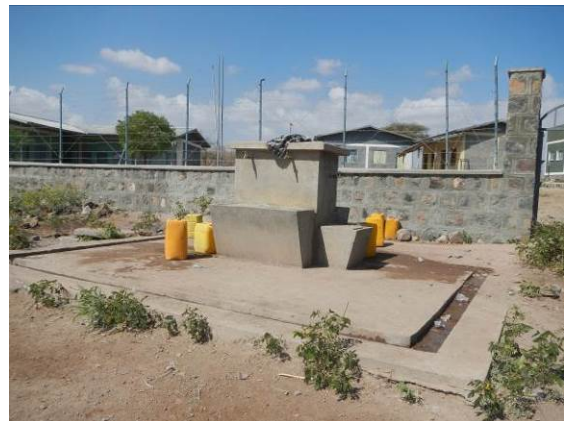
Figure 1-24 Public fountain No.1

Public fountain No.1, which was constructed by the previous grant aid, was working. The flow meter and gate valve were also working.

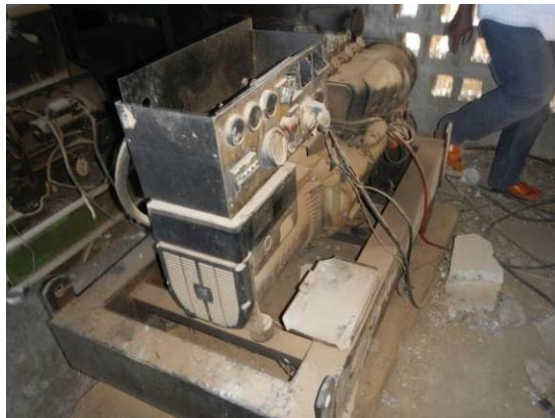
Figure 1-29 Existing generator

The submersible pump installed by the previous grant aid malfunctioned and was replaced by the AWRB. The flow meter of the pump unit had broken down. The facility was electrified with a photovoltaic power plant provided by the Afar community initiative sustainable development association (ACISDA) in 2014, and therefore the existing generator was used as a standby power source.

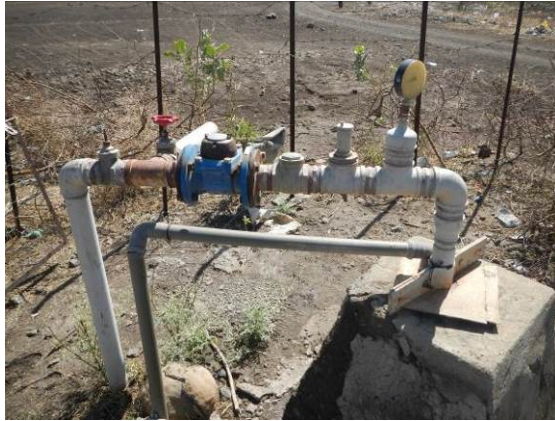
Figure 1-30 Test well

The submersible pump installed by the previous grant aid was working. The flow meter and compound gauge of the pump unit were also working. A generator installed by the previous grant aid was not working and was no longer in use at the time of inspection because the control system and an alternator had malfunctioned. The facility has been operating with photovoltaic power since ACISDA electrified it in 2014.

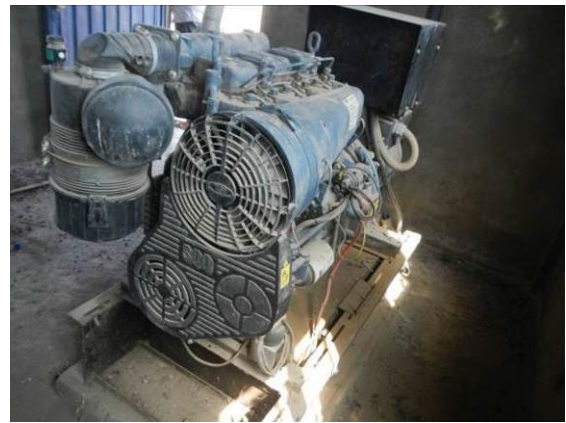
Figure 1-33 Generator

A submersible pump installed by the previous grant aid had not been used and was left in the well since 2014 due to the above-described reason. The pump was confirmed to not work in the Study. In addition, thread connections of riser pipes were damaged by corrosion. A flow meter was removed and a compound gauge, a check valve, an air release valve and gate valves of the pump unit failed. A generator installed by the previous grant aid was also out of operation, and had been left unused since 2014.

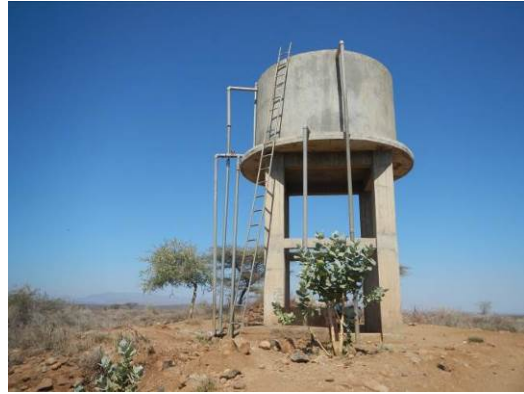
Figure 1-34 Existing elevated tank

An existing elevated tank of 50 m³ was working properly.

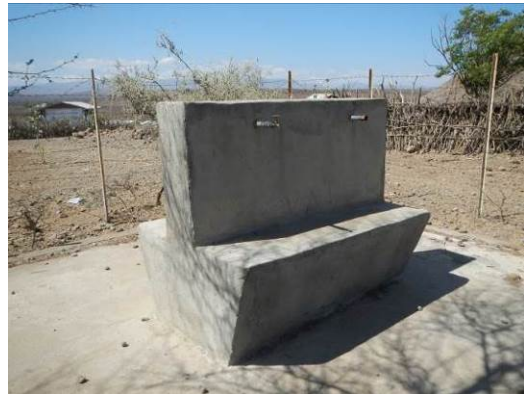
Figure 1-35 Existing public fountain No.1

Existing public fountain No.1 was not used because using the fountain caused the lowering of the water supply pressure in the area. The AWRB intended not to use the fountain because frequency of use was low.

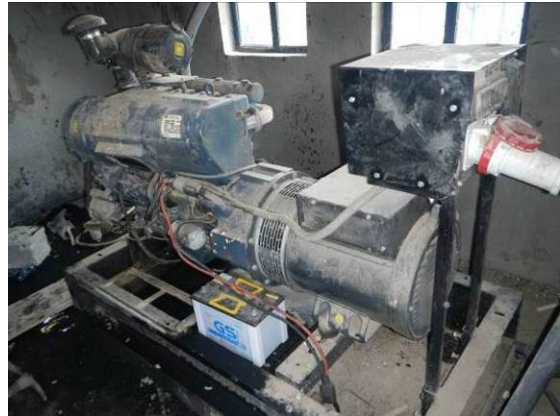
Figure 1-41 Generator

A submersible pump installed by the previous grant aid malfunctioned and was replaced by the AWRB in 2011. Thereafter, two submersible pumps continuously malfunctioned and were replaced, and thereby the forth pump was operating. However, according to AWRB, the performance of the pump was not sufficient and the specifications were unknown. The flow meter and the compound gauge of the pump unit failed. The facility was electrified with commercial power by CARE Ethiopia and USAID in 2013, and therefore a generator installed by the previous grant aid was used as a standby power source.

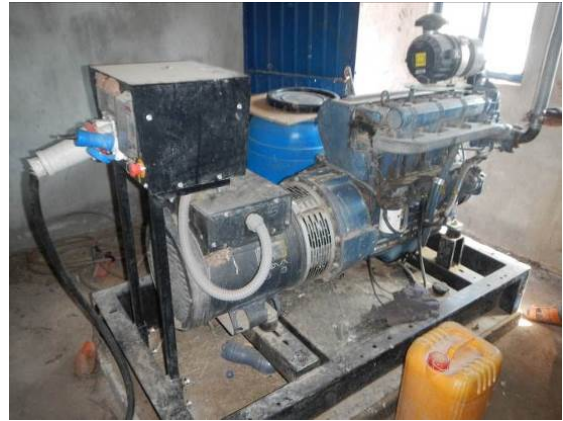
Figure 1-44 Generator

A generator installed by the previous grant aid has not been used since the facility was electrified with commercial power in 2013.

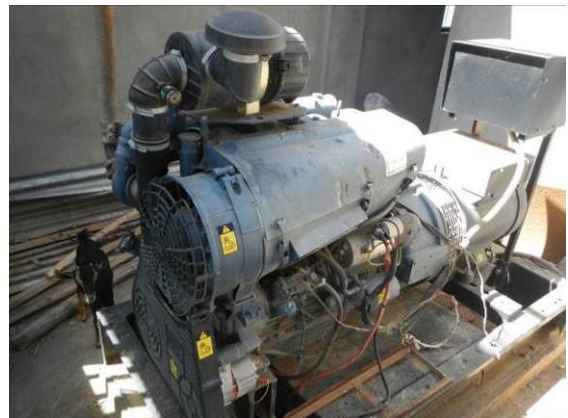
Figure 1-46 Generator

A booster pump installed by the previous grant aid malfunctioned and was replaced with a backup pump in 2015. The replaced booster pump was operating and leaking some water from the body. A generator installed by the previous grant aid has not been used since the facility was electrified with commercial power in 2013.

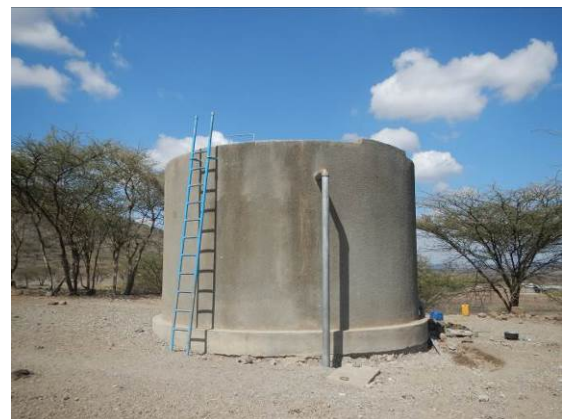
Figure 1-47 Reservoir

A reservoir of 50 m³, which was constructed by the previous grant aid, was working properly.

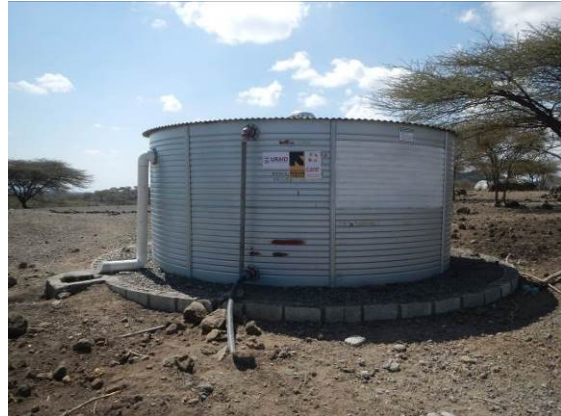
Figure 1-48 Reservoir constructed by other donors

A reservoir of 50 m³ was constructed by CARE Ethiopia and USAID next to the reservoir constructed by the previous grant aid. Each reservoir was connected by an underground pipe.

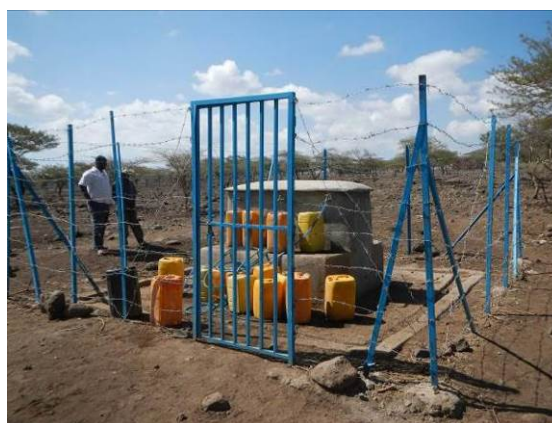
Figure 1-52 Public fountains constructed by other donors

Four public fountains were constructed by CARE Ethiopia and USAID. Three of them were connected to distribution pipelines constructed by the previous grant aid and another public fountain was connected to a collection chamber of booster pump station No.1.

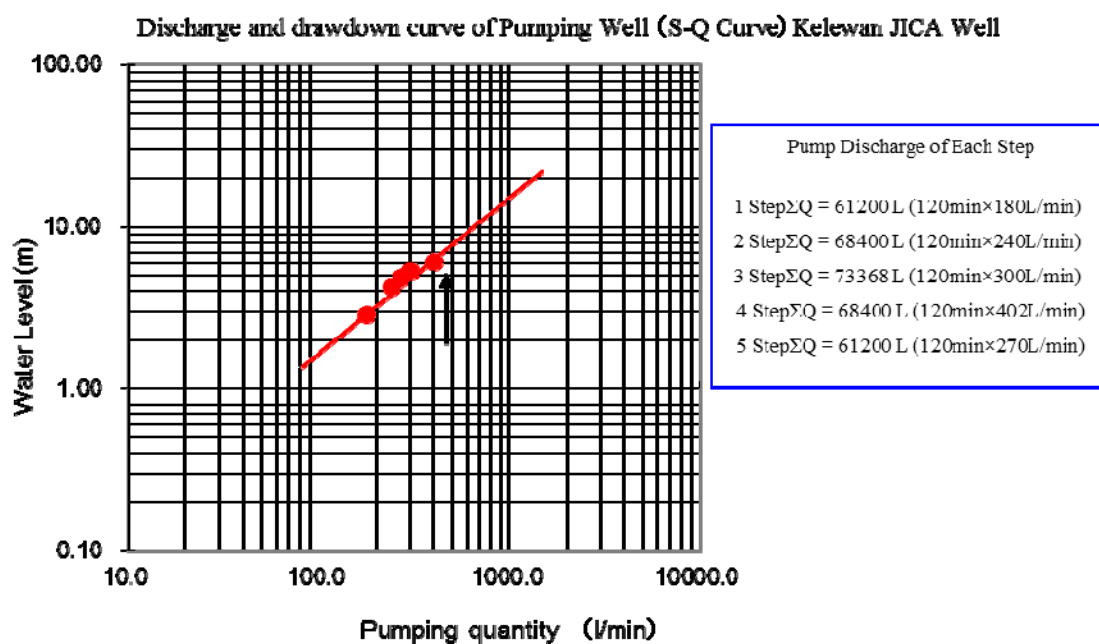
Figure 1 S-Q curve diagram

- The minimum yield was set at 3.0 L/s and the maximum yield was set at 6.7 L/s for the step-drawdown test.
- The static water level (SWL) was 25.69 m¹, and the dynamic water level (DWL) was 31.73 m.
- As can be seen from the following figure, it was estimated that the critical yield was greater than 6.7 L/s.

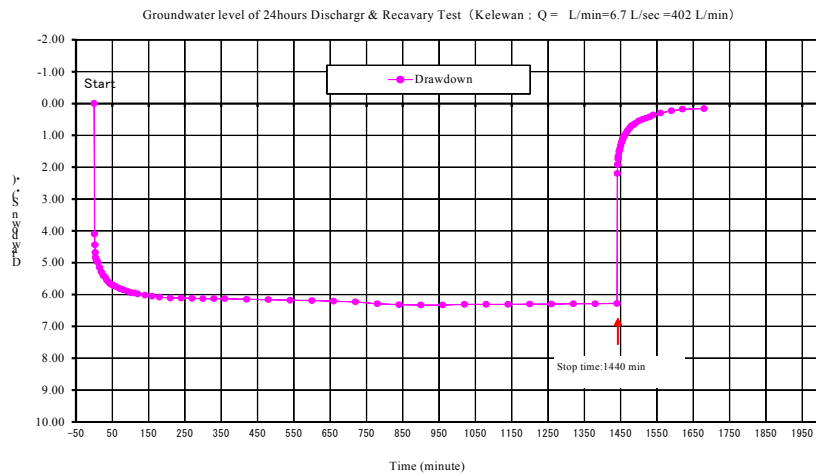
Figure 2 Fluctuation of groundwater level of the continuous pumping test (24 hours)

- The maximum yield was set at 6.7 L/s for the continuous pumping test.
- The static water level (SWL) was 25.65 m, and the dynamic water level (DWL) was between 31.94 m and 31.98 m.

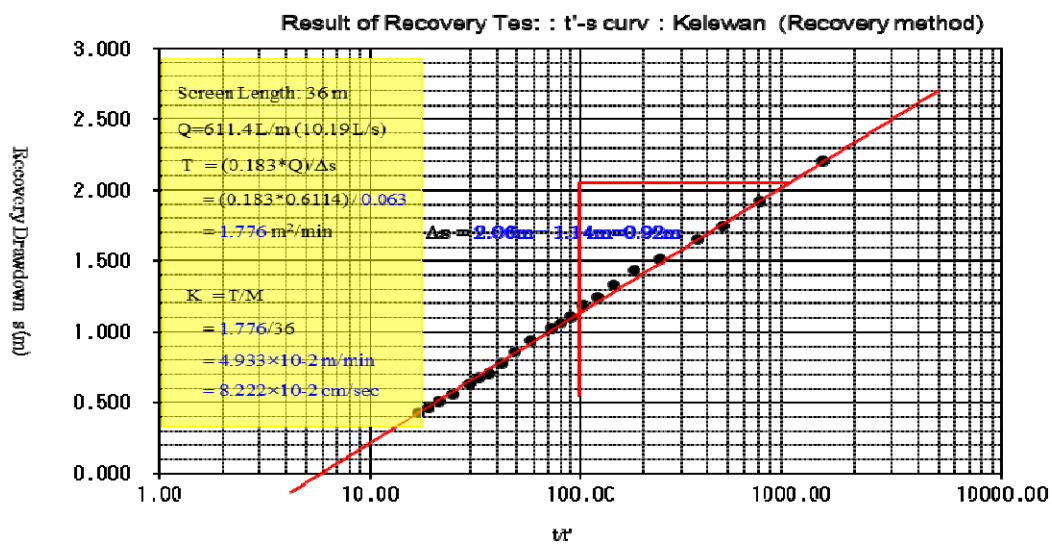
Figure 3 Graphical analysis of the recovery test

- The groundwater level recovered up to 97.9 %, 60 minutes after stopping the pumping.

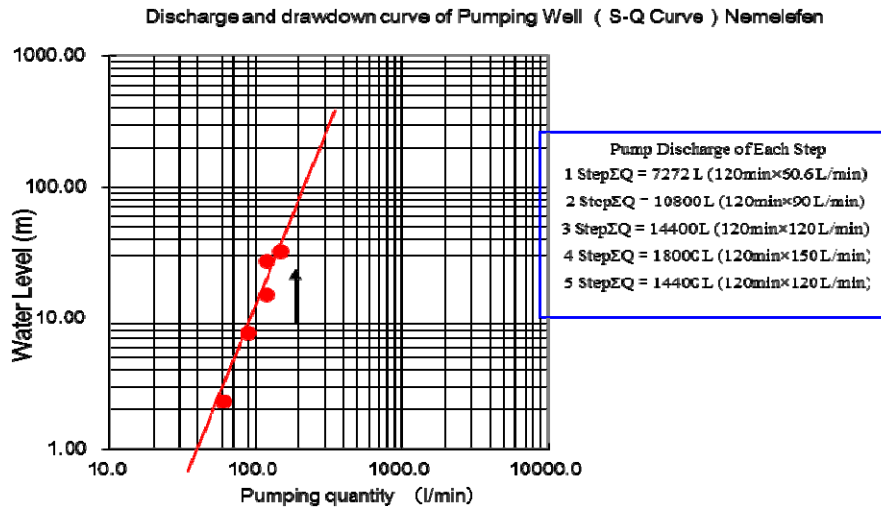
Figure 4 S-Q curve diagram

- The minimum yield was set at 1.01 L/s and the maximum yield was set at 2.5 L/s for the step-drawdown test.
- The static water level (SWL) was 9.50 m, and the dynamic water level (DWL) was 24.39 m (2.0 L/s) and 41.70 m (2.5 L/s).
- As it can be seen from the following figure, it was estimated that the critical yield was greater than 2.5 L/s.

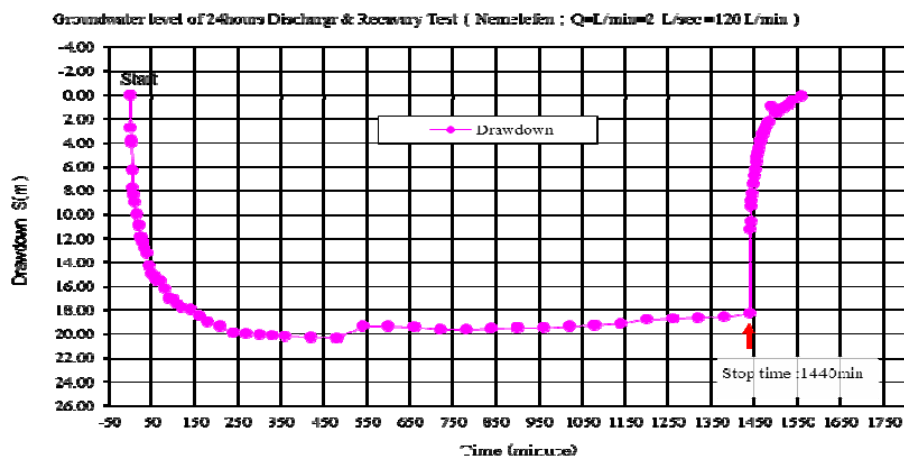
- The maximum yield was set at 2.0 L/s for the continuous pumping test.
- The static water level (SWL) was 9.10 m and the dynamic water level (DWL) was between 28.33 m and 28.72 m.

Figure 5 Fluctuation of groundwater level of the continuous pumping test (24 hours)

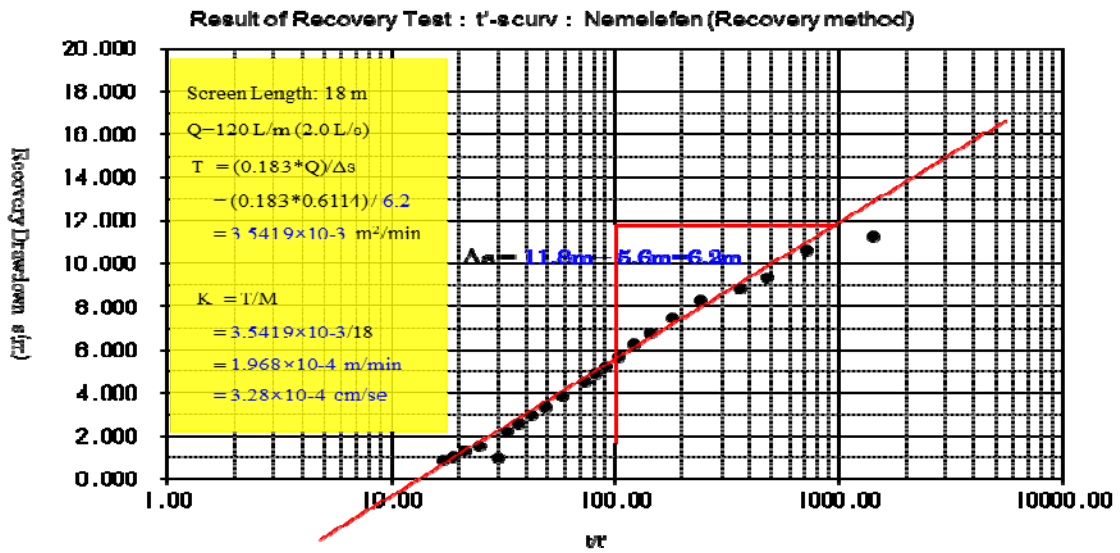
- The groundwater level recovered up to 99.2 %, 120 minutes after stopping the pumping.

Figure 6 Graphical analysis of the recovery test

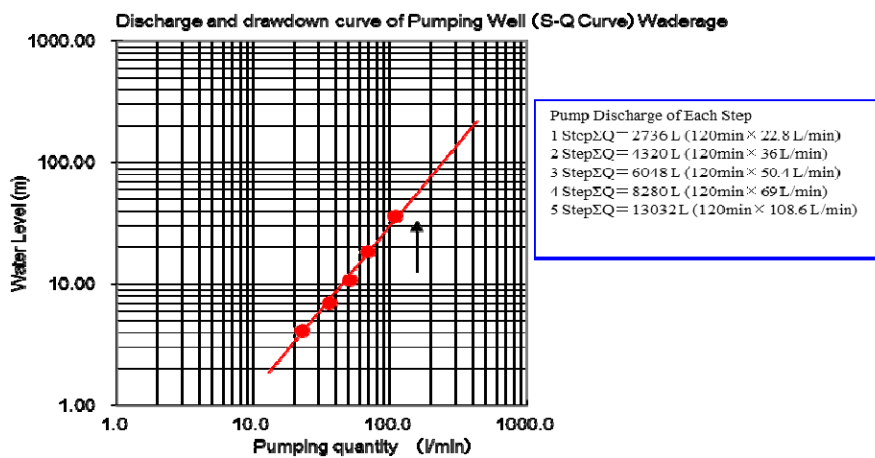
- The minimum yield was set at 0.38 L/s and the maximum yield was set at 1.81 L/s for the step-drawdown test.
- The static water level (SWL) was 20.95 m, and the dynamic water level (DWL) was 58.52 m.
- As it can be seen from the following figure, it was estimated that the critical yield was greater than 1.81 L/s.

Figure 7 S-Q curve diagram

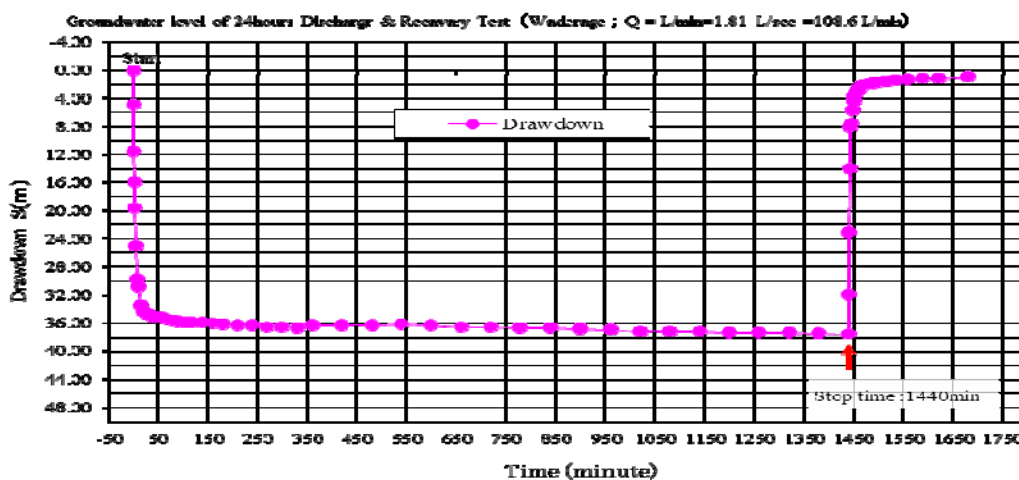
- The maximum yield was set at 1.81 L/s for the continuous pumping test.
- The static water level (SWL) was 20.95 m, and the dynamic water level (DWL) was between 57.31 m and 58.52 m.

Figure 8 Fluctuation of groundwater level of the continuous pumping test (24 hours)

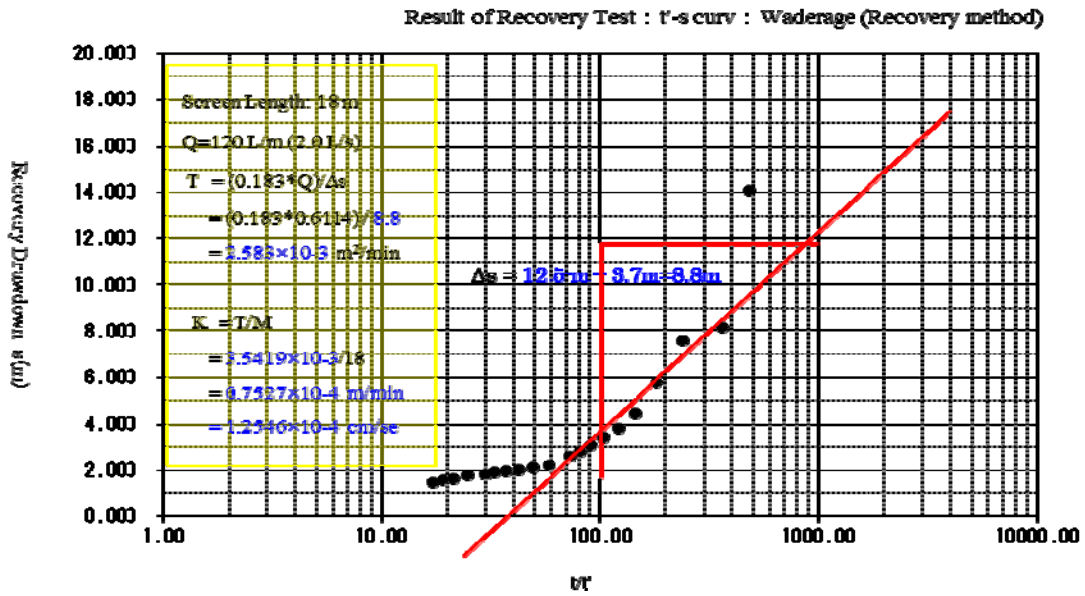
- The groundwater level recovered up to 94.0 %, 360 minutes after stopping the pumping.

Figure 9 Graphical analysis for the recovery test
