3.3.8 Madiwela South Diversion

3.3.9 Bolgoda Canal

Appendix-3

Baseline Environmental and Social Conditions of Project Area
(Mudun Ela Drainage Improvement Project)

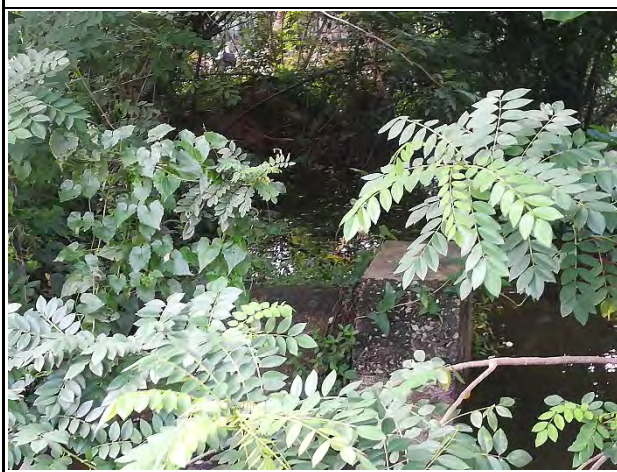
ID: MSD-9	JICA 2003 M/P	SLDC 2017	2018 F/S
	Anicut at 2+854		
COORDINATE	E		N
	79.935288		6.833840
PURPOSE	Anicut		
OPERATION	Not confirmed

No accessN

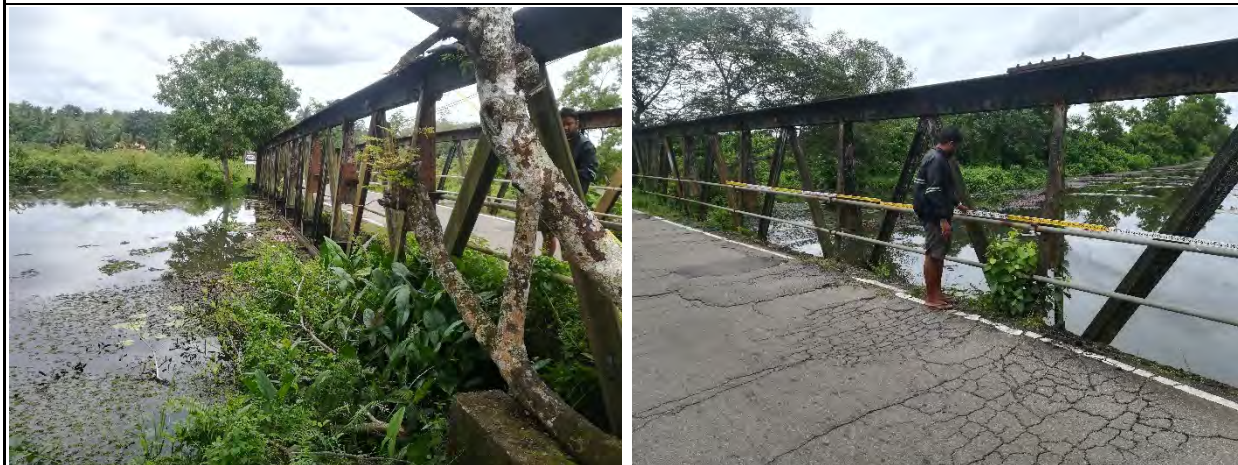
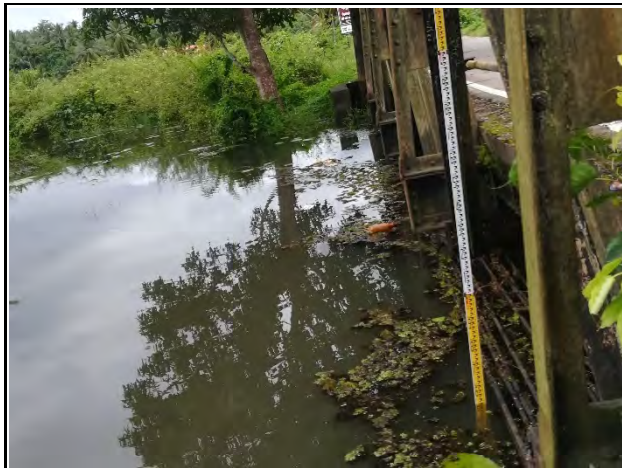
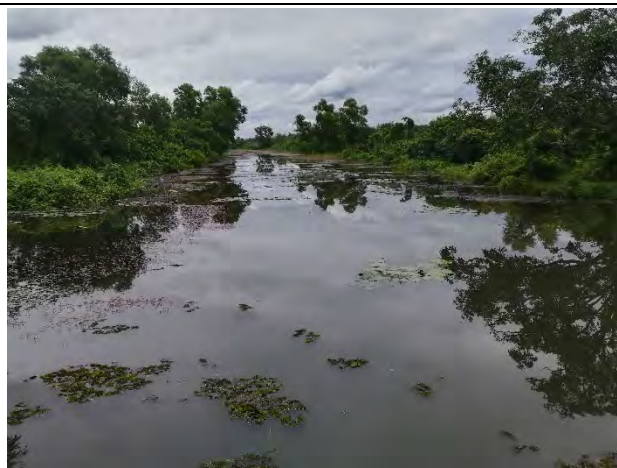
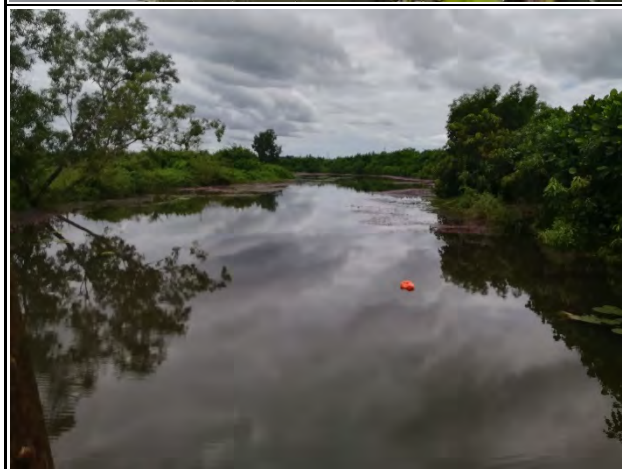
SITE CONDITION

ID: KE-2	JICA 2003 M/P	SLDC 2017	2018 F/S
	Bridge at 2+731		
COORDINATE	E		N
	79.983087		6.678947
PURPOSE	Gate for flood control		
OPERATION	in use

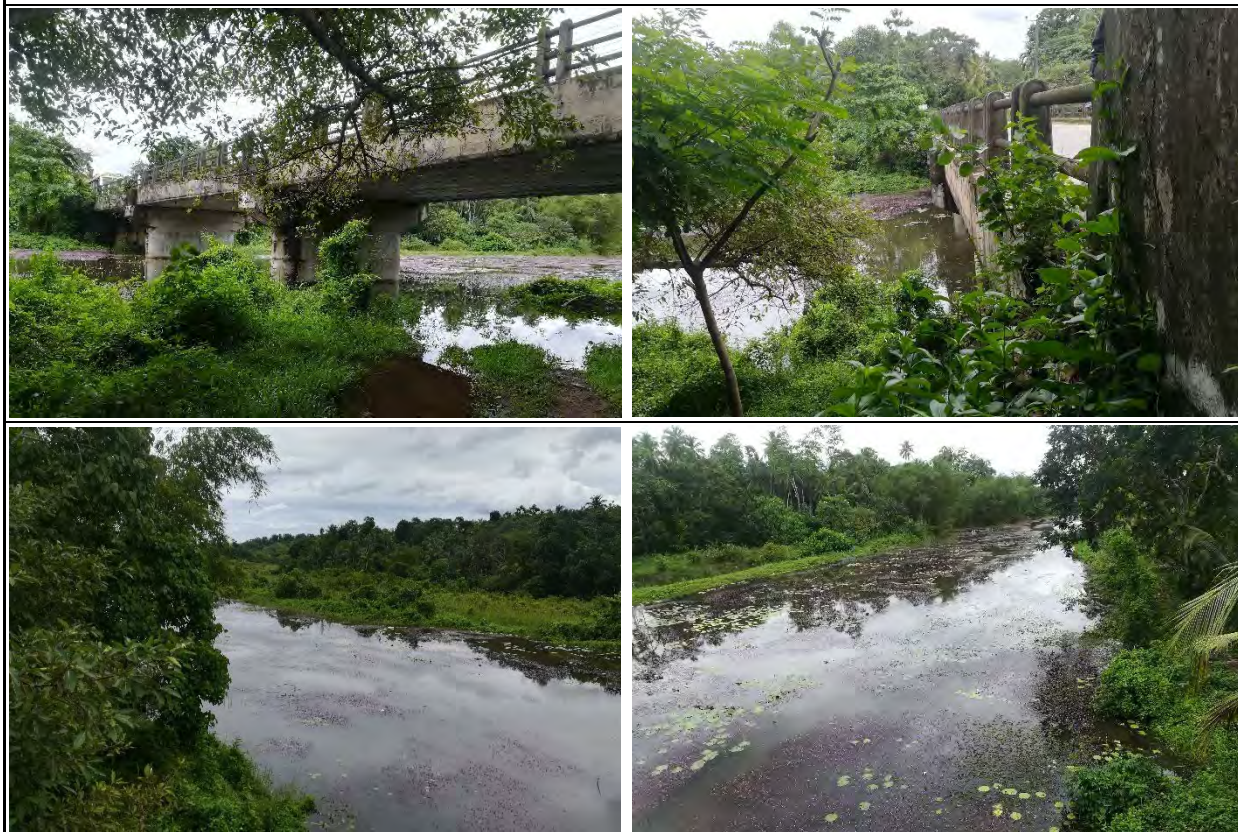
SITE CONDITION

ID: KE-3	JICA 2003 M/P	SLDC 2017	2018 F/S
	Bridge at 3+828		
COORDINATE	E		N
	79.986716		6.670445
PURPOSE	Gate for flood control		
OPERATION	in use

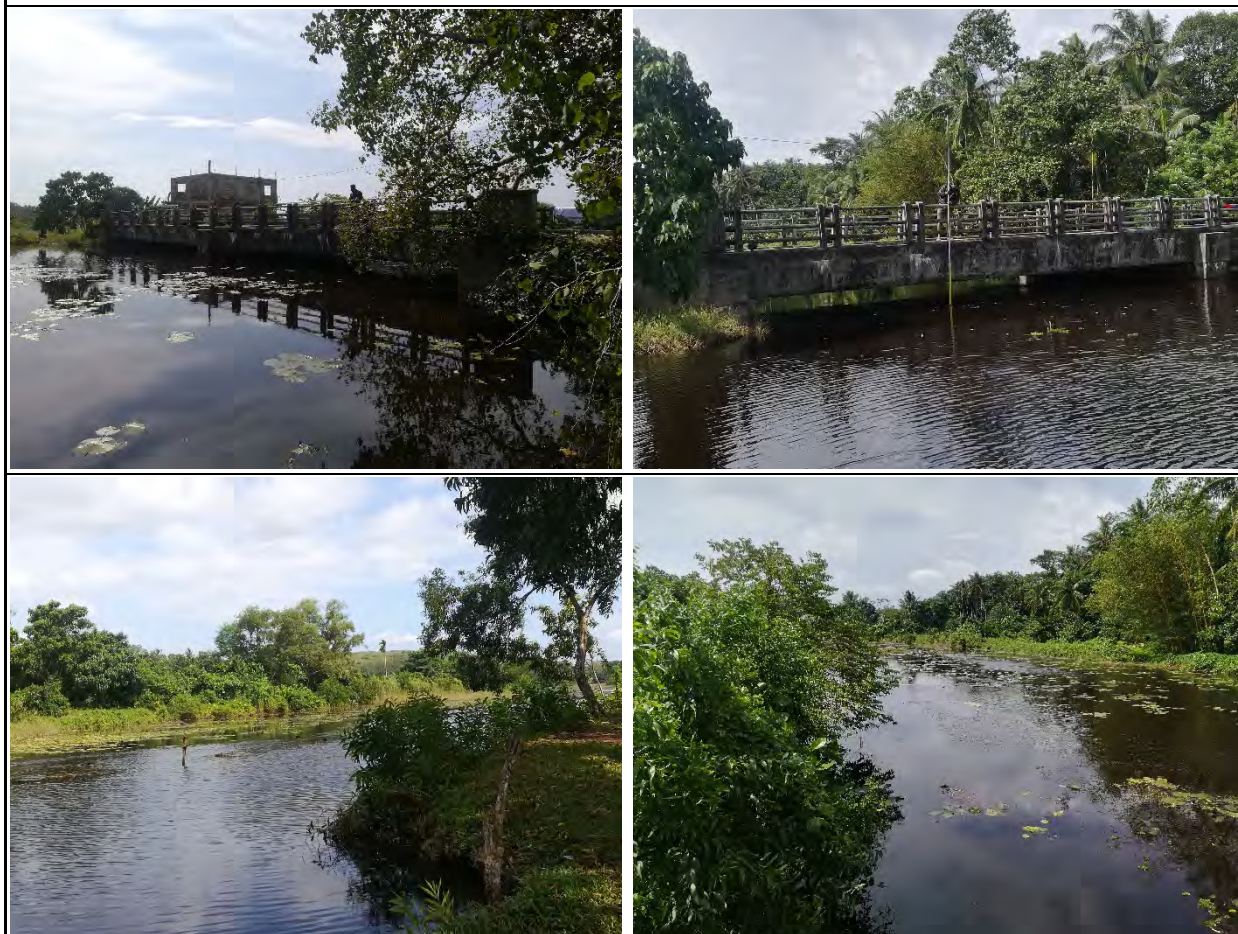
SITE CONDITION

ID: KE-4	JICA 2003 M/P	SLLDC 2017	2018 F/S
	Bridge at 6+714		
COORDINATE	E		N
	79.993142		6.646406
PURPOSE	Gate for flood control		
OPERATION	in use		
DRAWING			
(No drawing was shown in JICA 2003 M/P Report.)

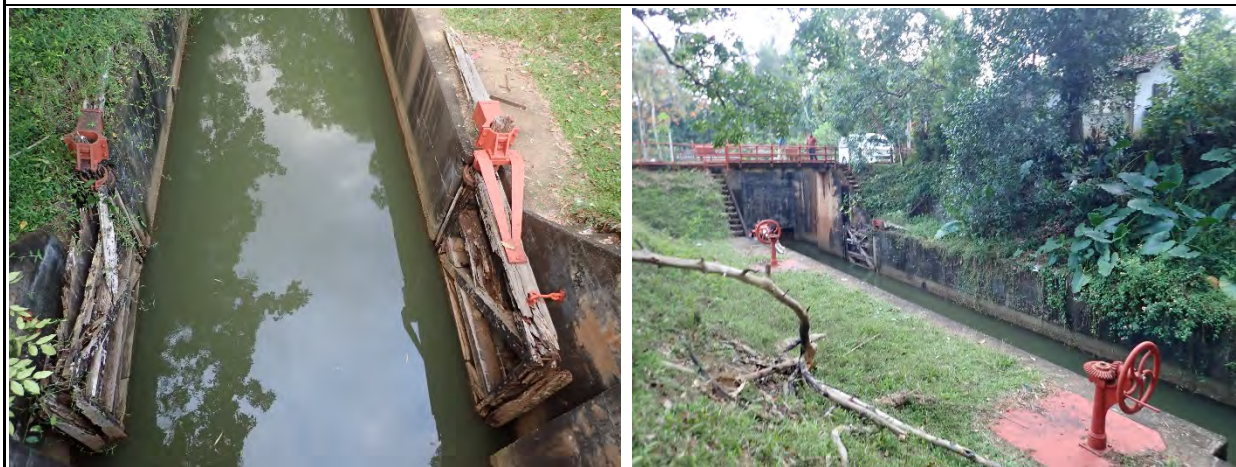
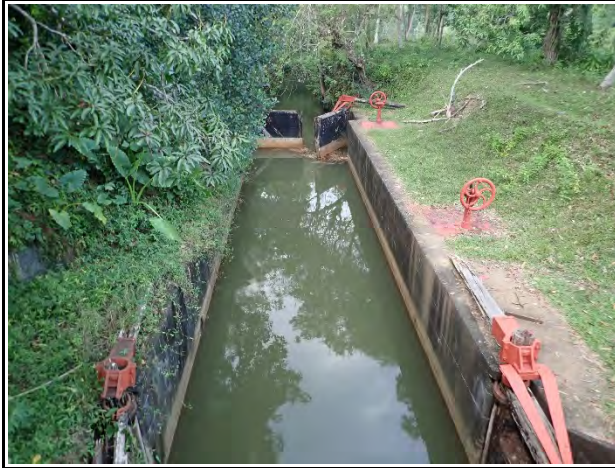
SITE CONDITION

ID: KE-6	JICA 2003 M/P	SLDLC 2017	2018 F/S
	Anicut at 8+402		
COORDINATE	E		N
	80.002609		6.637968
PURPOSE	Gate for flood control		
OPERATION	in use

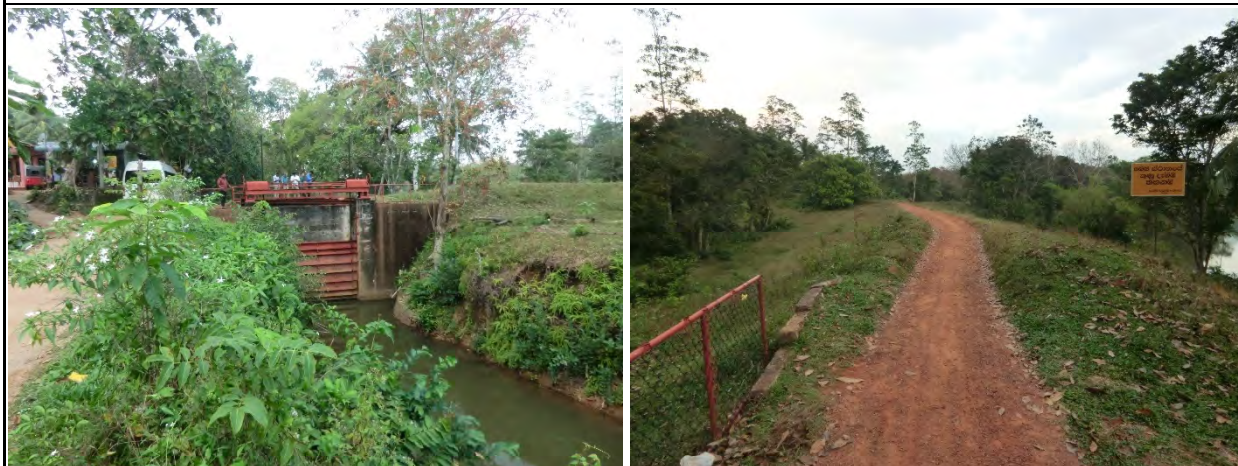
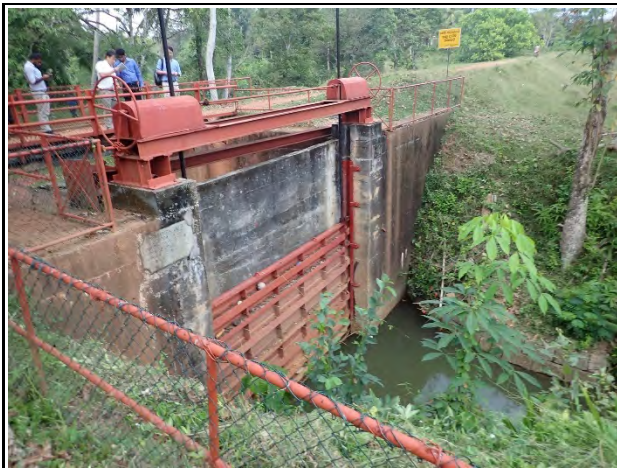
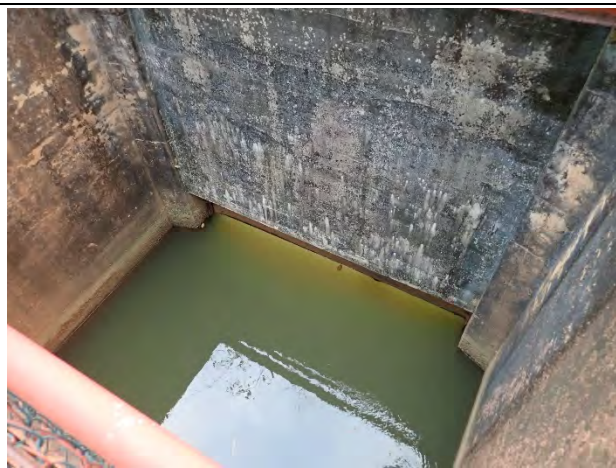
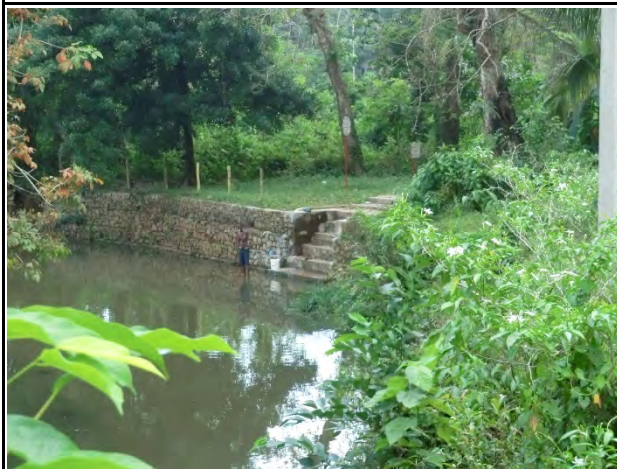
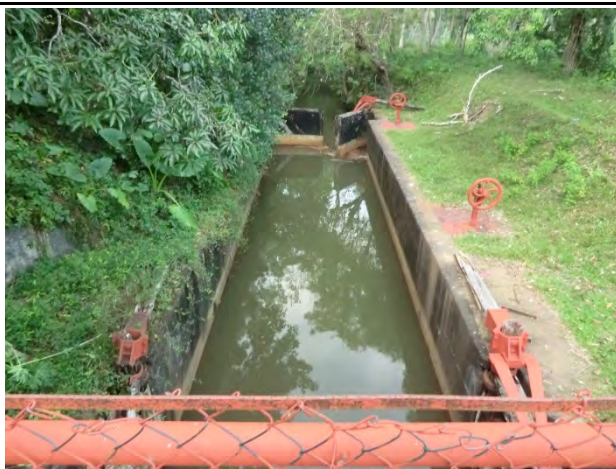
SITE CONDITION

ID: KE-7	JICA 2003 M/P	SLDLC 2017	2018 F/S
	Gate at 8+409		
COORDINATE	E		N
	80.002724		6.637900
PURPOSE	Gate for flood control		
OPERATION	in use

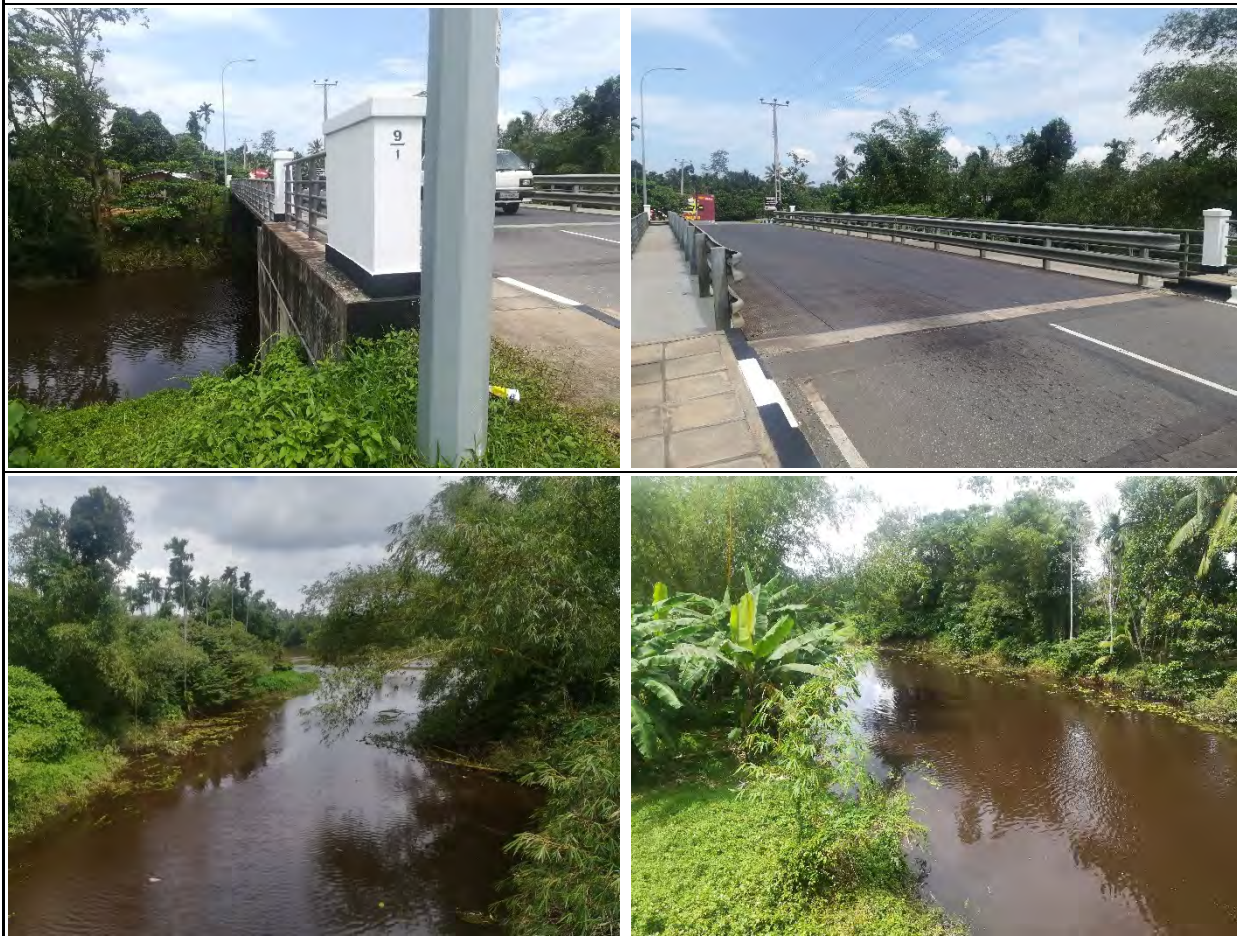
SITE CONDITION

ID: KE-8	JICA 2003 M/P	SLDC 2017	2018 F/S
	Bridge at 9+507		
COORDINATE	E		N
	80.009892		6.636096
PURPOSE	Gate for flood control		
OPERATION	in use

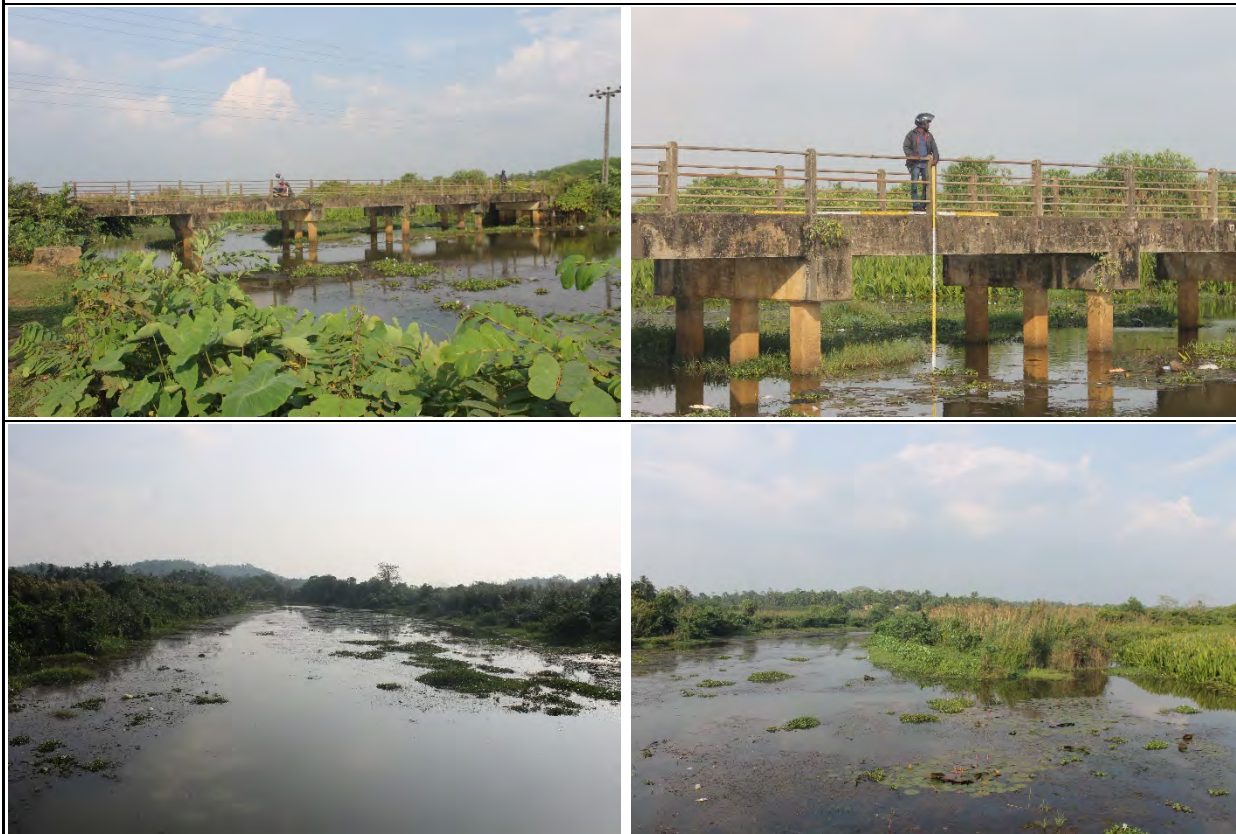
SITE CONDITION

ID: PE-1	JICA 2003 M/P	SLDLC 2017	2018 F/S
	Bridge at 11+485		
COORDINATE	E		N
	79.997562		6.692770
PURPOSE	Bridge		
OPERATION	in use

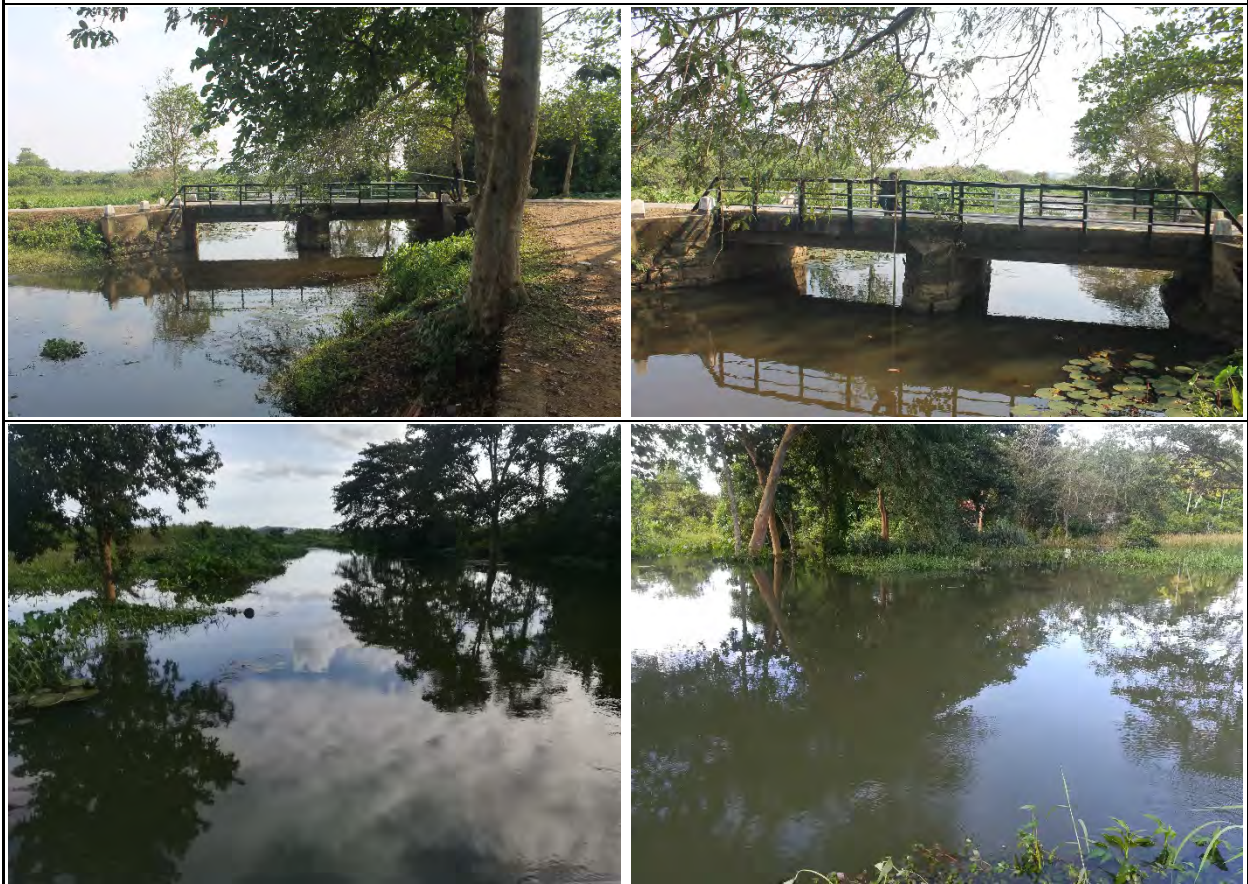
SITE CONDITION

ID: PE-3	JICA 2003 M/P	SLDC 2017	2018 F/S
	Bridge at 10+106		
COORDINATE	E		N
	80.007160		6.697707
PURPOSE	Bridge		
OPERATION	in use

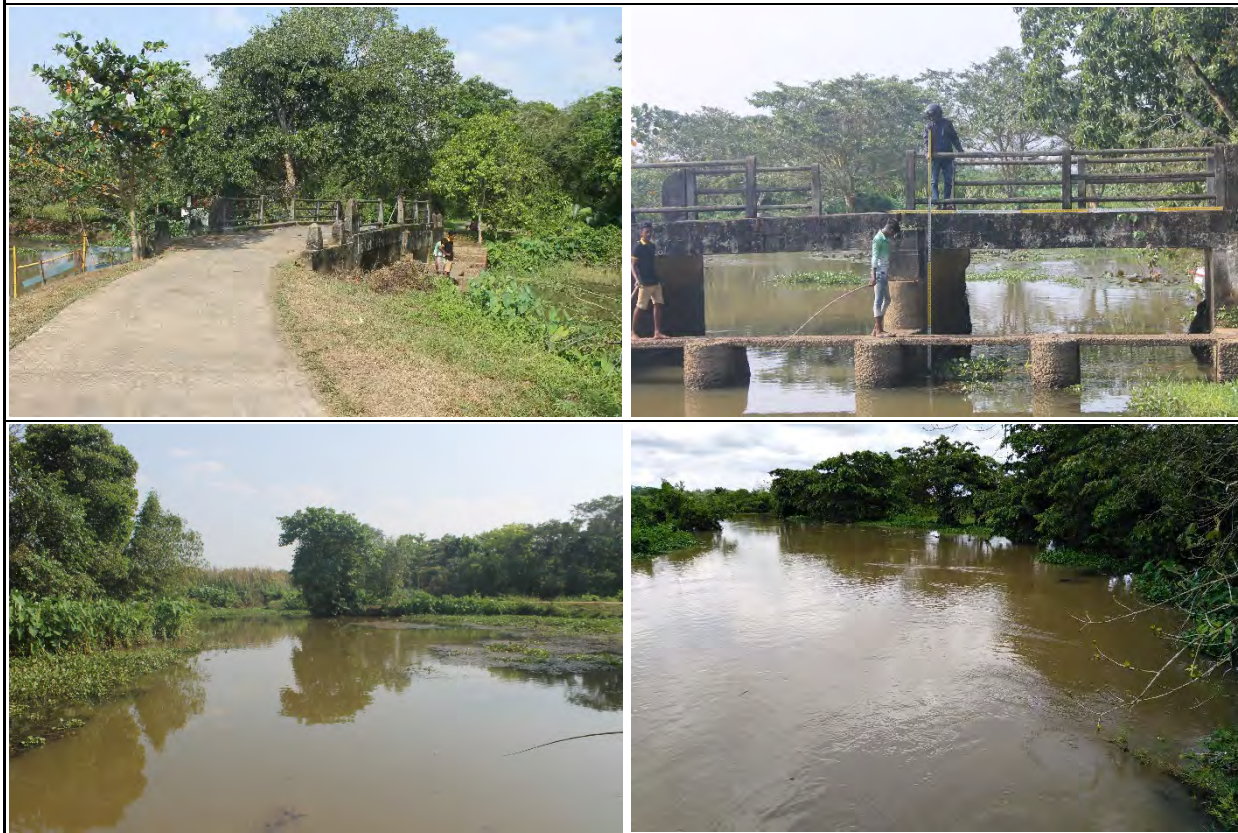
SITE CONDITION

ID: PE-4	JICA 2003 M/P	SLDLC 2017	2018 F/S
	Bridge at 8+980		
COORDINATE	E		N
	80.013259		6.696423
PURPOSE	Bridge		
OPERATION	in use

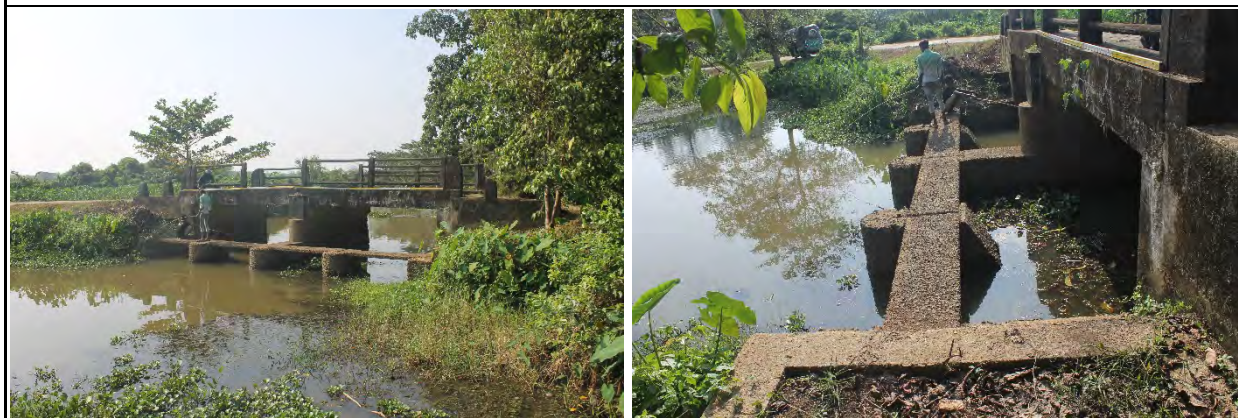
SITE CONDITION

ID: PE-5	JICA 2003 M/P	SLDC 2017	2018 F/S
	Anicut at 8+973		
COORDINATE	E		N
	80.013288		6.696342
PURPOSE	Anicut		
OPERATION	in use

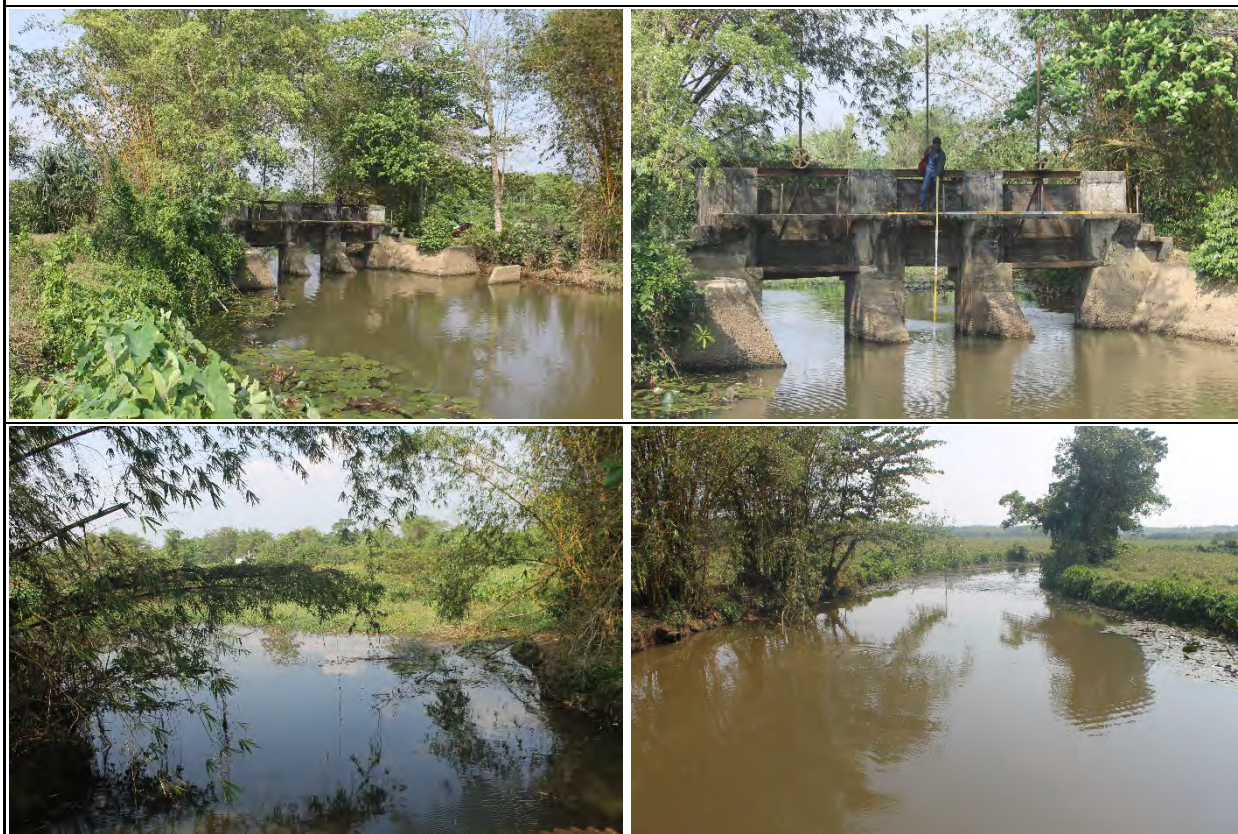
SITE CONDITION

ID: PE-6	JICA 2003 M/P	SLDLC 2017	2018 F/S
	Anicut at 7+832		
COORDINATE	E		N
	80.019878		6.696448
PURPOSE	Anicut		
OPERATION	in use

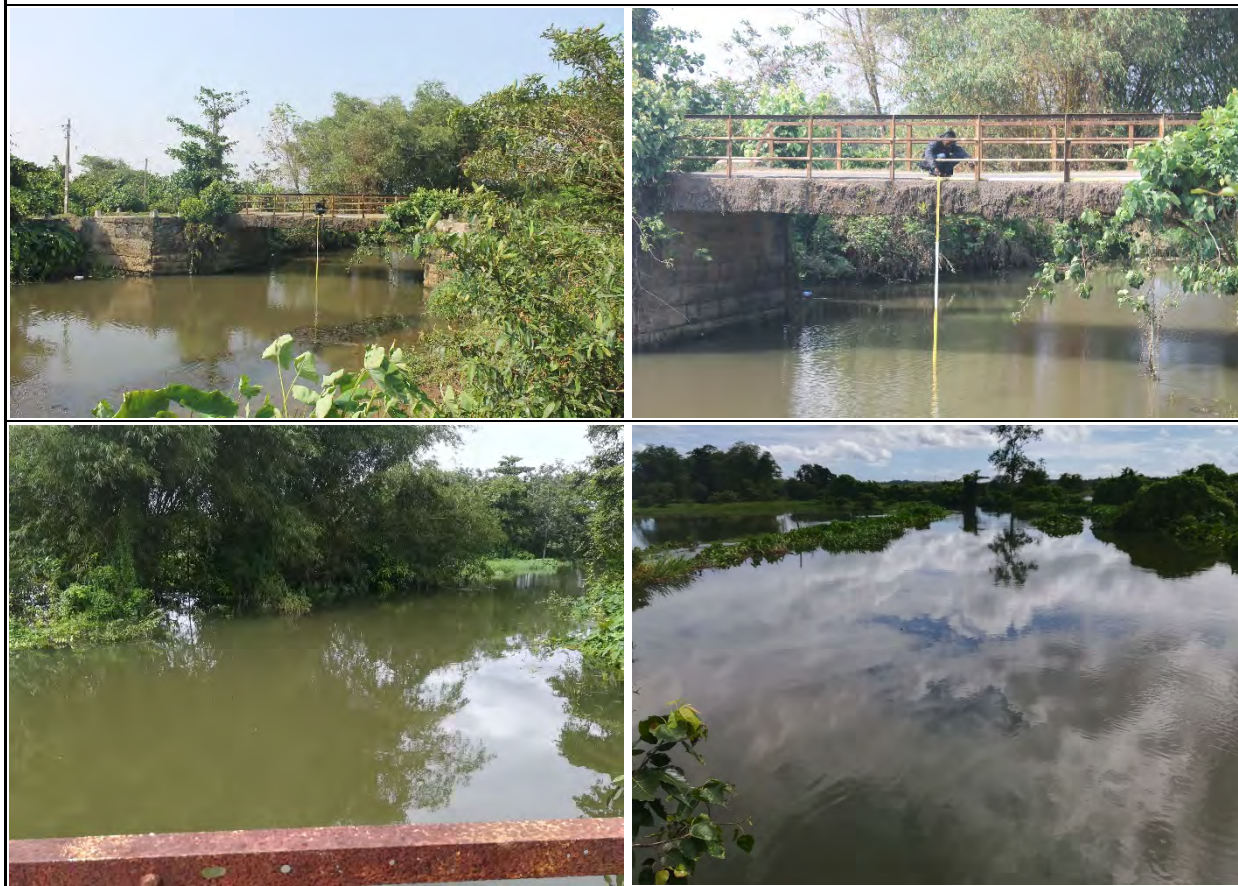
SITE CONDITION

ID: PE-7	JICA 2003 M/P	SLDC 2017	2018 F/S
	Bridge at 7+642		
COORDINATE	E		N
	80.020022		6.697967
PURPOSE	Bridge		
OPERATION	in use

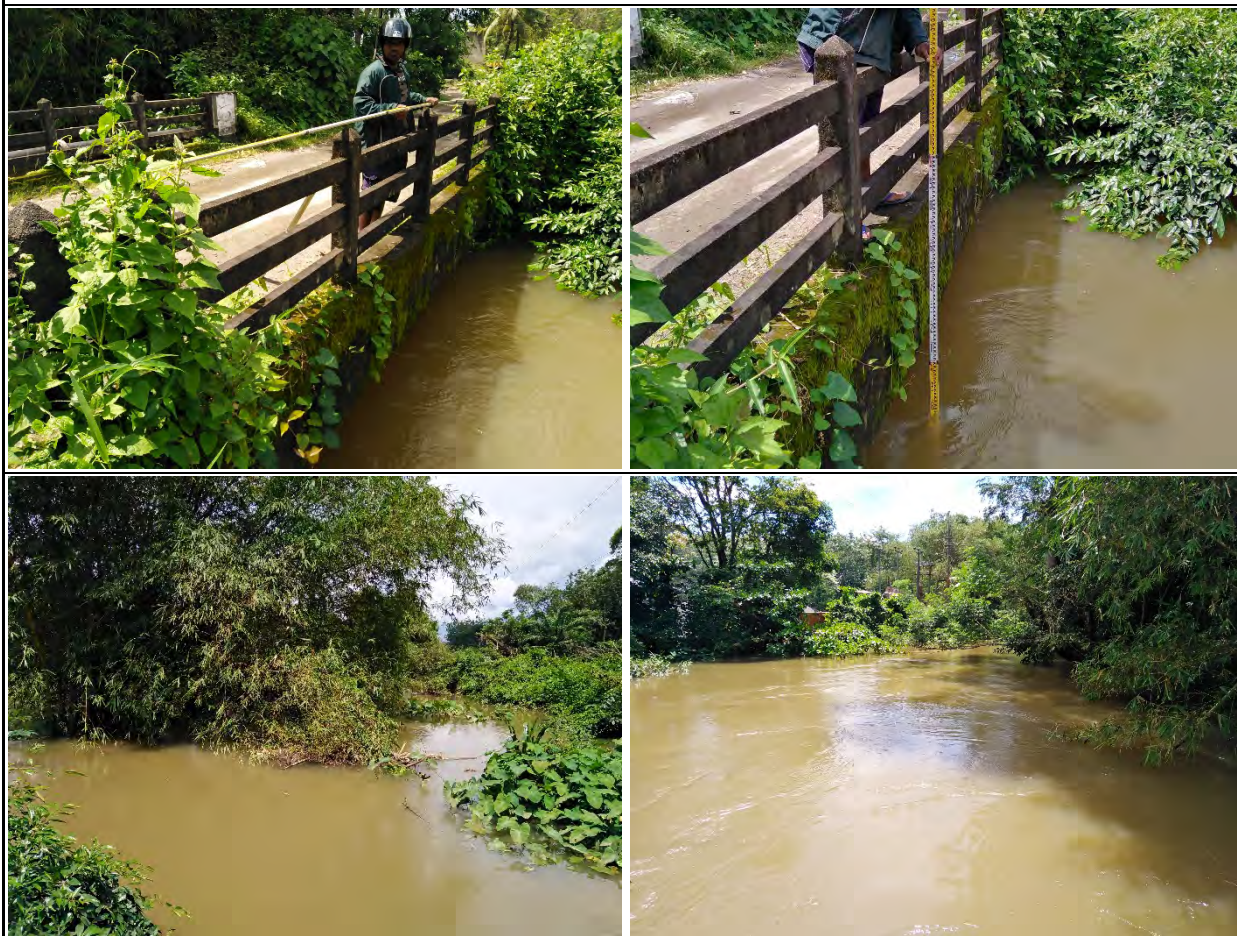
SITE CONDITION

ID: PE-8	JICA 2003 M/P	SLDC 2017	2018 F/S
	Bridge at 4+703		
COORDINATE	E		N
	80.028162		6.710860
PURPOSE	Gate for flood control		
OPERATION	in use

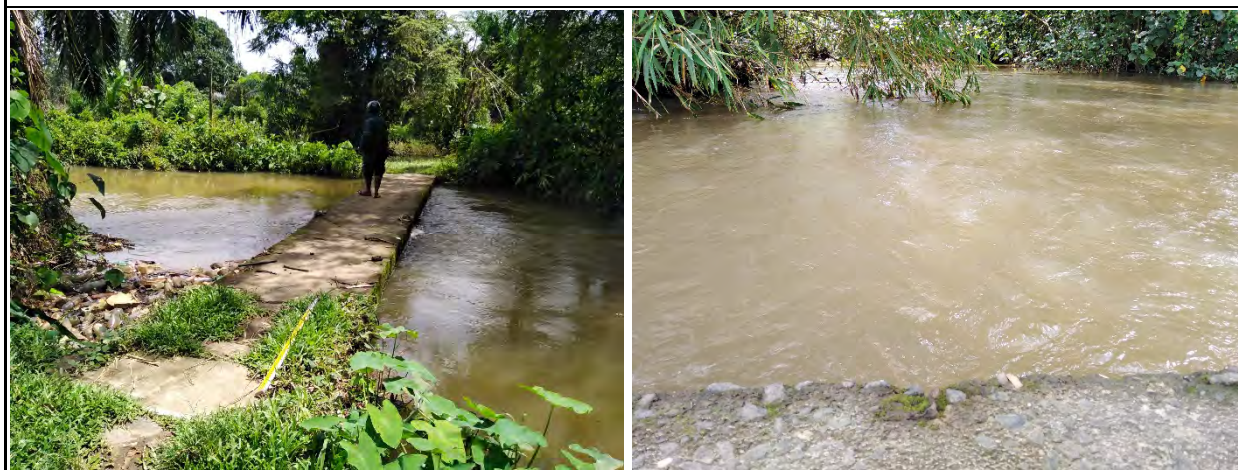
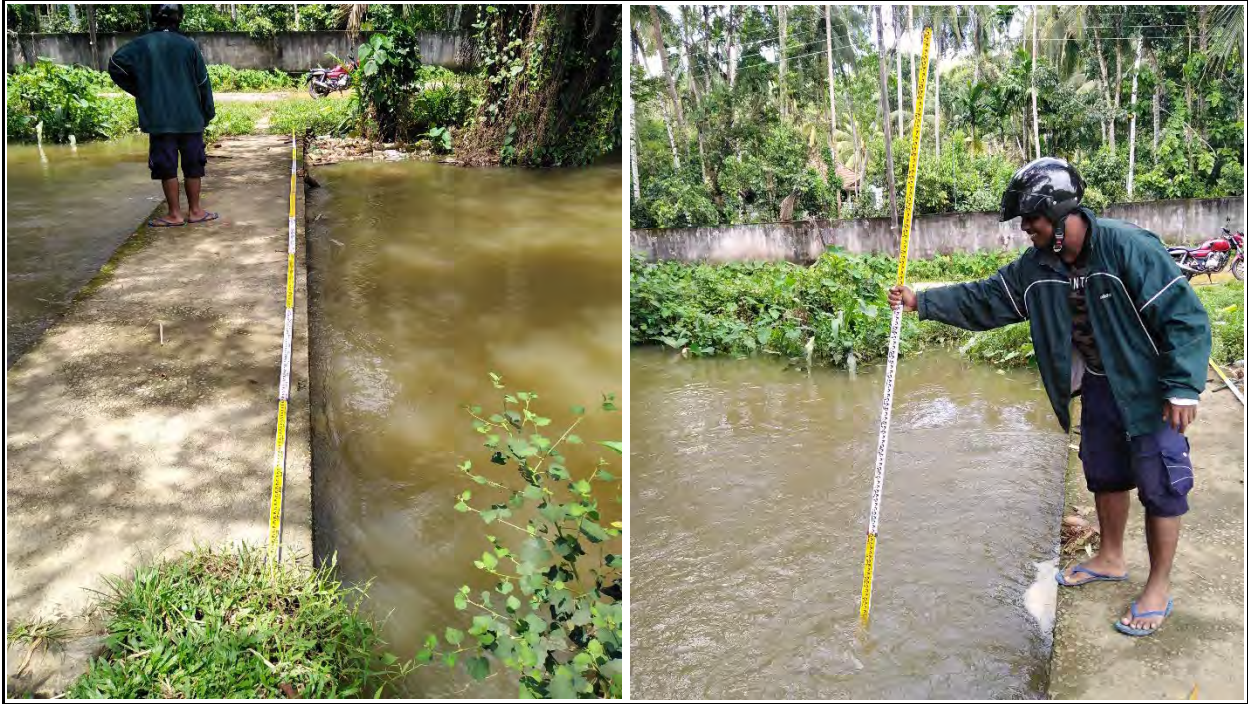
SITE CONDITION

ID: PE-9	JICA 2003 M/P	SLDC 2017	2018 F/S
	Bridge at 4+517		
COORDINATE	E		N
	80.029251		6.711812
PURPOSE	Bridge		
OPERATION	in use

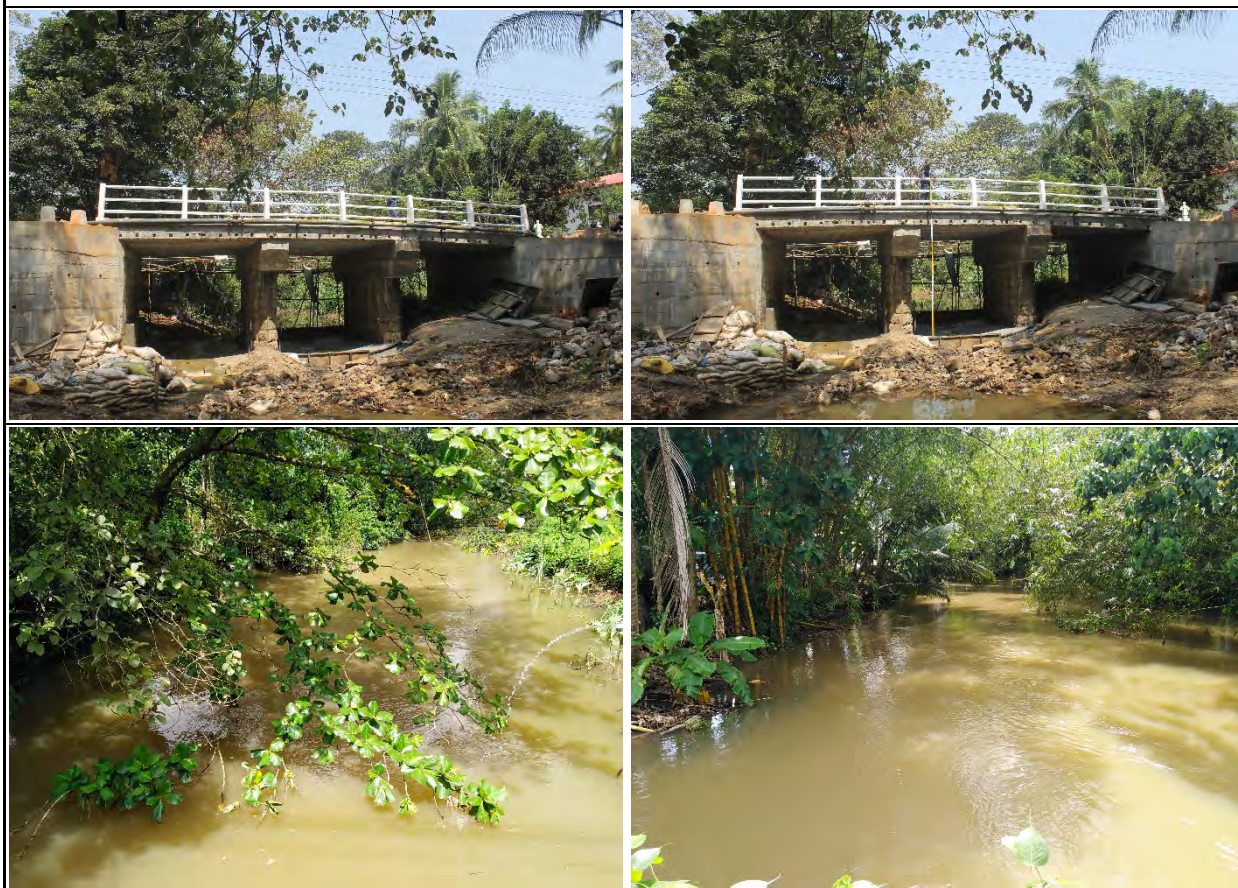
SITE CONDITION

ID: PE-11	JICA 2003 M/P	SLDLC 2017	2018 F/S
	Bridge at 3+336		
COORDINATE	E		N
	80.038105		6.712908
PURPOSE	Bridge		
OPERATION	in use

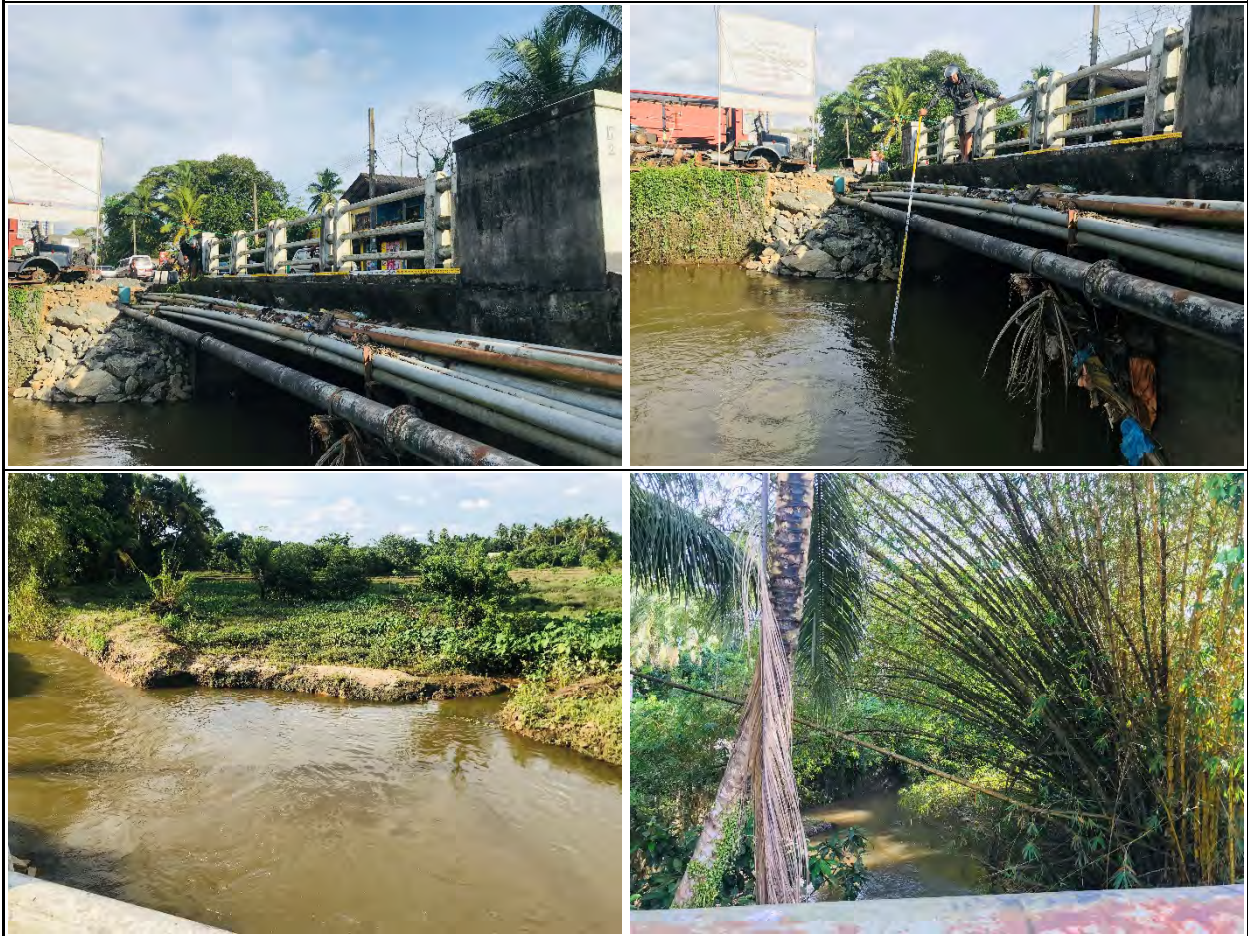
SITE CONDITION

ID: PE-12	JICA 2003 M/P	SLDC 2017	2018 F/S
	Bridge at 2+028		
COORDINATE	E		N
	80.043017		6.721354
PURPOSE	Bridge		
OPERATION	in use

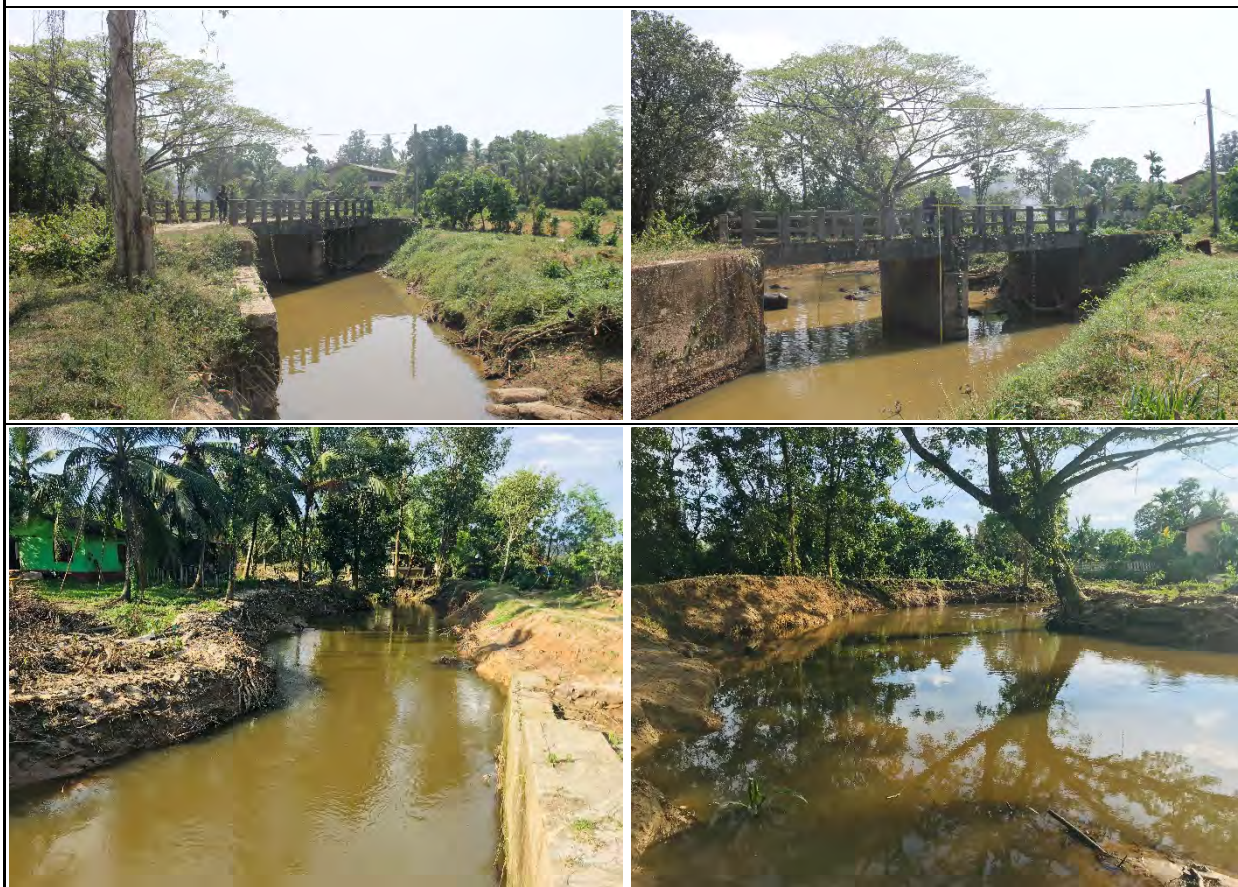
SITE CONDITION

ID: PE-13	JICA 2003 M/P	SLDC 2017	2018 F/S
	Bridge at 1+592		
COORDINATE	E		N
	80.042169		6.724555
PURPOSE	Gate for flood control		
OPERATION	in use

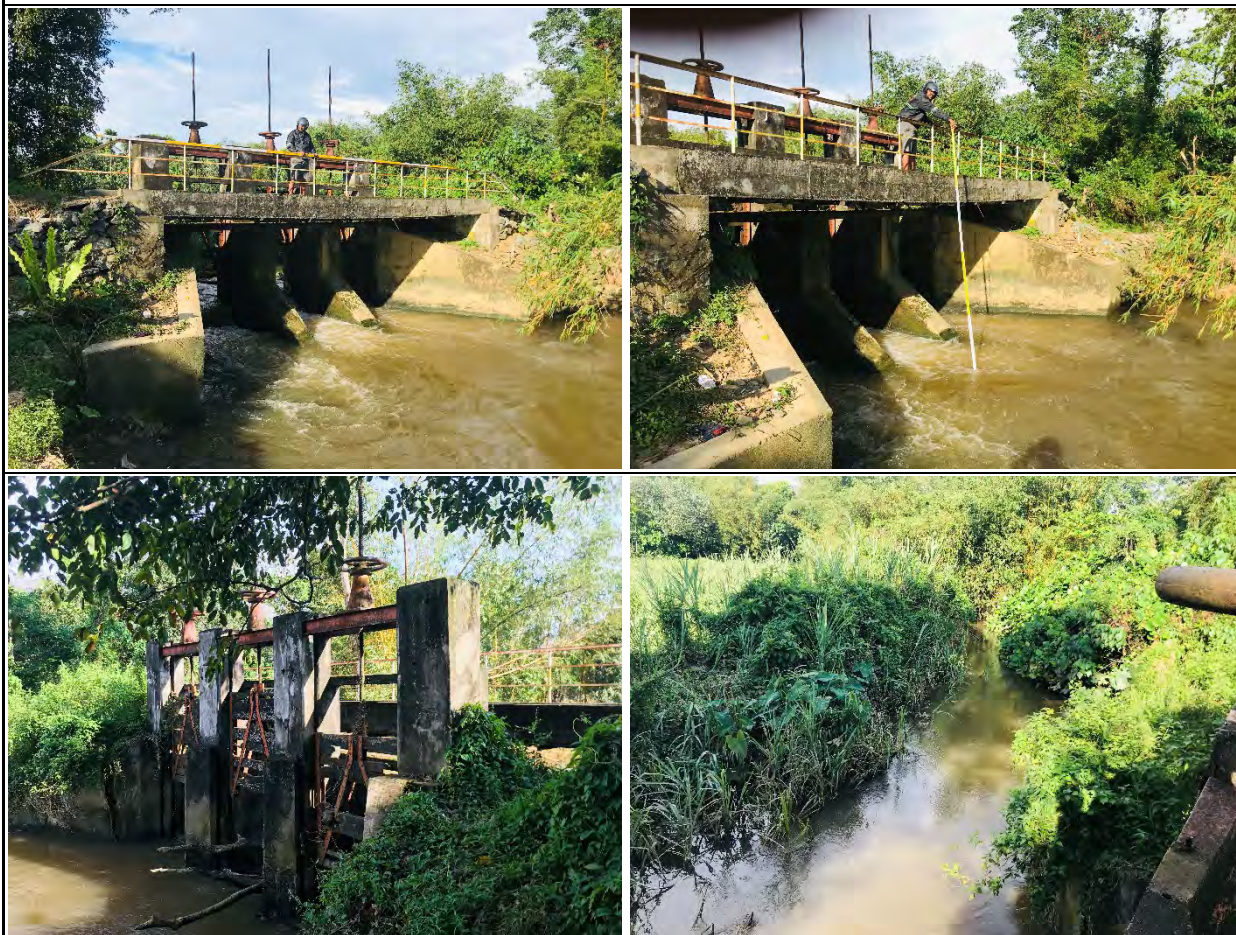
SITE CONDITION

ID: PE-14	JICA 2003 M/P	SLDC 2017	2018 F/S
	Anicut at 1+307		
COORDINATE	E		N
	80.042080		6.726638
PURPOSE	Anicut		
OPERATION	in use

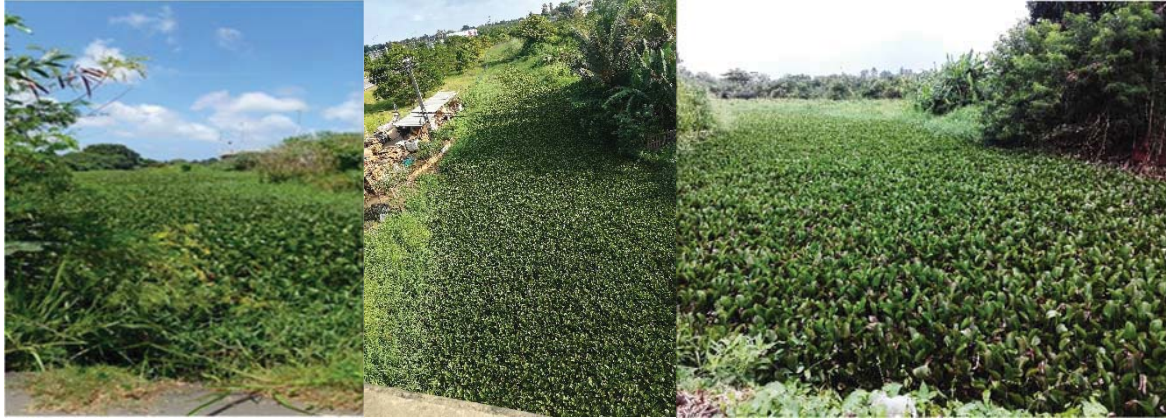
Major land-uses in the Mudun Ela catchment are urban built-up areas, marshy lands, and bare lands. During the field visit it was observed that large extents of the canal sections are silted and become part of the marsh covered with marshy vegetation such as *Eichhornia*, commonly called **water hyacinth** (Photo 1-1).

Photo 1-1: The canal sections covered with vegetation

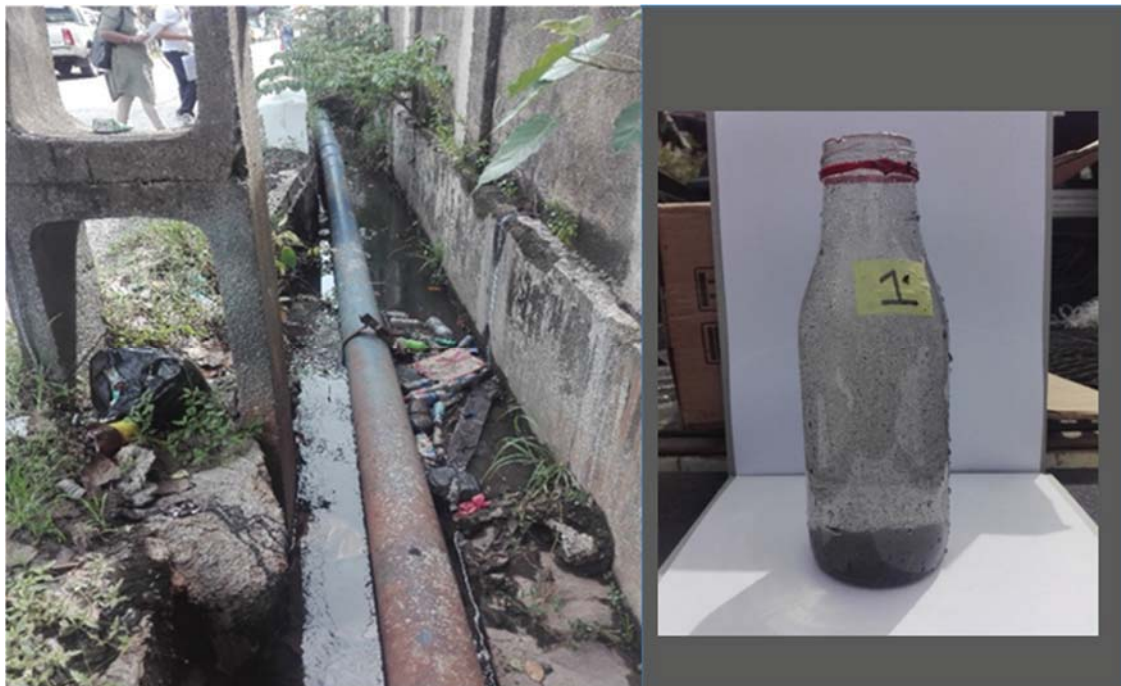
Colored effluents were observed in the Telawala road canal network presumably released from textile factories. The residents who live on the sides of the canal confirmed frequent flow of colored effluents, foamy wastewater, discharges with kerosene oil and acid fume smell. Further, at location 1 (Figure 1-8) near the entry point of the Telawala road from the Galle Road, the canal water smelled sewage and H₂S. Some residents informed of septic tank overflow during heavy storms. The black color surface sediments collected from sampling locations (location 3 Figure 1-10) suggest possible high organic pollution, and low oxygen levels of the canal water. High BOD levels, Fecal pollution, low

Figure 1-8: Location -1: Telawala Road canal
Stagnant canal water with litter, floating scums and oils; A water sample collected from the Telawala

canal at location 1. The water appears turbid, light straw color and smelled sewage and H₂S, Canal sediment is soft & black in color suggesting impaired water quality
