3.3.8 Madiwela South Diversion

3.3.9 Bolgoda Canal

Appendix-3

Baseline Environmental and Social Conditions of Project Area
(Mudun Ela Drainage Improvement Project)

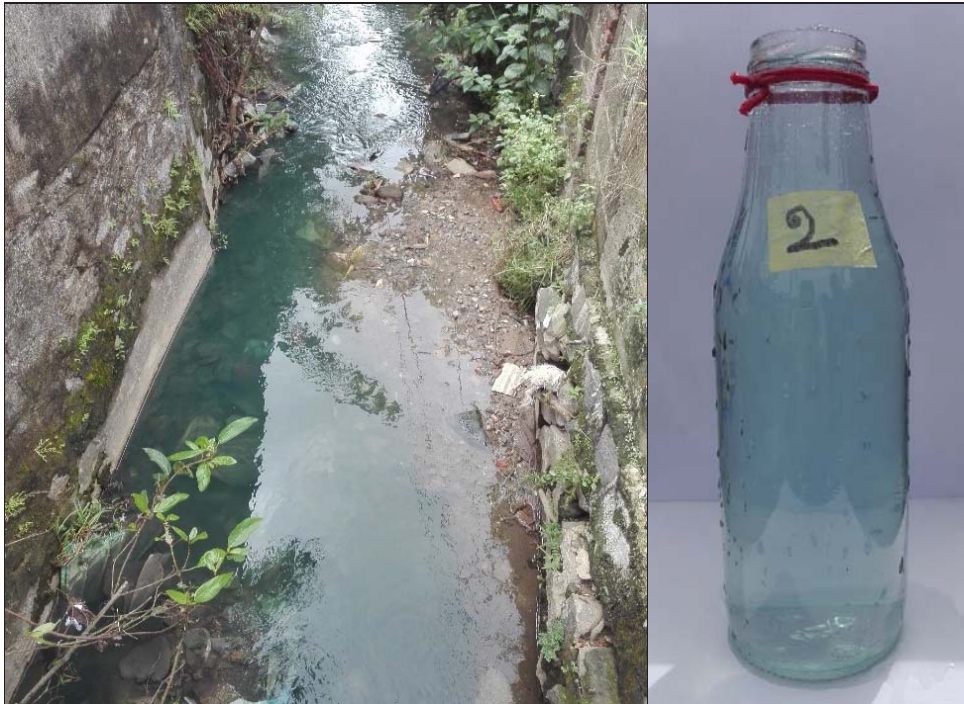
Figure 1-9: Location-2: Telawala canal

The drain carrying green color murky effluent presumably discharged from a textile dyeing factory, Green colored sample of water collected from location 2

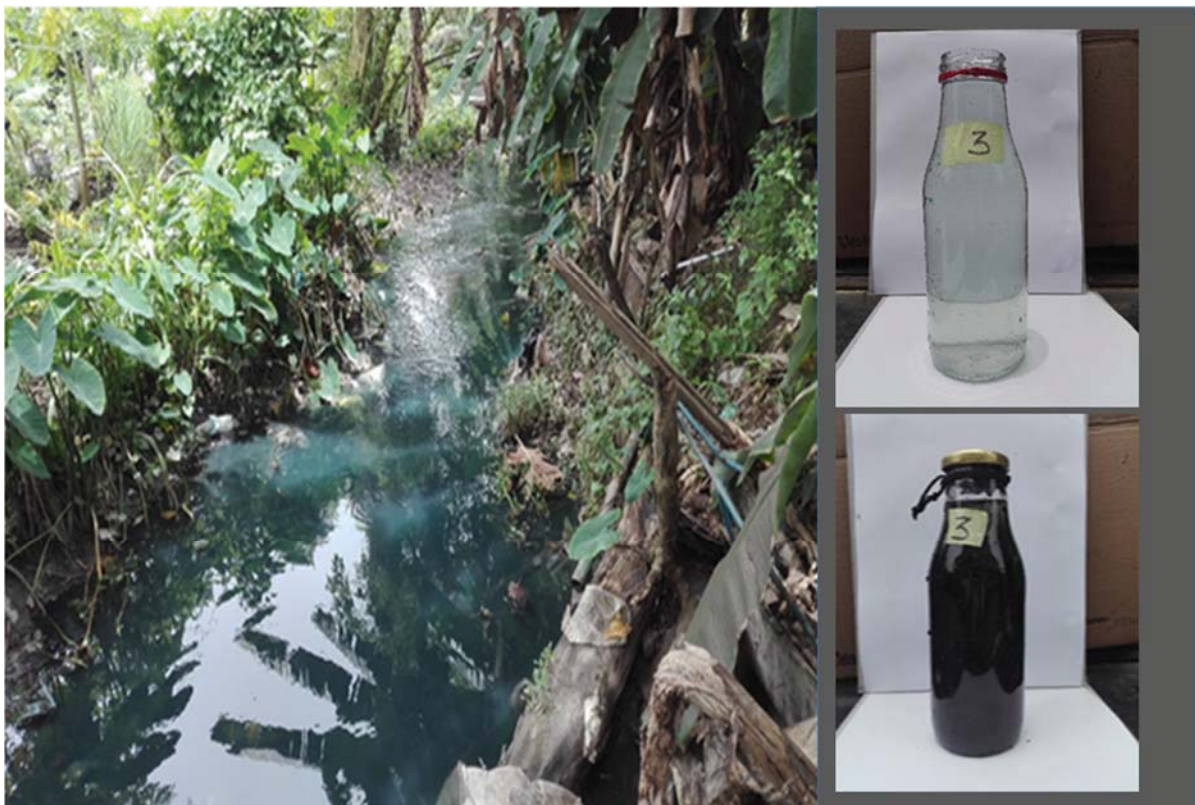
Figure 1-10: Location 3: Telawala canal further downstream

Unlined earth drain carrying colored effluent possibly discharged from a textile dyeing factory; The blue

A grab sample of sediment at location no 03 (Figure 1-10) was collected and tested for heavy metals, Chromium, Cadmium, Lead, Arsenic, Copper. Table 1-9 present the Concentration of tested heavy metals in dry sediment. As Sri Lanka does not have sediment quality guidelines for ambient water bodies the results were compared with Canadian Sediment quality Guidelines for protection of aquatic
