### 日本人制限域における調査報告書

# **SLOPE FAILURE ANALYSIS ALONG THE MAJOR ROADS NETWORK IN NORTHERN PAKISTAN**

Kokusai Kogyo Co., Ltd, Tokyo, Japan

Dr. Muhammad Basharat  
Dr. Muhammad Shafique  
Mr. Yasir Sarfraz  
Mr. Sajid Ali

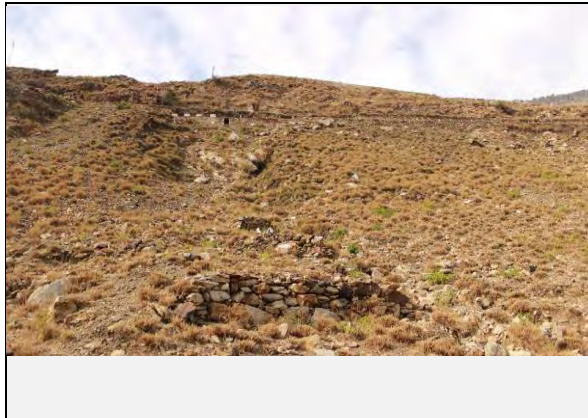
Full view of the landslide

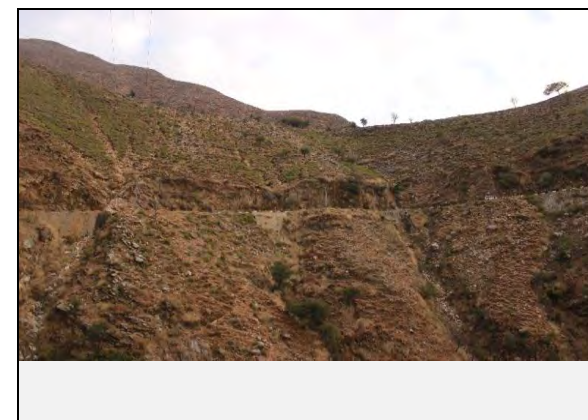
Close View of slope failure

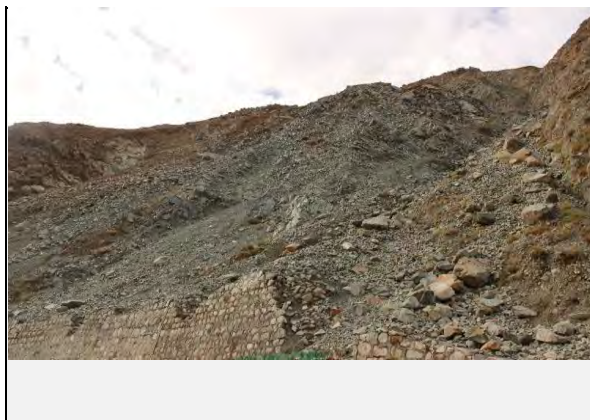
Full view of the landslide

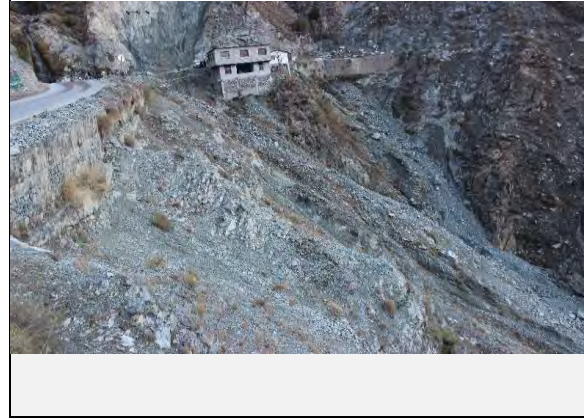
View of landslide on Valley side:

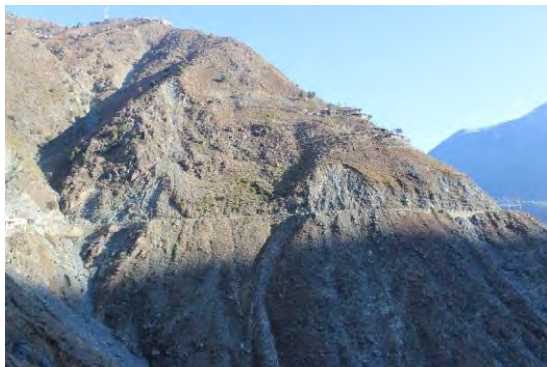
Full view of the landslide

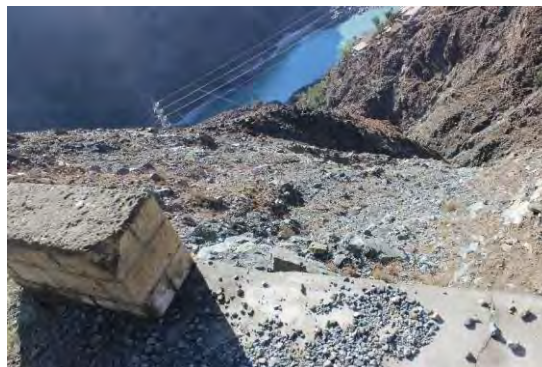
View of landslide on Valley side:

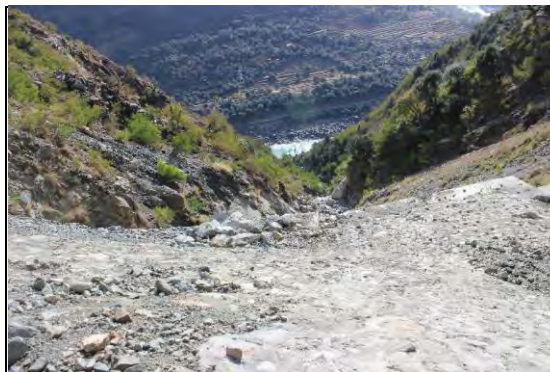
Valley side view of the debris flow

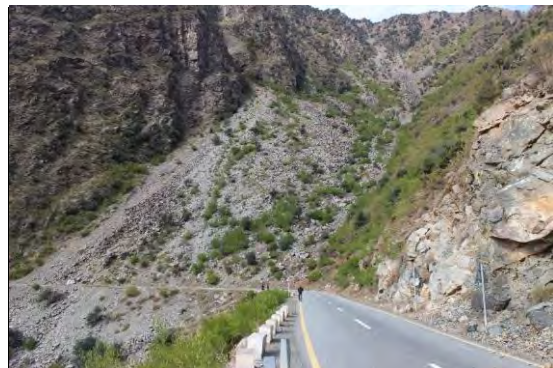
Full view of the landslide

This is a deep seated multiple rotations landslide. The main body of the landslide is consolidated with presence of grasses, however, the left and right flanks of the landslide is activated mainly due to the road cutting. The debris of the slide is mainly comprised of boulder, gravels, silt and sand. Active erosion on the slide debris leads to development of well-developed gullies. Hanging boulder are also present in the debris that pose threats to the road and traffic. The slide is mainly activated during the rainy season and the loose debris can also leads to debris flow. Despite the continuous damages of the road and disruption of the traffic due to falling debris and rocks, not mitigation measures are adopted to stabilize the slide. A retaining wall is constructed to protect the road, however, it is also buried by the falling debris. A house is located on the ridge of the slide. Tension cracks and open joint are present on the slide. Talus is present on the upper and lower side of the road. Slide is void of any thick vegetation.

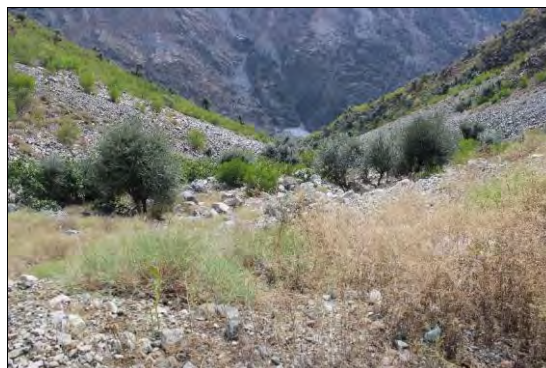
View of landslide on Valley side:

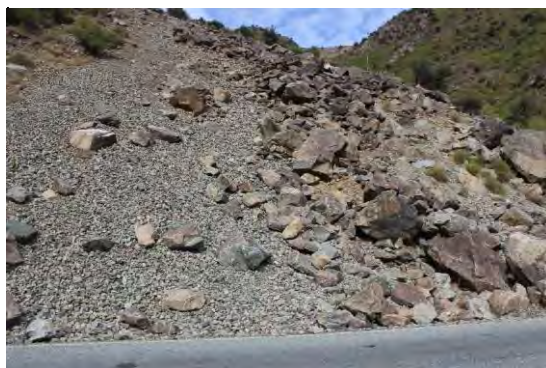
Existing countermeasures / anomalies: No counter measures

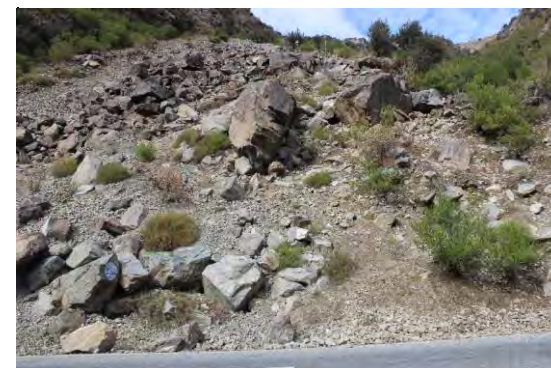
View of fallen blocks

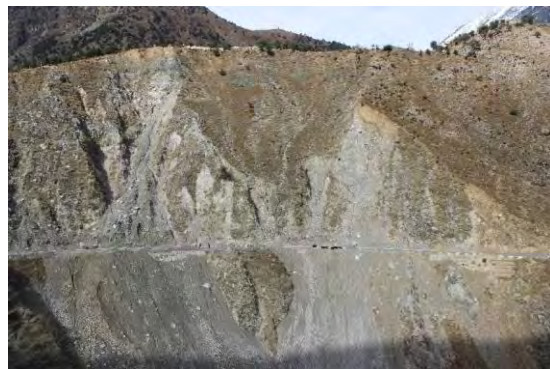
Full view of the landslide

This is a complex landslide comprising of rock fall, debris flow and slope failure. Active erosion on the loose material leads to development of deep gullies that often leads to debris flow during rainy season. The exposed bed rock on the left flank of the slide has detached, fractured and jointed boulders that are prone to rock fall and therefore posing threats to the road and traffic. Three roads are passing through the slide at different heights. However, no mitigation measures are constructed to stabilize the slide. A retaining wall is constructed on the valley side of all the three roads. Tension cracks were present on the slide and it is void of thick vegetation. Talus is present above and below the road.

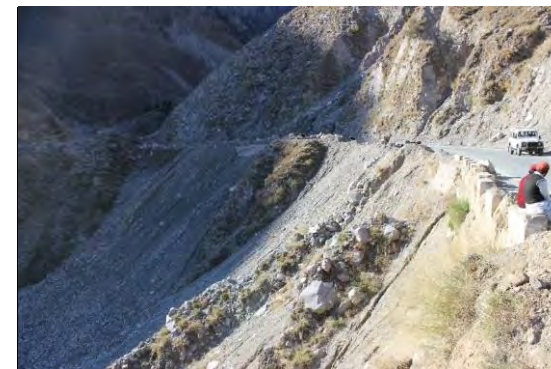
View of fallen blocks

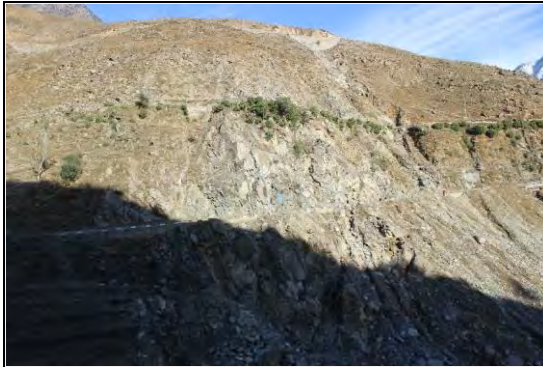
Full view of the landslide

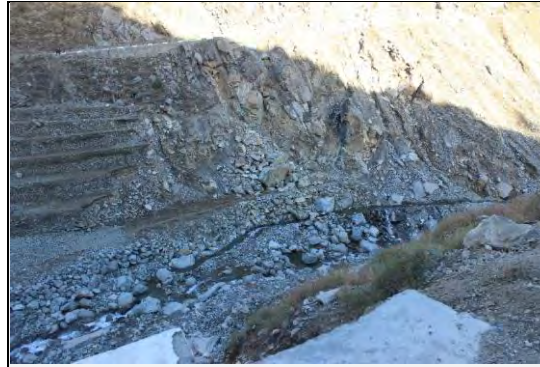
View of landslide on Valley side:

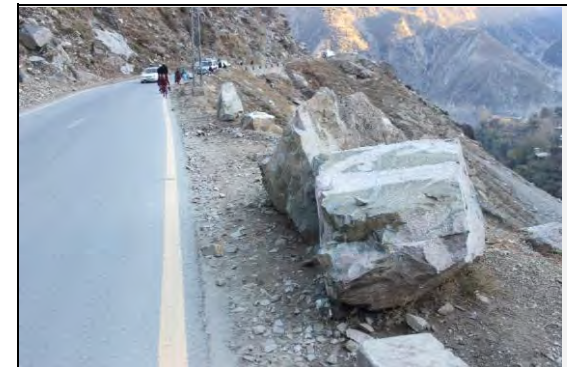
View of fallen blocks on road

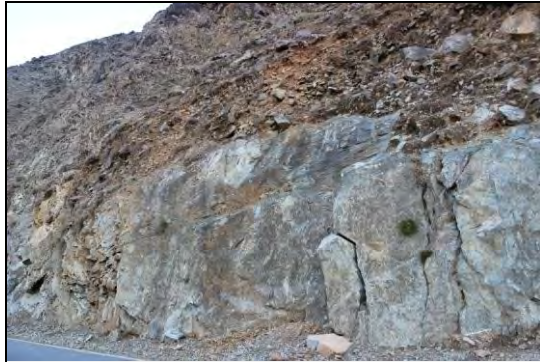
Full view of the landslide

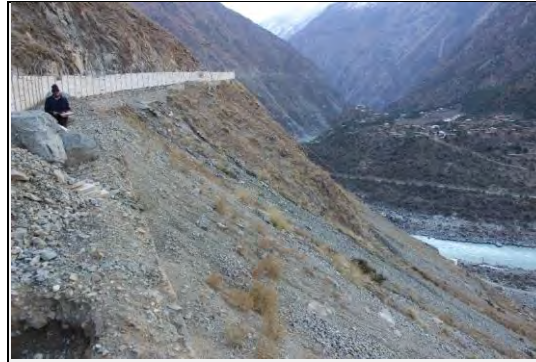
View of landslide on Valley side:

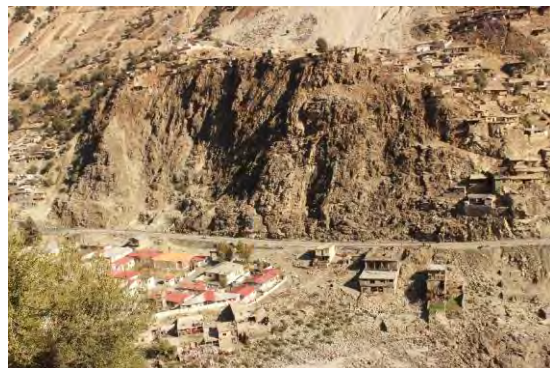
Full view of the landslide

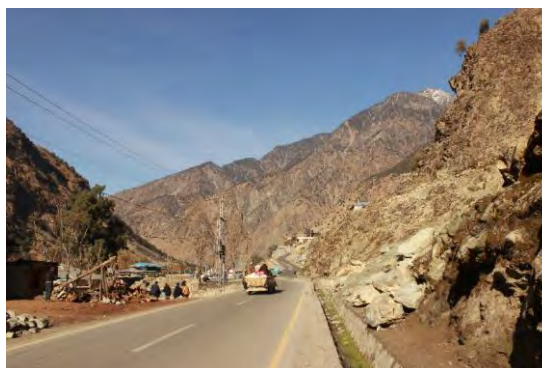
View of landslide on Valley side:

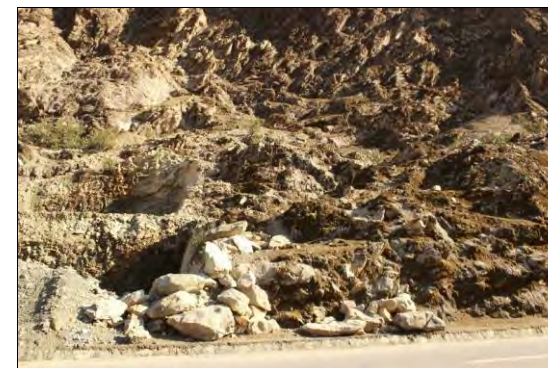
View of fallen blocks

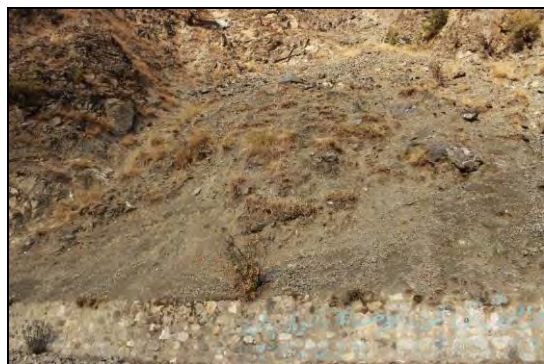
Full view of the landslide

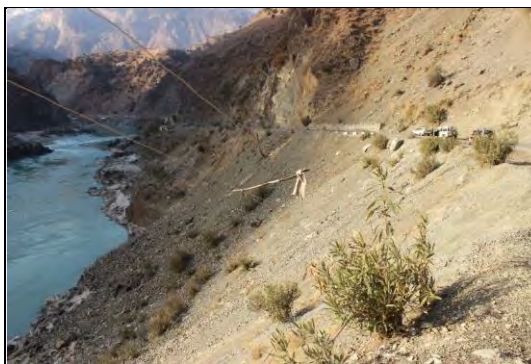
View of landslide on Valley side:

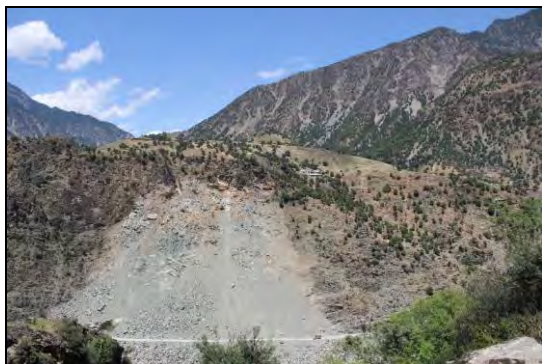
The site (Chochang) has a history of road blockade in past. It is a historical landslide, which is reactivated many times. Initially it was rockfall but now it is slope failure in debris/talus deposit. Deposit comprises of some boulders of size >6 m3.

Full view of the landslide

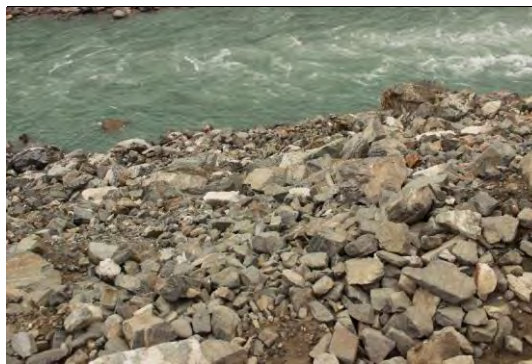
View of landslide on Valley side:

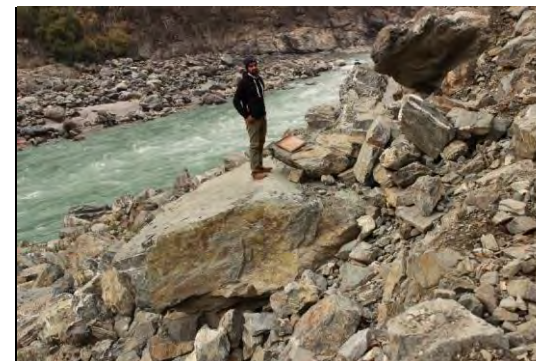
View of fallen block

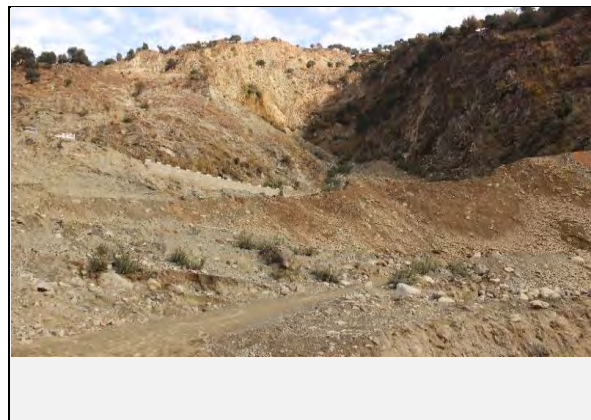
Full view of the landslide

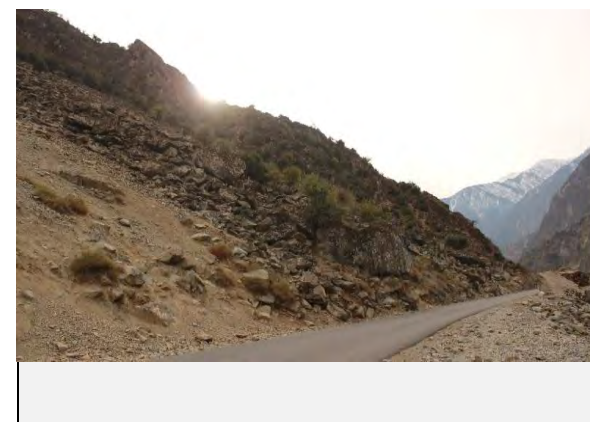
View of fallen blocks

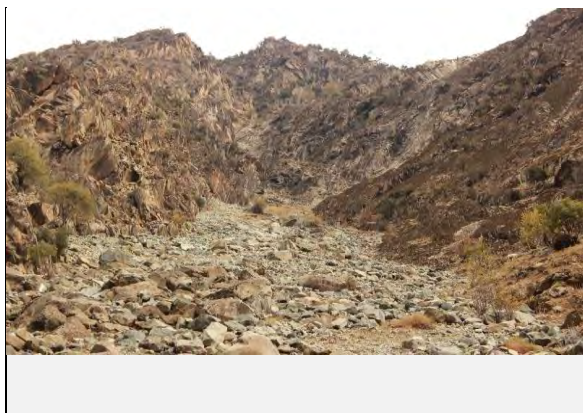
Full view of the landslide

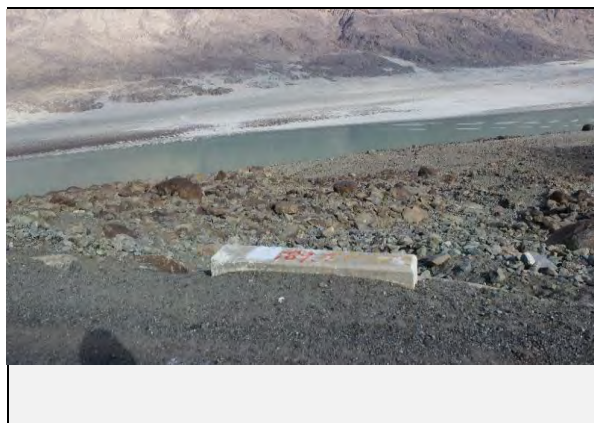
Valley side view of the debris flow

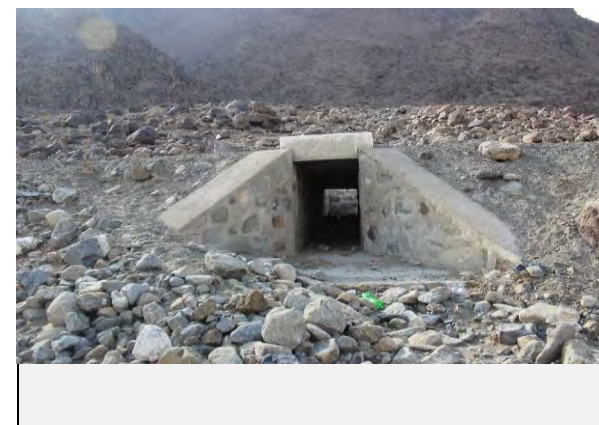
Existing countermeasures / anomalies: Culvert outlet view

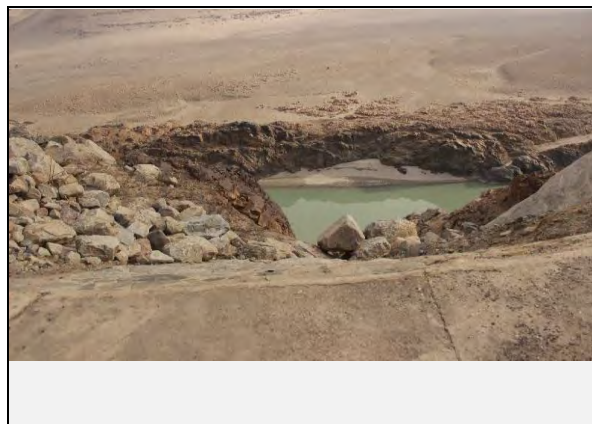
Valley side view of the debris flow
