Islamic Republic of Pakistan  
The Ministry of Communications, National Highway Authority (NHA)

# Data Collection Survey on Road Landslide Measures in Pakistan

## Final Report

January 2019

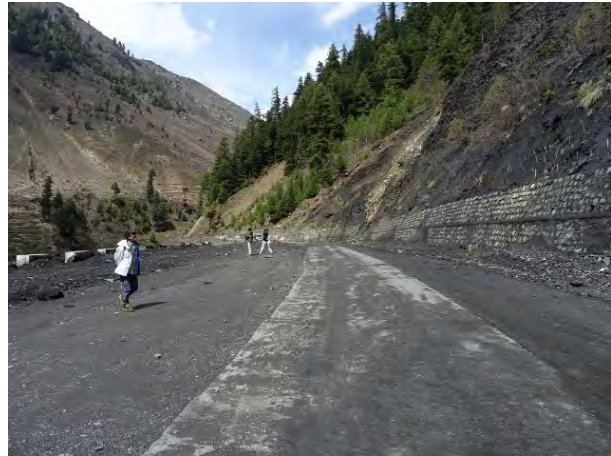
Photograph 8: Site survey of slope failure along N-15

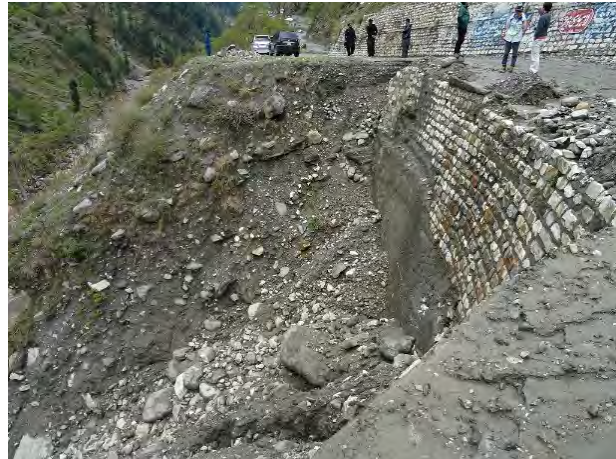
Photograph 10: Debris flow (N-15)

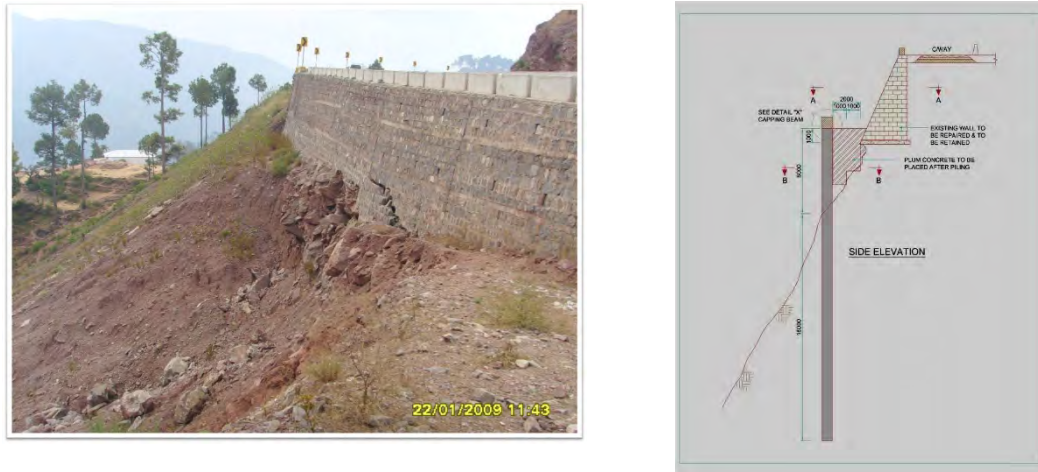
Figure 2.8 Road Landslide (Jan, 2009) and Countermeasure in N-75

In this section, large-scale landslides that occurred from 2009 to 2015 are summarized. These landslides motivated the NHA to think that countermeasures against landslides were necessary. After minor landslide disasters repeatedly occurred along N-75, Murree Maintenance Unit implemented several countermeasures, such as protection walls. However, those countermeasures did not function well and led to a large-scale landslide disaster. Figure 2.8 shows the landslide disaster and countermeasures carried out by the NHA in January 2009. Figure 2.9 shows the landslide disaster and a supplemental countermeasure application in 2015 at the same place.

As mentioned in Chapter 2.5, several countermeasure works were undertaken after a large disaster in 2009 (Figure 2.8) and 2015 (Figure 2.9) in N-75. The budget expenditure for the countermeasure at from 2014 to 2016 at these three sites was approximately Rs. 300 million. Although, the budget expenditure for the countermeasure works in 2009 is unknown, the total expenditure for the emergency countermeasure works at this site is likely to be approximately Rs. 600 million (estimating the same expenditure as 2014 to 2016 based on the drawings of Figure 2.8).

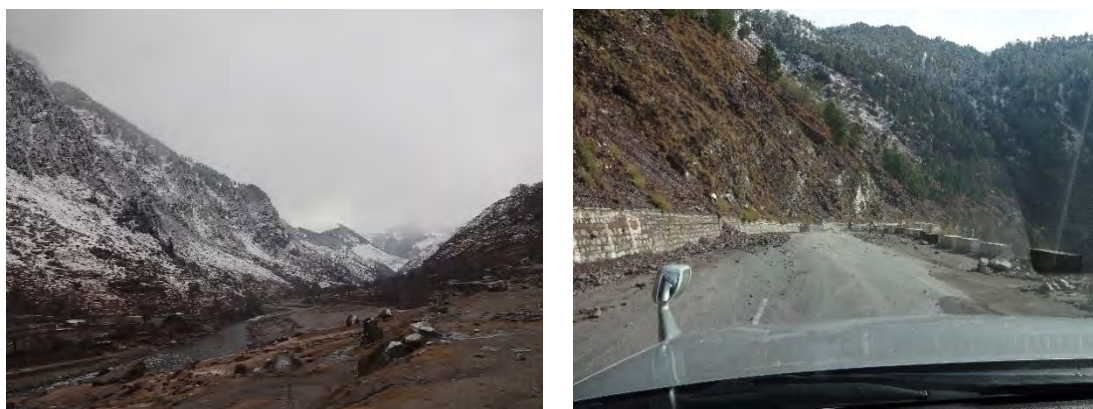
Figure 4.33 Road Situation of N15

As for the road, it is mostly constructed along the steep cut slope, which is prone to slope failures/rockfalls as the slopes have become unstable owing to weathering and erosion. In addition to the slope failures/rockfalls, the road has become prone to the debris flow during snow melting season (March to April) and rainy season (June to September), where the road could be closed for several days.

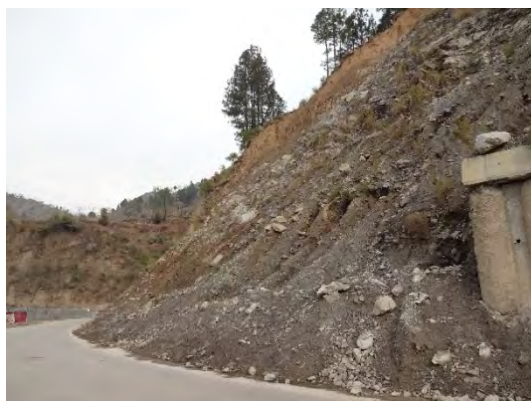
Surface collapse at N35\_1

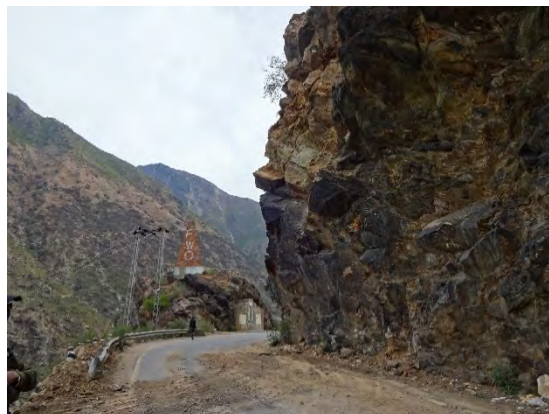
N35\_8: The site could not be identified during the topographic interpretation. The cracks were observed on the detached rock located on top of the road, which could fall at any time.

Rockfall at N35\_8

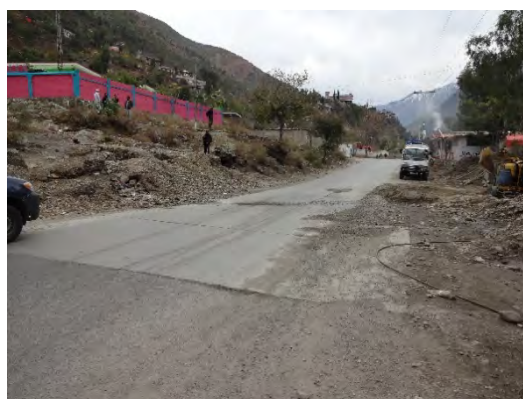
Exit of the stream (N35\_9)

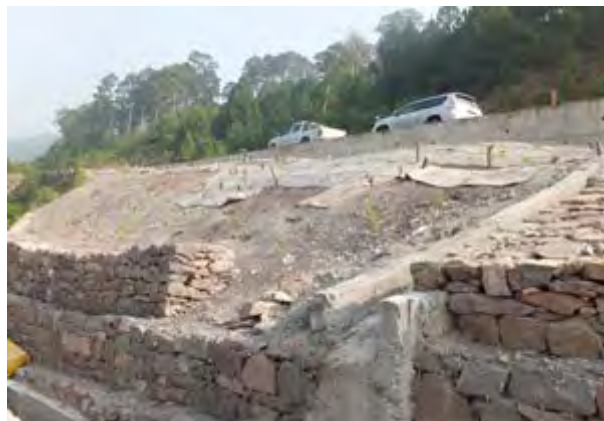
Figure 4.42 Masonry on the Valley side of N75 Source: JICA Survey Team

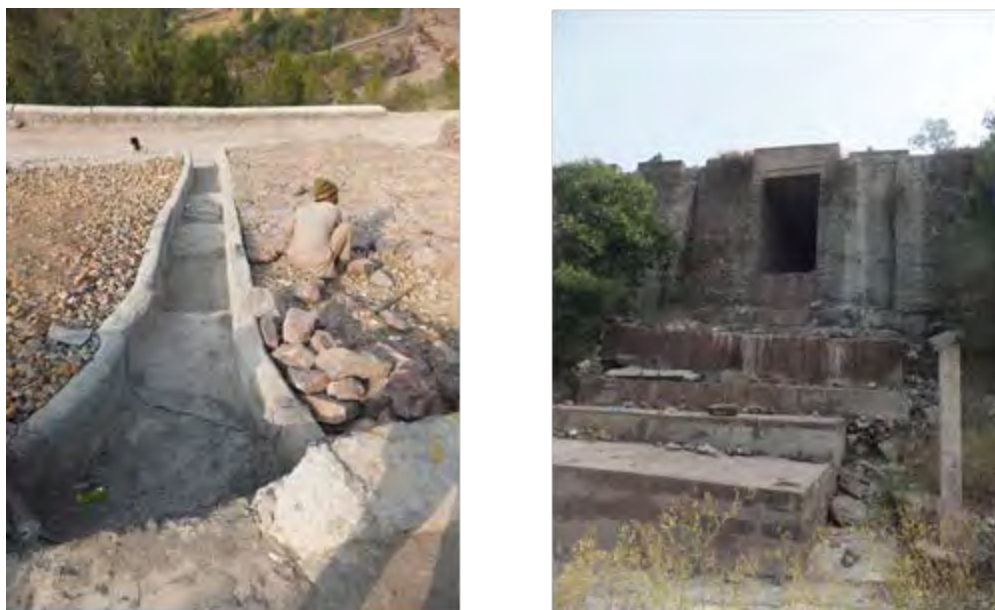
Figure 4.43 Surface Drainage on the Valley side (Left) and Box Culvert Crossing the Road (Right):  
Both functions are to Reduce Flow Speed Source: JICA Survey Team

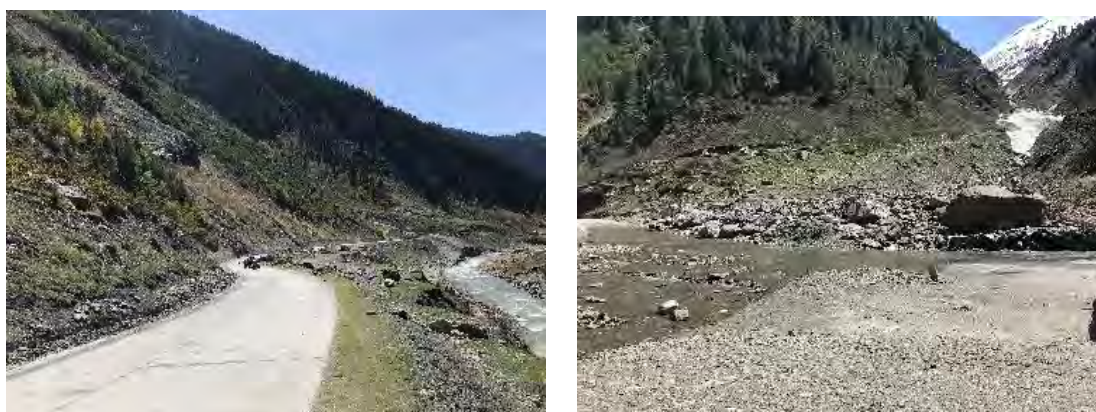
As for the treatment of the road surface (pavement), rigid roadbed (concrete pavement) is combined with asphalt pavement and reinforcement used within the concrete pavement does have enough thickness and density. The concrete pavement is used instead of box culvert, particularly at the road near the stream exit to endure the force of glacier melting. Concrete pavement is stronger than normal pavement and constructed with the lower gradient toward the valley side to invert the glacier on the road (taking adaptive measure at present).

Figure 4.44 Examples of Concrete Pavement (N15\_8) and Inverted Pavement to Minimize the  
Impact of Glacier (N15\_10) Source: JICA Survey Team

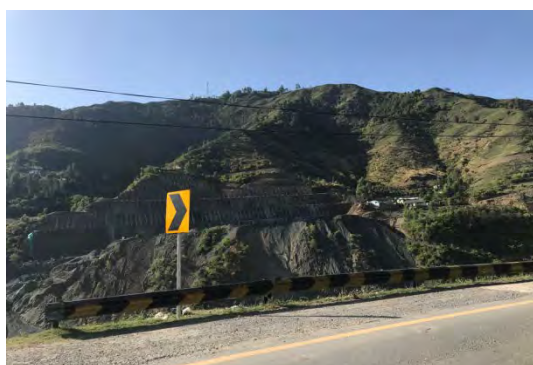
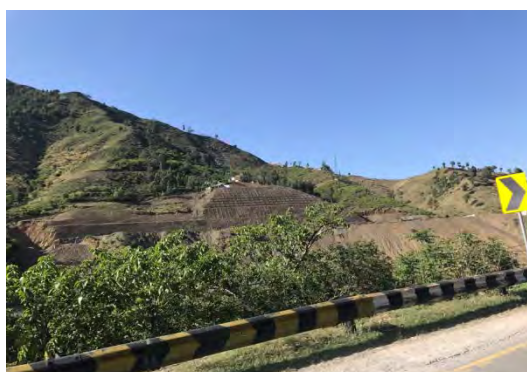
The road landslide countermeasure works carried out on CPEC (particularly along N35) include large-scale slope cutting, crib works, shotcrete, and others. At one of the construction sites managed by China Communication Construction Company Ltd. (CCCC) (CPEC, N35, Havelian section), the re-profiling of the cut slope was being conducted from the upper part, which was then followed by the crib works from the bottom of slope (normal lining method). This method can lead to the possibility of slope failure during the construction if the slope angle is steep, if there is a large/long slope, or if there is an unstable slope (remains of slope failure). Therefore, this slope stabilization method is limited in its applicability. Specifically, the application of this method is difficult at the slopes observed in N15, which are relatively large (length: more than 100 m, height more than 20 m), with much deposition of unstable soil (colluvium).

Figure 4.52 Situation of Slope Stabilization along N35 by Chinese Company (Between Havelian and Abbotabad) Source: JICA Survey Team

The inverted lining method (the series of work is undertaken stepwise when it has reached a certain height to avoid the slope failure) considers the safety of construction as the period of the cut slope being exposed is shorter than the other method and thus is recommended. Moreover, it can be applied at a steep angle slope and is environmentally friendly (less area of vegetation removal). Furthermore,

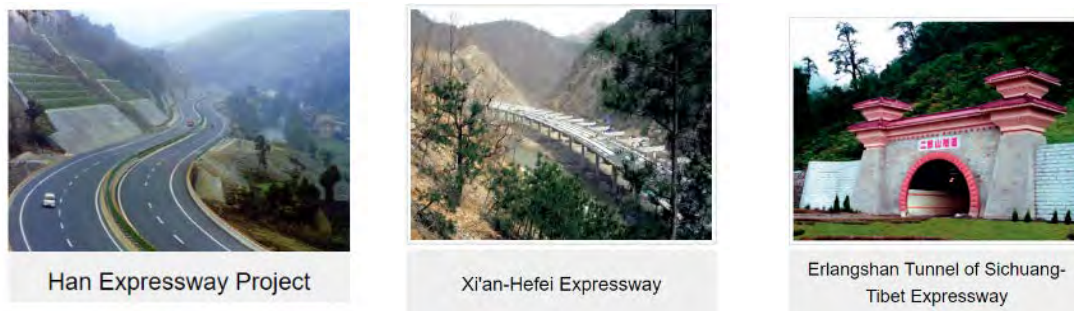
Figure 4.53 Situation of Road Landslide Countermeasure undertaken by China Communication Construction Company Ltd. Source: CCCC Webpage

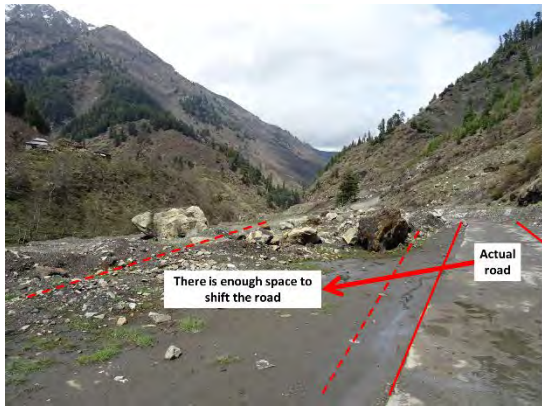
Figure 4.66 Road can be shifted toward the Valley Side because there is enough flat space (Example in N15\_8). It should be Noted that shifting the road does not mean the disaster can be avoided

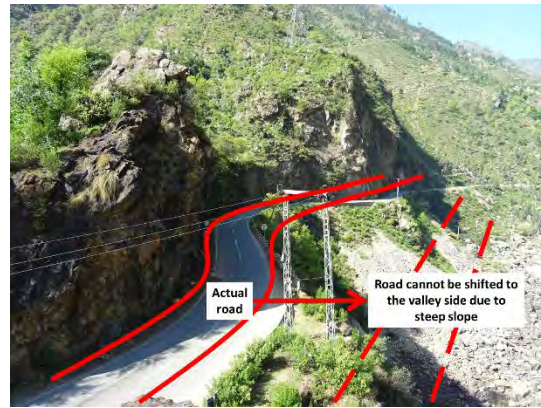
Figure 4.67 Road cannot be shifted toward the Valley Side because there is not enough flat space (Example in N35\_8)

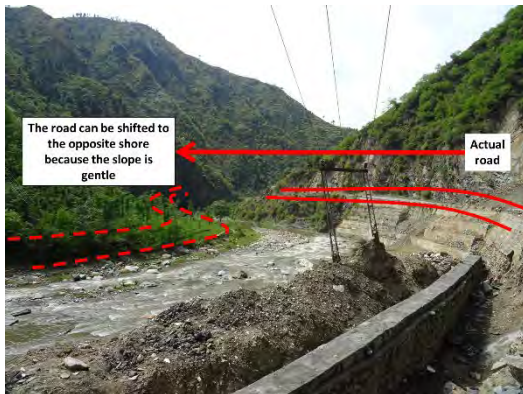
Figure 4.68 Similar Road can be Constructed in the Opposite Shore (Detouring is Possible by Construction of a Bridge) (Example in N35\_3)

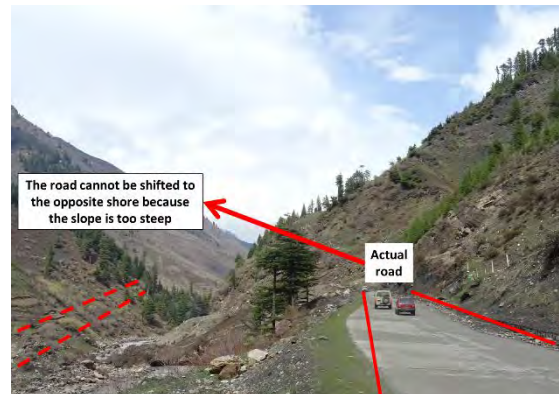
Figure 4.69 Similar Road cannot be Constructed in the Opposite Shore because the Slope is too Steep. (Detouring is not Possible by Construction of a Bridge) (Example in N15\_8)
