Appendix 2

Survey Result of Slope Chart

Code no.	N	1	5	-	1						
Region Office	Abbottabad										
Maintenance Unit	Balakot

Evaluation sheet (Slope failure/Rockfall)

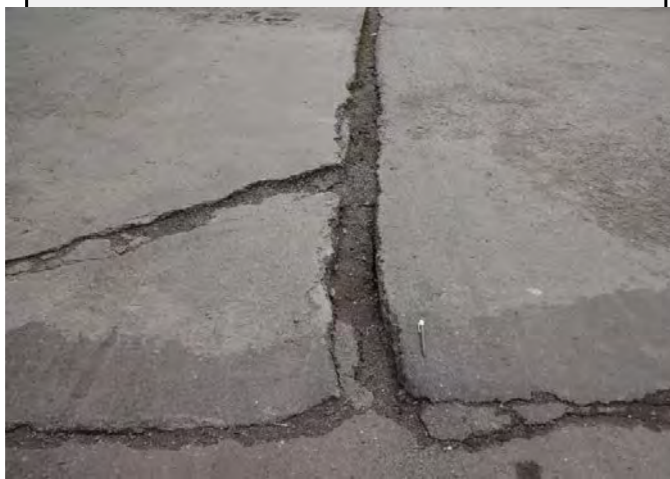
Existing anomalies: Cracks (20cm) was confirmed on the replaced portion of the road.

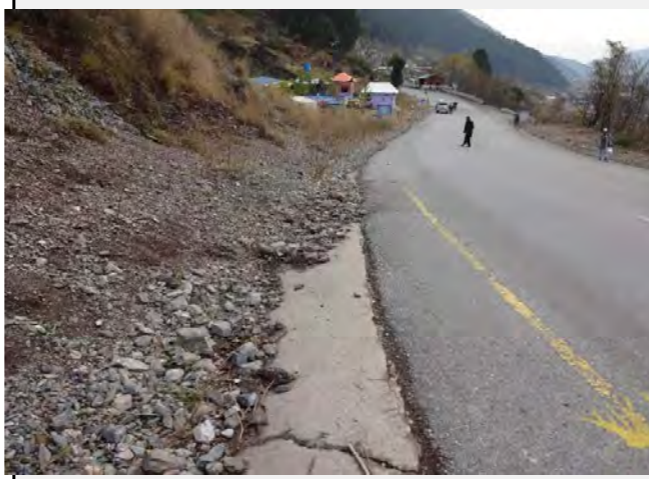
Existing countermeasures: The waterway is filled mostly by the talus.

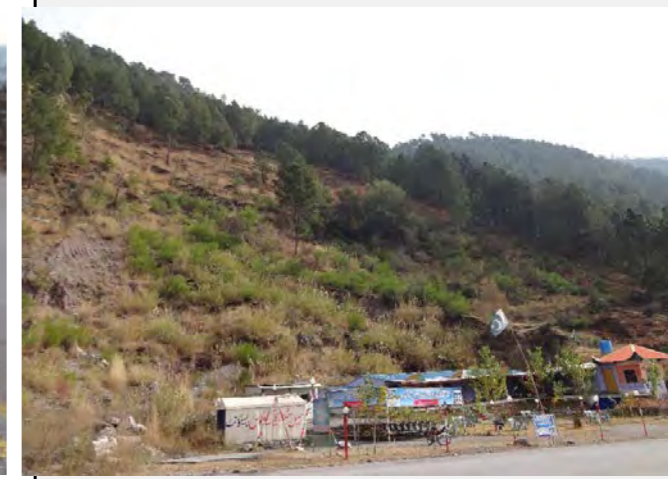
Others: A restaurant was constructed six months ago at the toe of the slope.

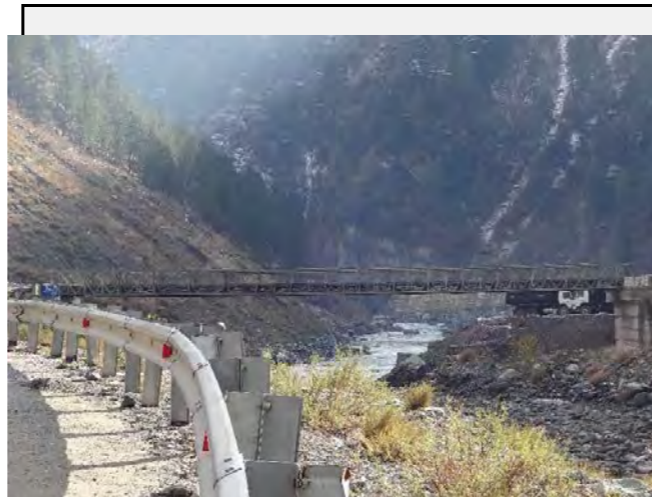
Existing countermeasures: Bailey bridge is used as temporary on the bypass road.

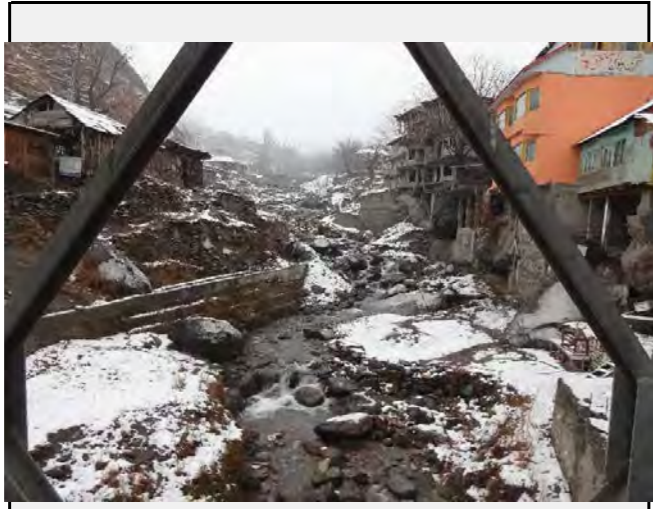
Mountain side: Boulders and debris deposited along the gentle angle of the stream.

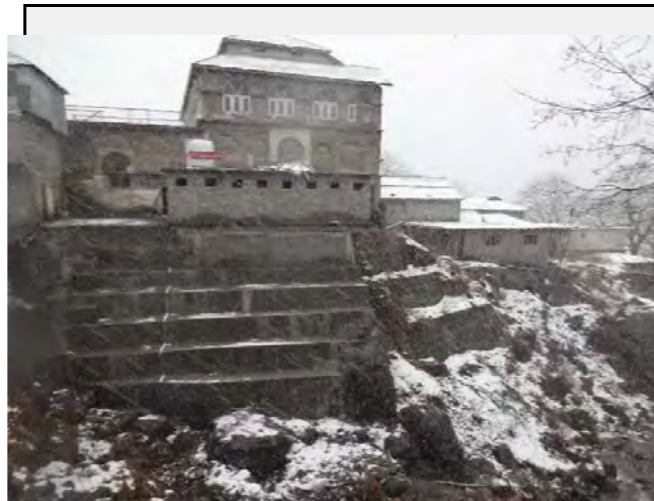
Existing countermeasures: Retaining wall is constructed on the both side of the bridge to protect the bank erosion.

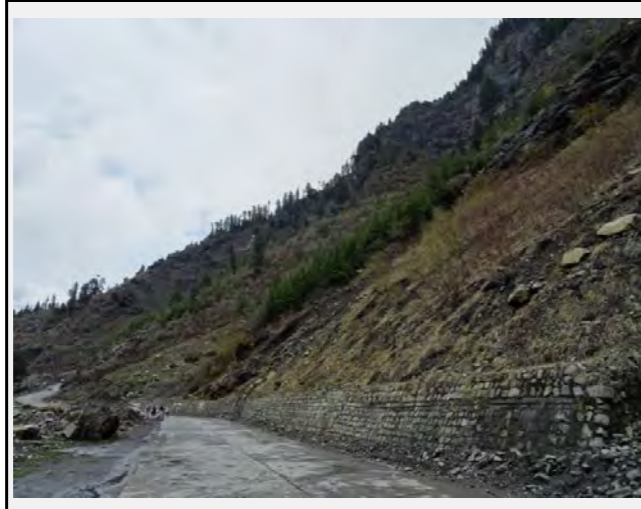
A vertical rock wall of approximately 250 m produces rock falls towards the road. The retaining wall has no effect as a countermeasure for rock falls

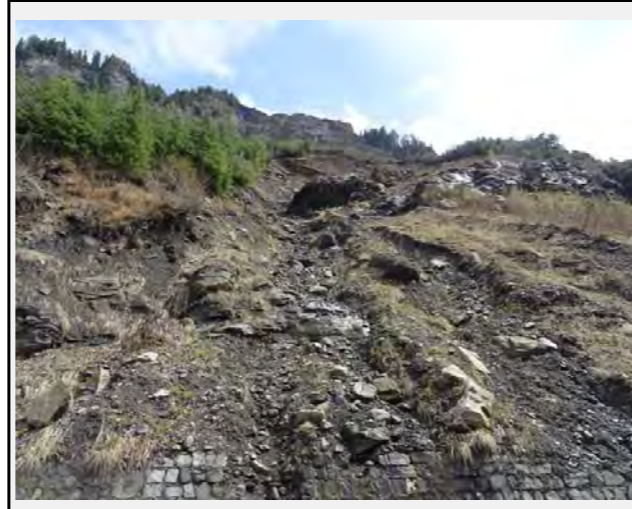
Fallen rocks that have not reached the road but may collapse and fall again can be identified throughout the slope

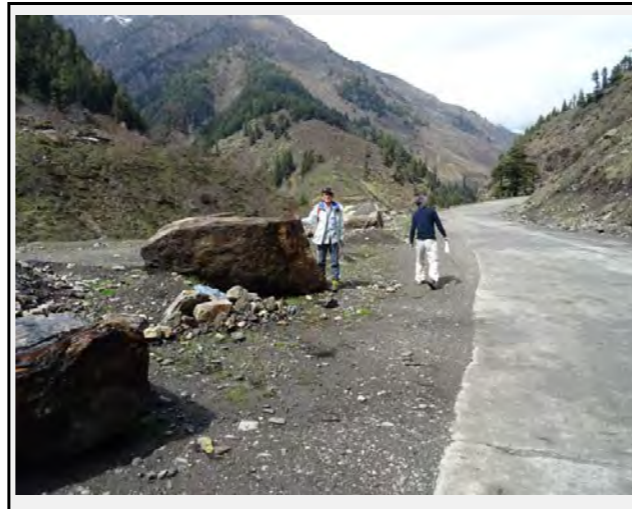
The biggest fallen rock identified (2m*1m*1m) has been pushed to the road side

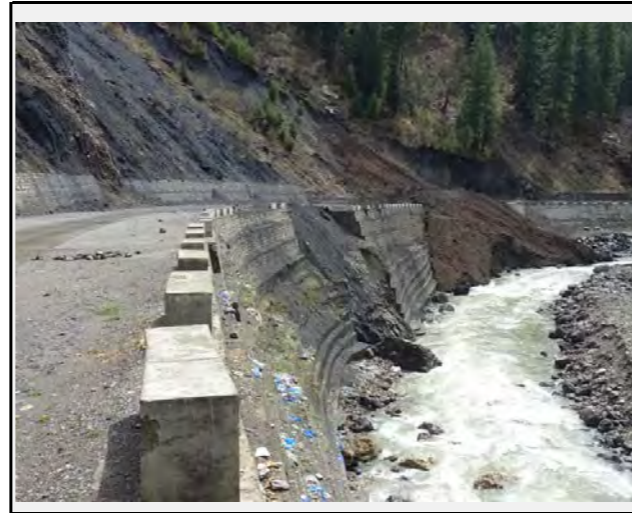
The valley side of the road is located in the outer curve of a river but it is protected by a concrete wall

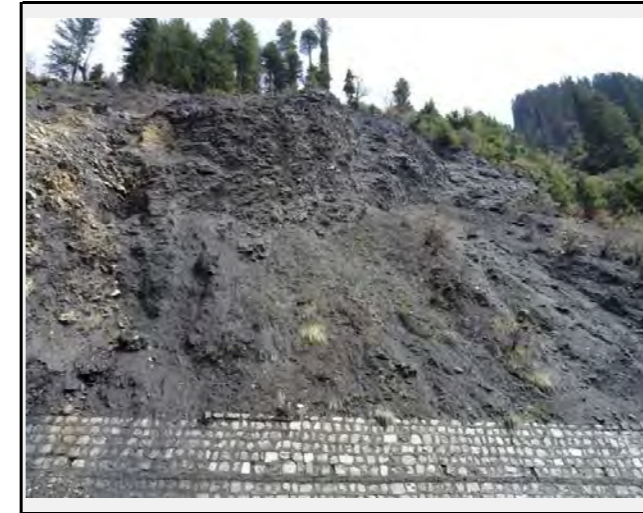
The debris and rocks detached from the highly weathered base rock surpass the retaining wall and fall on top of the road

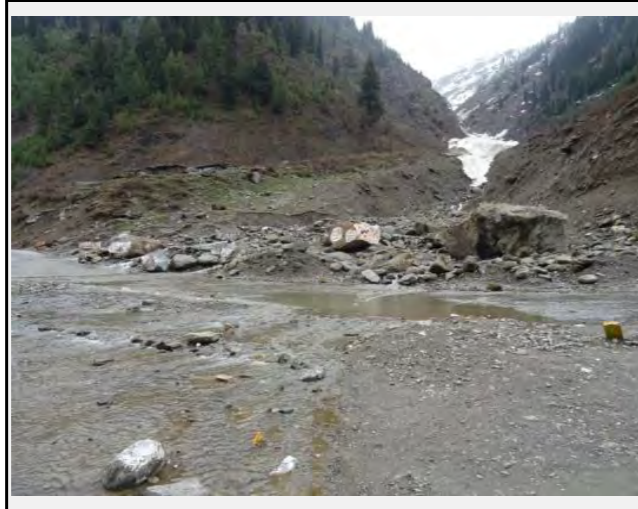
Overall view of the debris flow affecting the road

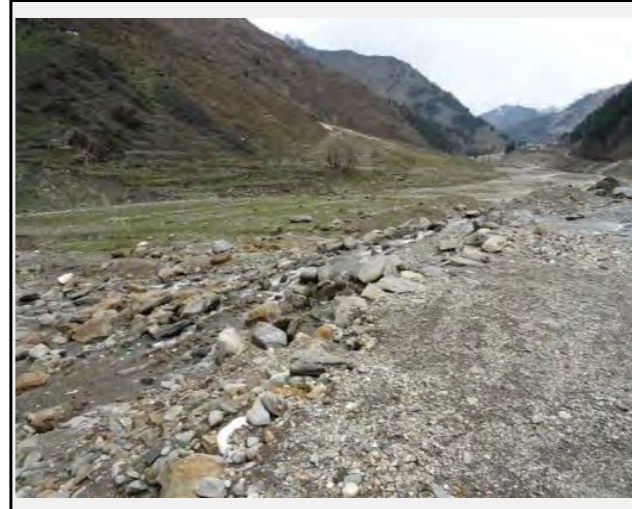
Valley side: debris flow deposits head towards the river. The geomorphology on which it lays is an alluvial fan

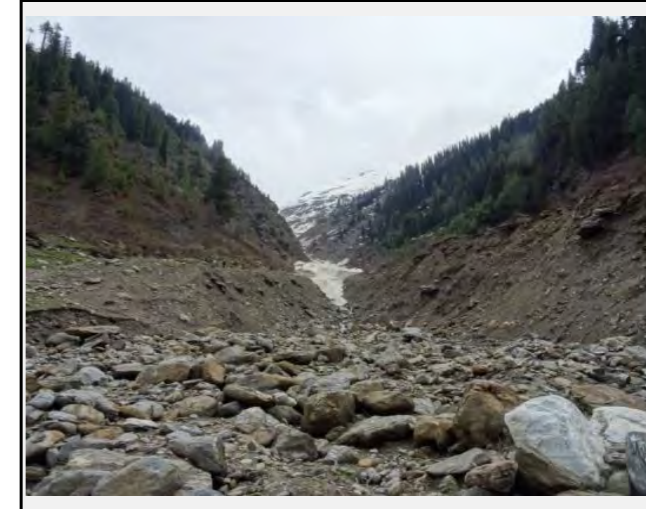
The mountainside of the road is full of debris flow deposits and a glacier can be seen at the end of the valley

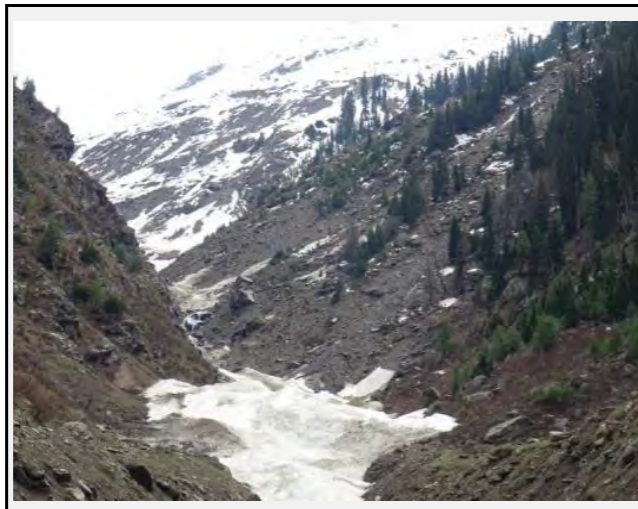
There is a big collapsed slope in the water catchment area

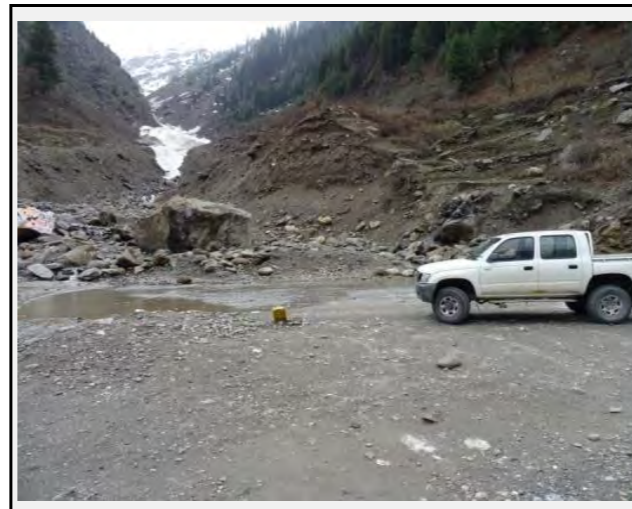
Big sized boulders (5m*8m*3m) can be seen on the stream bed. The Sides of the stream are completely bare and highly erodable

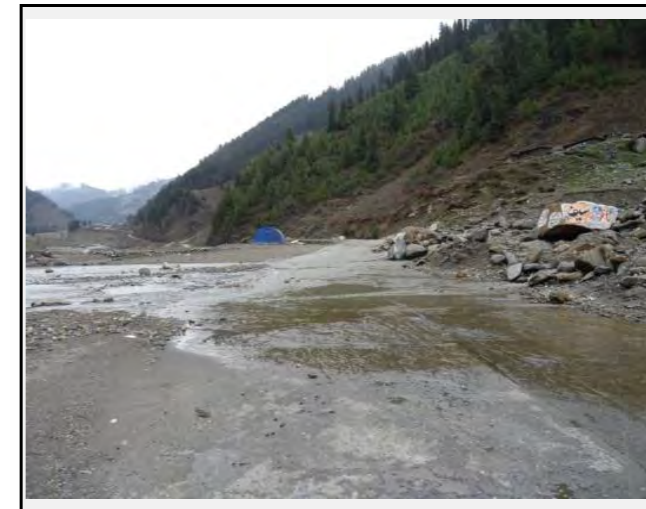
The road is flooded and partially covered by debris

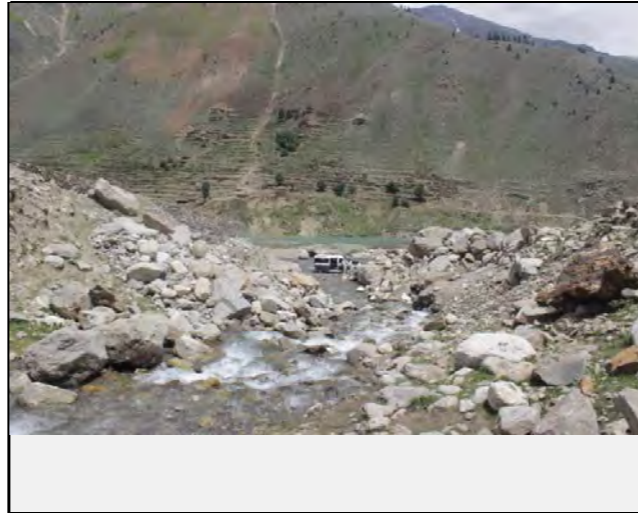
Valley side view of the debris flow

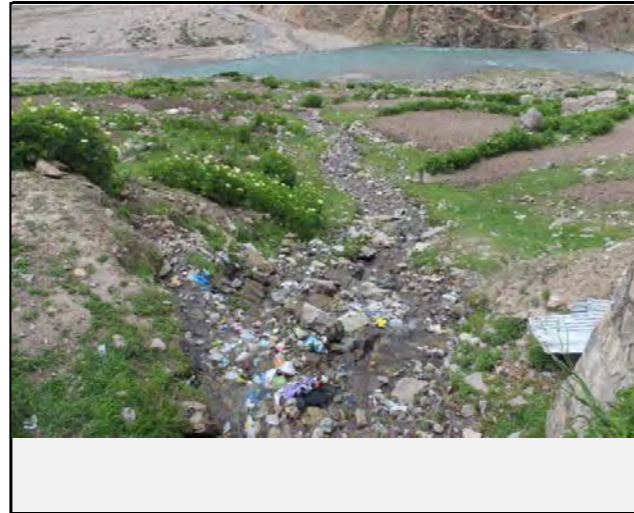
Valley side view of the debris flow

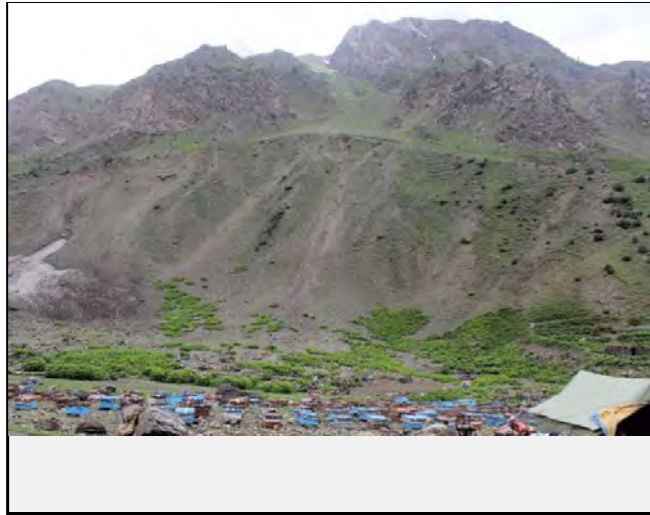
Full view of the landslide

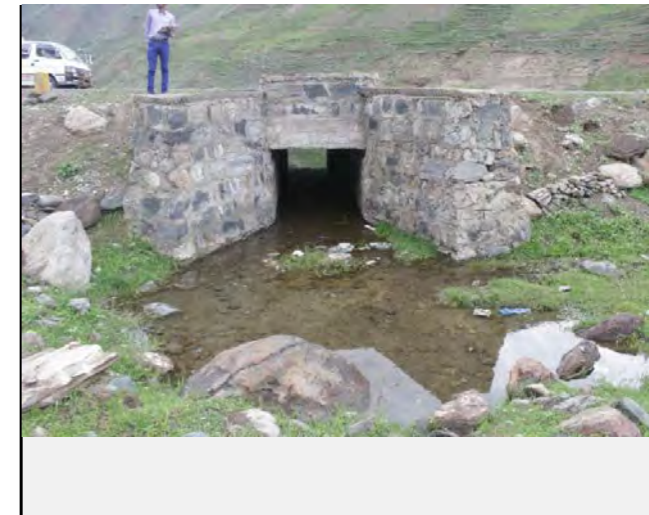
View of Box Culvert at the toe of slope

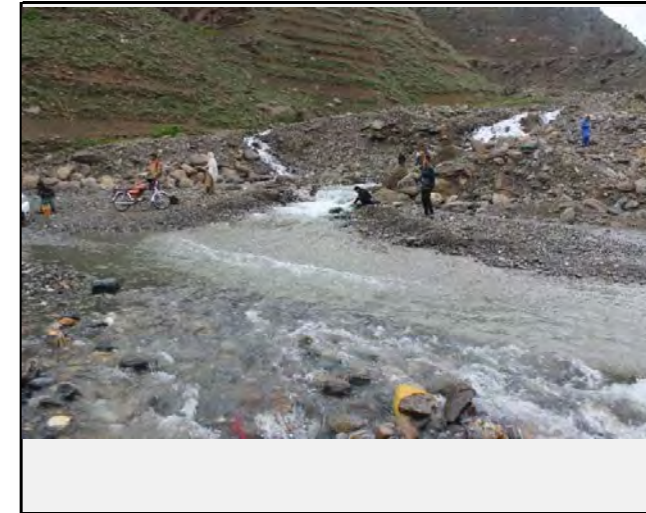
Front view of the debris flow

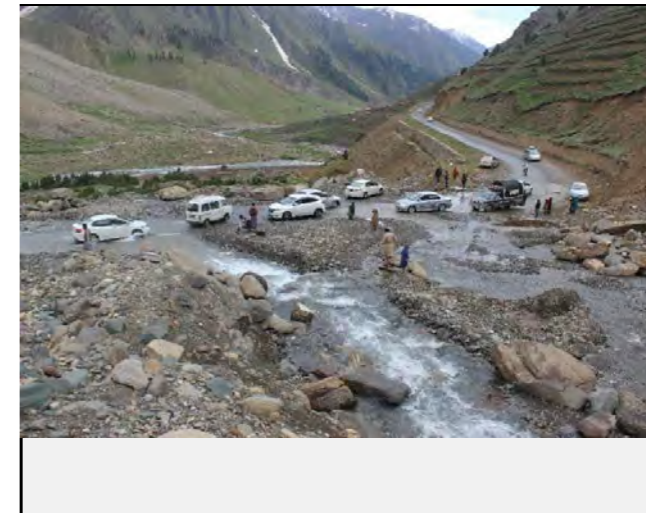
Debris flowing on road

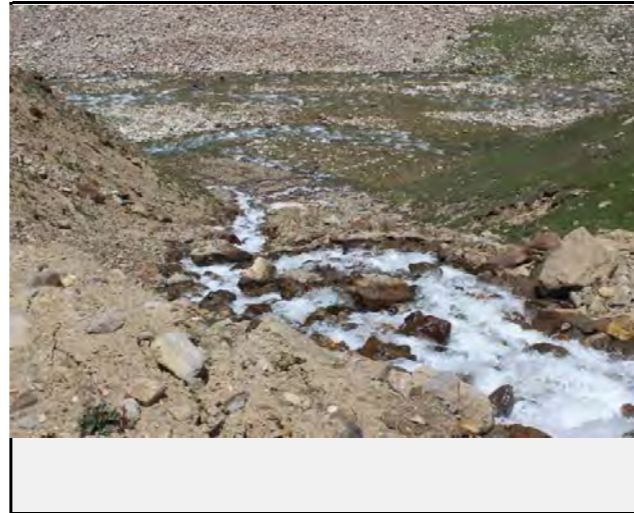
Valley side view of the debris flow

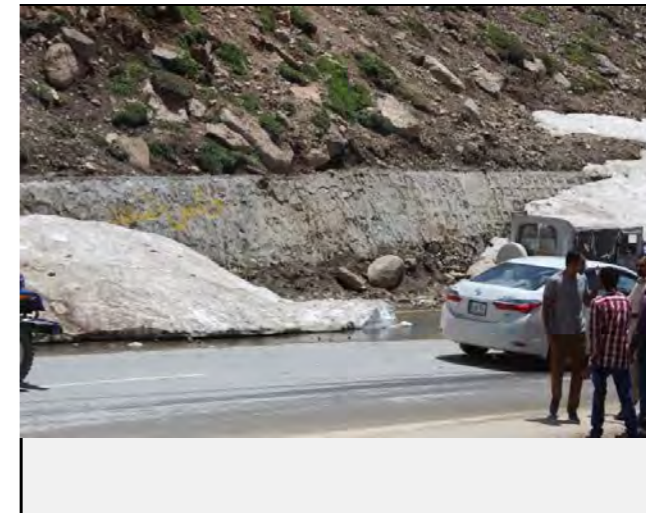
Existing countermeasures / anomalies: Retaining wall has been constructed along the Debris Flow

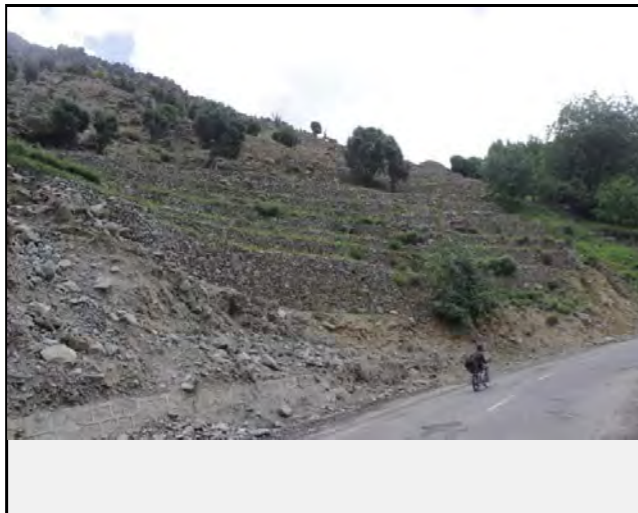
The Check dams has been built along the debris flow

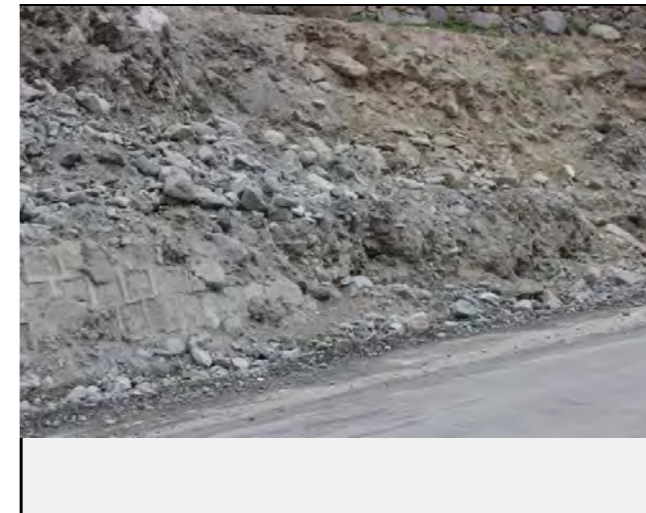
Existing countermeasures / anomalies: Retaining Wall has been constructed along the Debris Flow

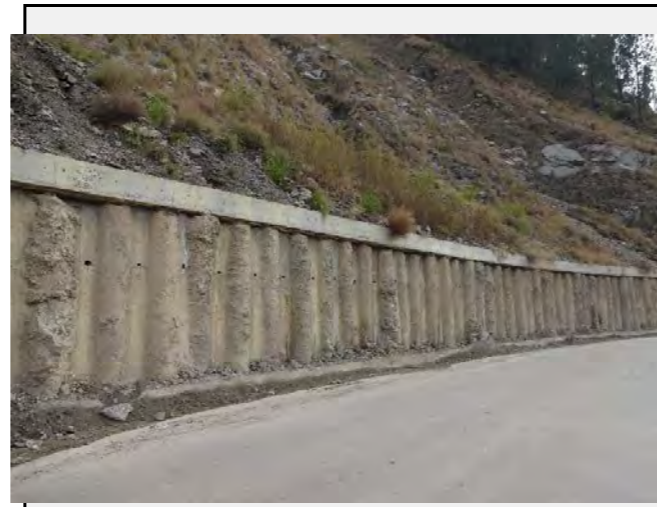
Existing countermeasures: Retaining wall (with piling) constructed at the toe of the slope.
