| Region Office | Abbottabad |

## Evaluation sheet (debris flow)

| Road Name | N 3 5 | Km 1 8 4 + 4 0 0 |

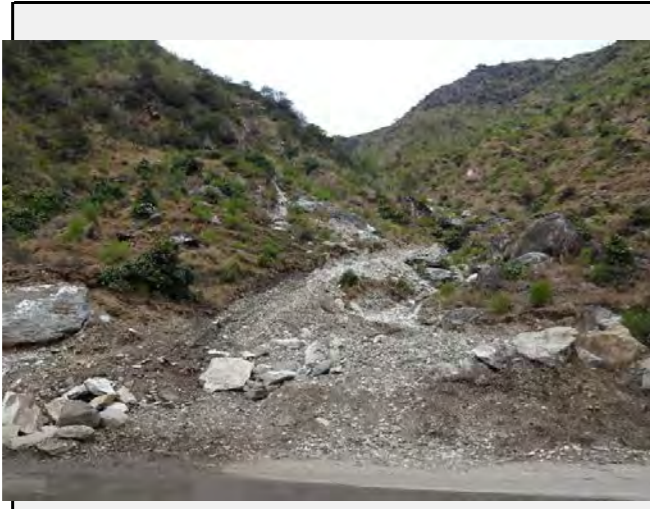
Mountain side: The debris from the mountain side is flooding near to road side. The site was used as a blasting site for the CPEC to collect the rock material for the construction.

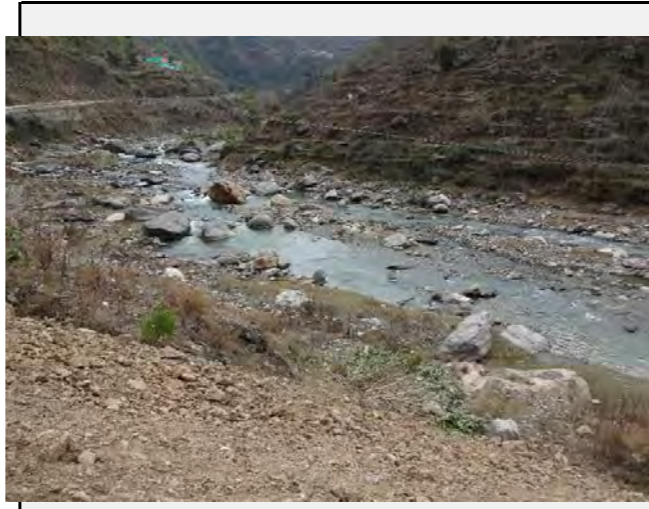
Valley side: Surface of the valley side is filled with the exavated materials from the other site.

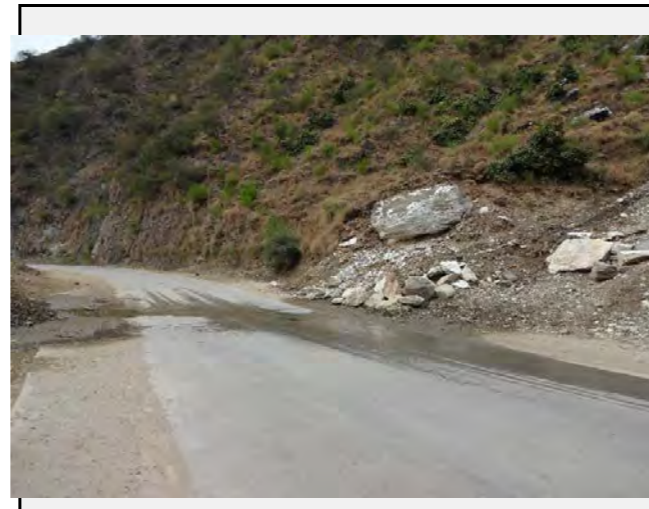
Existing countermeasures / anomalies: Big rock is overhanging just aside of the road. Removal of this rock is recomendable.

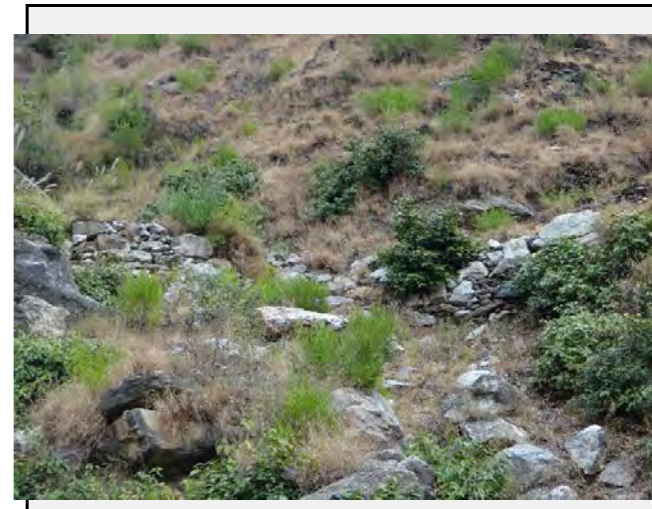
Existing countermeasures: Remains of check dam built by rocks was confirmed at the 120m from the road.

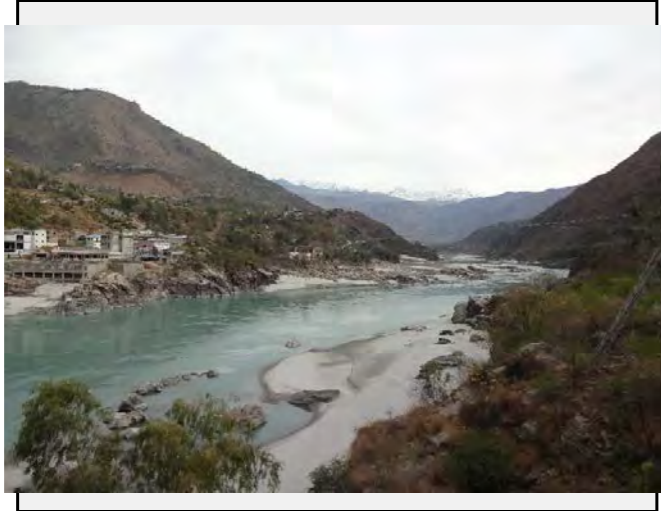
Upstream: The gradient of the river bed is very gentle on the upstream.

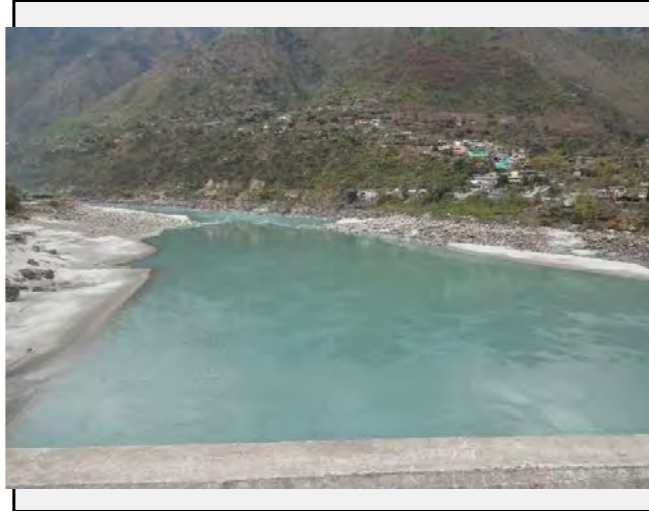
Downstream: The gradient of the river bed is very gentle on the downstream.

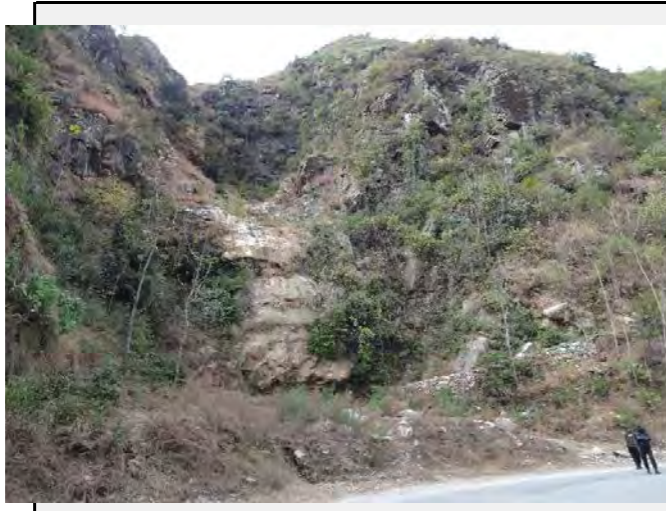
Mountain side: The stepped slope on the mountain side. There are dirt road at passing the stream to the village nearby.

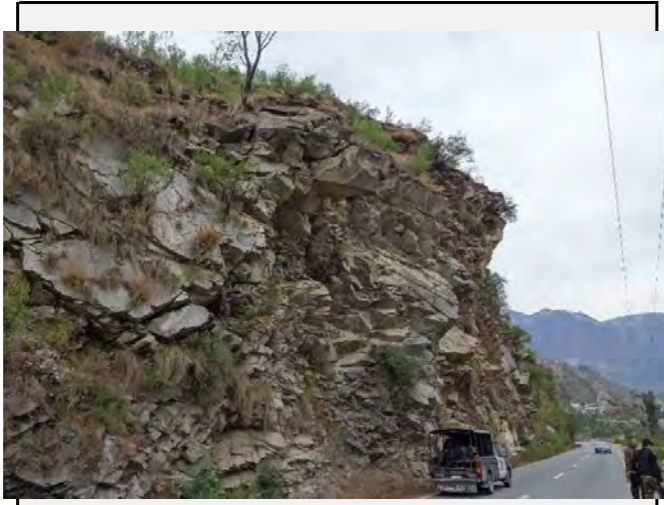
Mountain side: Vertical cut slope along the road is prone to rockfall.

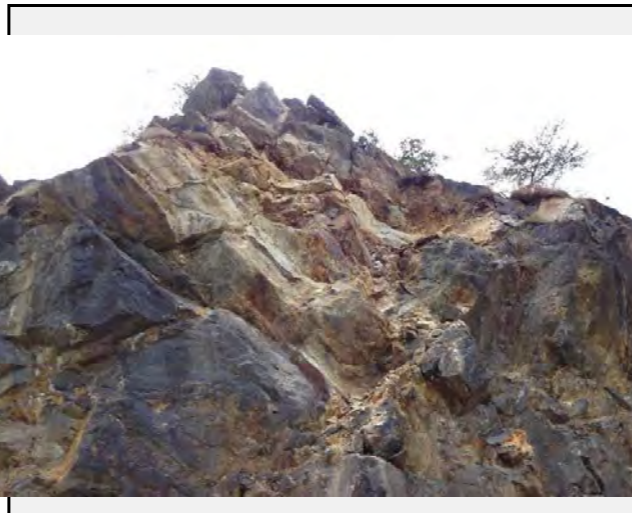
Existing anomalies: Portion of the fallen rock (from bottom)

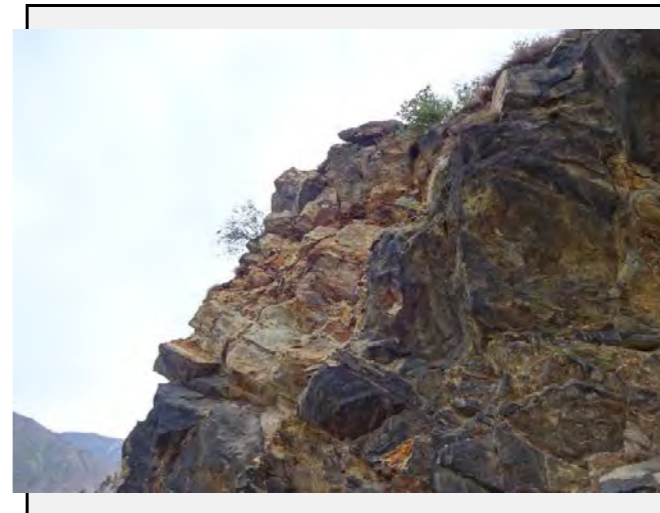
Existing anomalies: Portion of the fallen rock (from side)

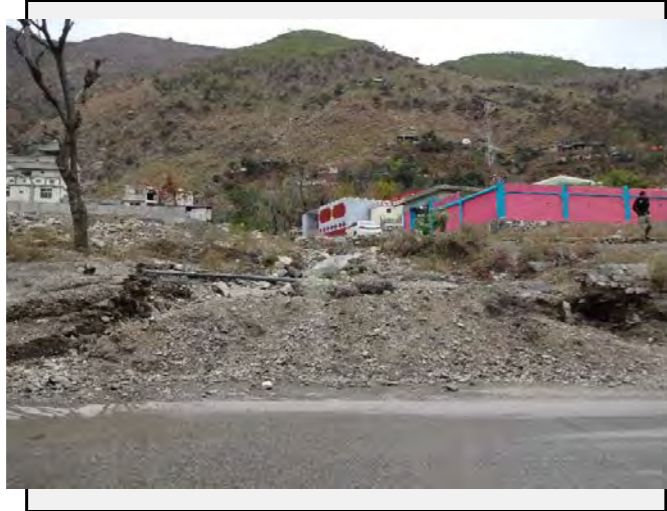
Mountain side: The exit of stream to the road is filled with the debris

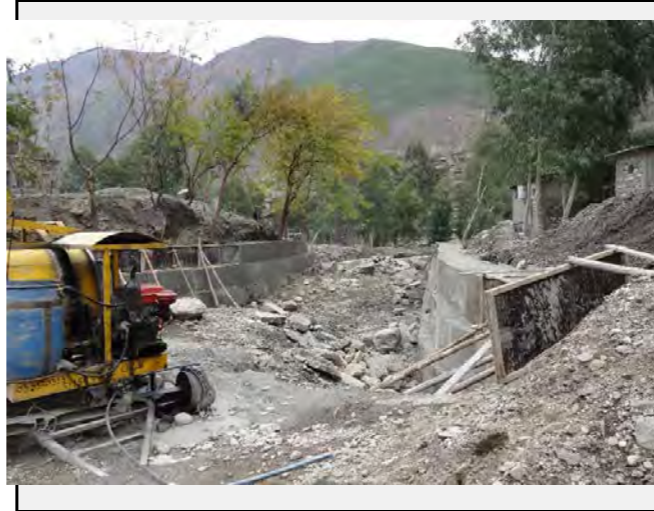
Valley side: Construction of the retaining wall by the inhabitants on the valley side is in progress to protect their houses.

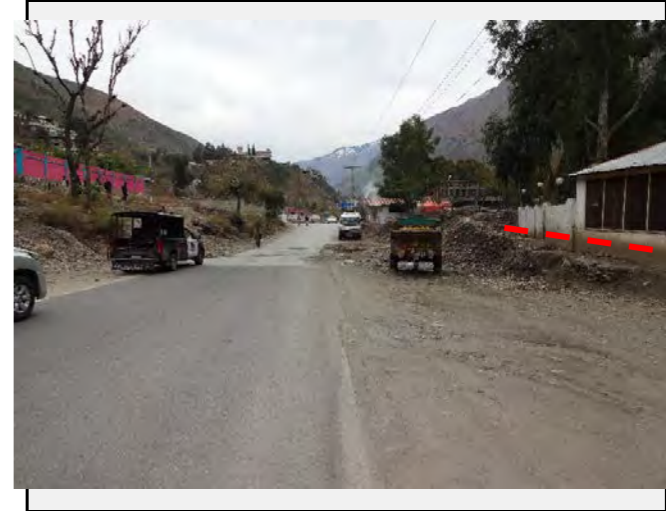
Road condition: Causeway is build on the to allow the stream to flow to the valley side. The red line shows the height of the previous debris flow.

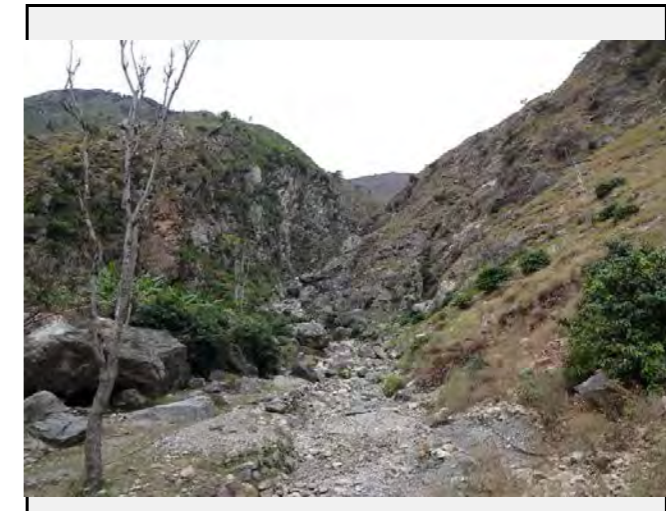
Others: Big sized boulders can be observed at the starting point of the mountain where the angle of the stream bed is changing.

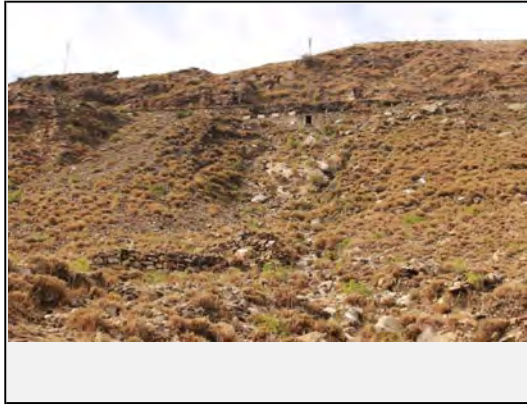
Full view of the slope failure

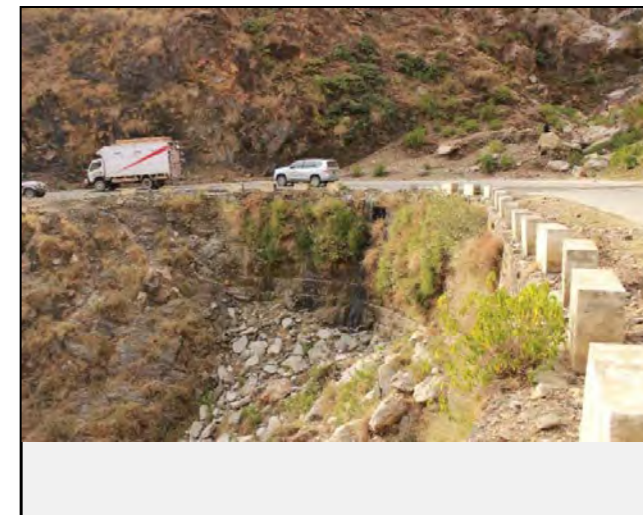
Existing countermeasures / anomalies: Culvert outlet has been constructed at the toe of the debris flow

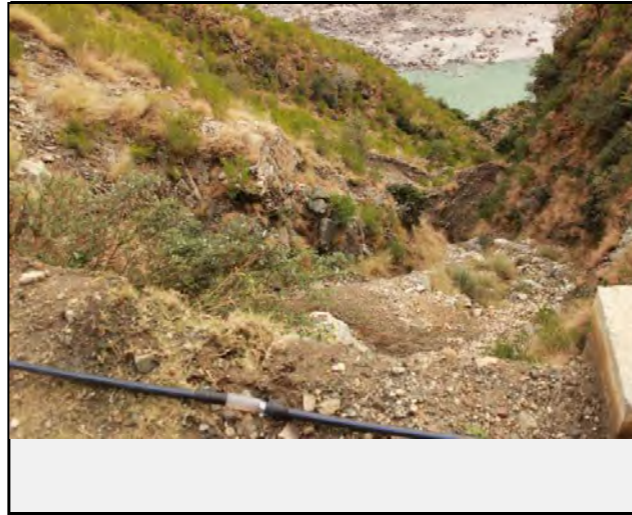
Valley side view of the debris flow

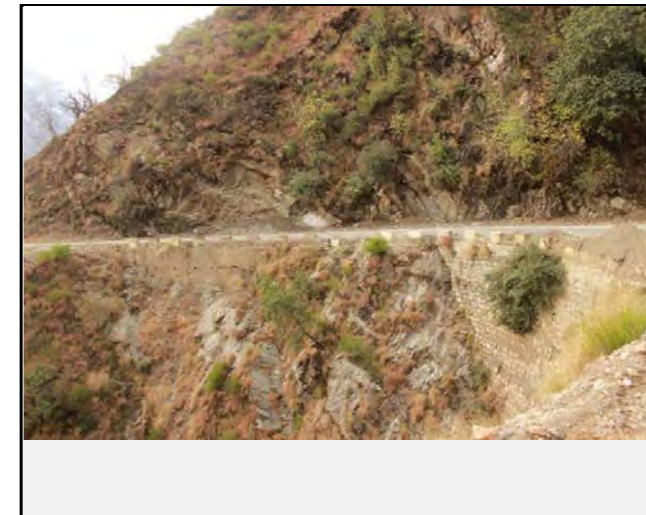
Existing countermeasures / anomalies: Retaining wall has been constructed at the toe of the slope failure

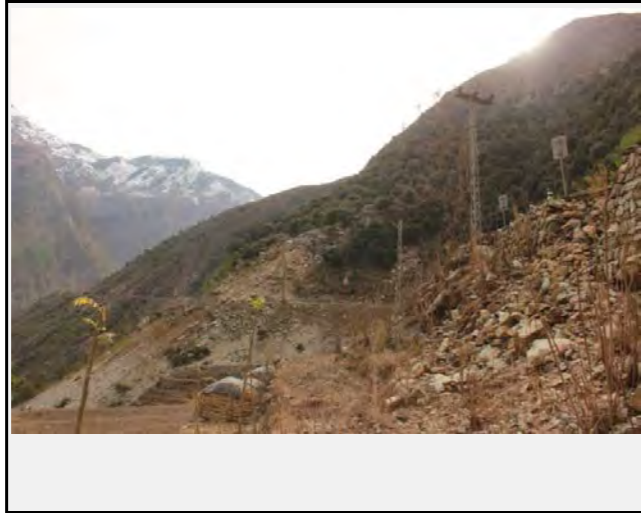
Full view of the slope failure

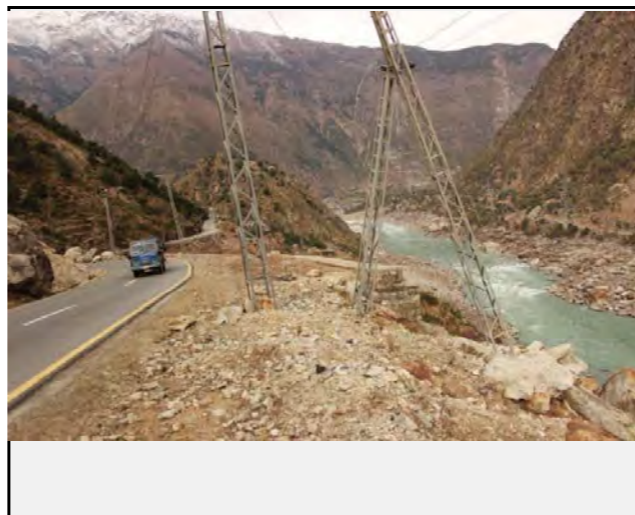
Existing countermeasures / anomalies: Retaining wall has been constructed

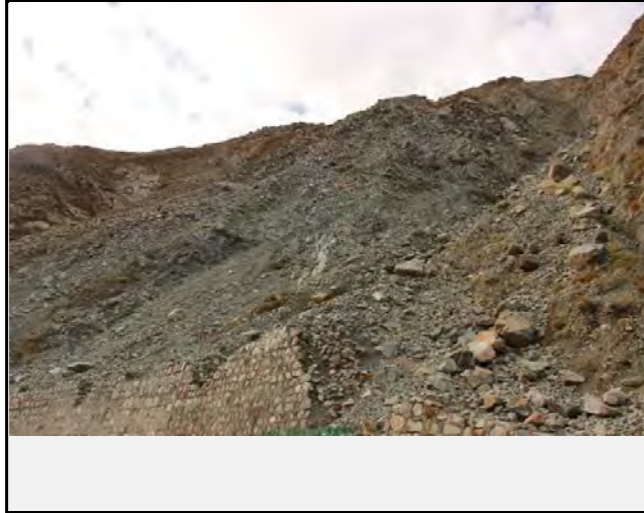
Full view of the slope failure

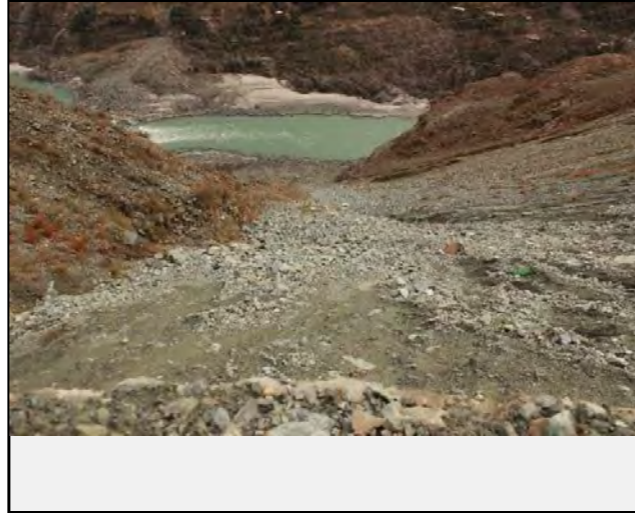
View of slope failure on Valley side:

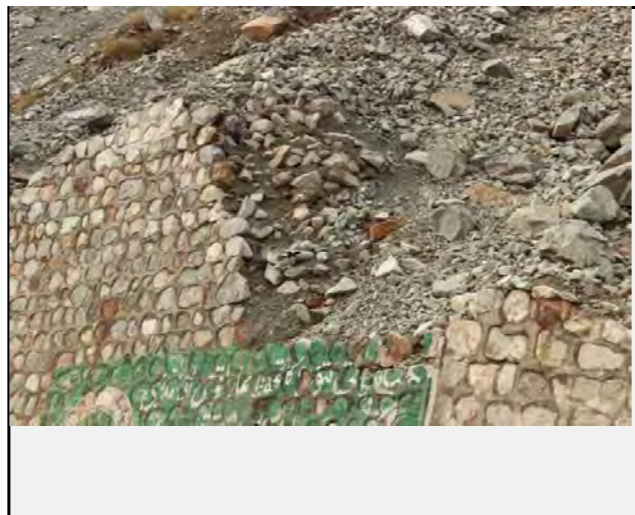
| <i>This is an active slope failure and rock fall. The failure has historically affected the road. The wedge shape failure is found on the slide. Detached boulders and gravels are hanging on the slide that combine with the sand and silt leads to debris flow during the rainy season. Bedrock is highly fractured and jointed pyroxinite. Drainage is developed on the slide and active weathering and erosion leads to development of gullies on the slide. Retaining wall is constructed to stabilize the slide, however, the right side of the retaining wall is already damaged.</i> |

Existing countermeasures / anomalies: Retaining wall has been damaged due to slope failure

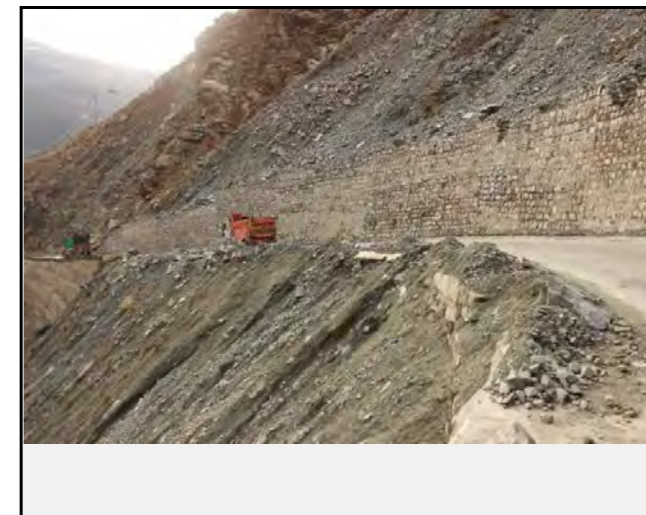
Retaining wall has been constructed to protect the road from the slope failure

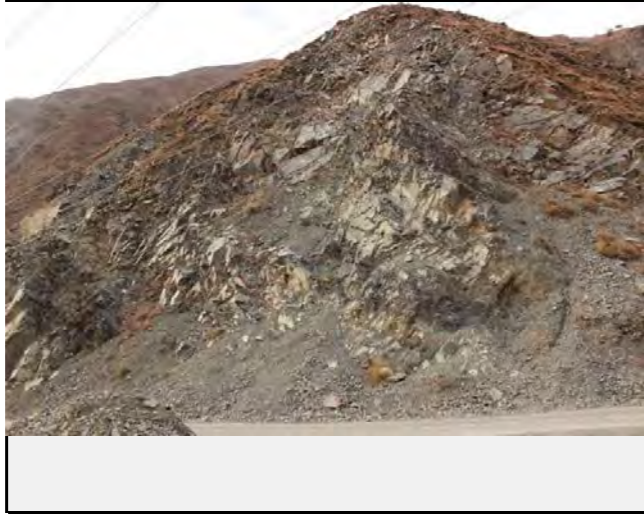
Full view of the rockfall

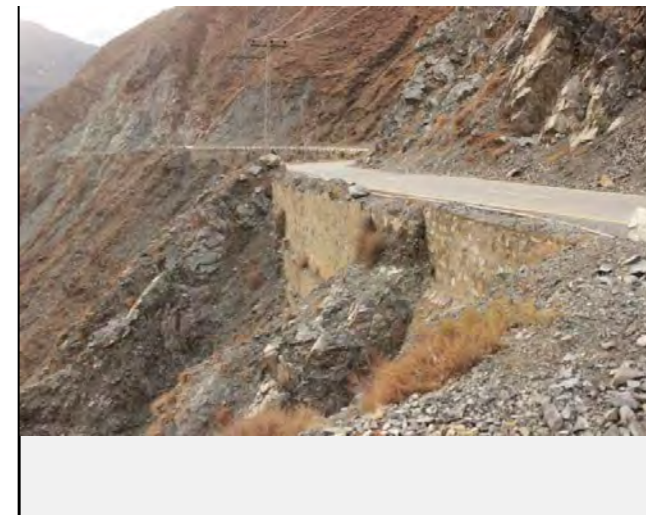
Retaining wall has been constructed to protect the road

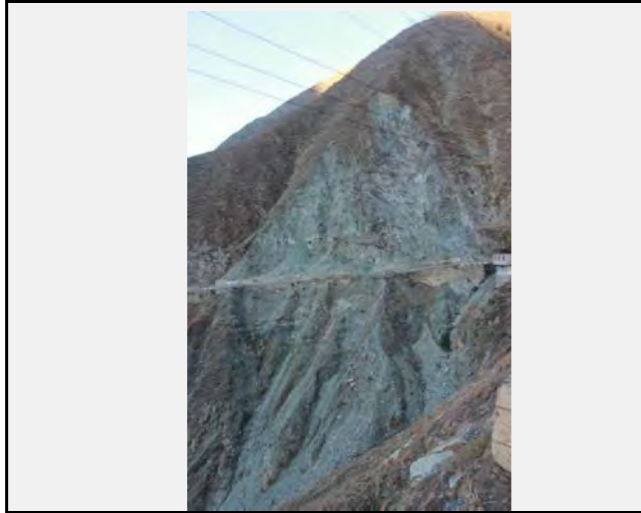
Full view of the rockfall

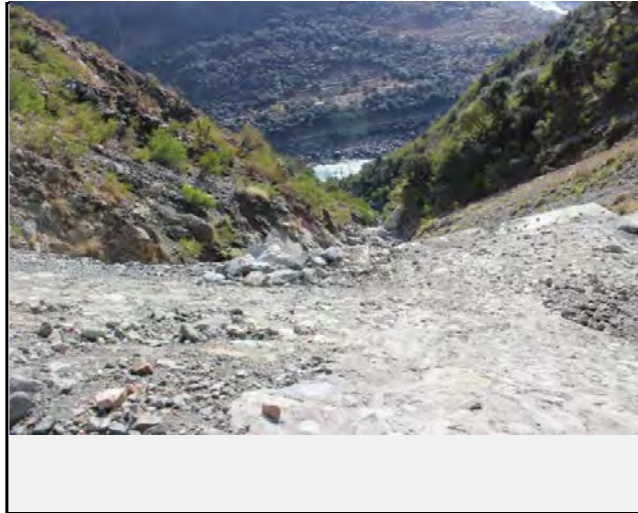
Valley side view of the debris flow

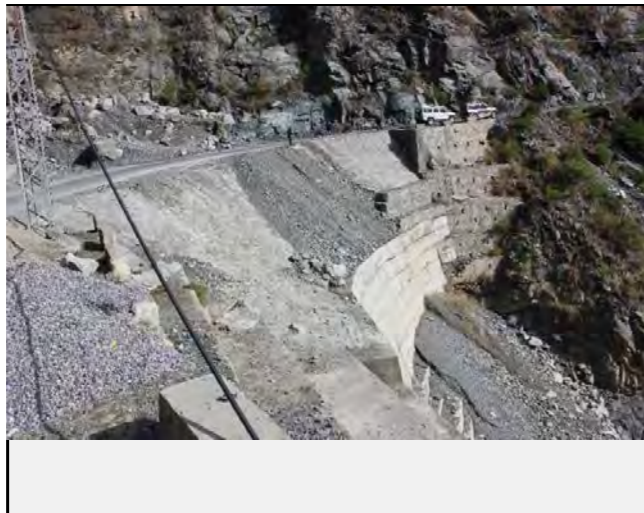
Existing countermeasures / anomalies: Sloped Retaining wall has been constructed for outflow of debris material

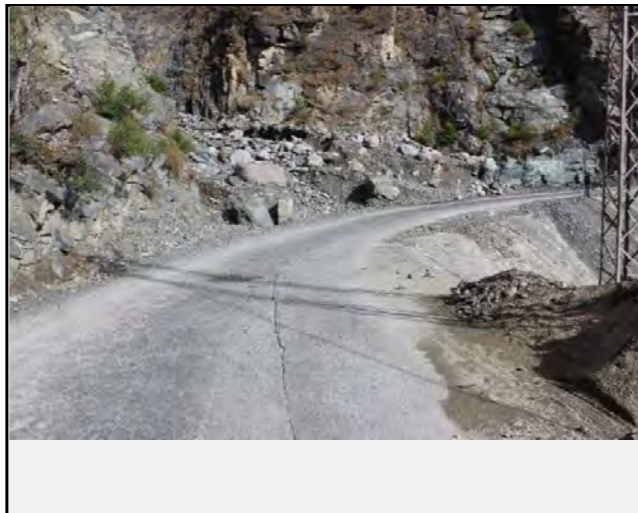
Road condition at start point

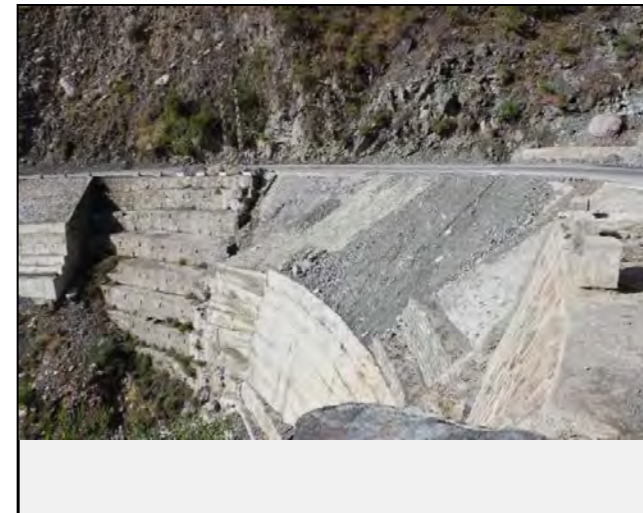
Existing countermeasures / anomalies: Retaining wall has been constructed to protect the road

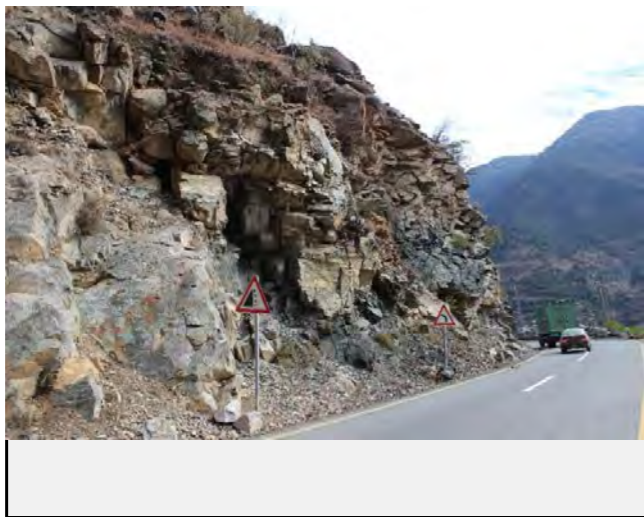
Road condition: Cut slope at the end point

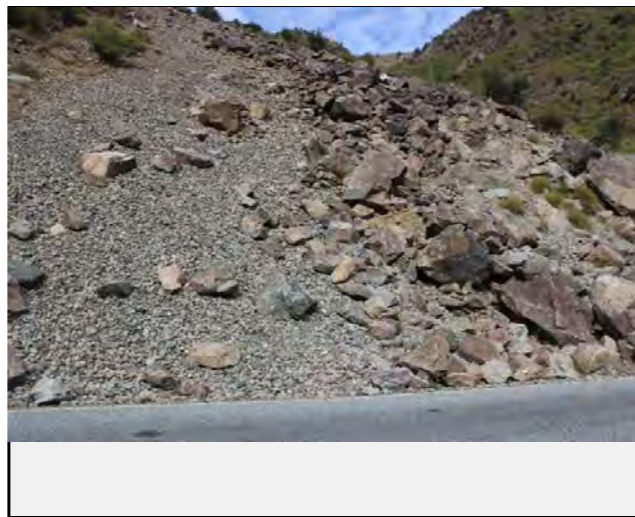
Existing countermeasures / anomalies: No counter measures

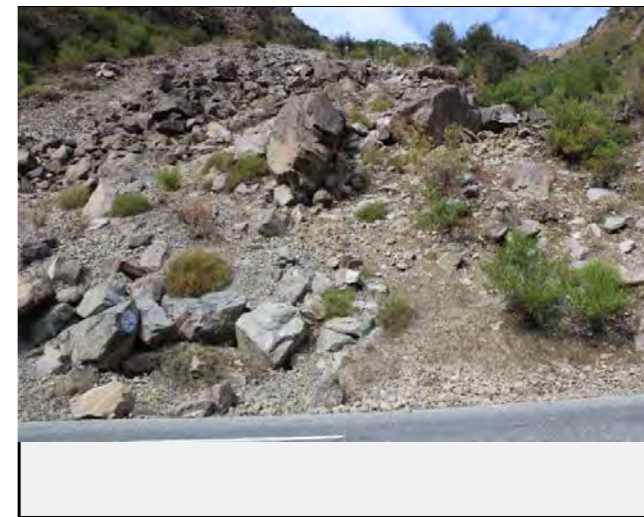
View of fallen blocks along the road

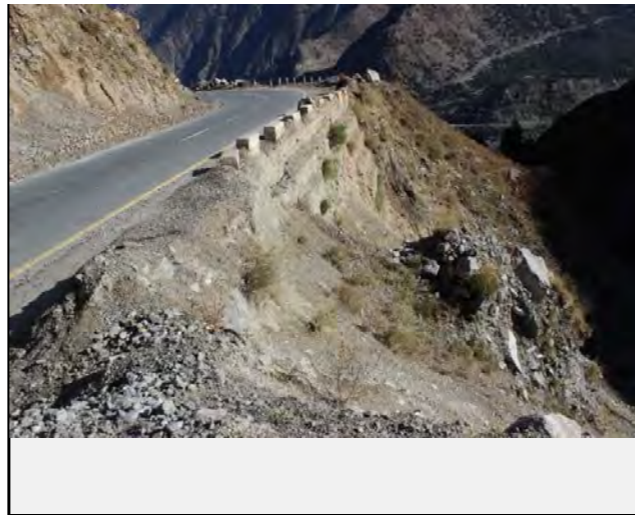
Existing countermeasures / anomalies: View of Retaining wall as counter measure for N-35

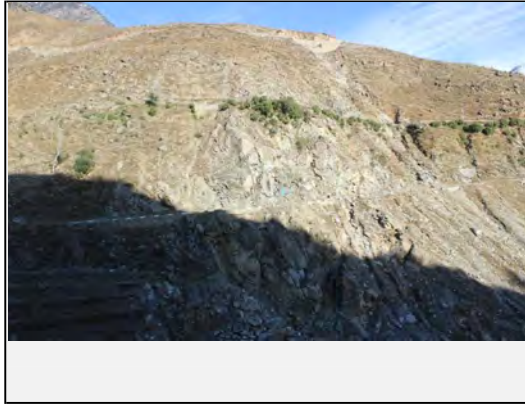
Full view of the Slope Failure

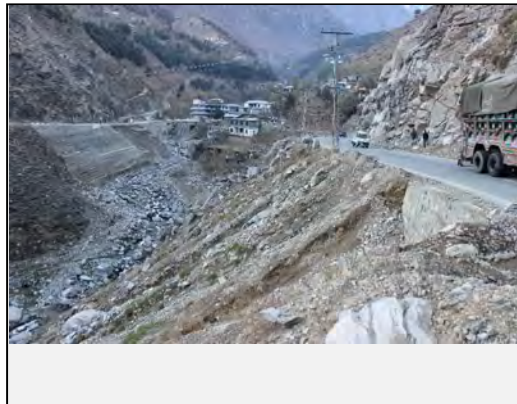
View of the slope failure at the middle point

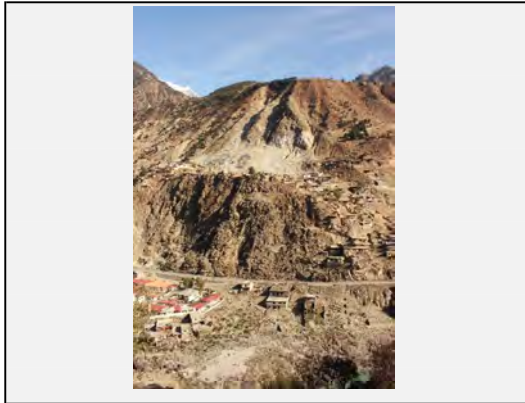
Full view of the Slope Failure/Rock Fall

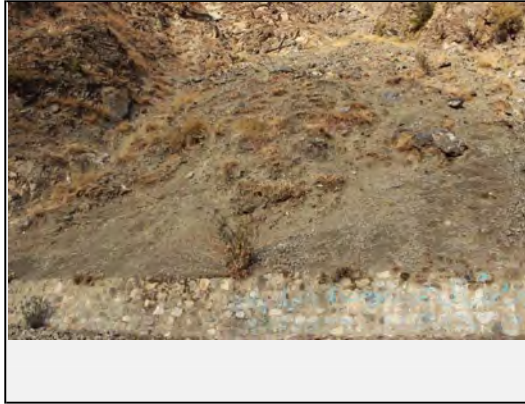
Full view of the Slope Failure

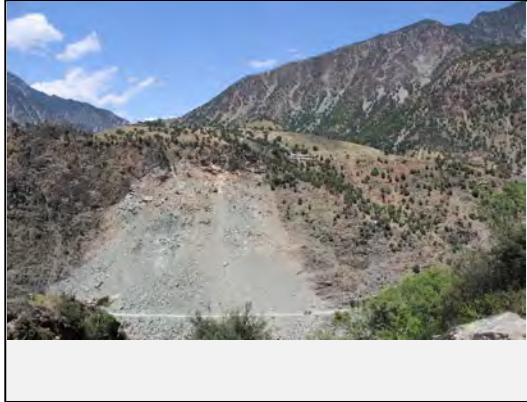
Full view of the Slope Failure

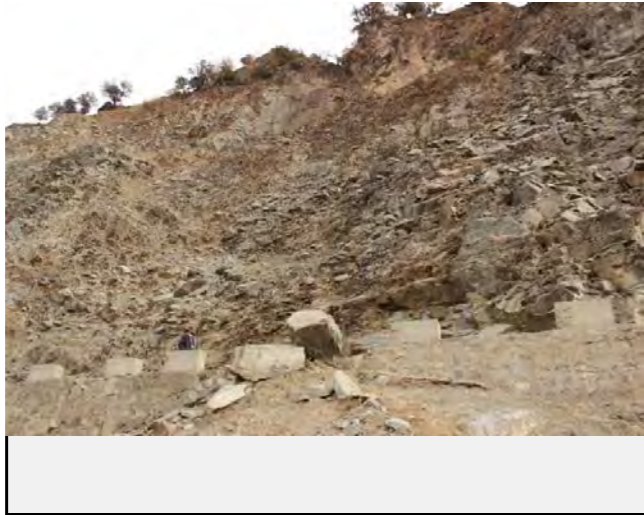
Full view of the slope failure

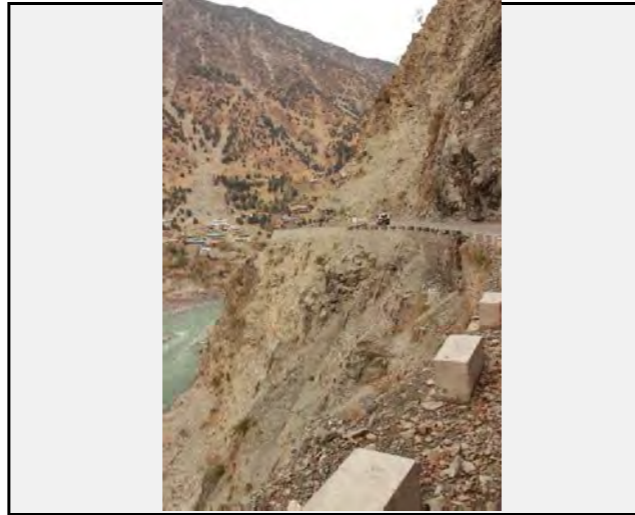
View of the slope failure on Valley side:

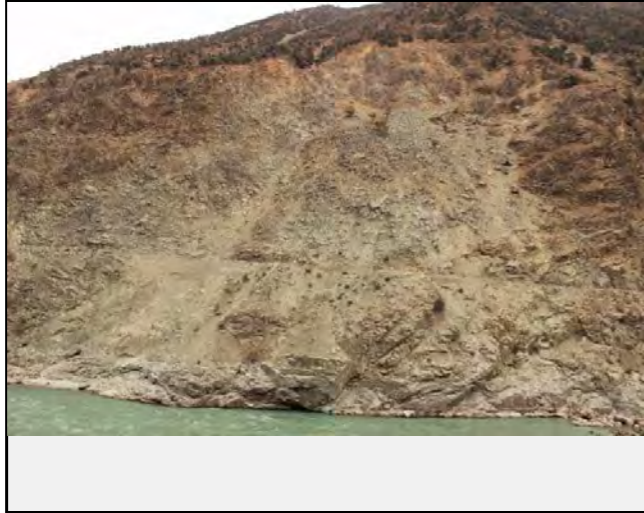
Full view of the slope failure

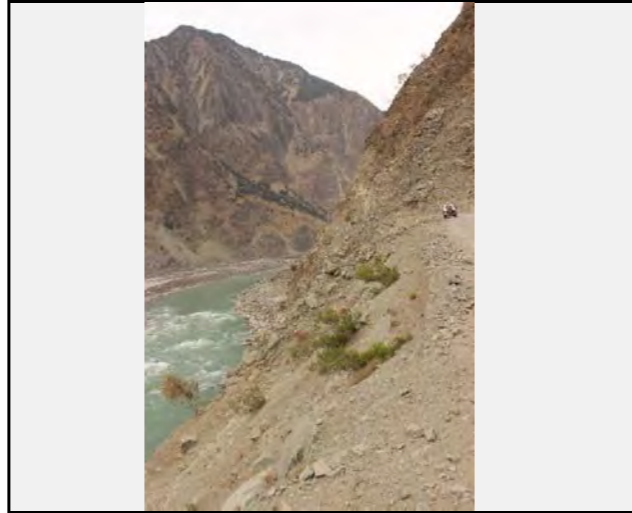
View of slope failure on Valley side:

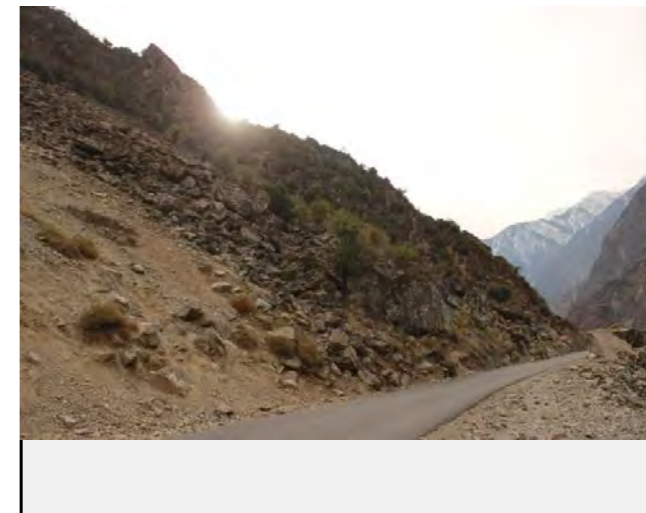
View of fallen blocks
