Appendix 6

Survey Result of Restricted Area

SLOPE FAILURE ANALYSIS ALONG THE MAJOR ROADS NETWORK IN NORTHERN PAKISTAN

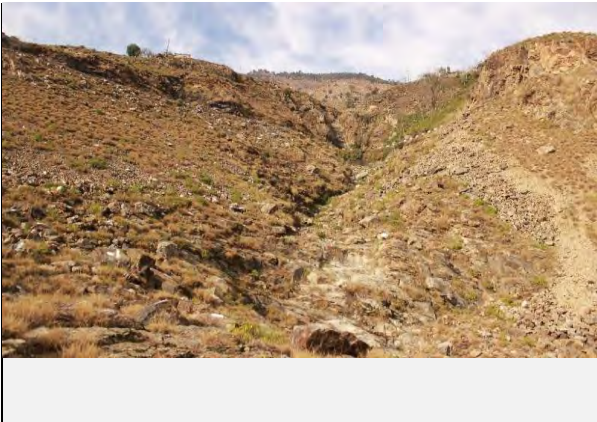
Code no.	N	-	3	5				0	2
Region Office									
Maintenance Unit

S#	ID	Location	Type	Proposed Mitigation Measures	Description	Priority
01	N-35-01	34°56'26.6" 72°52'40.3"	Slope Failure	Retaining Wall	This slope failure is actually cut slope due to the excavation for N-35 and link road above the scarp. Meta-sedimentary sequence of besham basement group is exposed along the cut slope. The rock is highly jointed and cracked. Three gullies has marked towards the valley side. Erosion along these gullies is endangering the stability of N35. Retaining wall is partially damaged.	Medium
02	N-35-02	34° 56' 36.1" 72° 52' 40.6"	Debris Flow	Construction of culvert, Construction of check dams on upstream	A seasonal stream crosses the highway at this location. Small catchment area with debris fall/rock fall material are present on the upstream. Small landslide was also observed along the stream which contribute in the debris volume. Granite is exposed along the stream. Various boulders of granite size more than 1 m3 has also been observed. The culvert has been blocked due to debris material along this channel.	Medium

Mountain side view of the debris flow

Valley side view of the debris flow

Front view of the debris flow

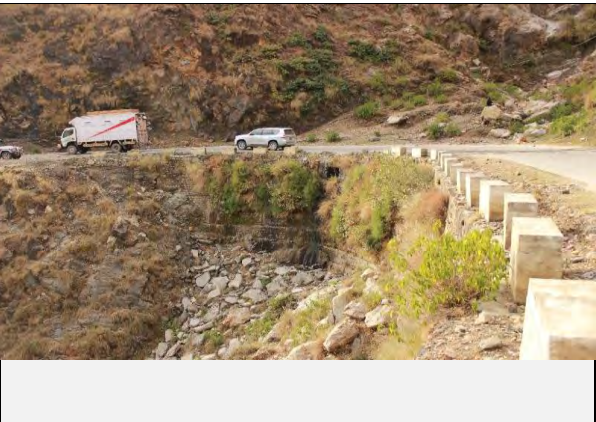
Existing countermeasures / anomalies: Culvert outlet has been constructed at the toe of the debris flow

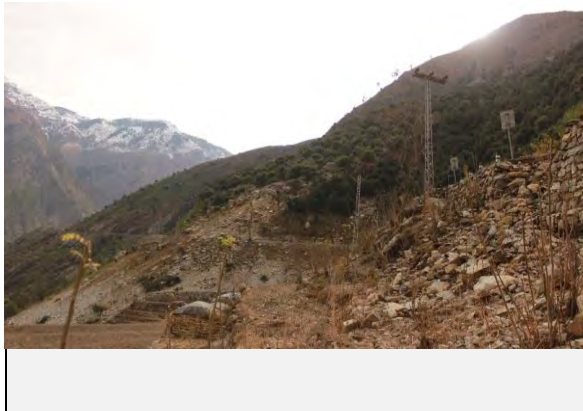
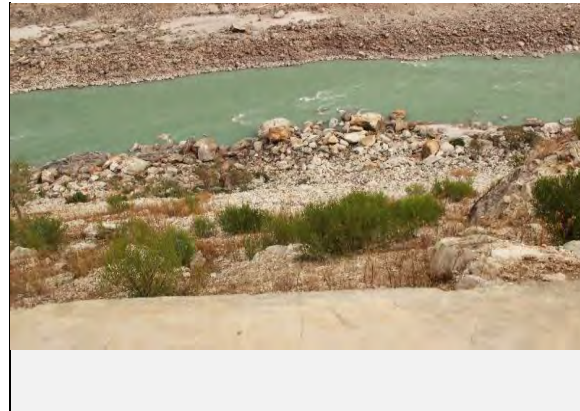
Code no.	N	3	5	1	4	
Region Office						
Maintenance Unit

05	N-35-14	35°00' 11.9" 72°53' 53.90"	Slope Failure	Construction of retaining wall	<p>This rotational landslide is located on N35. It is historically active slope failure. The slide was mainly triggered during the 2005 earthquake and also reactivated during the torrential and prolonged monsoonal rains of 2010. The slide also become active during the rainy seasons. The scarp and upper parts of the slope is partially stable with thick vegetation. However, the portion of the landslide close to the road is still active and prone to frequent sliding and rock fall and therefore posing threats to the road. Many detached boulders and gravels are hanging on the slope posing threat to the road and traffic. No mitigation measures are constructed to protect the road from the fallen rocks or debris. Bedrock of the slide is fractured and weathered granitic rocks. Water erosion leads to development of gullies on the slide.</p>	High

Full view of the landslide

View of landslide on Valley side:

Road condition: Cut slope at the start point

View of the slope failure at the middle point

Existing countermeasures / anomalies

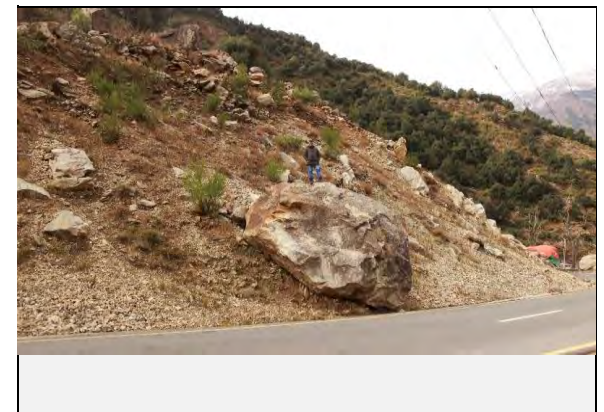
View of fallen blocks on road

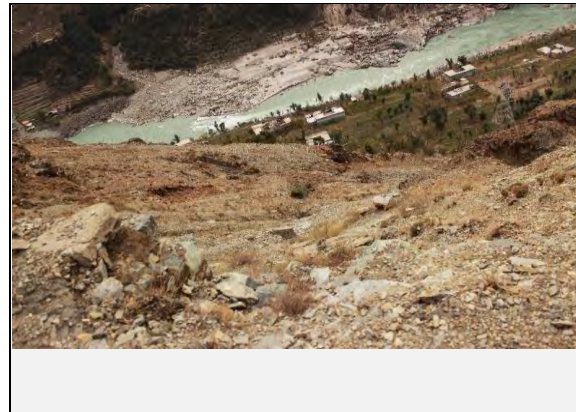
Code no.	N	3	5	_	2	6			
Region Office									
Maintenance Unit

06	N-35-26	34° 02' 19.4" 72° 52' 49.3"	Rock Fall/Slope Failure	Retaining Wall/ Rock bolting, Wire mesh	<p>The slide is active rock fall and cut slope posing great and frequent risk to road. Bedrock of the slide is highly fractured and weathered pyroxinite. The slide has hanging boulders and gravels posing threats to road and traffic. Some sections of the slide are very steep with slope of around 60 degrees. Slide is void of vegetation. During the rainy season the slide is also prone to debris flow comprising of boulders, gravels, sand and silt. Rock fall is planar in nature. Water seepages is observed on the right flank of the slide. Intersecting joints leads to wedge failure. Drainage is developed on the slope and at the stream outlets fan shaped talus are developed. No effective mitigation measures are constructed for the rock fall.</p>	Medium
07	N-35-28	35° 02' 25.7" 72° 56' 6.8"	Slope Failure	Construction of shed/ Drainage diversion	<p>This is an active slope failure and rock fall. The failure has historically affected the road. The wedge shape failure is found on the slide. Detached boulders and gravels are hanging on the slide that combine with the sand and silt leads to debris flow during the rainy season. The slide is void of vegetation. Bedrock is highly fractured and jointed pyroxinitic rocks. Drainage is developed on the slide and active weathering and erosion leads to development of gullies on the slide. Retaining wall is constructed to stabilize the slide, however, the right side of the retaining wall is already damaged. Rainfall is the major trigger for the slide and therefore leads to road damages and disruption of traffic during the rainy season. One of the trigger of the slide is also the freeze and thaw phenomenon. Since this slide is frequently damaging and disrupting the slide and therefore needs quick and comprehensive mitigation measures to minimize its impact on road.</p>	High

Full view of the landslide

View of landslide on Valley side:

Road condition: Cut slope at the start point

View of the slope failure at the middle point

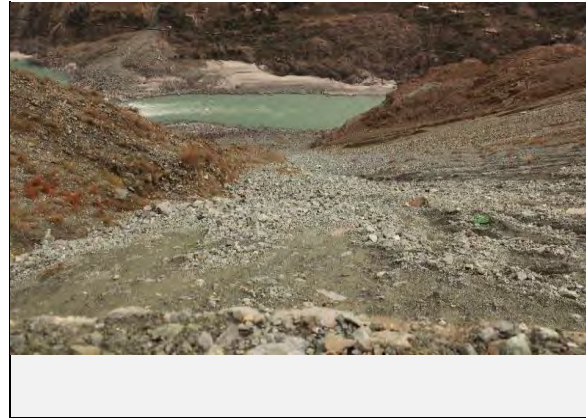
View of landslide on Valley side:

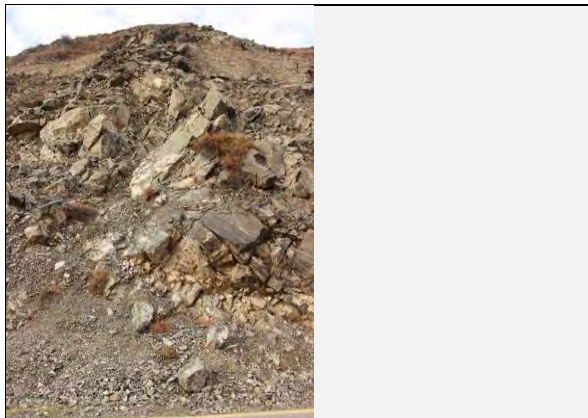
View of the slope failure at the middle point

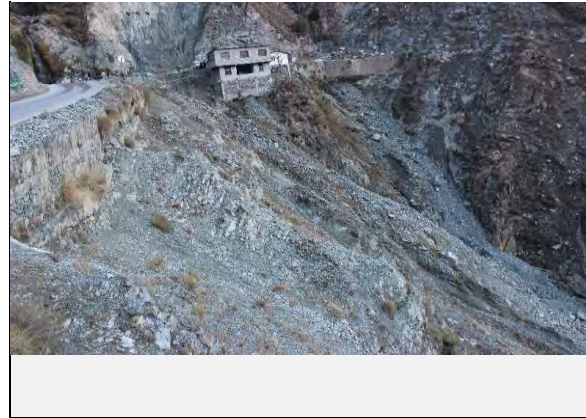
View of landslide on Valley side:

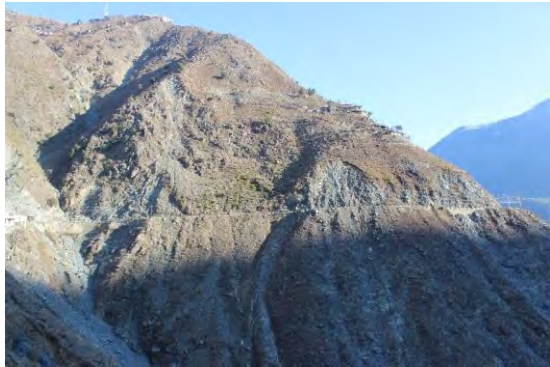
Full view of the landslide

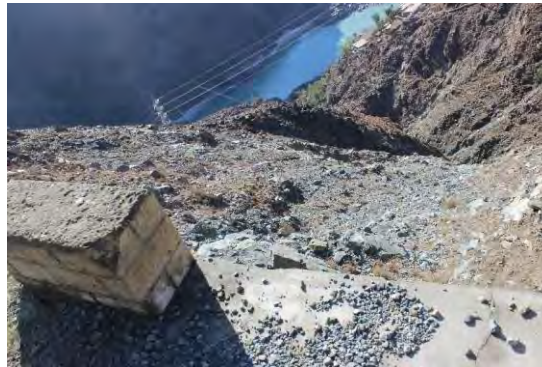
View of landslide on Valley side:

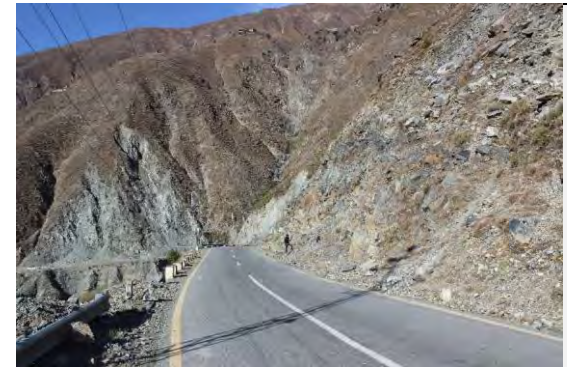
Road condition: Cut slope at the start point

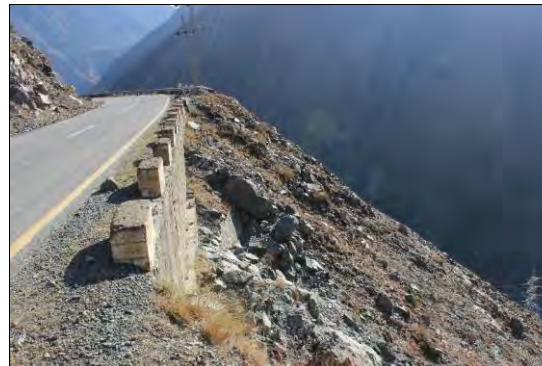
Existing countermeasures / anomalies: View of retaining wall for N-35 as counter measure

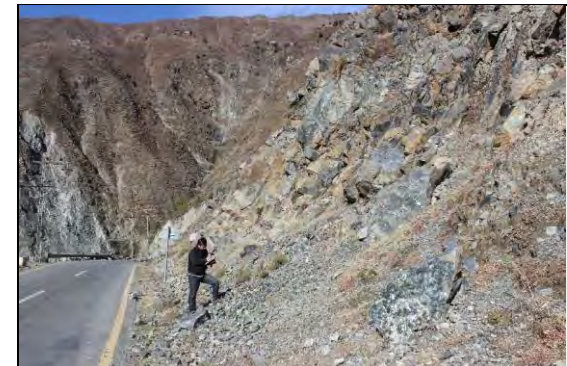
View of Large blocks fallen and talus deposit at the toe of Sloape Failure

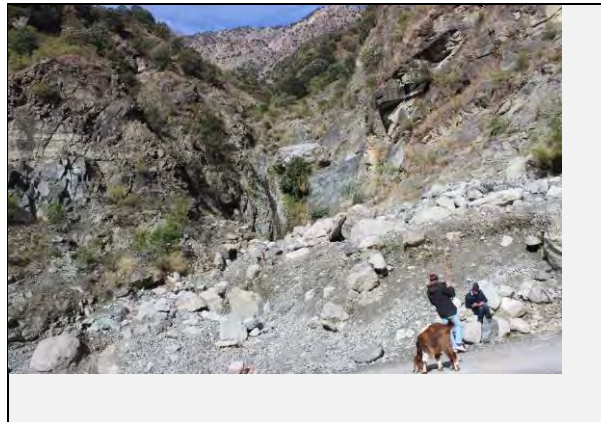
Mountain side view of the debris flow

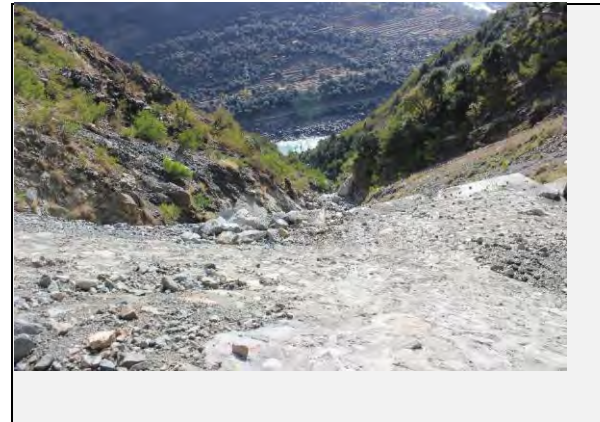
Valley side view of the debris flow

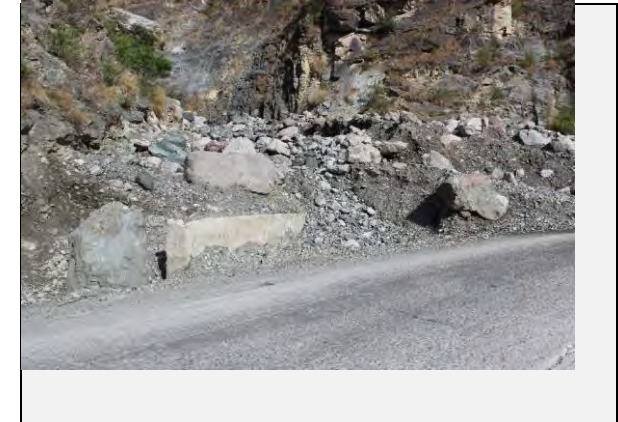
Front view of the debris flow

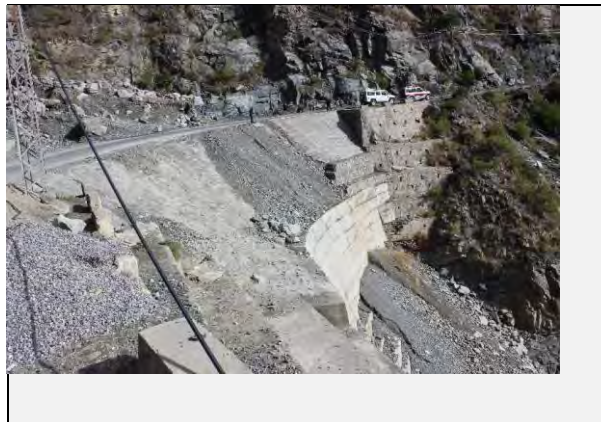
Existing countermeasures / anomalies: Sloped Retaining wall has been constructed for Debris material

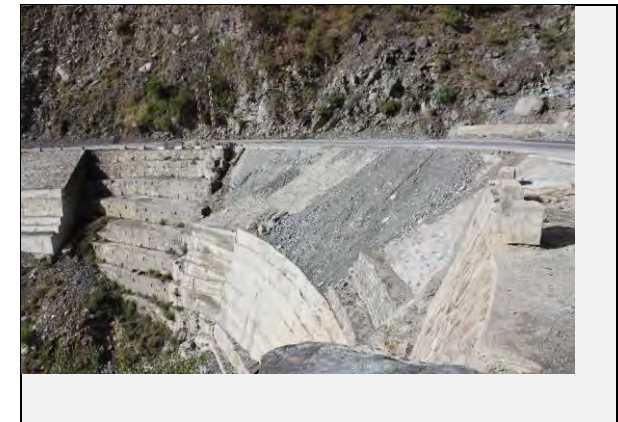
Road condition

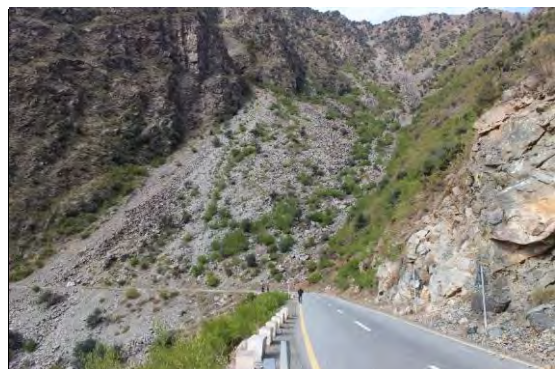
Full view of the landslide

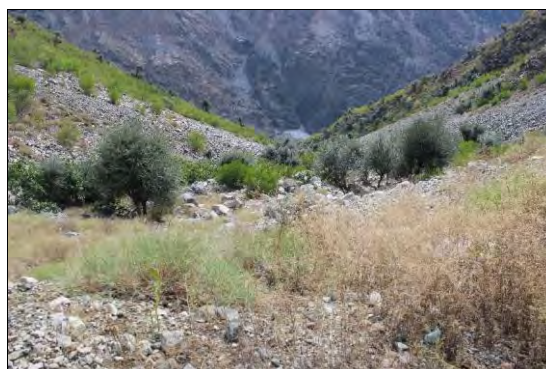
View of landslide on Valley side:

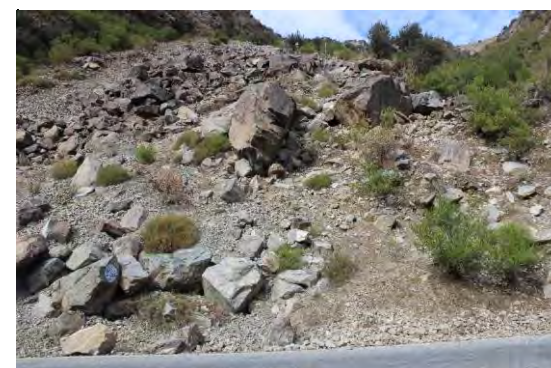
View of fallen blocks

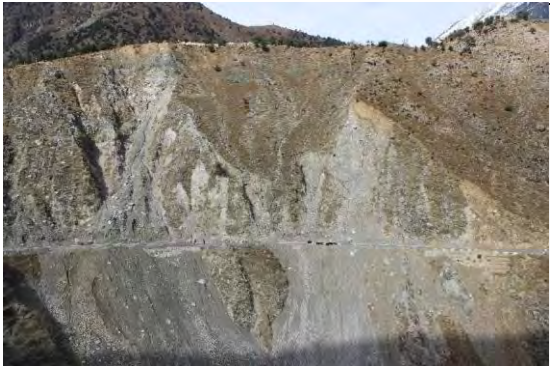
Full view of the landslide

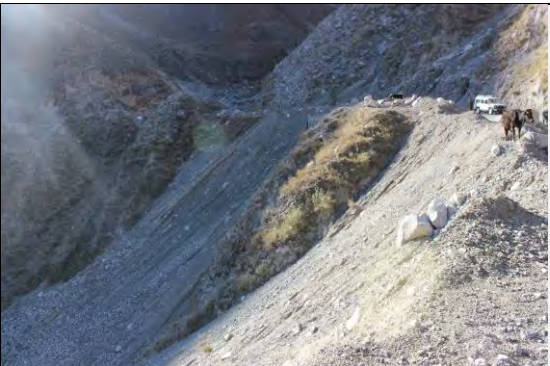
View of landslide on Valley side:

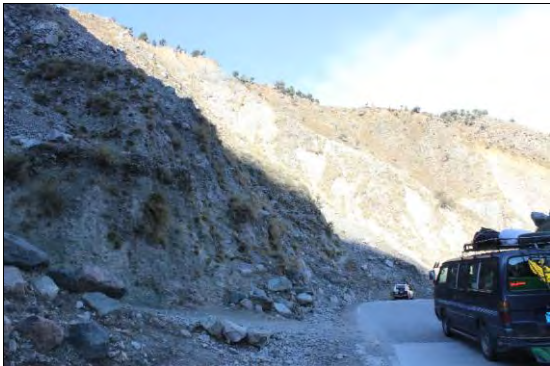
View of the slope failure at the middle point

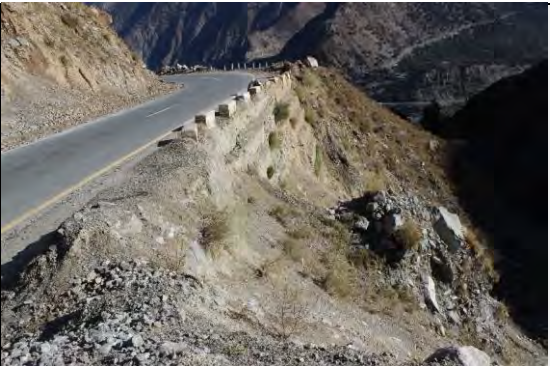
Existing countermeasures / anomalies: View of Retaining wall as counter measure for N-35

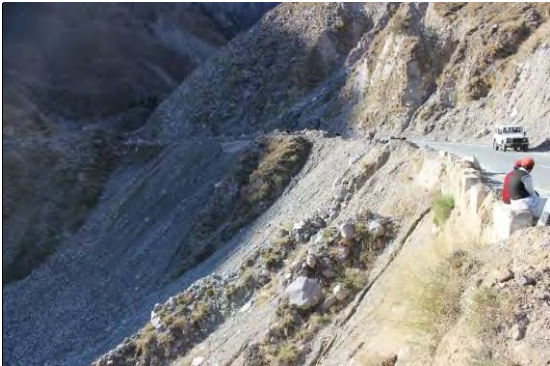
View of fallen blocks

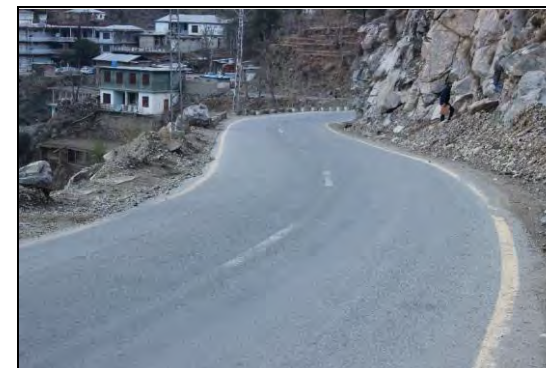
Road condition: Cut slope at the start point

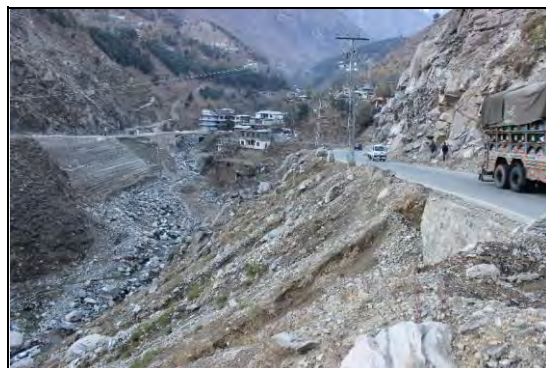
Existing countermeasures / anomalies: View of Retaining wall and benching as counter measure

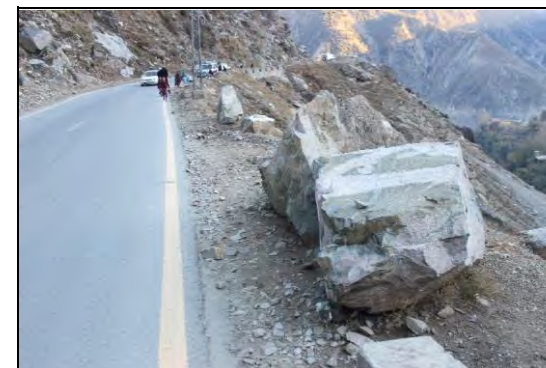
View of fallen blocks on road

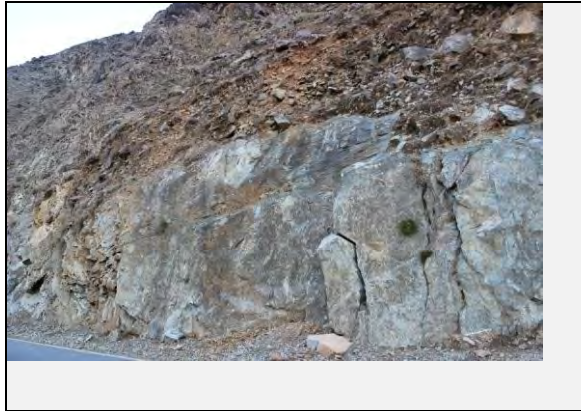
Full view of the landslide

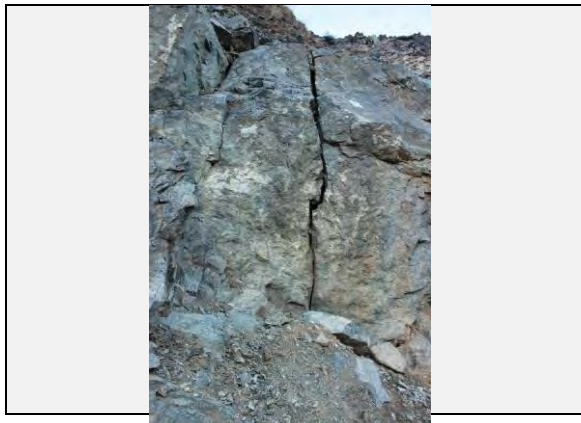
View of the slope failure at the middle point

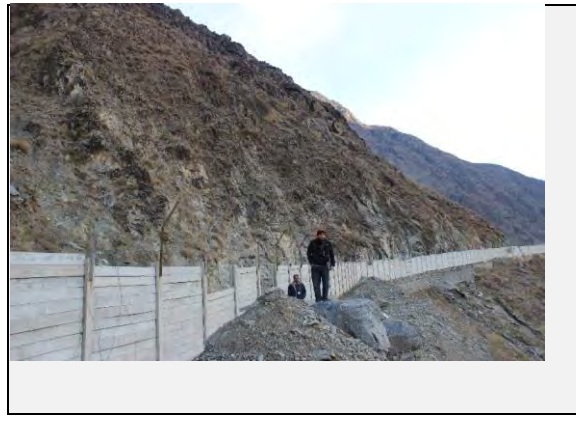
Existing countermeasures / anomalies: View of shed as counter measure

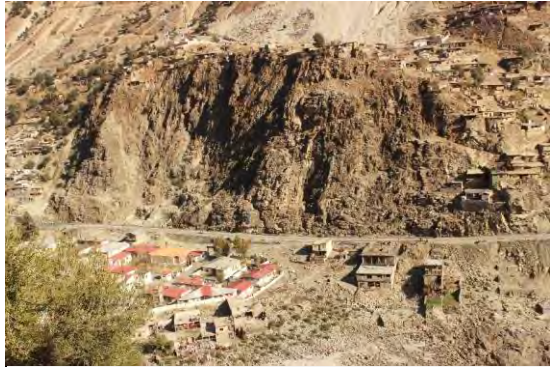
Full view of the landslide

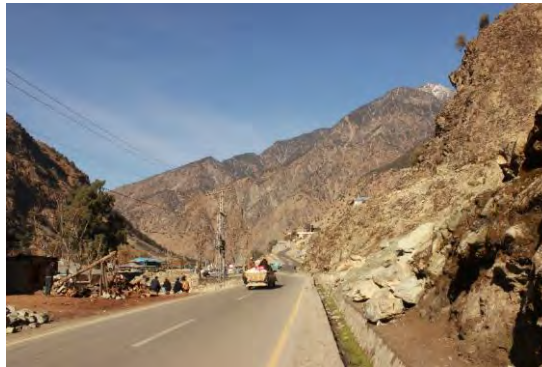
View of landslide on Valley side:

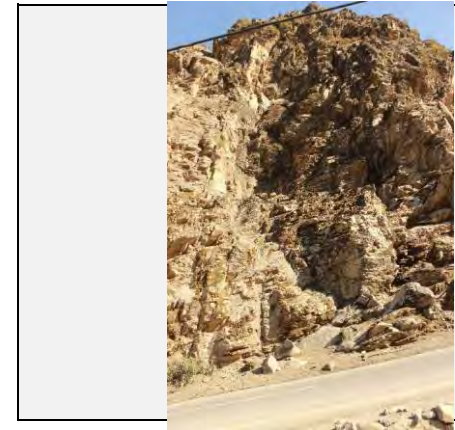
Road condition: Cut slope at the start point

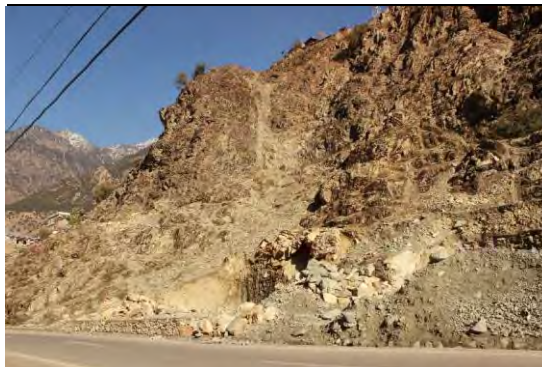
Existing countermeasures / anomalies: View of retaining wall as counter measure

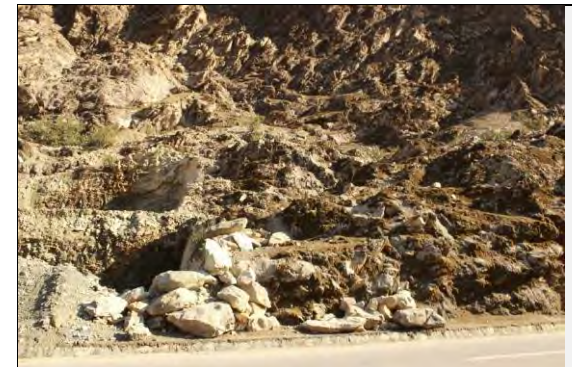
View of fallen blocks

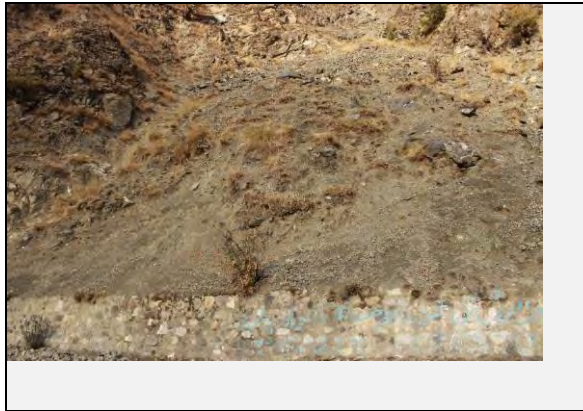
Full view of the landslide

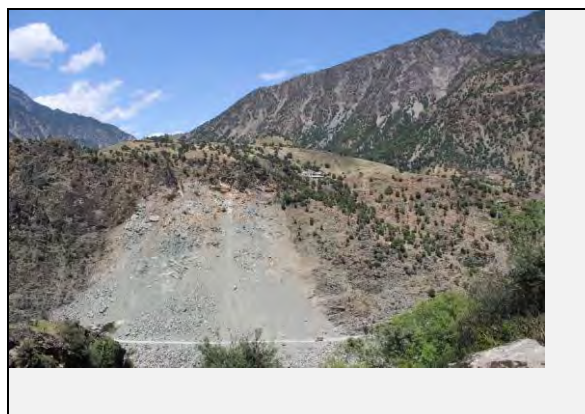
Full view of the landslide

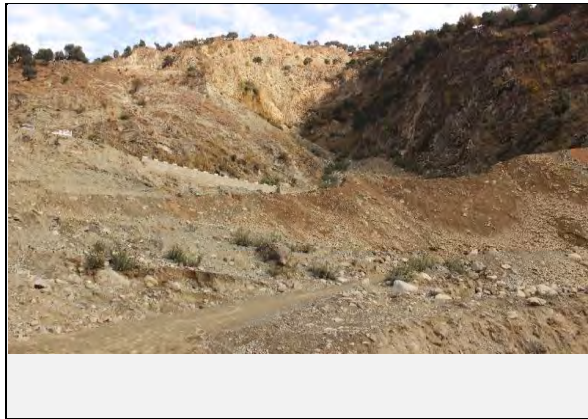
Full view of the landslide

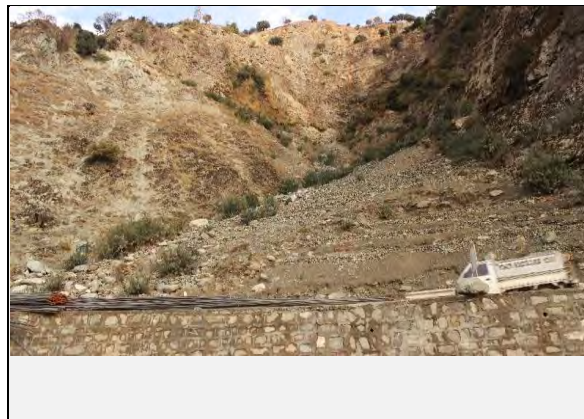
Existing countermeasures / anomalies: View of benching as counter measure

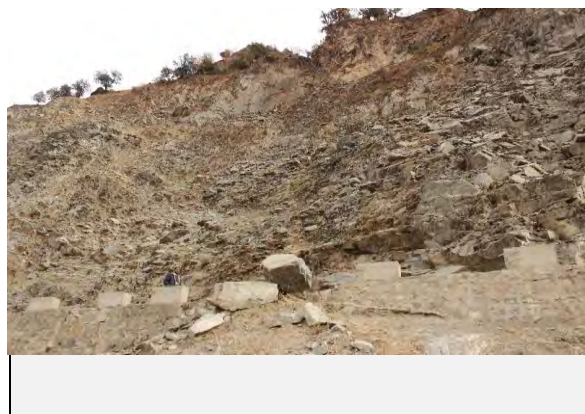
Full view of the landslide

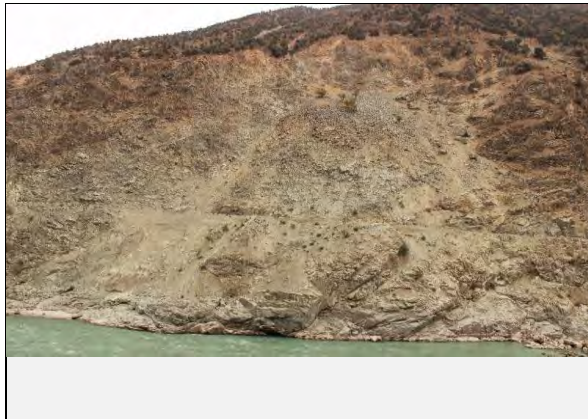
Full view of the landslide

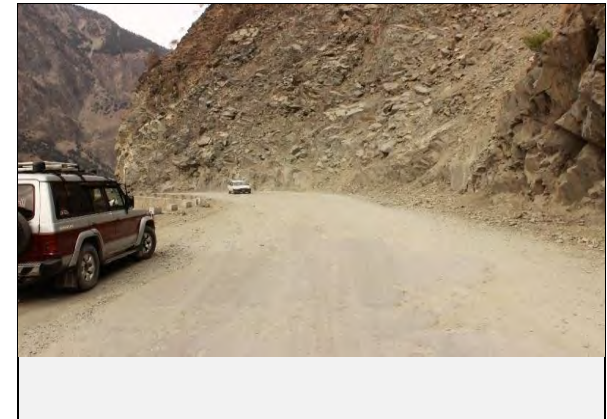
Road condition: Cut slope at the start point

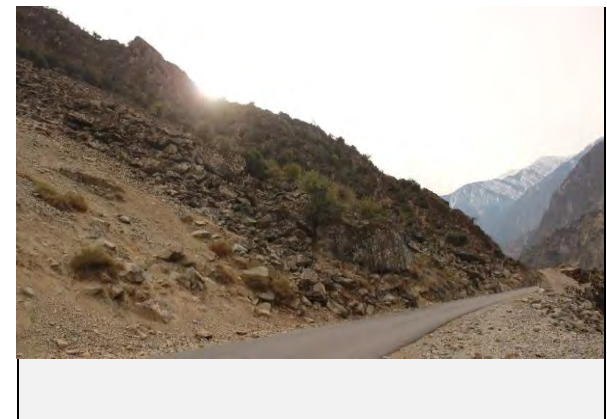
View of fallen blocks

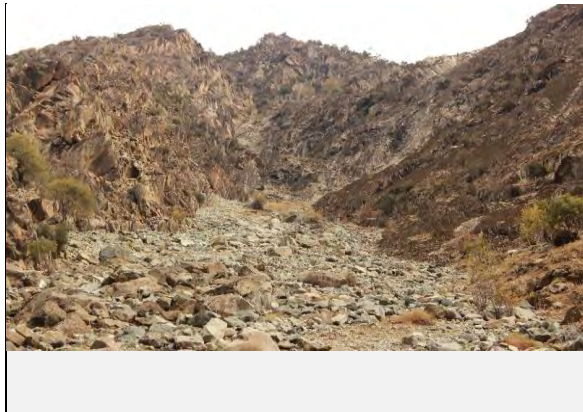
Full view of the landslide

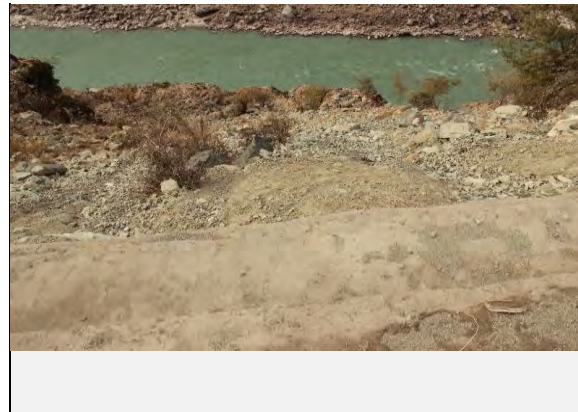
View of landslide on Valley side:

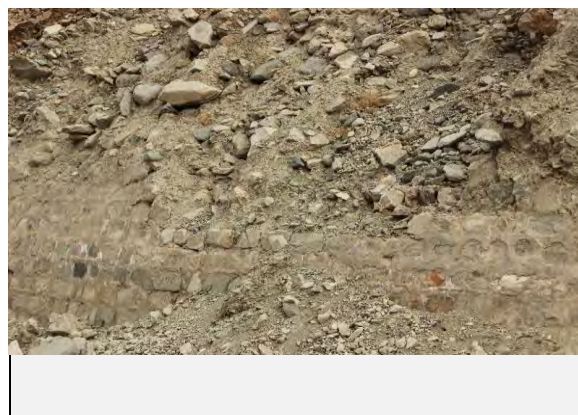
Existing countermeasures / anomalies: View of retaining wall as counter measure for slope failure

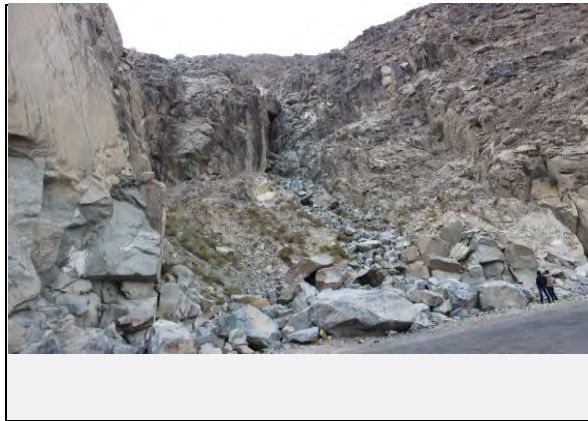
Full view of the landslide

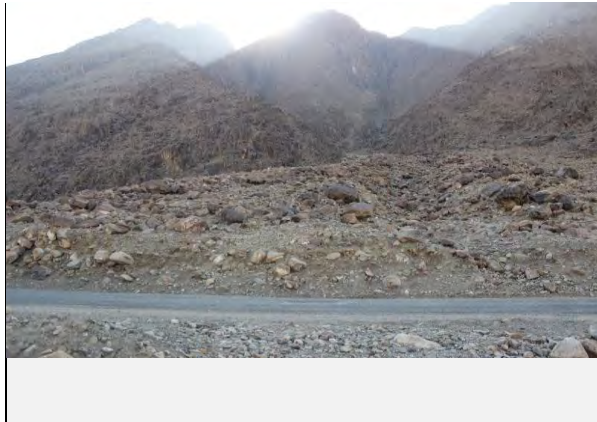
Mountain side view of the debris flow

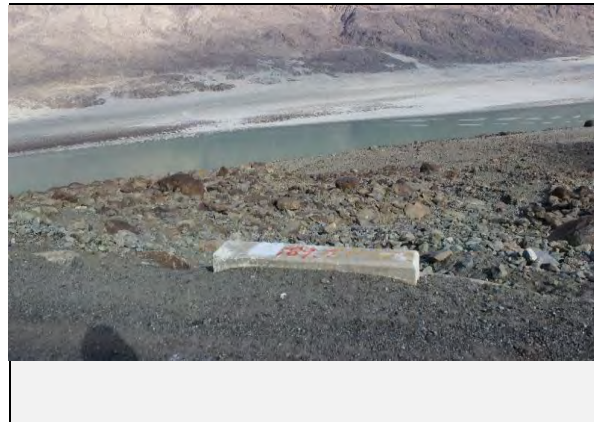
Valley side view of the debris flow

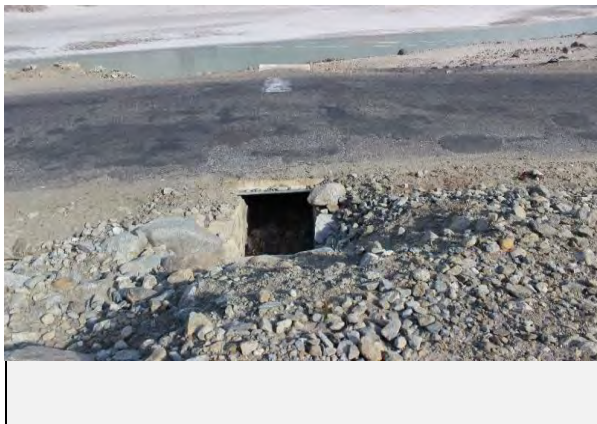
Inlet of the culvert for the debris flow

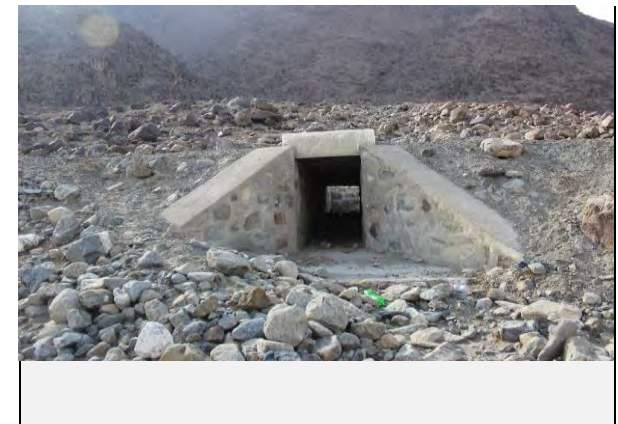
Existing countermeasures / anomalies: Culvert outlet view

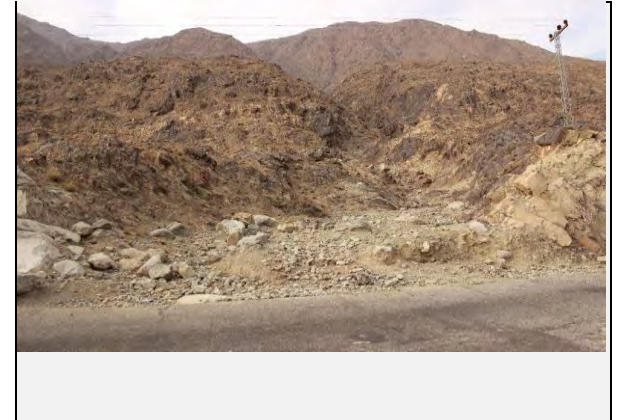
Front view of the debris flow

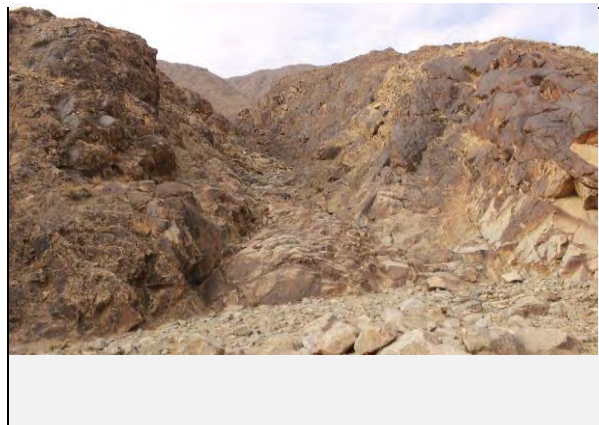
Mountain side view of the debris flow

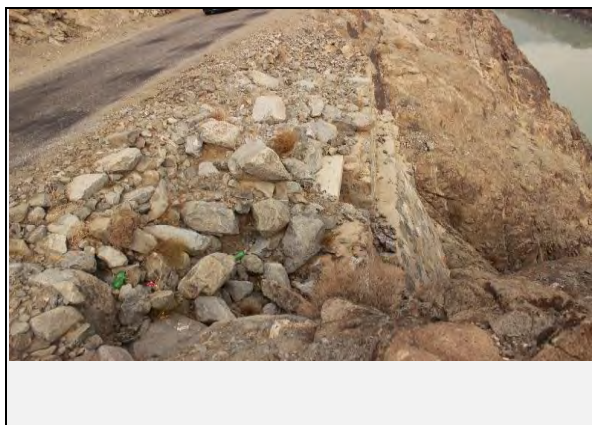
Valley side view of the debris flow

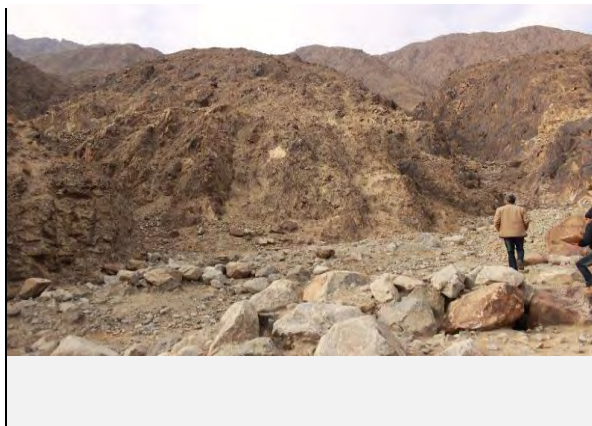
Boulders and Blocks along the Debris flo

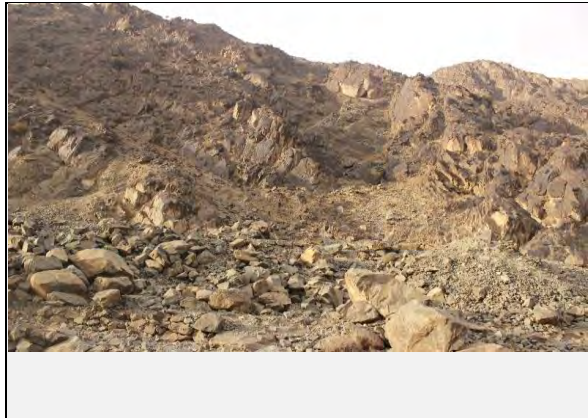
Full view of the landslide

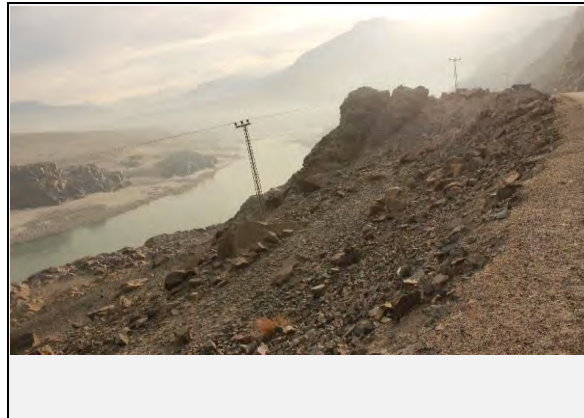
View of landslide on Valley side:
