Evaluation sheet (landslide)

Code no.	N	7	5		7			
Region Office								
Maintenance Unit

Date	12/9/2017
Inspector	asharat, Yasir, Sajid, Shafi

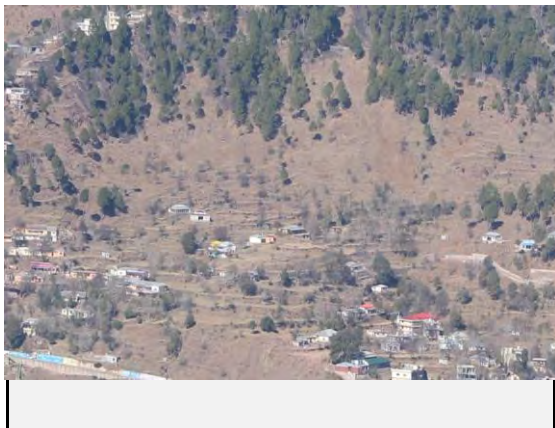
Mountain side view of landslide

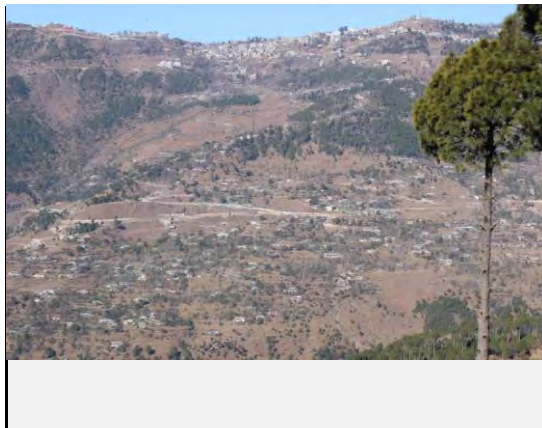
Valley side view of landslide

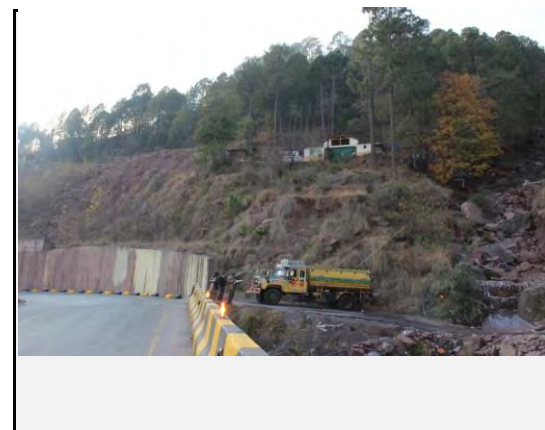
Existing countermeasures / anomalies: Retaining wall has been constructed at the toe of the slope failure

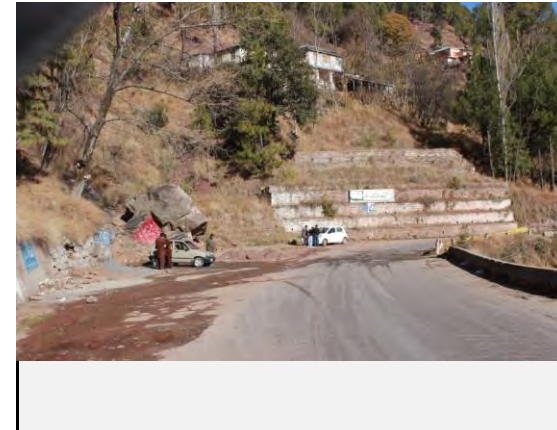
Road condition at location

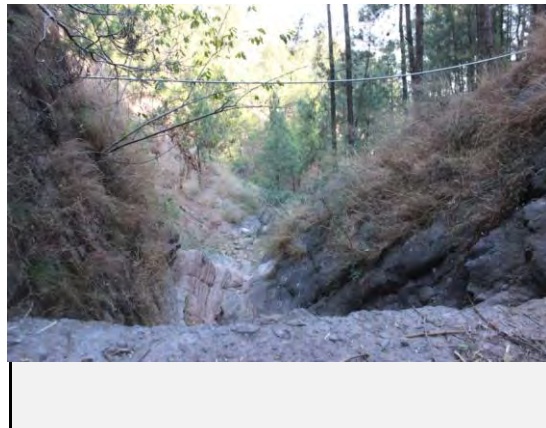
Valley side view of the debris flow

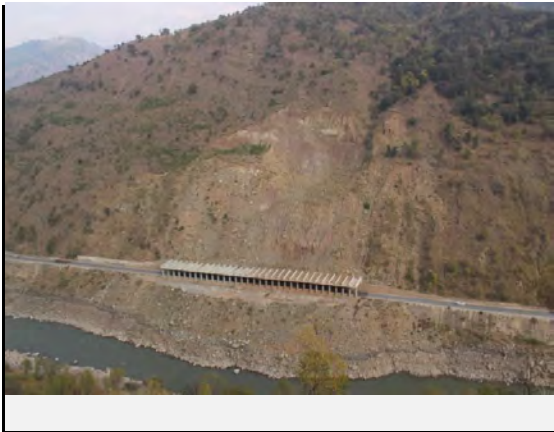
Full view of the landslide

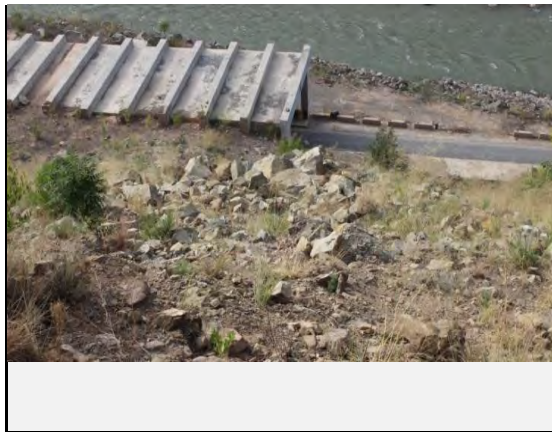
View of landslide on Valley side:

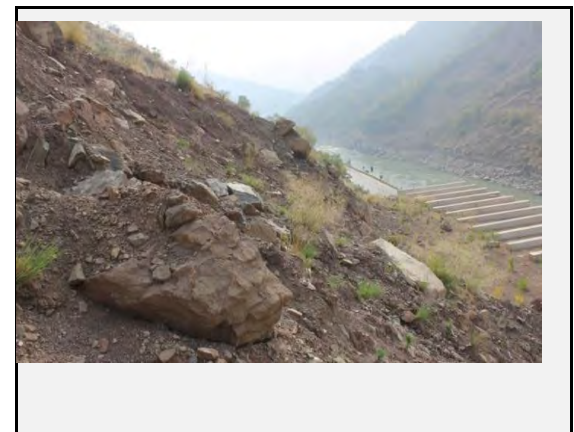
View of fallen blocks on Shed

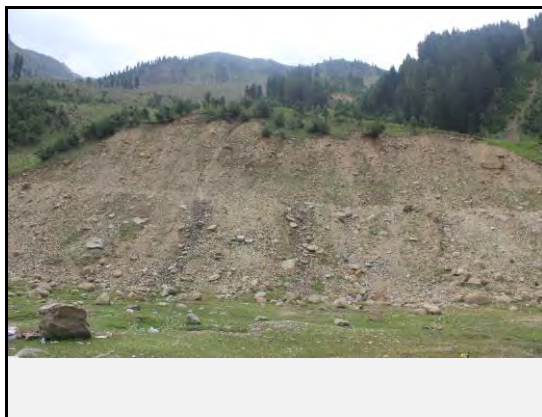
View of the Landslide at the middle point

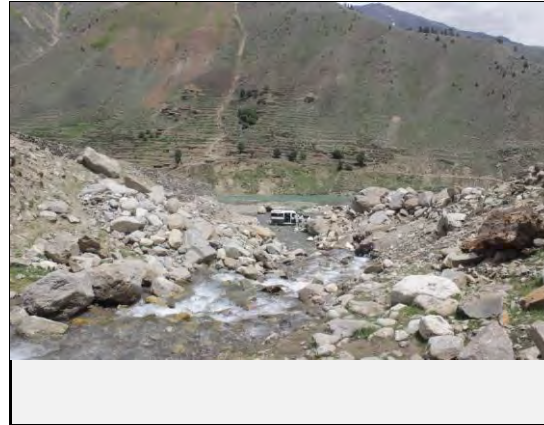
Valley side view of the debris flow

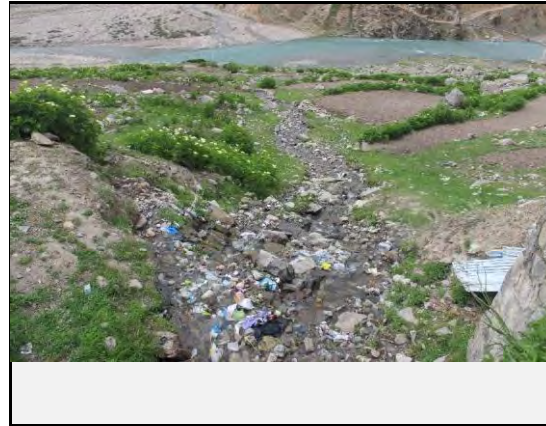
Valley side view of the debris flow

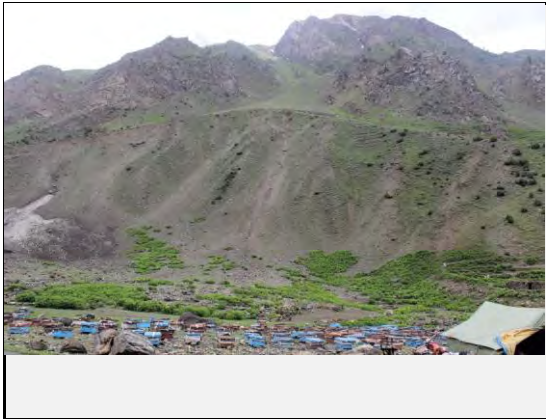
Full view of the Slope Failure

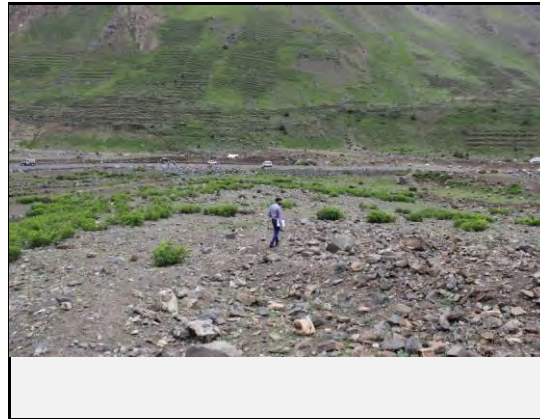
View of Slope Failure on Valley side:

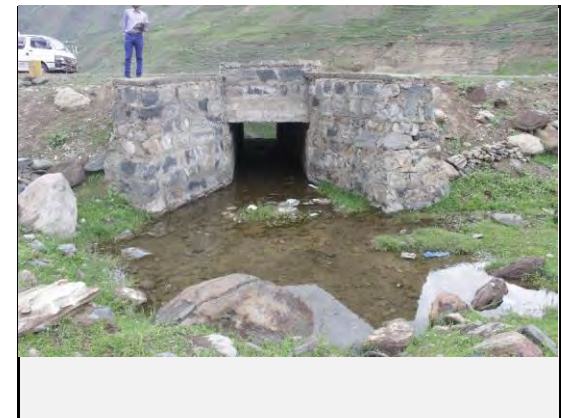
View of Box Culvert at the toe of slope

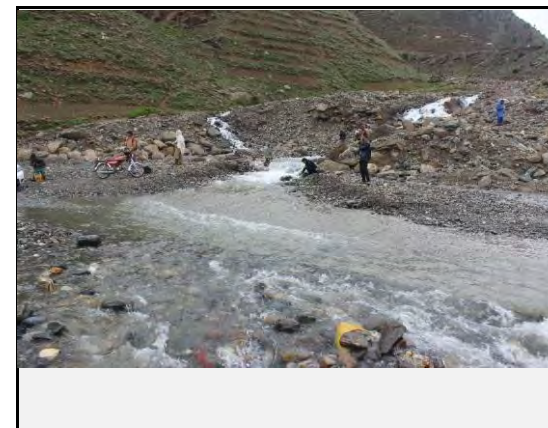
Front view of the debris flow

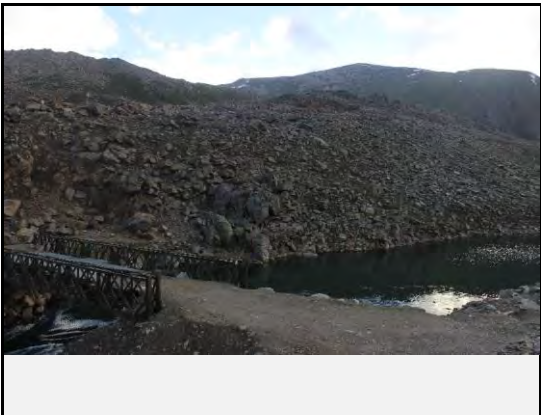
View of landslide on Valley side:

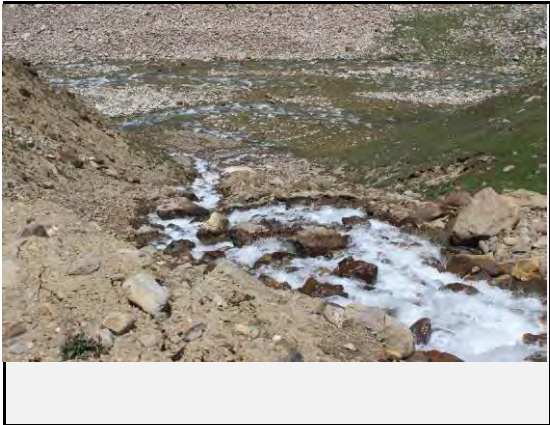
Valley side view of the debris flow

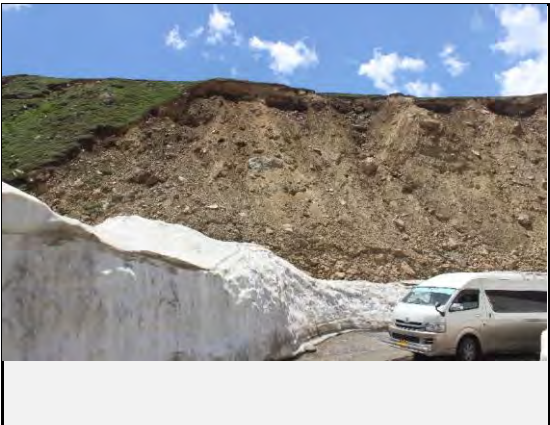
The new slope failures has been found along the debris flow

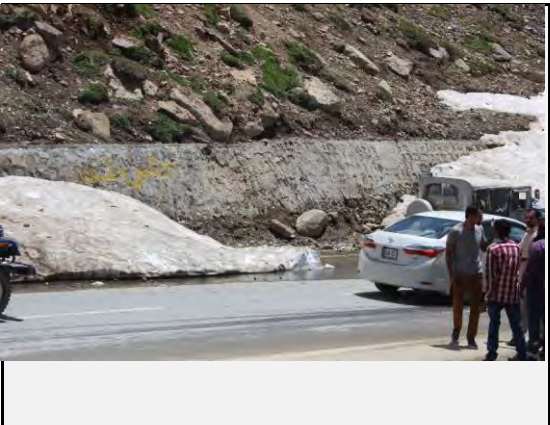
Road condition

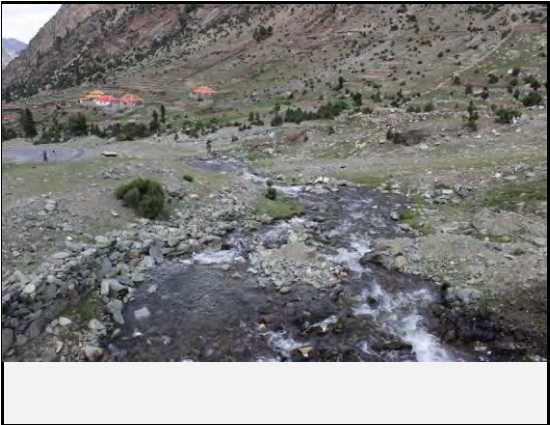
Valley side view of the debris flow

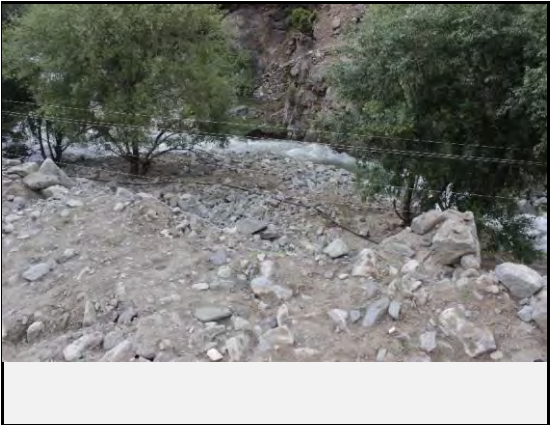
Valley side view of the debris flow

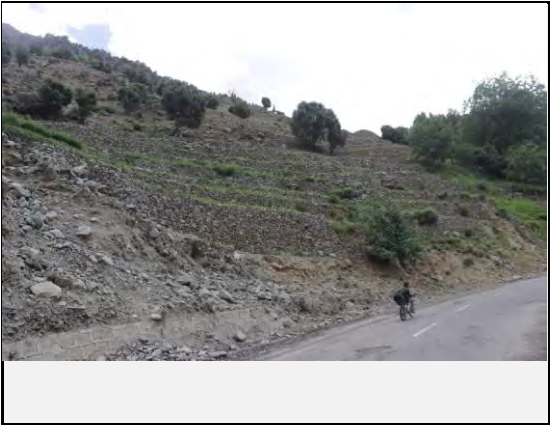
The Check dams has been built along the debris flow

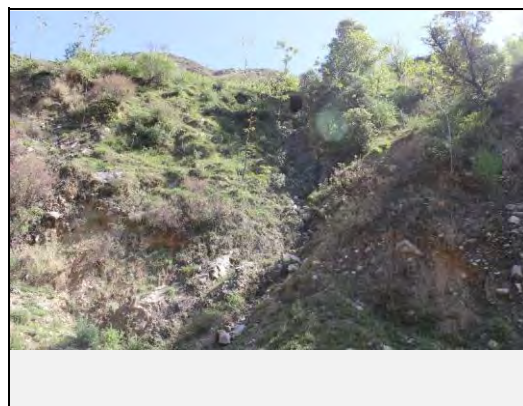
View of Gully erosion along the slope failure

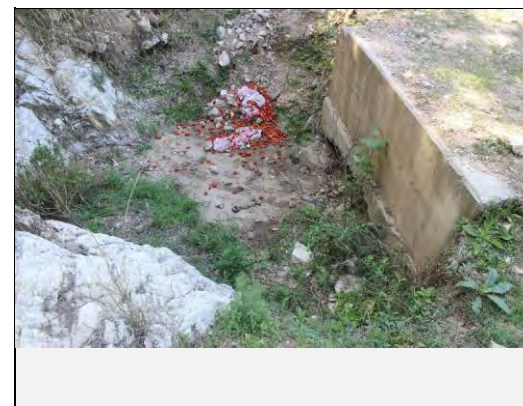
Existing countermeasures / anomalies: View of culvert inlet at the toe of slope failure

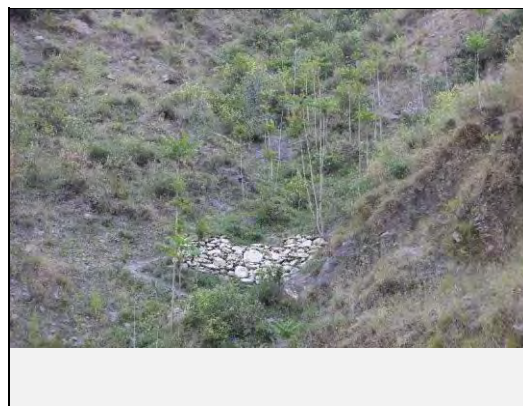
Existing countermeasures / anomalies: View of check dam as counter measure

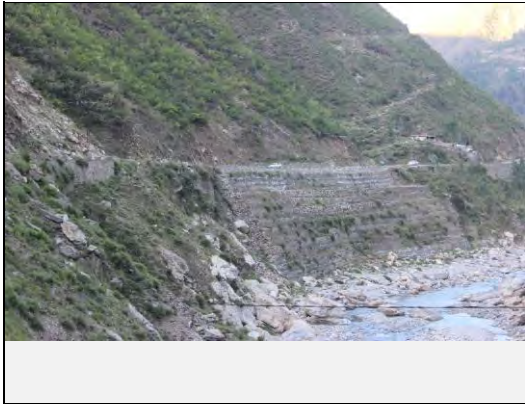
Full view of the slope failure

This is an old landslide which is retriggered during the construction of road. Detached boulder are present on the slide. Loose debris on the bedrock are prone to sliding. Active soil erosion on the slide leads to the development of gullies. Shrubs are present on the slide with no trees. No counter measures are present to protect the slide.

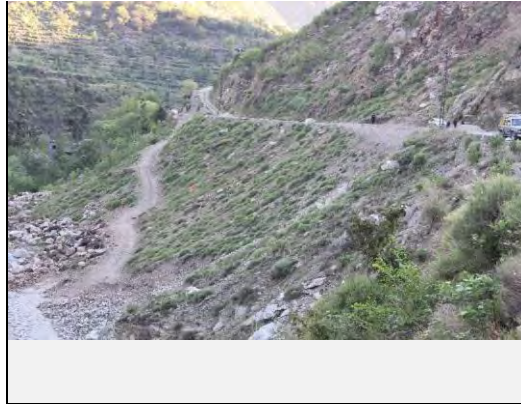
View of slope failure on Valley side:

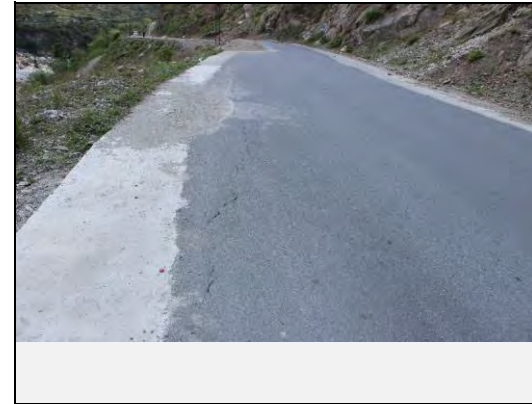
Road condition: Cut slope at the start point

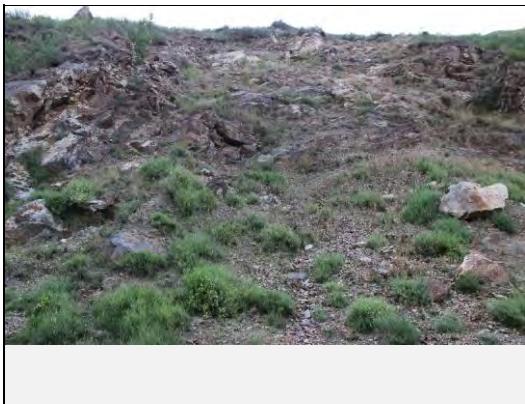
View of the slope failure at the middle point

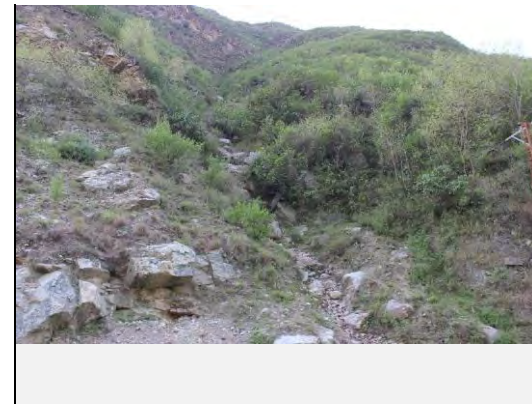
View of drainage that cuts the slope

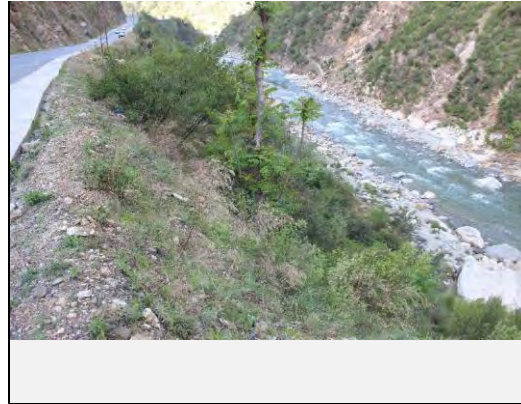
View of slope failure on Valley side:

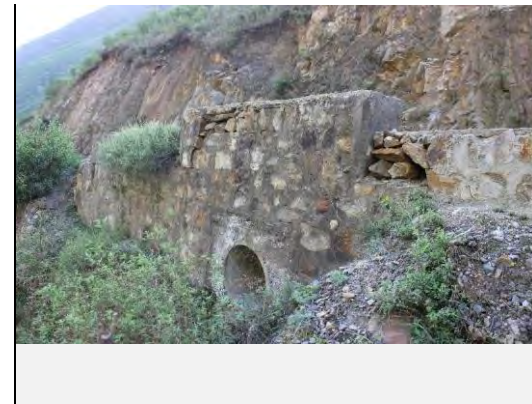
View of Drainage pipe and damaged retaining wall

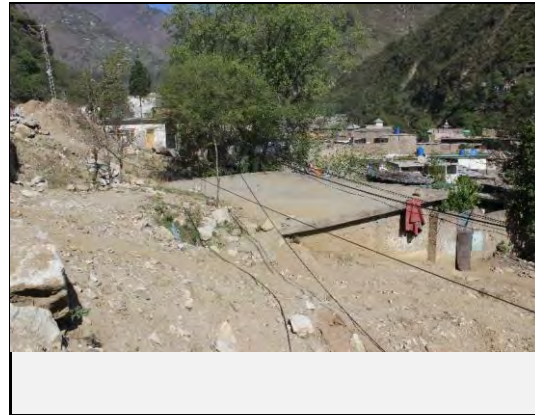
Valley side view of the debris flow

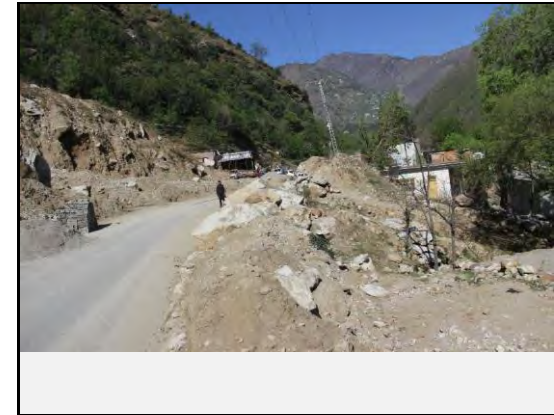
Front view of the debris flow

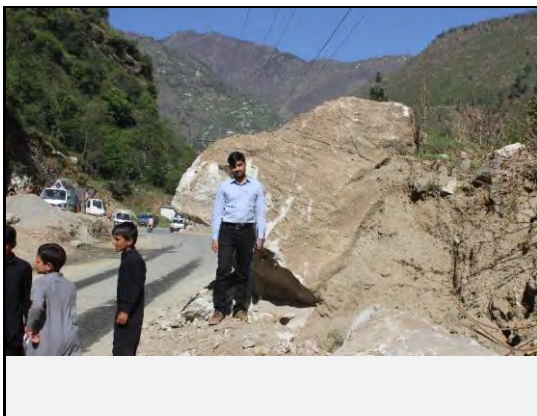
View of fallen block with the debris flow that can damage the population along the downstream.

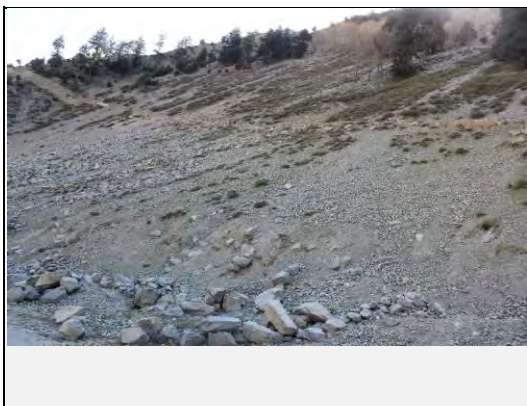
Full view of the slope failure

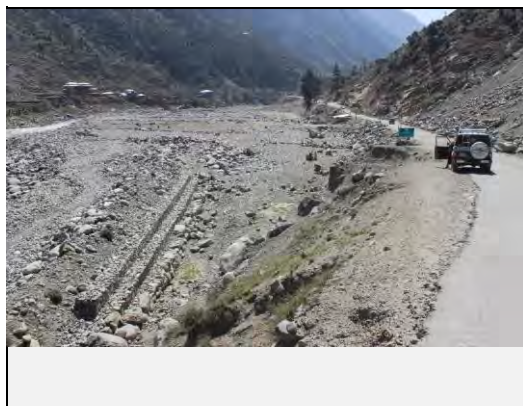
View of slope failure on Valley side and a river diversion structure built at the toe of the slope failure

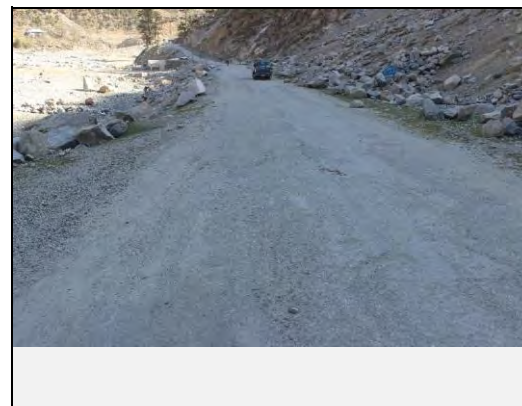
Road condition: Cut slope at the start point

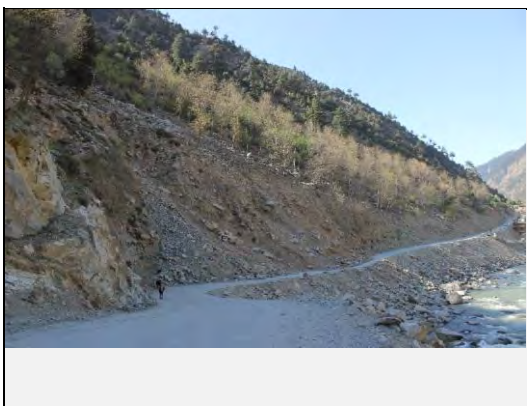
View of the slope failure at the left flank

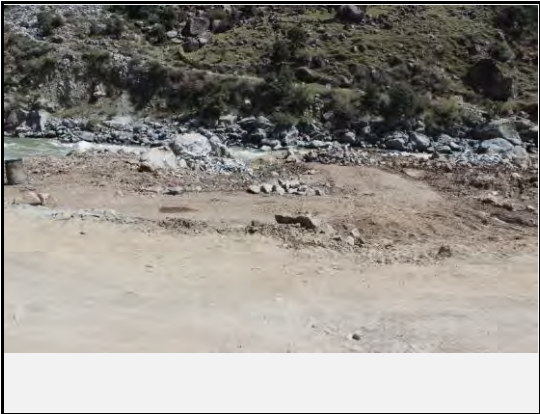
Valley side view of the debris flow

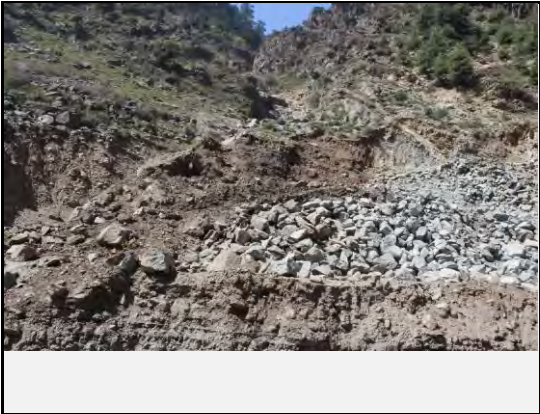
Front view of the debris flow

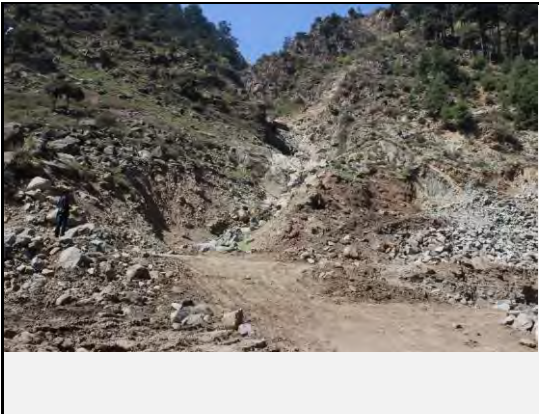
A view of slope failures along the debris flow

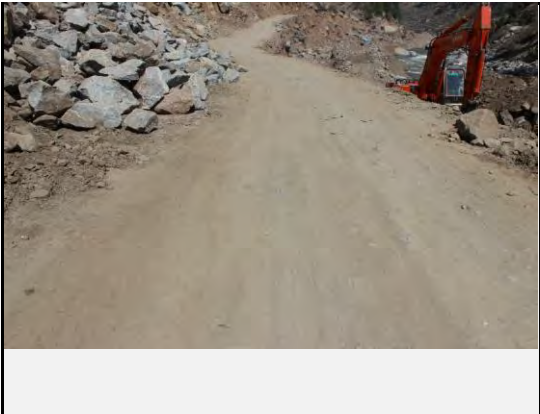
Existing countermeasures / anomalies: Retaining wall is being constructed at the toe of the debris flow

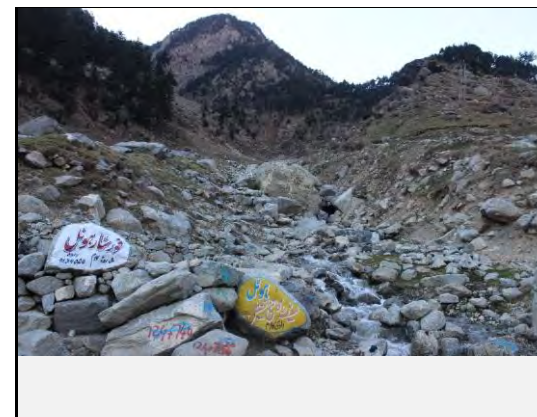
Front view of the debris flow

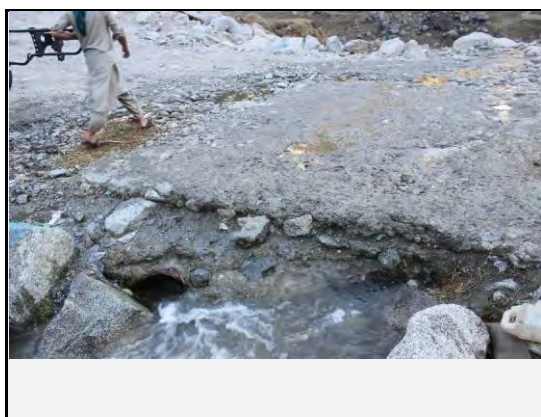
The damage on road has been observed with inlet of pipes for debris flow

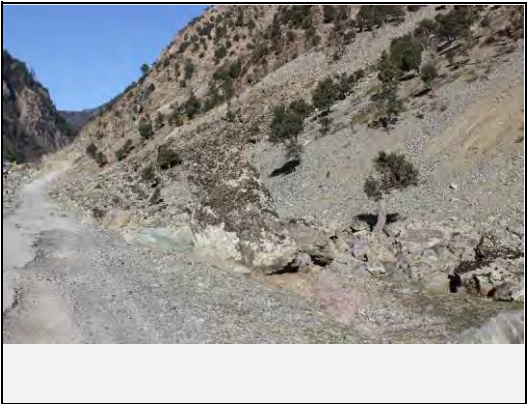
It is a complex slide comprising of rock fall and debris flow. Debris is comprised of boulders, gravels, sand and silt. Source of debris is from steep outcrop with fractured and jointed rocks. Hanging and detached boulders are lying on the debris that are prone to sliding during the rainfall. Soil erosion leads to development of water channels in the slide. The loose material on the slide is prone to debris flow during the rainy season. Excavation of the loose debris for construction material also trigger the slide. A small retaining wall is built, however, it is also damaged due to

Full view of the slope failure

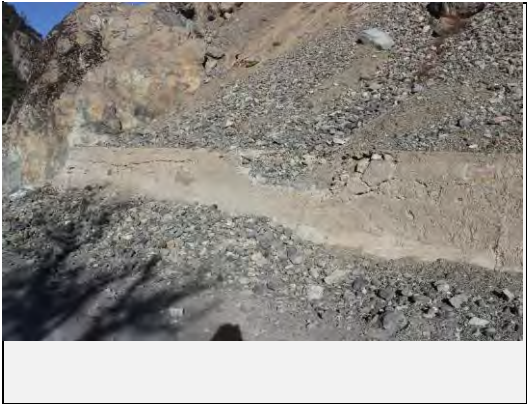
Existing countermeasures / anomalies: View of Retaining Wall as counter measure

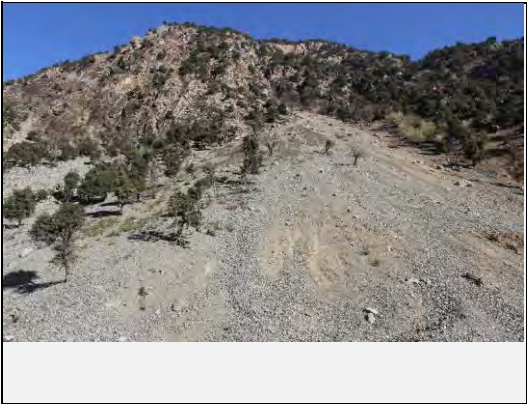
View of gully developed in the slope failure

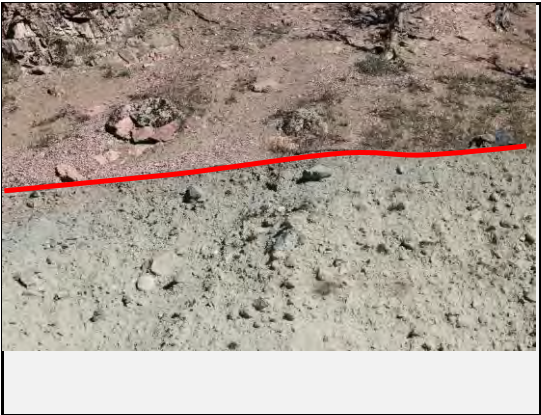
The existing road has been damaged. Red line shows the old road displaced by the debris flow.

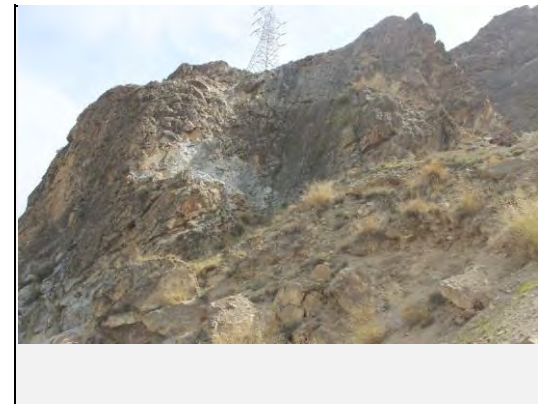
View of drainage that cuts the slope

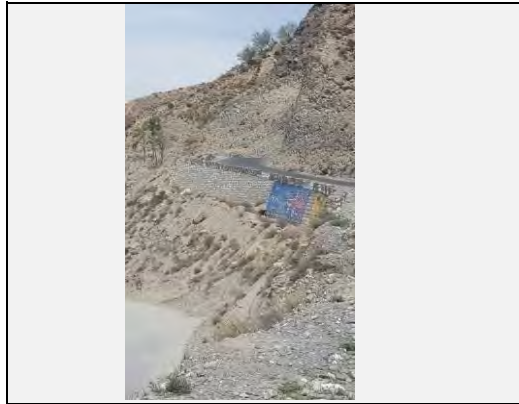
View of Slope Failure on Valley side:

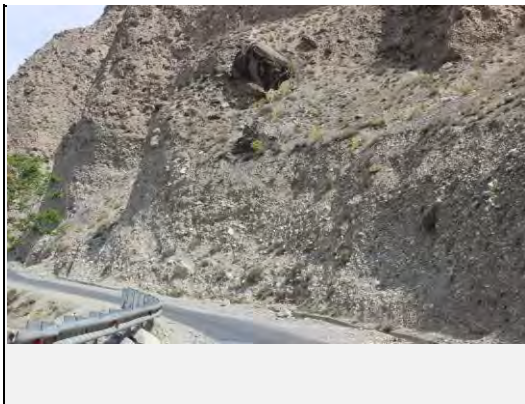
View of the slope failure at the middle point with boulder which threaten the road and traffic.

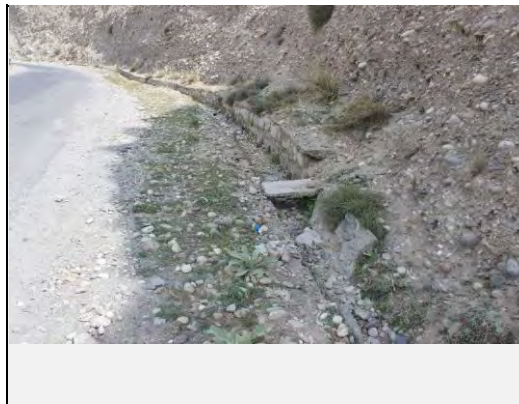
Existing countermeasures / anomalies: View of channel at the toe of Slope Failure

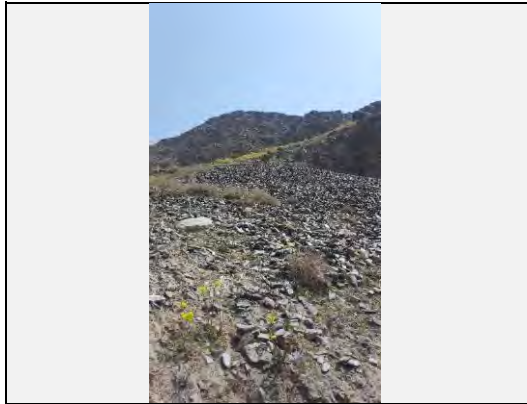
Full view of the slope failure

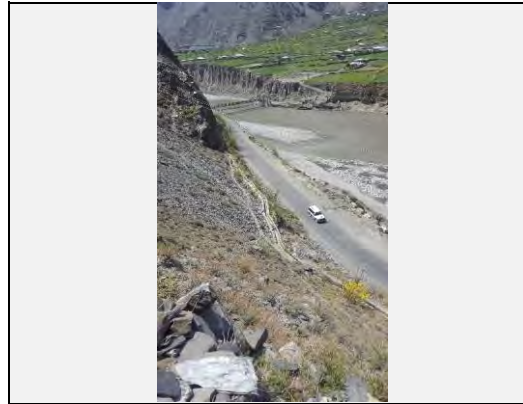
View of slope failure on Valley side:

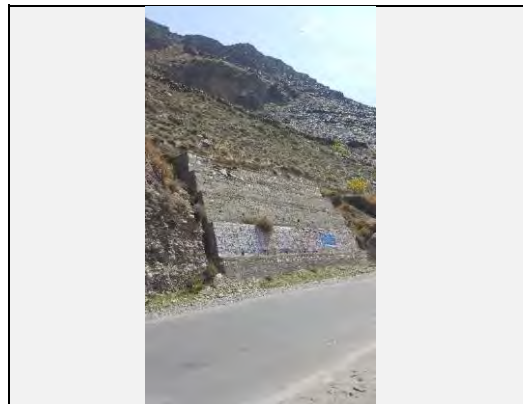
Existing countermeasures / anomalies: View of Stepped Retaining Wall as counter measure

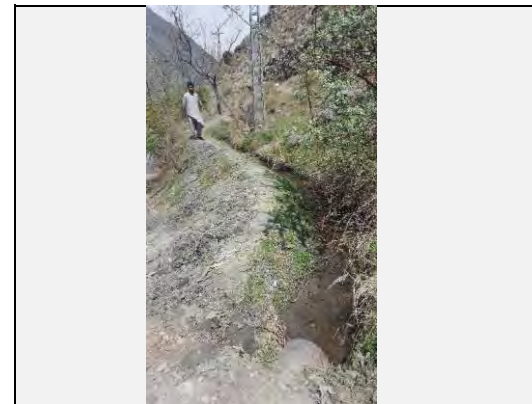
View of water Supply Scheme passing in the middle of the slope failure
