**THE PROJECT  
FOR  
PILOT GRAVEL BEACH NOURISHMENT  
AGAINST  
COASTAL DISASTER  
ON  
FONGFALE ISLAND  
IN  
TUVALU**

**FINAL REPORT  
(MAIN REPORT)**

**April 2018**

**JAPAN INTERNATIONAL COOPERATION AGENCY**

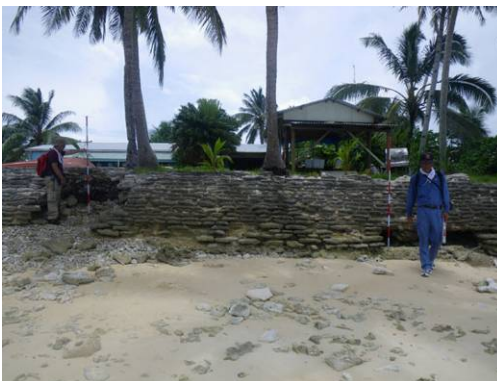
Figure 1.3.3 Stone Fence at North Side of Vaiaku Lagi Hotel

Figures 1.3.1 and 1.3.2 show the coastal facilities done through public works before the commencement of the Project. Coastal facilities done by private individuals are shown in Figures 1.3.3 and 1.3.4. Common protection measure before was just concrete seawall or vertical revetment using poor concrete block or coral rock. Such coastal protections did not have sufficient efficiency on protection function. Also, further deterioration on coastal use and environment was induced.

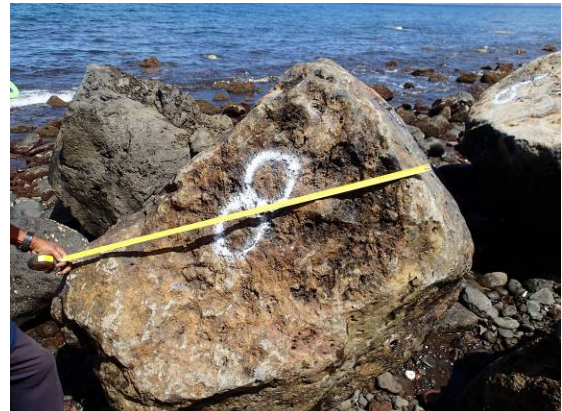
Figure 9.3.3 Inspection for Procurement of Armor Stones

Armor stones were procured in Taveuni Island, Fiji for the groin and backshore stones. The size and shape of the stones were inspected at the procurement site as shown in Figure 9.3.3.

(Size Measurement)

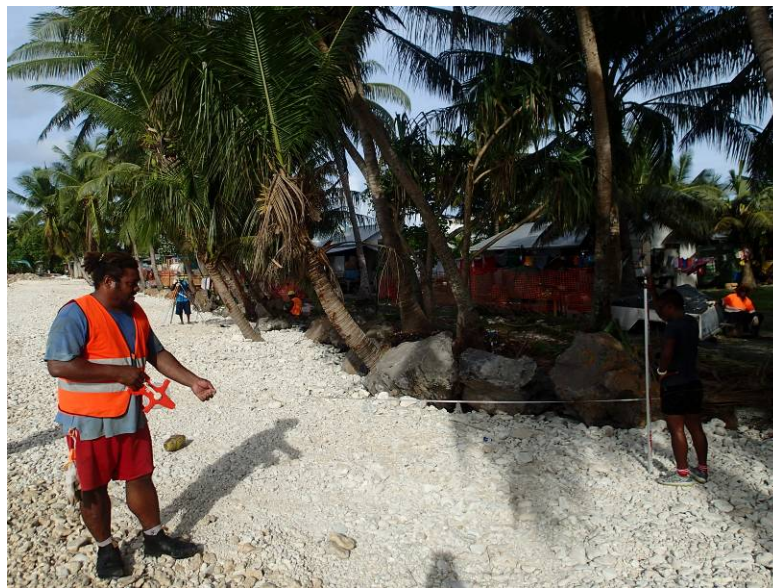
Figure 9.3.4 Photo During the Inspection (Gravel Beach Profile)

As part of the quality management, inspections related to the pilot construction of gravel beach had been conducted using inspection sheets prepared by JET and were completed as shown in Table 9.3.1. Figure 9.3.4 shows a photo taken during the inspection of the gravel beach profile. The inspection report can be referred to the Supporting Report-8.

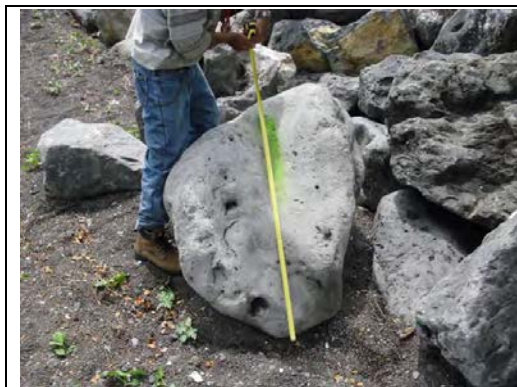
Figure 9.4.1 Inspection of Armor Stone in Taveuni Island, Fiji

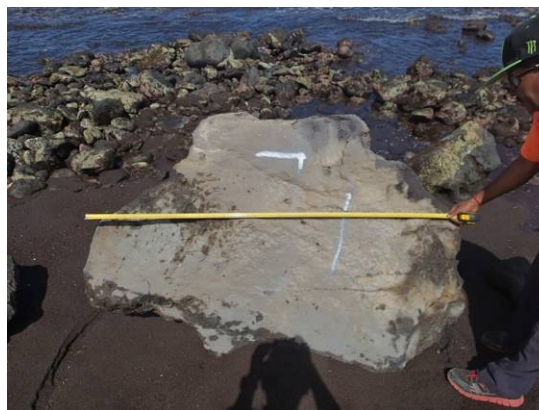
Figure 9.5.8 Example of Armor Stone at Quarry Site

With consideration of its stability and utilization, design weight was set as more than about 1 ton for both groin and backshore stones. Armor stones were procured at the quarry site in Fiji and the unit weight of those stones was confirmed at about 2.5 t/m<sup>3</sup> through the laboratory test conducted by the contractor. Therefore, armor stones of more than 0.5 m<sup>3</sup> of the volume (more than 0.8 m of a diameter) were procured to satisfy the design weight. For armor stones, the height, vertical, and horizontal length were measured and the JICA Expert Team confirmed whether the size met the requirement or not. Figure 9.5.8 shows an example of the armor stone selected at the quarry site with a length of 90 cm.

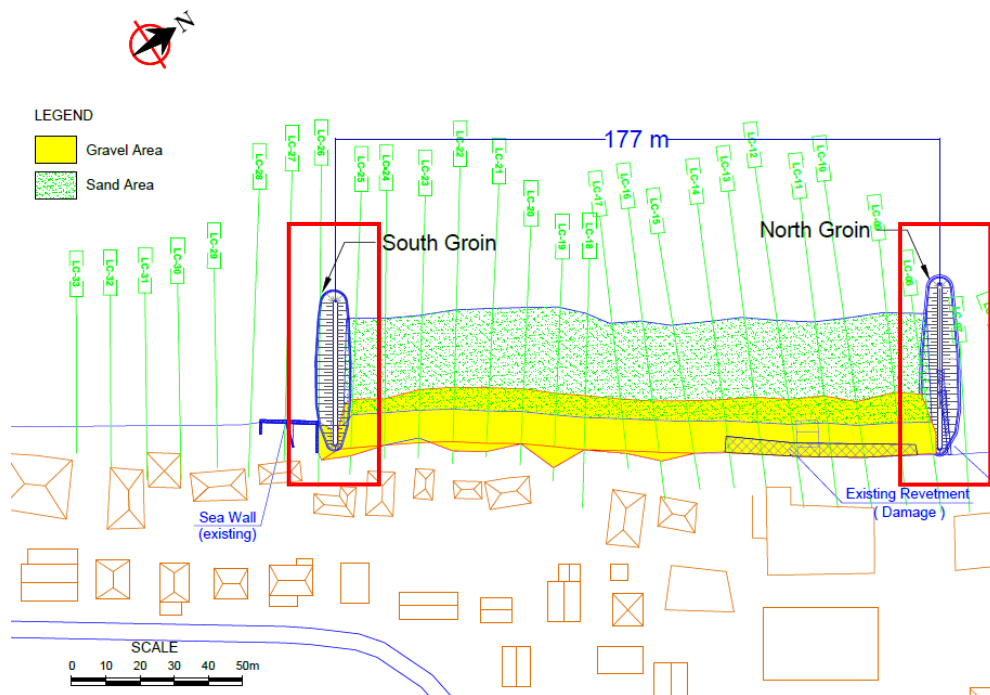
Figure 9.6.1 Location of Groins for Final Inspection

The final inspection after the defect liability period was implemented to the north and south groins, which are the permanent structures of the beach nourishment. The inspection items are listed in Table 9.6.1 and these items were inspected by visual examination, photo comparison, and leveling survey.

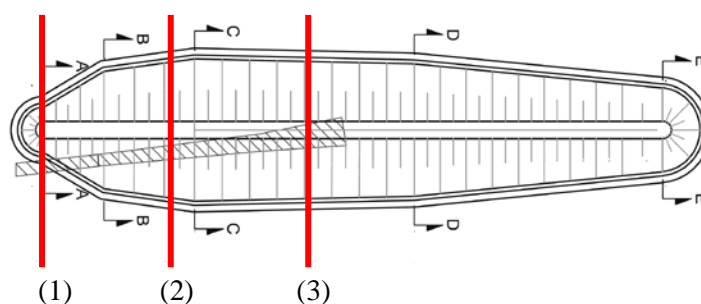
Figure 9.6.4 Survey Lines on Groins

Cross section survey was also conducted to check if changes in profile had occurred or not after the construction. The results are shown in Table 9.6.2 and Table 9.6.3. No major changes in height was observed from the survey but a slight subsidence was observed for both groins and its rate increased at seaward. This was caused by the sink of armor stones in sandy bottom due to wave action. Placement of large armor stones on sand bottom usually causes large subsidence, but the rate were repressed for these groins by the presence of gravel mat placed on the sand bottom. Subsidence of groins could occur in the future especially when high waves act on them. However, the rate of subsidence was expected to be not so large compared to what was observed in this survey.

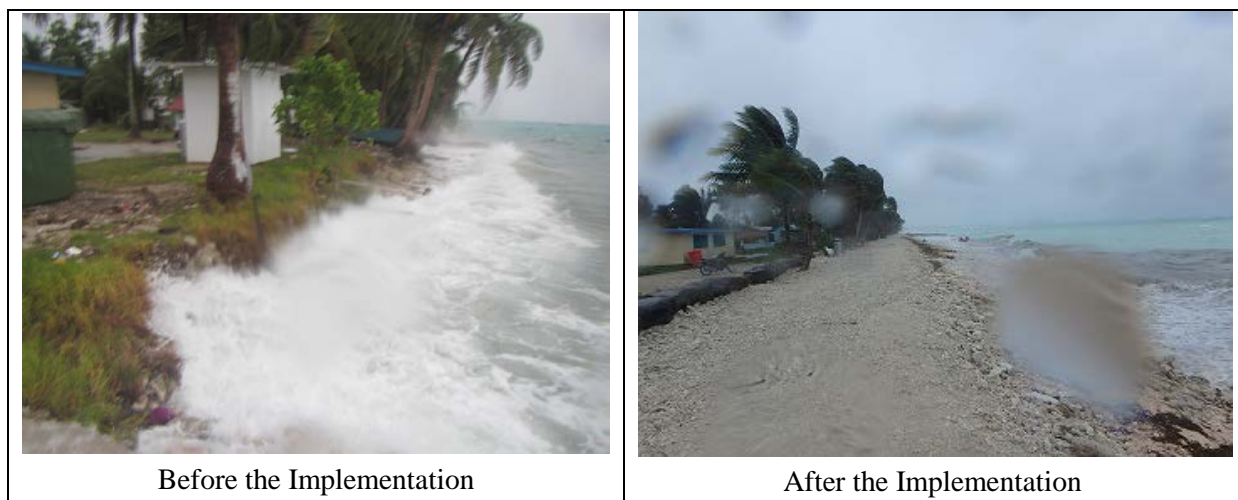
Figure 9.8.4 Comparison of Wave Condition Before and After the Implementation  
(in high wave condition)

Before the Project, wave intruded up to their property, easily. However, there was no wave intrusion at their property at this time even in the high wave condition (see Figure 9.8.4). The common opinions from the residents are that forming the gravel beach is surely effective to protect the land. On the other hand, some of the residents anticipated the gradual loss of gravel due to the same degree of storm frequently hitting.

As a result, the function to protect the land can be surely achieved as far as the beach maintains the present condition (width). However, it is not sure that the beach can maintain the necessary width for a long time or not under the same condition since hitting of storms is frequent. Continuous monitoring is still required to evaluate the validity of the proposed beach.
