DATA COLLECTION
SURVEY
ON
DISASTER RISK REDUCTION

Input from JICA for
Sulawesi Reconstruction Master Plan

FEBRUARY 2019

JAPAN INTERNATIONAL COOPERATION AGENCY
(JICA)

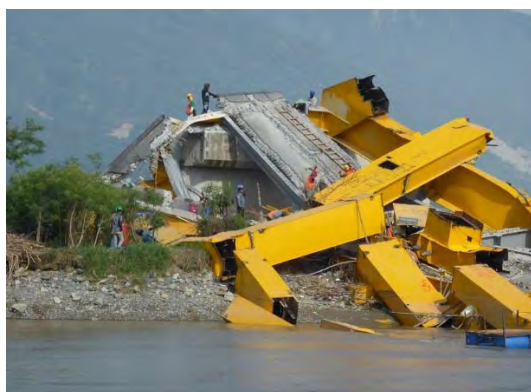
One steel arch structure (Jembatan Palu IV) was destroyed by the earthquake move in north-south direction.

Collapsed Jembatan Palu IV

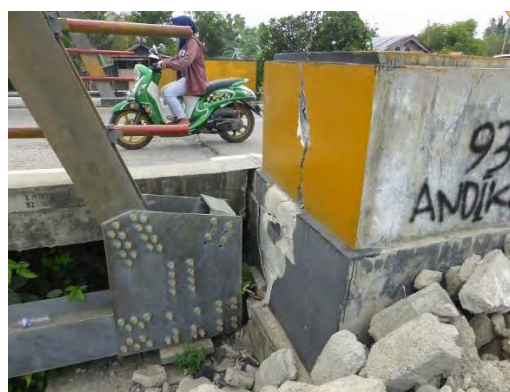
Hit of Girder on Abutment

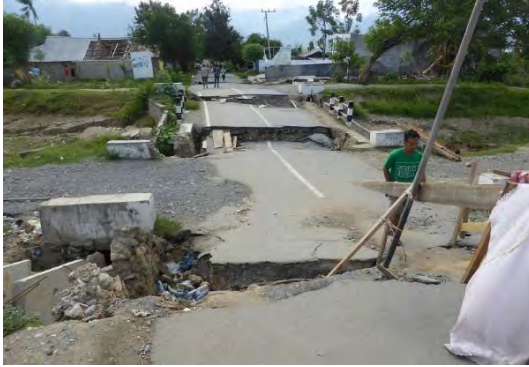
Collapse of Road near Liquefaction Area

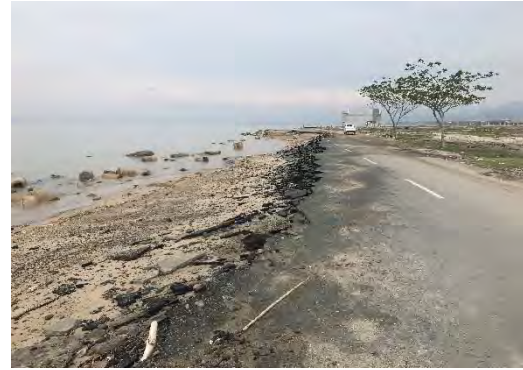
Damaged Road Surface by Tsunami

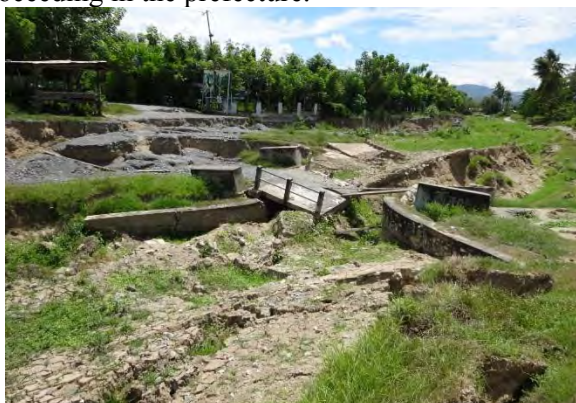
Destroyed irrigation canal in petobo area

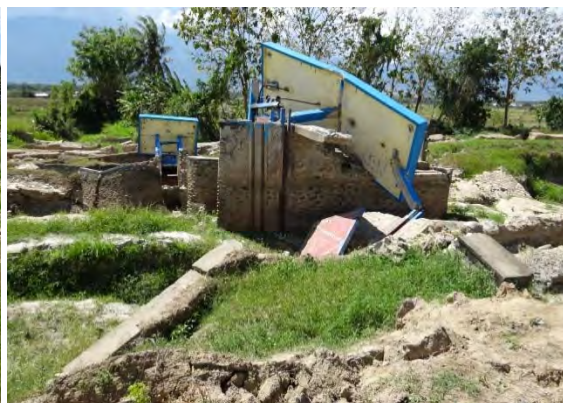
Destroyed diversion work in Jono Oge area

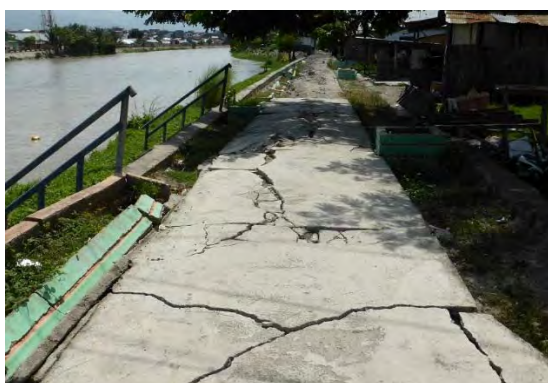
Most of the revetments along Palu River were damaged: cracked concrete walls, waved tops of bank, collapsed promenade of concrete bricks and lost walls. The small rivers are similar, too, and the same phenomena are seen.

Cracks on Top of Banks

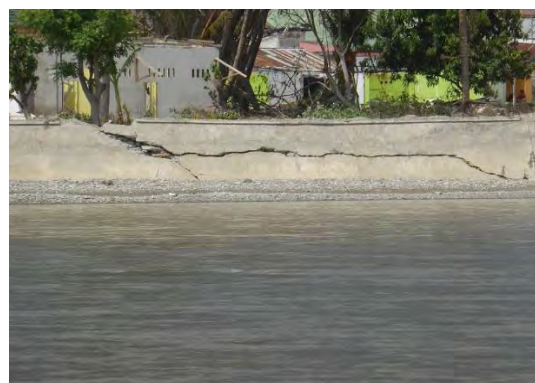
Collapse of Revetment

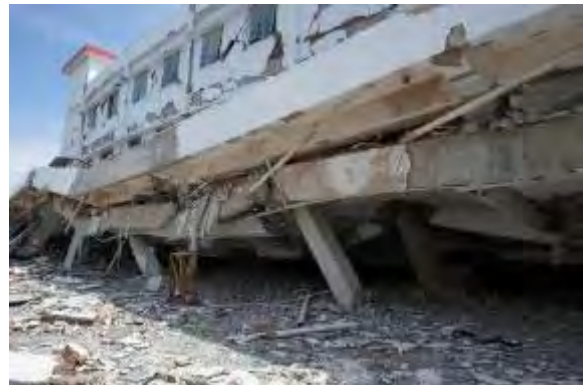
3) Palu City Hospital ANUTAPURA

After Earthquake: Totally damage

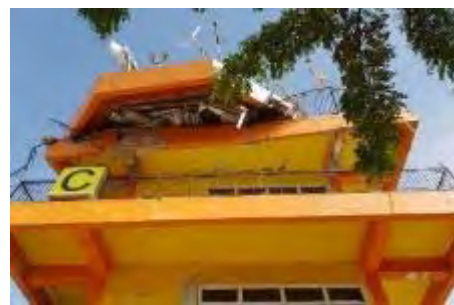
Due to earthquake, the control tower had critical damages

Destroyed control room

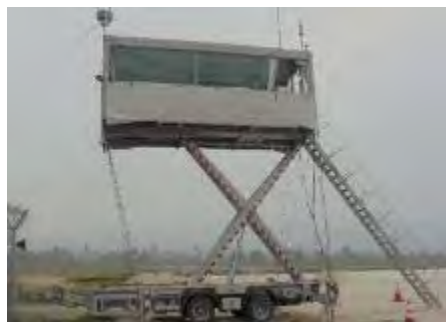
Temporary Operation in the Pre-fabrication house

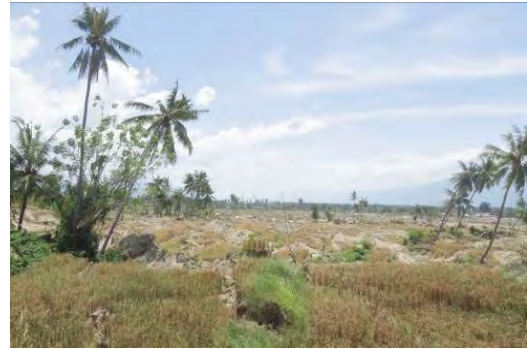
- Tensile crack initiation zone at the top: It has not reached flow (Figure 26).
- A zone where the surface layer is broken into a block of several meters in size and sliding fracture also occurs: Although it collapses, it has not reached a flow failure (Figure 27).
- Ground fluidized zone downstream from the sliding cliff: Long distance flow displacement of several hundred meters occurred, the surface ground was lost, and the lower layer from which water sprang out (Figure 28).
- Terminal flow material sedimentary zone: earth and sand and houses moving from upstream are accumulated (Figure 29)

Figure 27 : Collapse of Petobo Point

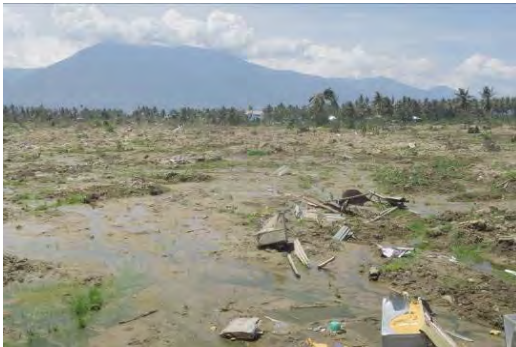
Figure 28 : Flow failed part of Petobo point

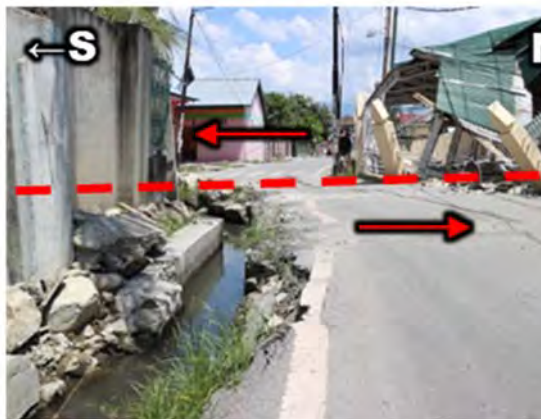
Figure 39 : Surface rupture at 20181102-6 site, Cemara str. Donggala Kodi districts.

- Left lateral displacement: 4.6m
- Vertical offset: None
- Strike direction: N20°W

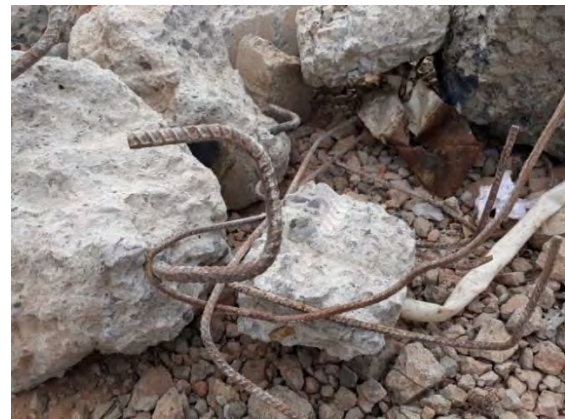
- Joint failure seems to have caused by column broken (Figure 52).
- Collapsed buildings doesn't seem to have used appropriate reinforced bars. Roa Roa hotel seems to have used very small reinforced bars narrower than 13 mm diameters, whereas in building code it should be minimum 13 mm (Figure 53–Figure 55).

Figure 51 : Too small reinforced bars used in Roa Roa Hotel

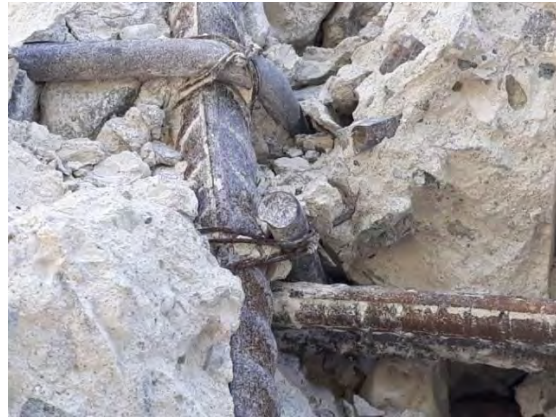
Figure 53 : Inadequate stirrup in Rusunawa Lere

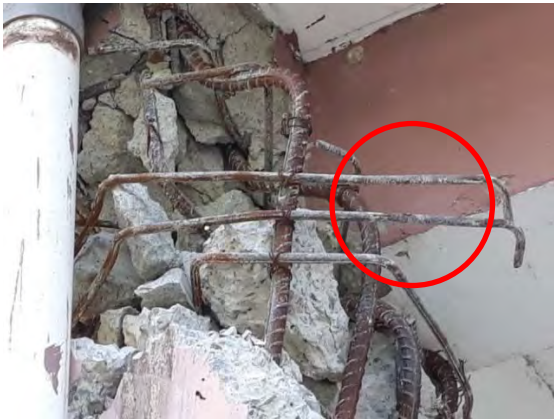
Figure 54 : Inadequate stirrup in Rusunawa Lere

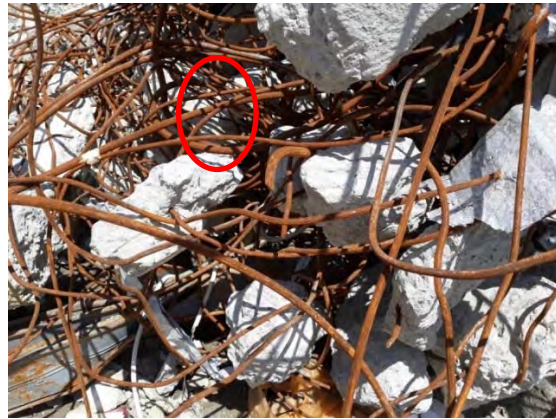
Figure 55 : Non-deformed bars still used in Lere,

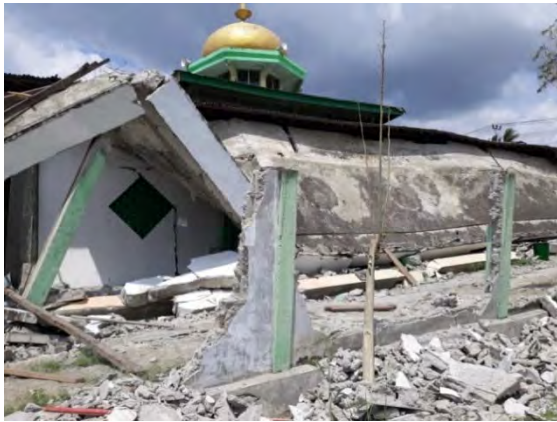
Figure 58 : Collapsed of Mosque

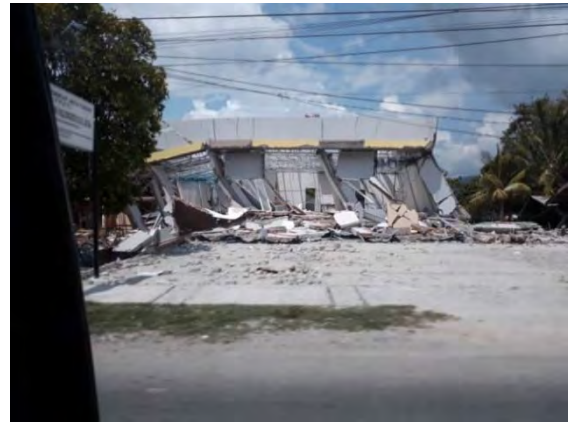
Figure 59 : Collapsed of Store

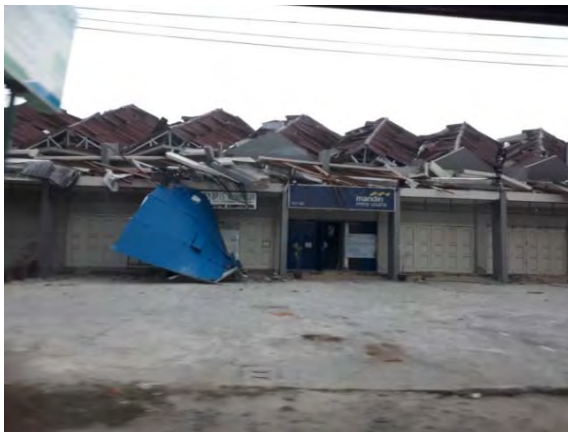
Figure 60 : Damaged Roof of Stores

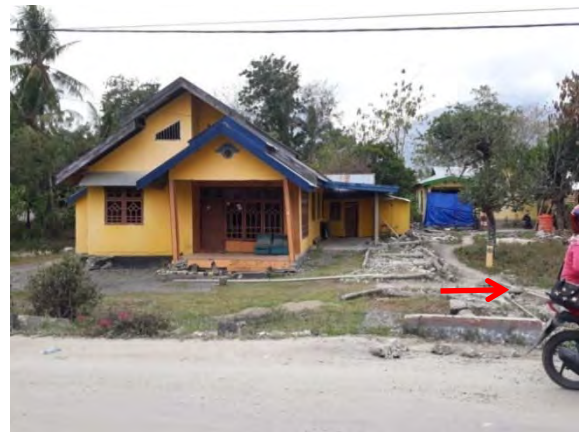
tilting column are found in Sigi. The movement of the ground was found which caused the fence of the house move around 1 meter to 2 meter from the gate (Figure 61), as it was measured.

Figure 61 : Tilting column of house and moving fence

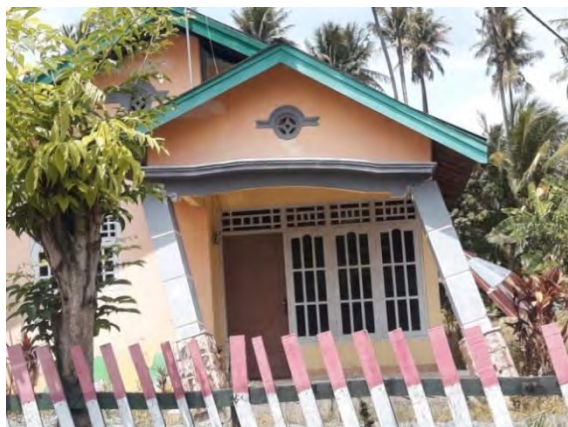
Figure 62 : Tilting column of house

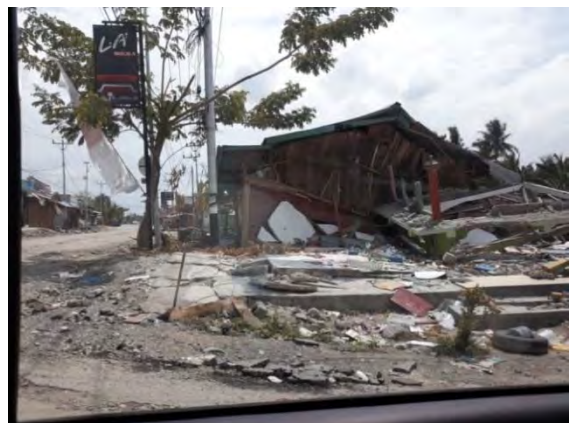
Figure 63 : Total Collapsed of House

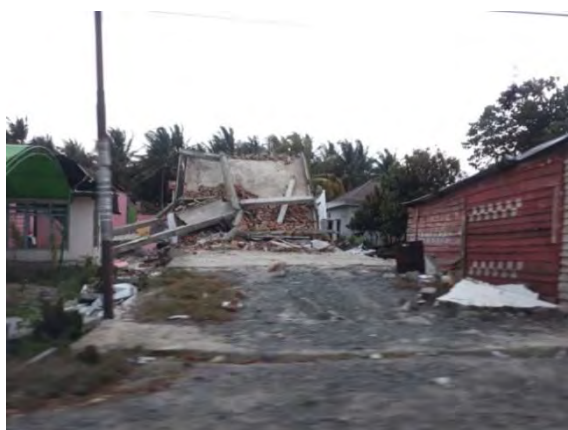
Figure 64 : Total Collapsed of House

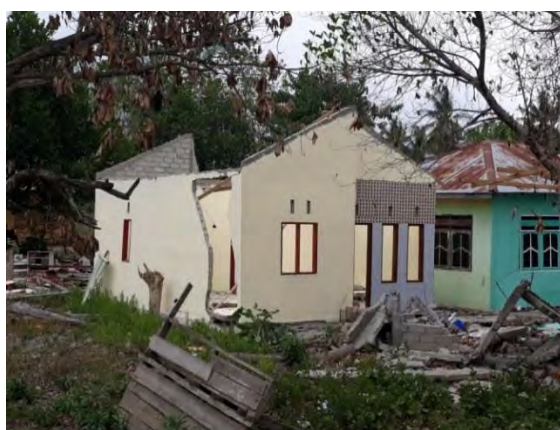
Figure 65 : Partial Collapsed of House

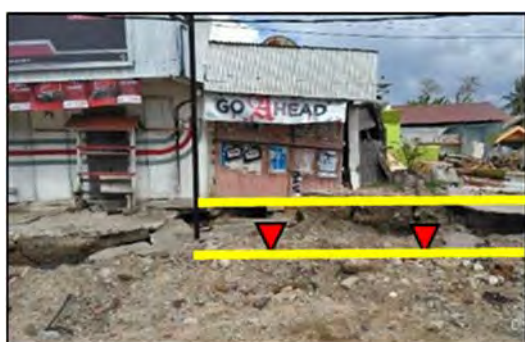
Figure 66 : Collapsed by Land Subsidence

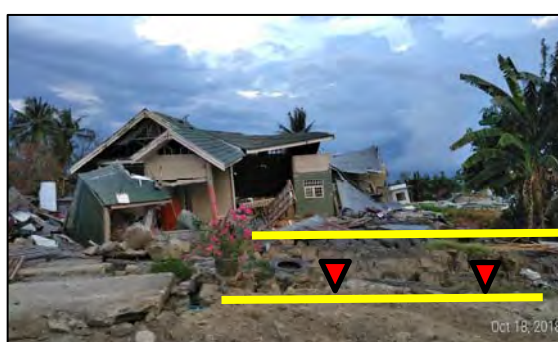
Figure 67 : Collapsed by Land Subsidence
