**Attachment 9: Kigali City Reservoir Inventory
Survey Results**

REPORT OF THE RESERVOIR SURVEY IN KIGALI

**THE PROJECT FOR STRENGTHNING OF NON-REVENUE
WATER CONTROL KIGALI CITY WATER NETWORK**

KYOWA ENGINEERING CONSULTANTS Co., Ltd/ WASAC Ltd

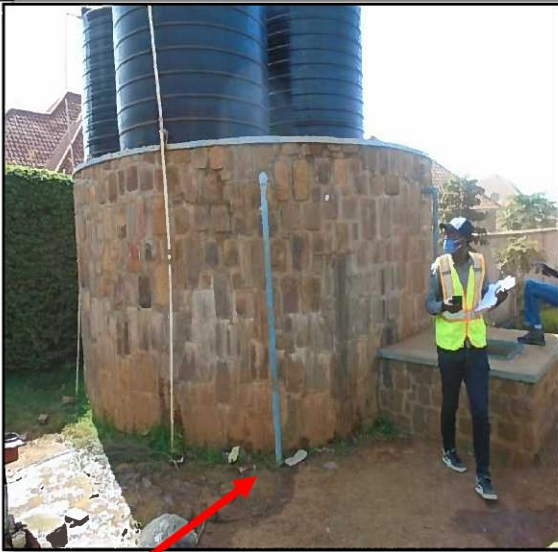
Outlet manhole need rehabilitation, cover and pipe reconnection

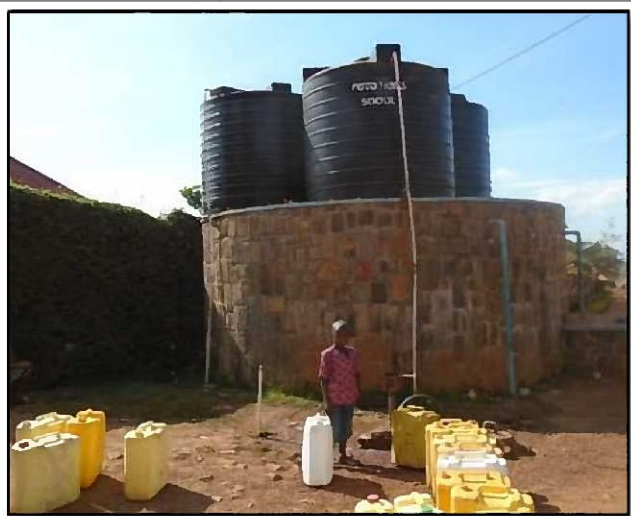
Inlet pipe needs a manhole and a valve.

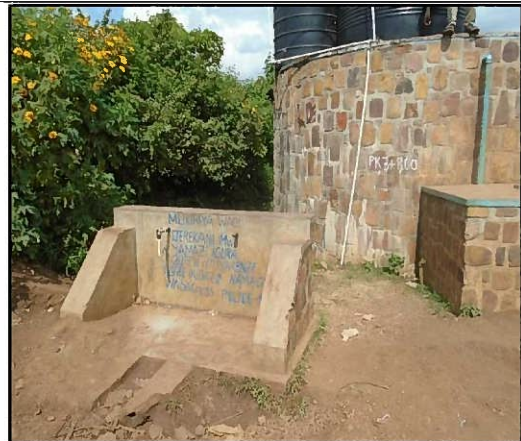
Reconnection to the existing Public Water Tap

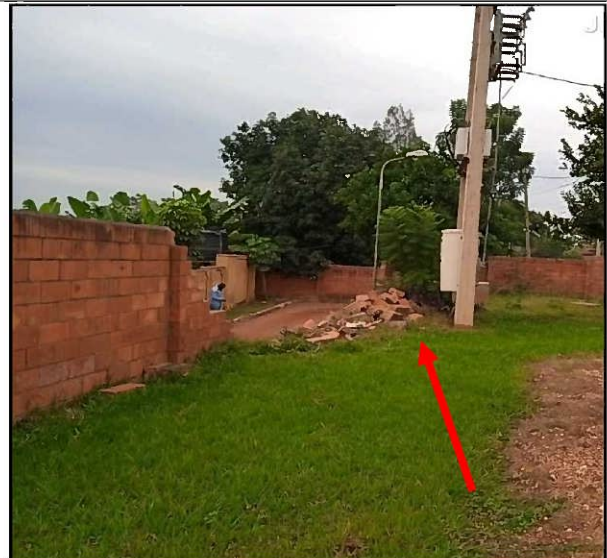
These fallen part of fence are being used by thieves and intruders

The fencing wall has fallen on upper and lower side of the station, this resulted in intrusion by passerby and theft of valve handle and now they have only one piece, if stolen consequences will be bad, meaning that the fence repairing is also a priority.

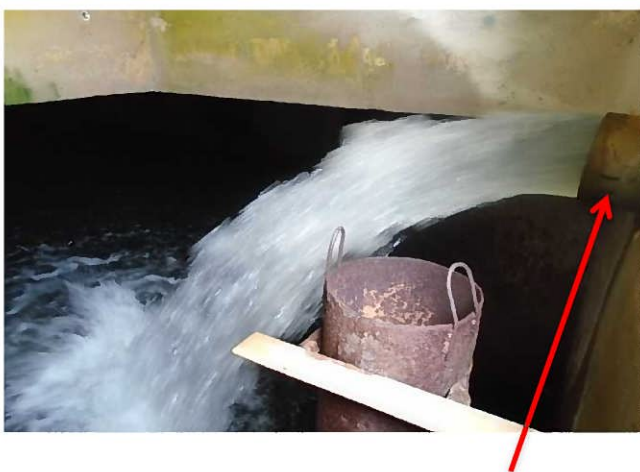
No Float Valve installed

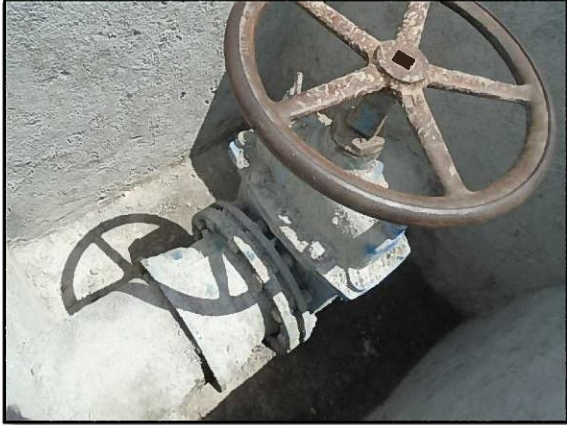
Inlet from Nzove Valve DN300 (Not working)

Action	Requirements
<ul style="list-style-type: none">• Replacement of Inlet Valve from Nzove DN300• Floater Valves installation for inlet pipes from Rwampara.• Installation of Inlet Valve for inlet pipes from Rwampara• Replacement of Outlet Valve• Pressure gauge• Cover for Inlet manhole (pipe from Nzove)	<ul style="list-style-type: none">• 1 Valve DN300• 2 Floater valves DN100• 2 Valve DN100• 1 Valve DN80• 1 Pressure Gauge• Construction workk

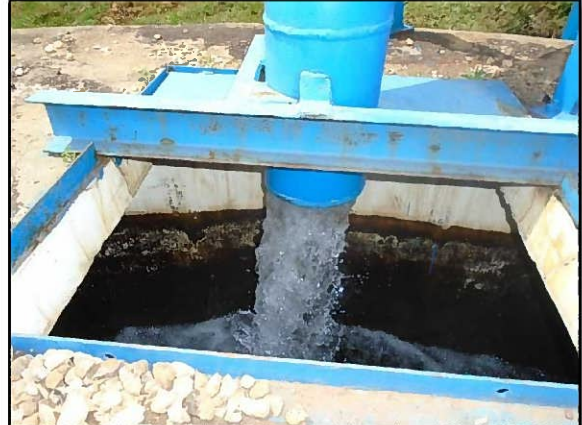
Inlet from Nzove Pipe DN300 (No floater)

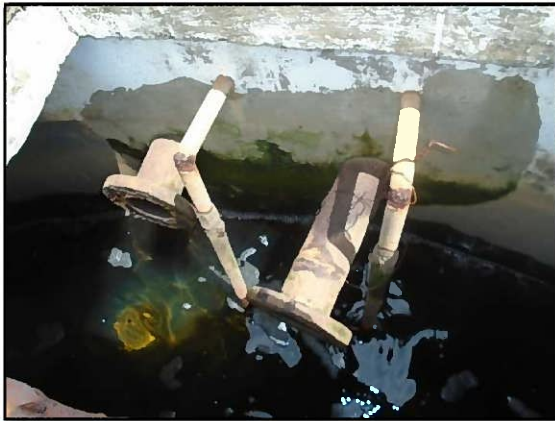
Inlet from Rwampara DN100 (no inlet valve or Floater valve)

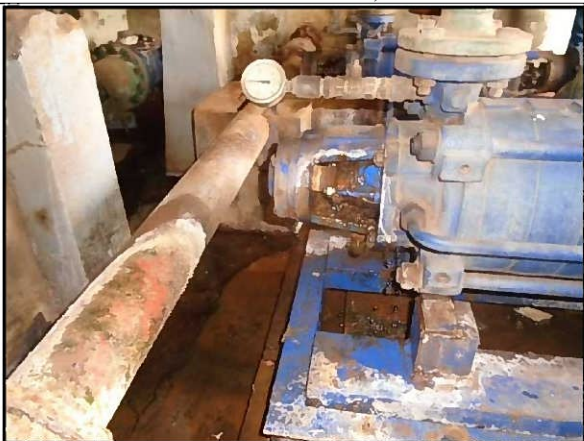
Pump with a Pressure Gauge which doesn't work

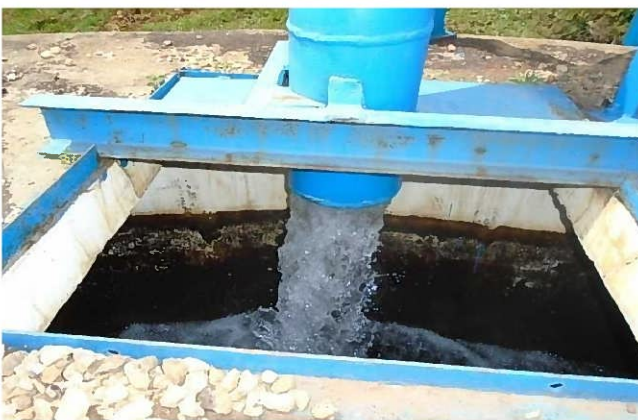
No Float Valve installed

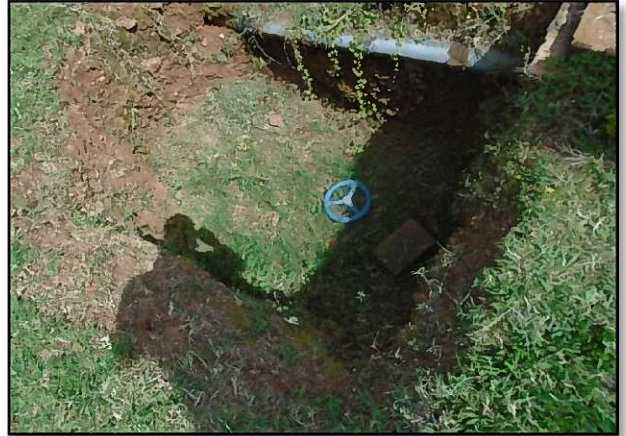
Collection Chamber drainage valve

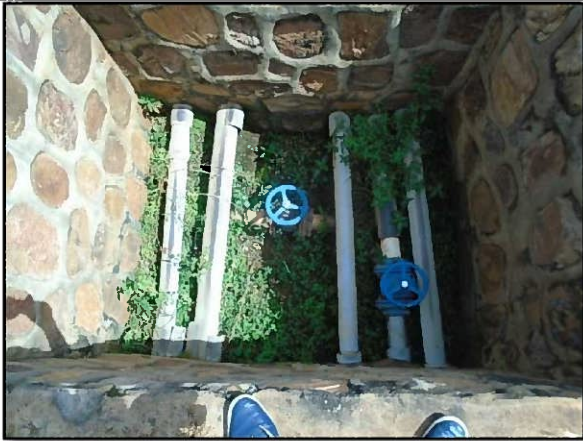
Drainage is need for 3 of the 5 inlet pipes

Action	Requirements
<ul style="list-style-type: none">• Replacement of Inlet Valves• Replacement of the existing Collection chamber outlet valve• Wrench Key (Cle à béquille : Key for inlet pipe drainage valve)• Providing drainage for 3 other inlet valves• Drainage system for existing manholes which become flooded during rain period.• Pump outlet valve replacement• Connecting the other 2 pipes to the collection chamber• Checking the 5th inlet pipe for functionality	<ul style="list-style-type: none">• 2 Valve DN80• 1 Valve DN80• 1 key Wrench• 6 Valve DN80• 1 Valve DN80• 1 Valve DN80• Construction work

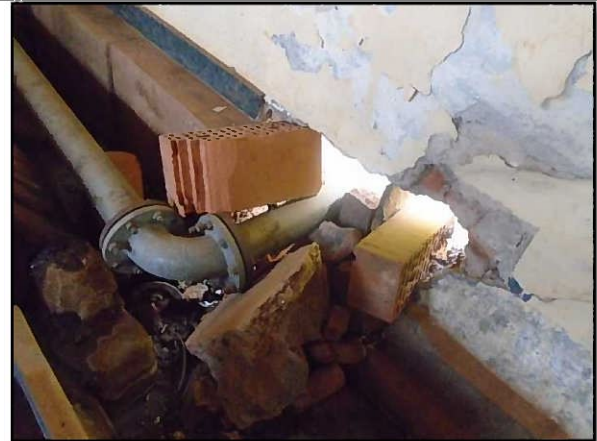
Pump House needs maintenance

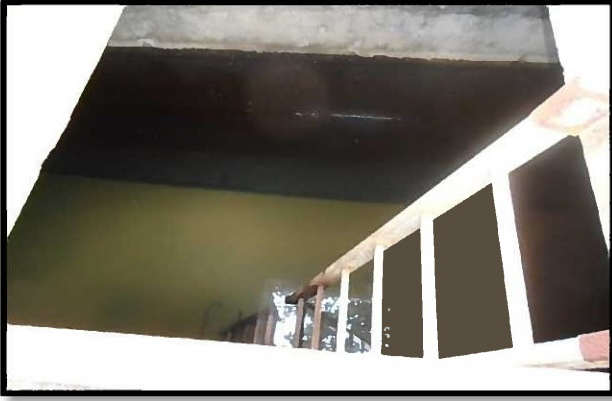
Drainage Valve (Leaking but not to much)

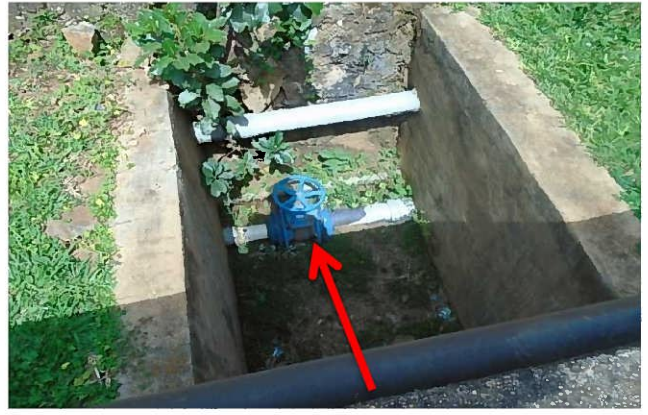
Inlet No. 4 with valve and needs to pass through a collection chamber

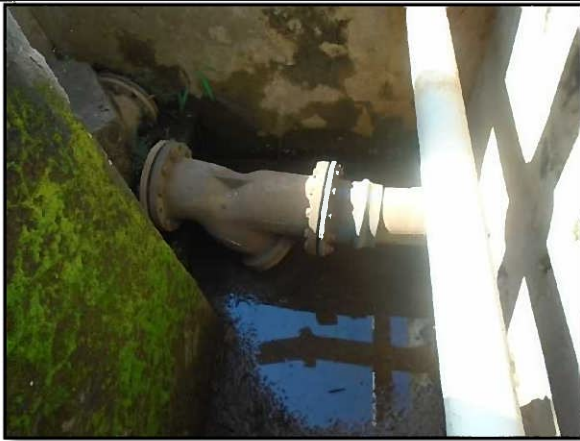
Rainwater drainage system needed.

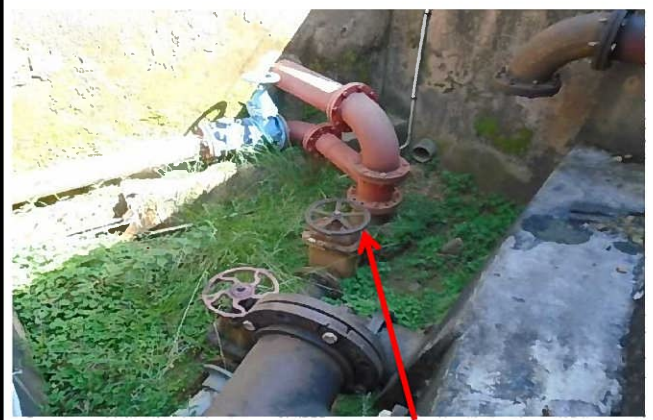
No Floater Valve

No Float Valve

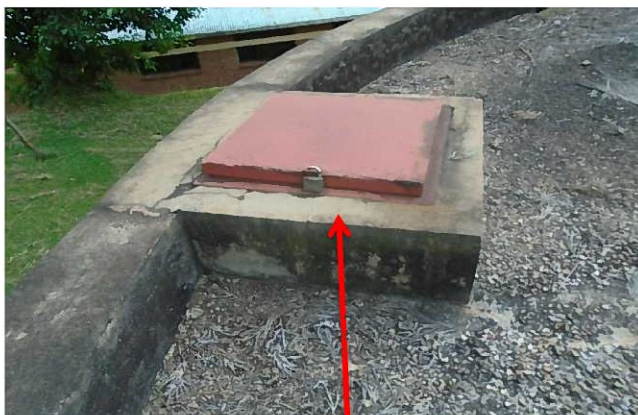
Reservoir closed (Floater is there but not fully functioning)

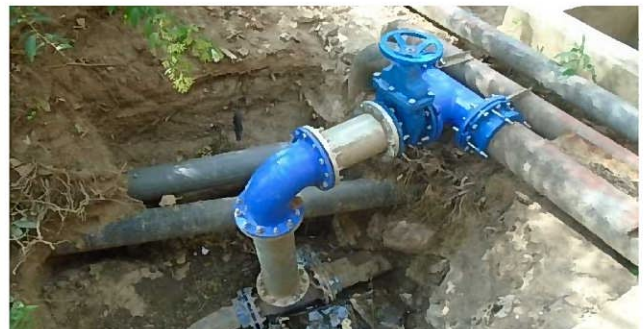
No Meter (Photo: Network modified and reservoir bypassed)

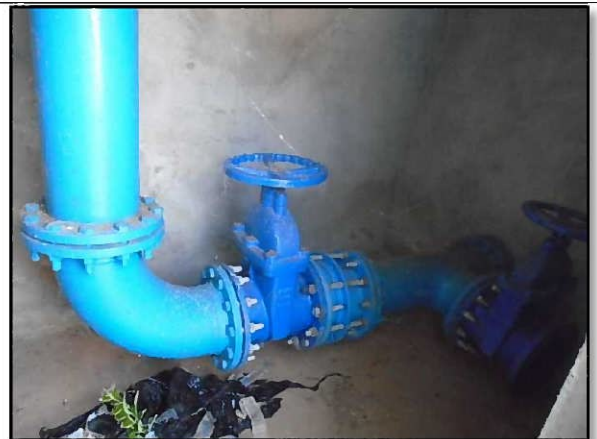
Bypass not connected

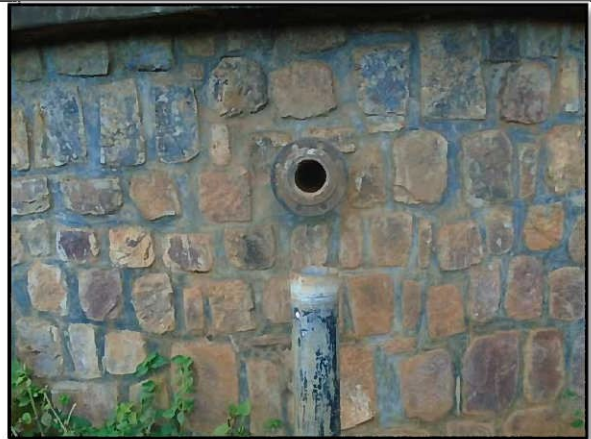
Reconnection will be needed

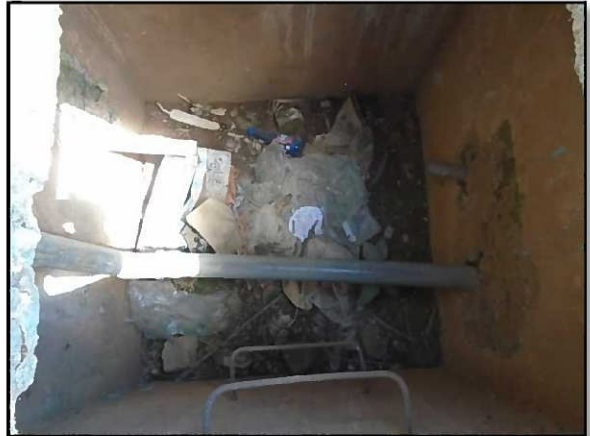
Reconnection and inlet valve needed

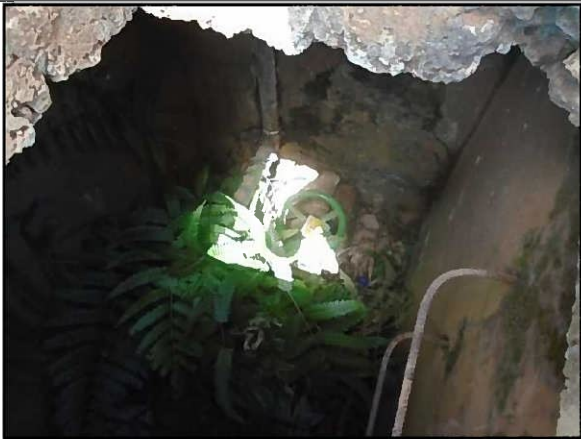
Outlet and drainage valves needed.

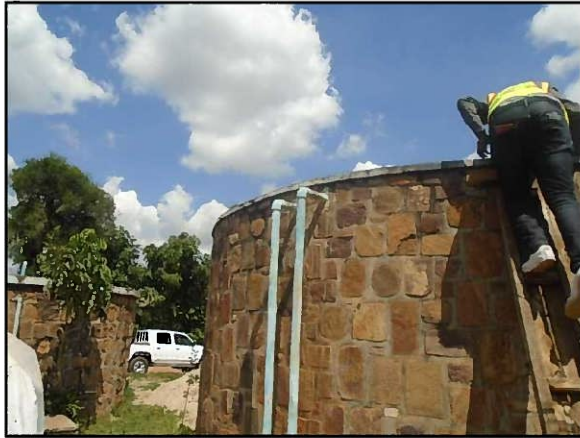
Floater valve needed for inlet pipe

Action	Requirements
<ul style="list-style-type: none">• General maintenance or replacement,• Replacement of inlet valve• Replacement of outlet valve• Replacement of drainage valve• Installing a Floater valve	<ul style="list-style-type: none">• 3 Valve DN50• 1 Floater valve DN50• Construction

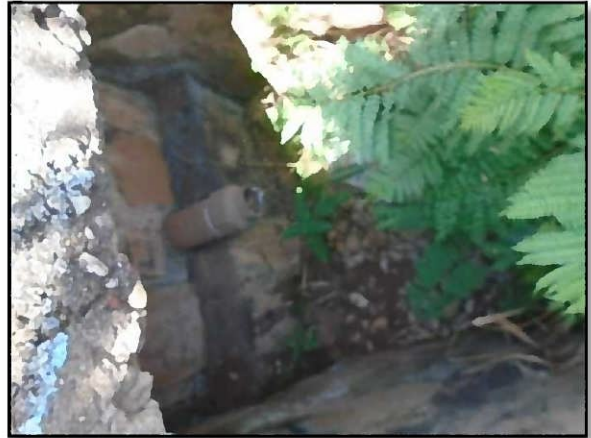
Recennection and outlet valve needed

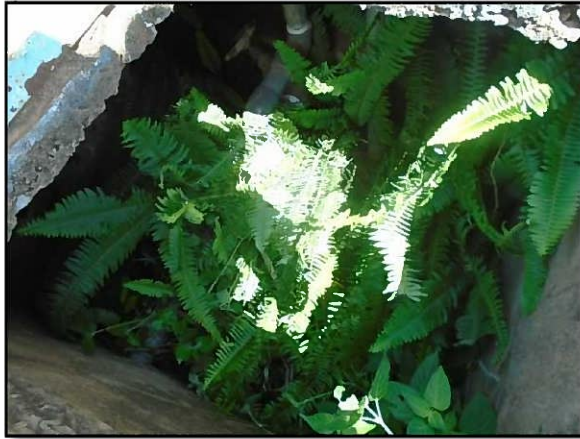
General maintenance works needed

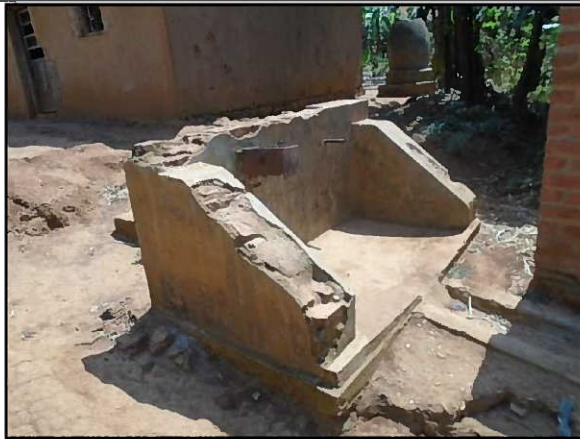
Rehabilitation of the nearby Water Tap will be necessary if reservoir is needed

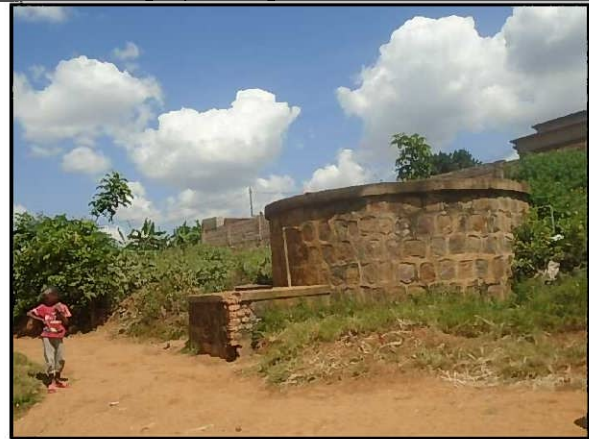
Reservoir in road dimension.

- . Tank abandoned and bypassed after realizing that kids were playing inside.
- . No fence, no protection, in the road
- . Cover defective
- . Outlet accessories disconnected and removed
- . Tank used to serve the nearby Public tap (BF)

Action	Requirements
<ul style="list-style-type: none">• Replacement of the cover• Installation of Floater valve• Protection (fencing)• Installation of Outlet valve• Rehabilitation of the nearby water tap	<ul style="list-style-type: none">• 1 Floater valve 1''• 1 Valve 1''• Construction works•

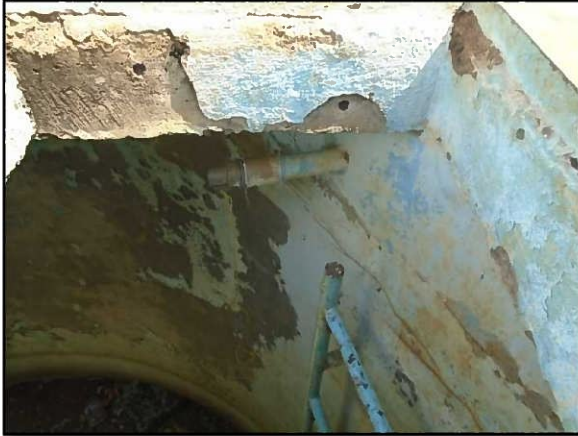
No floater valve installed

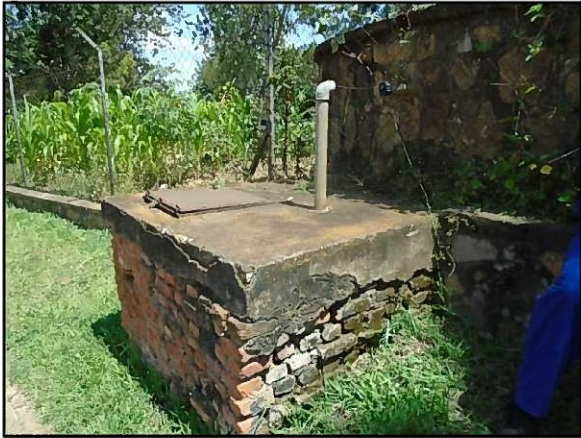
Inlet connection and valve

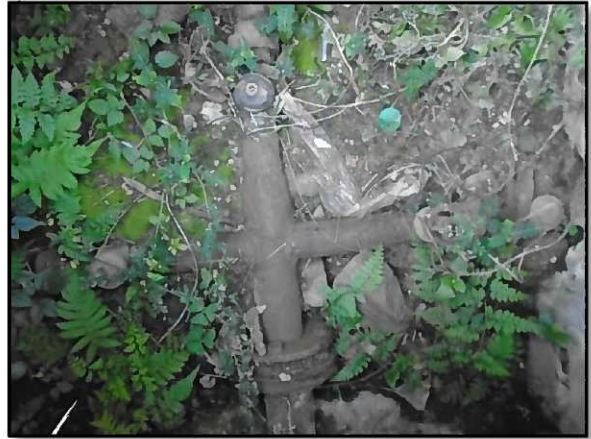
Outlet network need rehabilitation

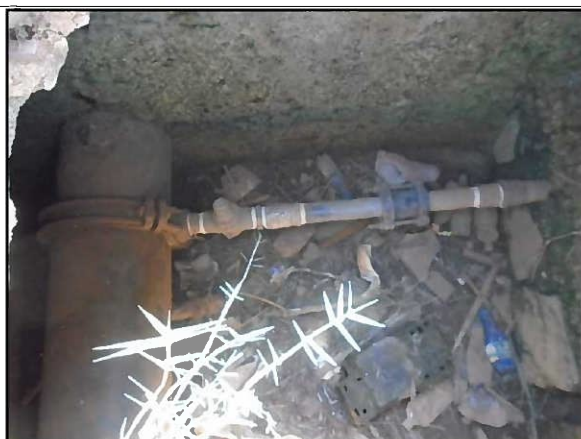
Installation of a Meter needed

Action	Requirements
<ul style="list-style-type: none">• Installation of flow meter in the inlet manhole,• Installation of a floater valve,• Repainting the inside of the tank• Installation of an overflow pipe,• Installation and connection of a drain pipe	<ul style="list-style-type: none">• 1 Floater valves DN80• Flow Meter, DN80• Paint• Drain valve DN80• Pipes

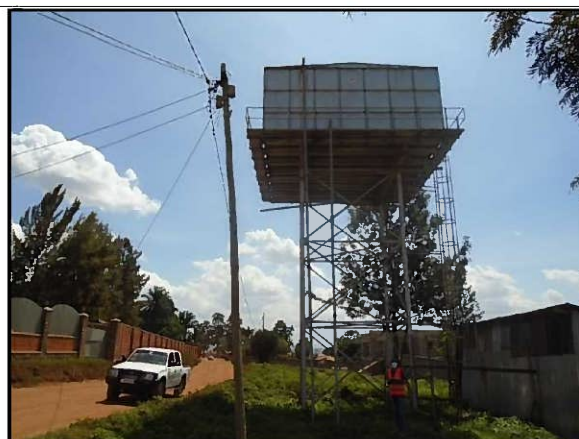
Overflow pipe and drain pipe needed

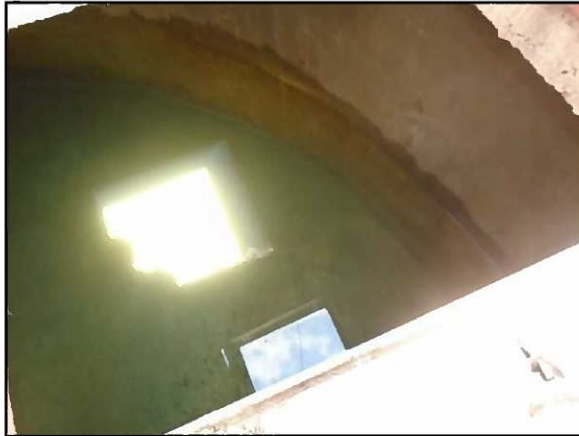
No floater valve installed

Action	Requirements
<ul style="list-style-type: none">• Replacement of the Outlet valve• Installation of a floater valve• Installation of a drain pipe• Repainting the reservoir cover and its refixing.	<ul style="list-style-type: none">• Valve 1''• 1 Floater valves ¾''• Wash out construction works.• Cover maintenance

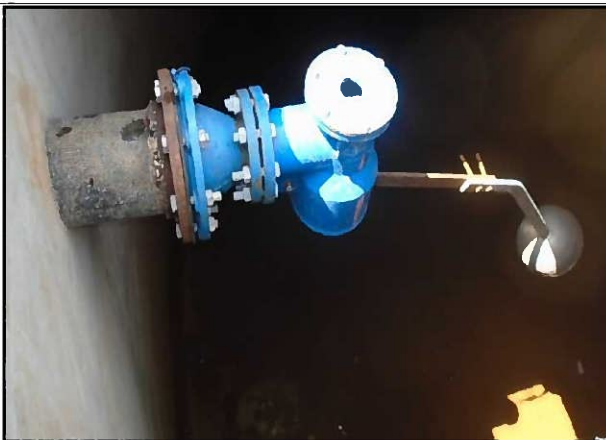
Installed floater valve not functional

Action	Requirements
<ul style="list-style-type: none">Installation of a floater valve	<ul style="list-style-type: none">1 Floater valve DN100

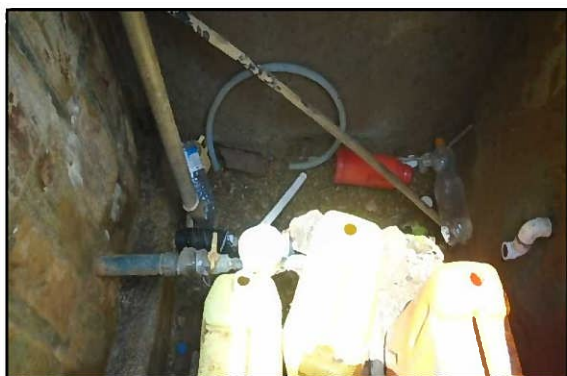
Outlet and drainage valves needed.

Action	Requirements
<ul style="list-style-type: none">• Installation of a floater valves for SP 1 1/2"• installation of outlet valve for SP 3/4"• installation of Valves for SP 1 1/4"	<ul style="list-style-type: none">• 1 Floater Valve DN100• 6 water tap valves of 3/4"• 2 Valves 1 1/4"

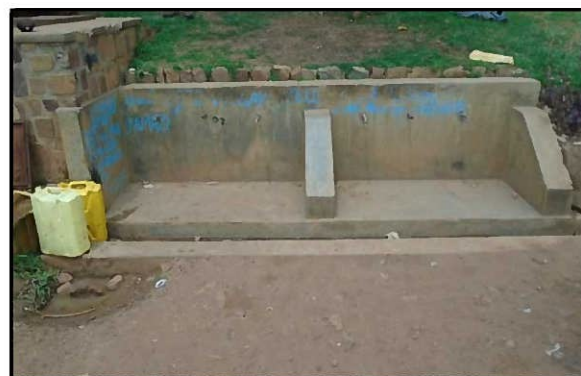
Water tap Valves needed.

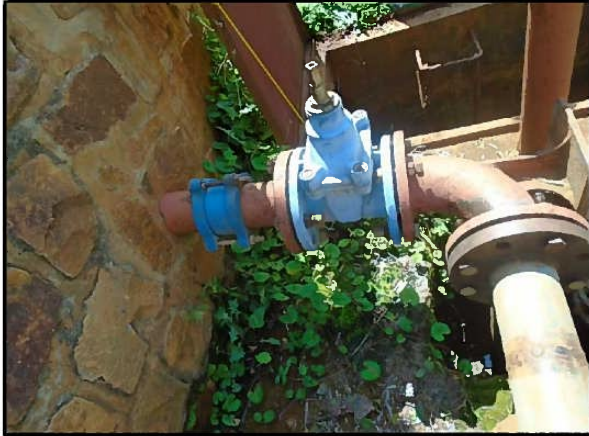
Inlet valve not operational

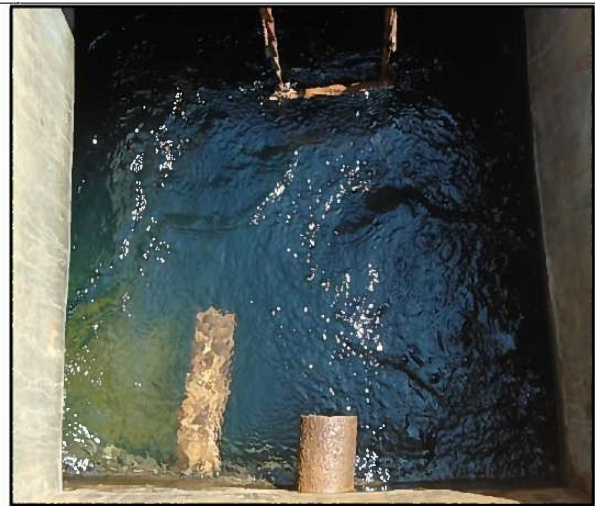
Floater valve needed + general maintenance of the tank

Action	Requirements
<ul style="list-style-type: none">• Revision of the existing installation• Replacement of valves• Installation of a floater valve• Sealing the leaking part of the reservoir• Manhole drainage pipes	<ul style="list-style-type: none">• 4 Valves DN80• 1 Floater valve DN80• Plastering the inside part• Drainage system

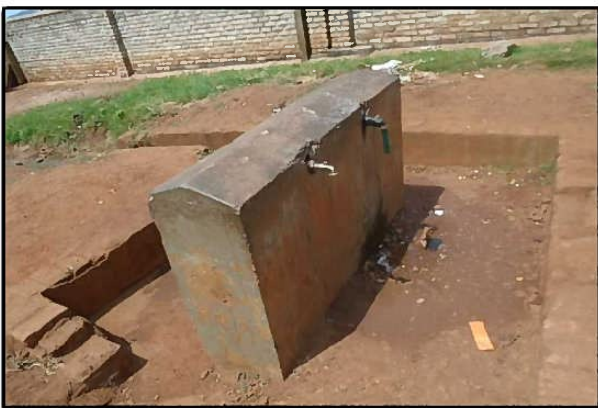
This water tap is dirty and it needs some construction works

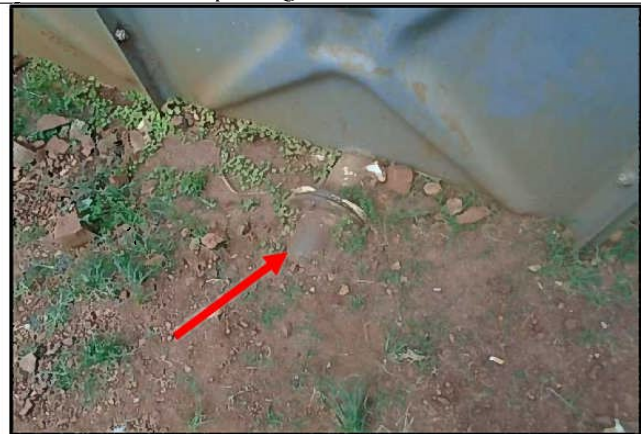
Drain pipe need a valve and a manhole

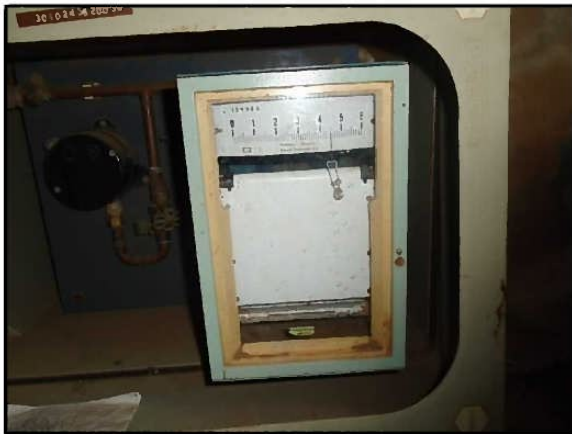
Non operational water level indicators
