FINAL REPORT ON THE RESERVOIR SURVEY IN NYAMIRAMBO BRANCH

**THE PROJECT FOR STRENGTHNING OF NON-REVENUE
WATER CONTROL KIGALI CITY WATER NETWORK**

Final report of the reservoir survey in REMERA Branch/KEC Co., Ltd/ WASAC Ltd/ JICA

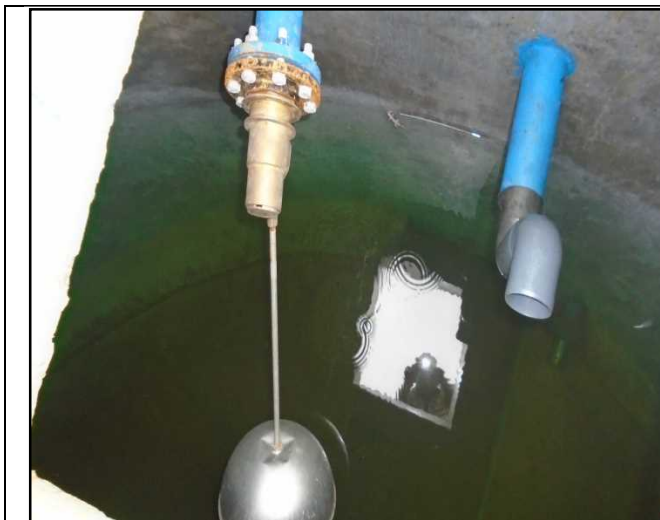
Floater Valve which doesn't fully close.

Action	Requirements
<ul style="list-style-type: none">• Insertion of 2 elbows to allow the reservoir floater to go down and be on level with the inlet pipe.	<ul style="list-style-type: none">• 2 Elbows of 90 degrees

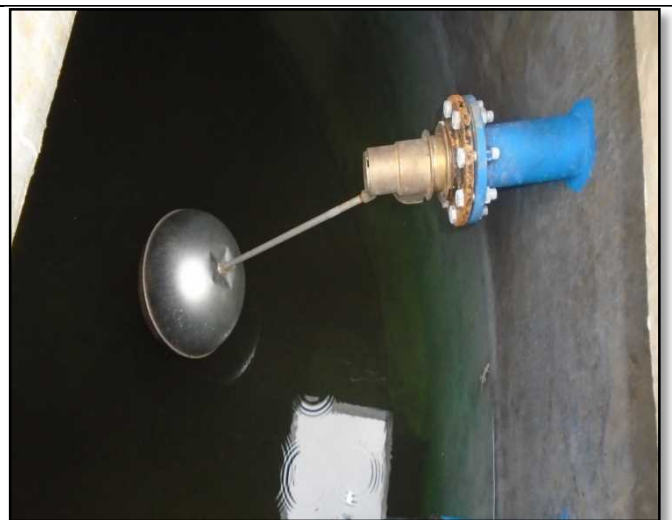
Floater Valve which doesn't fully close.

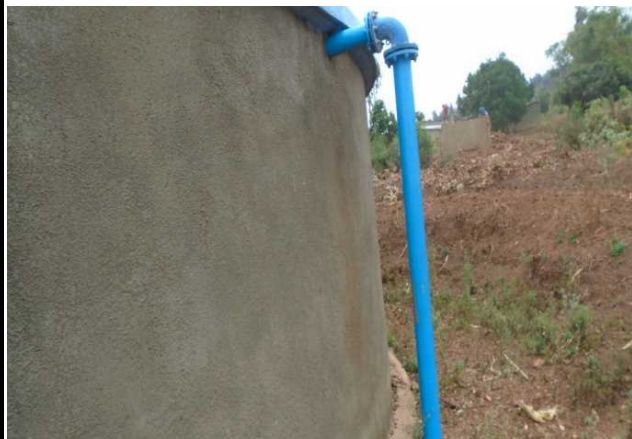
Inlet Pipe without

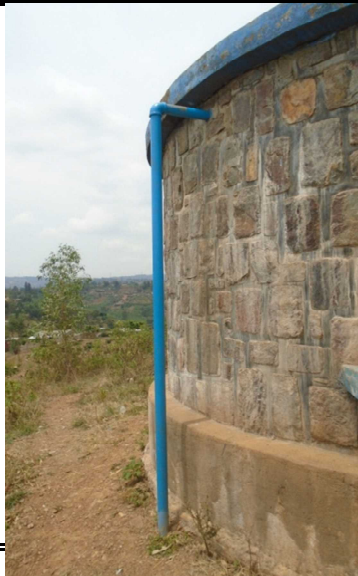
Inlet Pipe without Valve

No.	Item	Details
D: Equipment		
1	Floater Valve	Malfunction, DN:50
2	Water Level Gauge	No installation
3	Flow Meter	No installation
4	Inlet pipe No.1	SP, DN: 50, Top
5	Inlet valve No.1	No installation
6	Outlet pipe No.1	SP, DN: 50
	Outlet pipe No.2	SP, DN: 50 (Towards BF)
7	Outlet valve No.1	DN: 50, Function: DEFECTIVE
	Outlet valve No.2	DN: 50, Function: DEFECTIVE
8	Overflow Pipe	SP, DN: 50
9	Drain Pipe	SP, DN: 50
10	Remarks/ Issue

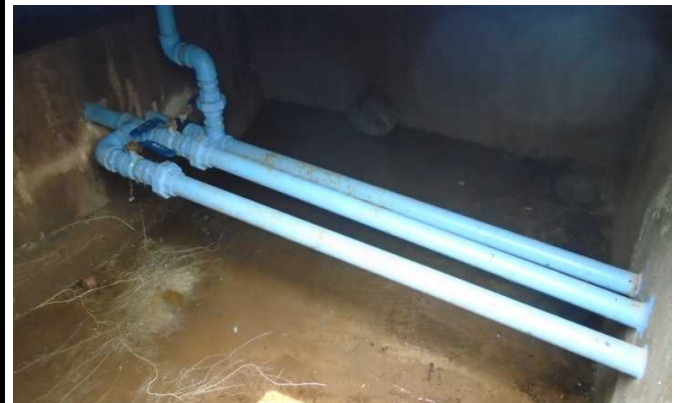
Outlet Pipe with Valve

No Floater valve, Outlet valve leaking.

<p>Can't open the reservoir to take a picture of the inlet without a floater</p>
<p>Leaking Outlet Valve</p>

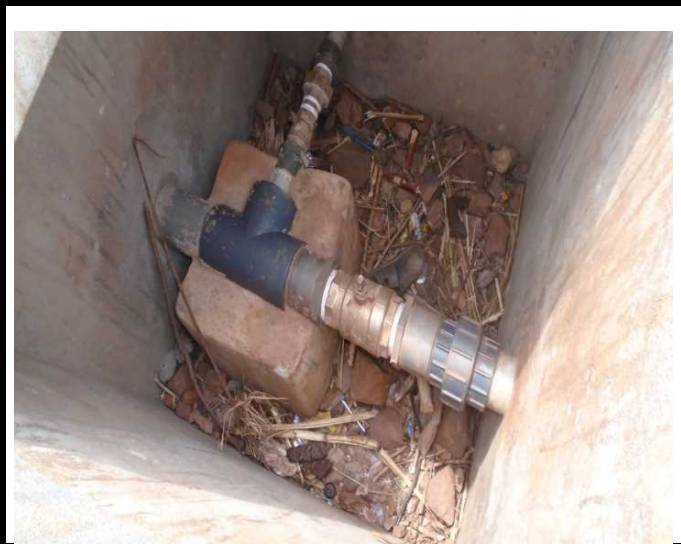
Outlet Pipe with Valve

No.	Item	Details
A: General		
1	Number of Reservoir	18
2	Name of Reservoir	Akarambi
3	ID Code	110503RE5
4	Ward	Sector: Mageregere, District: Nyarugenge, Cell: Mataba, Village: Karambi
5	Branch Office	Nyamirambo
6	Location	Latitude: -2.029057 , Longitude : 30.070052 , Altitude
7	Function of Reservoir	Storage
8	Age of Reservoir	Year: No data
9	Storage Capacity	15 m3
10	Service area of the Reservoir	Gahombo village + Camp Militaire reservoir
B: Operational Condition		
1	Operational Condition	Operational
2	Operator Assignment	No operator
	Action against to overflow	
3	Wall Leakage	Nothing
4	Overflow observation	0 times/month, 0 times/week
	Phenomenon	
	Reason of overflow	
5	Bypass-flow operation	Nothing
	Reason of bypass operation	
6	Inflow Condition	Source: Kajande Pumping Station
		Water pressure at inlet:
		Frequency and time:
7	Water level movement	Proper movement
8	Issue on Functional Condition	A leaking Outlet Valve Number 2, others are ok

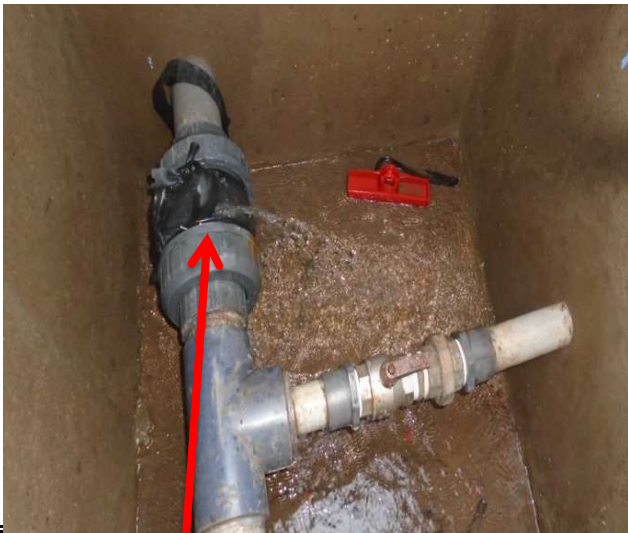
Inlet Pipe with Valve

PVC Valve 110 leaking, no floater valve installed.

Leaking Inlet PVC Valve

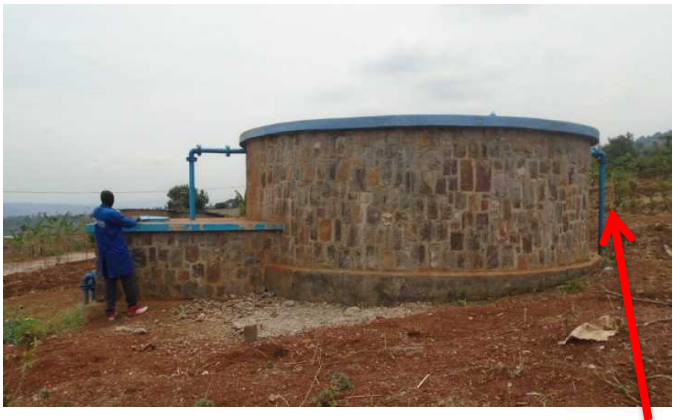
Inlet Pipe without Valve

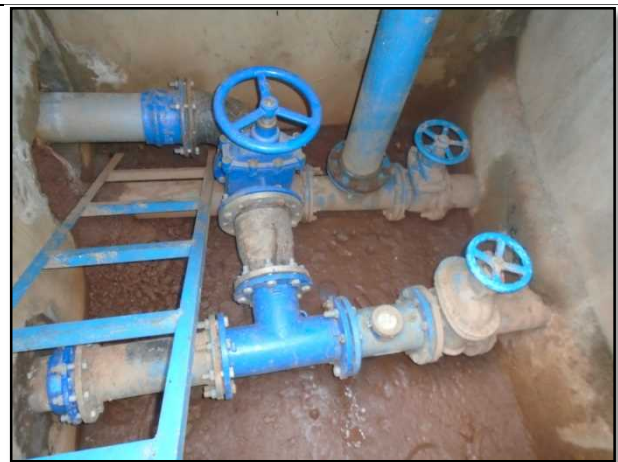
Manhole drainage system

Action	Requirements
<ul style="list-style-type: none">• Floater valve needed• Drainage system for inlet manhole, and its protection during rain season.	<ul style="list-style-type: none">• Floater DN150• Drainage construction

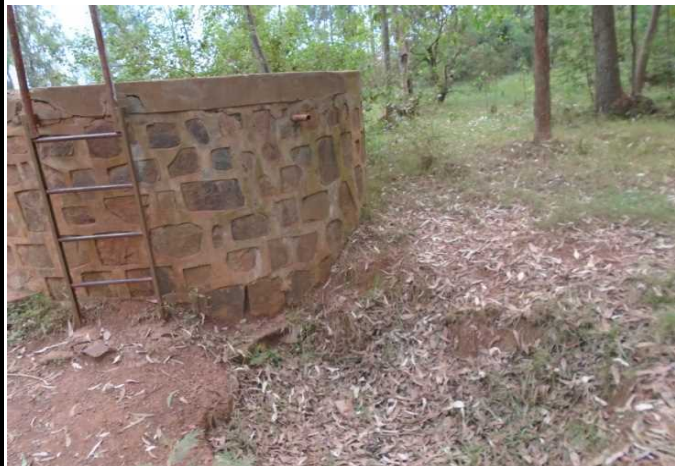
No Inlet Pipe

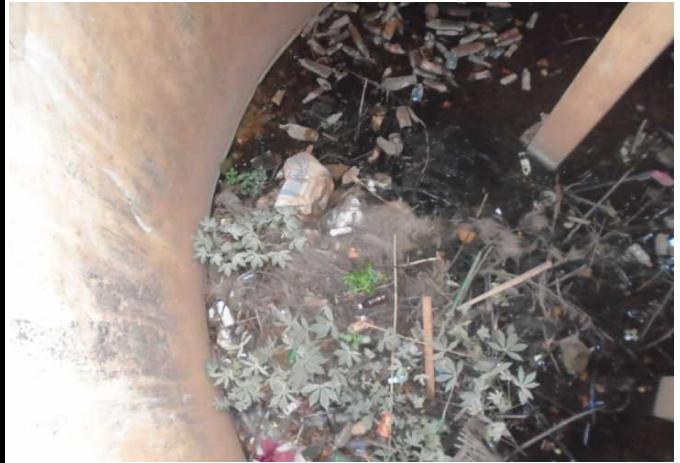
Inside of abandoned Reservoir

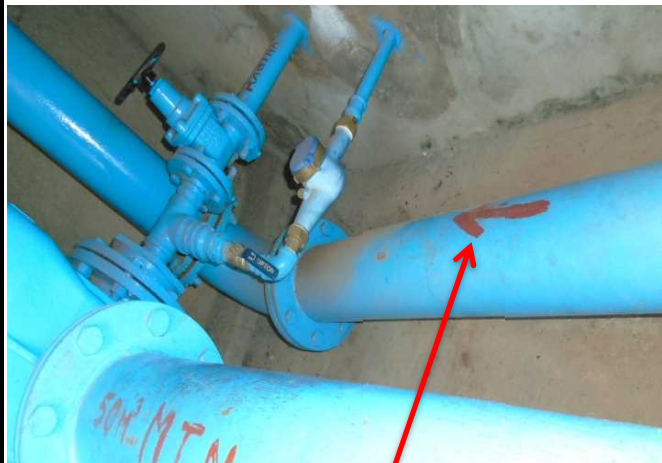
Inlet Pipe without Valve

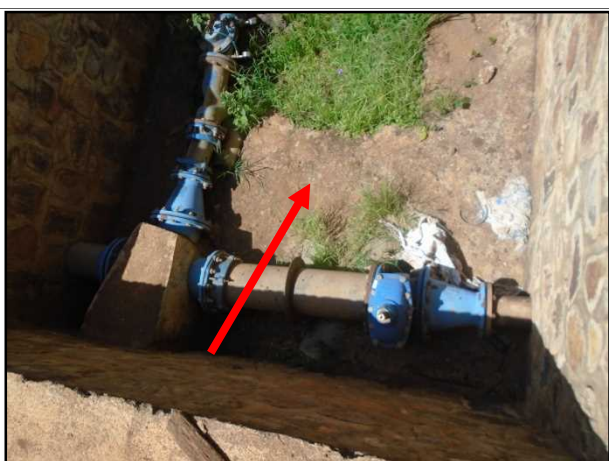
Manhoke bottom concreting works and covering

Action	Requirements
<ul style="list-style-type: none">• Manhole floor concreting and covering• Concreting of bottom floor of the tanks to protect the steel support and avoid mud on the outlet and inlet valves	<ul style="list-style-type: none">• Construction works

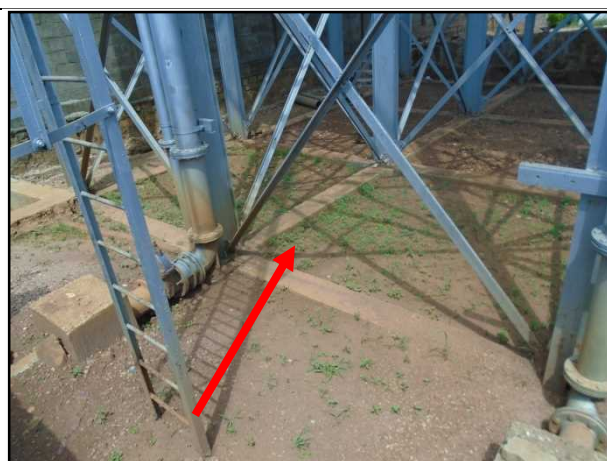
Bottom floor concreting for support protection

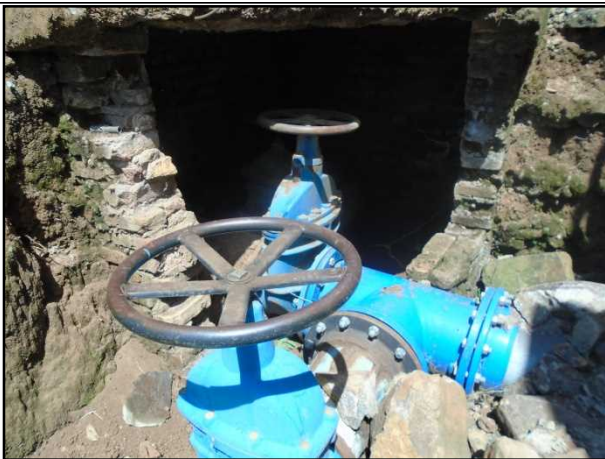
Rehabilitation of inlet manhole

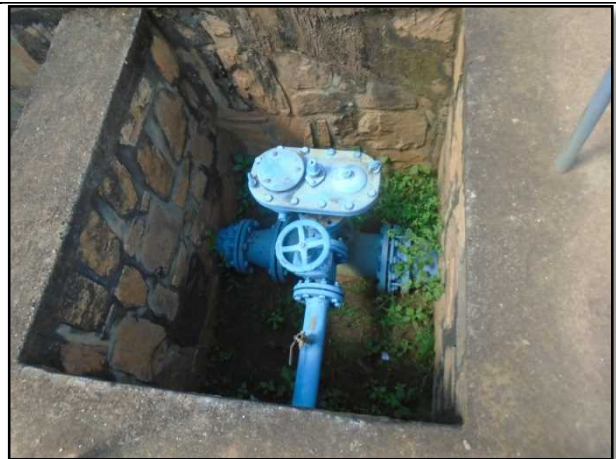
Covering of manhole

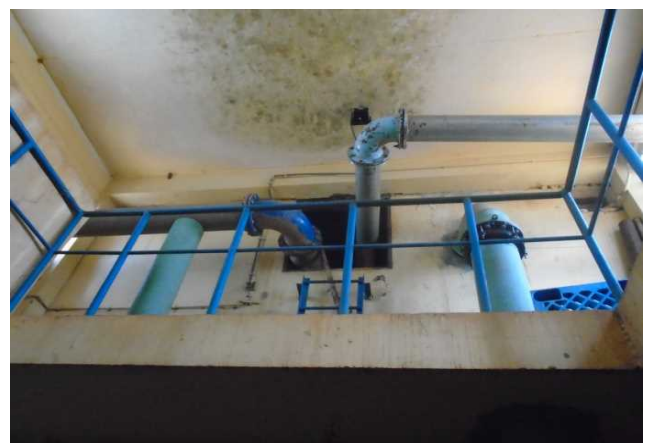
No Floater Valves installed for the whole 3 pipes

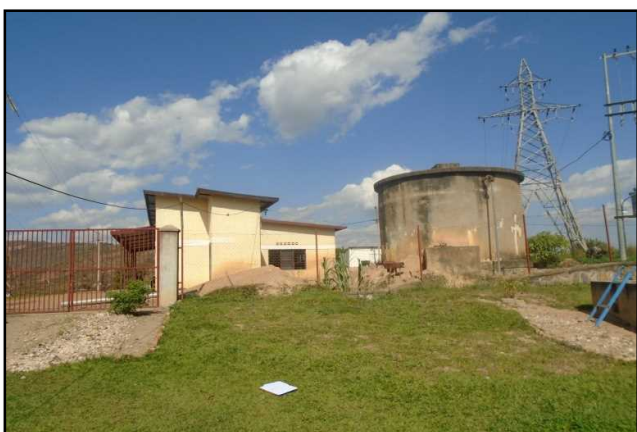
Support Reservoir located behind pump house.
Capacity: 25m3

Action	Requirements
<ul style="list-style-type: none">• Installation of a Floater valve for support tank.• Installation of outlet valve for support tank	<ul style="list-style-type: none">• Floater valve DN150• Valve DN150

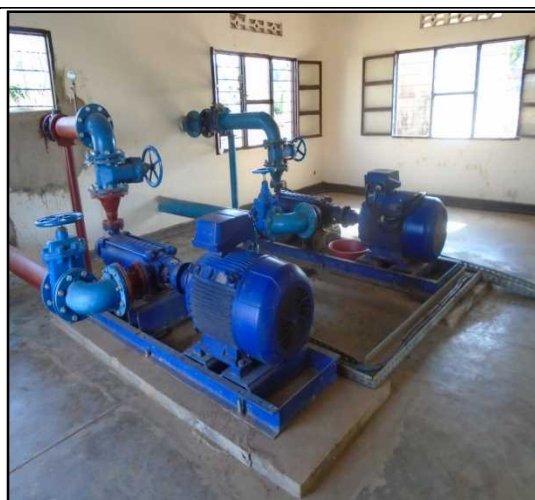
Pumps also connected to the old support Reservoir

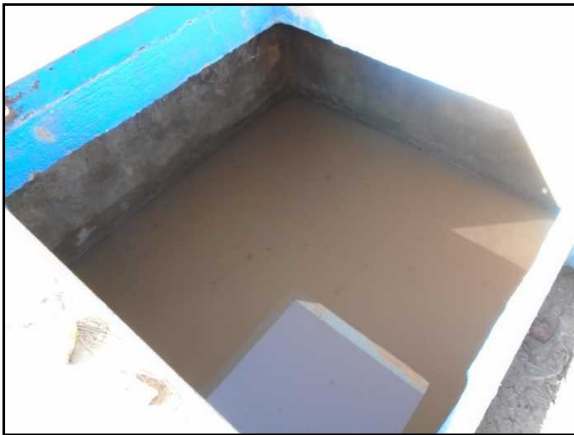
Reservoir drainage Valve manhole full of water

No.	Item	Details
D: Equipment		
1	Floater Valve	No installation (Not Needed)
2	Water Level Gauge	No installation
3	Flow Meter	Mechanical,& EMFM, DN: 125 , PN(bar): _____,
		Function: Malfunction
		Location: Outlet Pipe
4	Inlet pipe No.1	SP, DN: 80 Top
	Inlet pipe No.2	SP, DN: 80 Top
	Inlet pipe No.3	SP, DN: 80 Top
	Inlet pipe No.4	PVC, DN: 125 Top
5	Inlet valve No.1	DN: 125 , Function: No (leaking)
	Inlet valve No.2	DN: 125 , Function: No (leaking)
6	Outlet pipe No.1	SP/ DIP/ PVC/ Others (), DN:
	Outlet pipe No.2	SP/ DIP/ PVC/ Others (), DN:
	Outlet pipe No.3	SP/ DIP/ PVC/ Others (), DN:
7	Outlet valve No.1	DN: 80, Function: YES
	Outlet valve No.2	DN: 80, Function: YES
	Outlet valve No.3	DN: 80, Function: YES
8	Overflow Pipe	SP, DN: 80
9	Drain Pipe	SP/ DIP/ PVC/ Others (), DN:
10	Remarks/ Issue	Drain valve manhole flooded and full of water from December 2019

Action	Requirements
<ul style="list-style-type: none">• Installation of Drainage valve source inlet pipe.• Replacement of a leaking Tee• Repairing the crack on the tank wall,• Repairing of Drainage manhole• Construction of a Fence• Construction of a Toilet	<ul style="list-style-type: none">• PVC Tee and 2 Valves, pipes and accessories all DN125• Tee and straight pipe with double flange DN125• Construction works

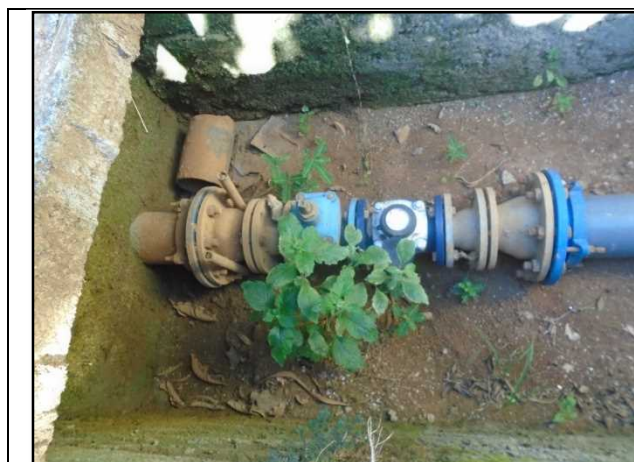
Inlet Manhole Needed

Action	Requirements
<ul style="list-style-type: none">• Installation of a floater valve	<ul style="list-style-type: none">• Floater valve DN 100
<ul style="list-style-type: none">• Construction of inlet manhole• Access echelon	<ul style="list-style-type: none">• Construction works

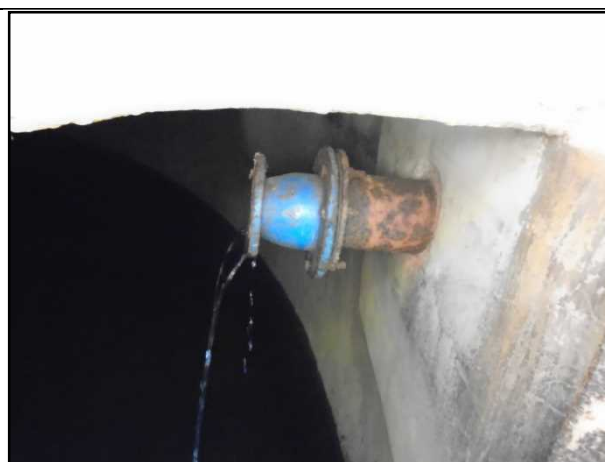
No floater valve installed
