**DATA COLLECTION SUEVEY ON
WATER SUPPLY IN TEGUCIGALPA
IN
THE REPUBLIC OF HONDURAS**

FINAL REPORT

DECEMBER 2021

**JAPAN INTERNATIONAL COOPERATION AGENCY
(JICA)**

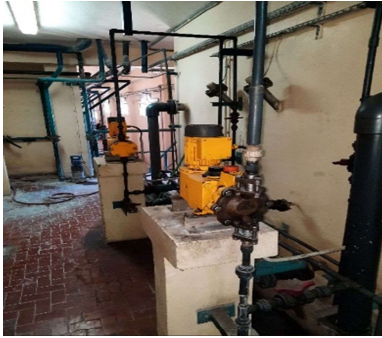
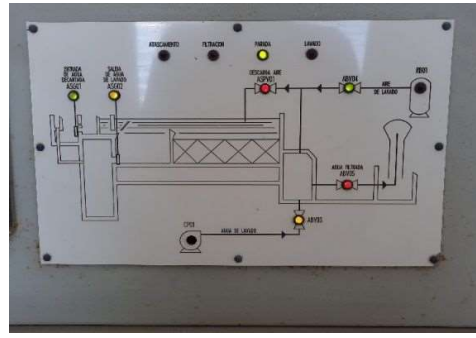
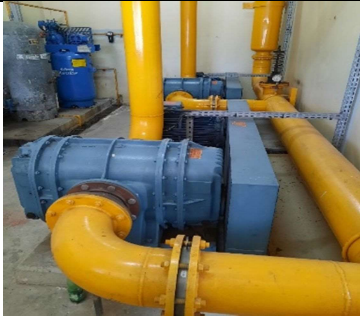
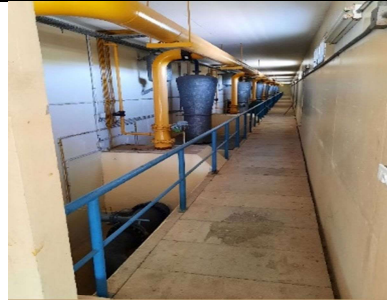
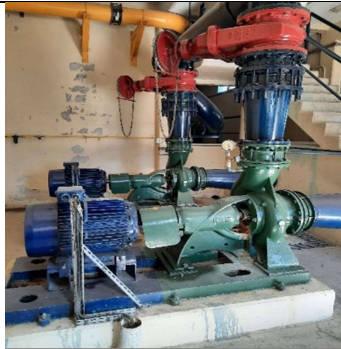
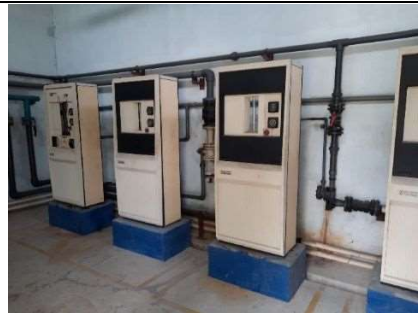
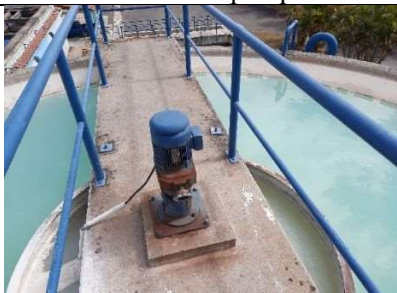
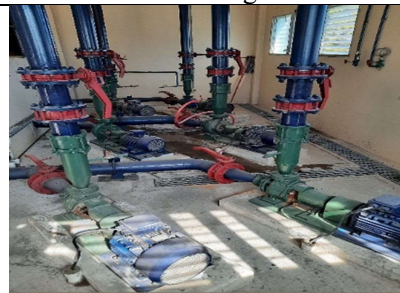
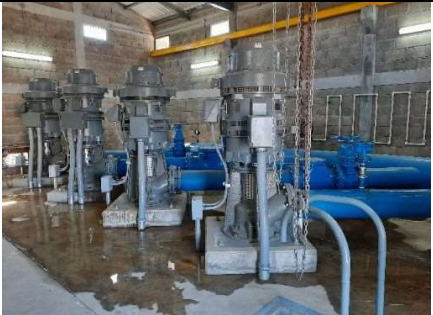
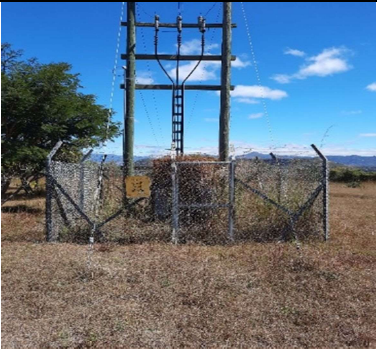
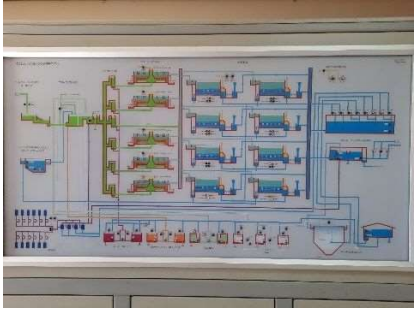
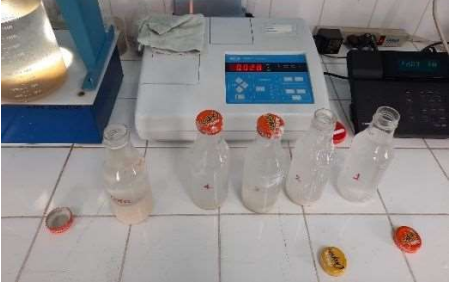
Figure 3-3-32 Status of Major Facilities and Equipment at Concepcion Water Treatment Plant

Table 3-3-23 and Figure 3-3-32 show the current status of the major facilities and equipment of this water treatment plant. Some equipment has been replaced; however, most of the equipment is the same one since the beginning of construction 28 years ago, requiring repair or replacement due to breakdown and aging. Above all, there is an urgent need to upgrade the chemical dosing equipment to ensure the treatment operation and the flow meters, etc. to monitor water volume.

4. Facilities and equipment	<p>a. Many pieces of equipment have been in operation since the beginning of construction (1996), aging/many breakdowns.</p> <p>b. Part of the chemical dosing system is replaced, but there are many breakdowns, no standby, lack of function.</p> <p>c. There are failures in the vacuum generator device No.5 of the sedimentation tank, device No.4 is used.</p> <p>d. Damage and blockages in the nozzle of the sand filtration tank drain collection device, many valve failures, filter sand has not been replaced.</p> <p>e. Lack of capacity of the main generator (295 kVA) for a 500 kVA transformer, unable to operate some equipment.</p>	<p>a. Repair or replacement is required after detailed study, also considering improving performance.</p> <p>b. Improvement of facilities, such as renewal and repair, after considering appropriate and efficient treatment operation</p> <p>c. Repair and renewal after checking the function</p> <p>d. Replace all nozzles, replace valves and filterer sand.</p>

<p>f. Chlorine injection facilities are outdated and inadequate for metering and safety measures.</p> <p>g. Obsolete and faulty flow meter makes it difficult to measure water volume.</p> <p>h. Failure in operation and handling due to failure of obsolete control panel.</p> <p>i. Some water quality test equipment is out of order, repair is required.</p>	<p>e. Check the capacity, then replace for higher capacity or install a new one.</p> <p>f. Replacing and upgrading by adding more measuring and safety equipment.</p> <p>g. Improvement of the instrumentation system for flow rates and water levels.</p> <p>h. Construction of systems considering the adequacy of operation, handling, and efficiency.</p> <p>i. Replacement and repair</p>

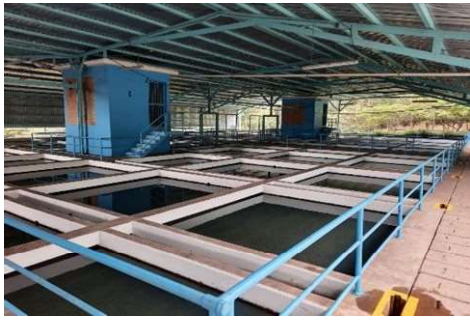
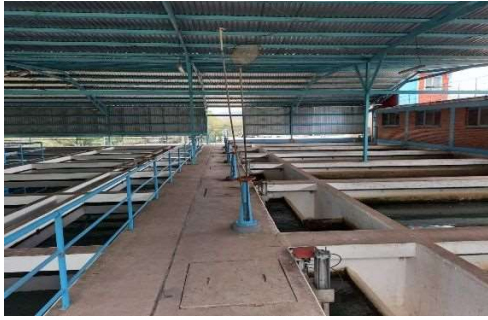
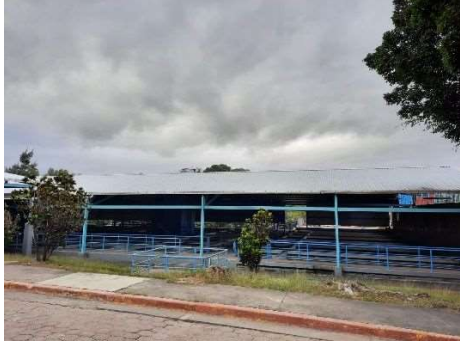
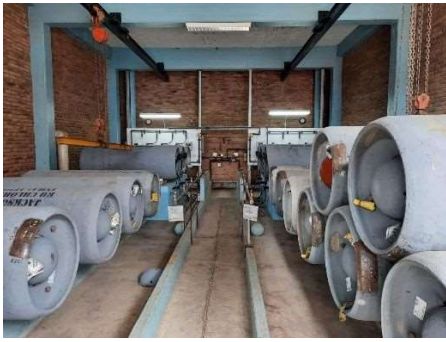
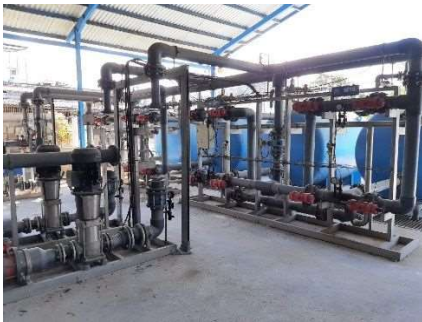
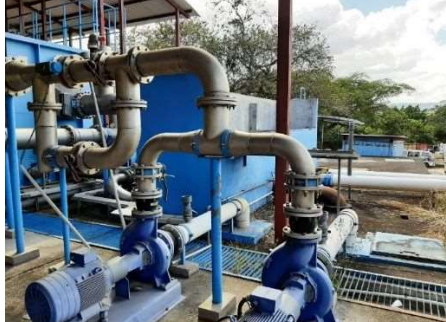
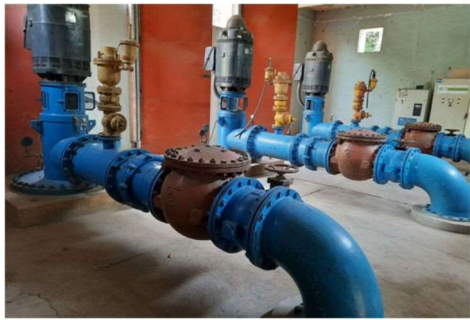
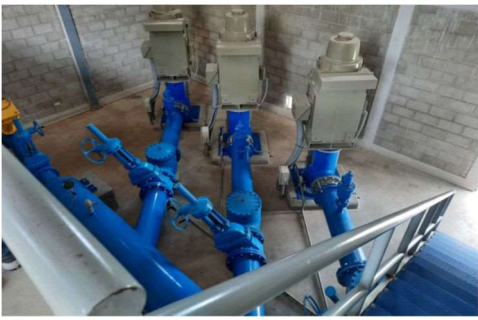
Figure 3-3-36 Current Status of Laureles Water Treatment Plant

Table 3-3-32 and Figure 3-3-38 show the current status of the major facilities and equipment of this water treatment plant. Some equipment has been replaced; however, most of the equipment is the same one since the beginning of construction 40 ago, requiring repair or replacement due to breakdown and aging. Above all, there is an urgent need to upgrade the chemical dosing equipment to ensure the treatment operation and the flow meters, etc. to monitor water volume.

- Purification system: failure of the automatic operation equipment, failure of the pressure filtration device, difficulty in obtaining spare parts, etc.
- Ultra-high speed coagulation and sedimentation system: failure of automatic operation equipment /SCADA system, difficulty in obtaining micro-sand and spare parts, etc.

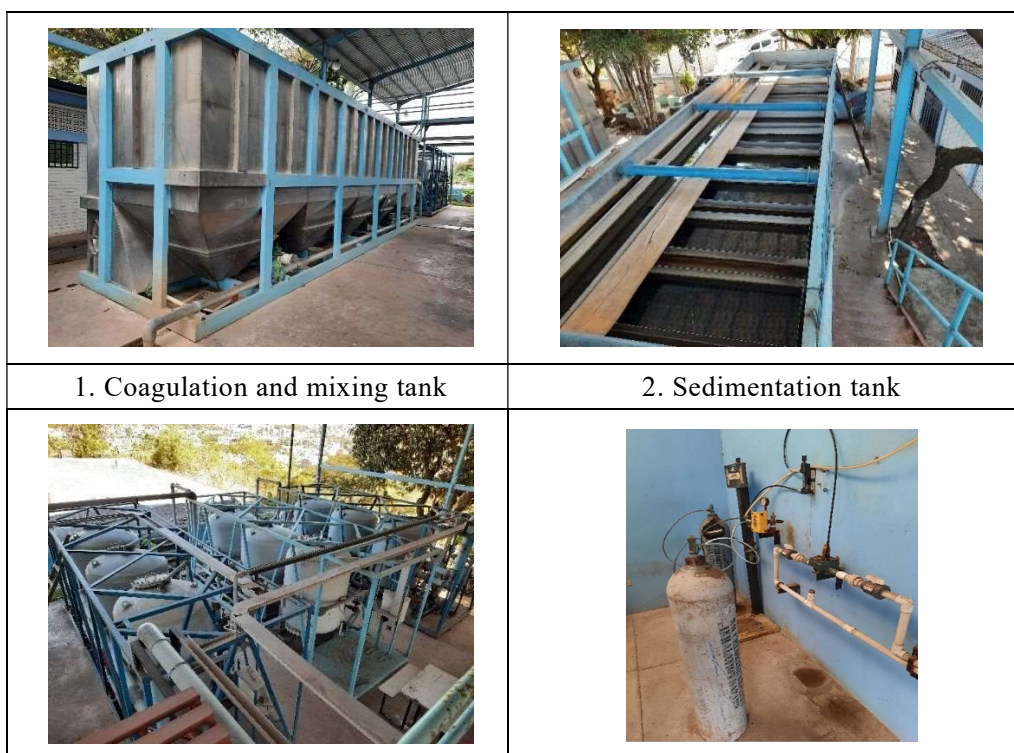
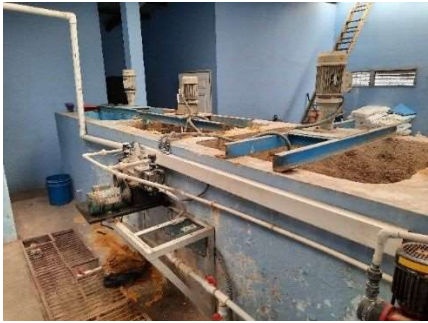
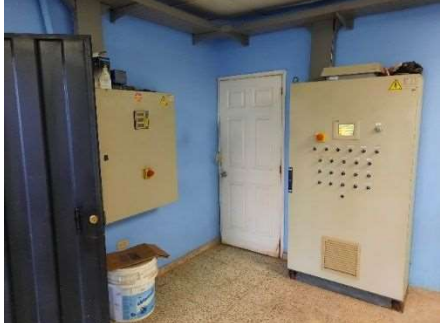
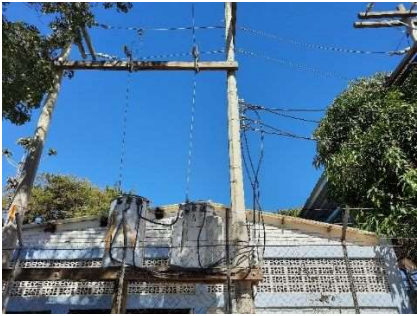
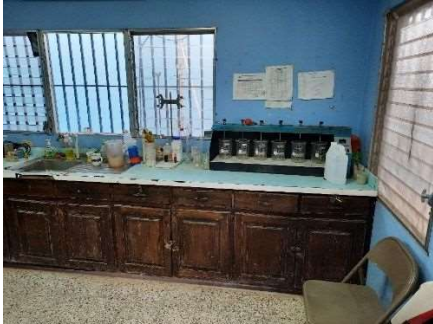
Figure 3-3-39 Current Status of Miraflores Water Treatment Plant

5	Electricity receiving system		• Transformer: 13.8kV x 100kVA x 1 unit and 75kVA x 1 unit	Installed in 1996
6	Monitoring and control equipment		• Control panel	No SCADA System
7	Water quality laboratory		• Turbidity, residual chlorine, jar test, etc.

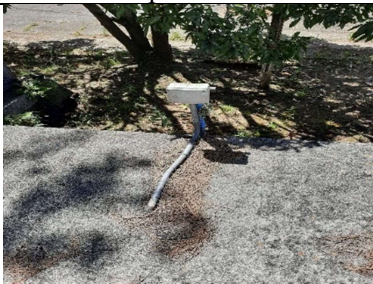
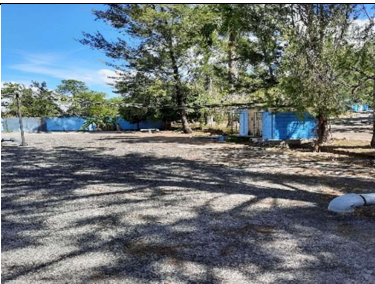
3. UHF antenna connection cable not suitable for outdoor use (not weather compatible).
 4. Lack of system server capacity

Water level sensor in the distribution tank	UHF connection cable

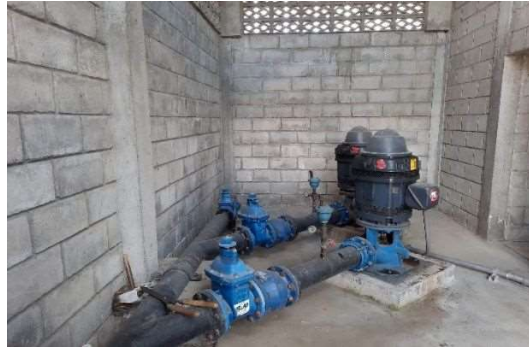
2. Same as left, pump (vertical)

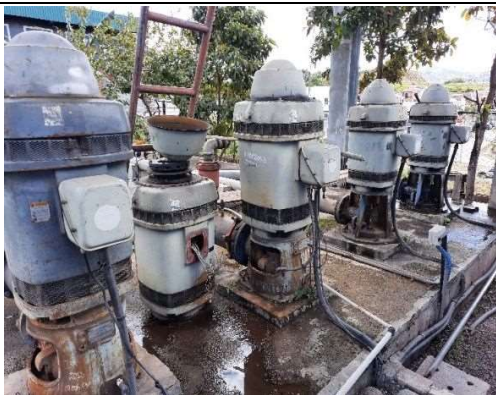
3. Pump at Nueva Suyapa pumping station
No.8.

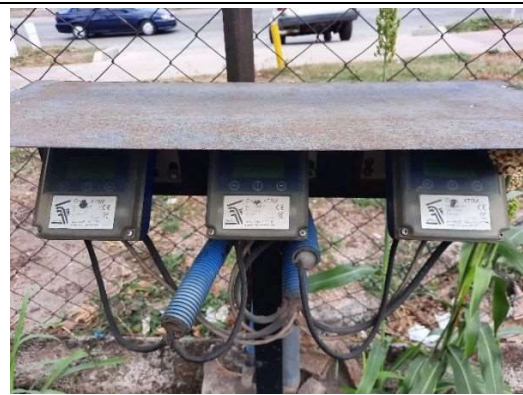
4. Same as left, Aquarum flowmeter.

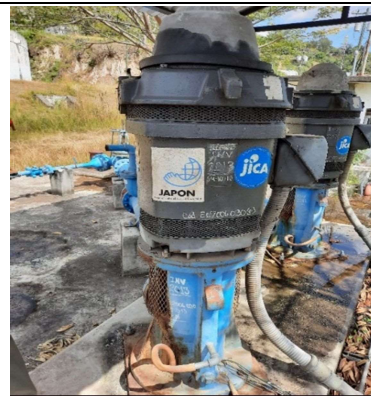
6. Same as left, vertical pump, donated by
JICA.

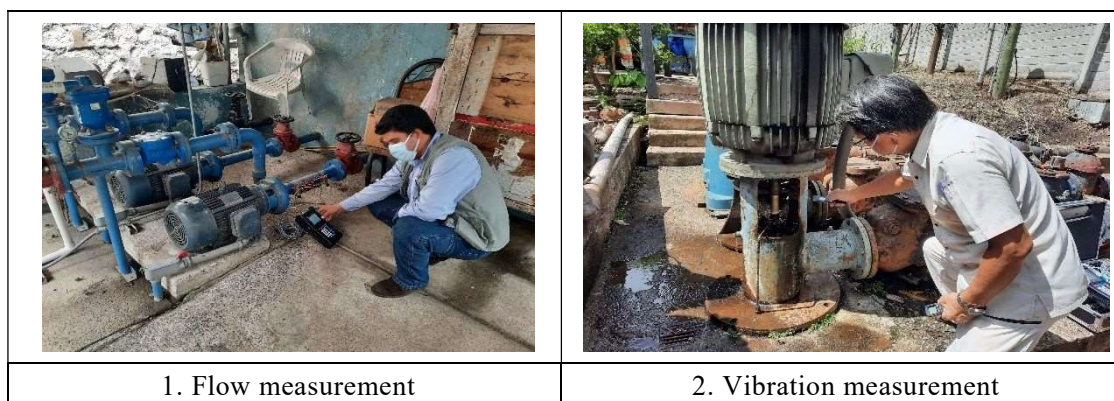
Figure 3-3-50 Energy Diagnosis Images

- Pump specifications are not compatible with the required flow/head, causing low efficiency at actual operating points.
- Low efficiency due to deterioration and damage to impellers and bearings.

Assessment of vibration and bearing temperature: According to the results of this measurement, no values above the parameters were observed.

If low efficiency and vibration problems are detected during the periodic implementation of this type of energy diagnosis as part of preventive maintenance, the pump might be damaged. It is important to perform this type of energy diagnosis for proper operation and maintenance.

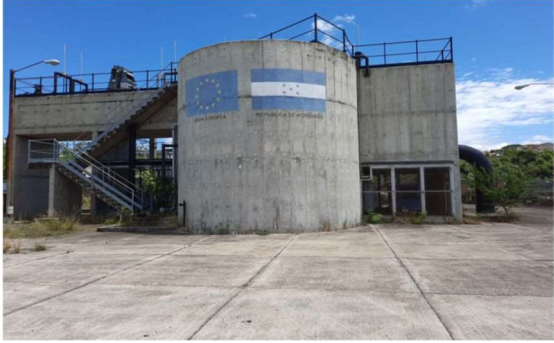
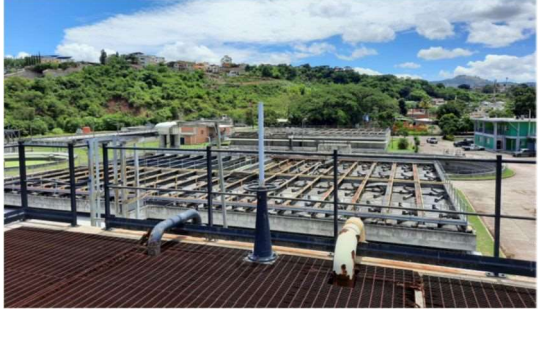
<p>Grid chamber</p>	<p>UASB</p>
