Ministry of Public Works and
Ministry of Agriculture and Fishery
Democratic Republic of Timor-Leste

**THE POST SITUATION AND DATA
COLLECTION SURVEY
FOR
THE FLOOD COUNTERMEASURES
IN DILI**

**Final Report
(Summary)**

December 2022

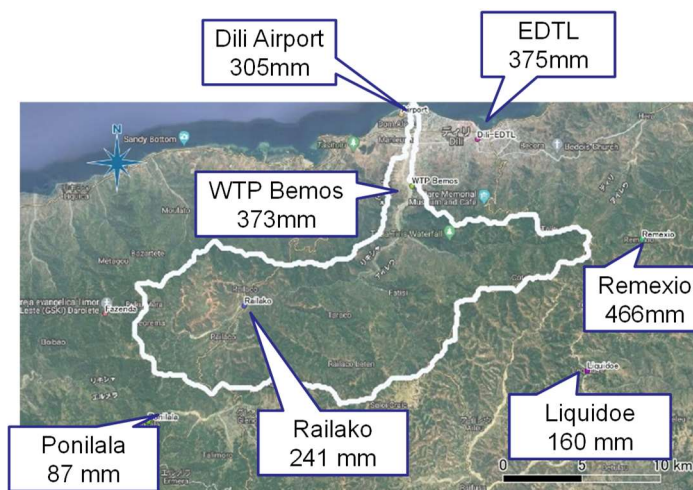
Figure 3.1-1 Rain gauge record(daily) around the Comoro River Basin on April 4th 2021

Dili Airport recorded daily rainfall of 305mm on April 4th, 2021 and other rain gauge stations managed by ANAS record peak daily rainfall on April 4th (Figure 3.1-1). According to the rainfall observation in Dili conducted by UNTL for research purposes, heavy rainfall occurred at dawn on April 4th. The two-day rainfall from April 3rd-4th was 359.6mm for Beto Leste and 338.4mm for Bairro Formosa.

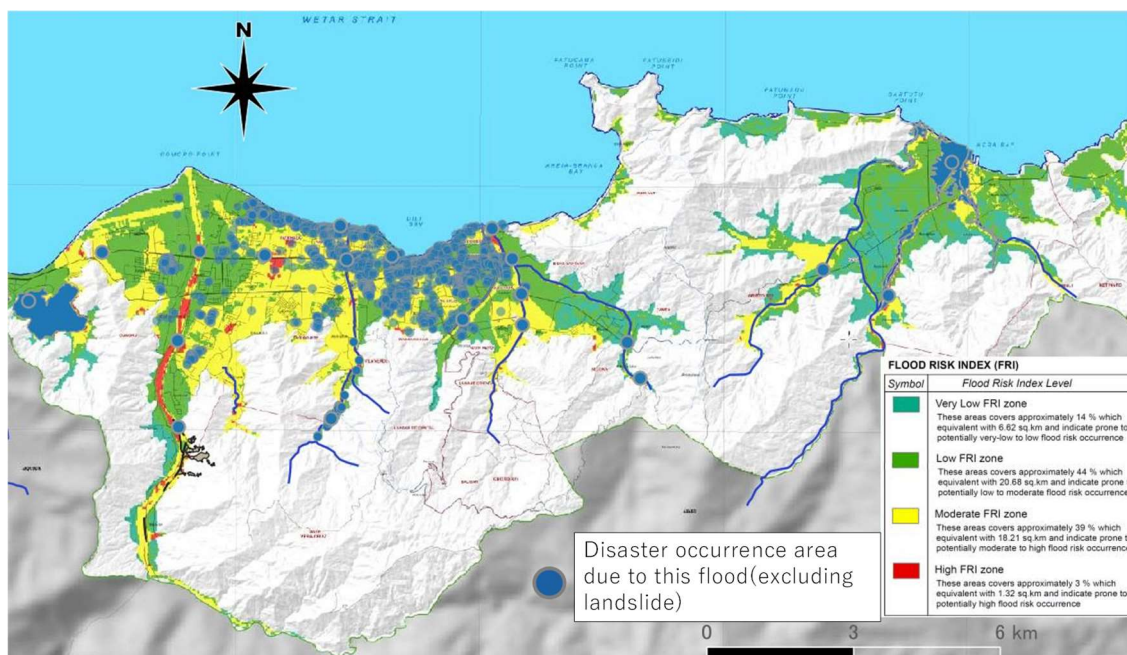
Figure 3.1-5 Flood risk assessment map

Regarding the Flood Risk, it can be confirmed that the damage caused by the April 2021 floods did not necessary occur in High-Risk zone. It is presumed that the cause of the April 2021 disaster was not only through flooding but a complex combination of sediment and water flooding.

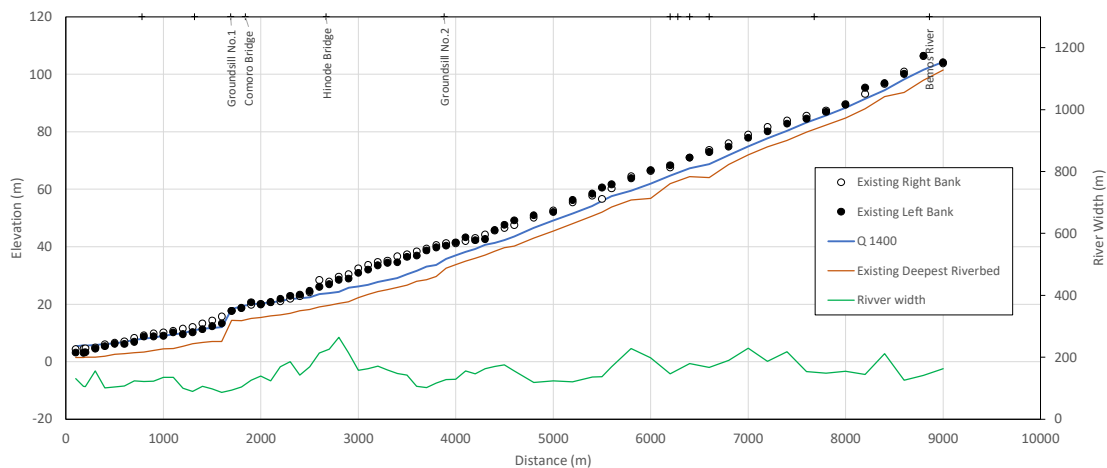
Figure 3.2-3 Longitudinal Profile

Figure 3.2-2 shows the existing longitudinal profile of the Comoro River prepared from cross-sections obtained by topographic survey implemented in this survey. The figure also illustrates the river width in green line and calculated water level of 1,400 m³/s. Carrying capacity of the existing river is estimated by non-uniform flow as shown in Figure 3.2-4.

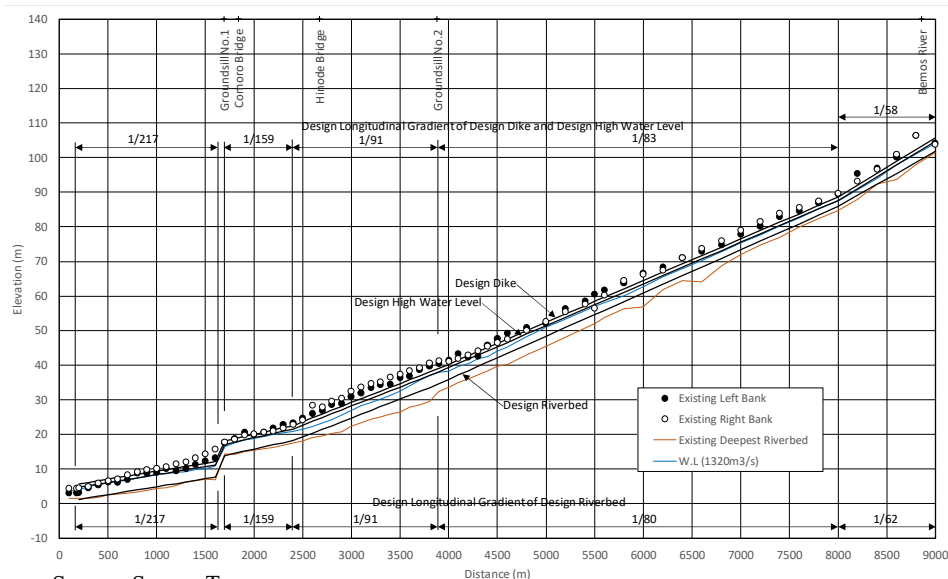
Figure 3.2-5 Design Longitudinal Profile

In the reach from 3.0km to 7.0km, the existing deepest riverbed is lower about 3m than design riverbed. Degradation of riverbed has merit that carrying capacity will be increased by cross sectional area expanded by riverbed degradation. On the other hand, it has demerit that it will cause shorten foundation depth of structures such as revetment, bridge pier, etc. In order to prevent further degradation, installation of groundsills (about 1.5m height) is recommended. It is recommended that a groundsill is installed from downstream and after confirmation of sediment accumulation upstream of the groundsill, the position of a second groundsill is studied.

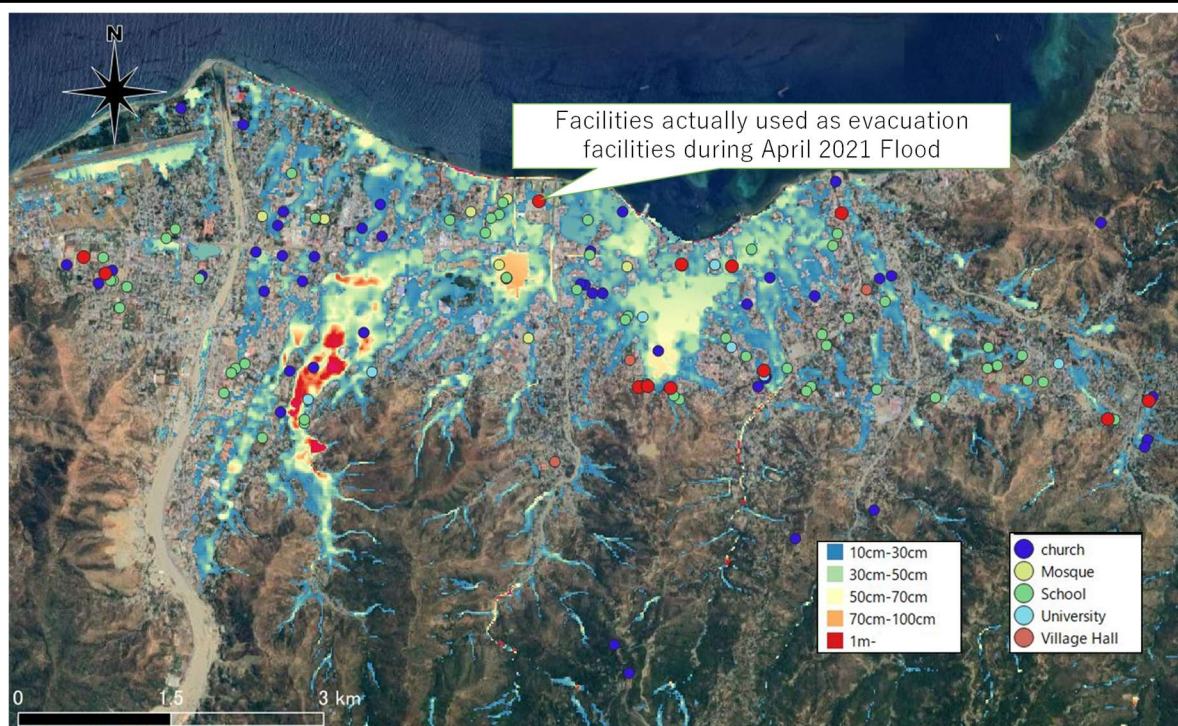
Figure 3.5-2 Distribution of potential evacuation sites in Dili with estimated flood map at the time of the April 2021 floods

Figure 3.5-2 shows the potential evacuation facilities in the vicinity of Dili overlaid on the map of the area expected to be inundated by a flood event. The red circles indicate facilities which have been used as evacuation facilities. While a number of facilities which have been used in the past are clearly insufficient, it is assumed that if other evacuation sites are to be included, the overall situation for evacuation will be improved.

However, many of the possible evacuation sites are located within the high risk flood zone. If they are to be used, it is necessary to take measures to reduce flood risk.
