**THE POST SITUATION AND DATA
COLLECTION SURVEY
FOR
THE FLOOD COUNTERMEASURES
IN DILI**

Final Report

December 2022

JAPAN INTERNATIONAL COOPERATION AGENCY (JICA)

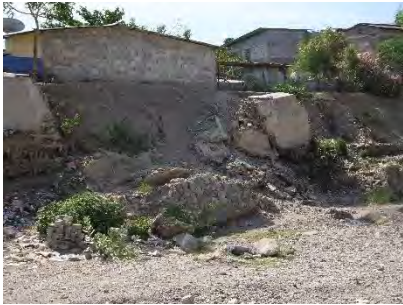
0.9km (Left bank): A part of the damaged section is closed to a runway of the airport.

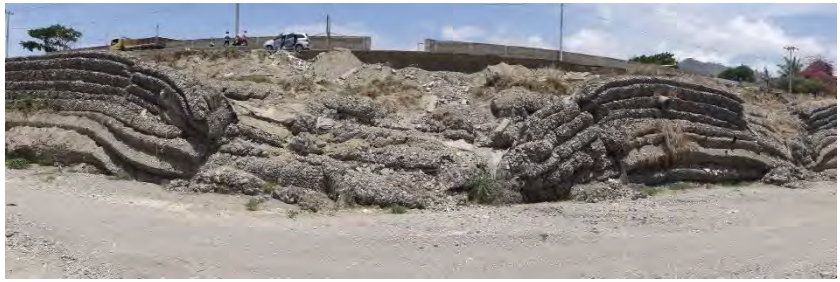
3.8km (Right bank): Gabion mattress is collapsed and traffic of a road on the bank is affected.

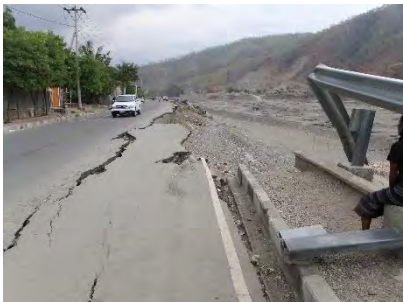
4.1km (R): Retaining wall is collapsed and a part of road is damaged.

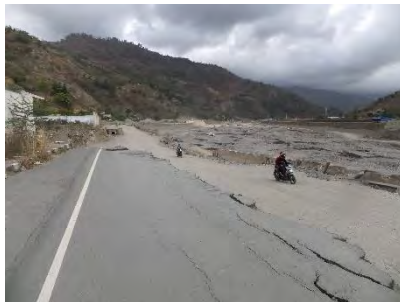
5.5km (R): Retaining wall is dropped and a road on the bank is washed out.

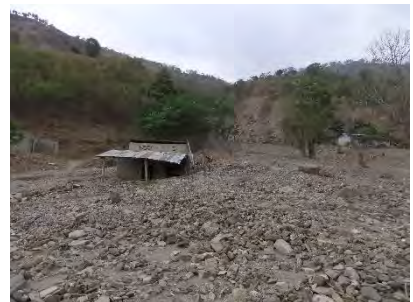
6.1 km (R): House on right bank side is attacked by debris flow.

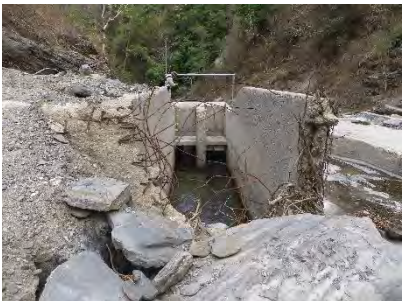
Intake: Falling rocks from the left slope devastated the wall, wing, etc.

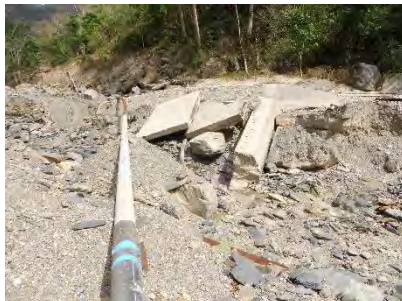
River crossing No.1: Catastrophically damaged except left riverbank

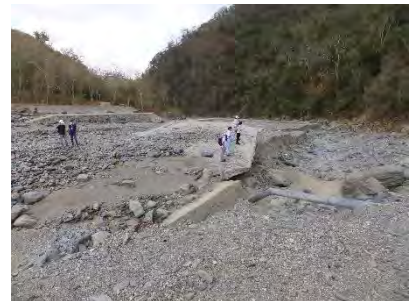
River crossing No.2: Flood flow changed the route beyond the right bank and damaged it.

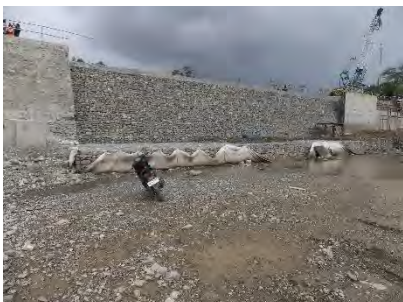
Buluto irrigation: Retaining wall (wet masonry) fell down and urgent recovery was finished.

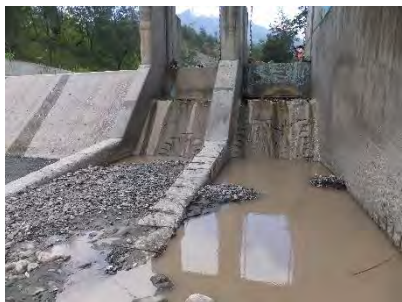
Maliana irrigation: Steel bars of flushing sluice are exposed by wear.

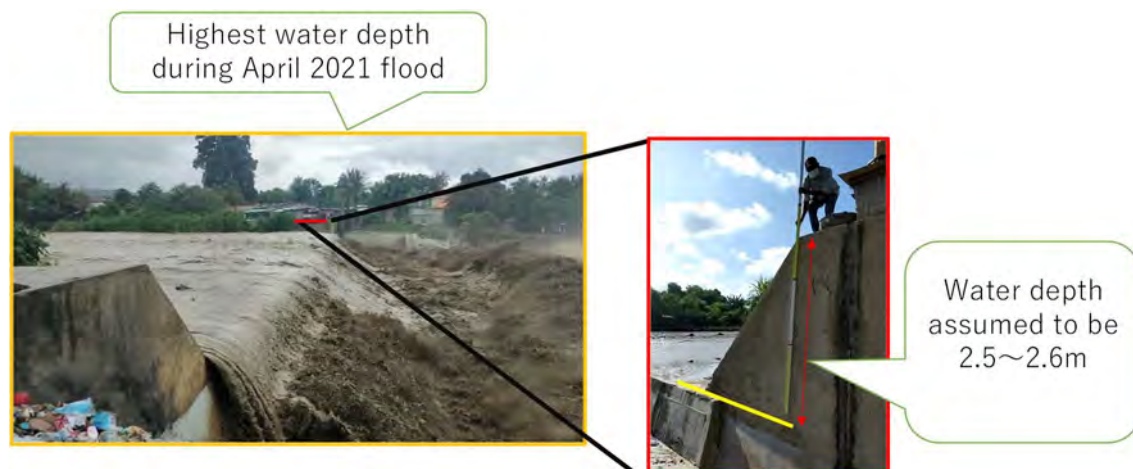
Figure 3.1-22 Peak Water Level during This Flood

According to interviews with local residents in the vicinity of the No.1 Check Dam, the Comoro River did not overflow during **This Flood**, but water level was almost as high as the top of the revetment. On-site survey indicate that the peak water level of **This Flood** reached 2.5m-2.6m(Figure 3.1-22). This depth corresponds to a flow rate of 848-898 m³/s from the weir formula, which is applicable to backward-facing step like this location based on hydraulic property.

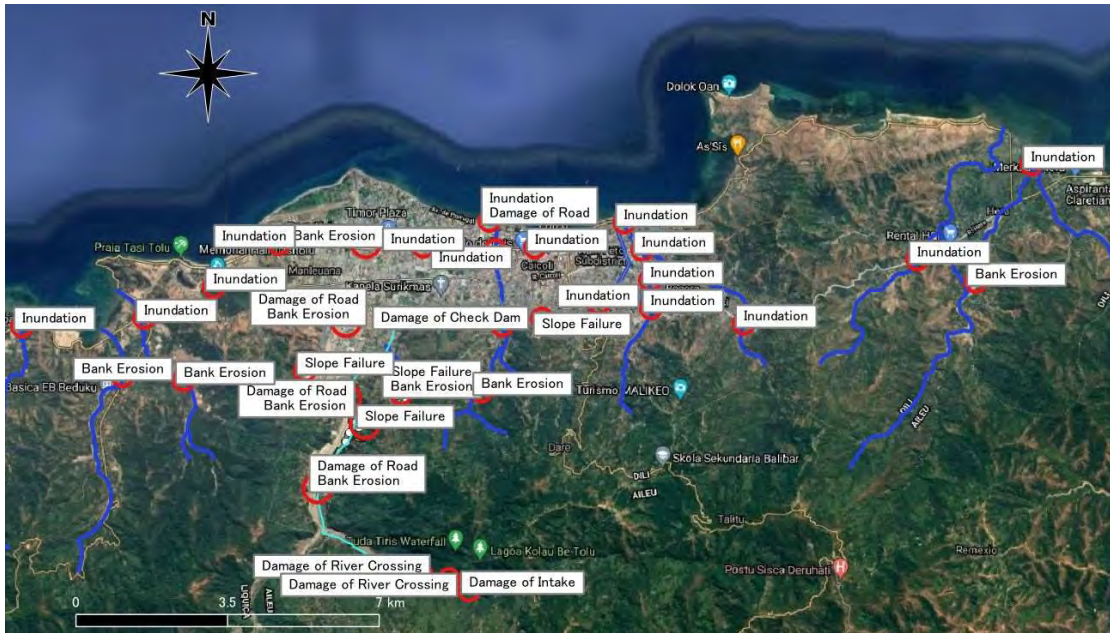
Figure 3.1-28 Damage situation around Dili Municipality caused by April flood

Regarding the April flood, damage occurred in various places around Dili Municipality as shown in Figure 3.1-28.

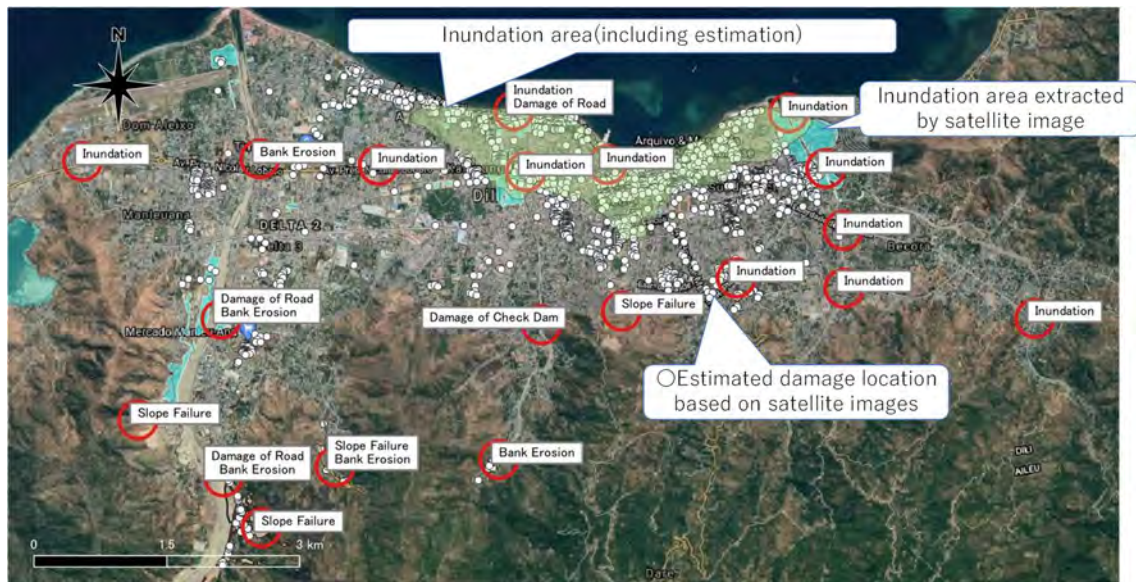
Figure 3.1-29 Damage situation in the center area of Dili during April flood

Figure 3.1-29 shows the damage in the center area of Dili caused by April flood. Damage has occurred in various places from upstream to downstream of the River and low-lying area.

Sediment disasters occurred in the upstream area and River channels is blocked in the middle reach due to the sediment accumulation at the intersection of road bridges and urban streams. In the downstream low-lying area, the possibility of flood damage due to storm surge and insufficient drainage capacity has been reported.

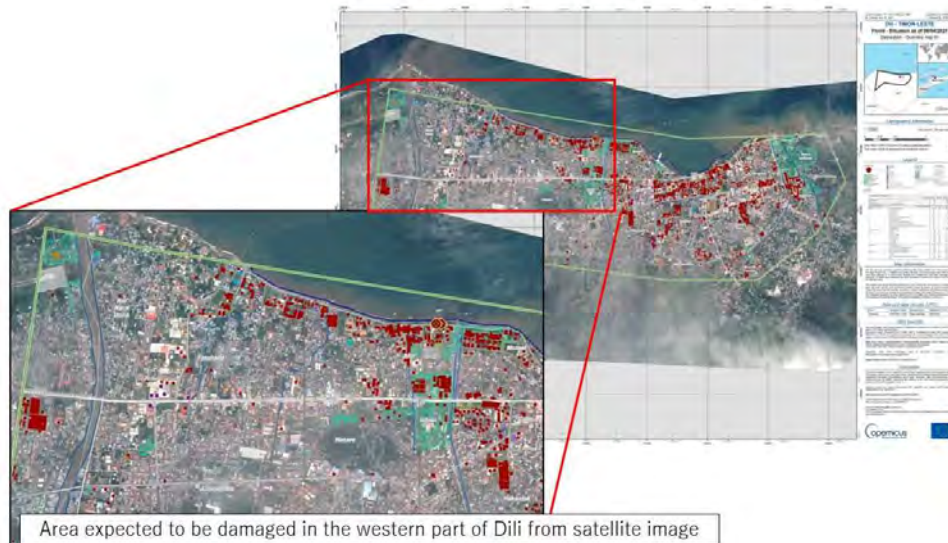
Figure 3.1-40 Area expected to be damaged in the western part of Dili by satellite image

In the low-lying area western part of Maloa River damage is assumed based on satellite image, though there is almost no specific description in various materials.

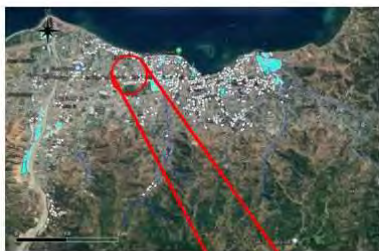
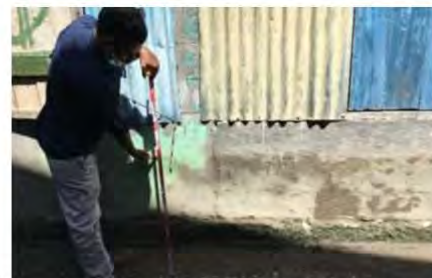
It is reported that the retaining wall of the drainage channel collapsed near Fatuhada, causing damage to an inundation depth of about 40-50cm.

Inundation trace of about 40~50cm

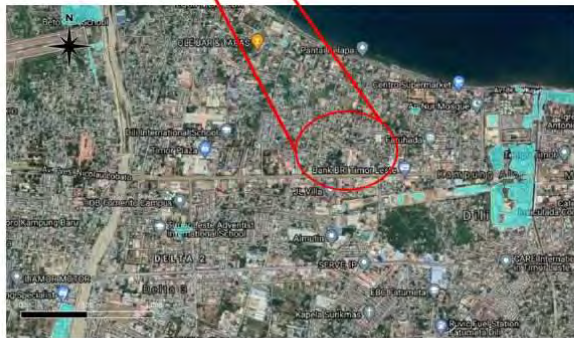
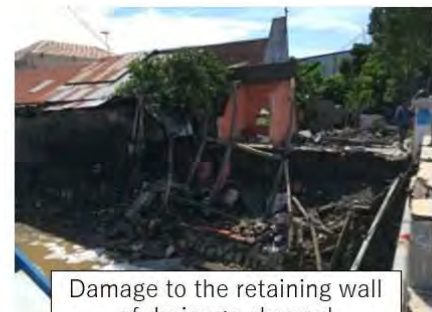
Damage to the retaining wall of drainage channel

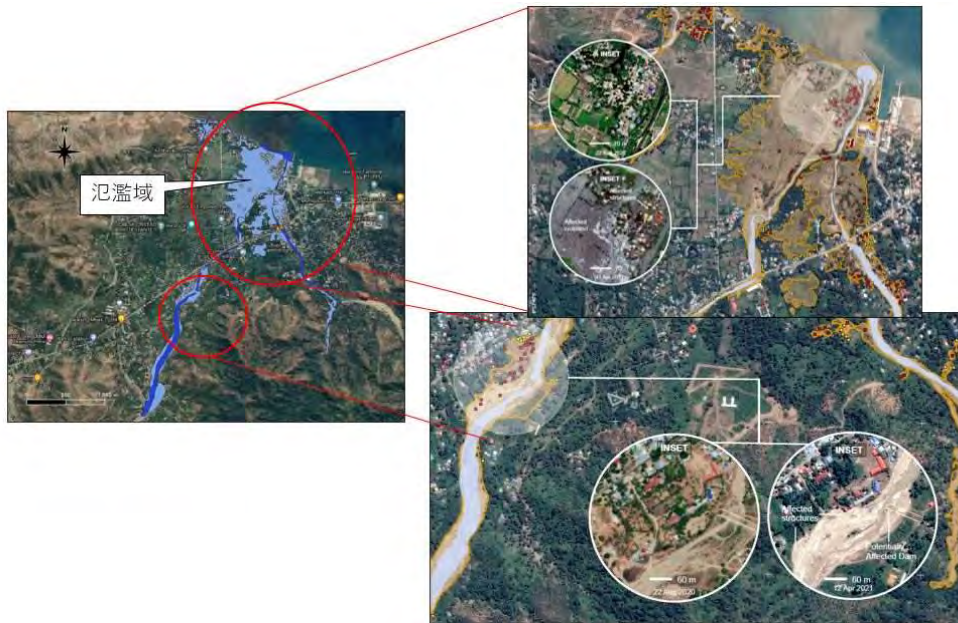
Figure 3.1-46 Damage situation in Hera

Figure 3.1-46 shows the flood damage in Hera. According to the FAO material³, crop land near the mouth of Mota-Kiik was washed away by flash flood. Other reports says that large-scale riverbank erosion occurred in the area about 1km south of UNTL Hera Campus, which washed away several houses.

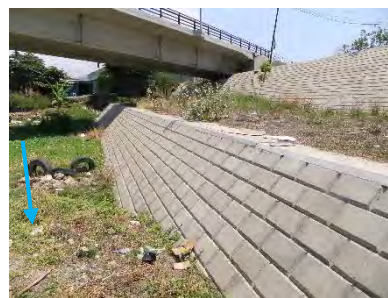
Figure 3.2-3 Revetment of Hinode Bridge

- River mouth – 1.2km: wet masonry is installed. The height is about 2m but the foundation of 1 – 2m is exposed. Houses are built on embankment filled in front of revetment at the upper reach.
- 1.2km – 1.69km (ground sill No. 1): Revetment for this section is not clearly visible because of densely packed houses.
- 1.7km - 2.3km: No revetment.
- 2.3km – 2.67km (Hinode Bridge built by Japan's Grant Aid in 2018): Low water channel revetment (wet masonry, H=1.6 – 2.5m) is placed 50m away from the high water channel bank.

- 2.67km: Concrete block masonries (1:0.5) are placed on highwater channel bank and low water channel bank in the upper/lower reaches. On the end of the concrete masonries, gabion mattress is placed as transition structure.
- 2.8km - 3.0km: Low water channel revetment of wet masonry with about 4m height is installed.
- 3.0km - 3.36km: Gabion mattress is laid in as low water channel revetment.
- 3.36km - 4.13km: The ground sill No.2 exists in this stretch. Wet masonry with 1.5m height is set in.
- 5.4km – 5.57km: Wet masonry revetment is placed. It seemed to be constructed in a little old time, because the surface of revetment is not mortar finish as other wet masonry.
- 6.1km - 6.5km: Wet masonry revetment is installed. In lower stream from 6.1km, it is not clear the stretch placing revetment because it is completely washed away.

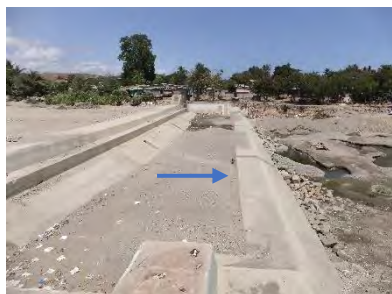
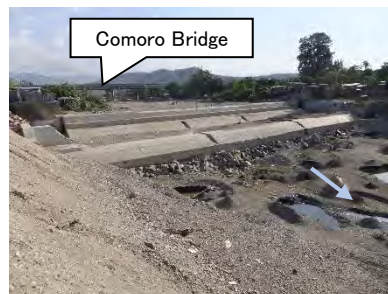
Figure 3.2-5 Ground sill No.1

Ground sill No.1 (1.69km, Figure 3.2-5): Ground sill No.1 is located 150m downstream of Comoro Bridge in order to prevent riverbed degradation at the bridge. It was renovated in 2019 because the damage became large from around 2017, the center of head part was missing, the sediment on the upstream side was washed away, and the range of the riverbed scouring could extend to the upstream

Comoro Bridge. The gap the upstream level and the downstream one is relatively large due to riverbed material mining on a large scale. DRBFC has a plan that installation of more groundsills near future.

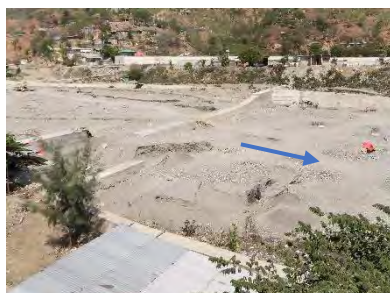
Figure 3.2-6 Ground sill No.2

Ground sill No.2 (3.88km, Figure 3.2-6): Ground sill No.2 was constructed in 2017 aiming to prevent riverbed degradation caused by excessive riverbed material mining. Figure 3.2-7 shows the changing of riverbed elevation before and after 2021 April flood. Comparing the riverbed heights, the riverbed rise is remarkable upstream of the groundsill No.1, while the riverbed decline tendency is shown downstream, and the ground sill No.1 restrains the movement of the riverbed material.

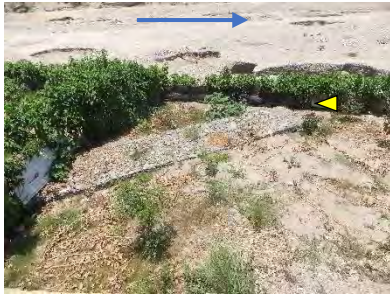
Figure 3.2-8 Groin No.1

Groin No.1 (0.78km on the right bank, Figure 3.2-8): A groin made of gabion mattress is installed, but it is filled with embankment according to the height of the top and used as agricultural land. It can be said that it is in a safer state from the viewpoint of riverbank protection, but it is not preferable for river management to change the shape of the river channel and use it privately.

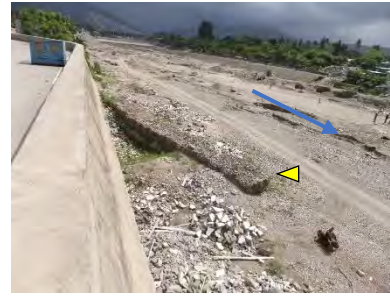
Figure 3.2-9 Groin No.2

Groin No.2 (1.32km on the right bank, Figure 3.2-9): A groin made of gabion mattress is set in. It is 20m long, 2m high (2 layers of gabion mattress), and faces 68 degrees downstream from the direction perpendicular to the revetment alignment.

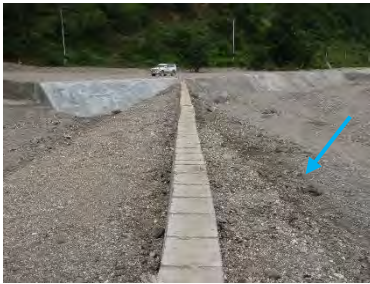
Groin No.3 (6.2km on the right bank): It is made of reinforced concrete and has a length of 45 m, facing 55 degrees downstream from the direction perpendicular to the revetment alignment. Figure 3.2-10 shows the photographs of June 2013 and October 2021. From the figure, it can be seen that the riverbed has declined in eight years. The 3rd to 4th and 5th groins are installed at intervals of 200m. It is probable that these three groins were installed as a group.

This groin has three cracks on the way. In "a) Revetment", the landfill by a gravel company on the right bank of 5.6km to 6.2km was described, but the groin No.3 located at the upstream end of the section eventually protects the landfill embankment.

2013 June: View from tip of groin to revetment

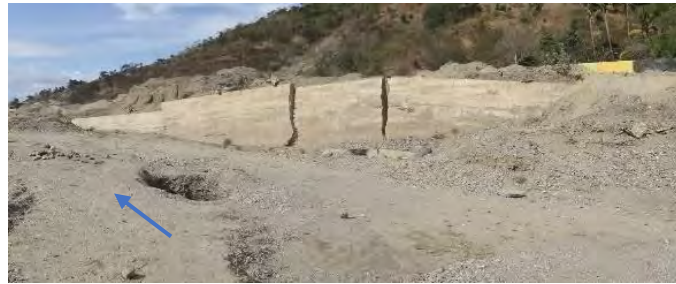
Figure 3.2-10 Groin No.3

2021 October: View from upstream to groin

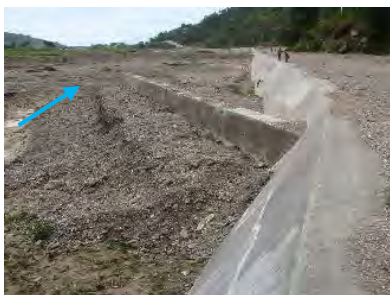
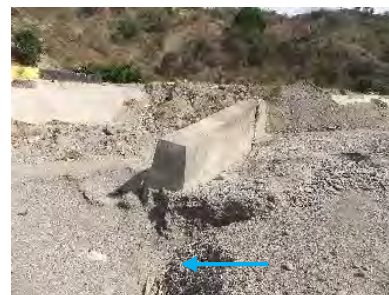
Figure 3.2-11 Groin No.4

Groin No.4 (6.4km on the right bank): It is made of reinforced concrete and has a length of 40 m, facing 55 degrees downstream from the direction perpendicular to the revetment alignment. The main body of the groin is tilted upstream as a whole, and there are large cracks in two places. Figure 3.2-11 shows the situation in 2013 and 2021.

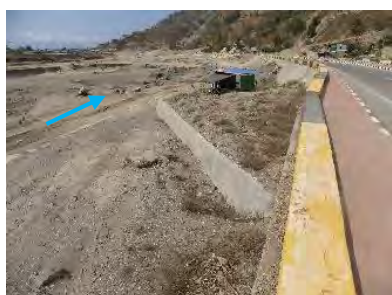
Figure 3.2-12 Groin No.5

Groin No.5 (6.6km in the right bank, Figure 3.2-12): Since it is not damaged in appearance, it is not known whether or not there is a reinforcing bar, but it is considered to be made of reinforced concrete like the 3rd and 4th groins. It is 30m long and faces 48 degrees downstream from the direction

perpendicular to the revetment alignment. An embankment is built between the groin and the riverbank, and a work hut is built on it.

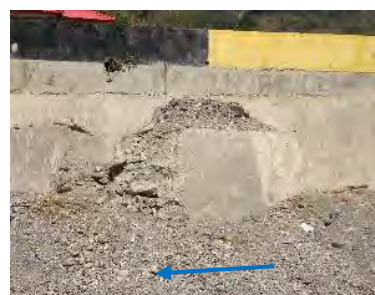
Figure 3.2-13 Groin No.6

Groin No.6 (7.68km on the right bank, Figure 3.2-13): The main body of the groin has already been destroyed, and now only the revetment attachment part can be confirmed.

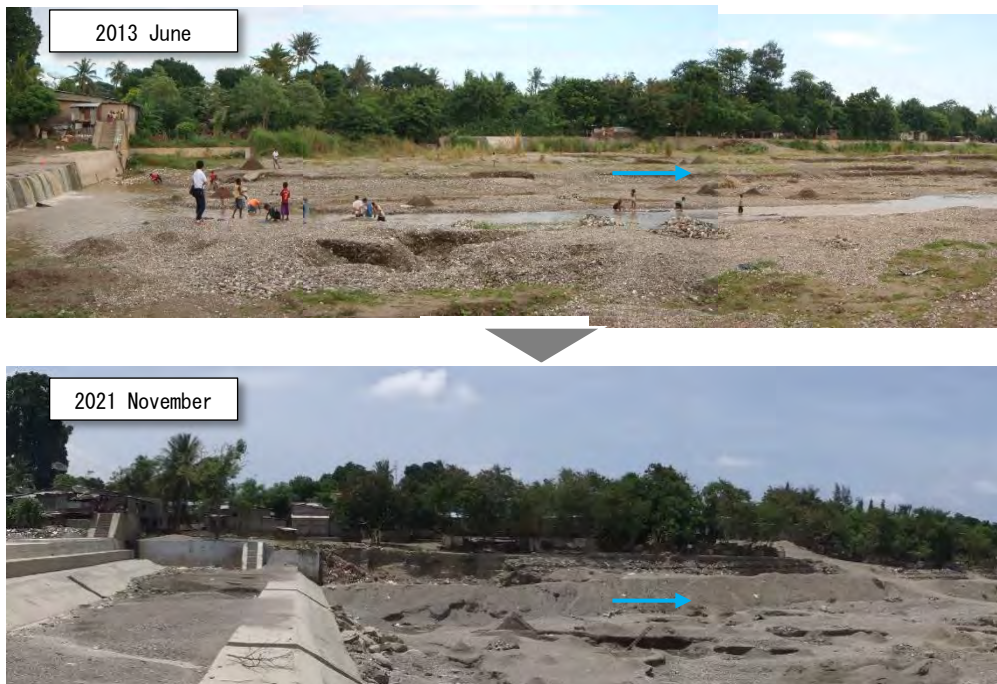
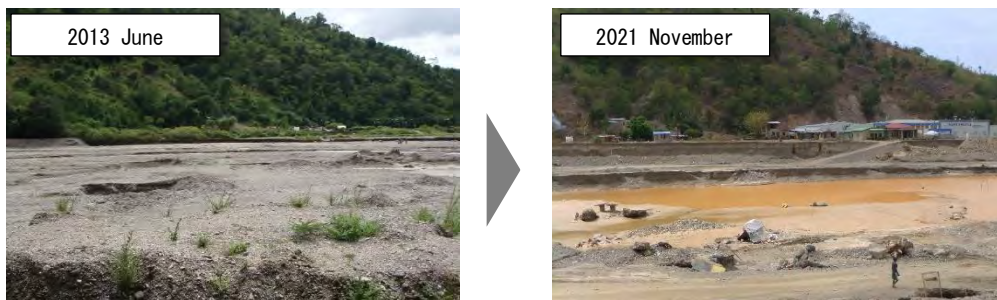
Figure 3.2-14 Changing of Riverbed (2013-2021)

Ground sill No.1 (1.69km)

6.7km

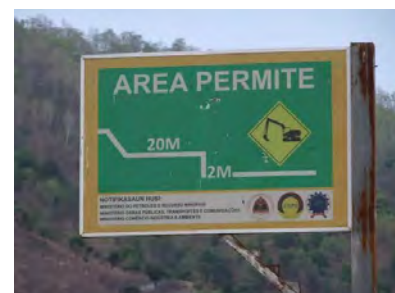
Figure 3.2-15 Signboard indicating minable range

Figure 3.2-14 is a signboard indicating the minable range by the Ministry of Petroleum and Natural Resources, the Ministry of Public Works, and the Environment Bureau. However, in reality, gravel mining is being actively conducted even in the vicinity of the revetment, where mining is not permitted, and it is thought that this is one of the causes of the revetment damage caused by the 2021 April flood.

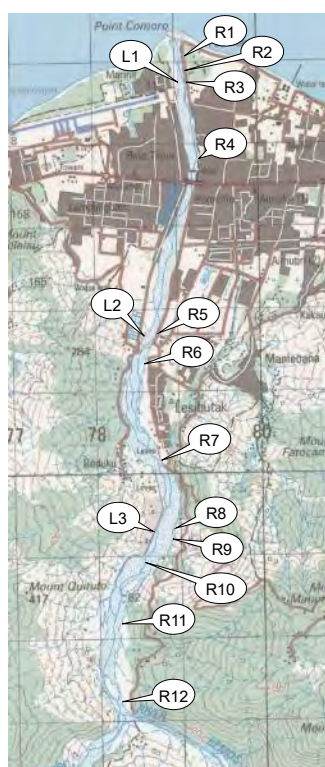
Figure 3.2-16 Location and Length of Damaged Revetment

Figure 3.2-16 shows the location of the damaged revetment and the length of the damage in the Comoro River from the river mouth to the confluence with the Bemós River. The damage to the revetment is concentrated on the right bank, and the number of damaged locations is four times that of the left bank and the damaged length is twice that of the left bank. In particular, the revetments constructed after 2013 have been continuously damaged on the right bank (R7 to R12) upstream of 5.5km. On the other hand, on the left bank side of the same section, the road on the riverbank is cut off in the middle, so the land development is not progressing, and the revetment is limited. Details of each damaged area are described below.

Length of damaged revetment		
Left/Right bank	Symbol	Length (m)
Left bank	L1	460
	L2	23
	L3	374
	Sub-total	857
Right bank	R1	168
	R2	39
	R3	38
	R4	141
	R5	100
	R6	110
	R7	142
	R8	100
	R9	112
	R10	232
	R11	560
	R12	53
	Sub-total	1,741
Total		2,598

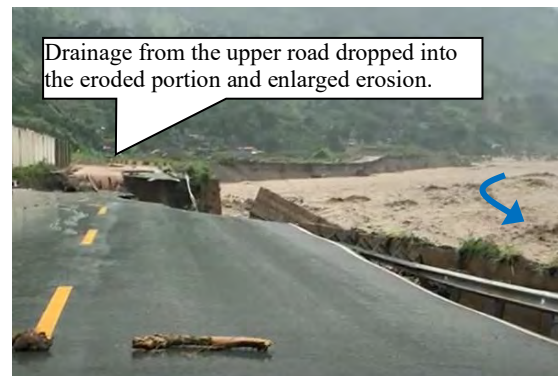
Figure 3.2-24 R7 site during 2021/4 Flood

At the point where the Comoro River passed through the mountains and entered the alluvial fan, the revetment collapsed, and riverbank erosion occurred over 142 m. Since the river on the right bank upstream of this section is being reclaimed by a gravel company, the flood flow hits the section directly, which causes the revetment foundation to be washed and the back sediment to be sucked out. It is thought that this progressed and led to the collapse of the revetment. This damaged riverbank section was reclaimed for construction of the bypass road in the past, and this narrow river width caused bank erosion by rapid flood flow. Furthermore, as shown in Figure 3.2-24 drainage from the upper road dropped into the eroded portion and enlarged erosion.

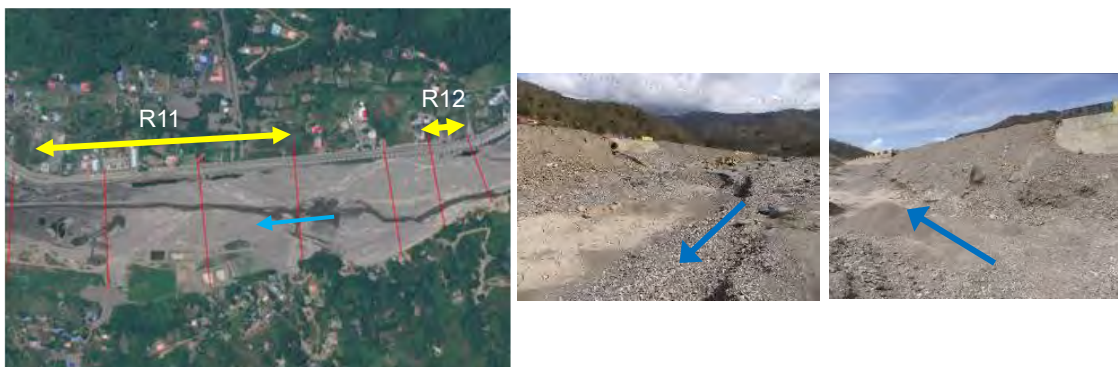
Figure 3.2-28 Damaged Revetment (R11, R12)

560m and 53m revetment with wet masonry were damaged in the straight section after the confluence with the Bemos River. Gravel is piled up on the riverbank as an emergency restoration, but since the gravel is collected from the riverbed closed to the foot of damaged slope. As a result, flow course is

formed near the riverbank. The damage length of R11 is 560m, which is the longest in the section covered by this survey. In the restoration, it is recommended to put lateral spits in the revetment at regular intervals and to lay a floor protection works (concrete block) on the foot of riverbank.

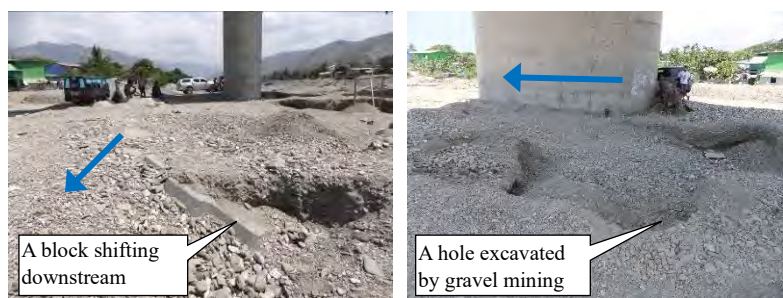
Figure 3.2-30 Riverbed around P3 pier

On the P3 pier, a large hole has been dug for gravel mining right next to the pier, and the original foot protection block cannot be confirmed. In addition, three foot protection blocks can be confirmed outside of laying range at the construction time. (Figure 3.2-30).

The causes of the washout and movement of these foot protection blocks are considered to be as follows. In restoration, it is necessary to pay attention to these points and try to prevent disasters again.

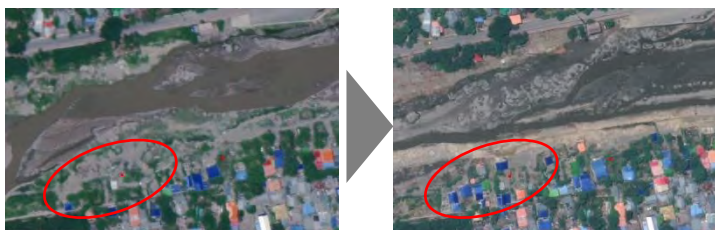
1.15km on the left bank:
Approximately 15 houses have been newly constructed after the flood.

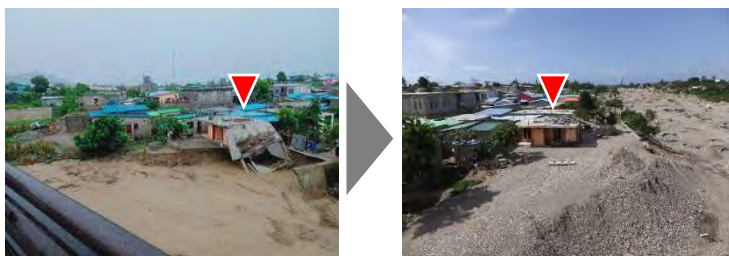
2.65km on the left bank: A house on a high-water basin downstream of Hinode Bridge. The high-water basin was eroded, and part of the house was washed away.

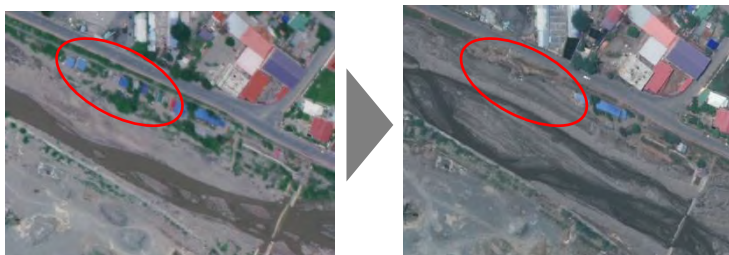
Figure 3.2-31 Changing of Houses before/after Flood

3.8km on the right bank: The location of the damaged revetment R5 shown in 3.2.2 (1) (f). The 5 or 6 houses on the river side have disappeared after the flood.

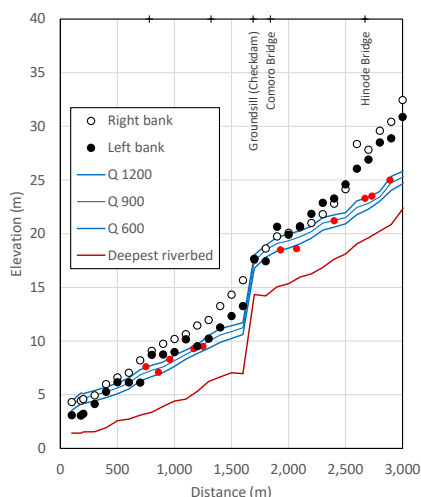
Figure 3.2-36 Flood Marks of 2021 April Flood

The figure also illustrates the river width in green line and calculated water level of 900 m³/s and 1,400 m³/s. 0.04 is adopted for roughness coefficient because the riverbed material is mainly gravel. Water level of 900m³/s, which is equivalent to the peak discharge of 2021 April flood (described in 3.1.3 (2) 2), is under the riverbank elevations. It is consistent with the fact that no overflow occurred in these reaches. Figure 3.2-36 shows the flood marks obtained by hearing survey.

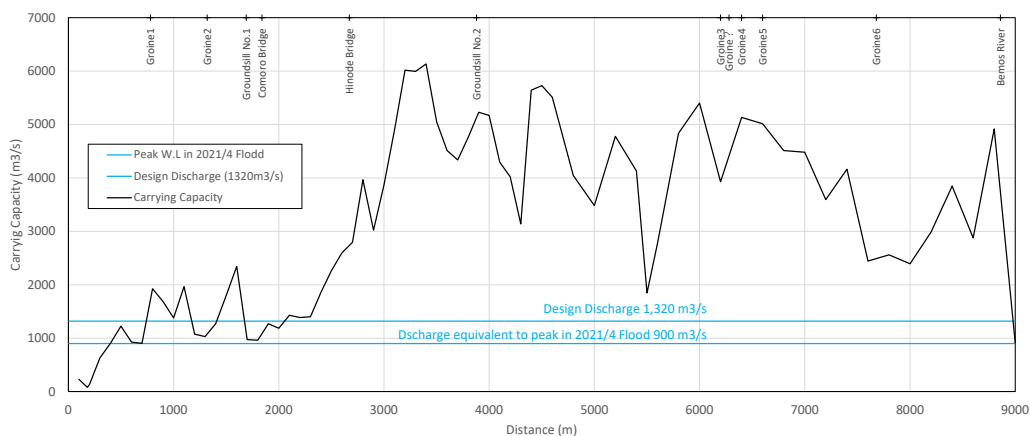
Figure 3.2-37 Carrying Capacity of Existing Comoro River

Carrying capacity of the existing river is estimated by non-uniform flow as shown in Figure 3.2-37. Carrying capacity is estimated using the lower elevation of left and right riverbank elevations.

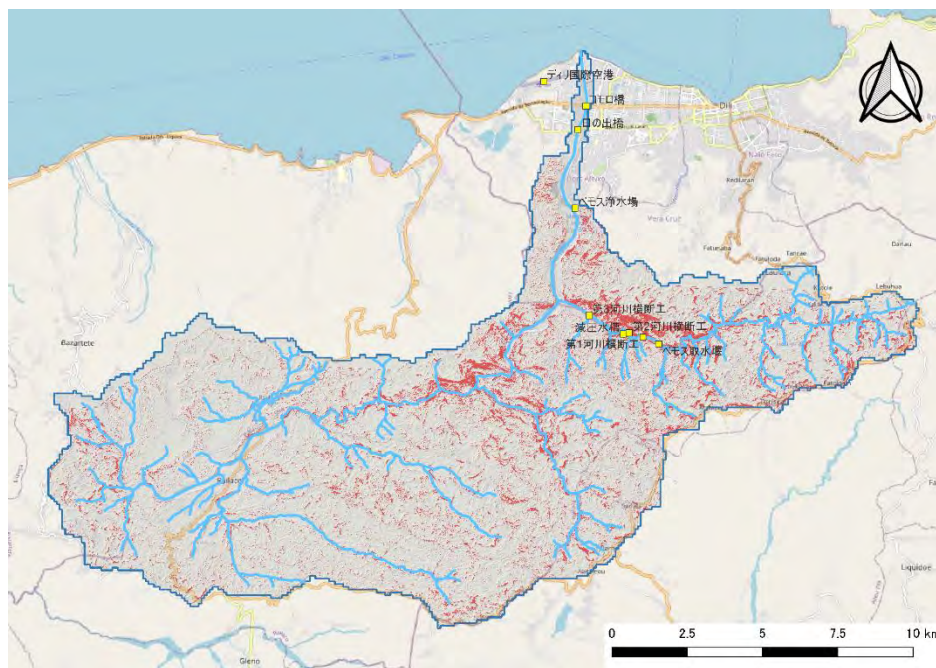
Figure 3.2-60 Steep Slopes in the Comoro River Basin

Figure 3.2-60 shows the results of extracting points with an inclination of 30 degrees or more from the Digital Elevation Model (NTT DATA) of the Comoro River basin. According to the figure, steep slopes are concentrated on the right bank of the Bemos River. In the 2021 April flood, a large number of stones and gravel flowed into the Bemos River and accumulated from the both the left and right banks. In the Bemos River, it is thought that gravel and sediment accumulated on the riverbed will be supplied to the Comoro River every time floods occur in the next few years. Fortunately, the section from the confluence of Bemos (around 9km) on the Comoro River to about 2.5km downstream has sufficient flow capacity, so it is not necessary to actively prevent sediment outflow from the Bemos River, but regular monitoring is necessary.

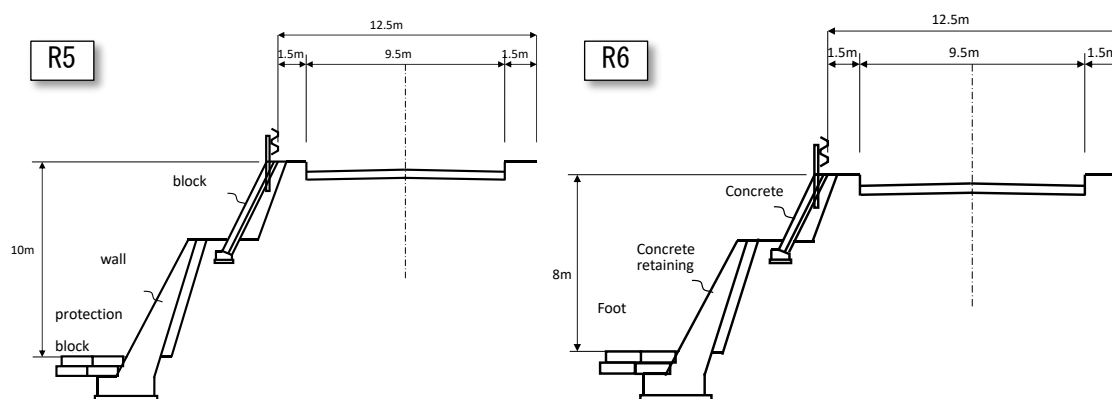
Figure 3.2-61 Standard Cross Section of the Rehabilitation

R5 (3.8km point, damage length 100m) and R6 (4.1km point, damage length 110m) will be candidate subject to rehabilitation by Japan's Grant Aid. Reasons of selection of these 2 sites are as follows.

- Ensure a sufficiently safe foundation depth against scouring and lay a foot protection blocks to prevent local scouring at the foot of slope.
- A lateral strip will be installed on the revetment at regular intervals in the extension direction to insulate the revetment so that transfer or damage at one point will not spread to others.
- If the riverbank is high, a small step will be provided in the middle of the slope to stabilize the slope. However, the width of the small steps should be such as to discourage housing construction.
- The above ideas of plan and design for rehabilitation are adopt to other sites and projects.

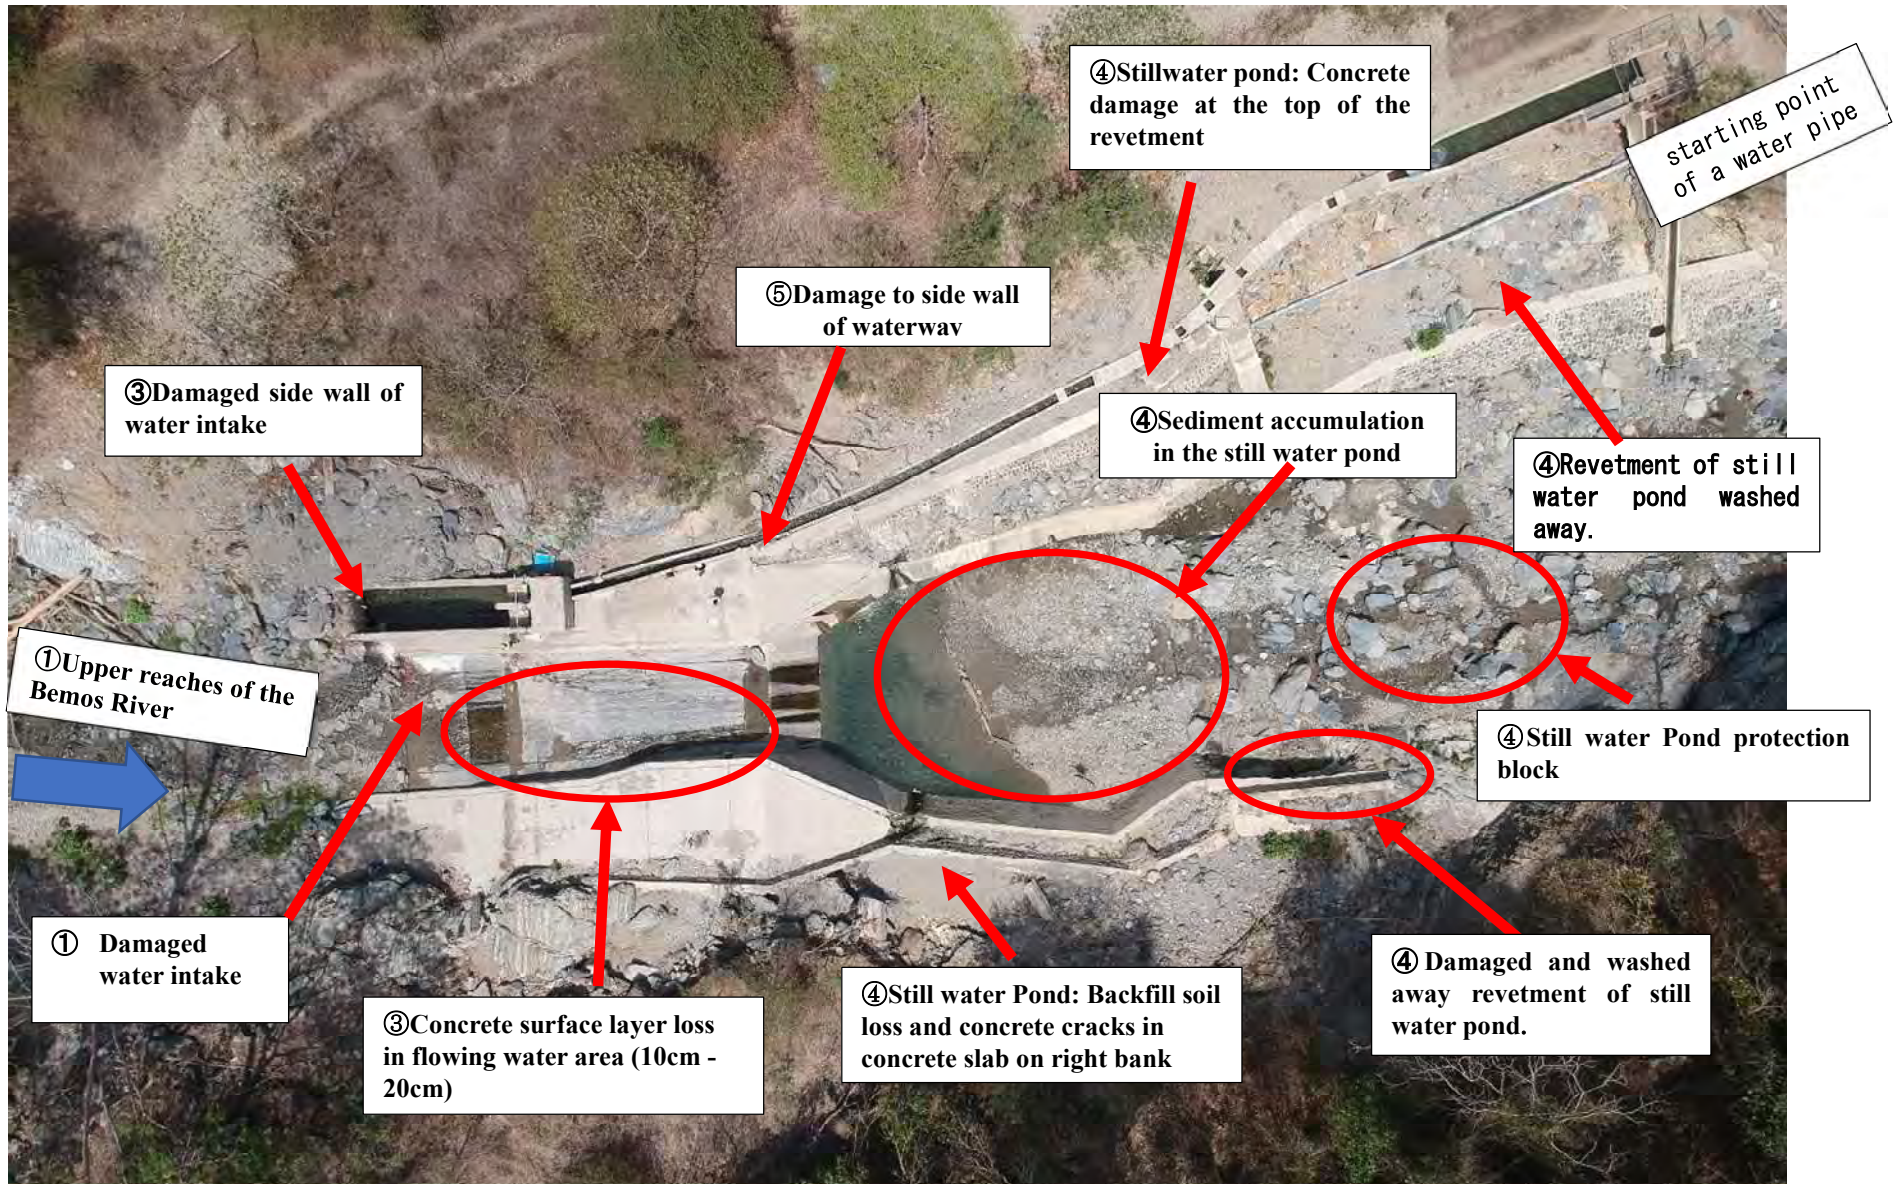
Figure 3.3-5 Damaged area of Bemos intake weir.

Facility Location	Situation
① Intake	The water intake is damaged. The upstream side wall is severely damaged.
② Water intake gates (2 locations)	A couple of places have been removed. In two places, the spindles were bent, making it difficult to operate them properly. There was damage to the hardware at the gate guide in both locations.
③ Fixed weir	Defects were observed on the concrete surface, and the reinforcing steel was exposed. Considering the rebar cover, about 20 cm of the concrete surface has flowed out. The surface of the concrete section of the bottom slab was scraped off, exposing the steel bars. The concrete slab on the right bank side is cracked and floating.
④ Still-water pond	Revetment on the right bank: soil on the back of the revetment has been washed away along with the blocks.

<p>Left bank side: Slope sediment has been washed away. The concrete at the top of the left bank revetment was found to be floating. The protective floor blocks have been washed away. The pond bottom elevation of the still-water pond is EL.217.0, but sediment and gravel are deposited up to the top elevation of the protective bed block downstream (EL.221.5). The function of the pond is not fulfilled.</p>
⑤ Canal	<p>The side wall of the waterway is damaged. (However, it is difficult to determine if it was caused by the flood.)</p>

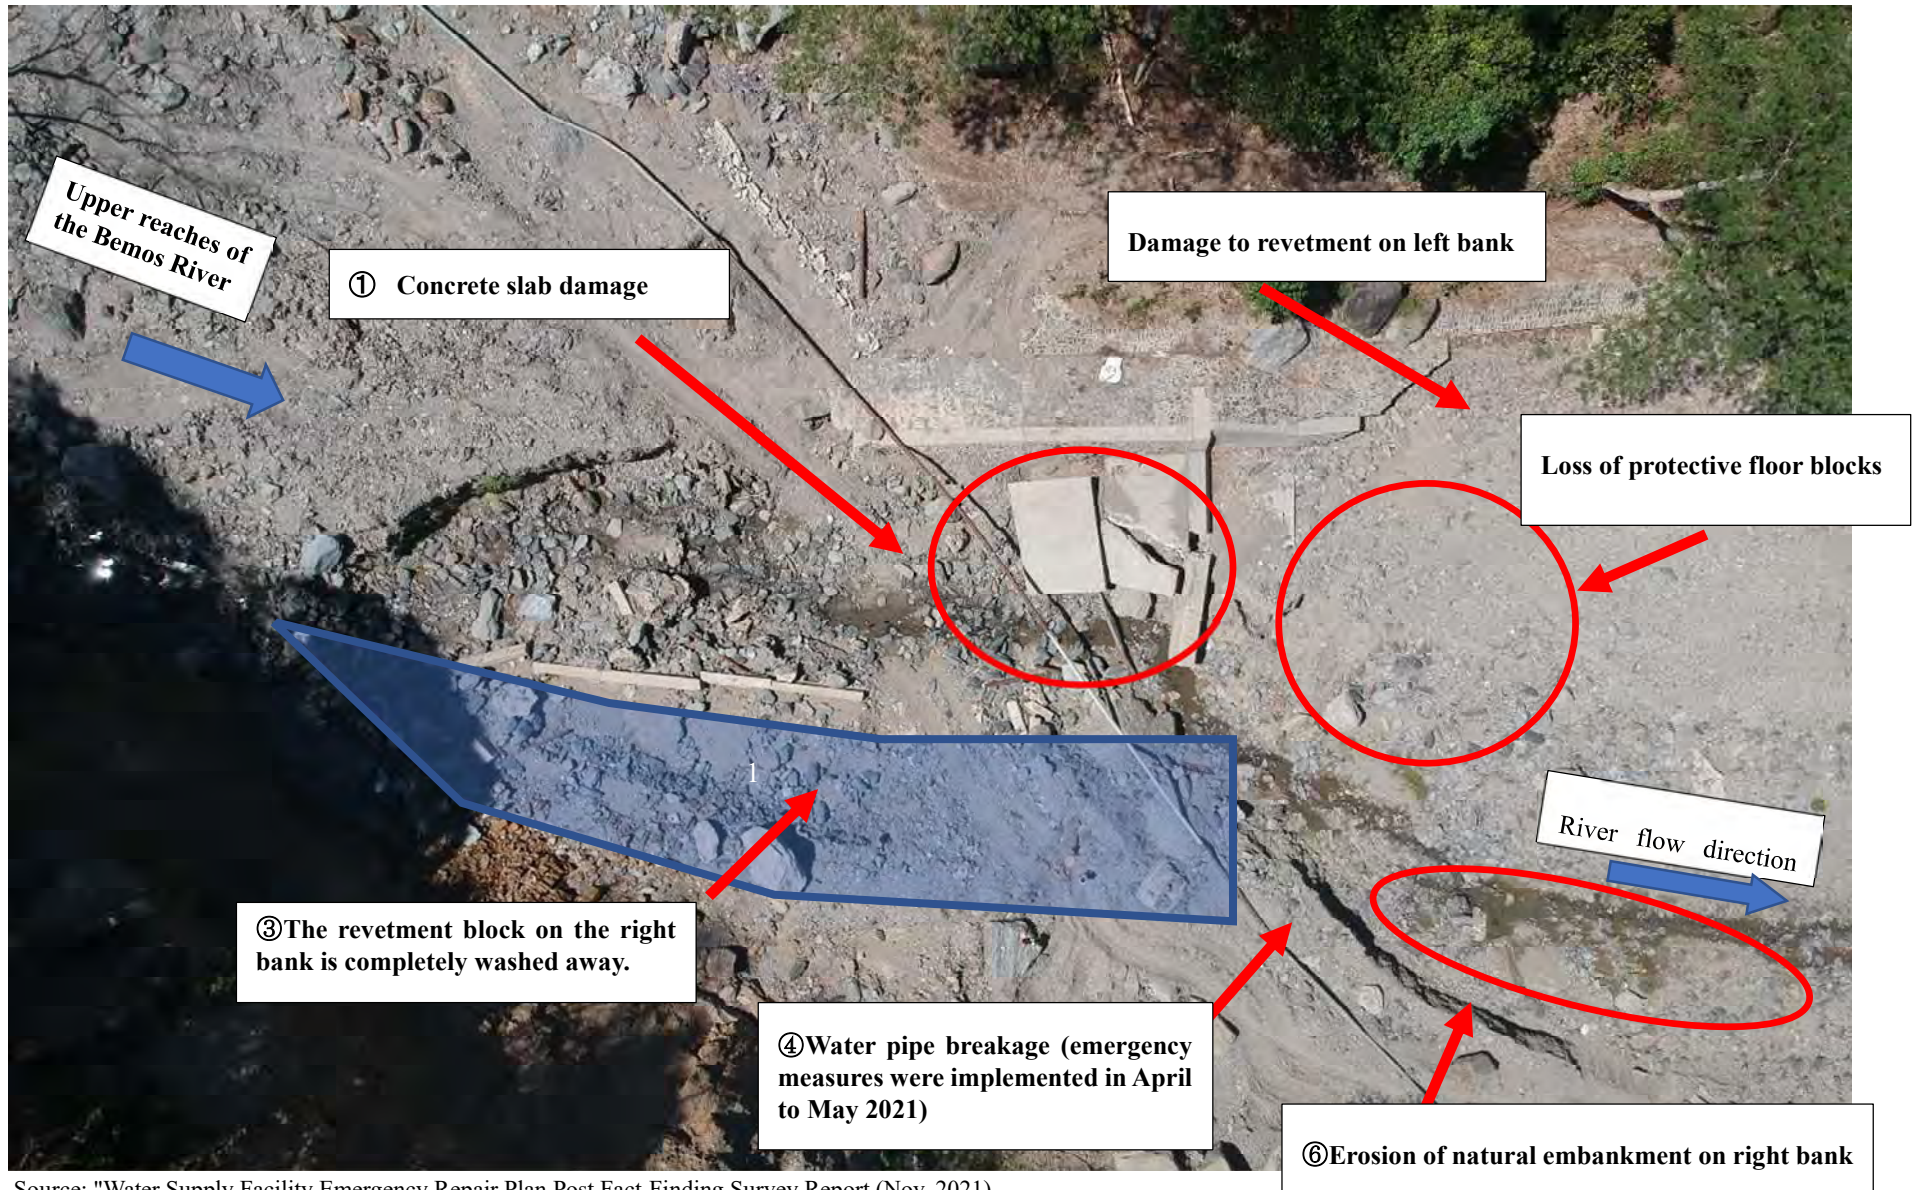
Figure 3.3-7 River Crossing No. 1

Item	Damage
① Concrete slab damage	While some of the concrete slab on the left bank remain, most of the floorboards on the right bank have been washed away.
② Damaged revetment on the left bank side	The revetment on the downstream side has been damaged and is washing away.
③ Revetment block on the right bank	Completely lost.
④ Water pipe breakage	State exposed due to destruction of protective concrete (Emergency measures were implemented in April to May 2021)
⑤ Drifting away of bed protection blocks	The existence of the block could not be confirmed. There is a possibility that the block was washed away because the right bank side is deep.
⑥ Erosion of the right bank embankment downstream of the crossing	The sediment of the natural embankment downstream of the crossing was washed away. This is thought to be because the flow direction is toward the right bank.

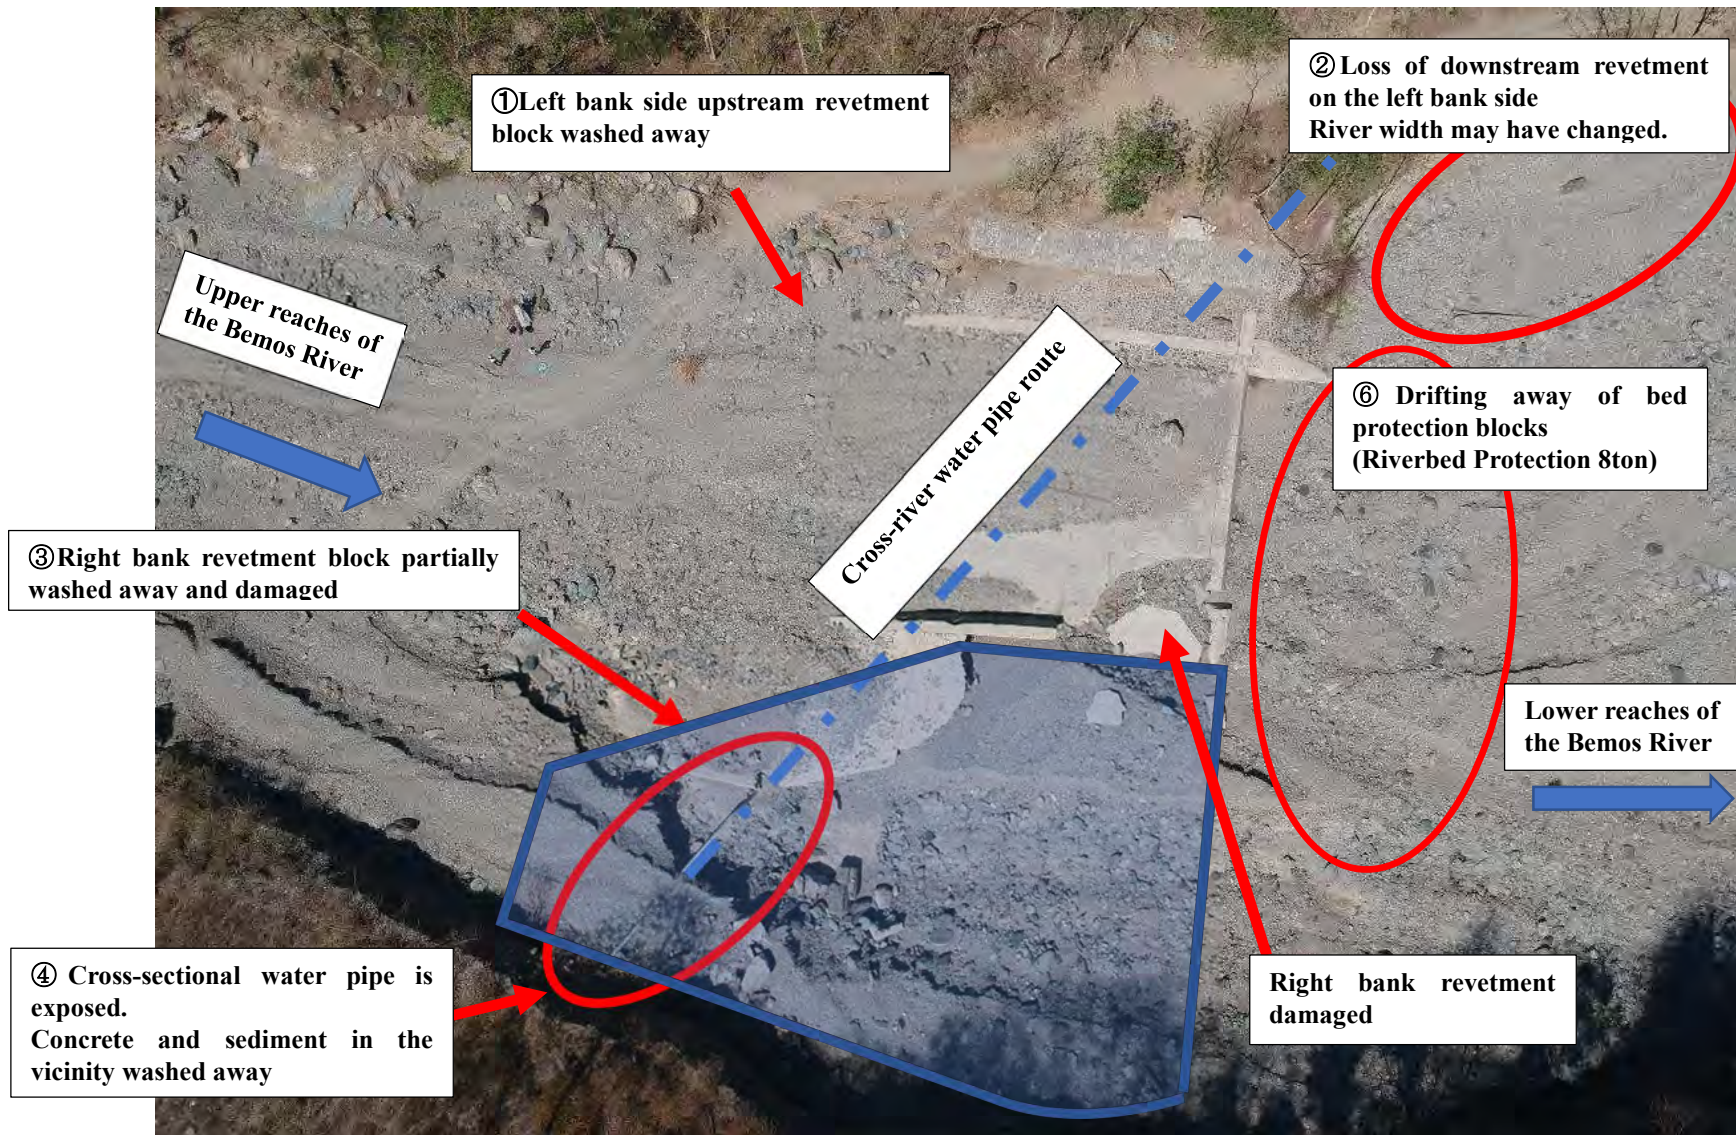
Figure 3.3-8 River Crossing No. 2 Damage Status

Item	Damage
① Loss of upstream revetment block on the left bank side	The block on the upstream side has been washed away, but the damage is less severe than on the right bank.
② Washed away of the downstream revetment on the left bank side	The revetment (natural dike) on the downstream side is being eroded.
③ Right bank revetment block partially washed away and damaged	The revetment has been washed away. Damage is greater than on the left bank.
④ Loss of concrete and sediment around water pipe	The concrete and backfill soil that protected the pipes were washed away, exposing the pipes.
⑤ Washed away of the bed protection blocks	The right bank revetment and concrete slab on the right side of the flowing water section are damaged.
⑥ Washed away of the bed protection blocks	Since the block (8 tons) cannot be confirmed, it may have been washed away. Especially on the right bank side, the operation is deeply scoured, and it is thought to have been washed away.
