**THE POST SITUATION AND DATA
COLLECTION SURVEY
FOR
THE FLOOD COUNTERMEASURES
IN DILI**

Final Report

December 2022

JAPAN INTERNATIONAL COOPERATION AGENCY (JICA)

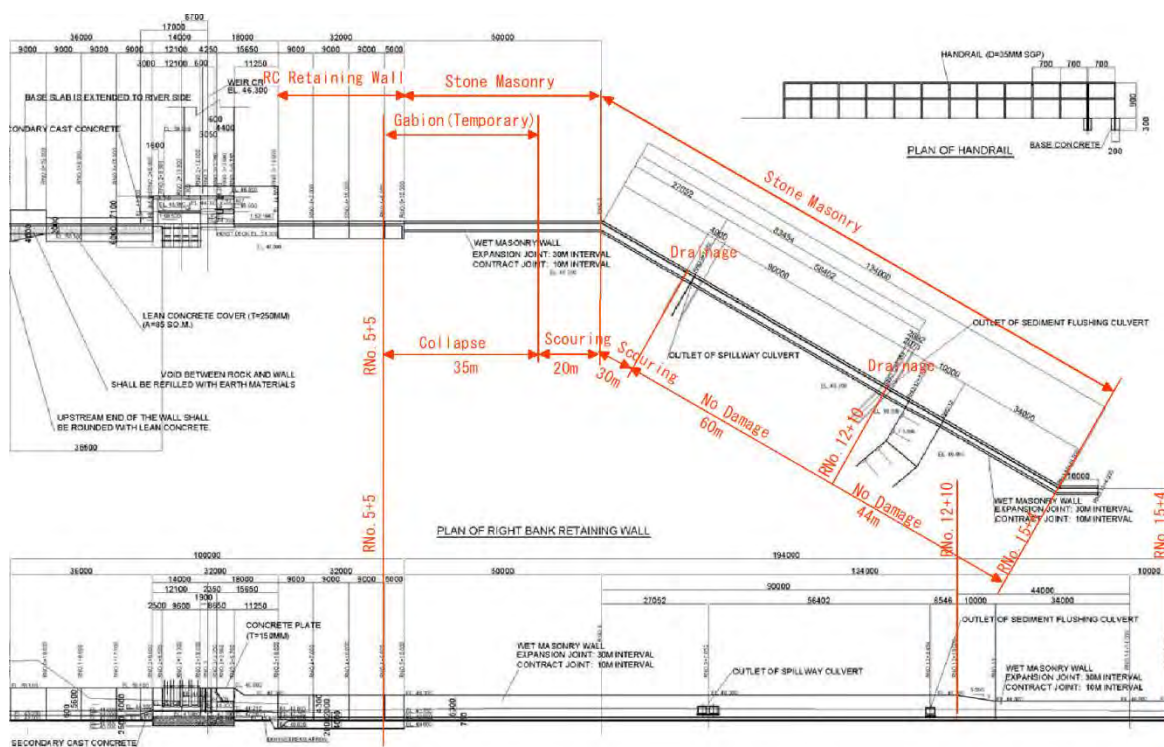
Figure 3.4-3 Damage of the stone masonry wall at the downstream of Buluto headworks

The 5 m RC retaining wall and about 30 m of the stone masonry on the downstream of the right bank of the headworks were collapsed due to the flood in April 2021. The 50m (20m+30m) b stone masonry downstream of the collapsed wall had not been collapsed, but its foundation has been scoured and needs to be restored.

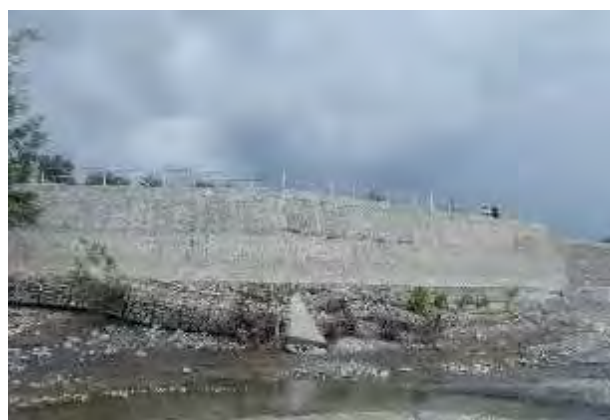
Figure 3.4-5 Temporary Gabion in the collapsed section

The stone masonry wall in the downstream of the headworks was damaged by the flood in April 2021. At present, the gabions have been installed in the damaged masonry's sections for emergency restoration, but it is necessary to utilize the Comprehensive Grant Aid for full-scale restoration.

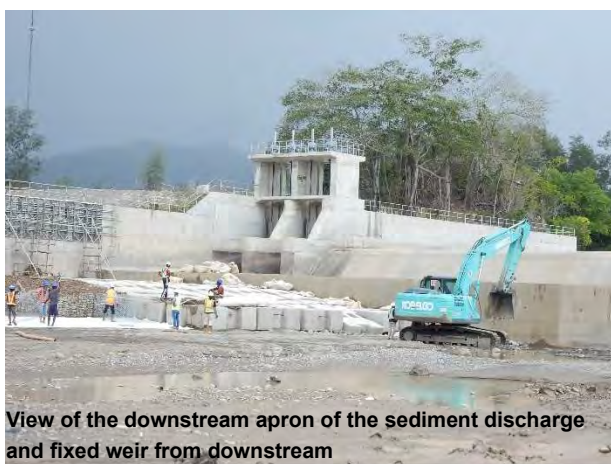
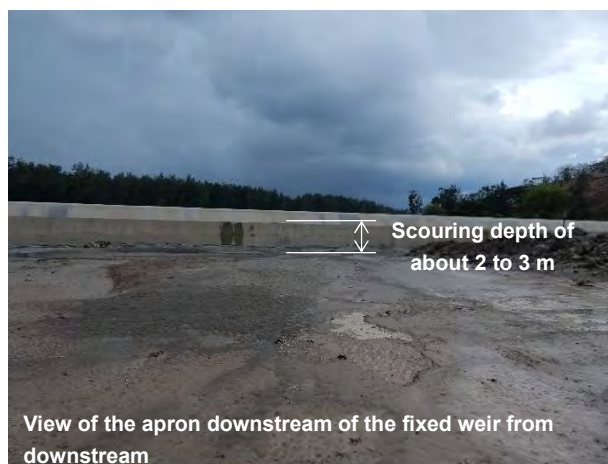
Figure 3.4-7 Scouring of the apron in the downstream of the Buluto headworks

The downstream part of the apron in the downstream of the headworks was scoured by about 2~3m due to flooding in April 2021.

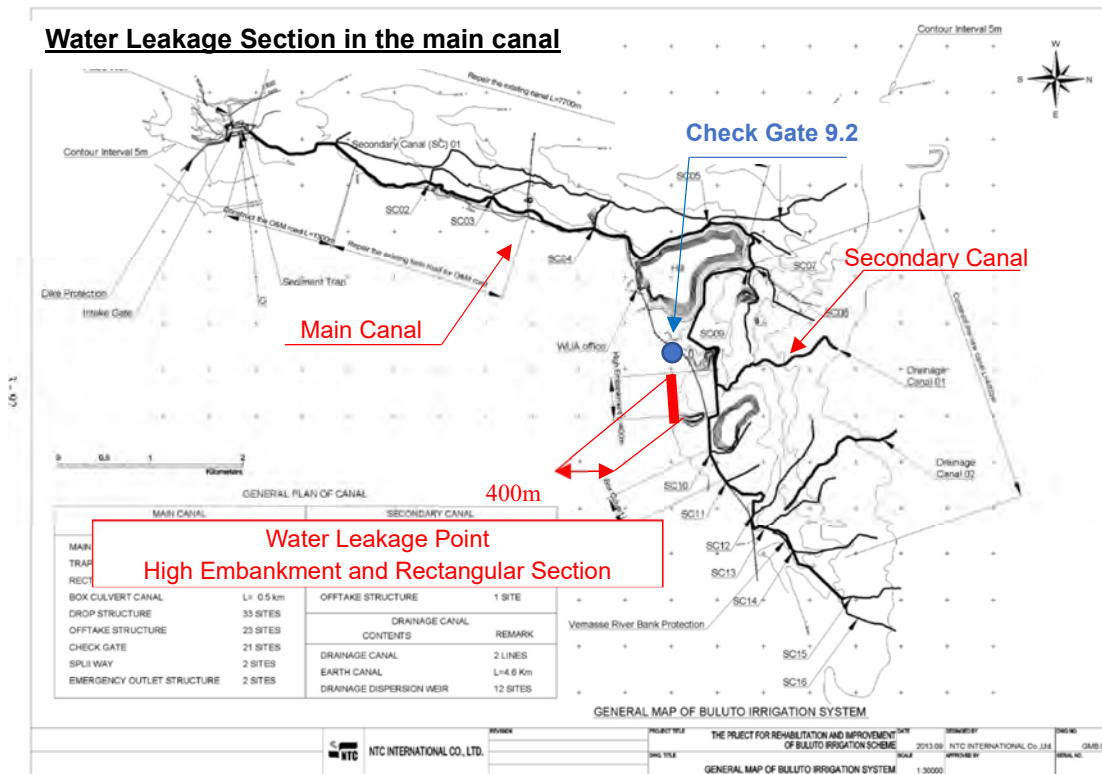
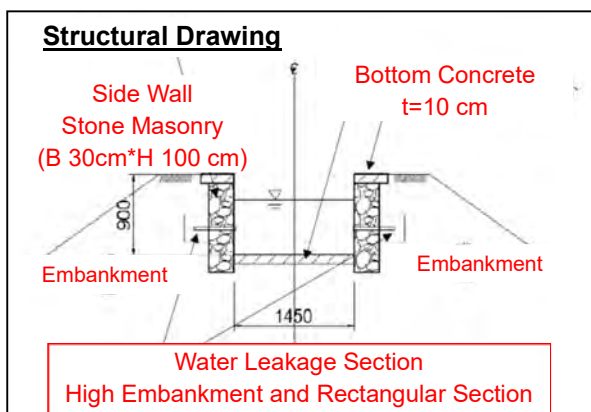
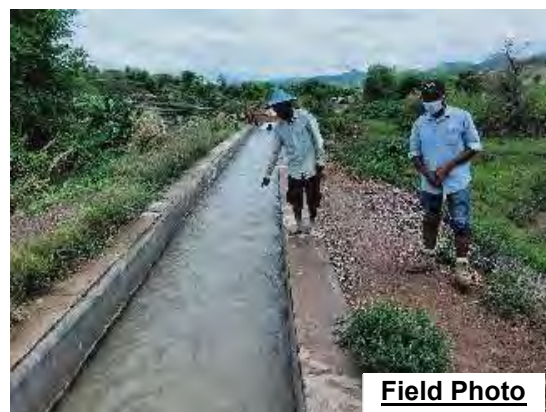
Fig3.4-8 Water leakage section in the main canal, structural drawing and field photo

Leakage in the main canal is occurring in the high embankment and rectangular canal cross-section

(approximately 400m) in the downstream of the check gate 9.2 point near Ware User Association meeting place.

As the water was flowing during the field survey, we were not able to confirm any cracks in the main canal. However, according to interviews with the Ministry of Agriculture and Livestock and the Water Users Association (WSA), water was leaking from the wall and concrete bottom slab in the high embankment and rectangular canal section (approximately 400 m), and then water was accumulating on the site under the embankment.

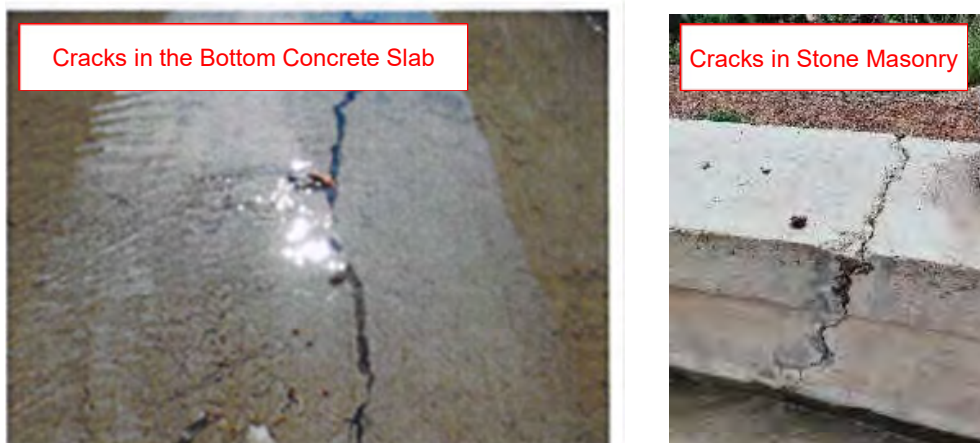
Fig. 3.4-9 Cracks in the cross section of the rectangular canal

As for the concrete leakage situation, cracks have been observed in the concrete bottom slab at various locations in the rectangular channel cross-section, ranging from 5m to 40m per site. At present, WSA is partially repairing the cracks, but the leakage has not stopped.

Since tensile stress occurred in the unreinforced bottom slab concrete, the entire 400m of the bottom slab concrete shall be repaired with reinforced concrete to cope with similar cases in the future. In addition, localized repair of joints and stone masonry in the direction perpendicular to the flowing water shall also be carried out. Temporary canal shall be installed in the main canal.

Since the bottom slab concrete is to be replaced with reinforced concrete, there is no risk of cracks in the bottom slab even if similar scouring occurs in the future, the repair plan (1) Bottom slab concrete replacement (unreinforced concrete to reinforced concrete) shall be adopted.

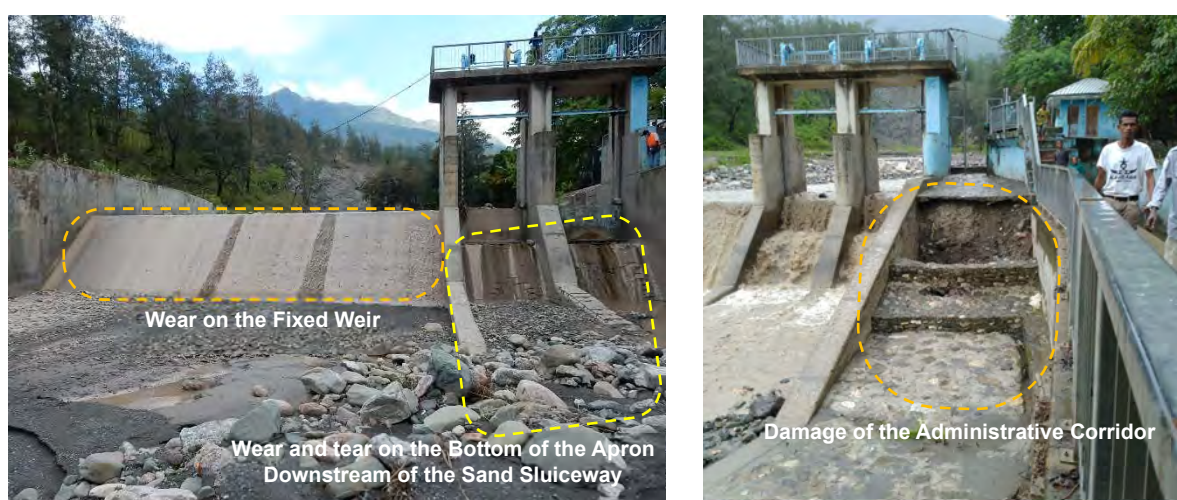
Fig. 3.4-10 Damage on the fixed weir, downstream apron of the sand sluiceway, and administrative corridor in Mariana headworks

The fixed weir and the bottom of the apron downstream of the sand sluiceway in Maliana headworks were worn out and damaged due to repeated flood damage, and the administrative corridor has also been damaged due to damage to the bottom of the apron.

For sustainable operation of the headworks, it is necessary to rehabilitate the headworks fixed weirs, sand sluiceway and administrative corridor that have suffered from the repeated flood damages. Basically, the rehabilitation shall be made to the original design condition.

The unreinforced concrete (high strength concrete $\sigma=35\text{N/mm}^2$) of the fixed weir shall be demolished and replaced with new unreinforced concrete (same high strength). The new concrete shall be fixed with anchor bars (D22*1.0m) at intervals of 0.5m. The scope of rehabilitation of the fixed weir is shown below.

Demolish the unreinforced and reinforced concrete (high strength concrete $\sigma=35\text{N/mm}^2$) downstream of the sand sluiceway and replace it with new unreinforced and reinforced concrete (same high strength).

Backfill the scoured administrative corridor and repair with unreinforced concrete.

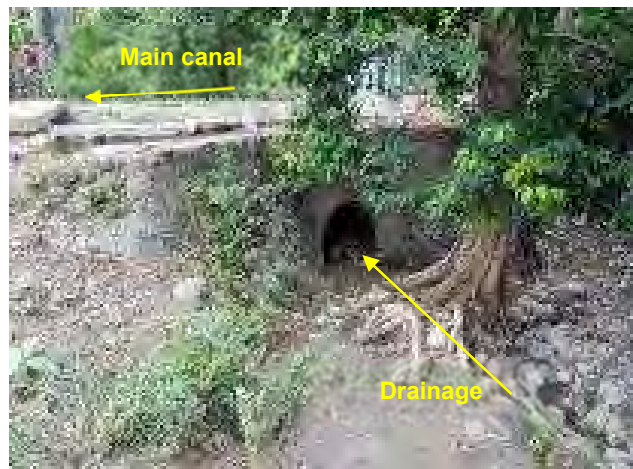
Figure 3.4-11 Narrowing point of the main canal and drainage channel

In the narrowed point of the drainage that intersects the main canal (STA.0+435), the drainage capacity is exceeded during floods and overflows into the main canal. As the result of overflows, the cross-section of the main canal is scoured.

Two (2) centrifugal reinforced concrete pipes (φ800) shall be arranged in the narrow point of the drainage canal intersecting the main canal (STA.0+435). The reason for using two (2) pipes is to allow drainage without delay when an unexpected flood amount of water flows down.

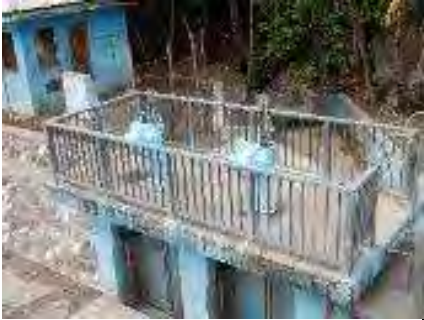
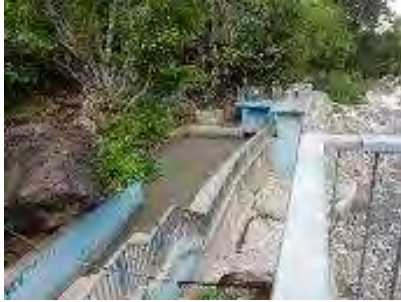
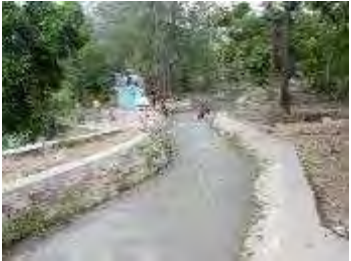
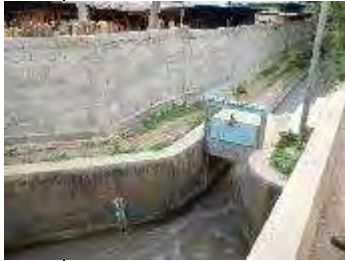
photo	Current status and details of modifications
Hoisting machine update	<p>Sand sluiceway gate 2unit, Intake gate2 unit</p>

<p>Main canal gate1 unit, Sand drainage gate1 unit</p>

<p>To replace malfunctioning hoists due to aging and lack of maintenance.</p>
	<p>Main drainage gate2, Branch line diversion gate</p>

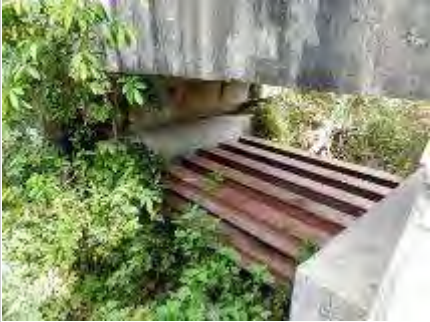
<p>The pier of the aqueduct bridge on the main canal has been leaning. The situation of the inclination was confirmed in 2010. Since then, in 2014 the countermeasures have been taken as shown in the photo.</p> <p>Since the cause of the inclination is considered to be due to the lack of bearing capacity of the foundation, it is considered difficult to eliminate the inclination by partial repair, and renewal of the aqueduct is necessary.</p> <p>In the future, it will be necessary to install inclinometers and other equipment to monitor the situation as well.</p>
Rehabilitation of Ramas Kola secondary canal

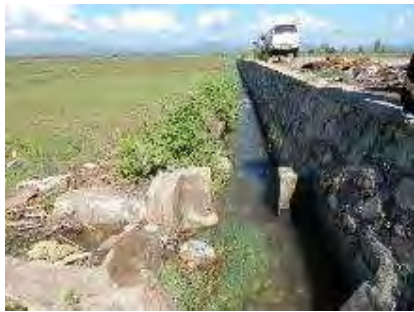
<p>The 300m end of the Ramas Khora secondary canal is an earthen canal.</p> <p>It should be rehabilitated to the masonry canal by the provincial Ministry of Agriculture and Fisheries, which operates and maintains the canal.</p>

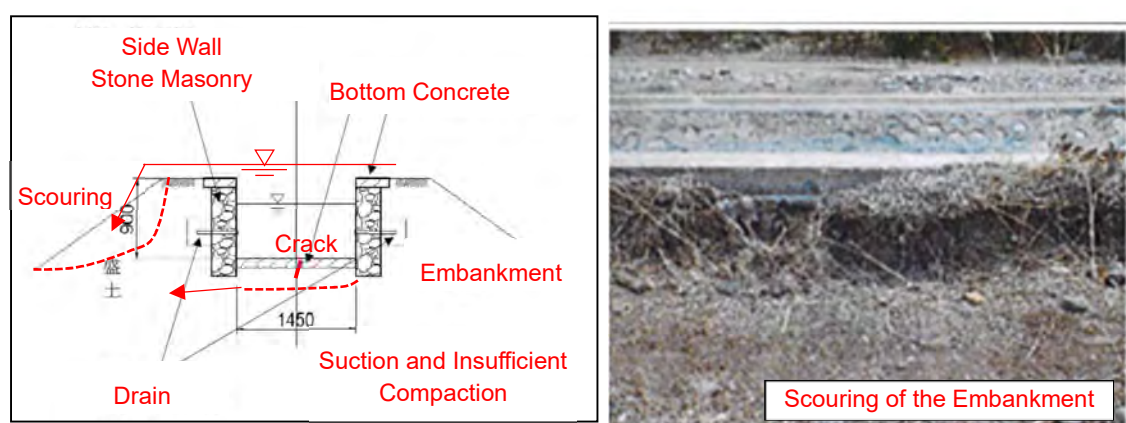
Figure 3.4-12 Causes of cracks in embankment section

- ✓ During the flood, more water than the specified flow rate flowed into the main canal, causing water to overflow from the canal and scour the embankment slope and bottom. Soil was sucked out of the concrete base of the bottom concrete slab of the rectangular channel. As a result, tensile stress was generated in the unreinforced concrete of the bottom slab, and cracks occurred.

- ✓ Due to the illegal operation of the gate by a member of the association, more water than the specified flow rate flowed down into the main canal, causing water to overflow from the canal and scour the embankment slope and bottom, which sucked out the soil from the concrete base of the rectangular canal bottom concrete slab. As a result, tensile stress was generated in the unreinforced concrete of the bottom slab and cracks occurred.

- ✓ Due to insufficient compaction of the concrete base of the bottom concrete slab during construction, tensile stress was generated in the unreinforced concrete, resulting in cracks.

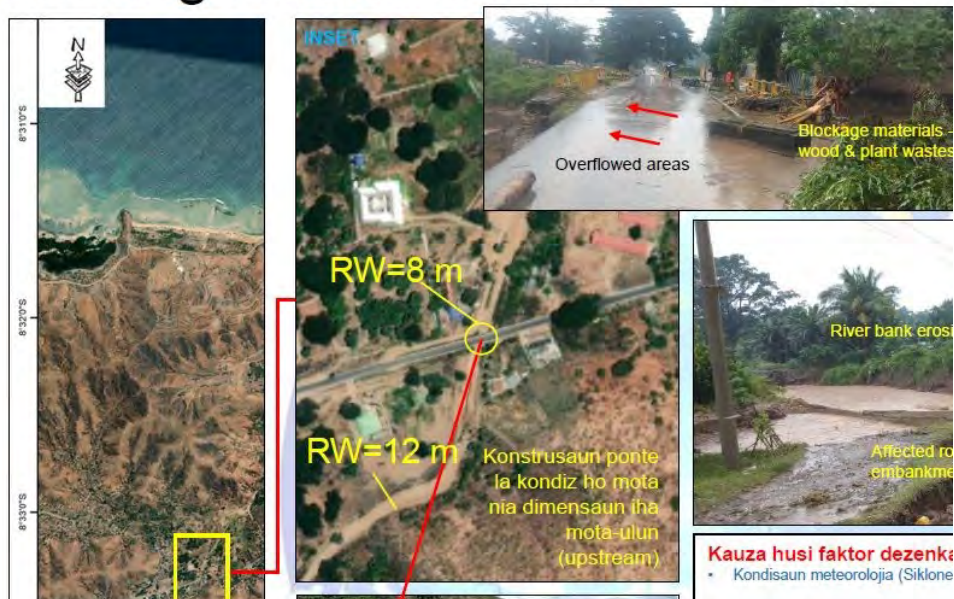
The intersection of the Akanunu River with the national highway (about 3.7km from the river mouth) is a narrowed part and driftwood clogged the box-culvert bridge during the ***This Flood***, and which caused flood damage.

Figure 3.5-24 Damage situation at the intersection of Akanunu River and the National road

The Akanunu River has a narrowed part at the intersection with the national highway in the middle course about 2.5 to 3 km from the mouth of the river and has a shape in which driftwood easily accumulates. To prevent driftwood damage at this location, measures to prevent driftwood from occurring in the upstream area (control measures: forest / soil management etc.) and measures to prevent damage to the downstream even if driftwood occurs (deterrence measures: installation of check dams etc.) are necessary. Both require medium to long-term studies. First of all, it is necessary to identify the area where measures are required.

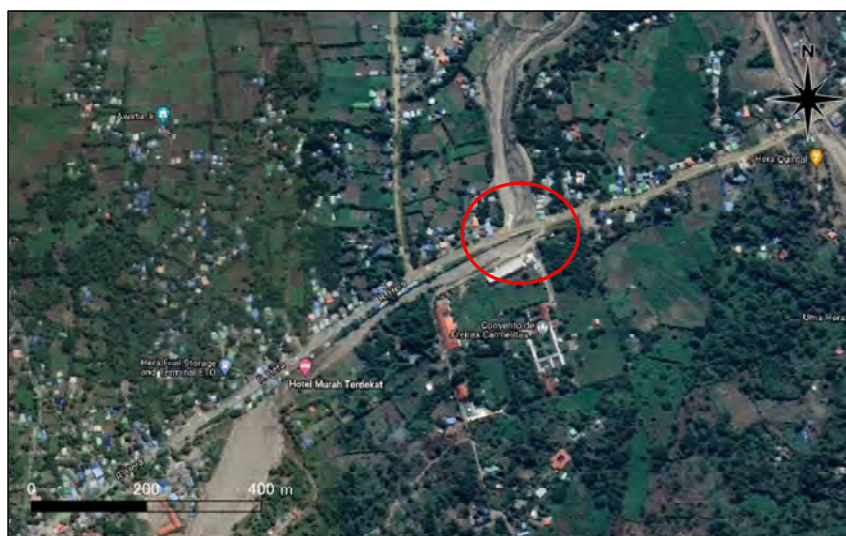
At the intersection of the Mota-Kiik and national road, the width of river is about 40 m and the water depth can be secured up to about 6m, so flood damage seems is unlikely to occur.

Figure 3.5-25 Intersection of Mota-Kiik and the National road

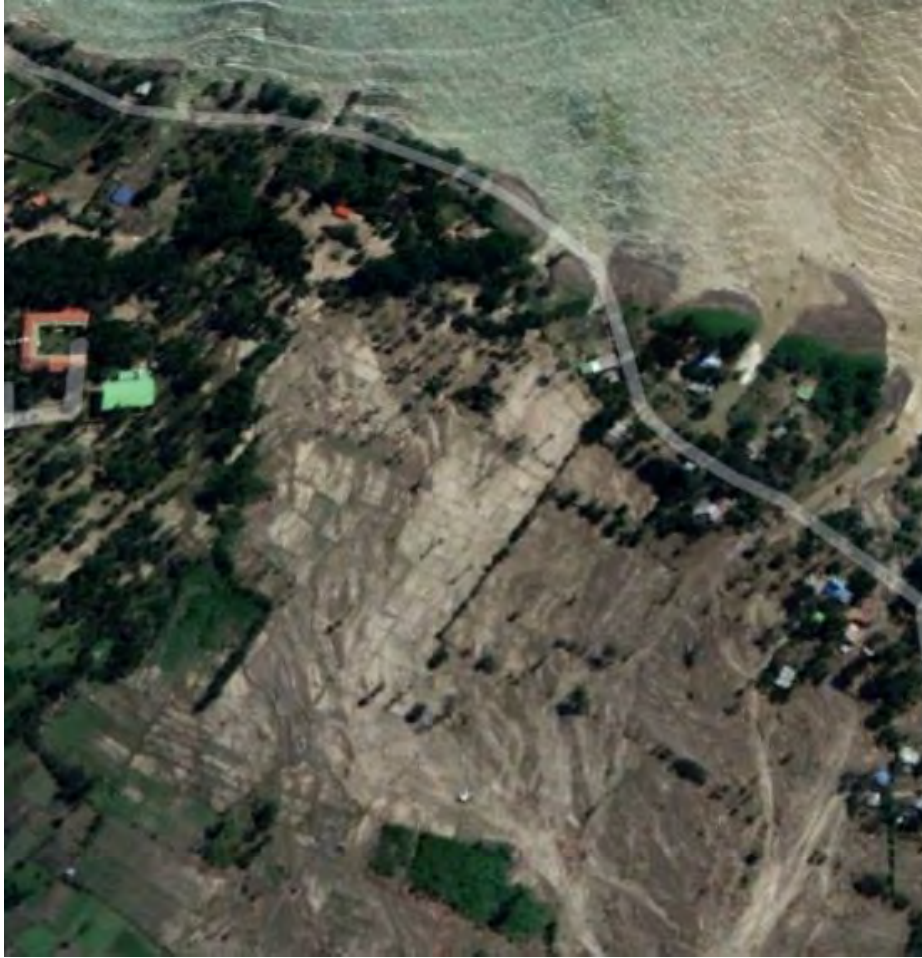
On the other hand, at the river mouth, the river join the stream from the east side. The embankment is filled and the crossing width is about 30m, which is narrower than the road intersection area as shown in Figure 3.5-26.

The mouth or the Mota-kiik is farmland and low-lying area, was damaged by flash floods and storm surges during *This Flood*. If the crossing width is narrower in the downstream than in the upstream, the water levels tends to rise during floods, and the risk of flooding becomes high.

Figure 3.5-26 Aerial photograph of the mouth of the Mota-kiik as of April 9th 2021

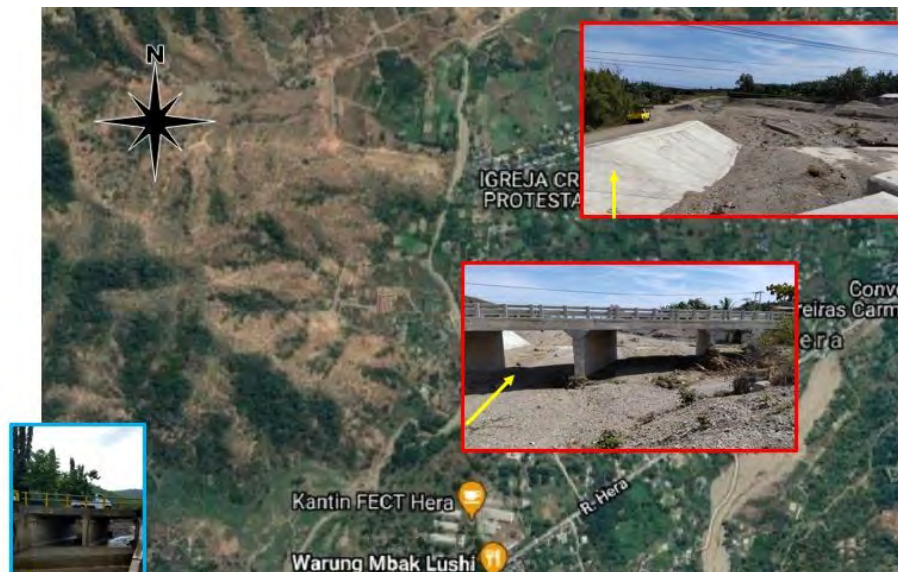
At the intersection of the Akanunu River and the national road, where driftwood caused flood damage during *This Flood* due to the obstruction of the river channel, flooding was confirmed from the flood analysis results, but the damage was local because it was originally a place where water was difficult to collect. On the other hand, there are multiple flooded areas in the neighboring areas. Assuming from “High Susceptibility Zone” for landslide risk around Akanunu and Mota-Kiik, there is a possibility that small-scale flooding and mudflow associated with flood flow occurred in several areas in the middle reaches of the Akanunu and Mota-Kiik.

Figure 3.5-28 Photos of the intersection of the national road, Akanunu and Mota-kiik

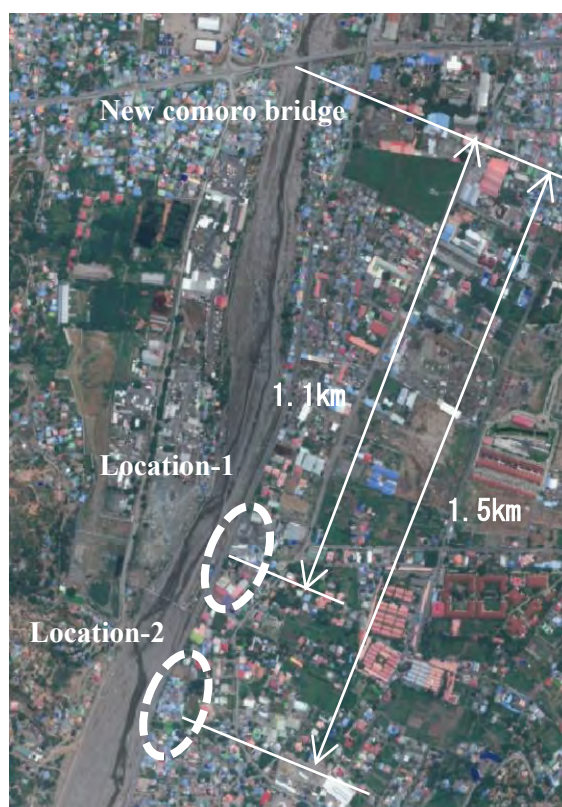
Figure 3.6-2 Fallen location of the Comoro revetment

Since the Comoro River revetment collapsed at the two locations shown in Figure 1, the estimated construction cost to restore the revetment was calculated as follows.

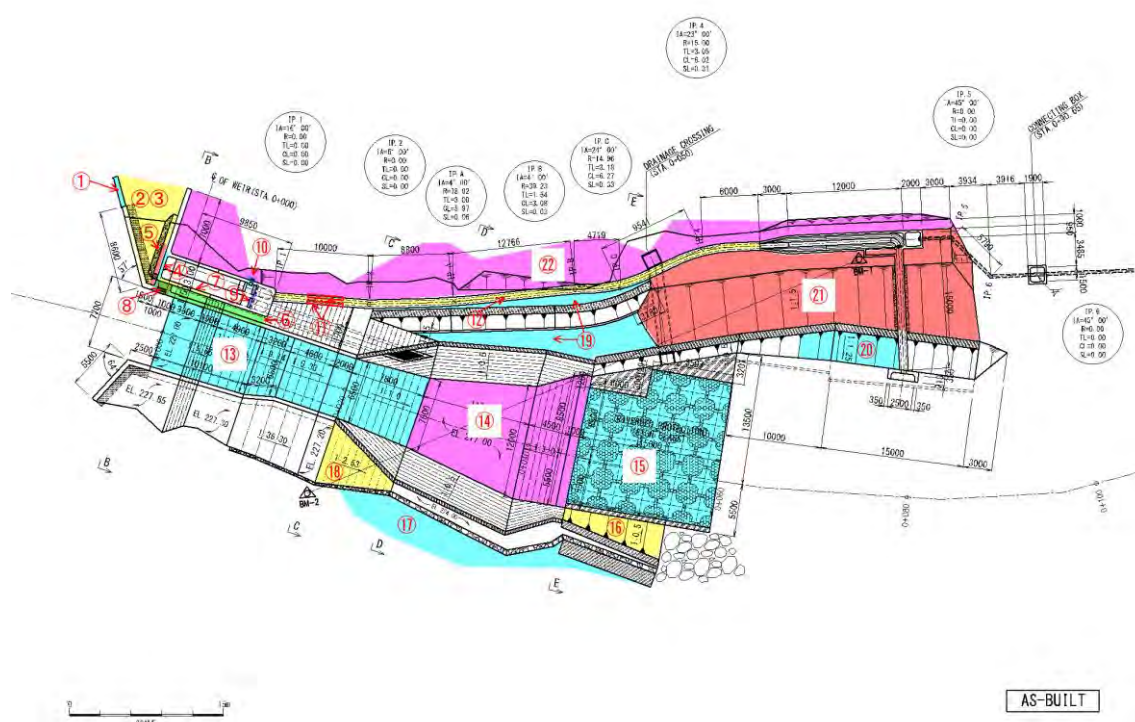
No	Structural classification	Target Facilities	Damage	Reconstruction Policy	Classification
①	Water intake	Wing walls	Megalithic deposition	Extension of wing wall	Reinforcement
②				Raising of RC at the top of wing wall	Reinforcement
③				Removal of rocks and other sediments	Restoration
④		Inlet side wall	All damage	Front wall reinstallation	Restoration
⑤				Front wall strengthen	Reinforcement
⑥				Reinforcement of gravity type retaining wall at side wall	Reinforcement
⑦				Repair of side wall above the opening (removal and restoration)	Restoration
⑧			Water intake	Damage	Reconstruction
⑨	Channel of approach	Sluice gate	Damage	Gate replacement (including guide)	Restoration
⑩		Waterway	Step breakage	Step replacement	Restoration
⑪			Damage to the top	Reconstruction upper 50cm of side wall	Restoration
⑫			Falling lid	Reinstallation of approach channel lid	Restoration
⑬	Fixed weir	Water flow section	Wear	Re-placing high-strength concrete	Restoration

⑭		Still water pond	Stone accumulation	Sediment removal	Restoration
⑮			Drifting away (from the floor)	Re-placing of floor protection works	Restoration
⑯	Right bank revetment	Protection of Stillwater Pond	Damage	Restoration by masonry blocks	Restoration
⑰			Slope protection	Concrete up to bedrock line	Reinforcement
⑱		Top concrete	Partially damaged	Re-placing high-strength concrete	Restoration

⑰	Left bank revetment	Bank protection top edge concrete	Damage	Demolition and high strength C restoration	restoration
⑱		Stone retaining wall at the bottom of the Stillwater Pond	Partially damaged	Restoration with RC leaning retaining wall	Reinforcement
⑳		Upper level of the stairs at the Pond	Damage	Restoration by masonry	Restoration
㉑			Slope protection	Concrete up to bedrock line	Reinforcement
㉒			Whole	Crack	Epoxy injection
㉓	Whole		Surface deterioration	Repair with high-strength mortar	Maintenance
㉔		Basin, channel, on top of concrete	Sedimentation	Removal of rock and sand	Restoration
㉕

Note: The coloring indicates the position of the repair shown in table 3.6-2 and dose not classify the repair method by color coding

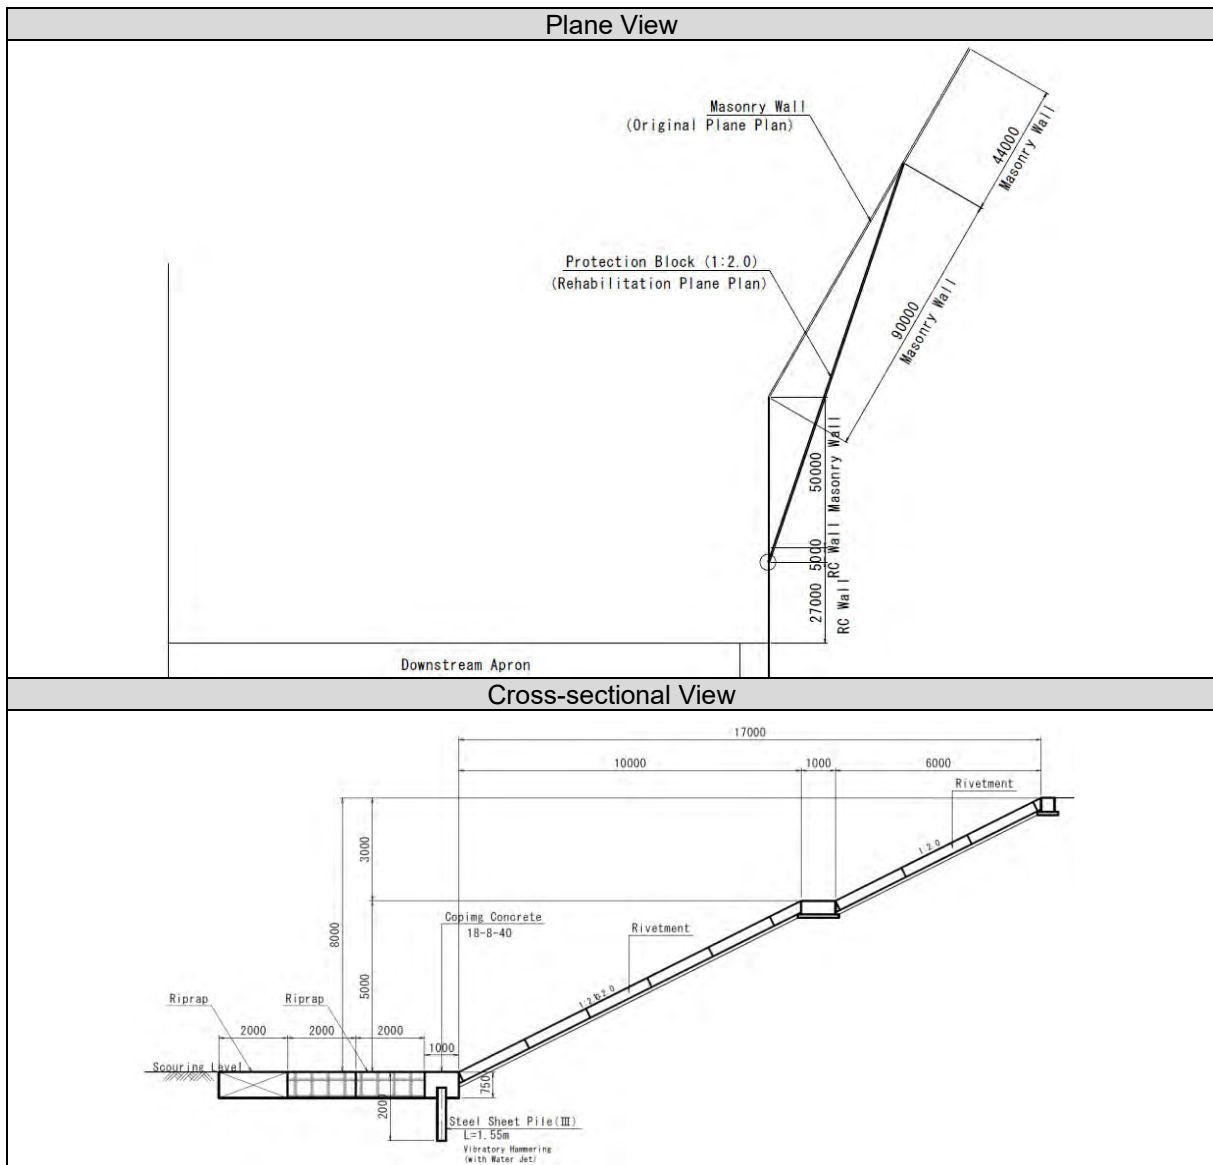
Figure 3.6-5 Rehabilitation plan of the retaining wall at the downstream of Buluto Headworks

1) The retaining wall at the downstream of Buluto Headworks

We propose the revetment blocks + Scour prevention measures as the rehabilitation plan of the retaining wall at the downstream of Buluto Headworks.

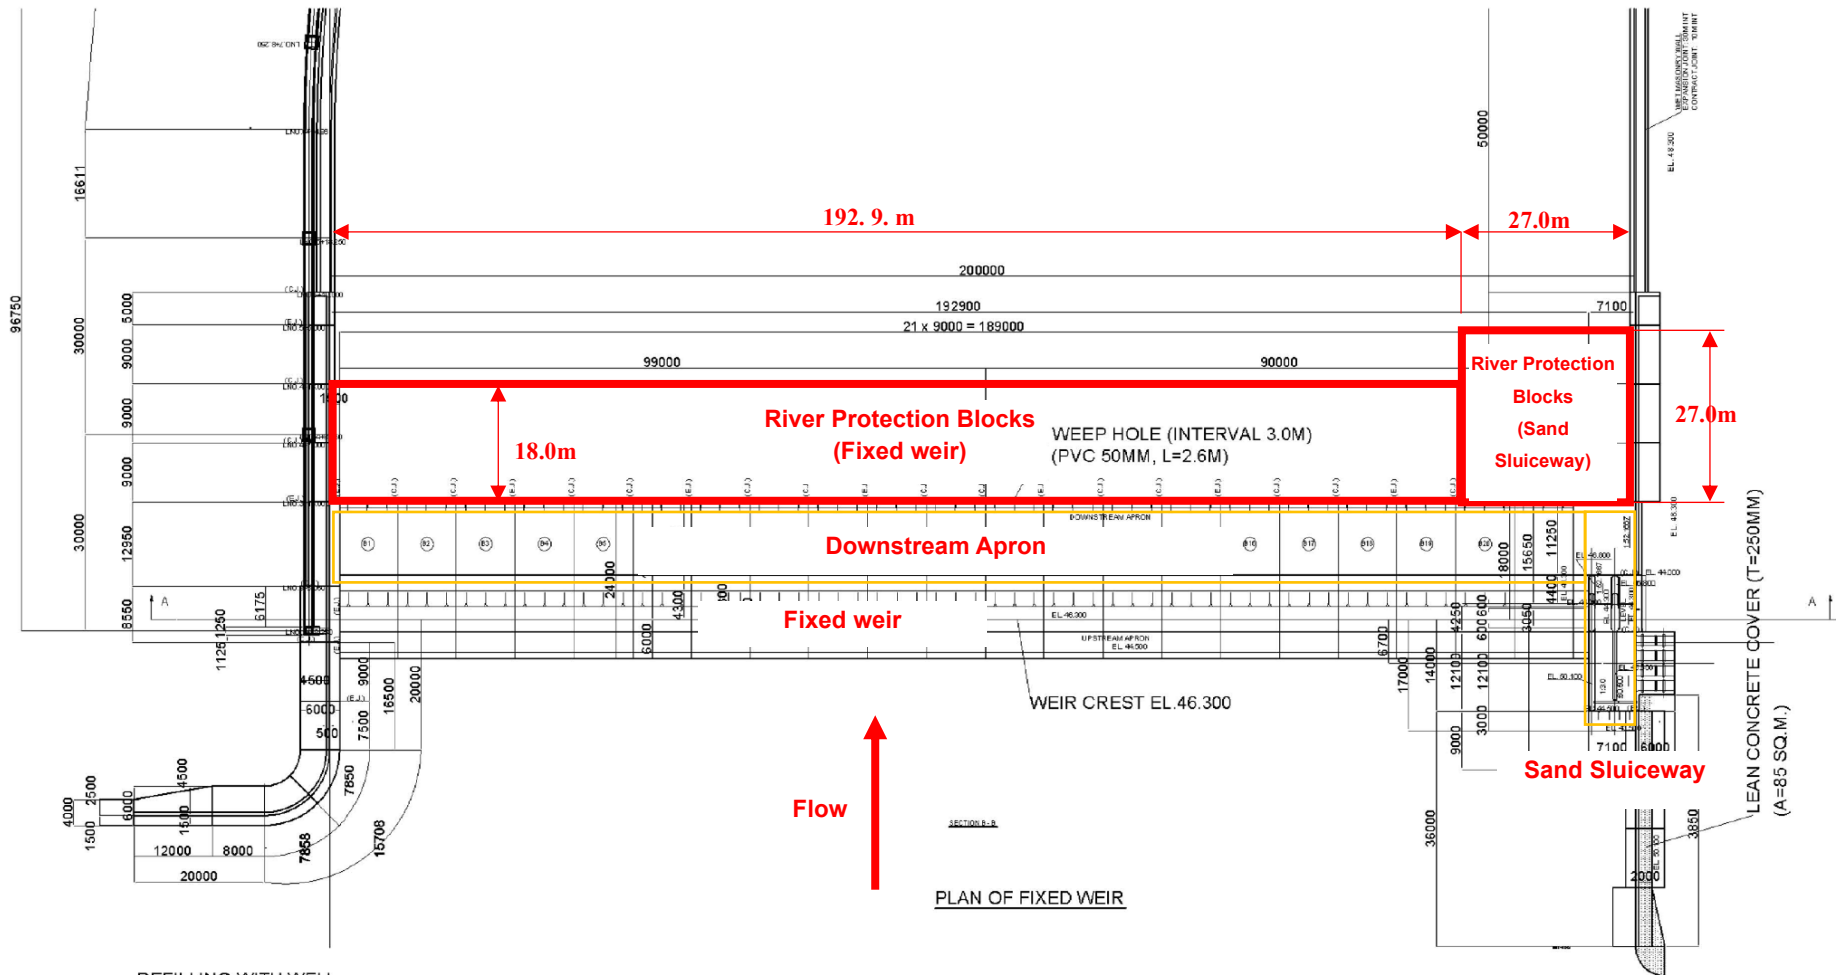
Figure 3.6-6 Rehabilitation plan of the river protection blocks for the Buluto headworks

2) River protection block at the apron downstream for the Buluto headworks

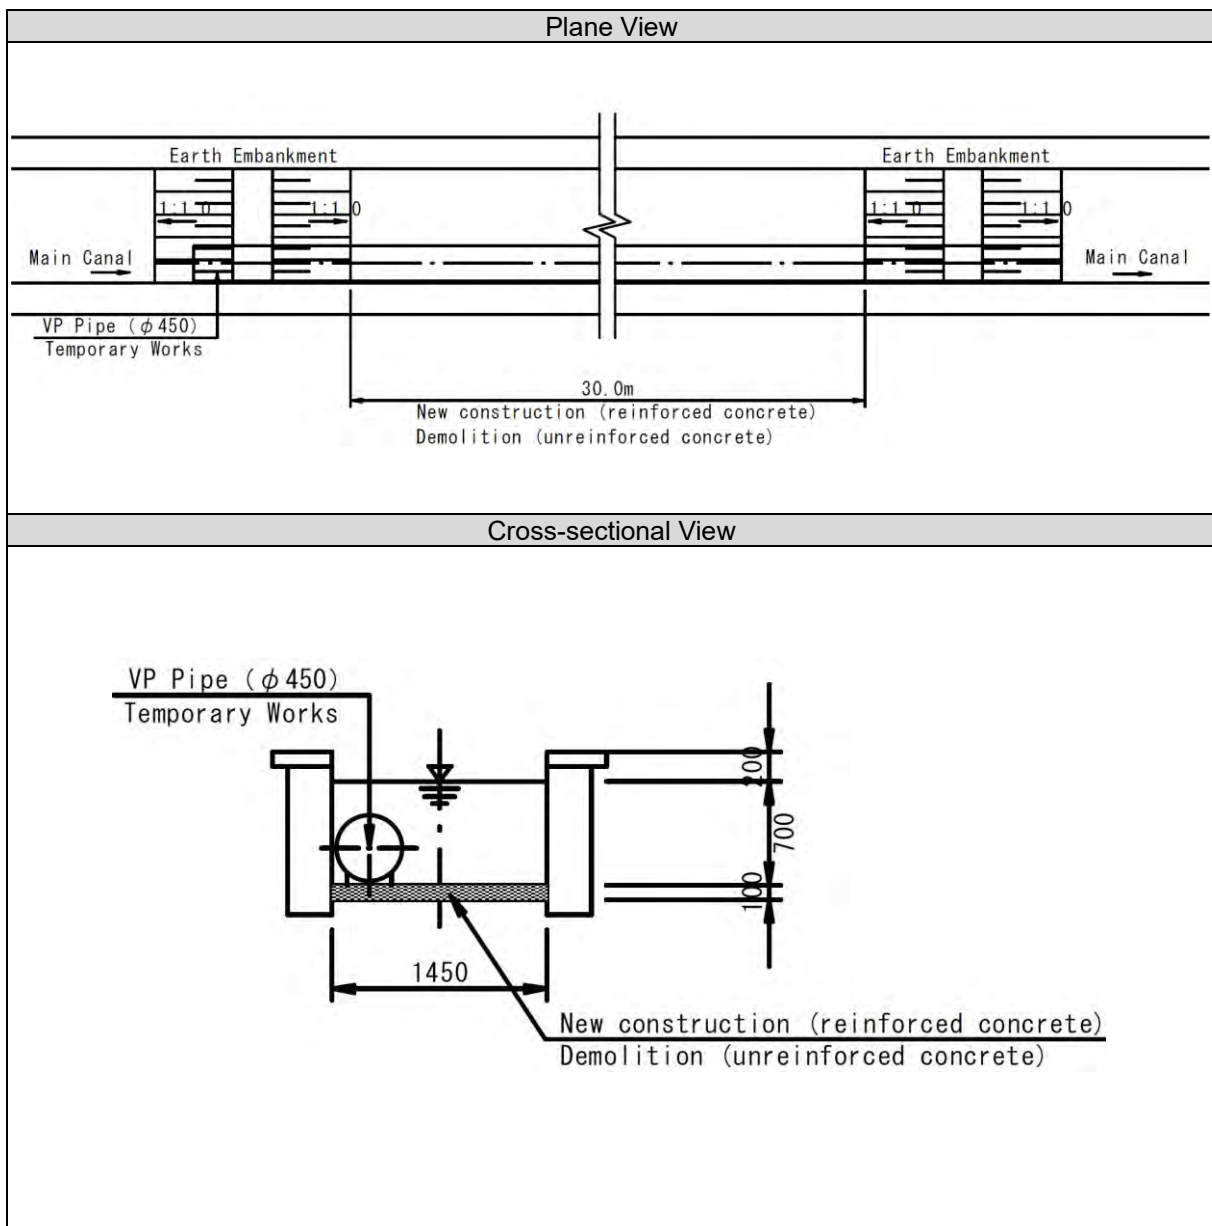
Figure 3.6-7 Rehabilitation plan of the bottom slab concrete of the main canal of the Buluto irrigation

3) Main channel (embankment section)

We propose Bottom slab concrete replacement (unreinforced concrete to reinforced concrete) as the rehabilitation plan of the bottom slab concrete of in the main canal of the Buluto irrigation.

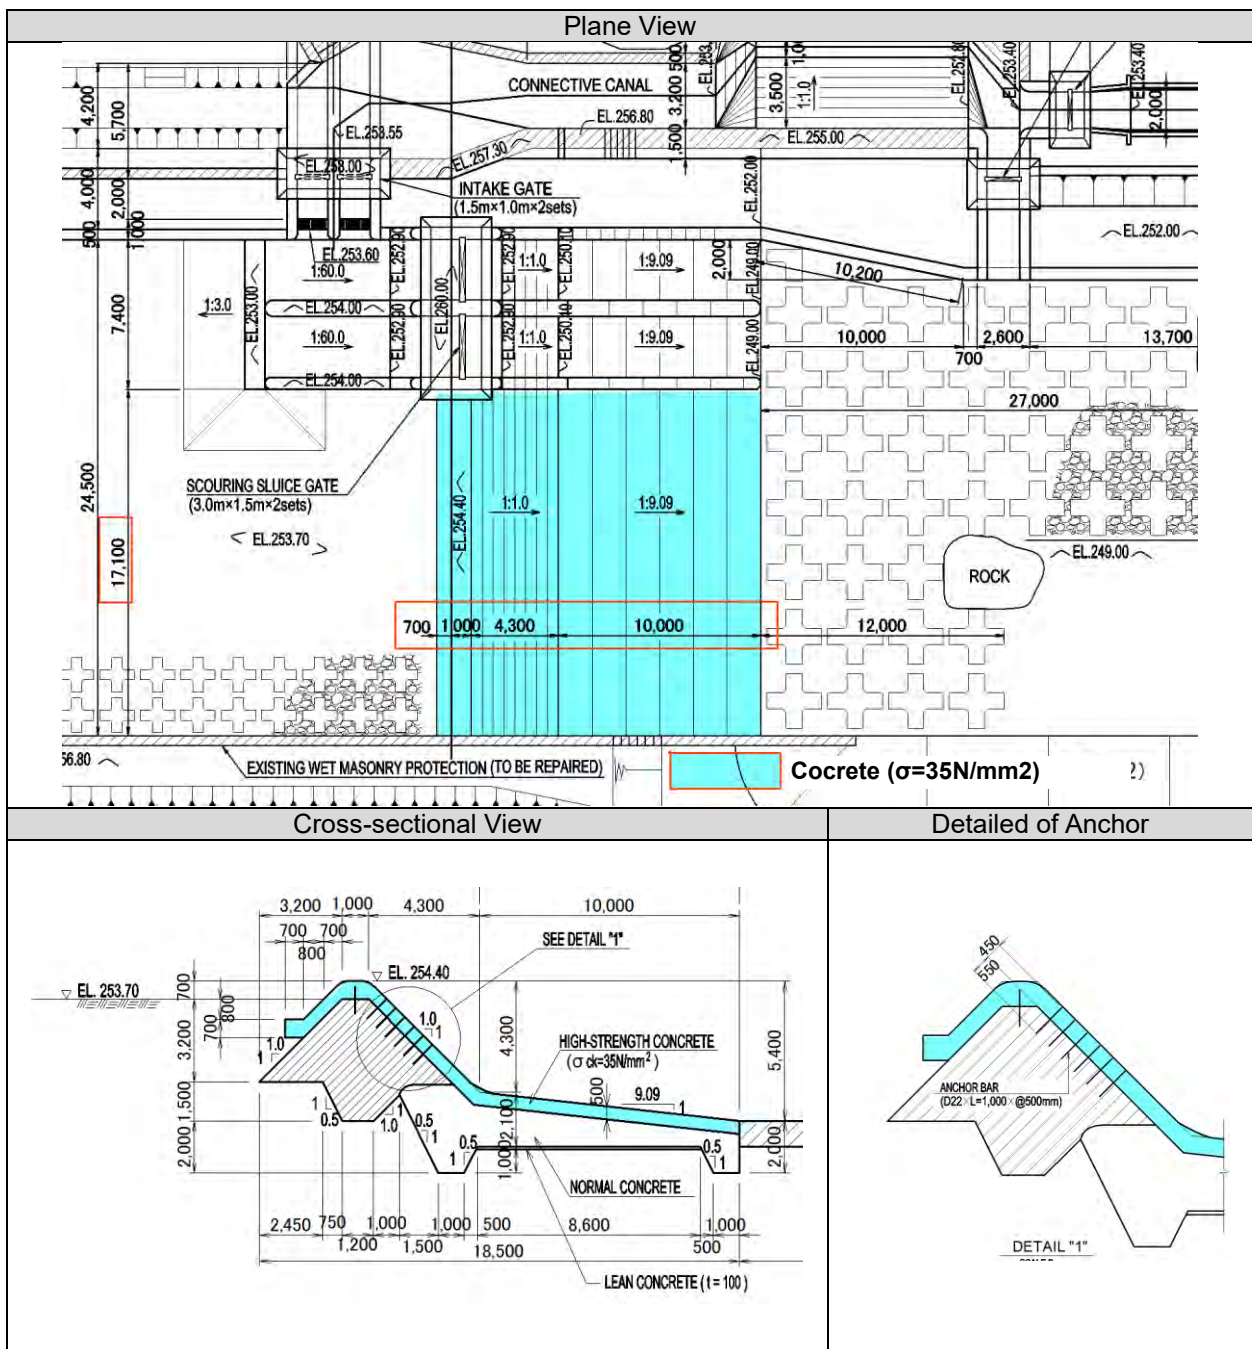
Figure 3.6-8 Rehabilitation plan of the fixed weir in Maliana Headworks

① Rehabilitation of fixed weirs

The unreinforced concrete (high strength concrete $\sigma=35\text{N/mm}^2$) of the fixed weir shall be demolished and replaced with new unreinforced concrete (same high strength).

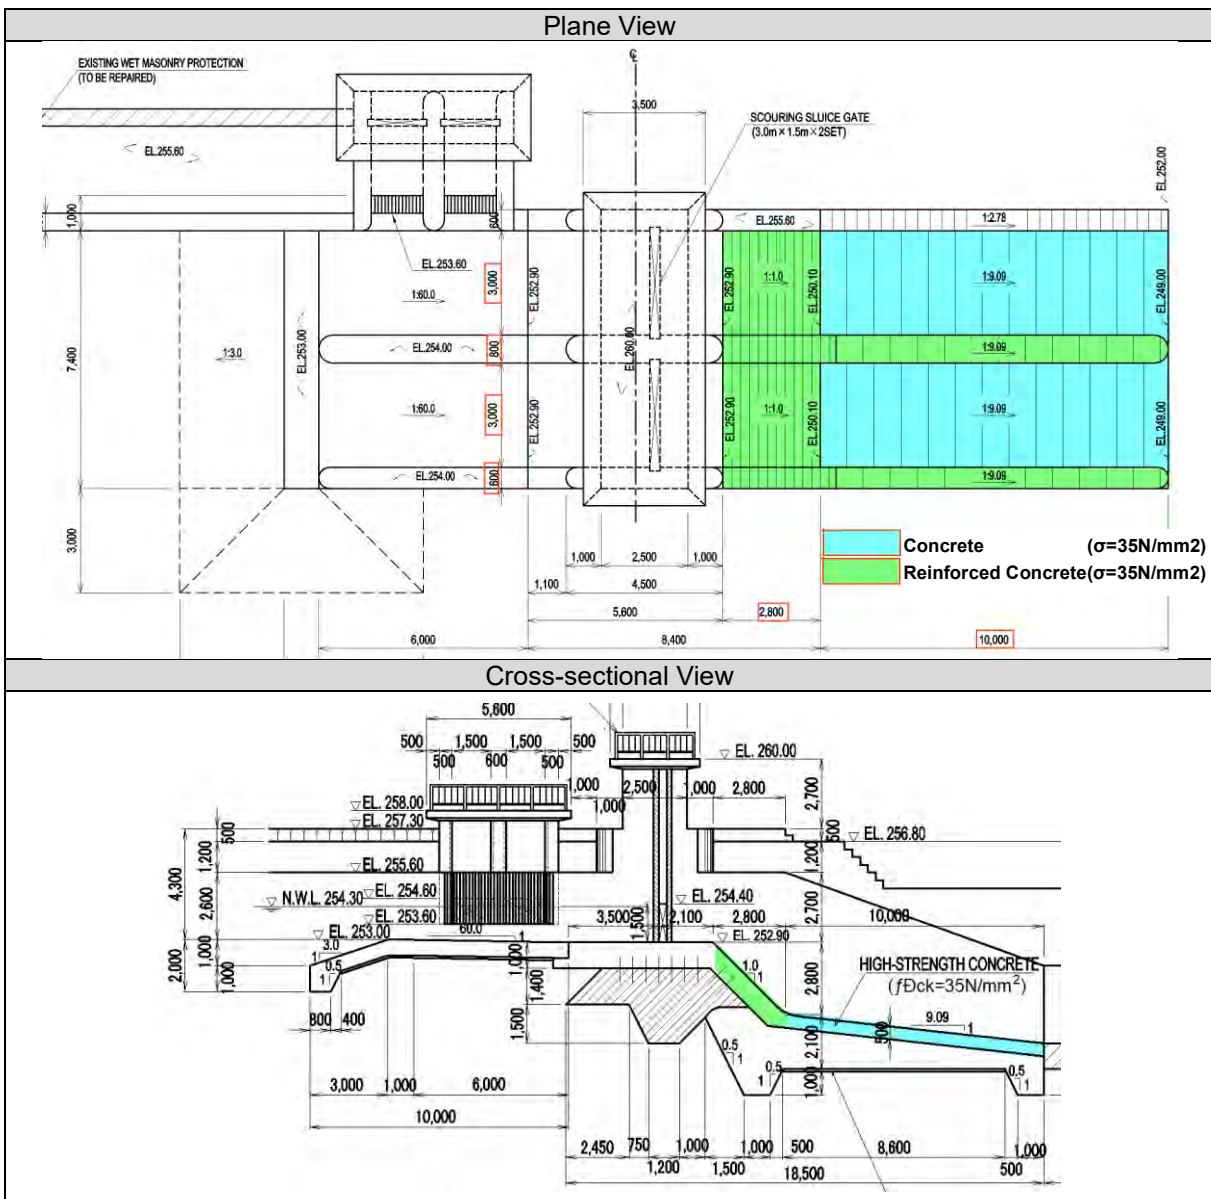
Fig. 3.6-9 Rehabilitation plan of the sand sluiceway in Maliana Headworks

② Rehabilitation of sand sluiceway

Demolish the unreinforced and reinforced concrete (high strength concrete $\sigma=35\text{N/mm}^2$) downstream of the sand sluiceway and replace it with new unreinforced and reinforced concrete (same high strength).
