**THE POST SITUATION AND DATA
COLLECTION SURVEY
FOR
THE FLOOD COUNTERMEASURES
IN DILI**

Final Report

December 2022

JAPAN INTERNATIONAL COOPERATION AGENCY (JICA)

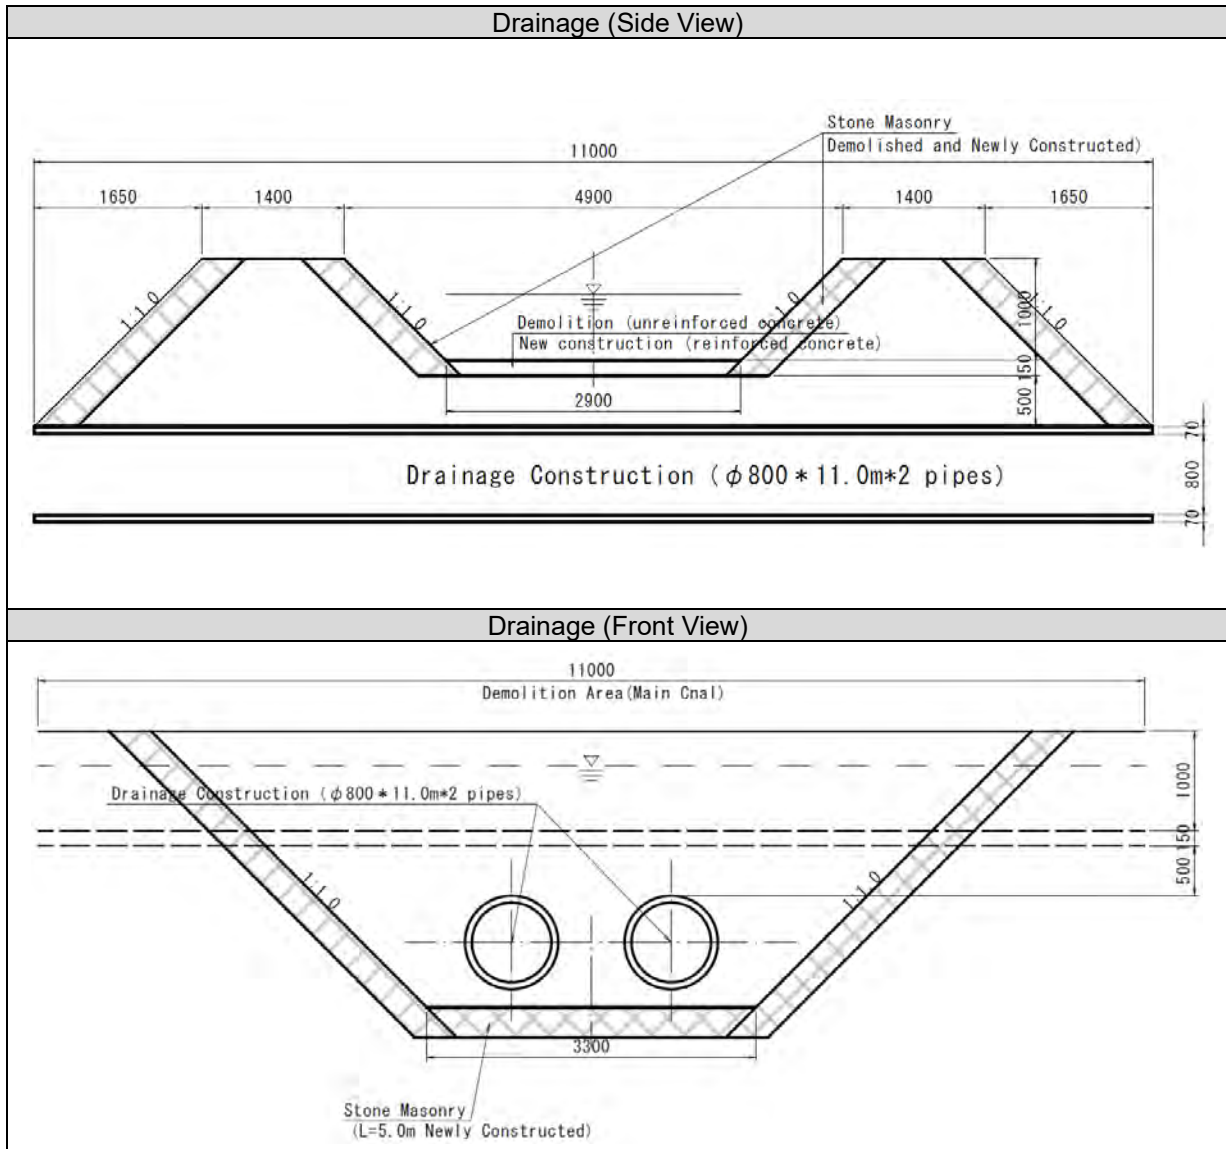
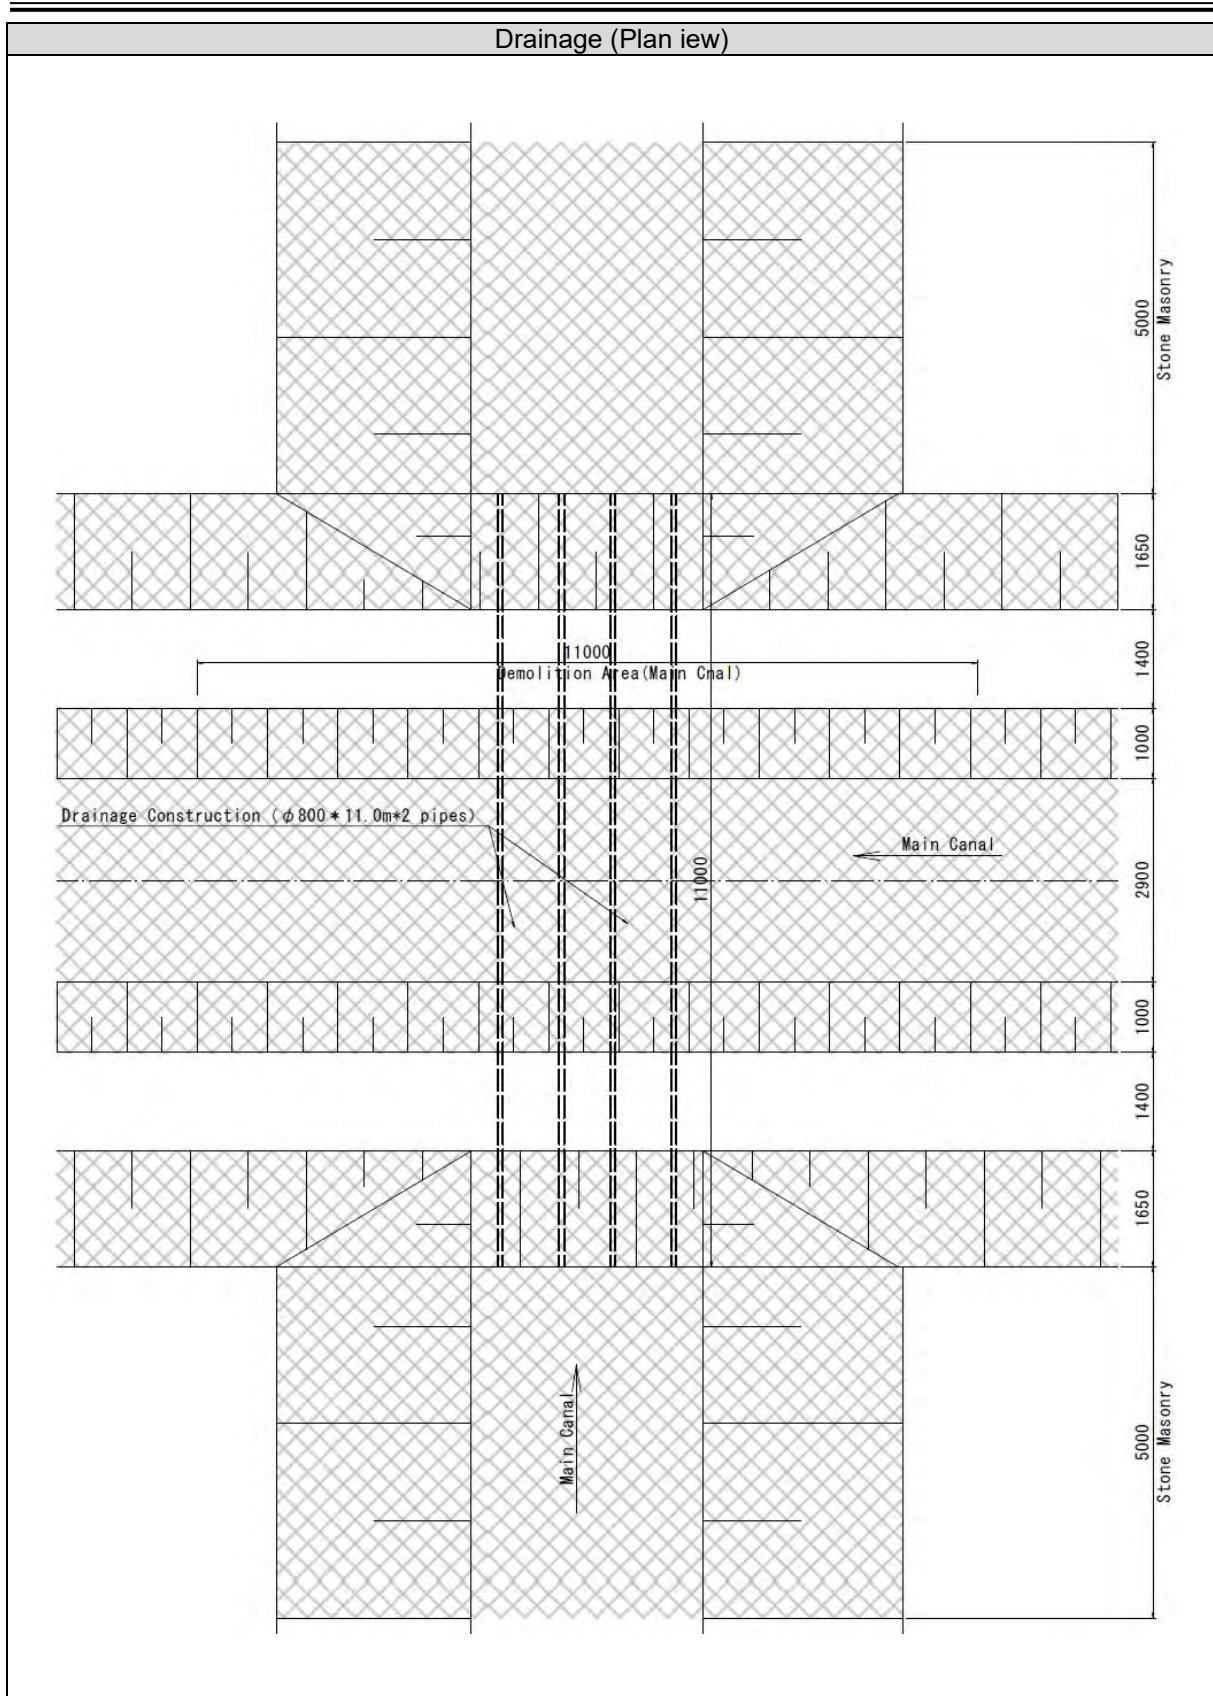
Figure 3.6-11 Rehabilitation plan of the drainage pipe (Side view, Front view)

2) Widening of narrowed drainage
